ECMC
Environmental
Field Inspection

MCU #43 Injection Line
04-Jun-25 10:16:46 AM
ECMC Environmental Inspection

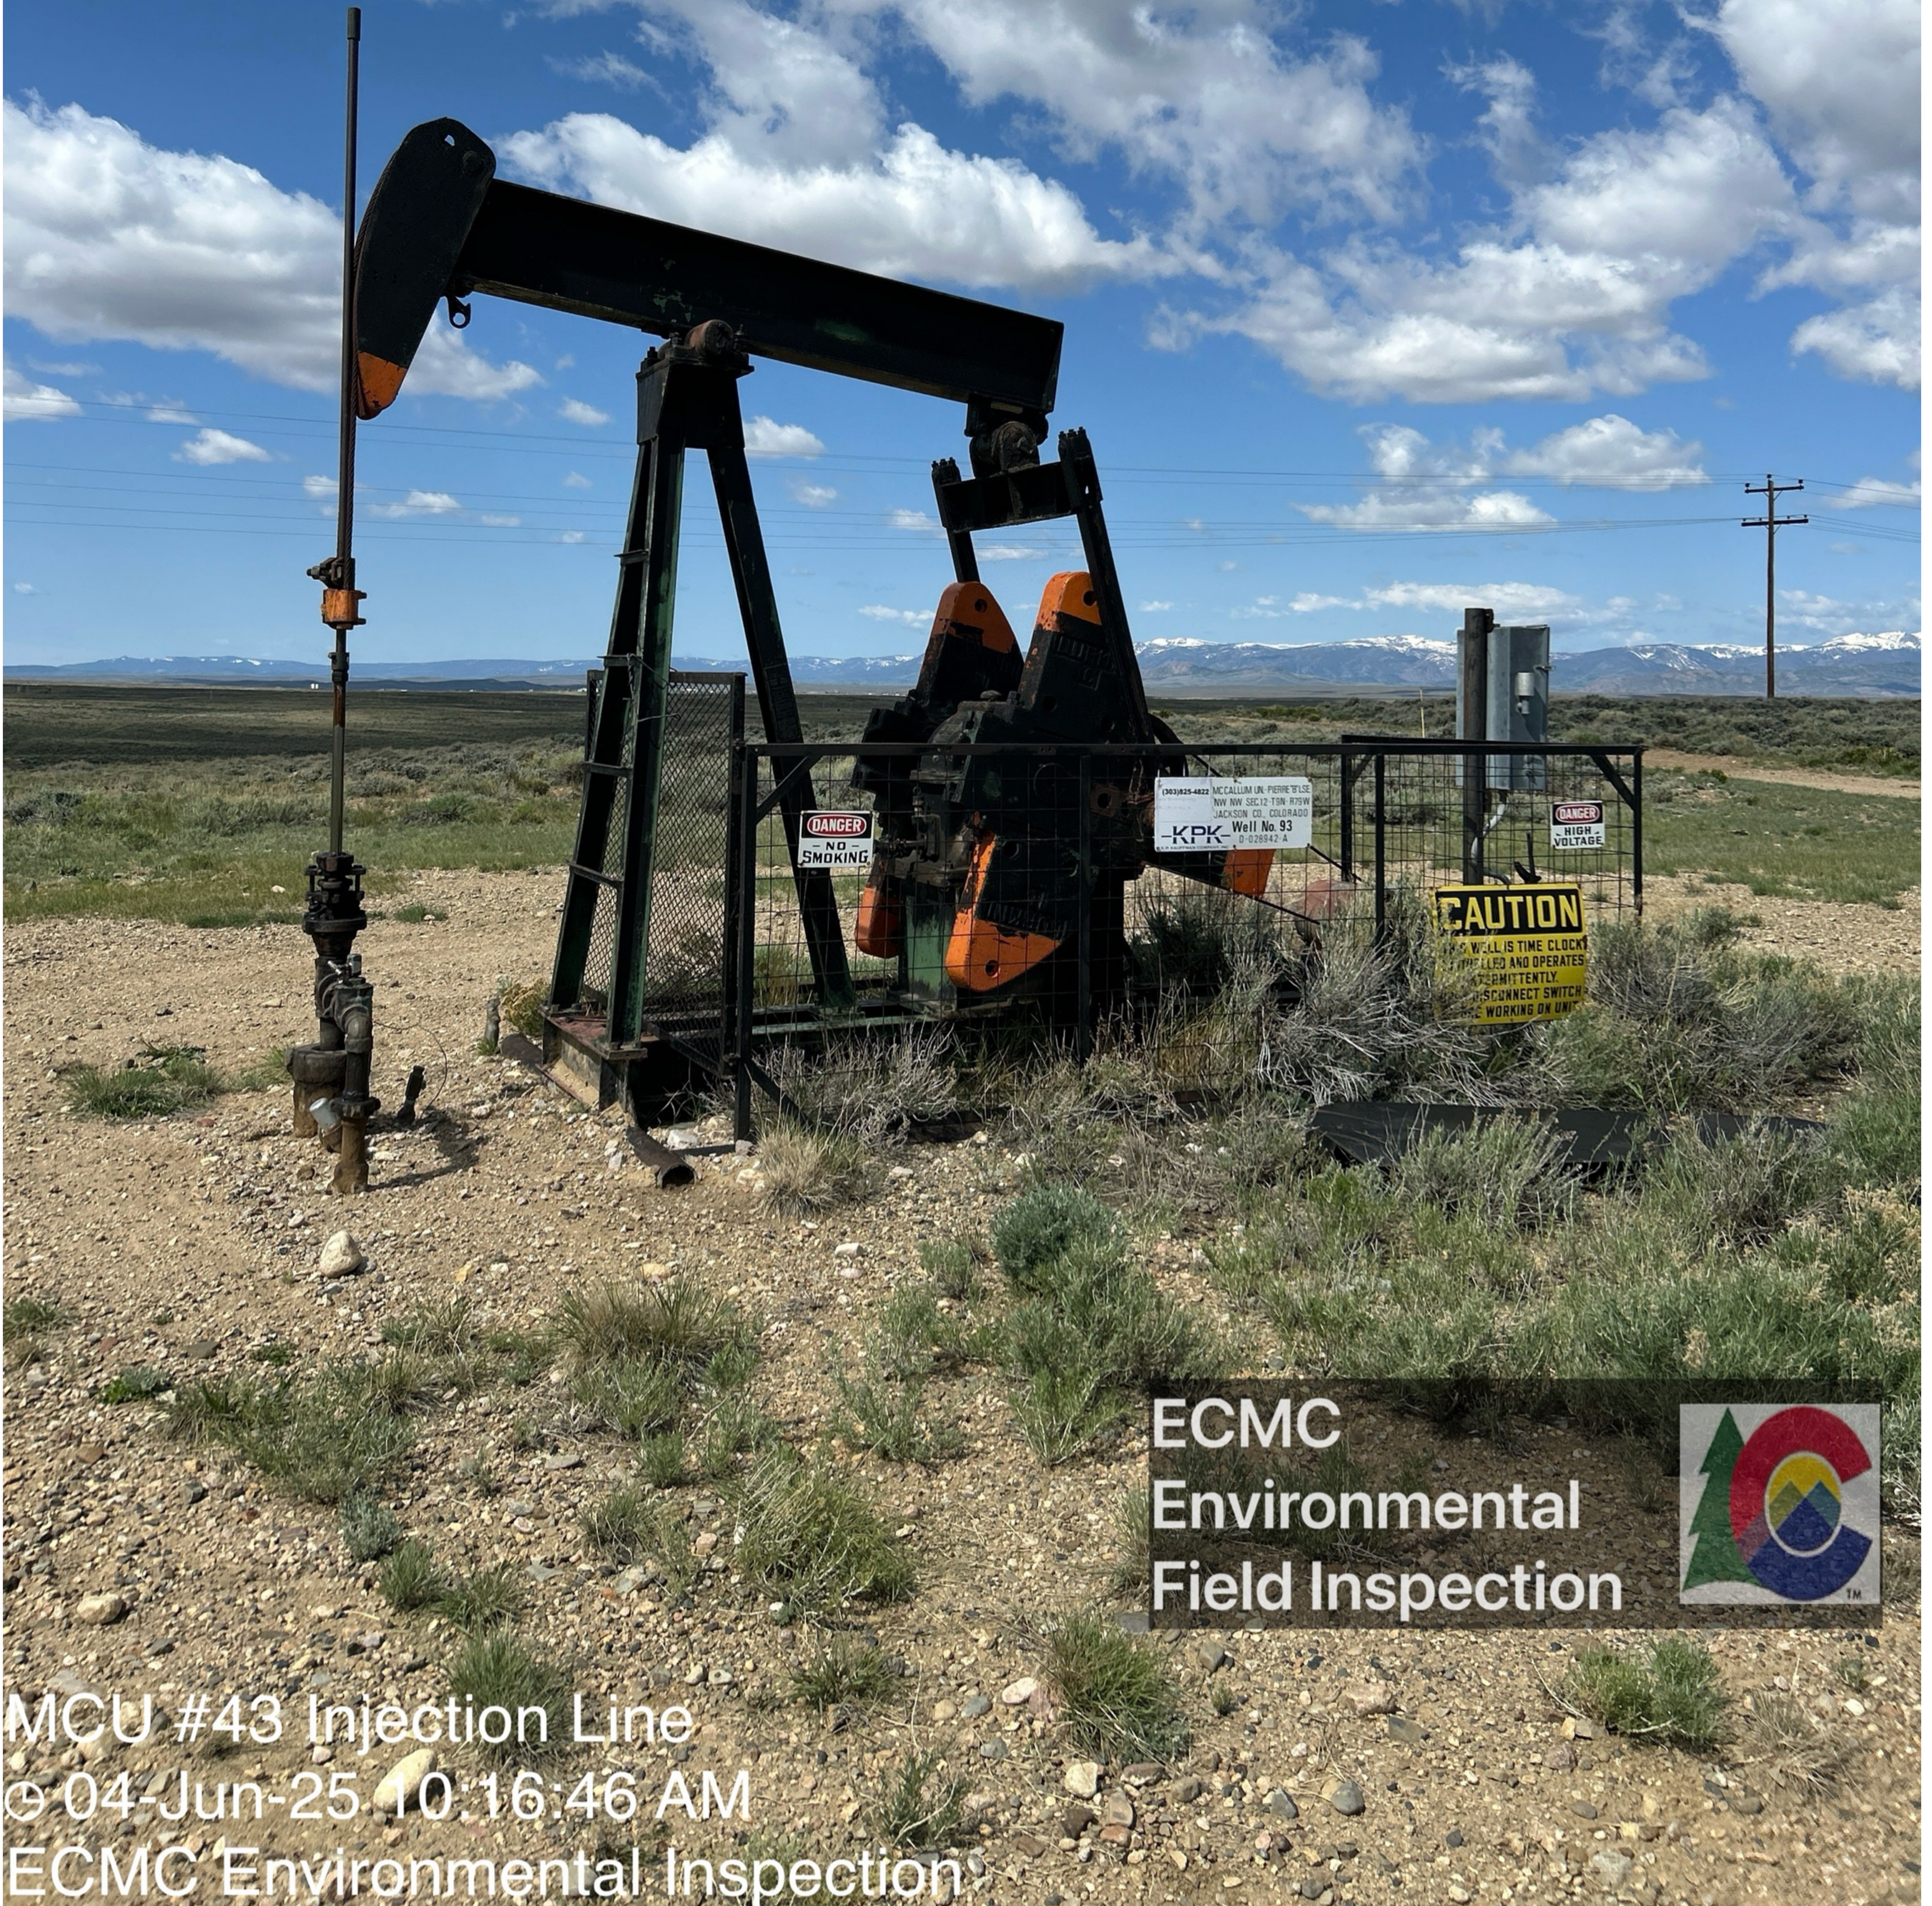
Looking at the McCallum Unit 93 well. Weeds are visible adjacent to the well.

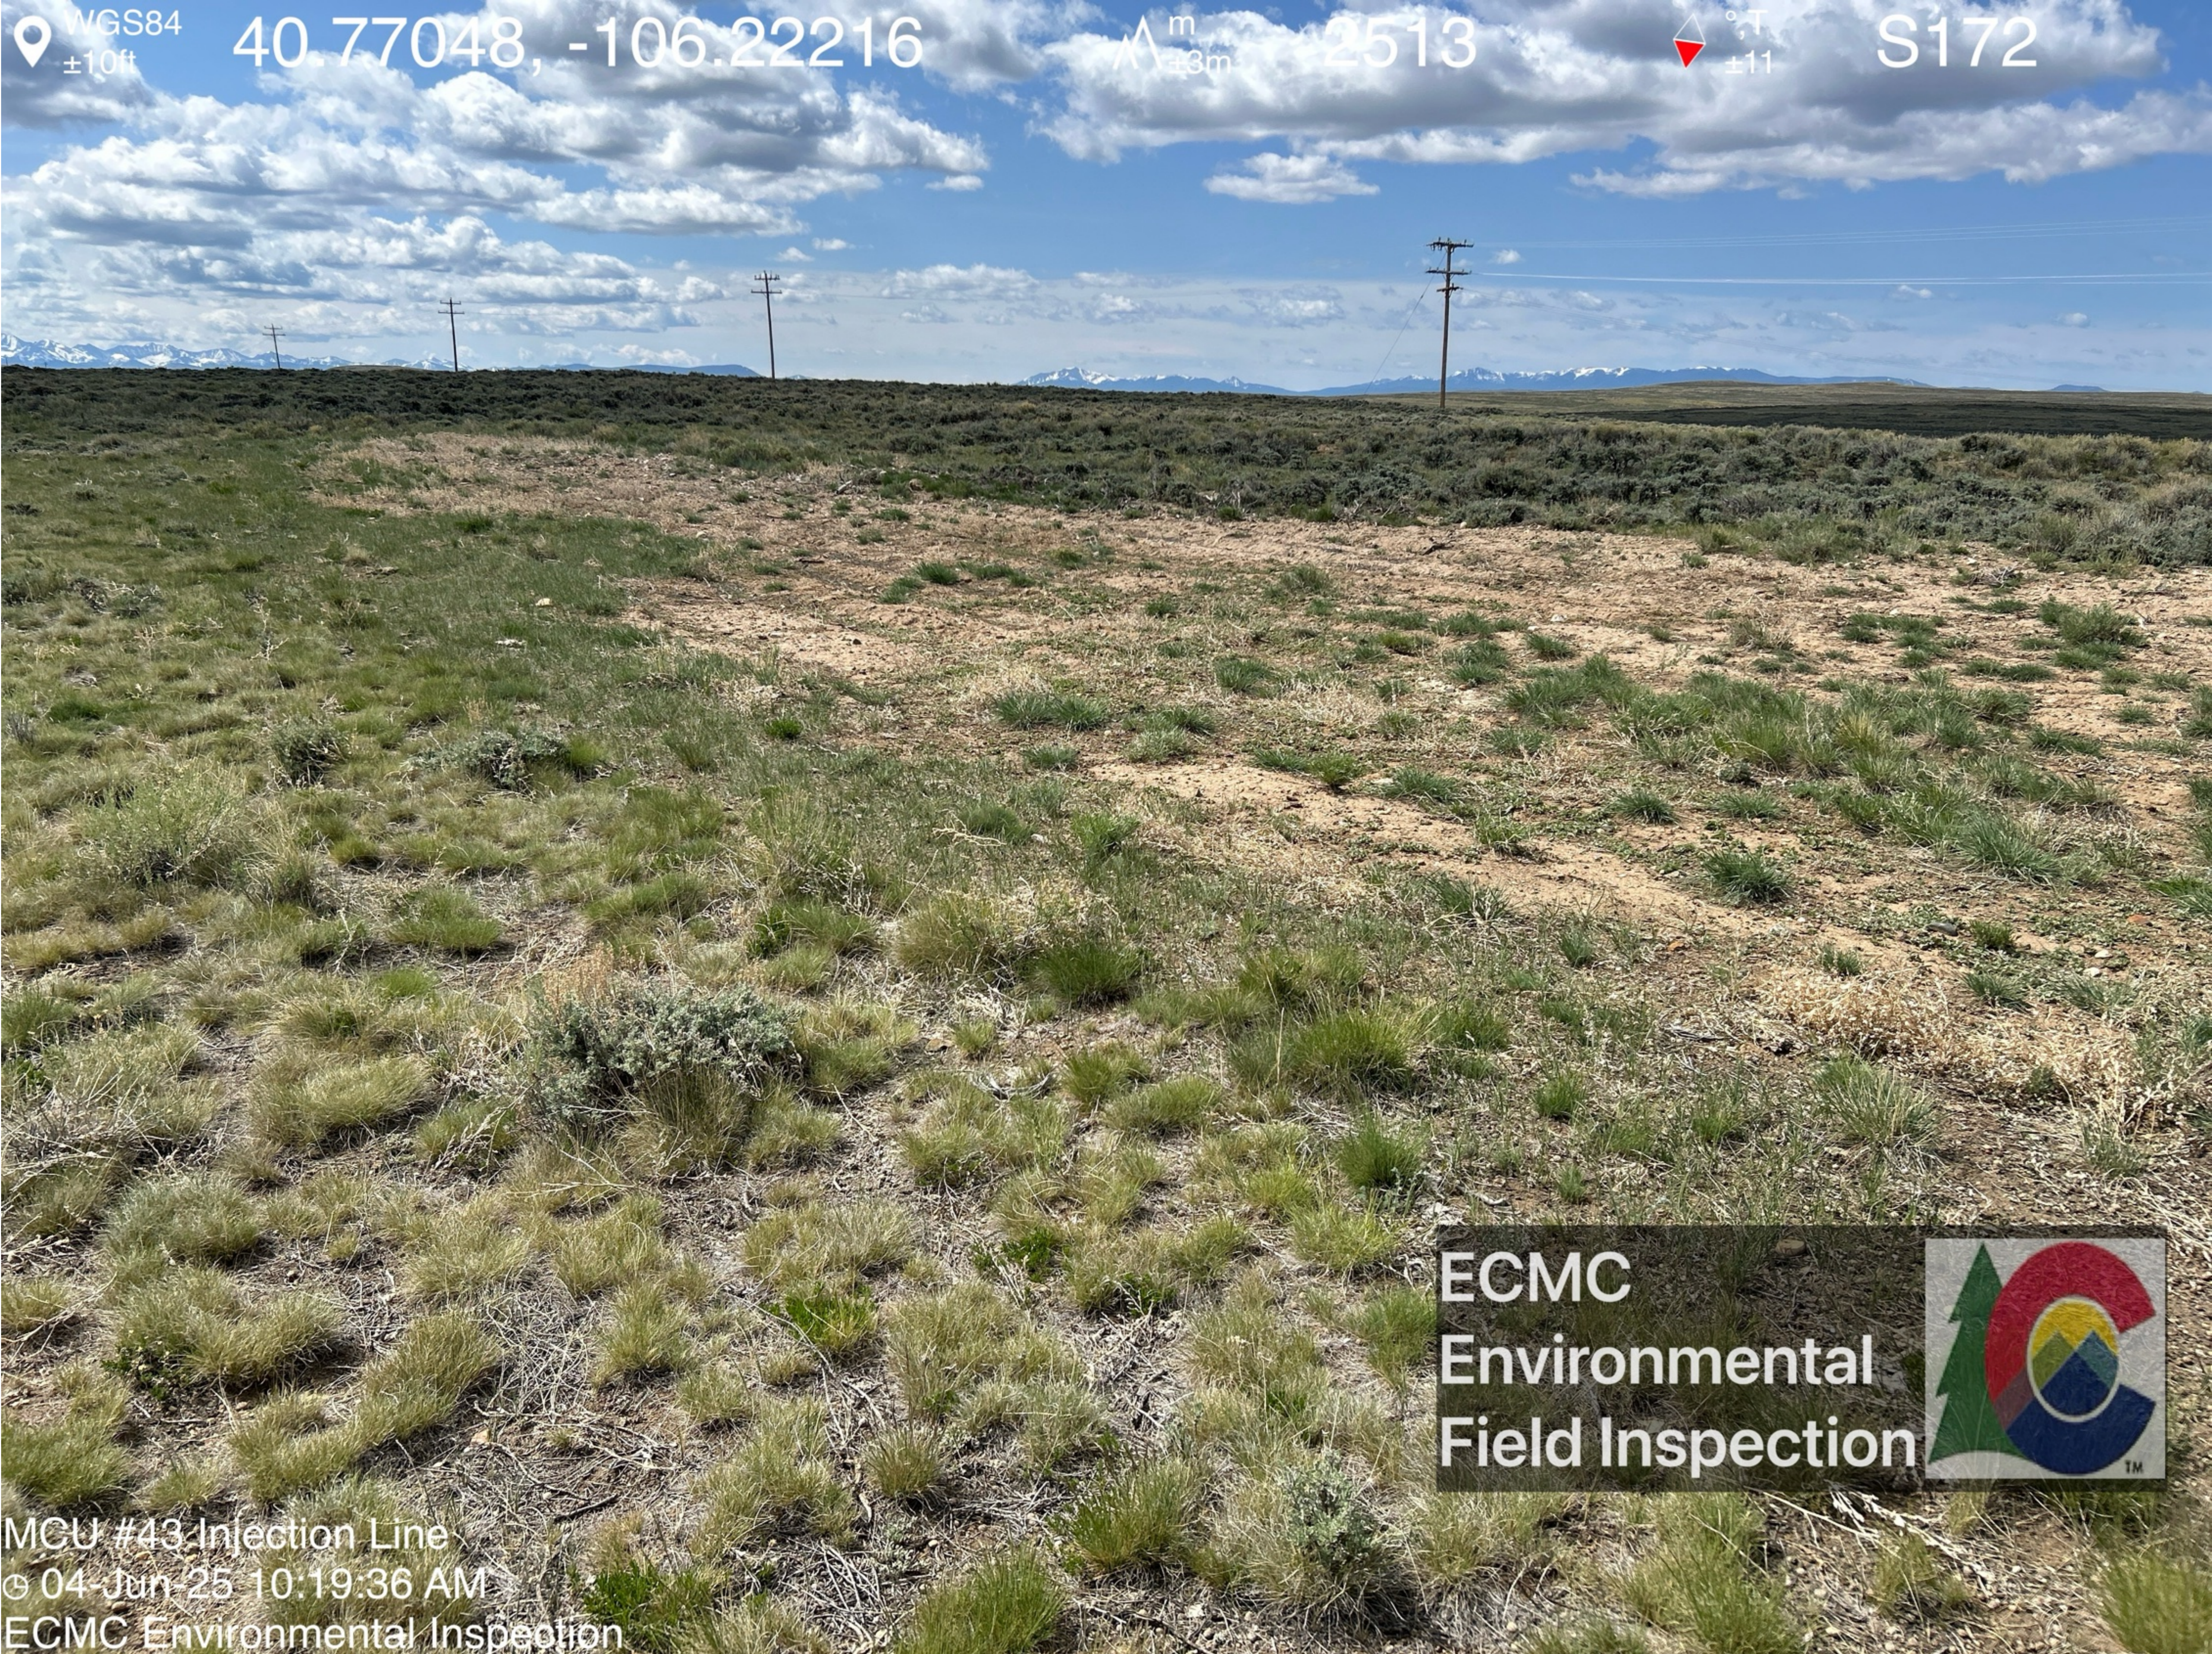
Looking at approximate spill location. Vegetation within the spill footprint appears limited in comparison to the surrounding field.

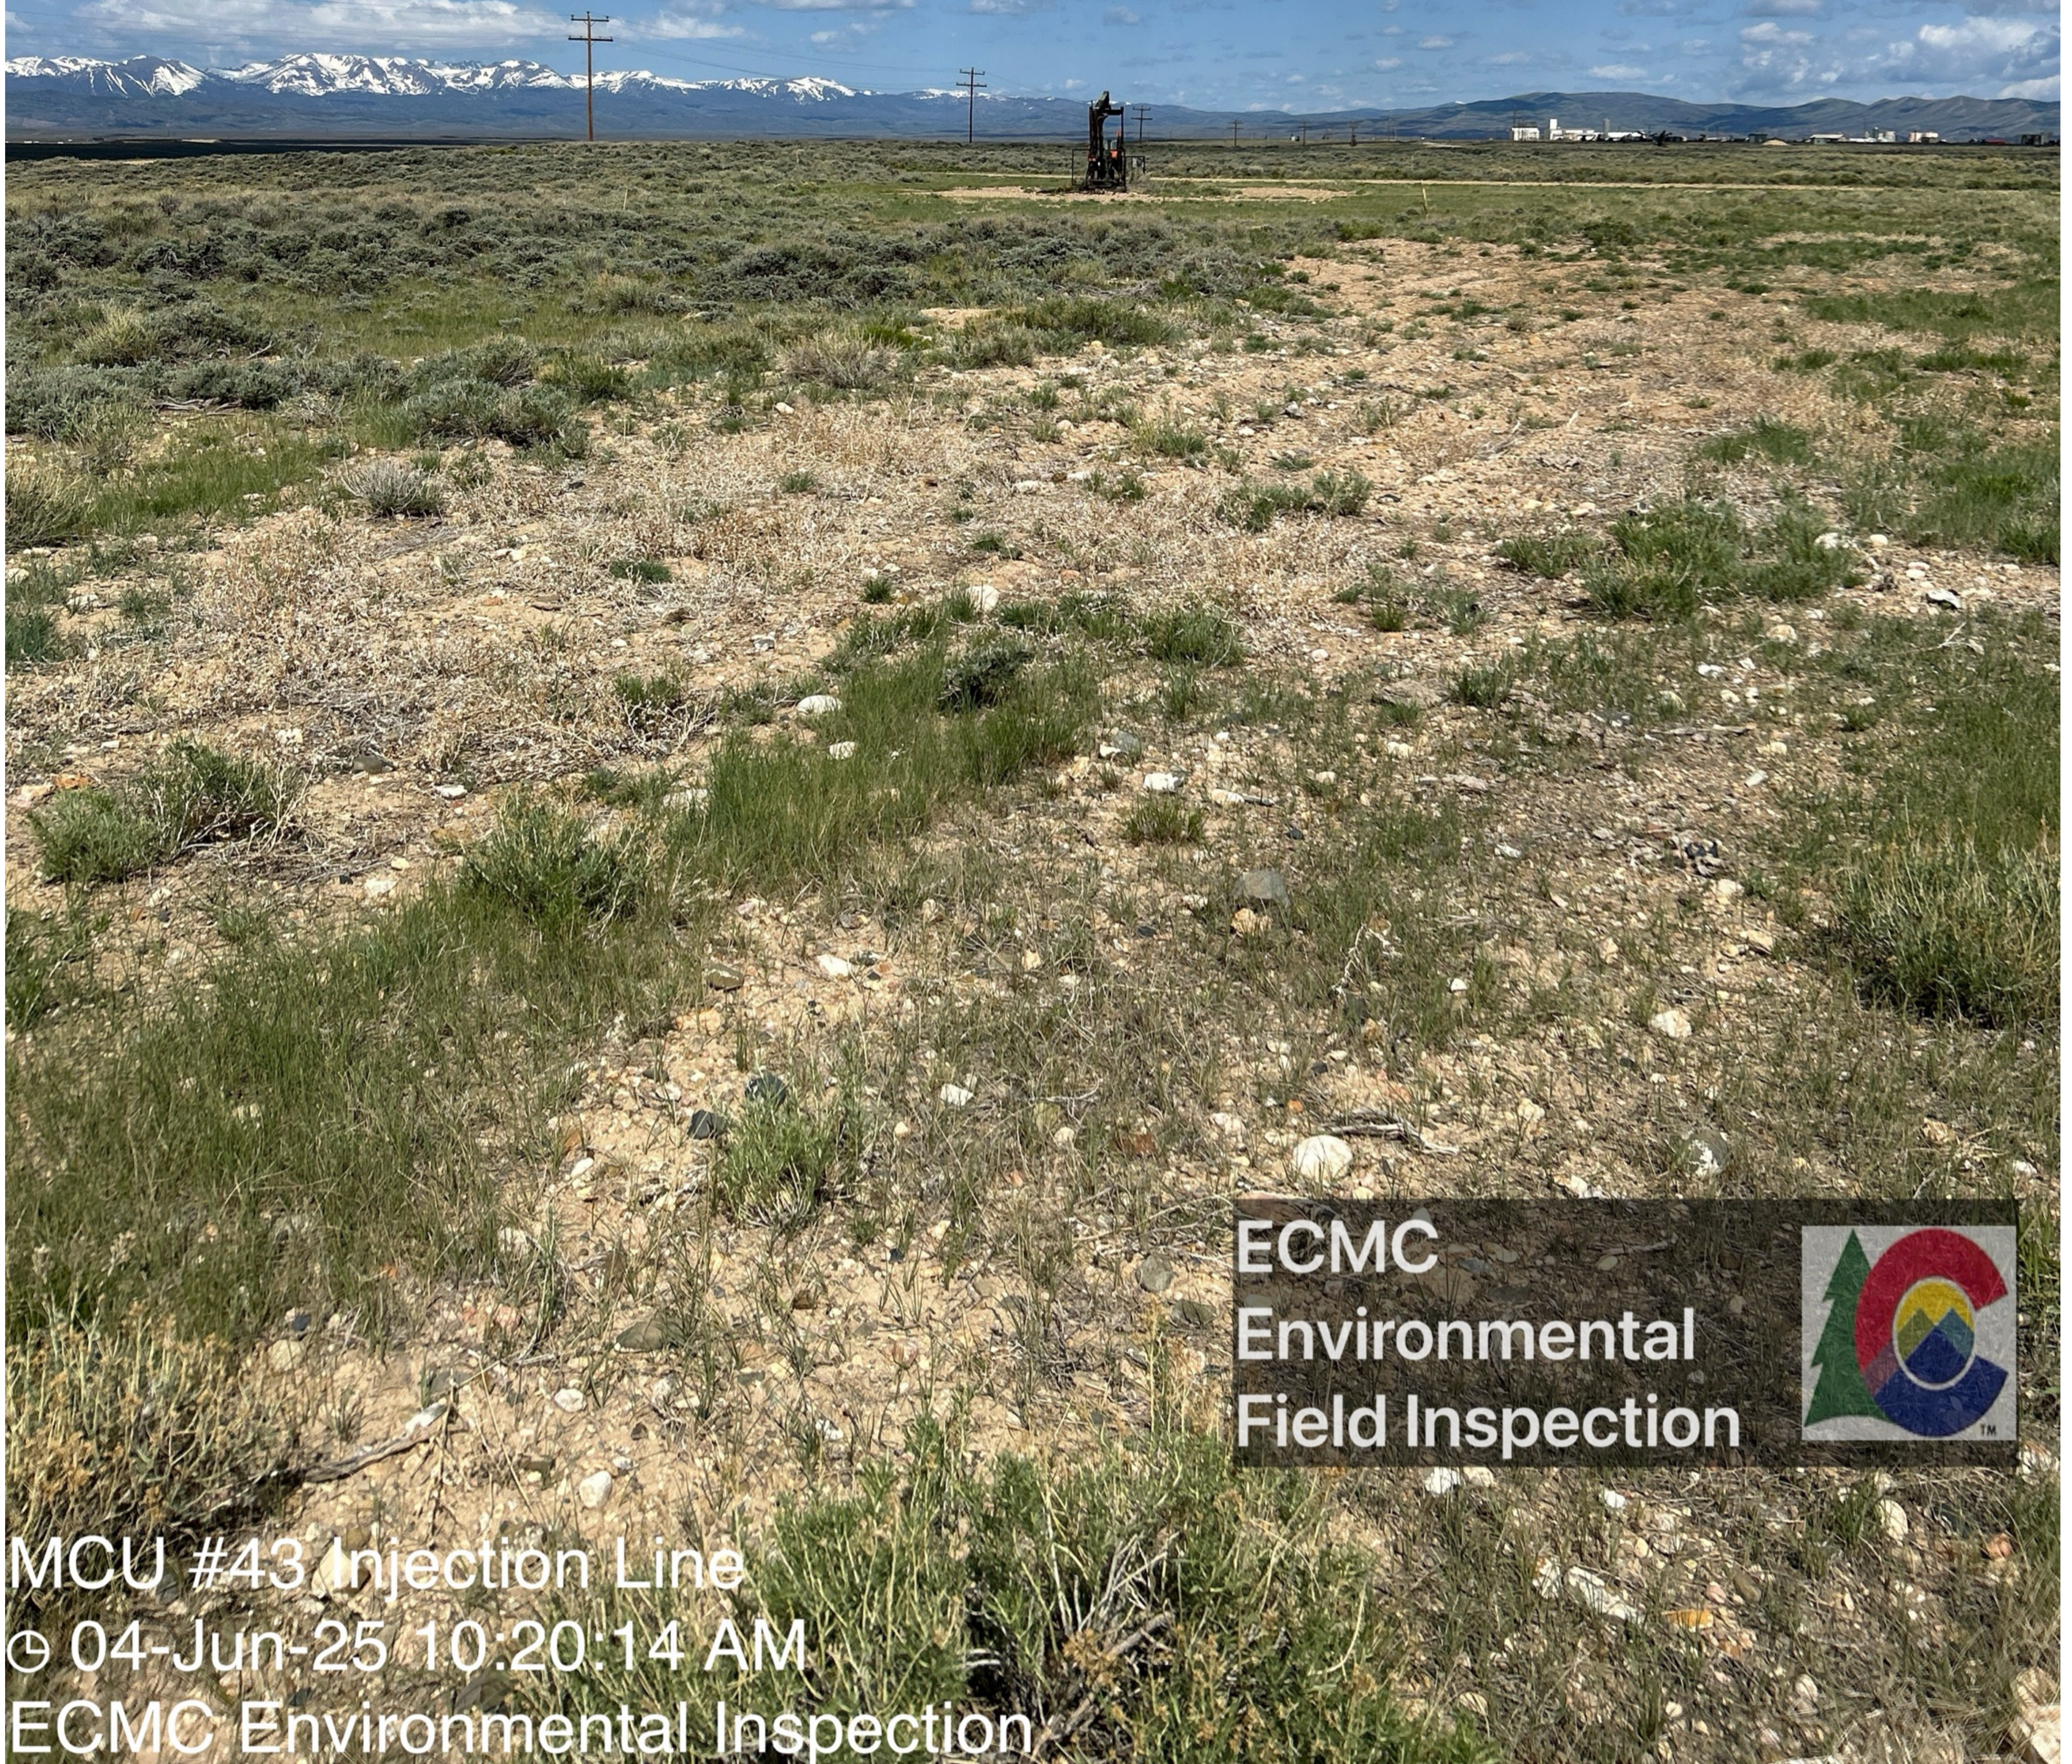
Looking at approximate spill location towards the McCallum Unit 93 well. Vegetation within the spill footprint appears limited in comparison to the surrounding field.
