ECMC
Environmental
Field Inspection

Walden Water Flood Facility
04-Jun-25 10:56:05 AM
ECMC Environmental Inspection

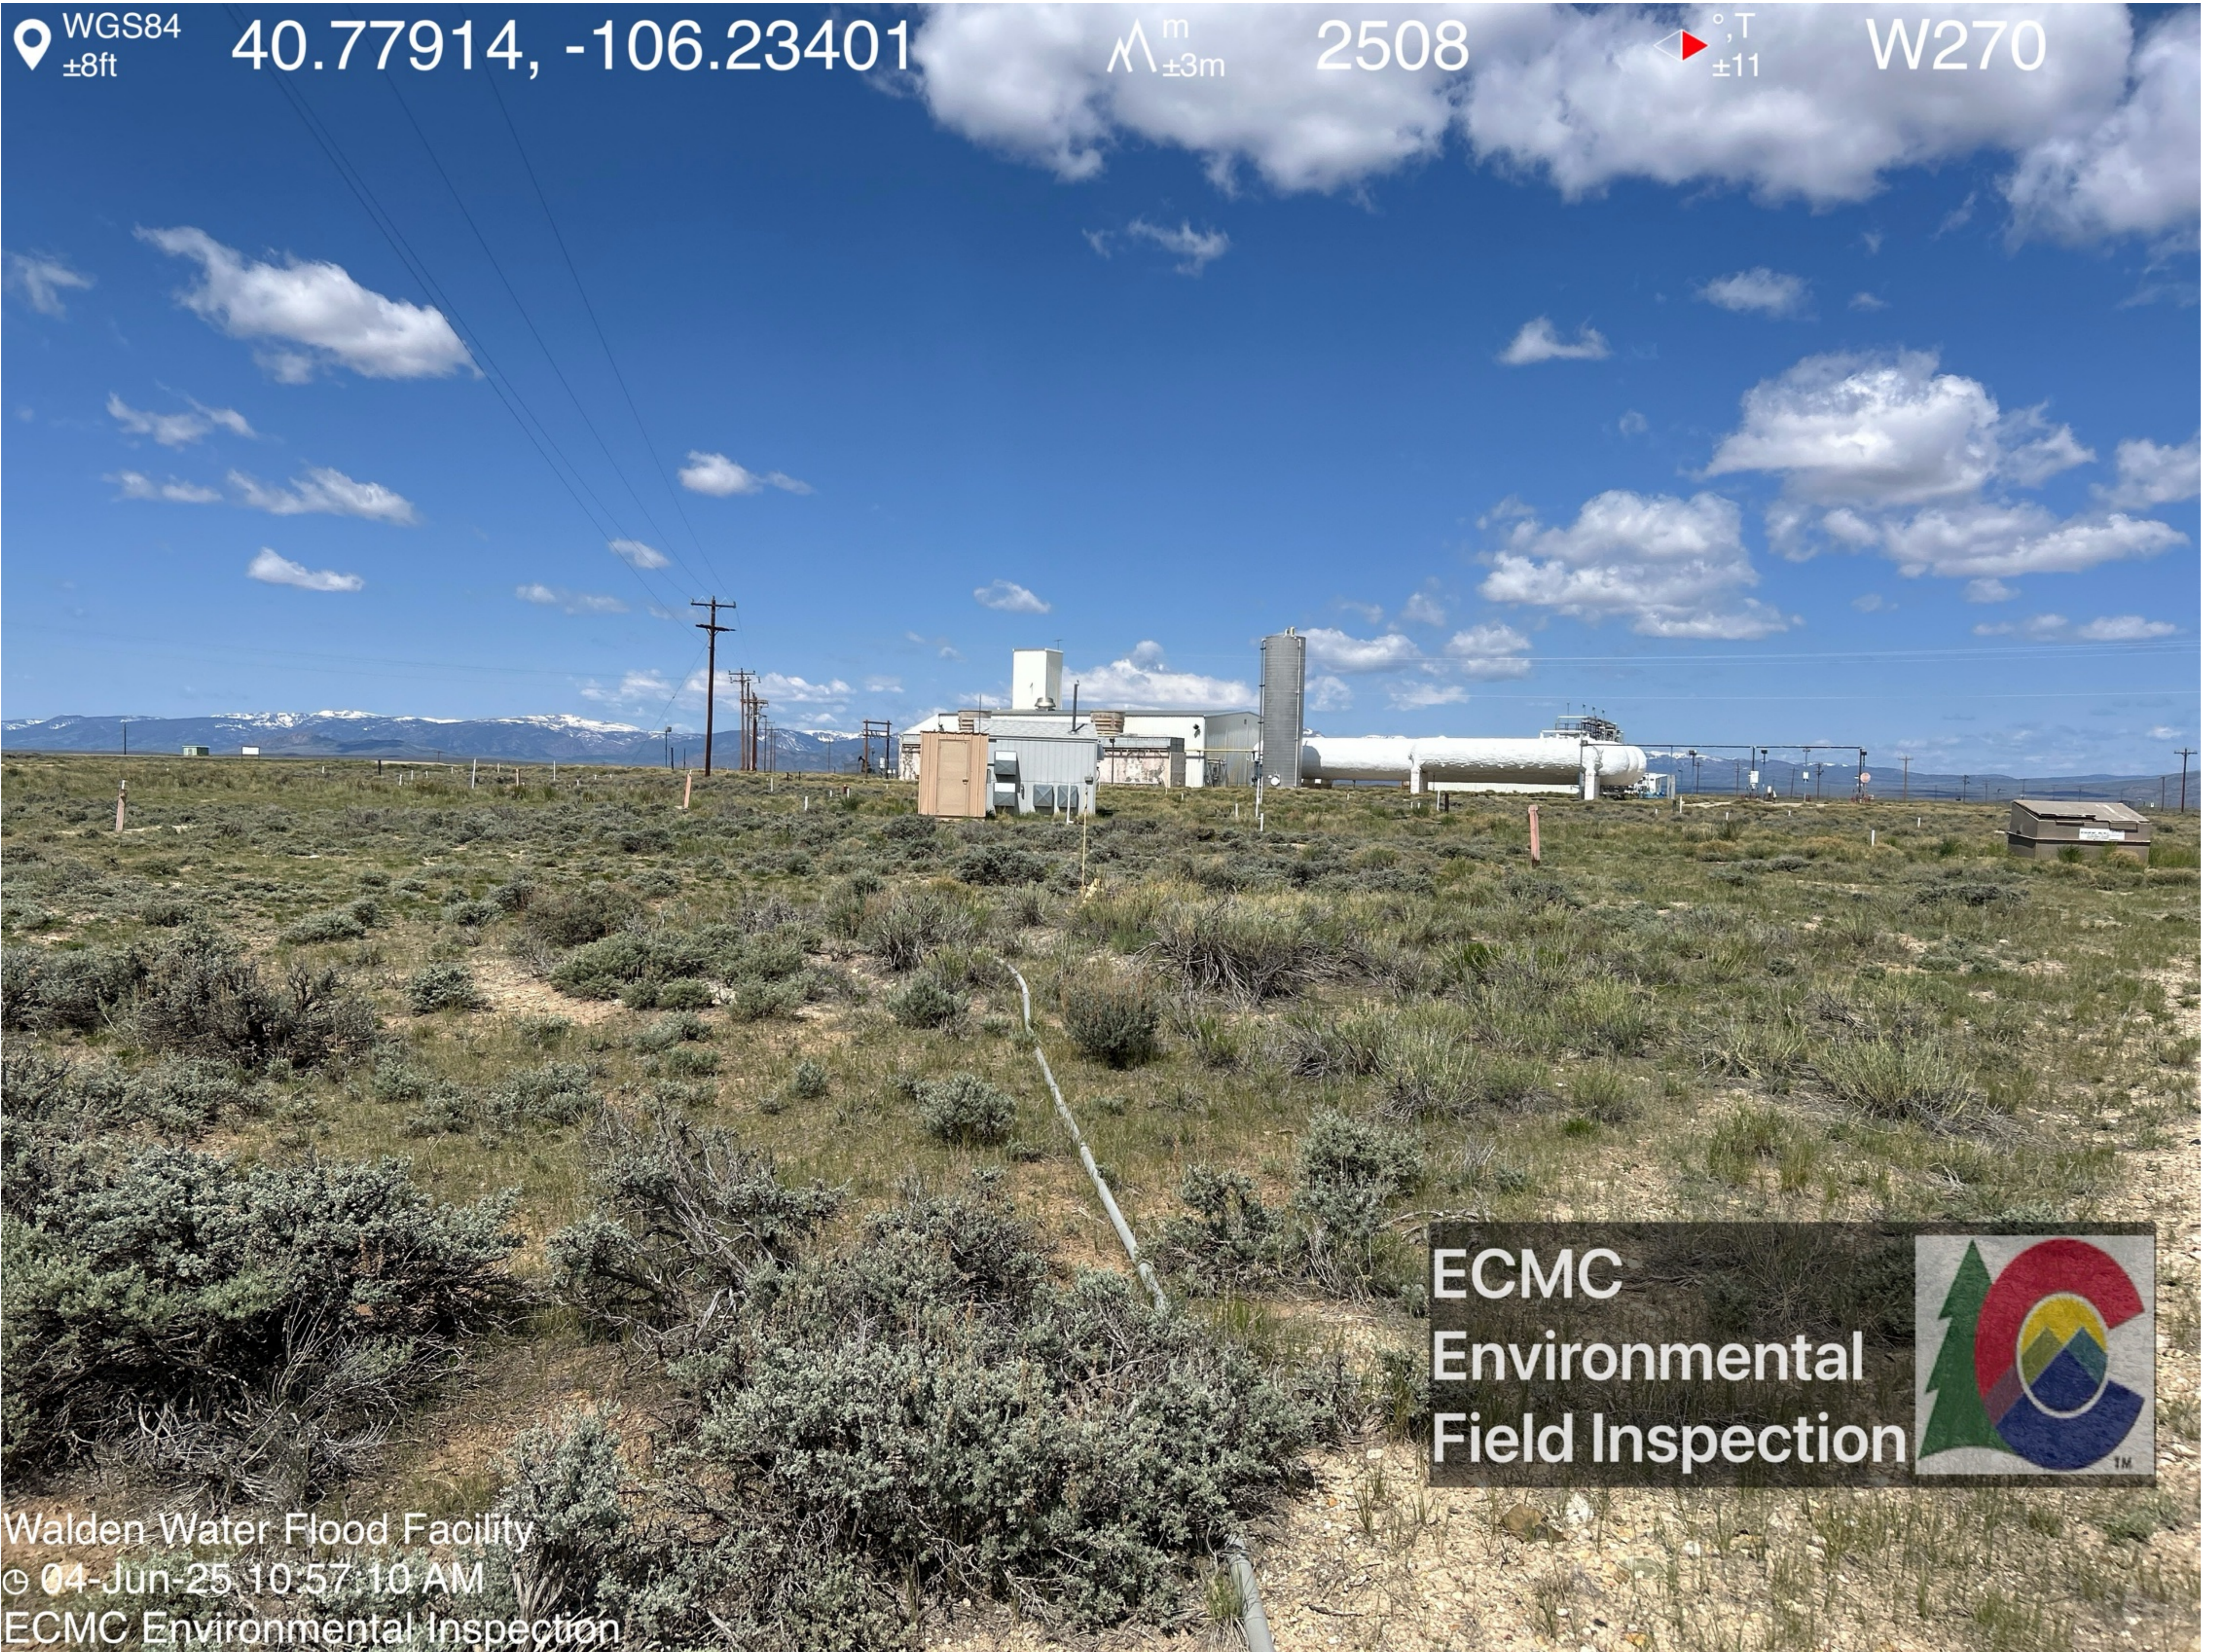
Looking west at the network of monitoring wells and air sparge/soil vapor extraction system wells. Metal monitoring well monuments are visible.

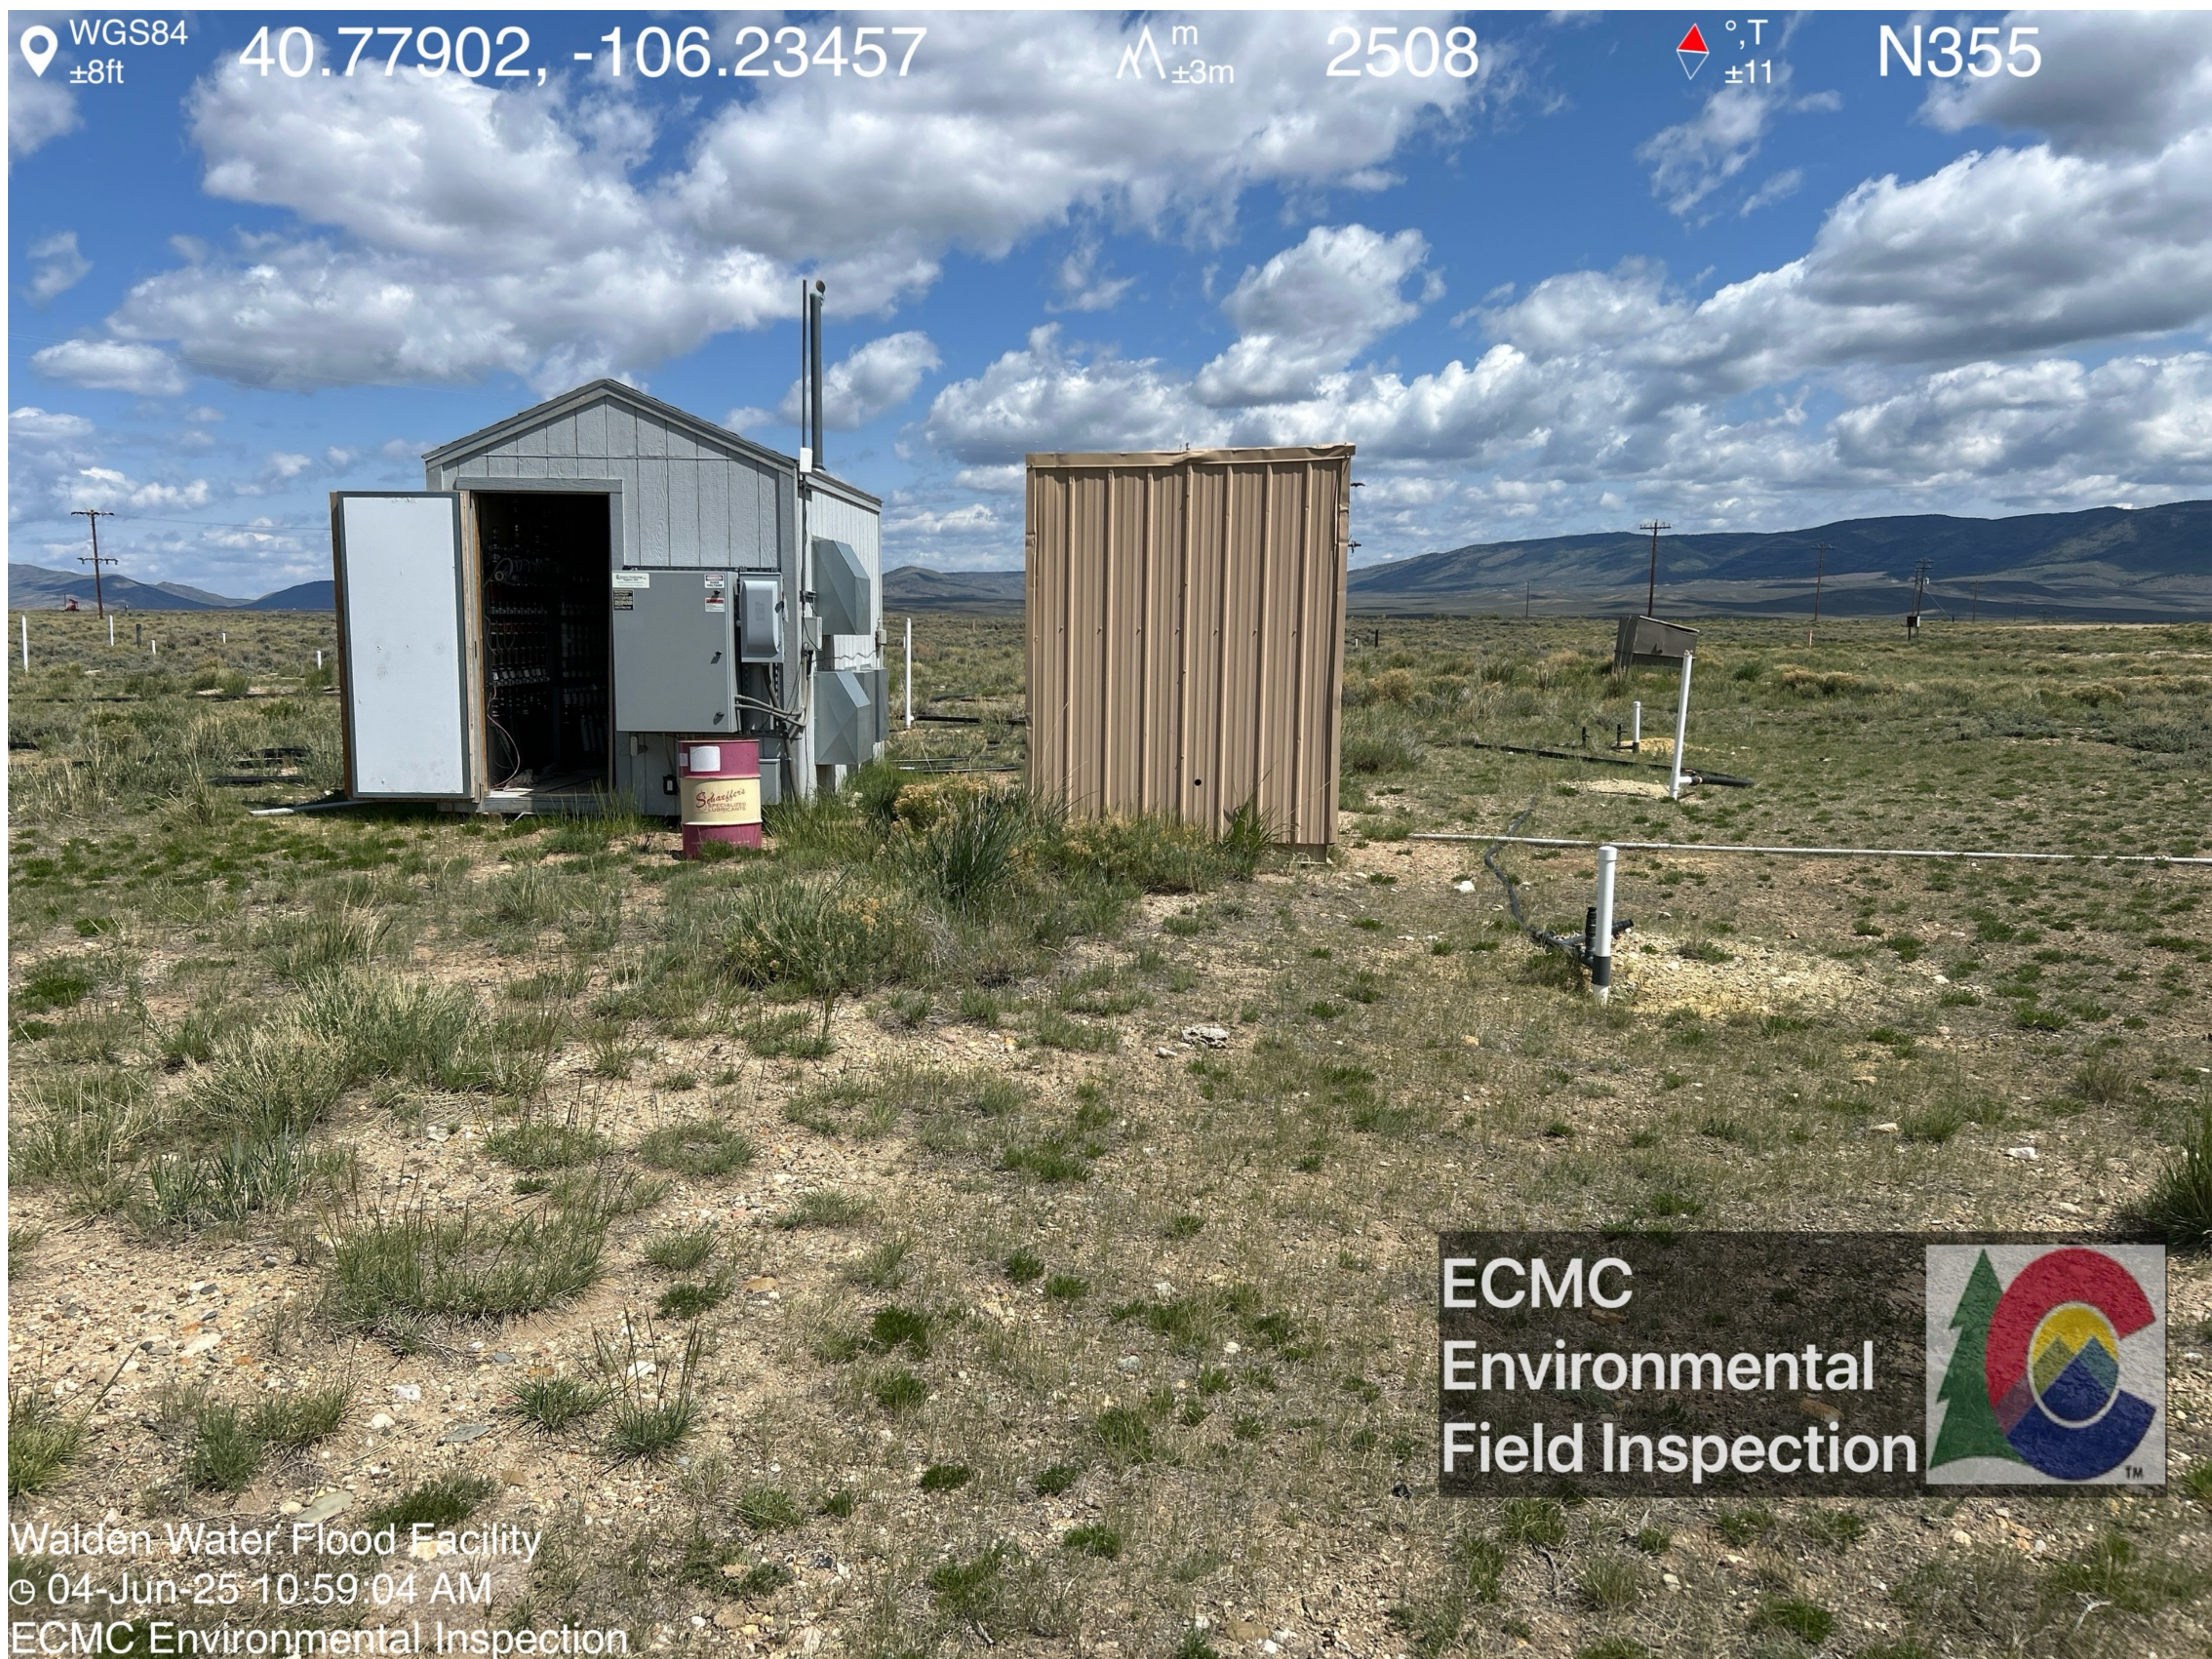
Above-ground conveyance lines are visible in the foreground; sheds surrounded by metal monitoring well monuments and white PVC stickup remedial and/or monitoring wells are visible in the backgrounds.

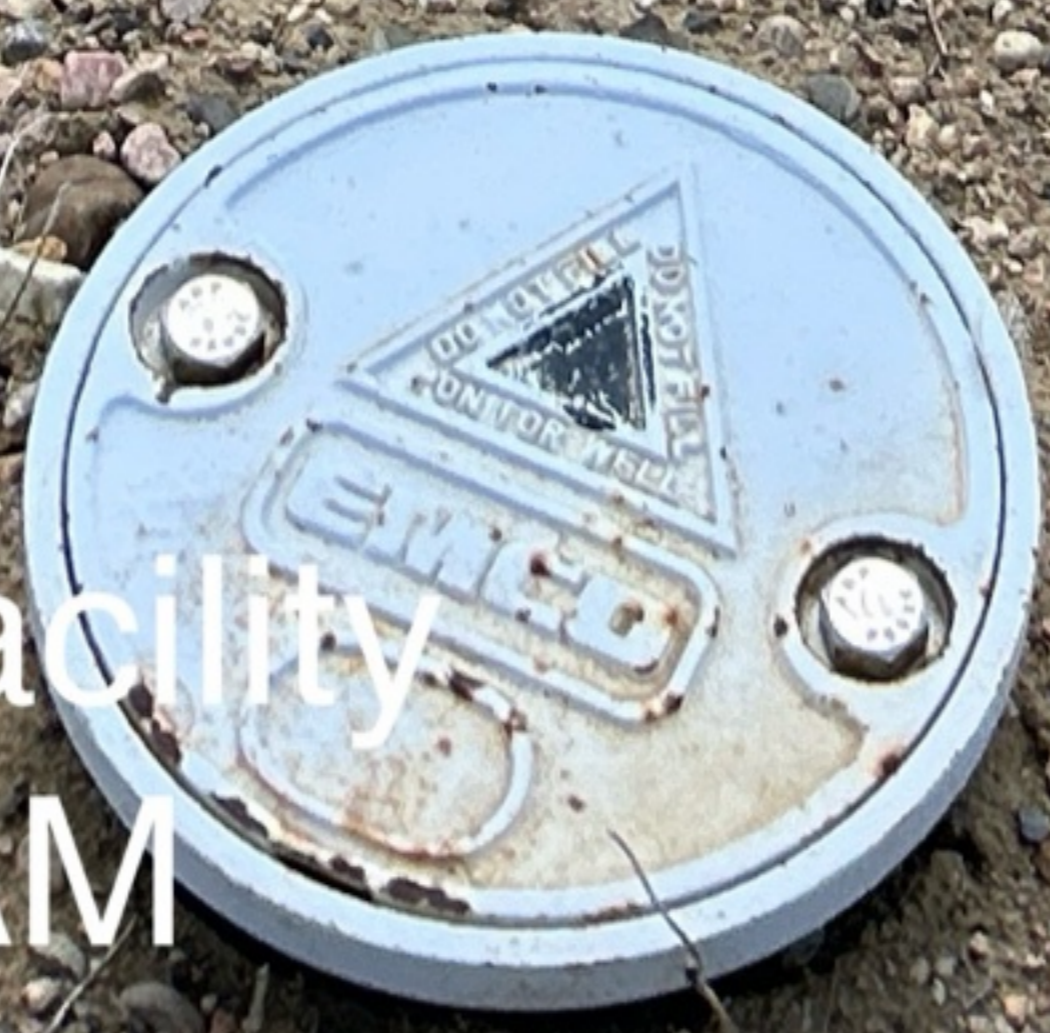
Looking east-southeast at the monitoring and remedial well network. A flush mount well is visible in the foreground; PVC stickup wells are visible in the background.
