Inspection Photos
Location Name: Norbert E Badding-62N68W 22SESE
Location ID: 318605

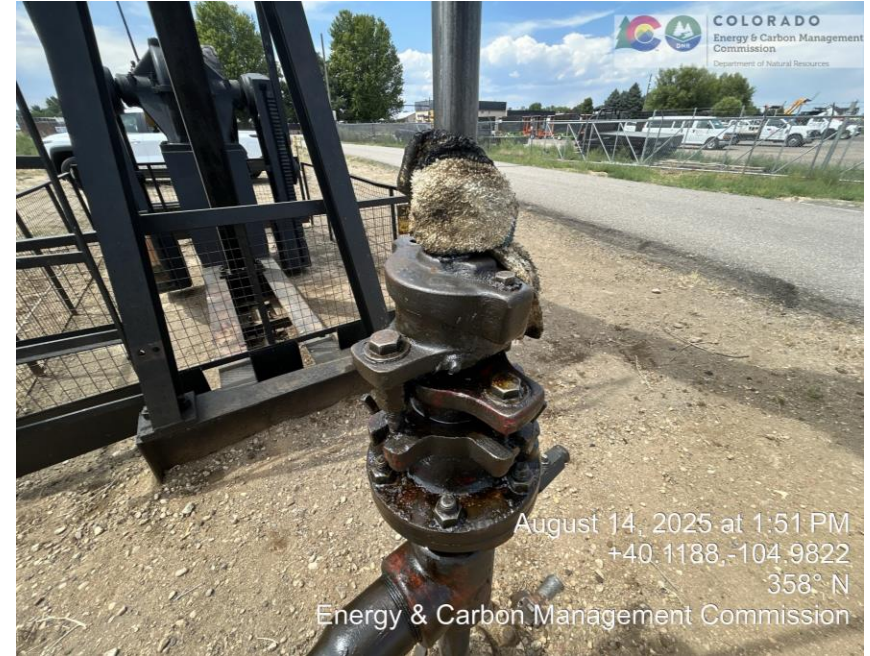
Mechanical Conditions

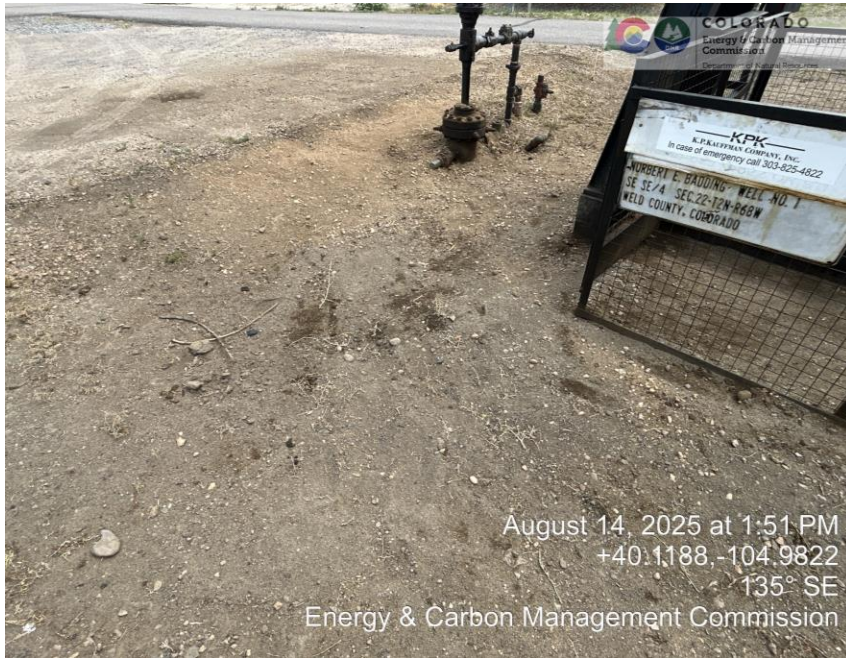
Stained Soil

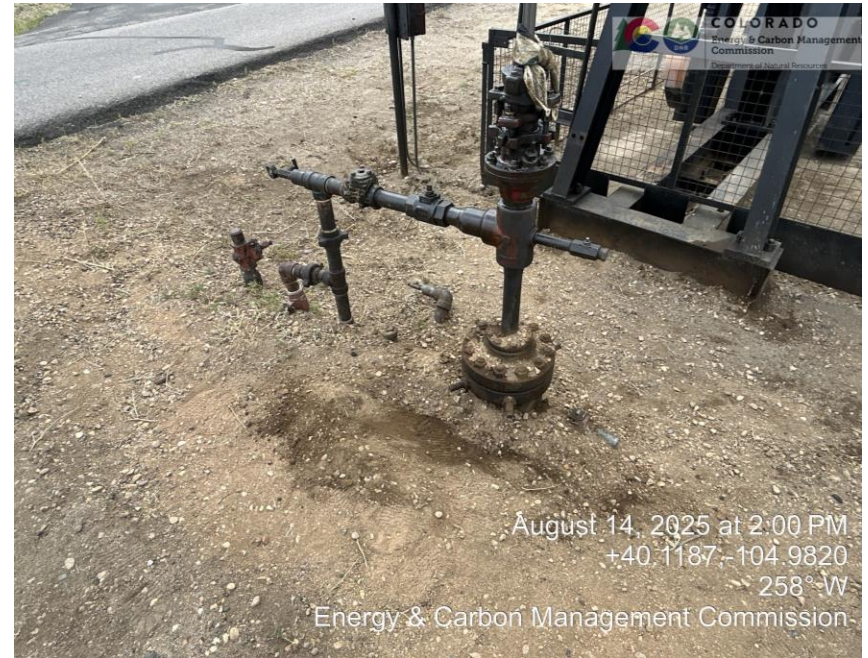
Stained Soil

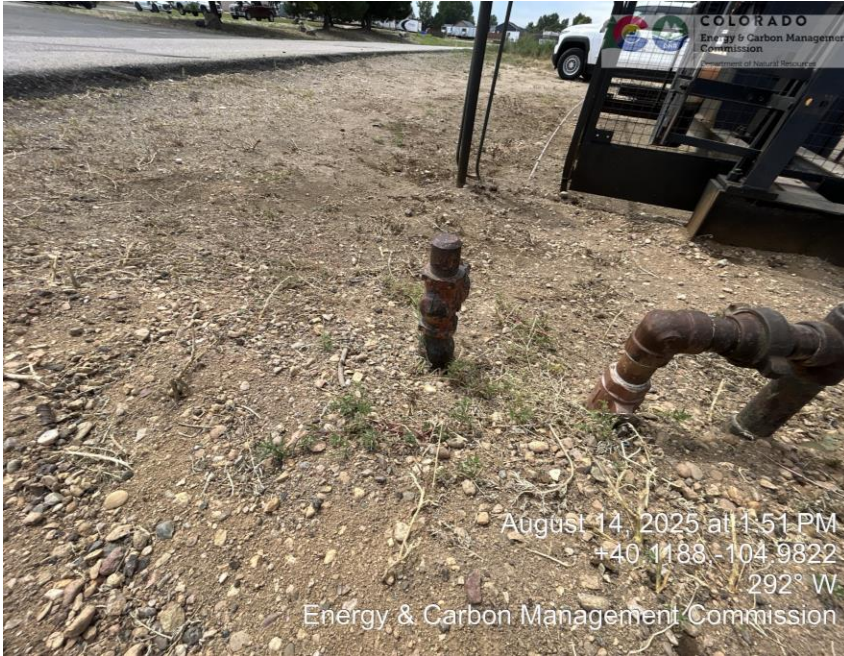
Unmarked Riser

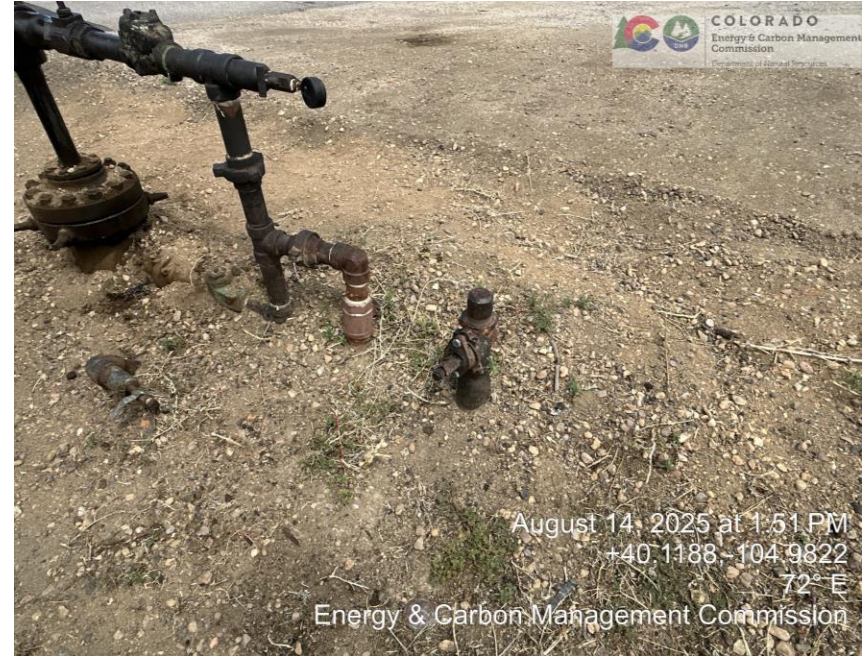
Unmarked Riser

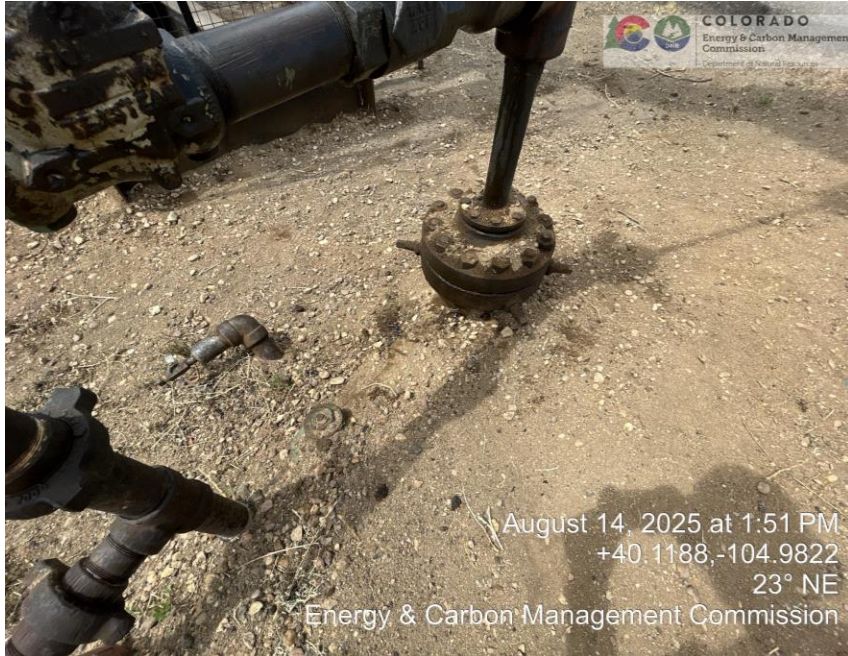
Stained Soil

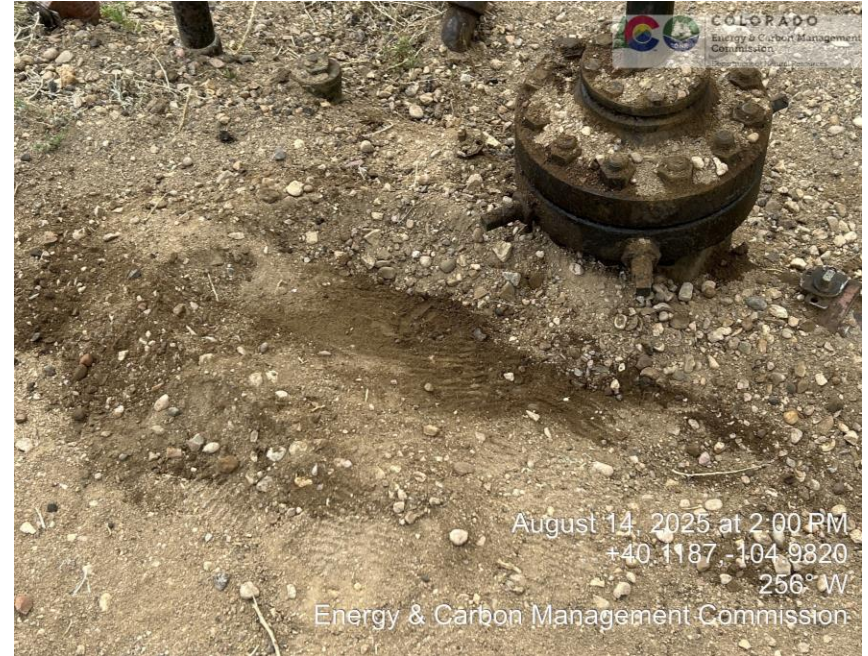
Stained Soil under clean soil

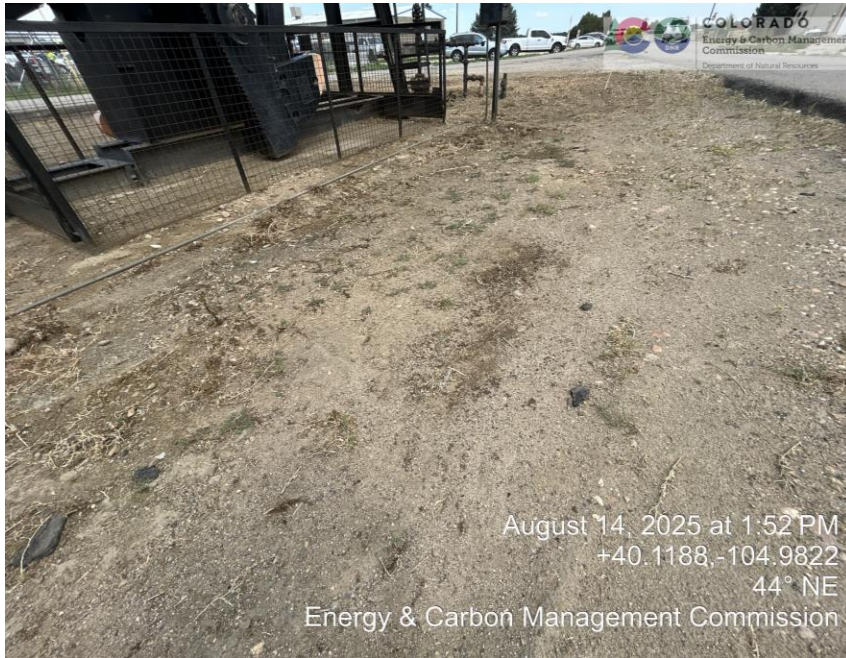
Stained Soil

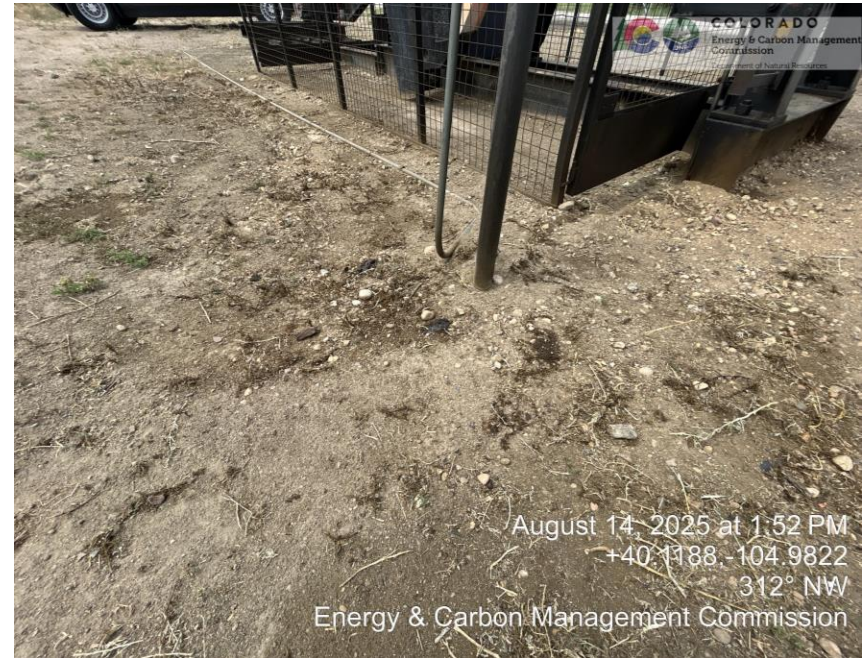
Stained Soil
