## Inspection/Audit Photos

Location: UTAH GAS OP LTD DBA UTAH GAS CORP FEDERAL #32-1 PAD

Location ID: 315161

Date: 08/12/2025

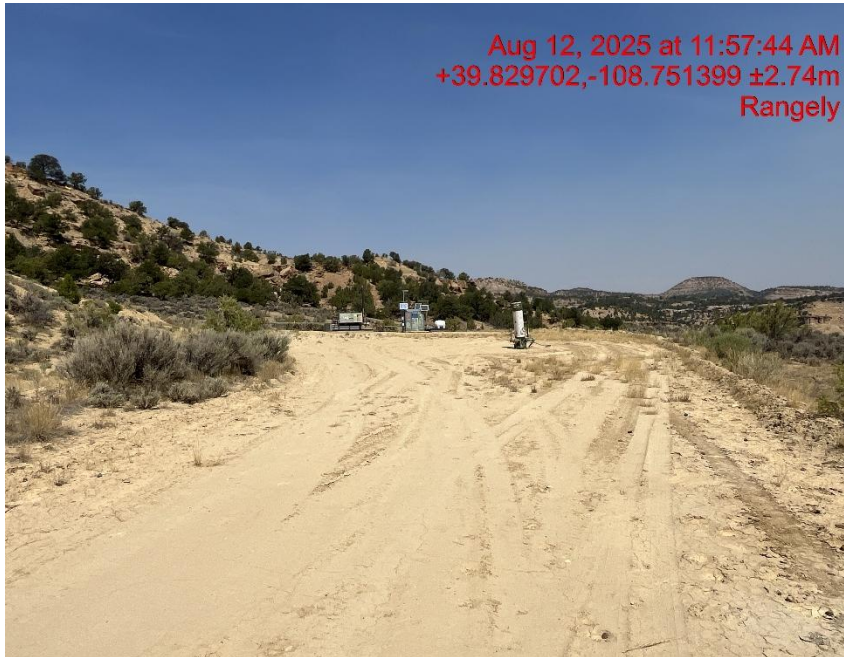
Photo # 1768 Entrance to location

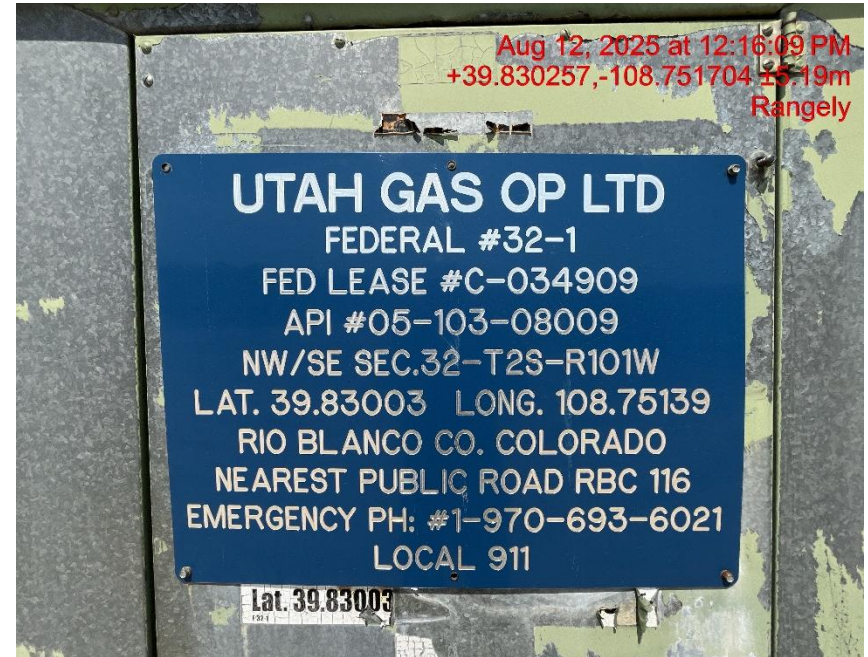
Photo # 1783 Location – inaccurate LAT/LONG

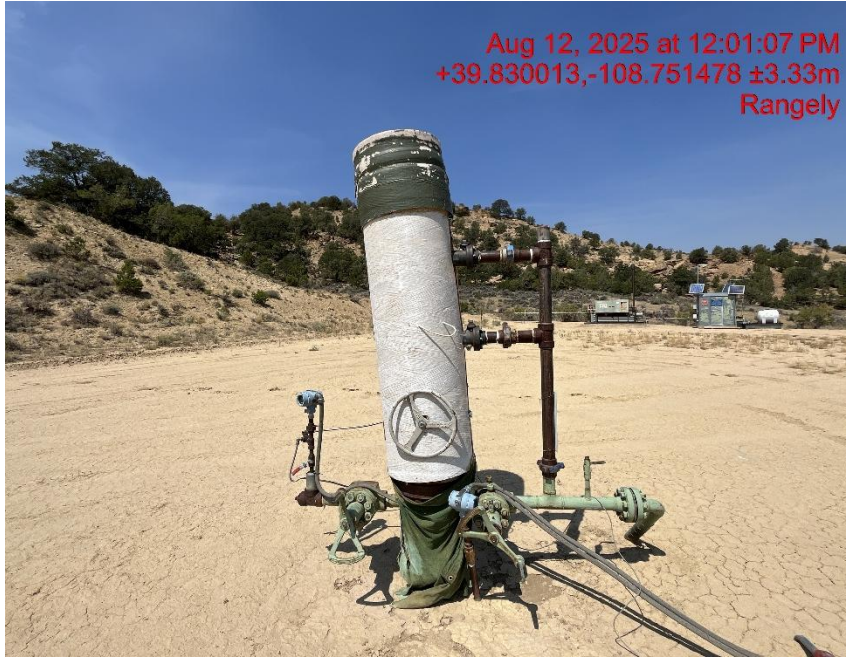
Photo # 1769 Location

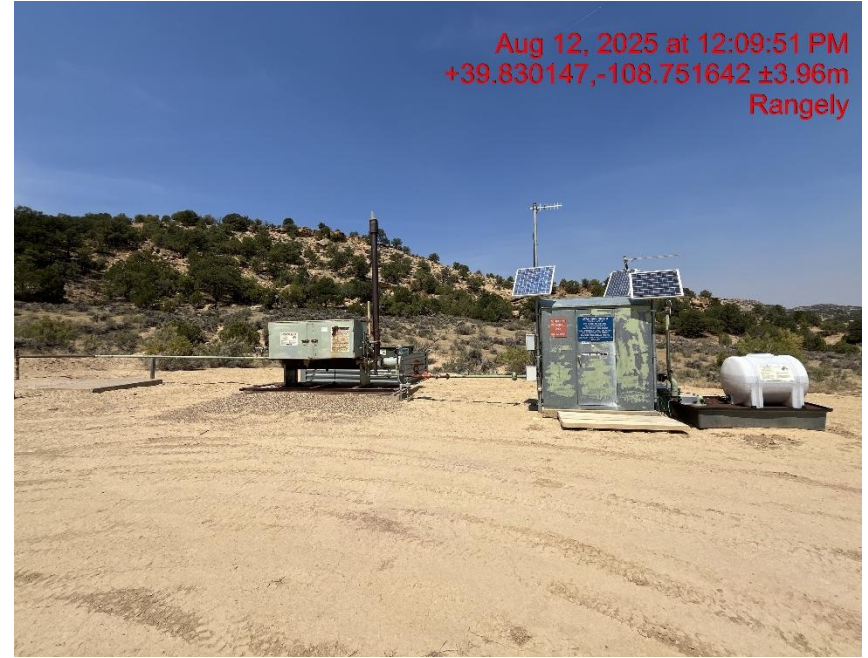
Photo # 1777 Location

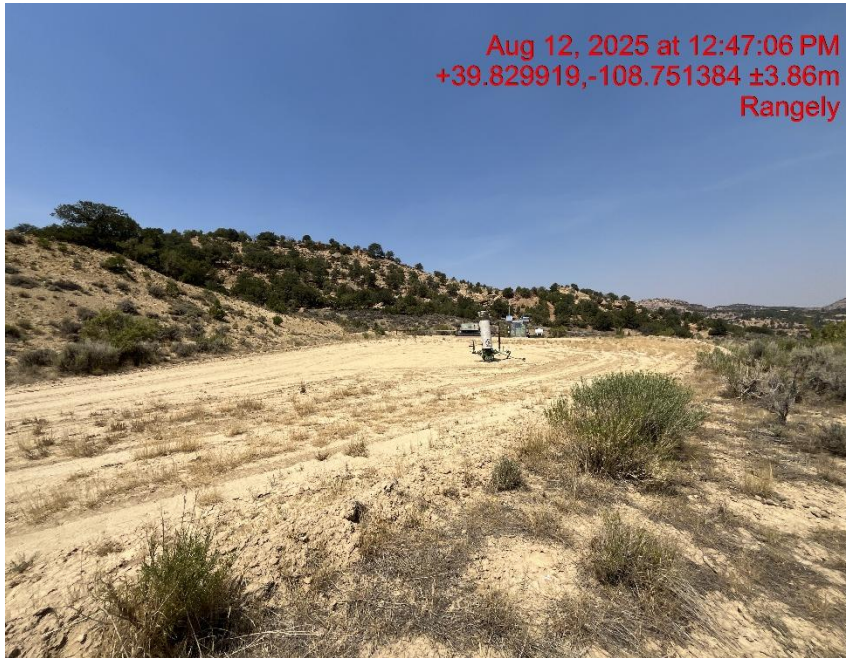
Photo # 1811 SE corner of location

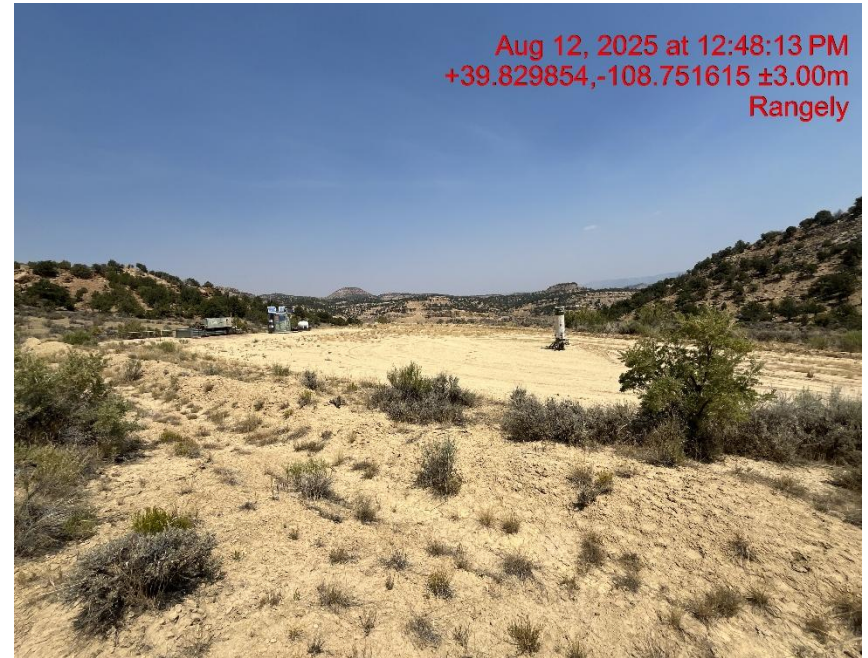
Photo # 1812 SW corner of location

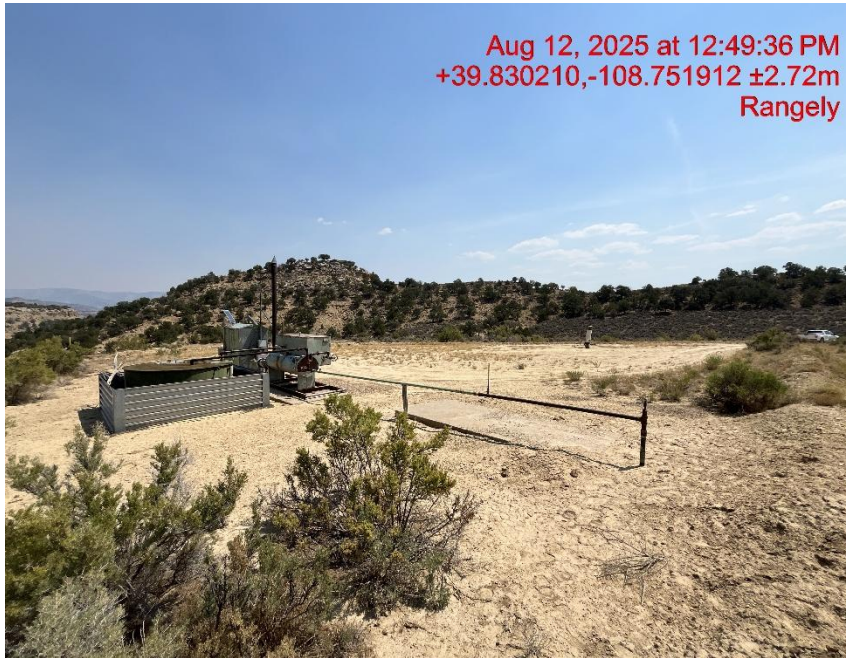
Photo # 1813 NW corner of location

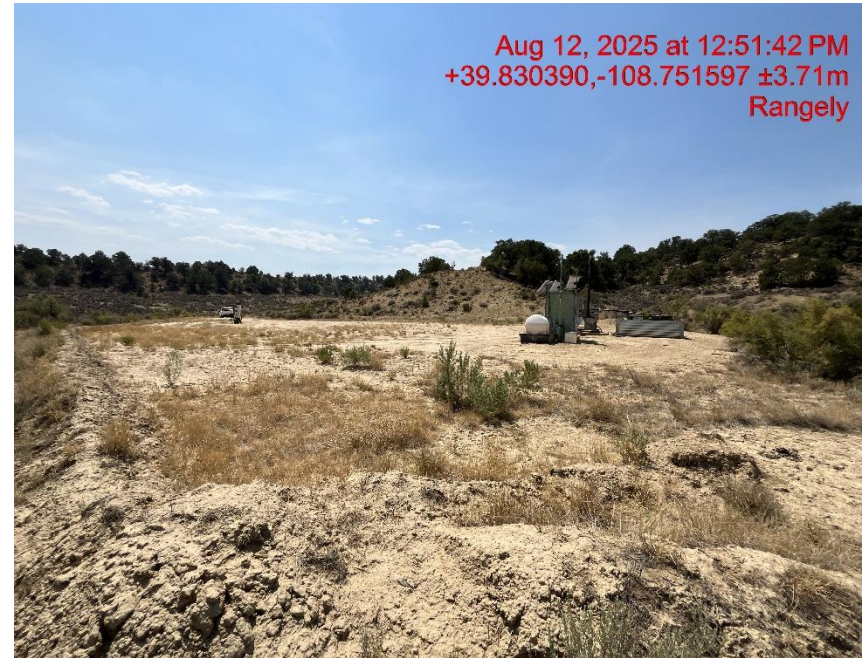
Photo # 1814 NE corner of location

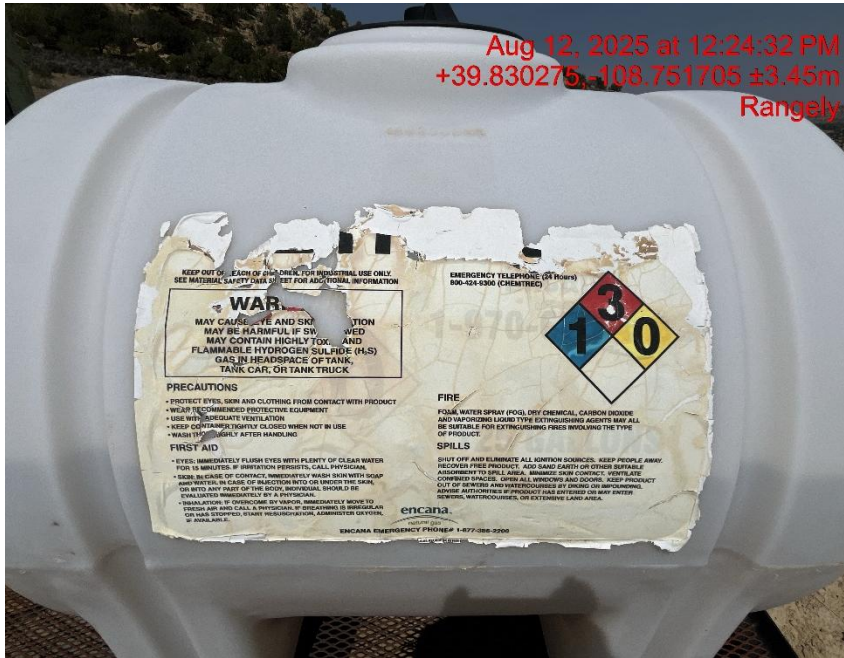
Photo # 1794 Chemical tank lacks required labeling & contains inaccurate operator information

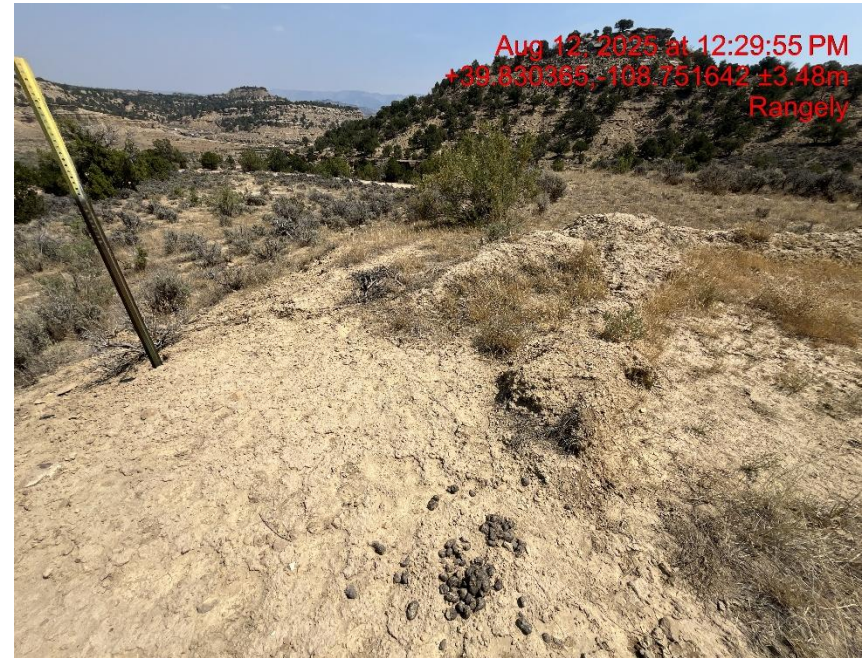
Photo # 1799 Failure to minimize erosion & transport of sediment off location/insufficient BMP's

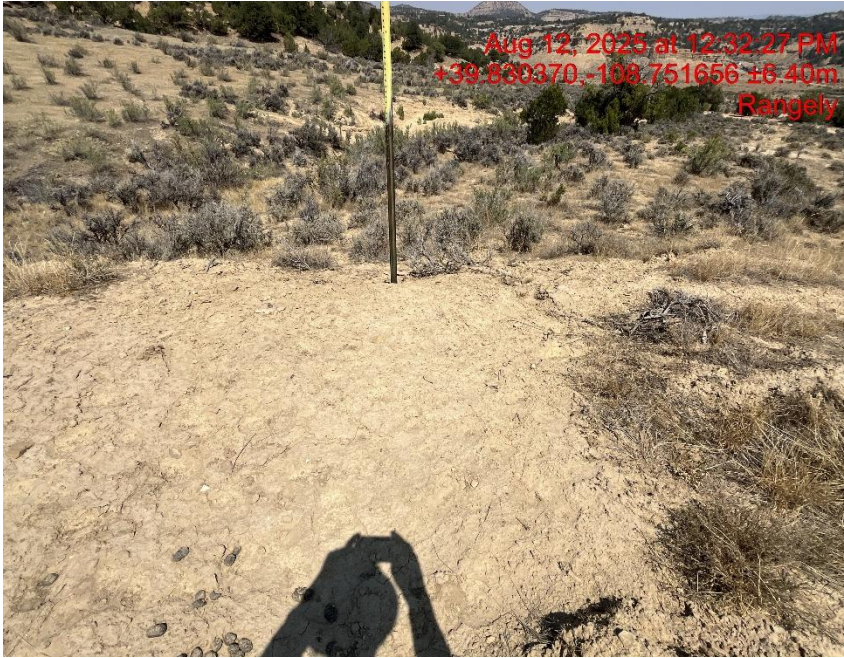
**Photo # 1800 Failure to minimize erosion & transport of sediment off location/insufficient BMP's**

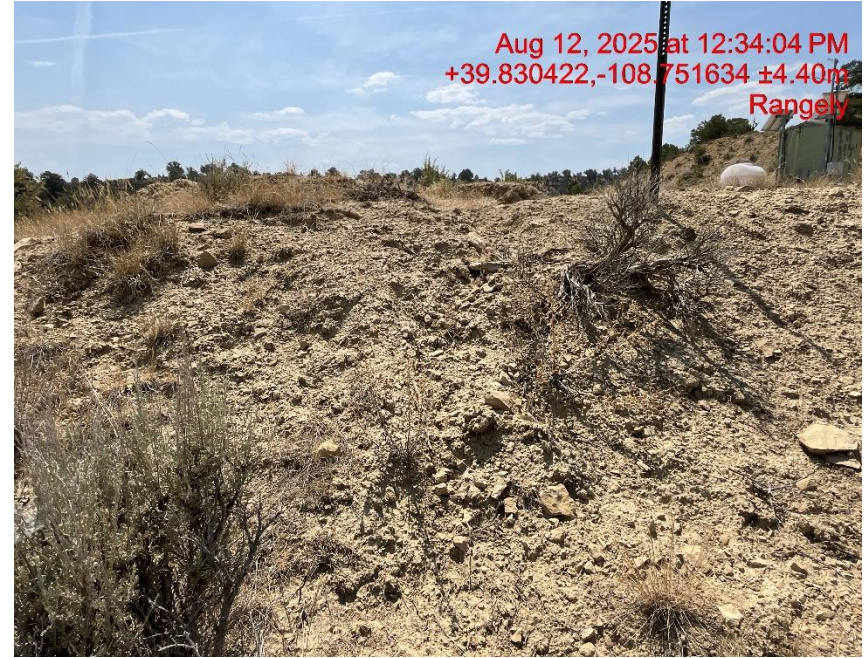
**Photo # 1803 Failure to minimize erosion & transport of sediment off location/insufficient BMP's**

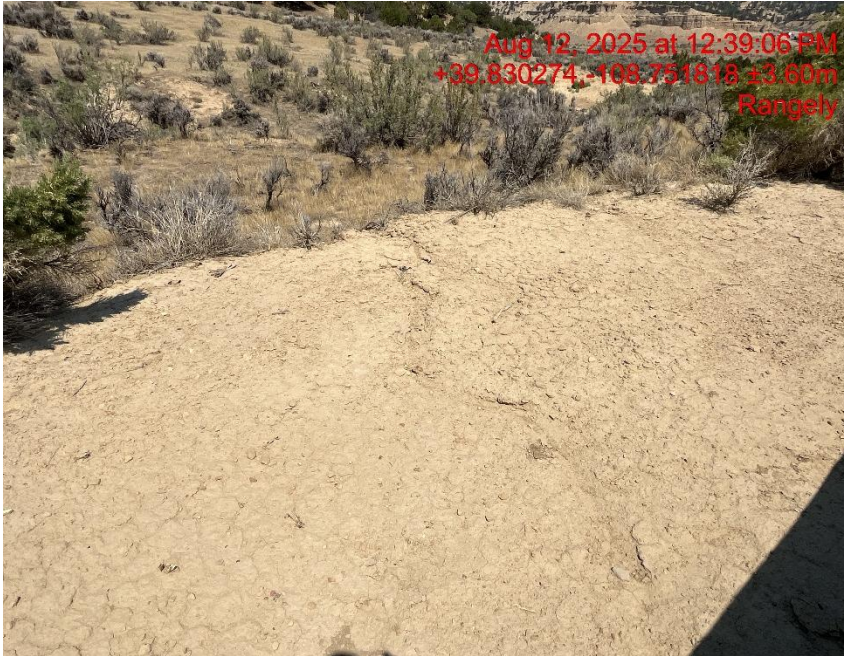
**Photo # 1806 Failure to minimize erosion & transport of sediment off location/insufficient BMP's**

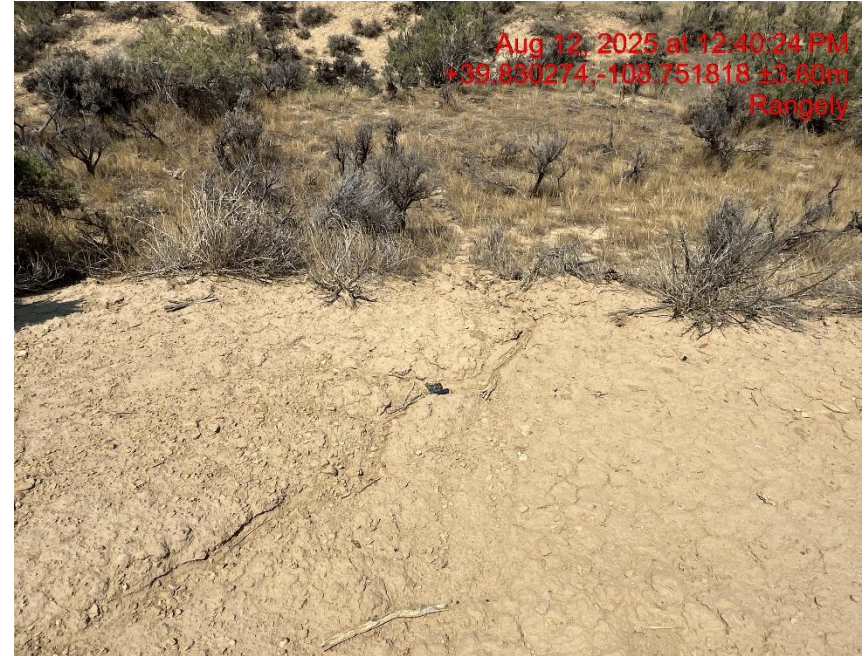
**Photo # 1808 Failure to minimize erosion & transport of sediment off location/insufficient BMP's**

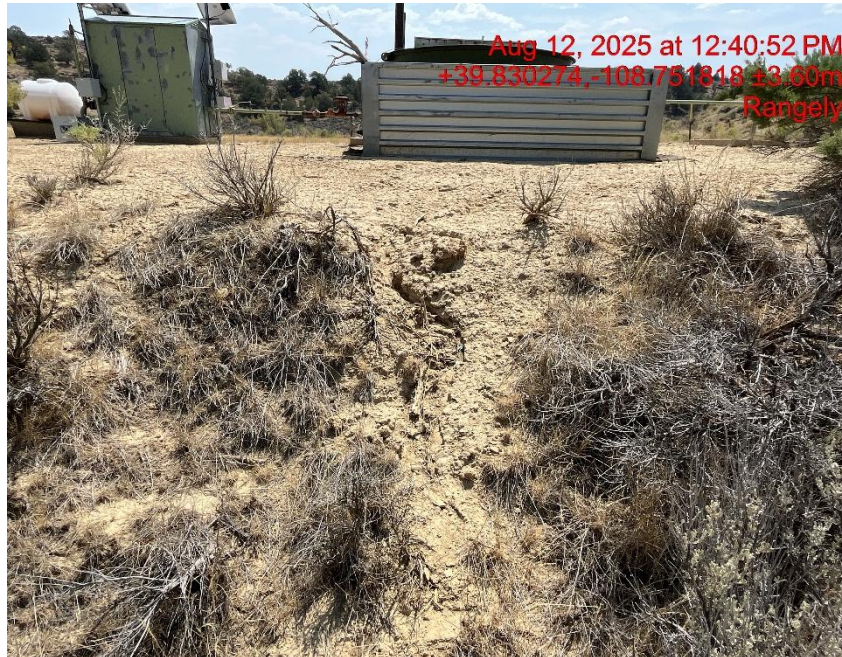
**Photo # 1809 Failure to minimize erosion & transport of sediment off location/insufficient BMP's**
