Inspection/Audit Photos

Location Name: QB ENERGY OPERATING LLC SHAEFFER 31-6 (H-36) Pad

Location ID: 334904

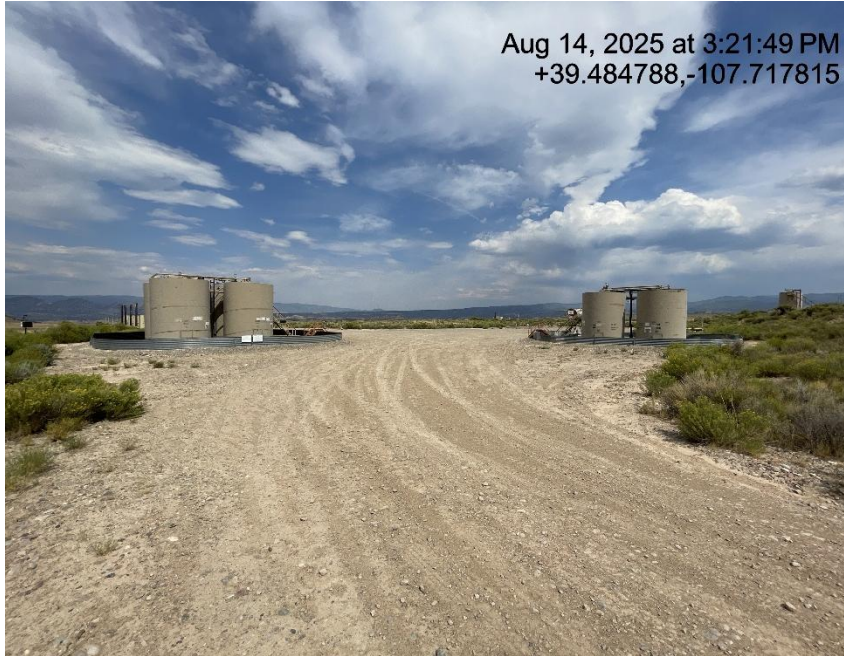
Photo # 939 From entrance to location

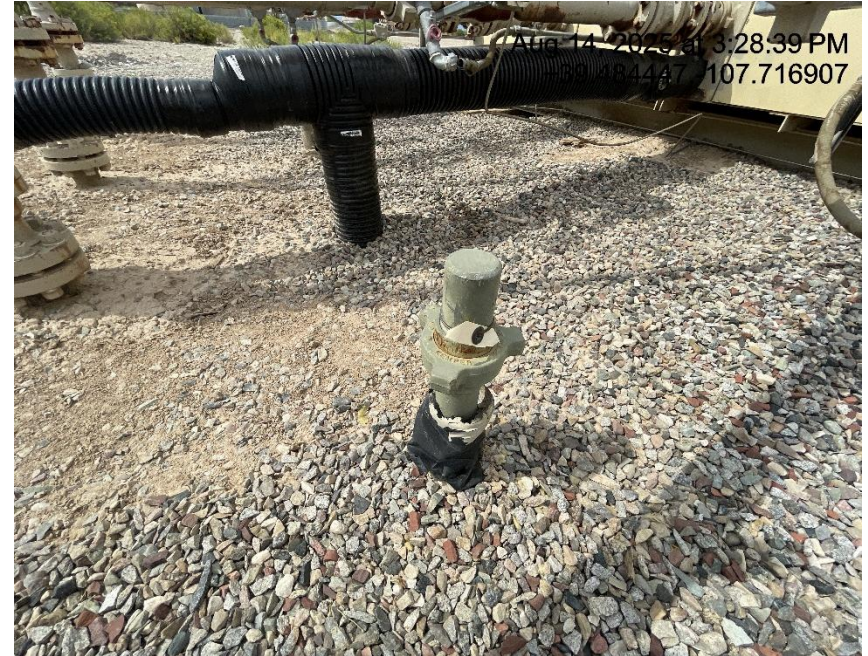
Photo # 952 Unused flowline lacks lockout tagout (OOSLAT)

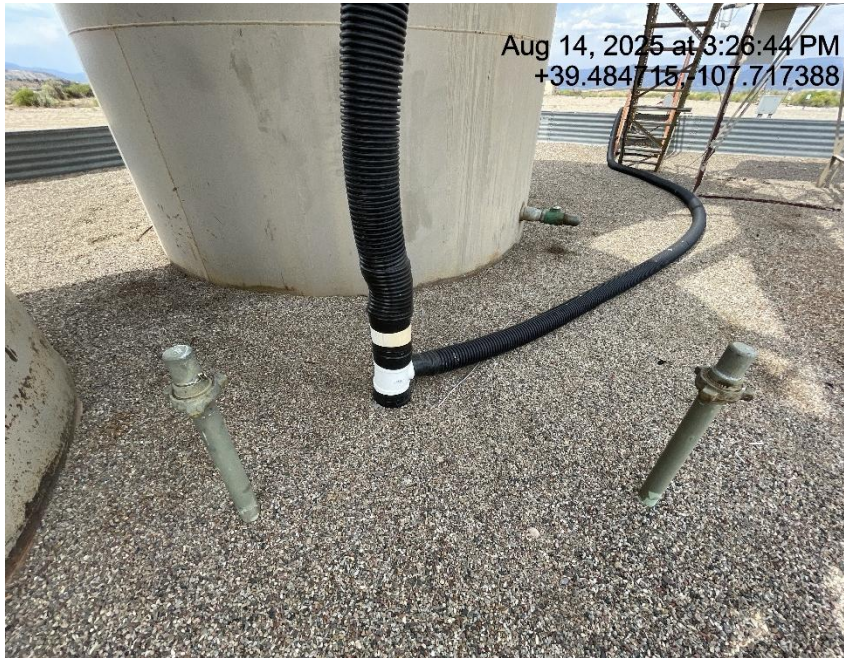
Photo # 953 Unused flowlines lack lockout tagout (OOSLAT)
