## Inspection/Audit Photos

Location Name: TEP ROCKY MOUNTAIN LLC LEVERICH 31-09 Pad

Location ID: 334711

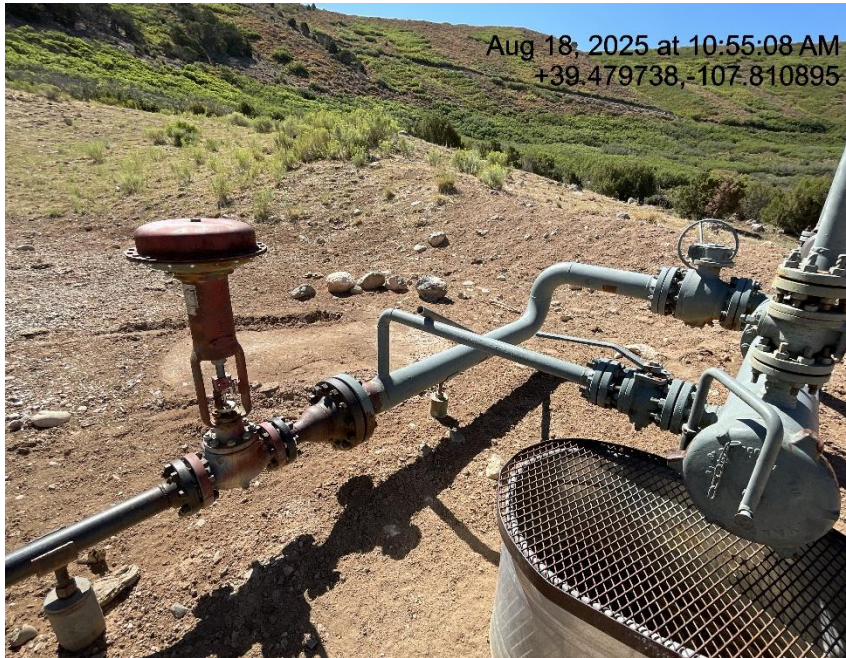
**Photo # 1068 Pneumatic control valve on Summit Midstream pipeline has been modified/valve no longer has the ability to close**

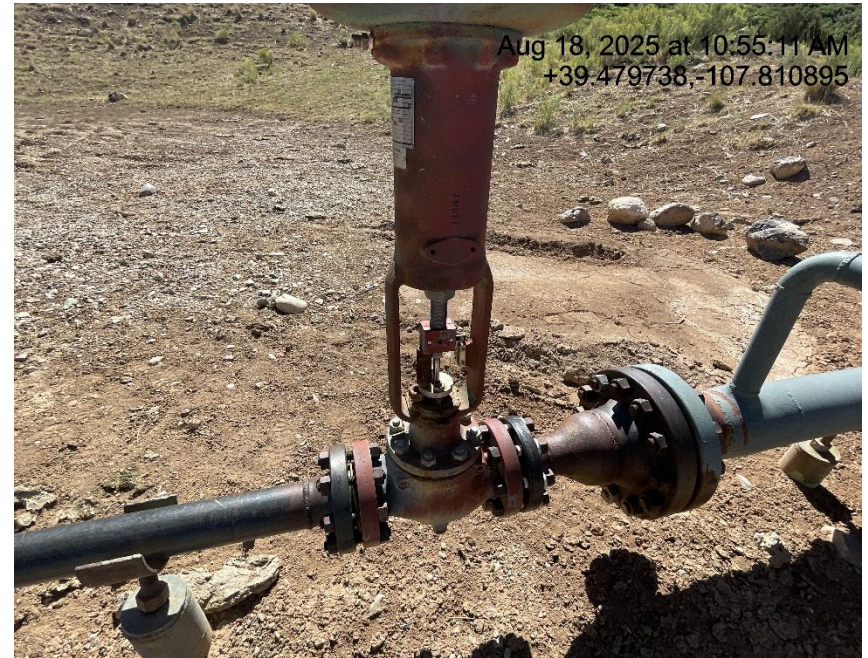
**Photo # 1069 Pneumatic control valve on Summit Midstream pipeline has been modified/valve no longer has the ability to close**

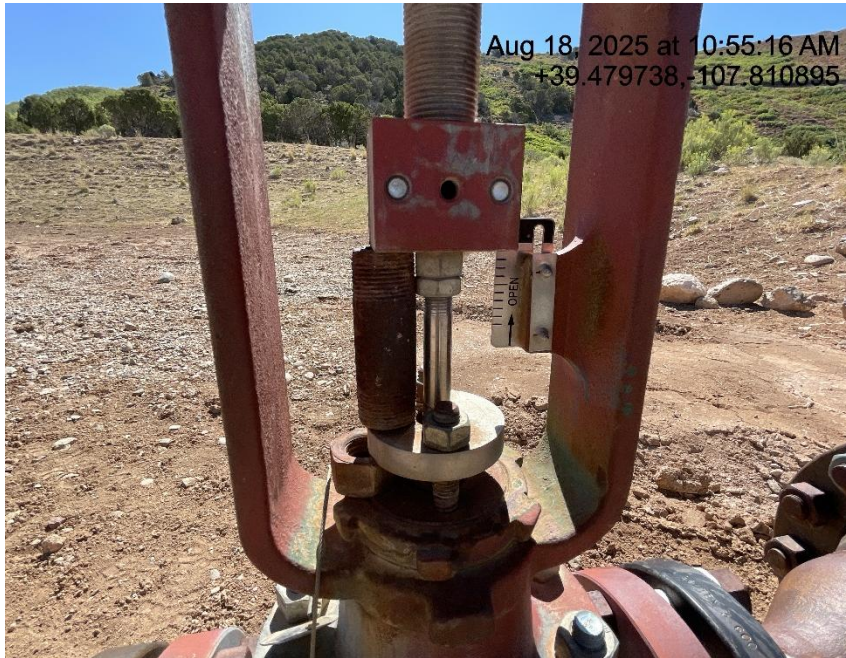
**Photo # 1070 Pneumatic control valve on Summit Midstream pipeline has been modified/valve no longer has the ability to close**
