Inspection/Audit Photos

Location: PLUG NICKEL OIL COMPANY INC MURPHY A-4 PAD

Location ID: 314344

Date: 08/18/2025

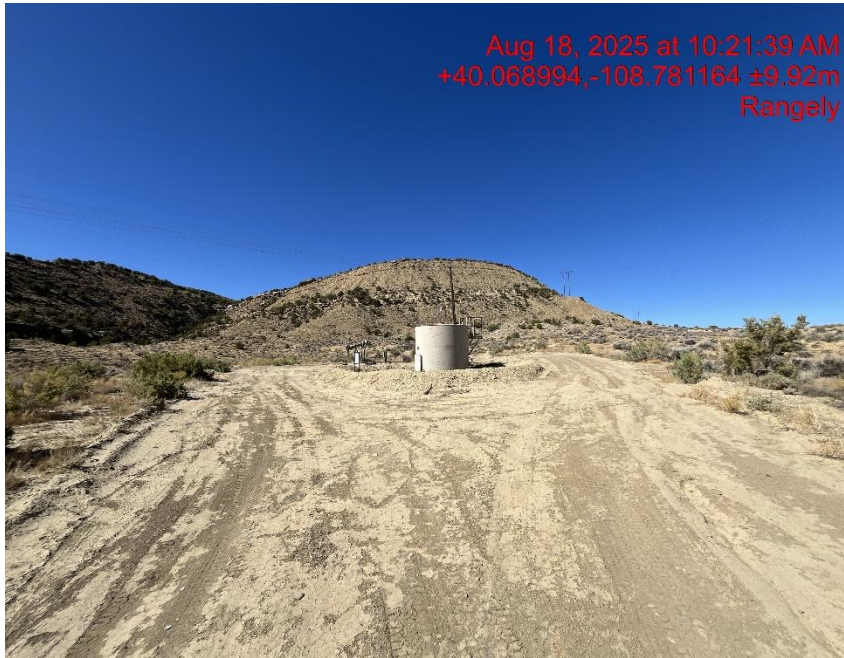
Photo # 2001 Entrance to location

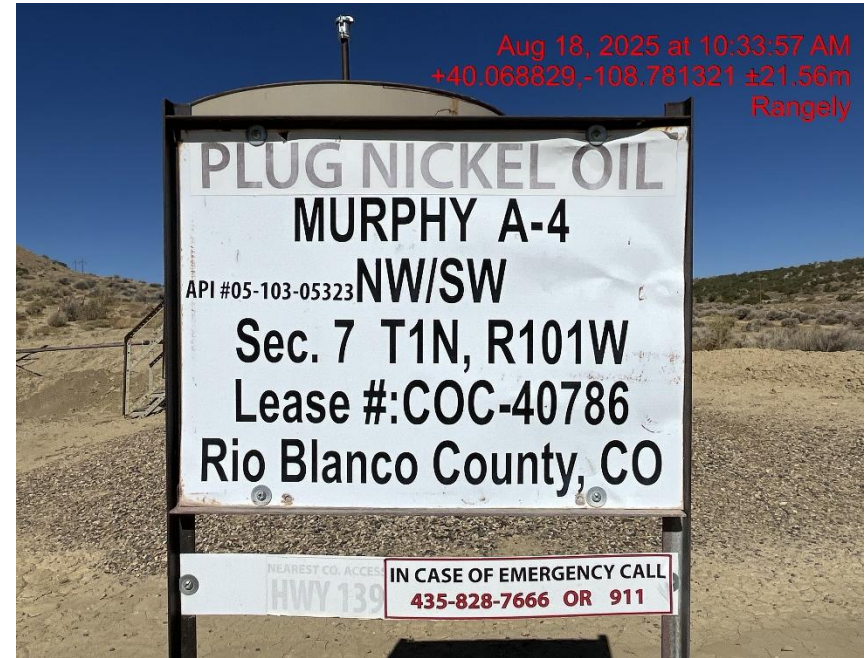
Photo # 2010 Location

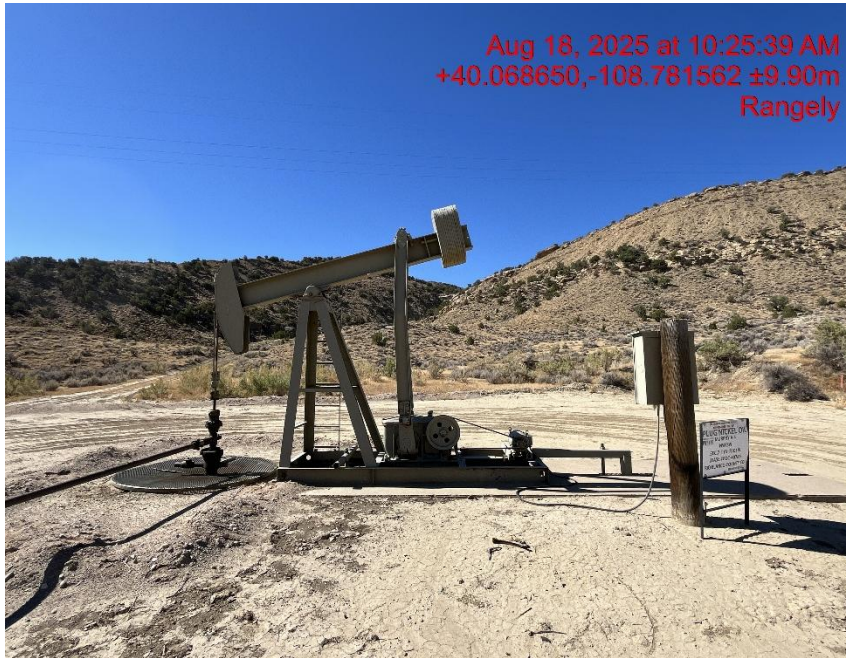
Photo # 2002 Location

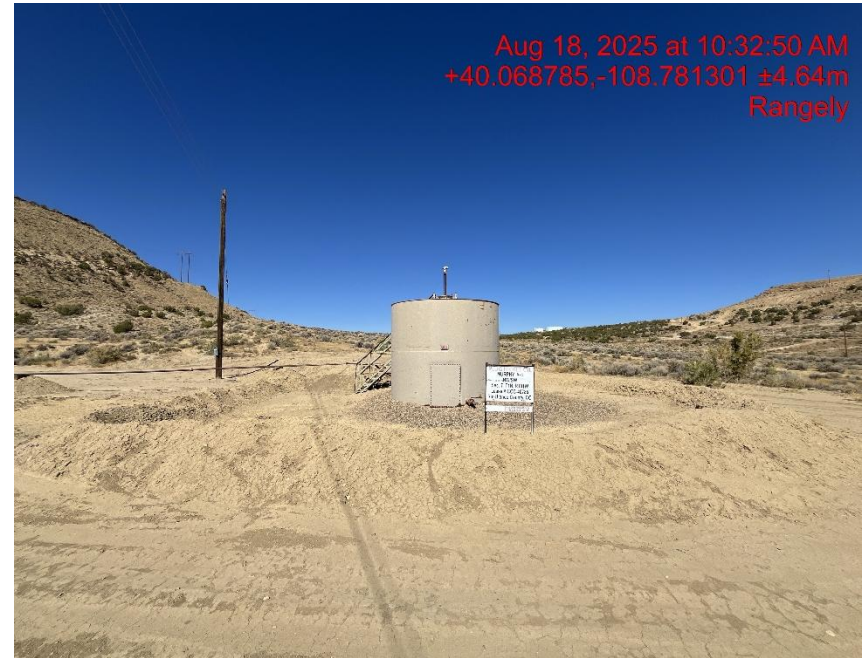
Photo # 2008 Location

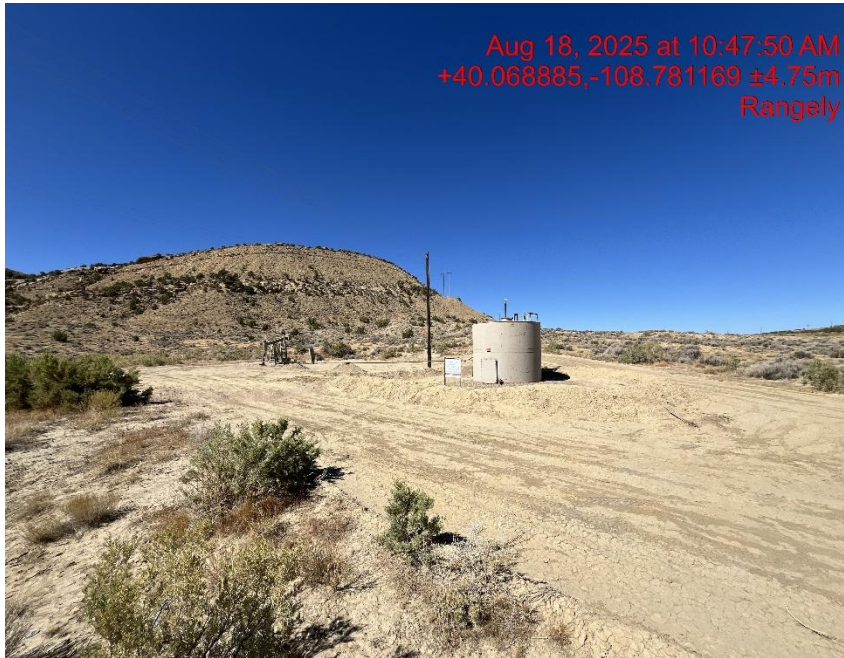
Photo # 2016 NE corner of location

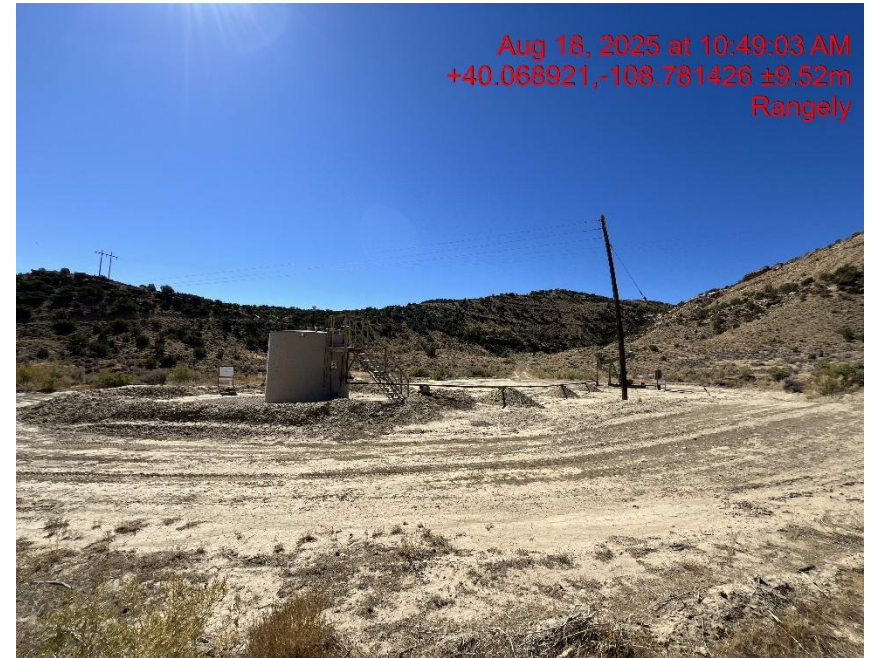
Photo # 2017 NW corner of location

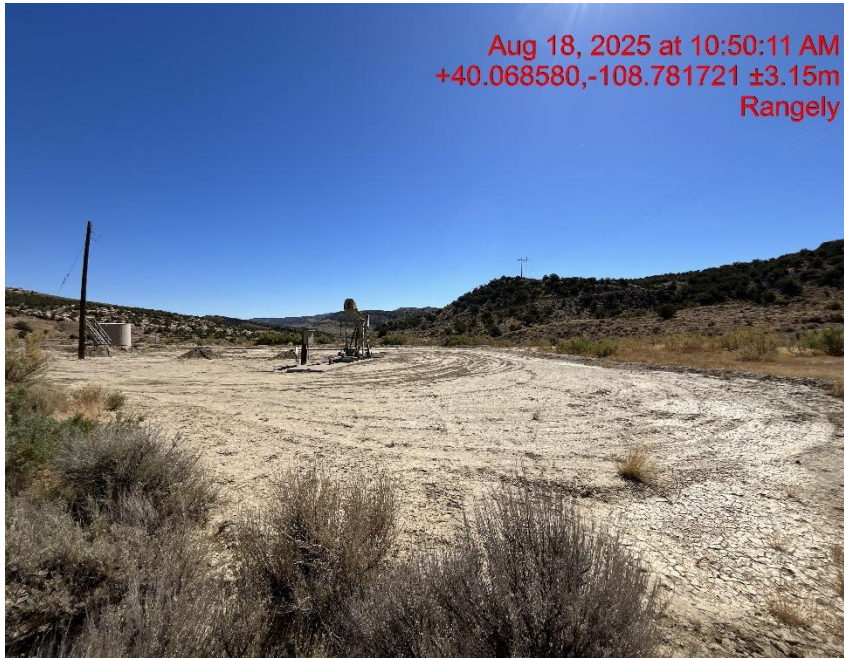
Photo # 2018 SW corner of location

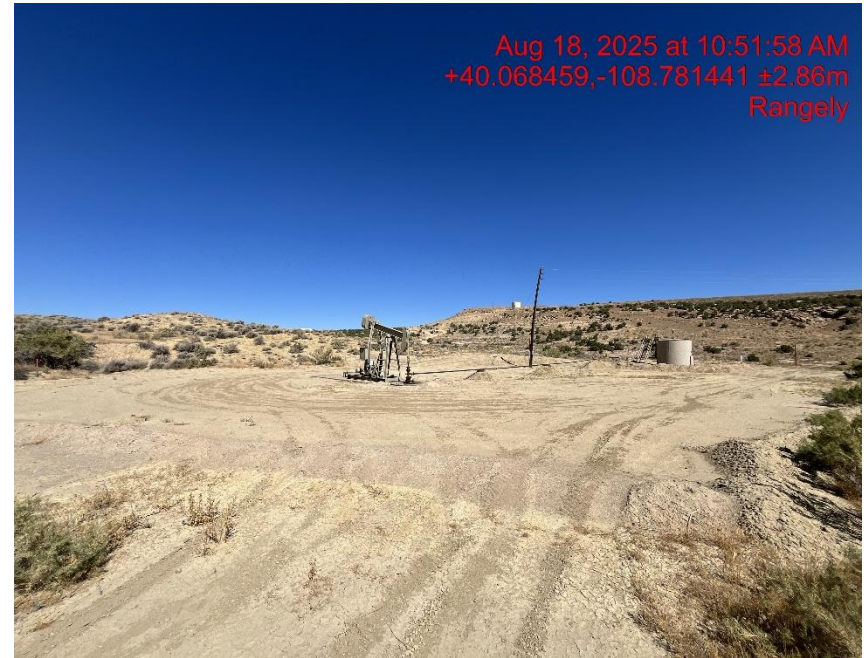
Photo # 2019 SE corner of location

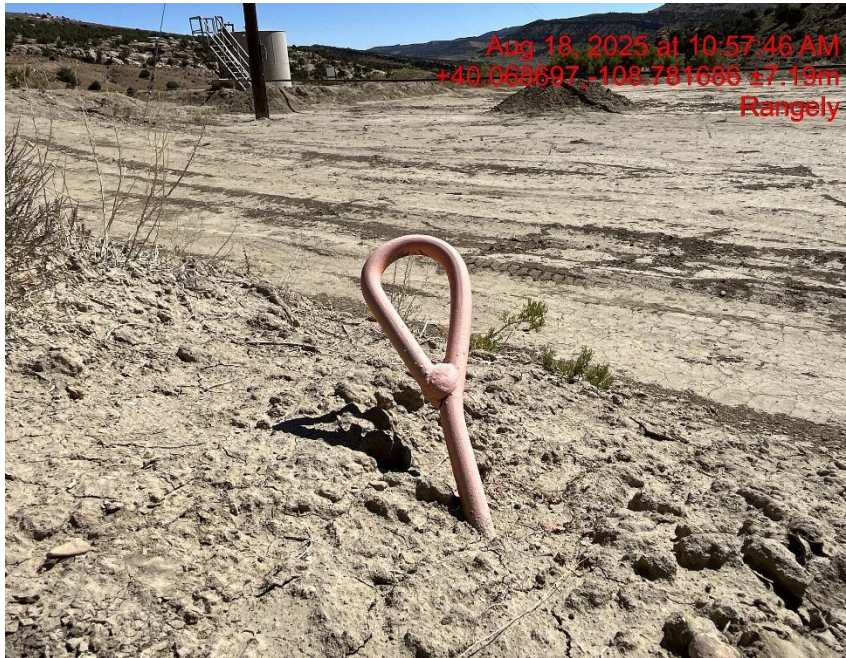
Photo # 2025 Unmarked deadman

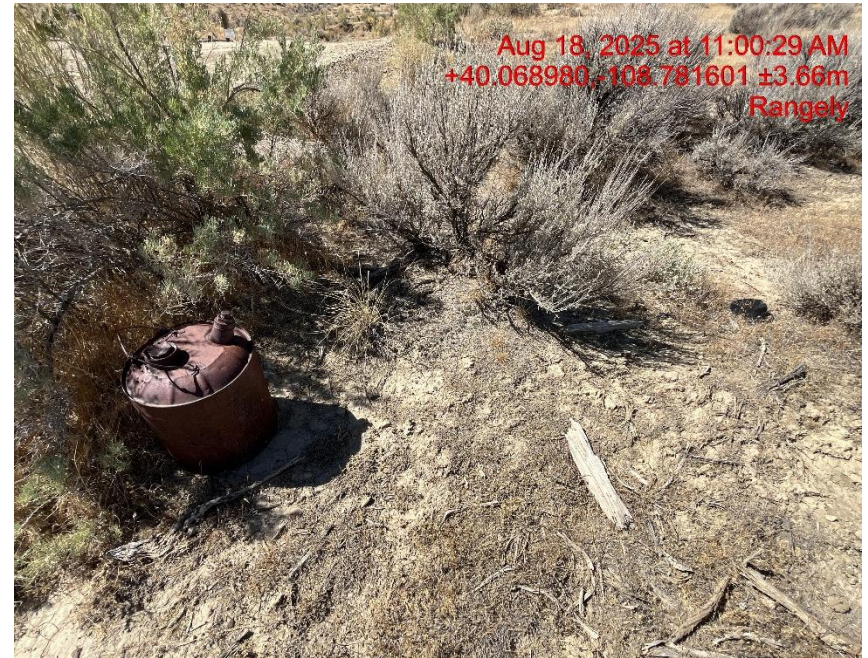
Photo # 2026 Debris

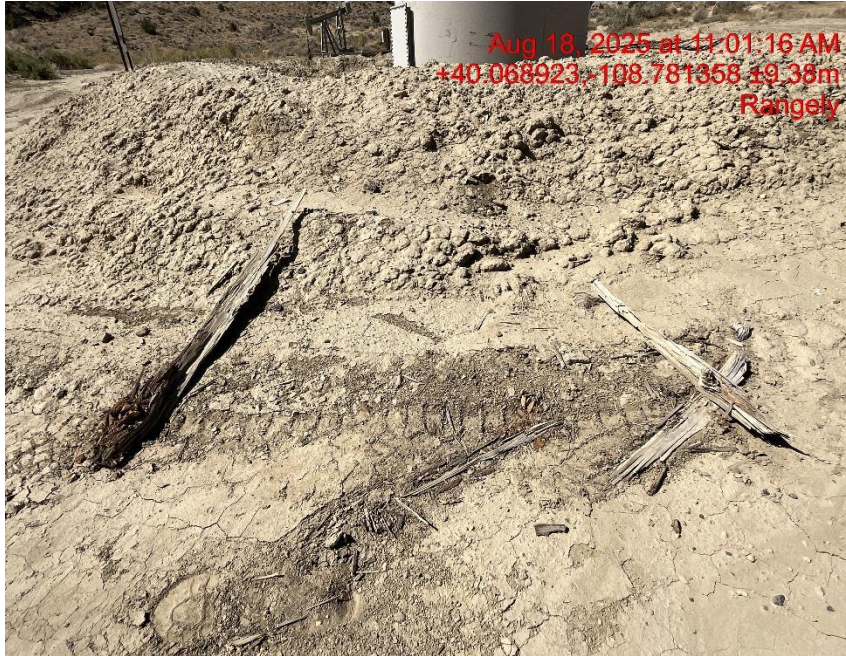
Photo # 2028 Debris

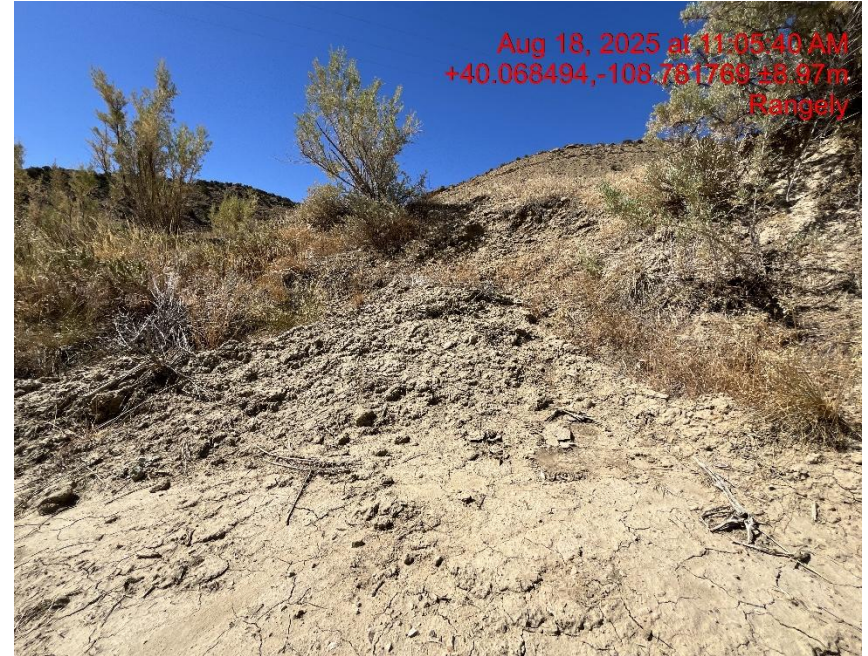
Photo # 2030 Stockpiled soils with no BMP's

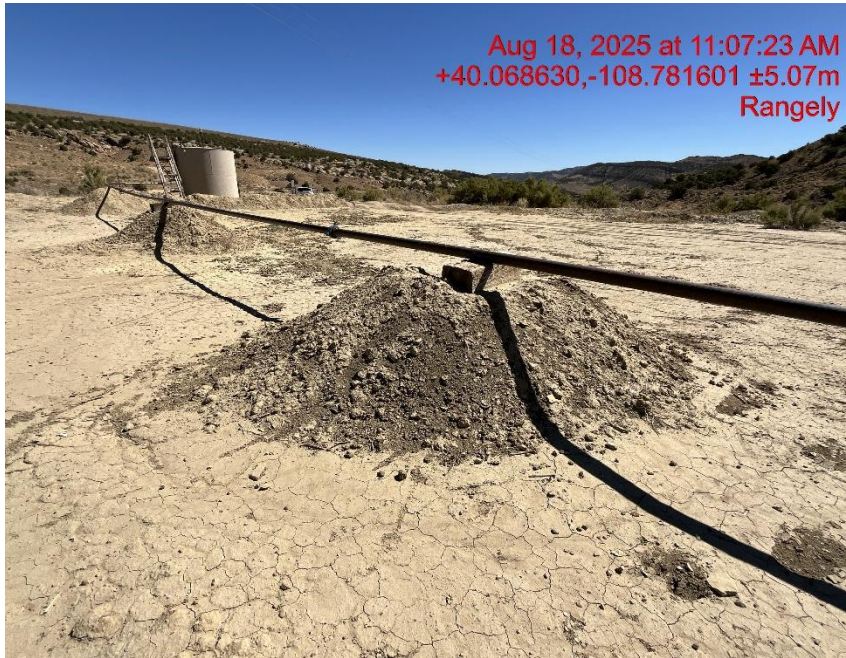
Photo # 2033 Stockpiled soils with no BMP's

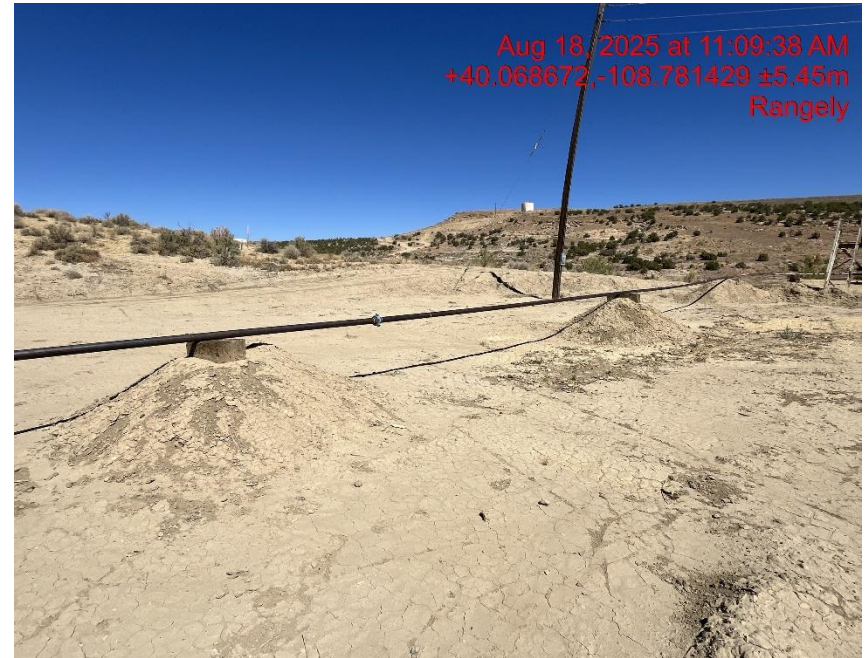
Photo # 2037 Stockpiled soils with no BMP's

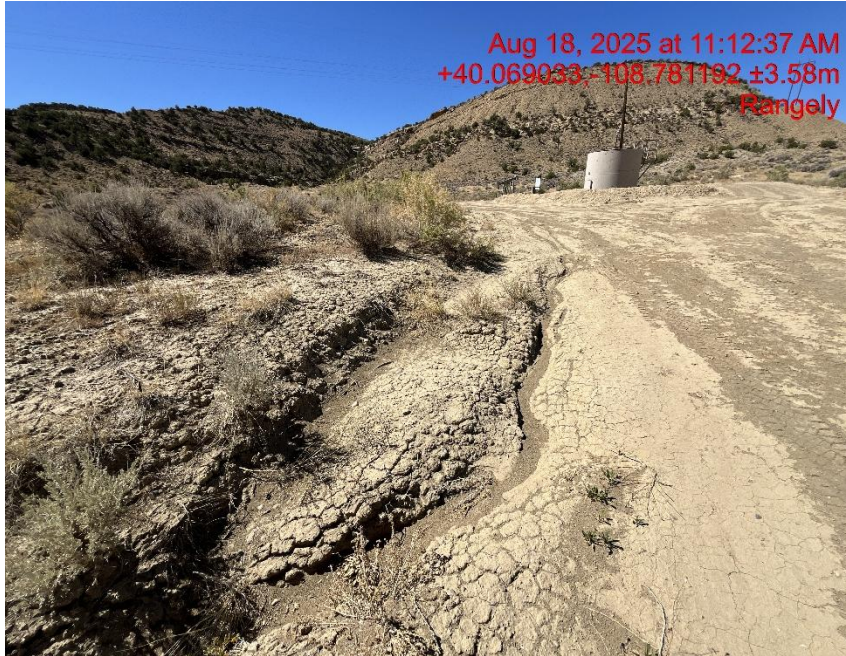
Photo # 2038 Failure to minimize erosion & transport of sediment off location/insufficient BMP's

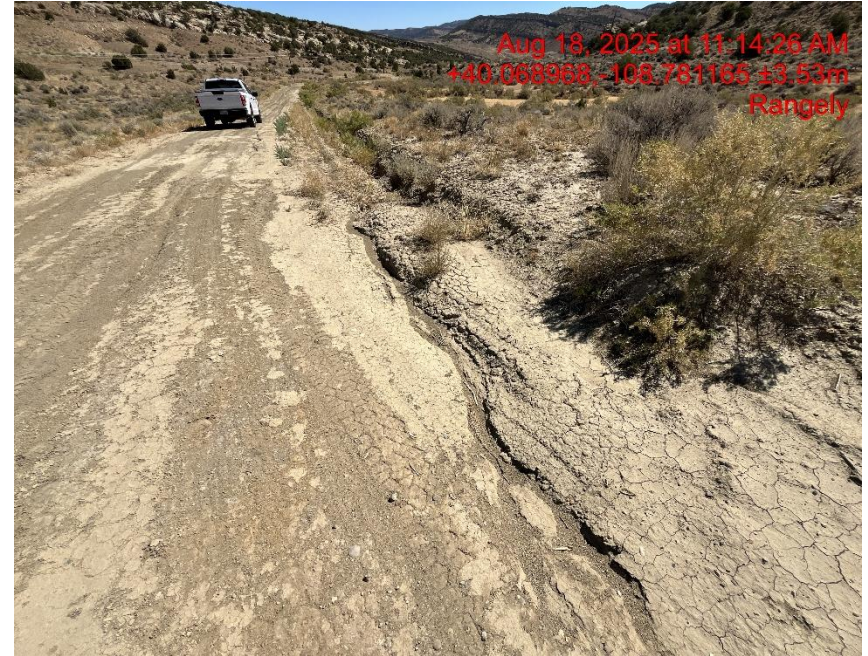
Photo # 2040 Failure to minimize erosion & transport of sediment off location/insufficient BMP's
