Inspection/Audit Photos

Location: PLUG NICKEL OIL COMPANY INC MURPHY A-2 PAD

Location ID: 314341

Date: 08/18/2025

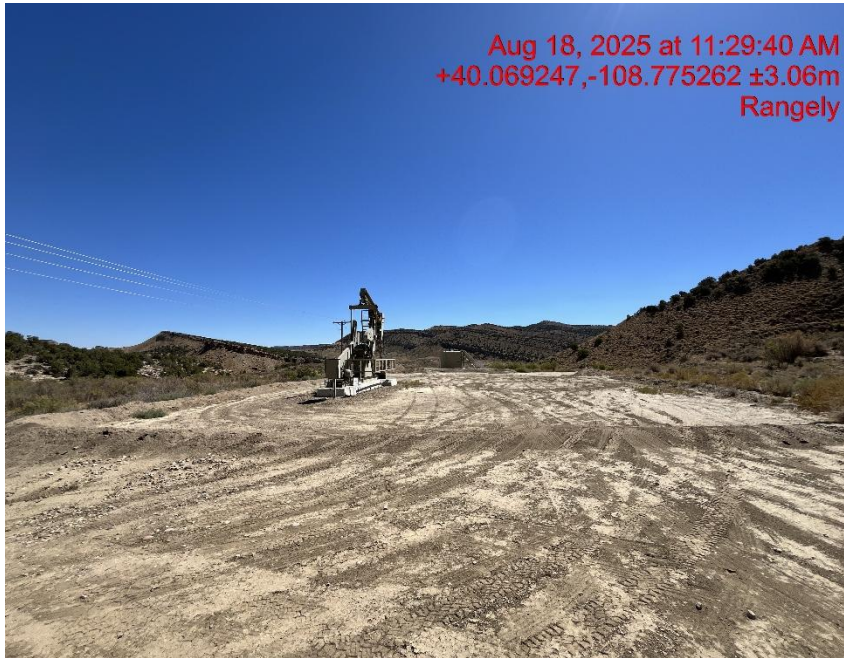
Photo # 2049 Entrance to location

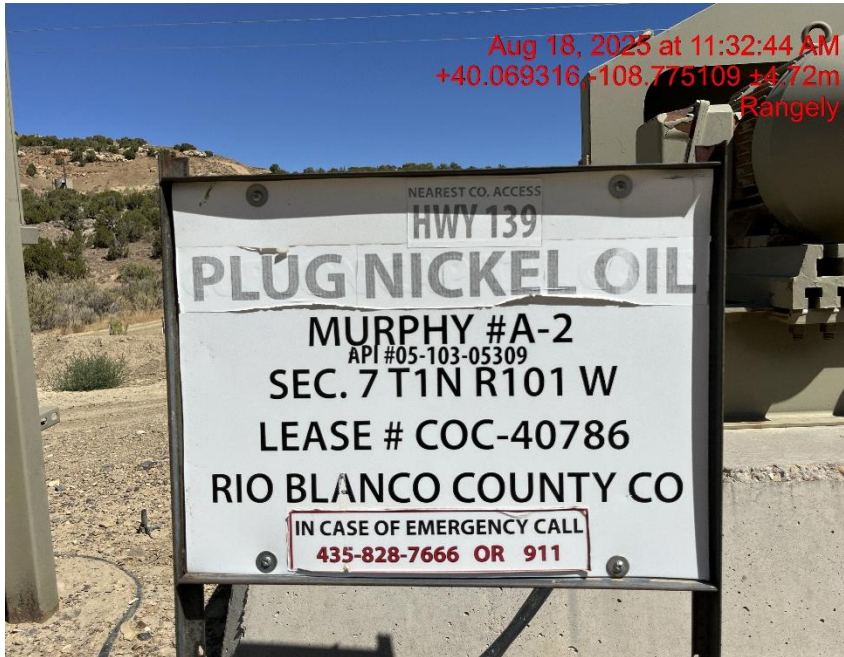
Photo # 2051 Wellhead sign lacks quarter/quarter section information. Additionally operator label is peeling but still legible.

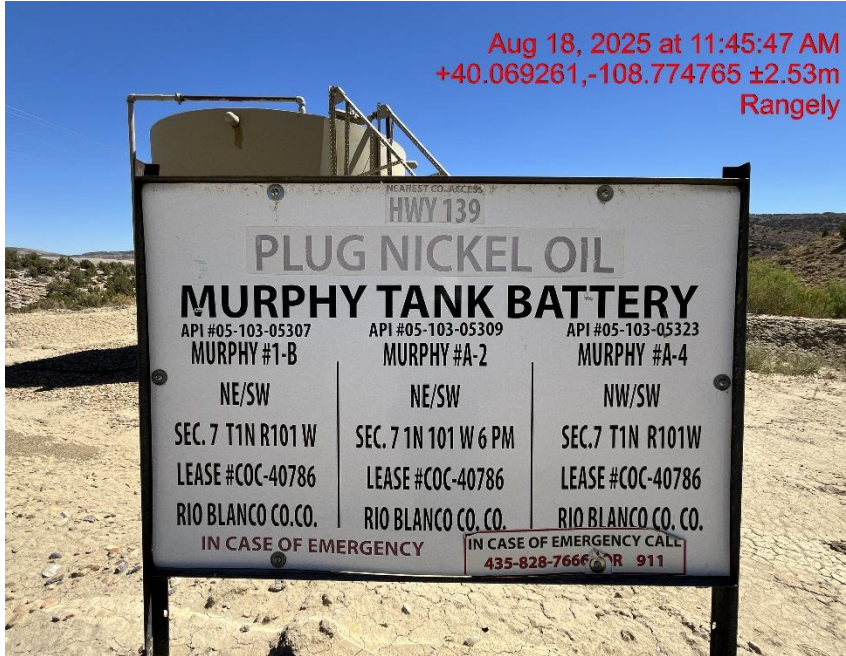
Photo # 2063 Tank battery sign

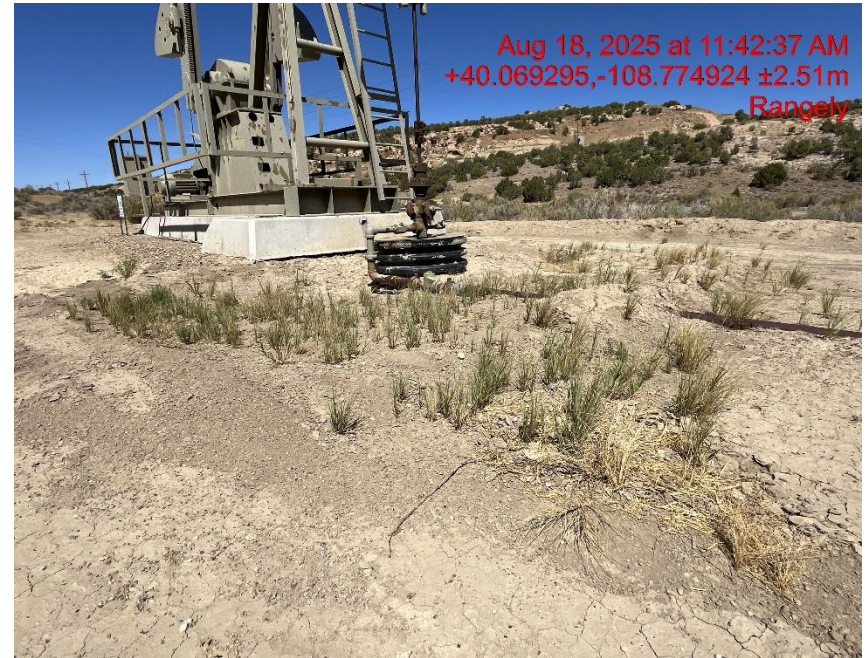
Photo # 2060 Small amount of weeds near wellhead

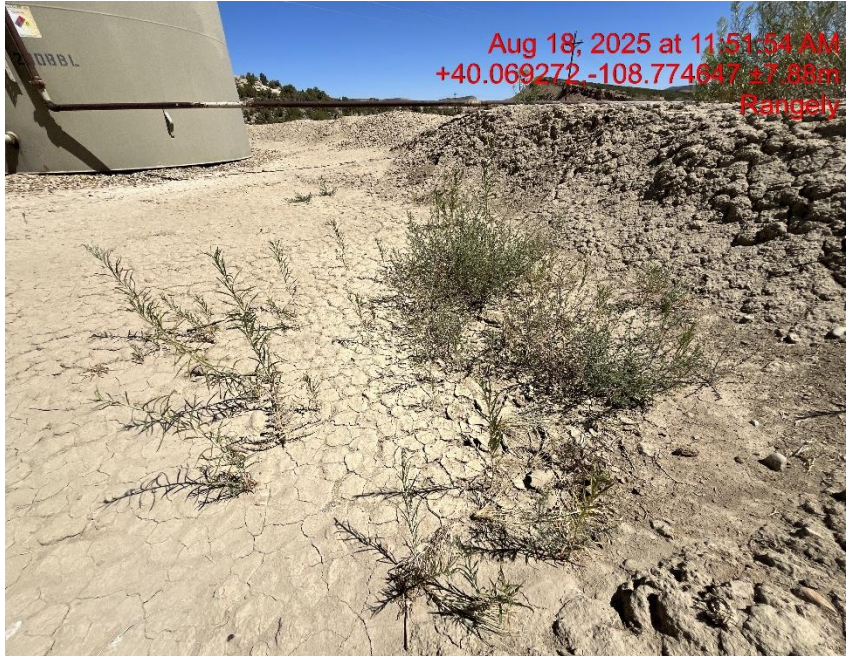
Photo # 2069 Small amount of weeds in secondary containment

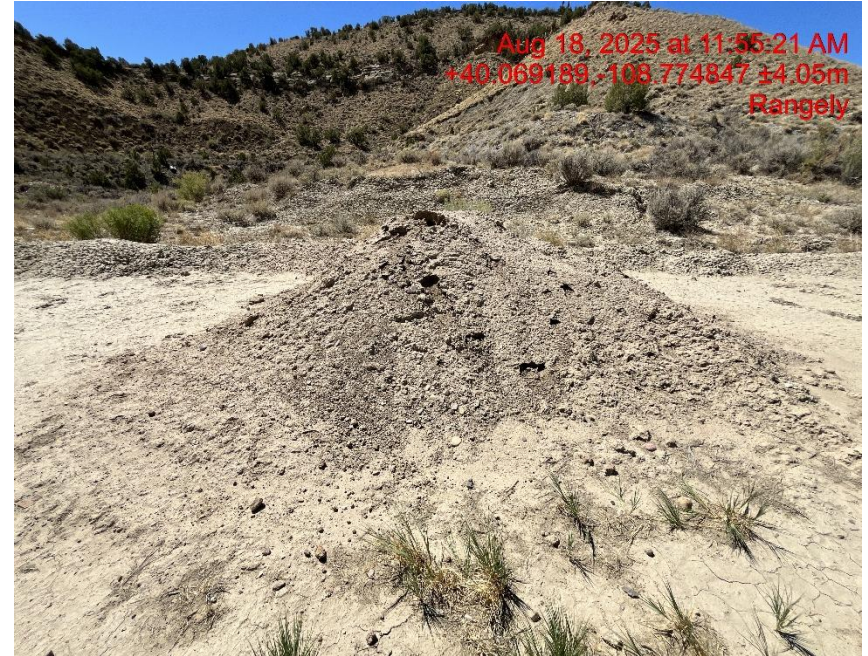
Photo # 2073 Stockpiled soils with no BMP's

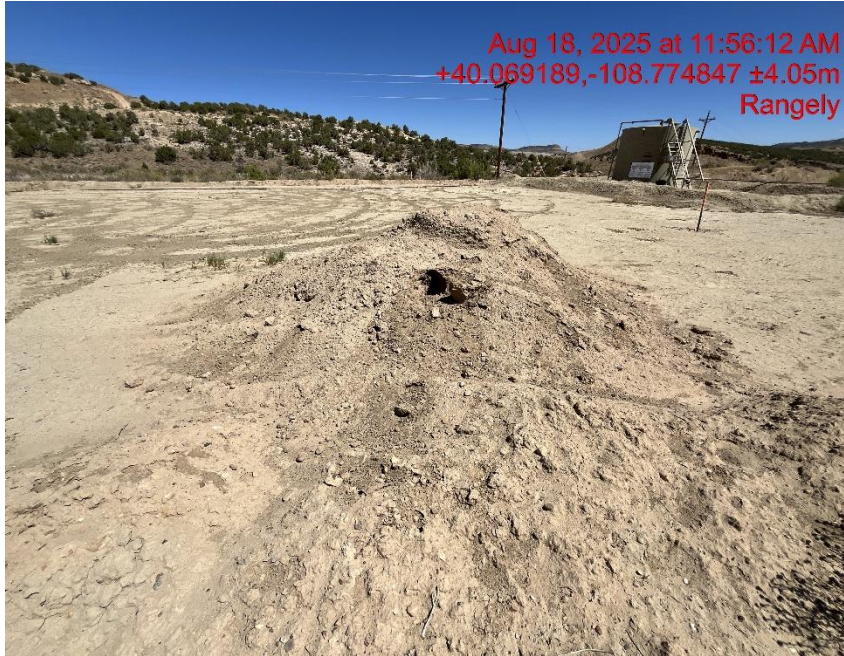
Photo # 2075 Stockpiled soils with no BMP's

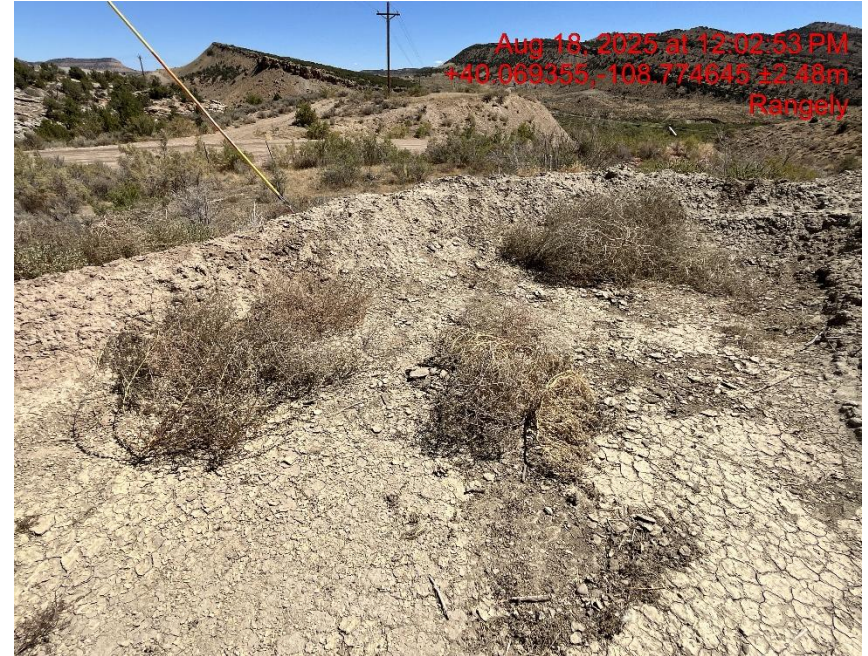
Photo # 2080 Debris
