Inspection/Audit Photos

Location: PLUG NICKEL OIL COMPANY INC MURPHY-GOVERNMENT 1-B PAD

Location ID: 314340

Date: 08/18/2025

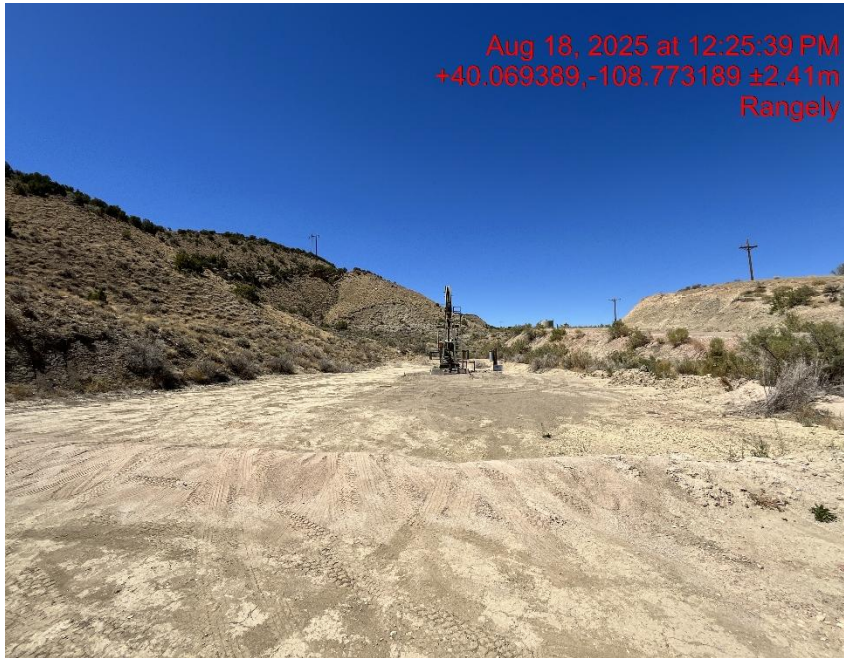
Photo # 2096 Entrance to location

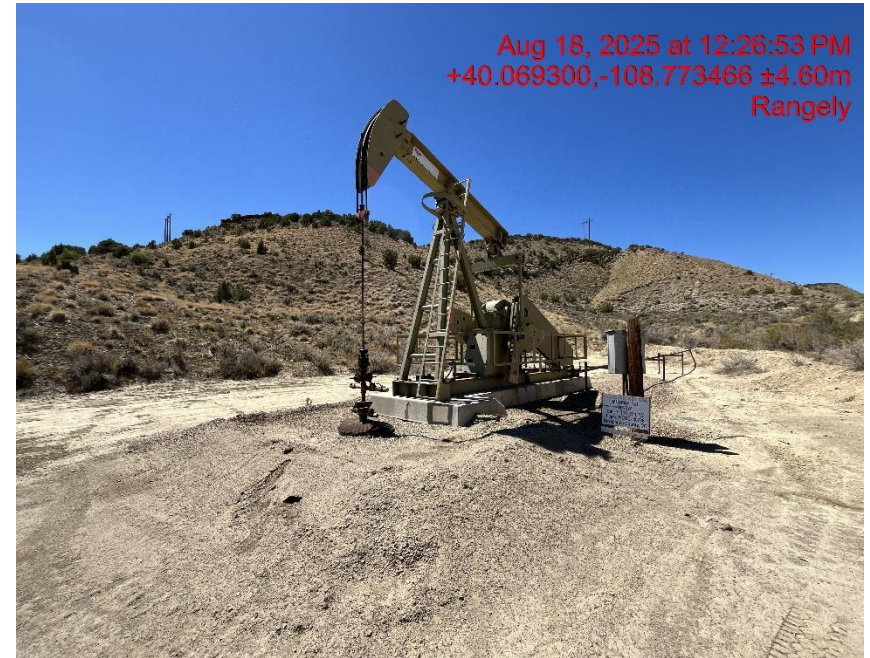
Photo # 2097 Location

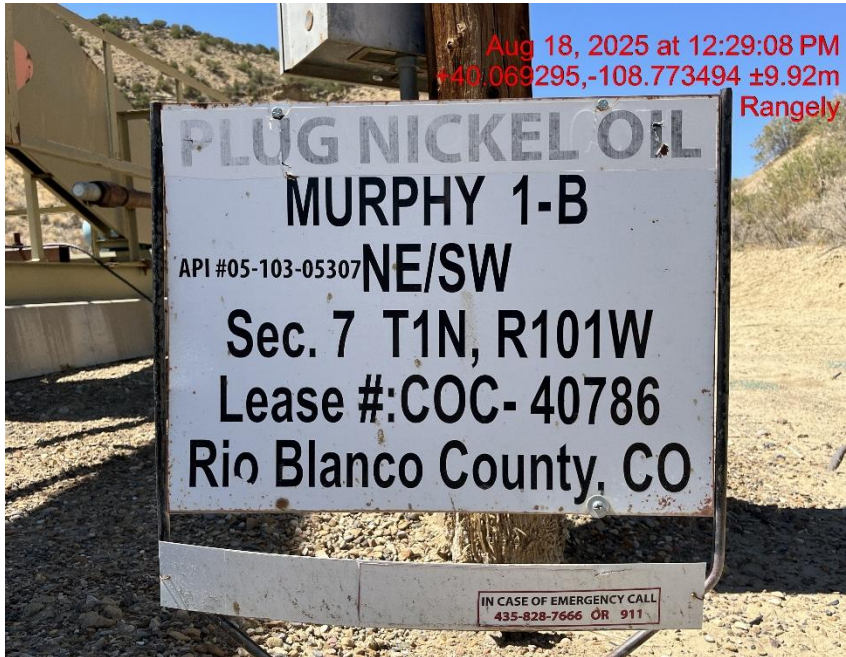
Photo # 2099 Wellhead sign lacks nearest public road access information. Additionally operator name is weathered & cracking/starting to become illegible

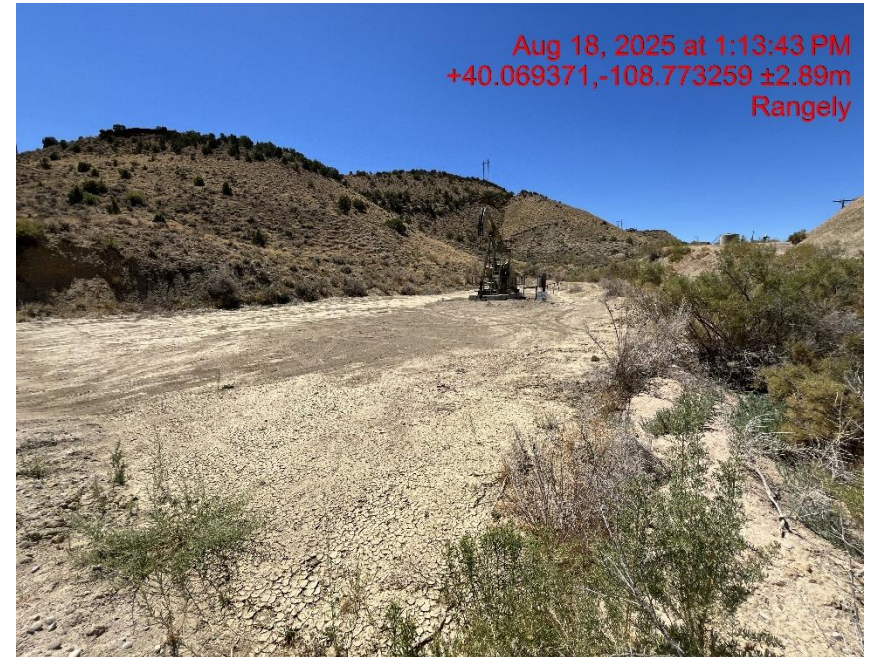
Photo # 2146 NE corner of location

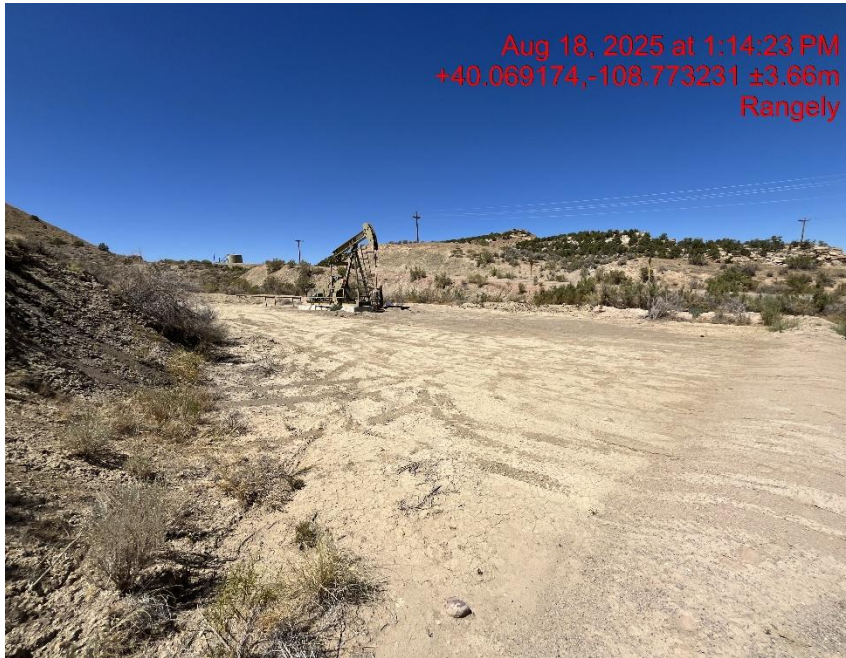
Photo # 2147 SE corner of location

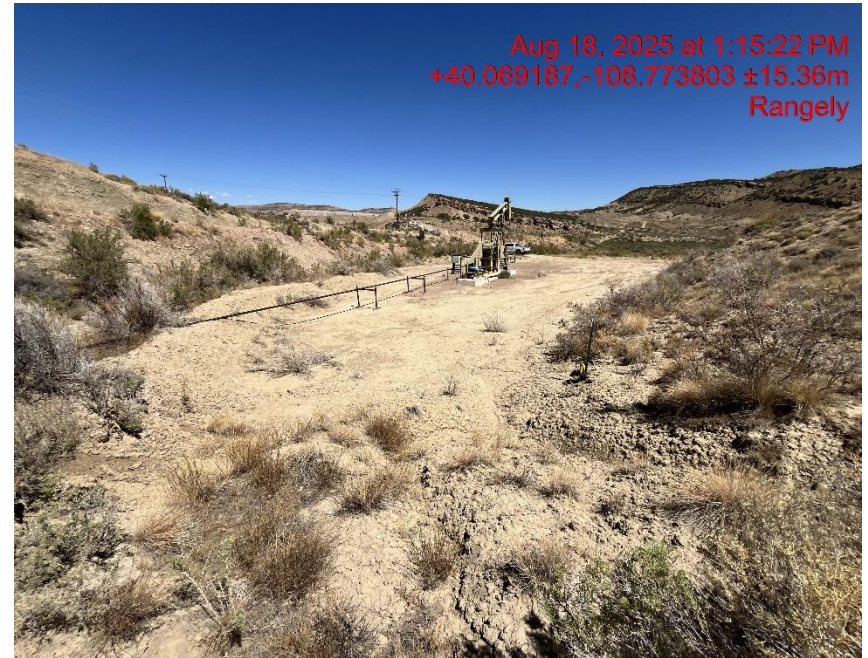
Photo # 2148 SW corner of location

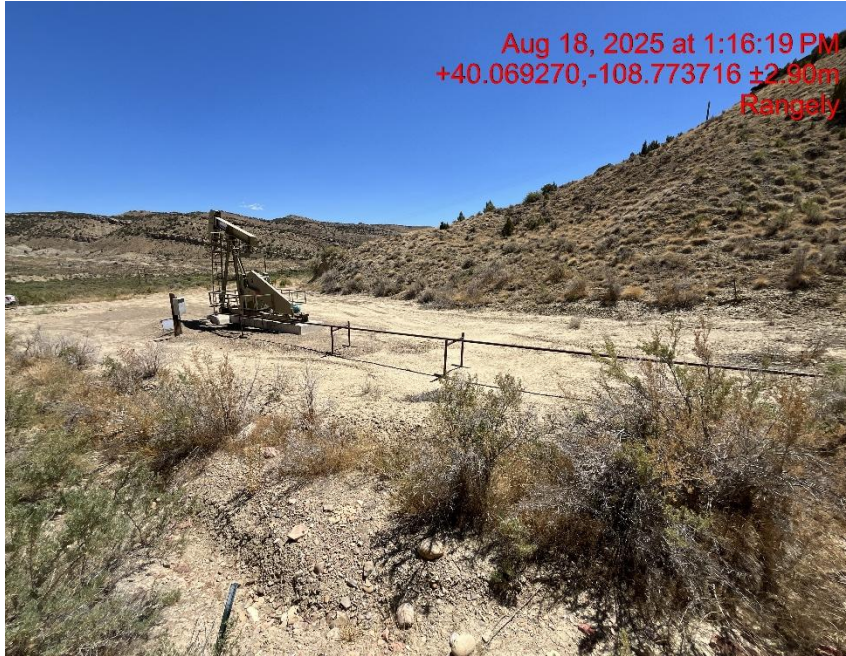
Photo # 2149 NW corner of location

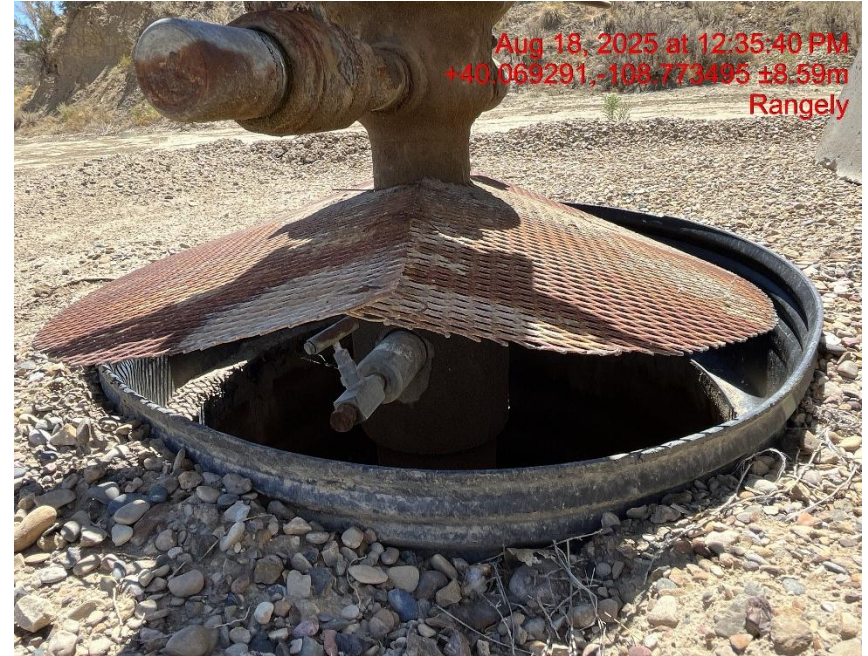
Photo # 2105 Improperly covered wellhead cellar lacks wildlife egress/available for entry by wildlife

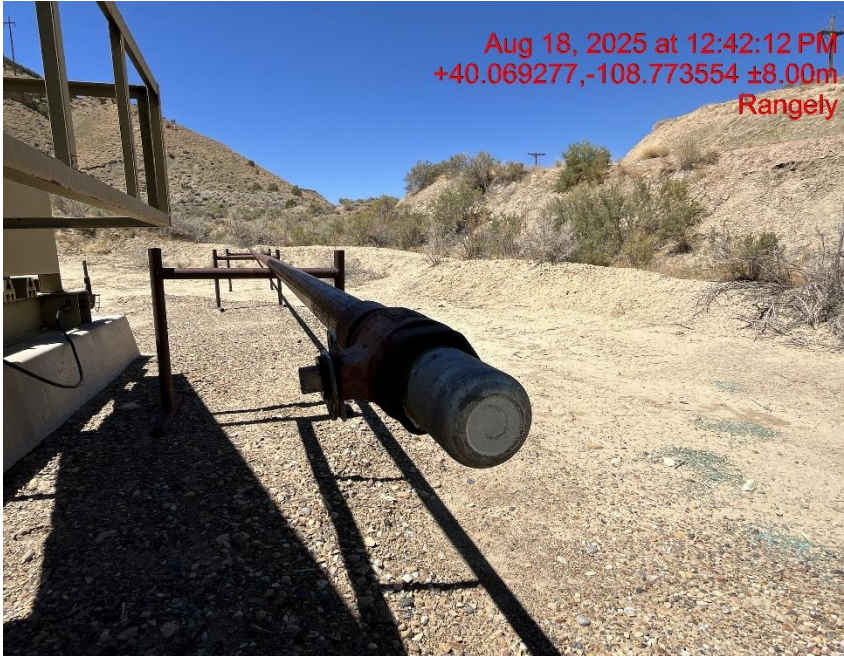
Photo # 2112 Unused flowline lacks lockout tagout (OOSLAT)

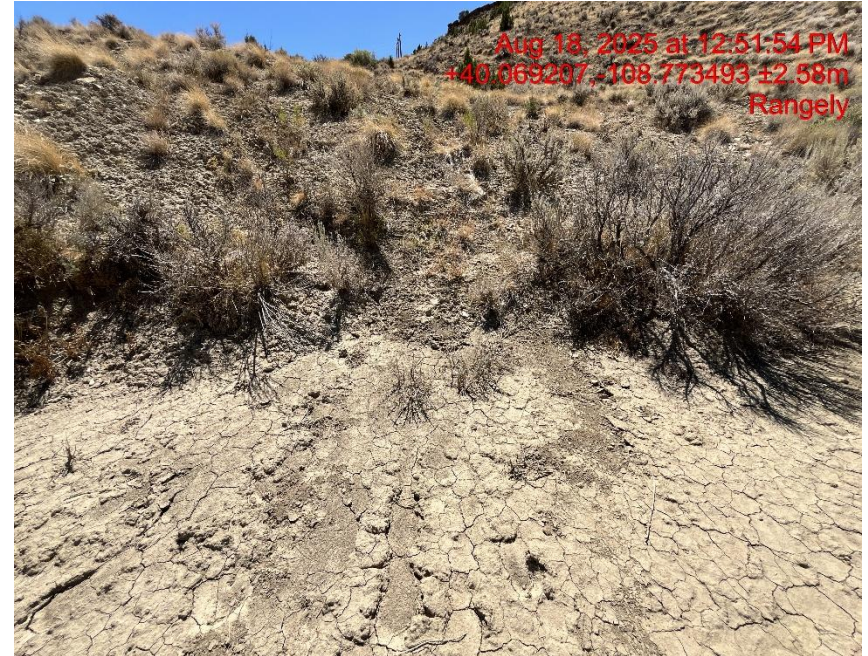
Photo # 2117 Failure to minimize erosion & transport of sediment onto location/insufficient BMP's

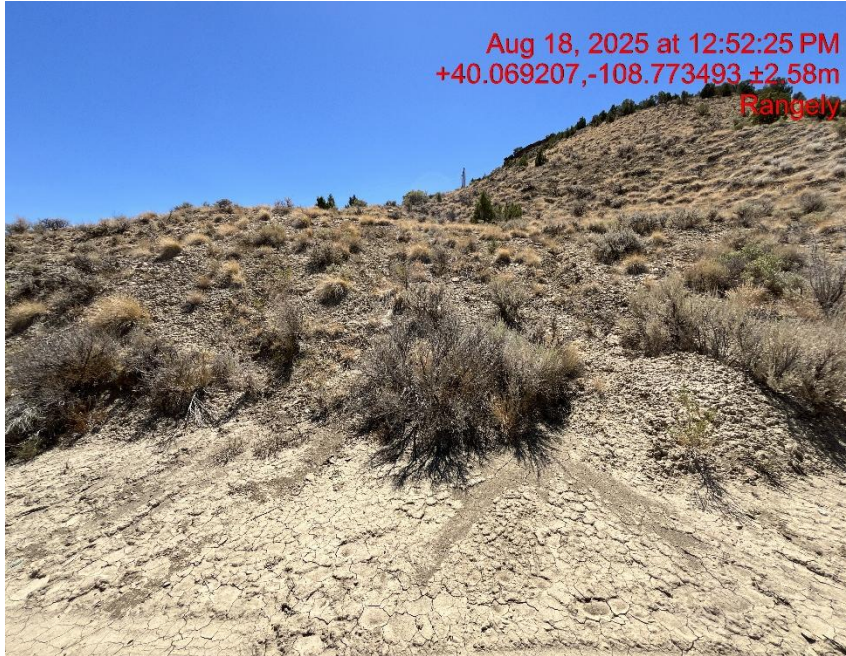
Photo # 2118 Failure to minimize erosion & transport of sediment onto location/insufficient BMP's

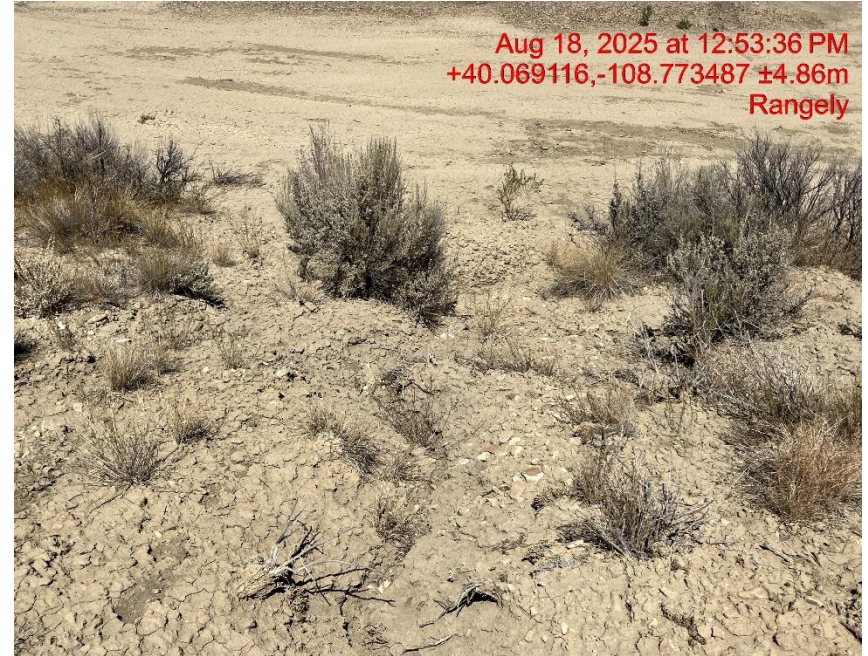
Photo # 2119 Failure to minimize erosion & transport of sediment onto location/insufficient BMP's

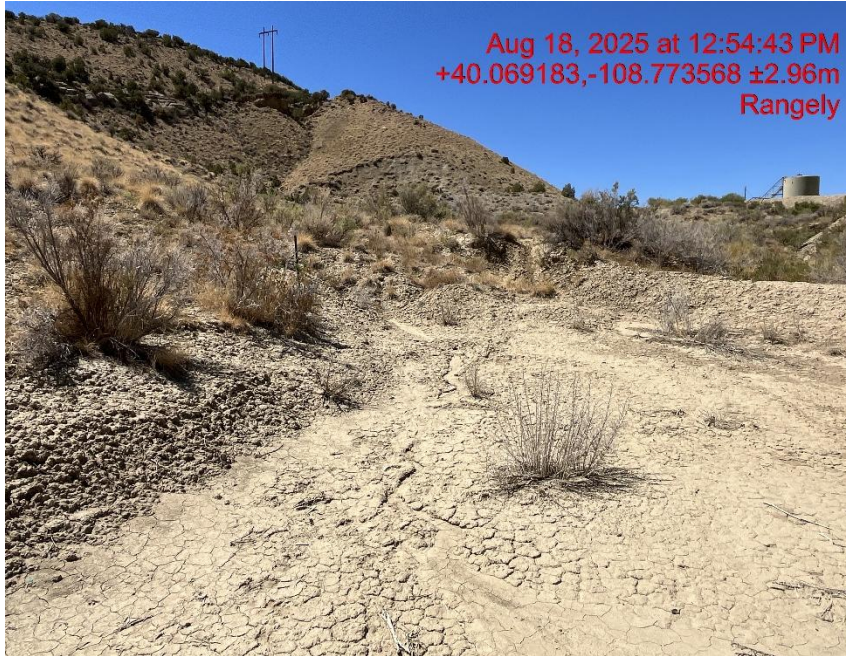
Photo # 2121 Failure to minimize erosion & transport of sediment onto location/insufficient BMP's

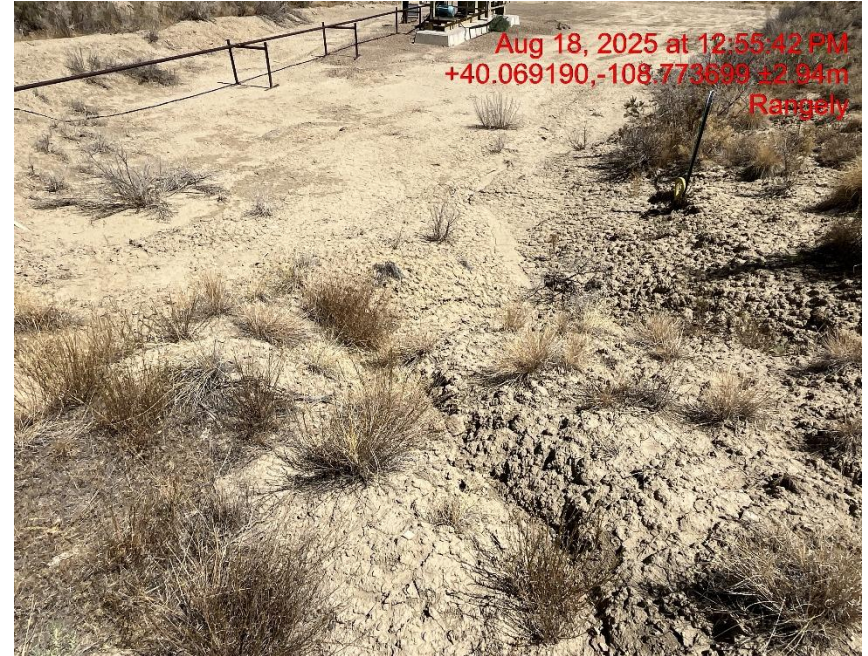
Photo # 2122 Failure to minimize erosion & transport of sediment onto location/insufficient BMP's

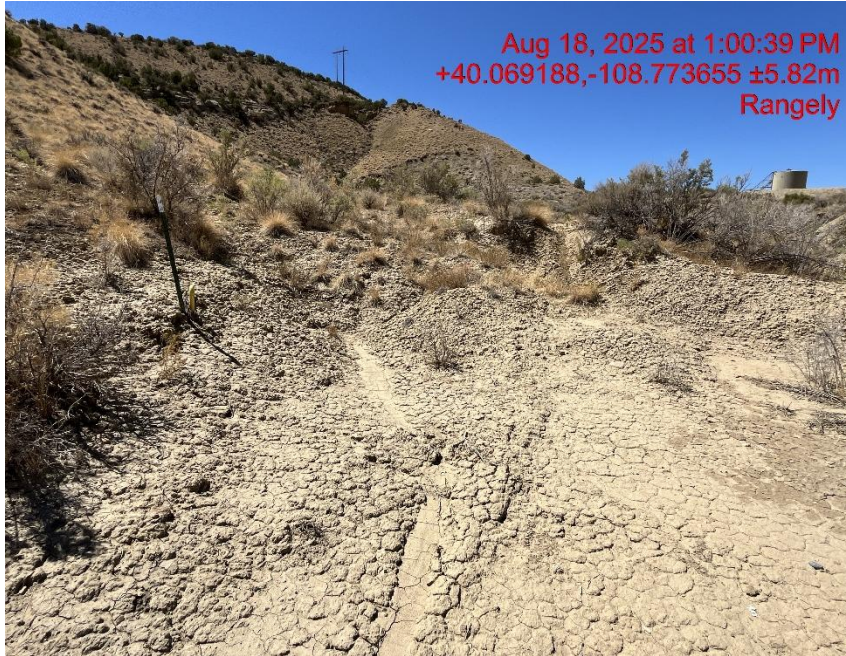
Photo # 2126 Failure to minimize erosion & transport of sediment onto location/insufficient BMP's

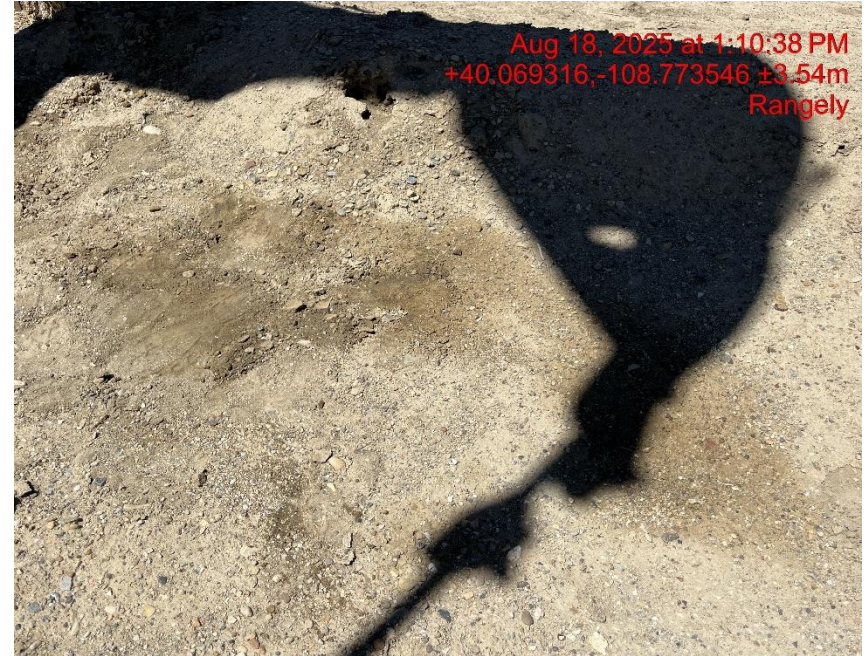
Photo # 2144 Staining
