Inspection/Audit Photos

Location: UTAH GAS OP LTD DBA UTAH GAS CORP FEDERAL #E-17-2-101-S PAD

Location ID: 315607

Date: 08/20/2025

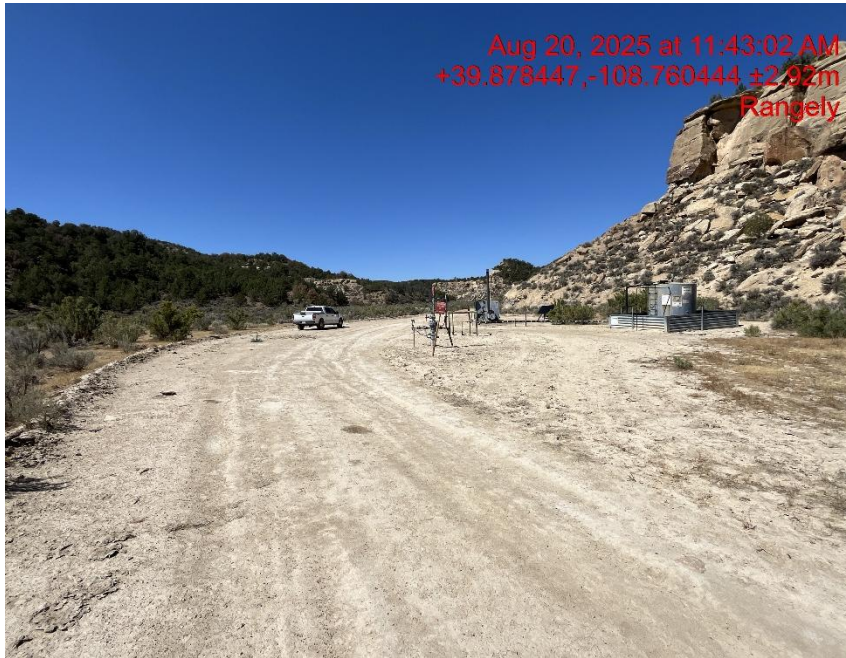
Photo # 2295 Entrance to location

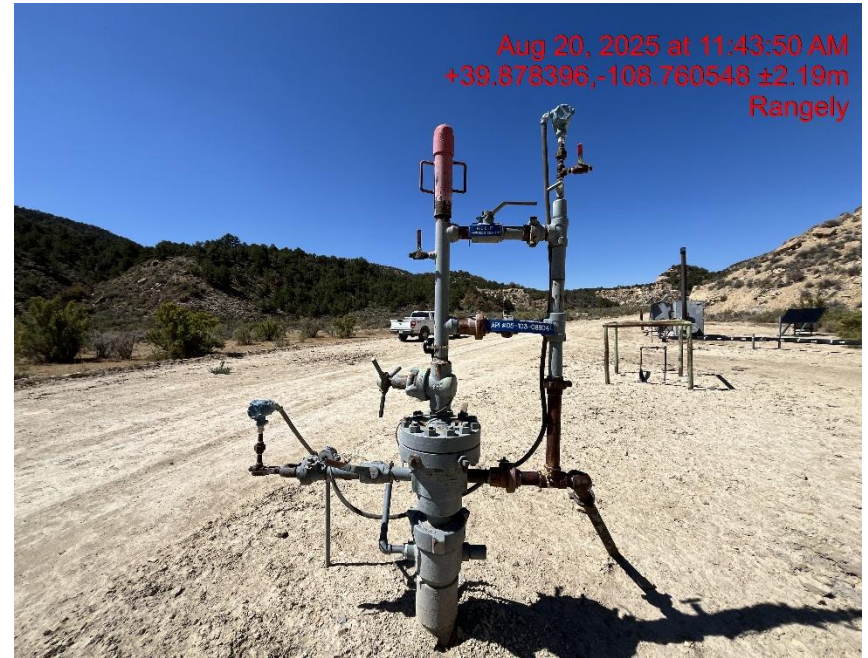
Photo # 2296 Location

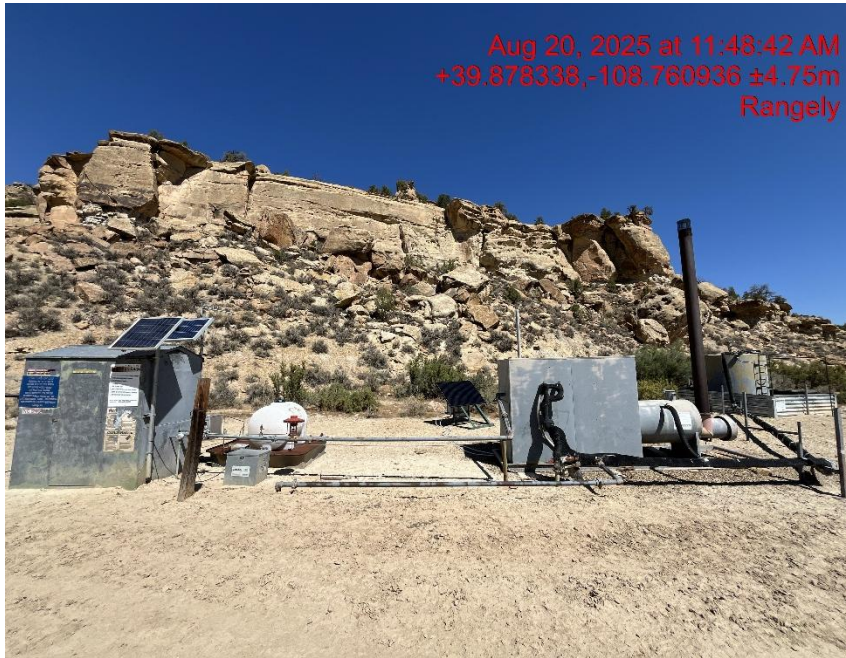
Photo # 2301 Location

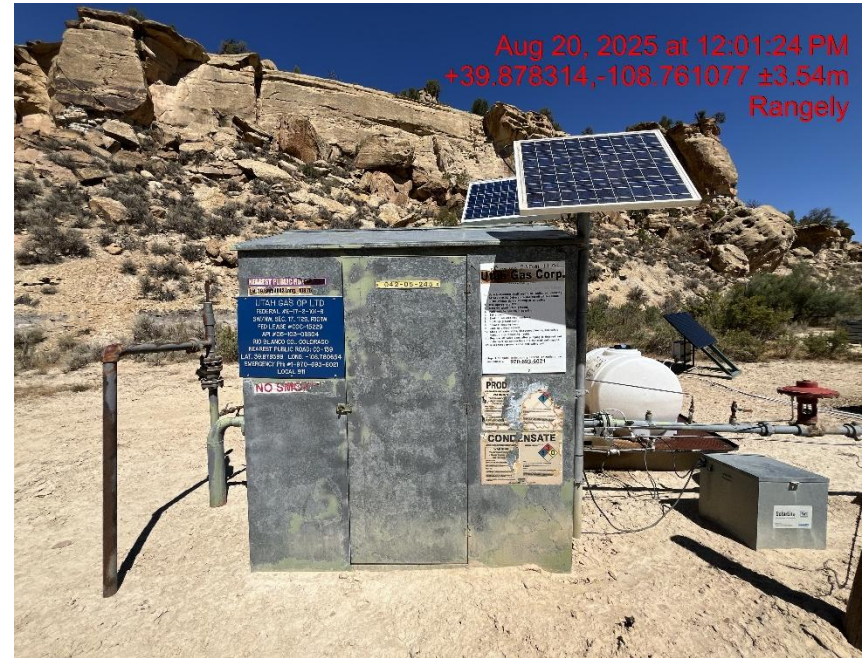
Photo # 2316 Location

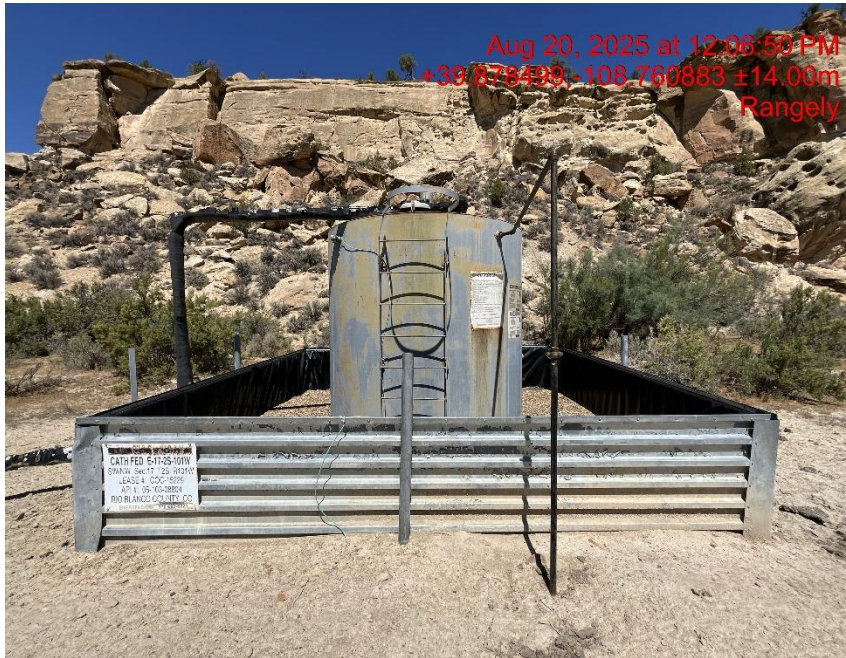
Photo # 2323 Location

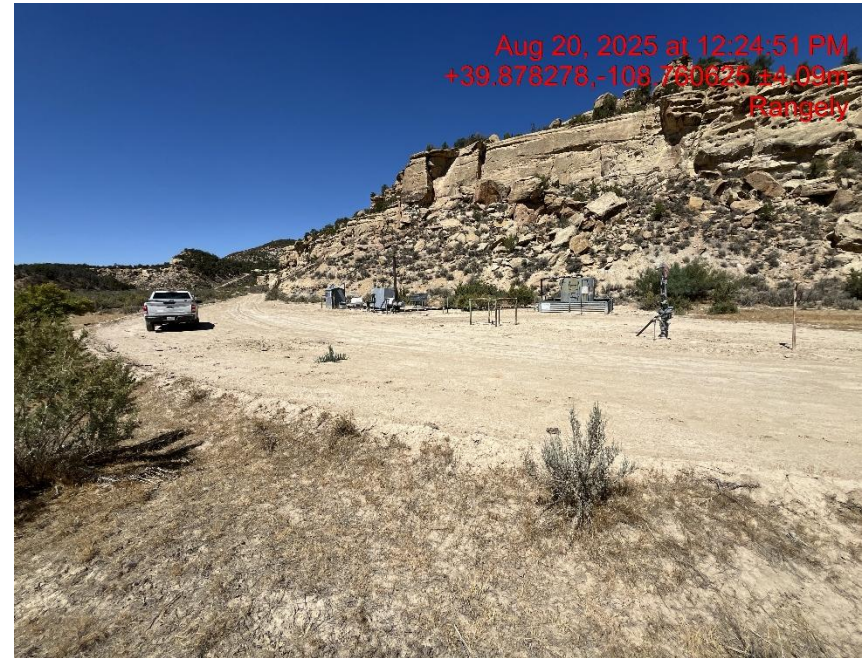
Photo # 2336 SE corner of location

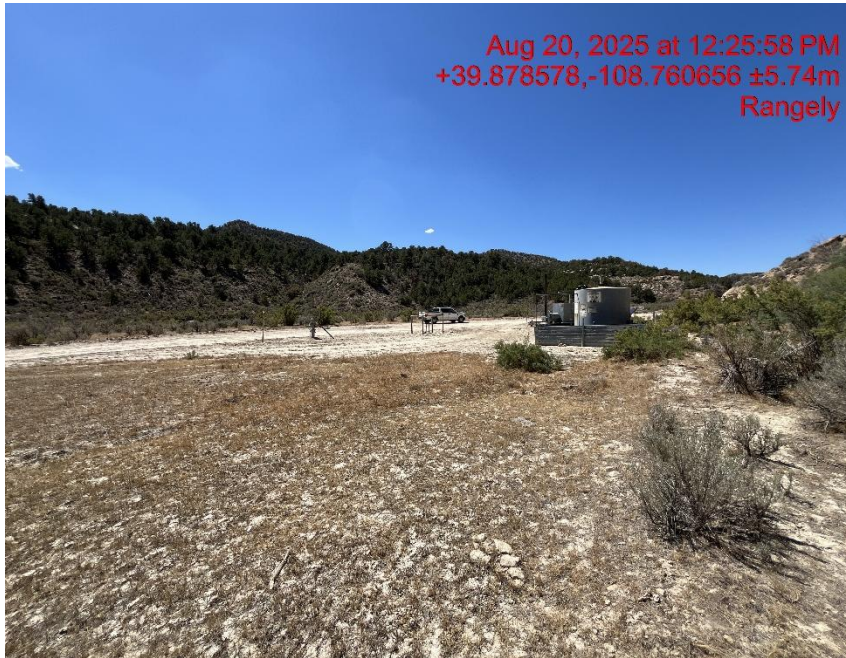
Photo # 2337 NE corner of location

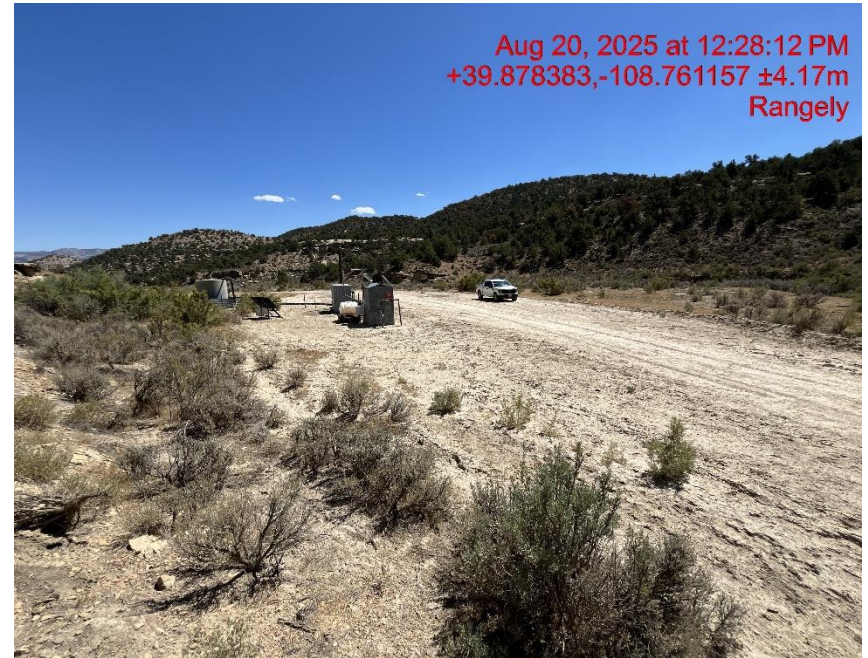
Photo # 2338 NW corner of location

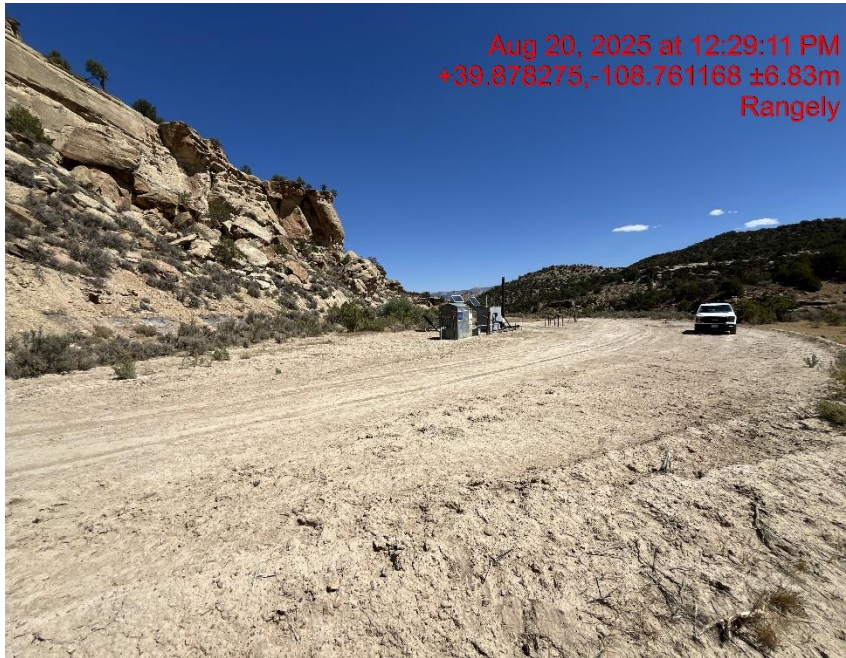
Photo # 2339 SW corner of location

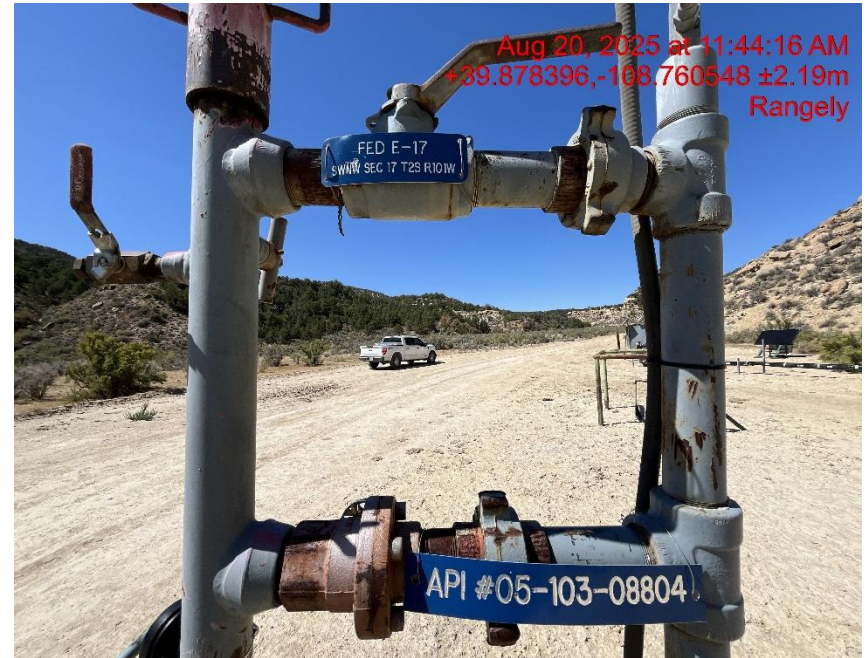
Photo # 2298 Wellhead sign lacks required information

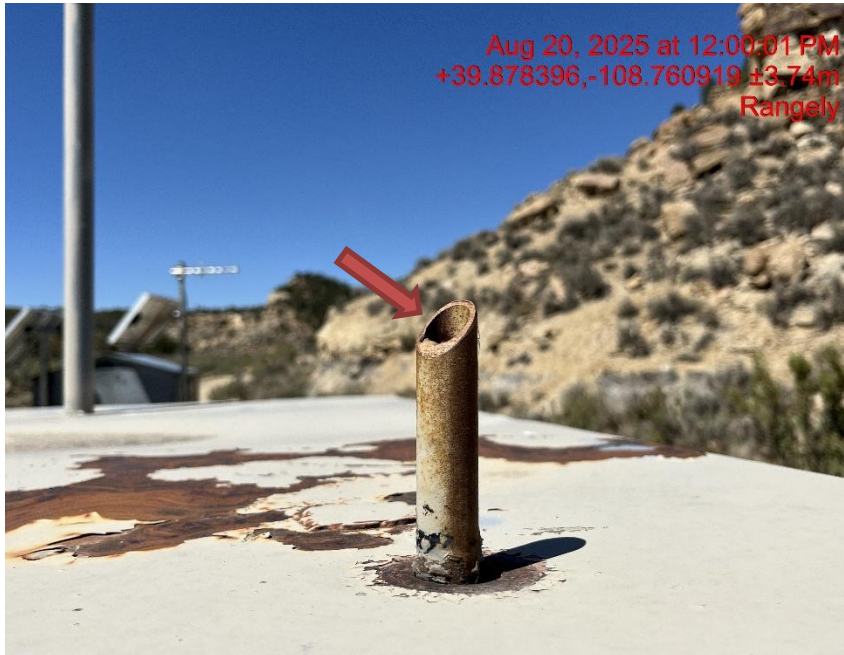
Photo # 2315 PRV vent line does not comply with CECMC pressure safety device rules

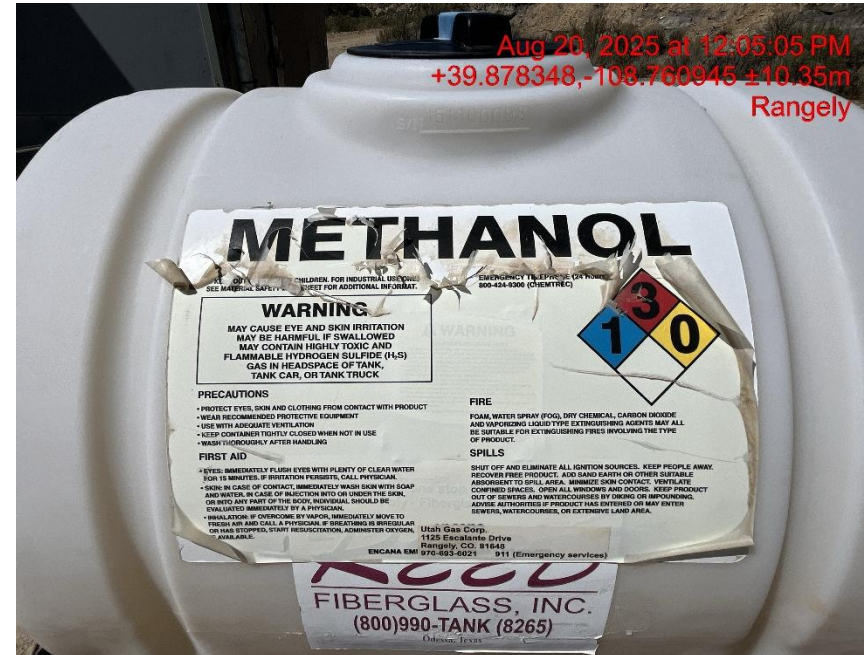
Photo # 2322 Label is weathered & starting to peel

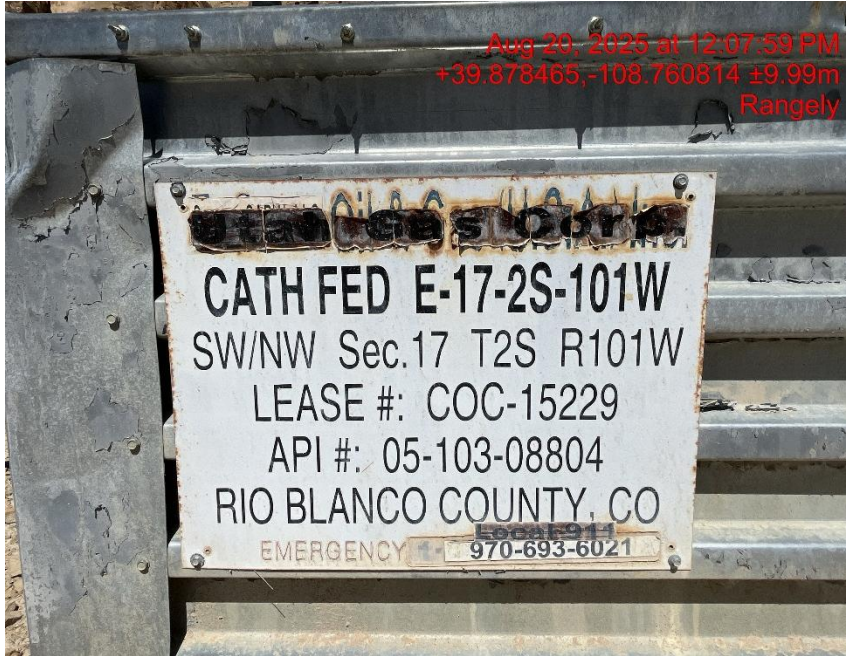
Photo # 2325 Battery sign lacks required information/not in compliance with CECMC rules

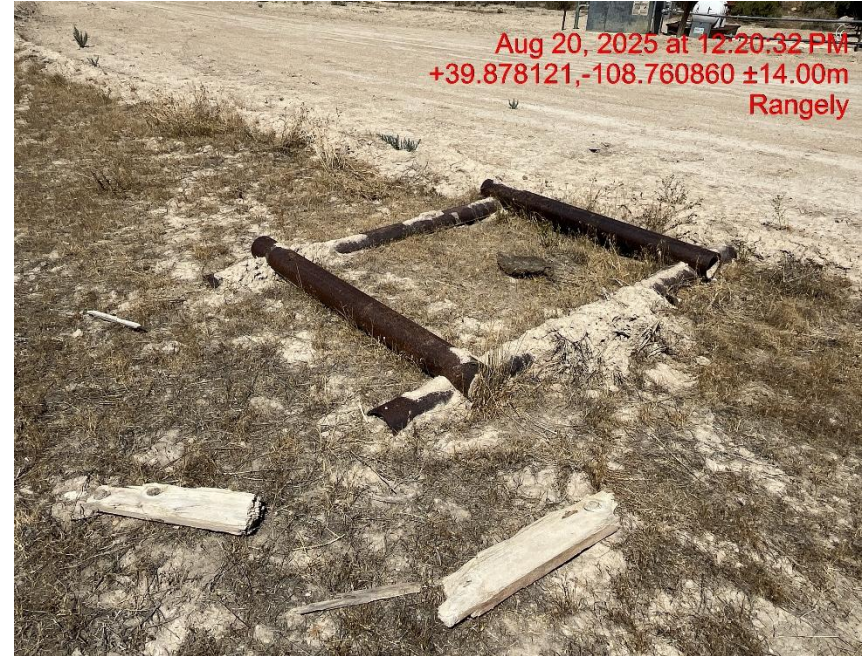
Photo # 2333 Debris

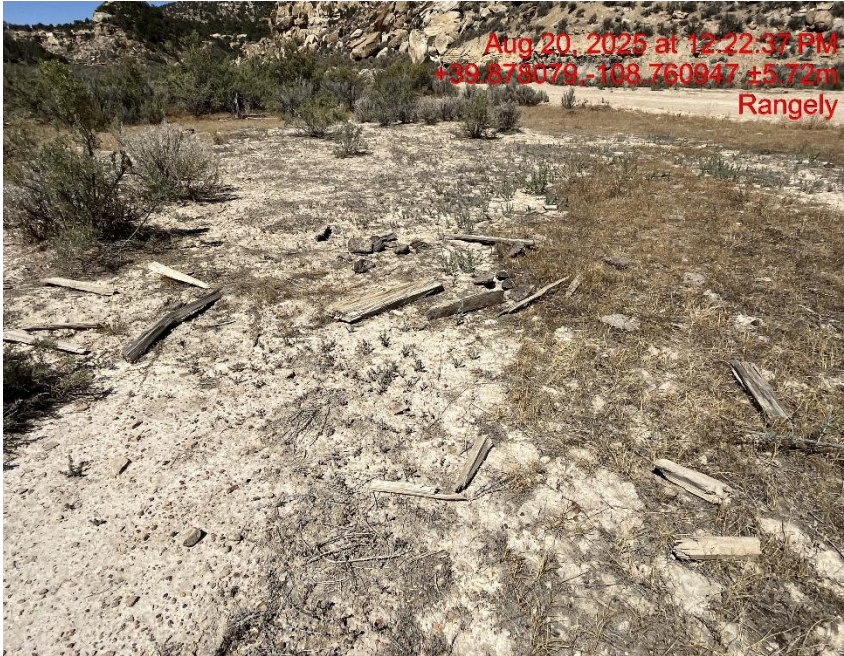
Photo # 2334 Debris

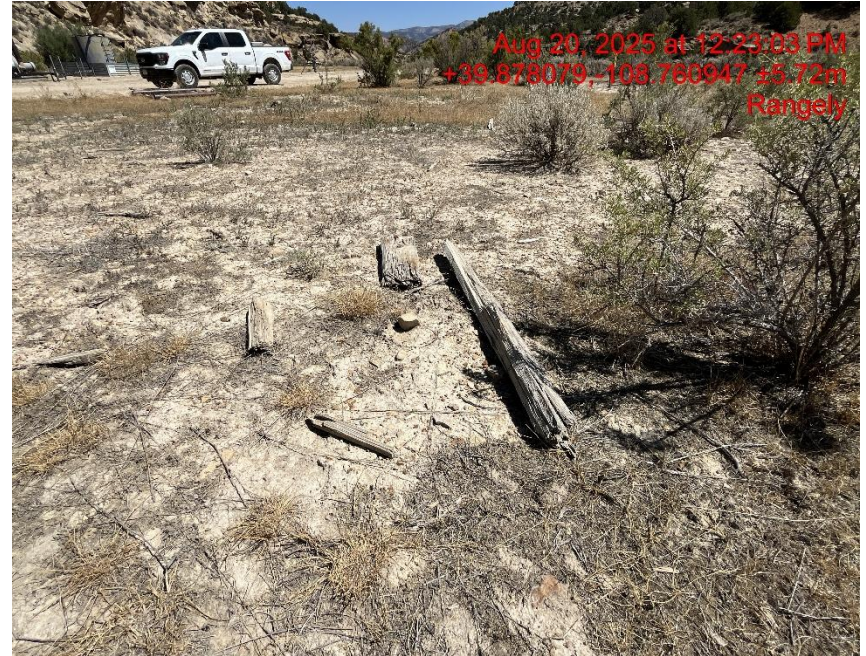
Photo # 2335 Debris

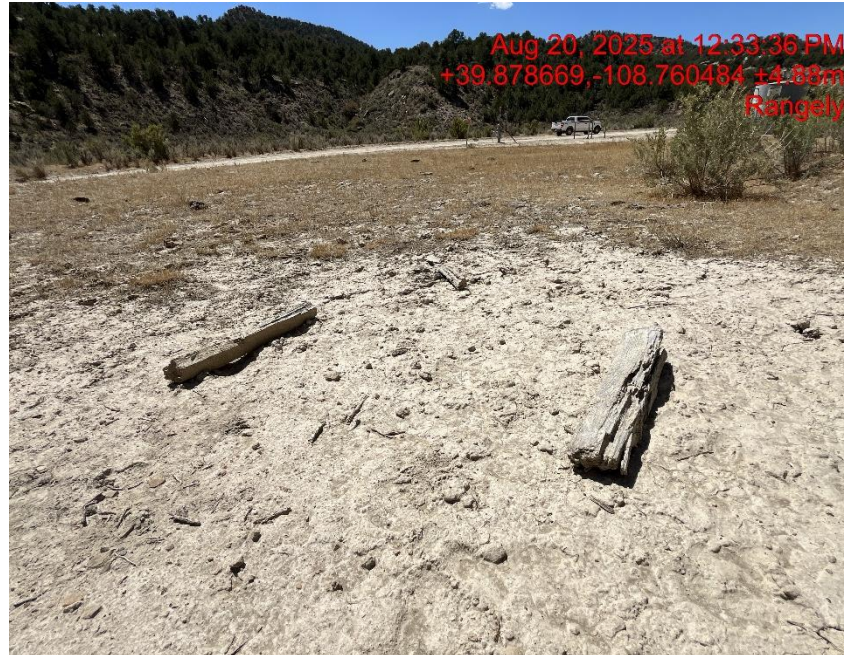
Photo # 2343 Debris
