## Inspection/Audit Photos

Location: UTAH GAS OP LTD DBA UTAH GAS CORP FEDERAL #H-18-2-101-S PAD

Location ID: 315606

Date: 08/20/2025

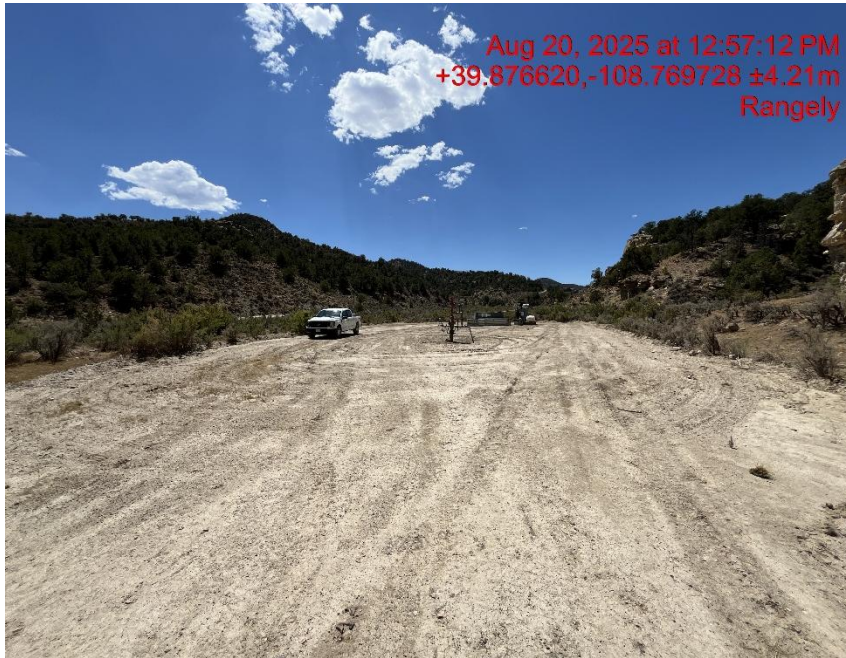
Photo # 2348 Entrance to location

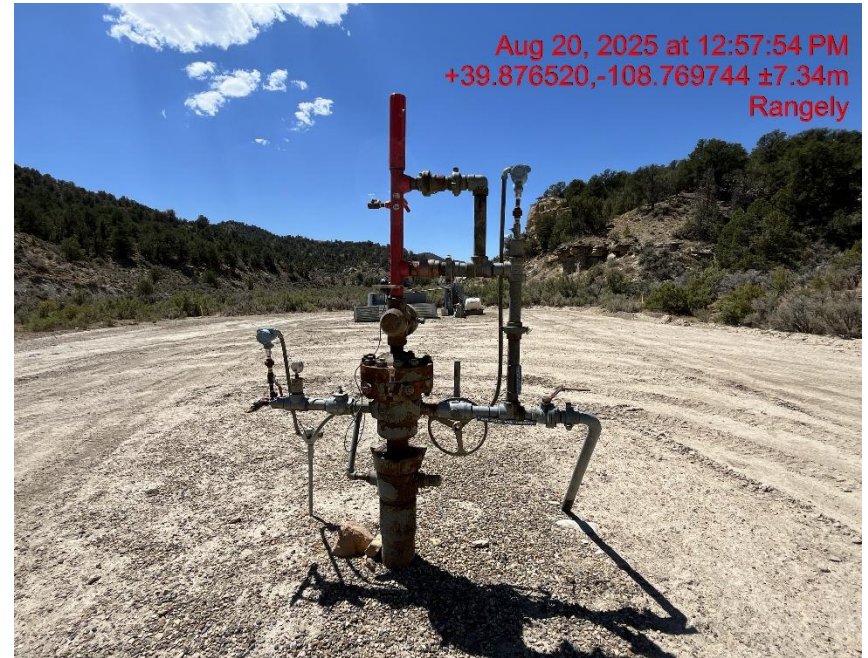
Photo # 2349 Location

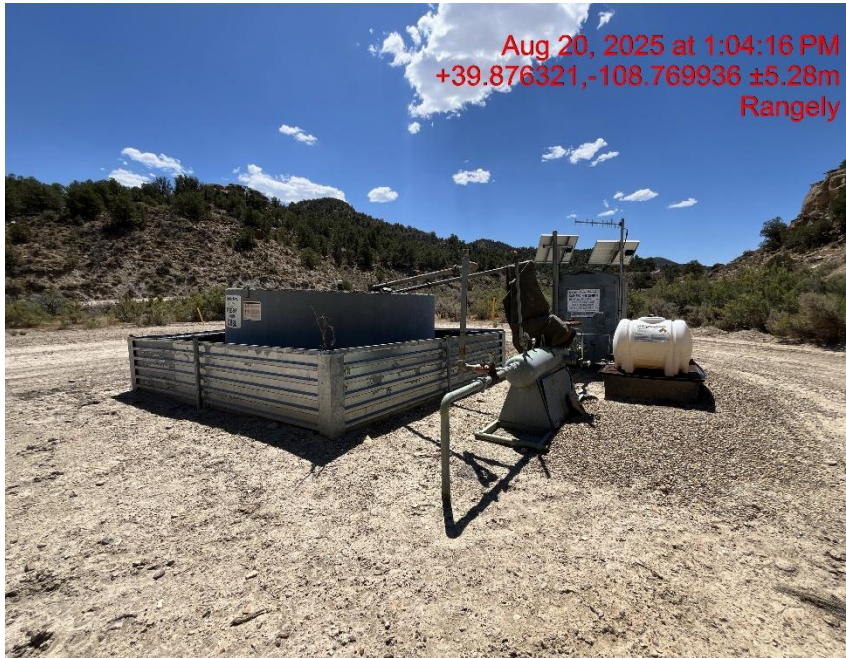
Photo # 2356 Location

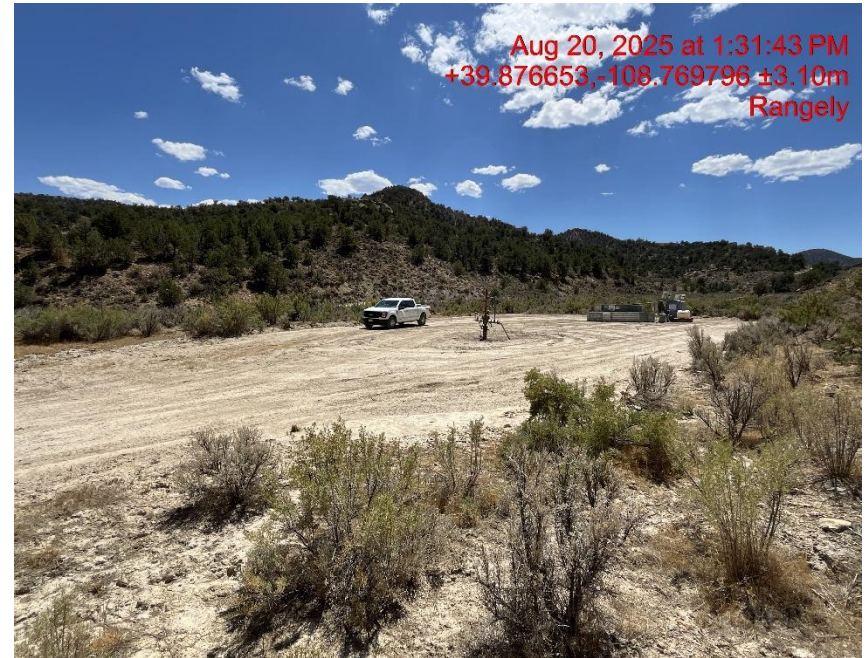
Photo # 2385 NW corner of location

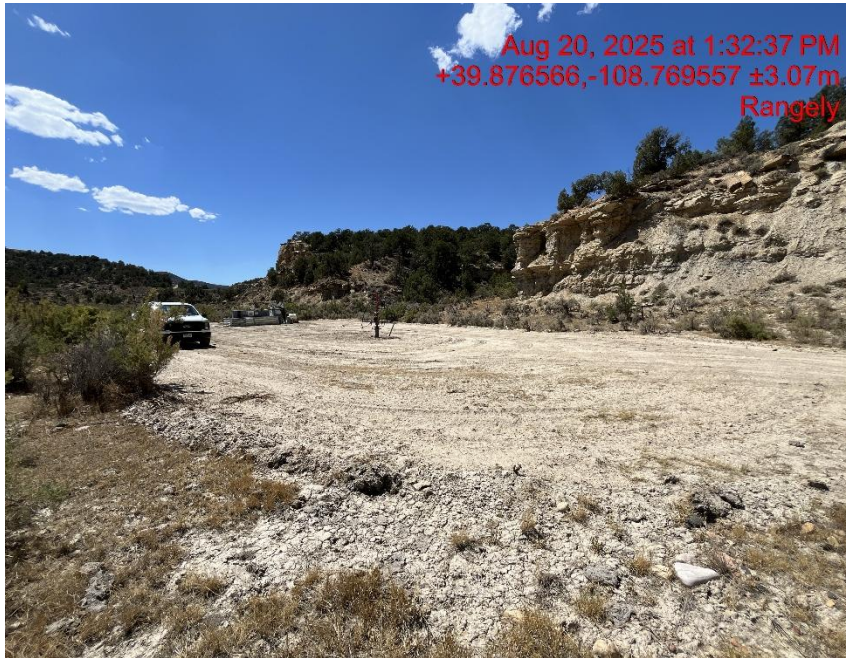
Photo # 2386 NE corner of location

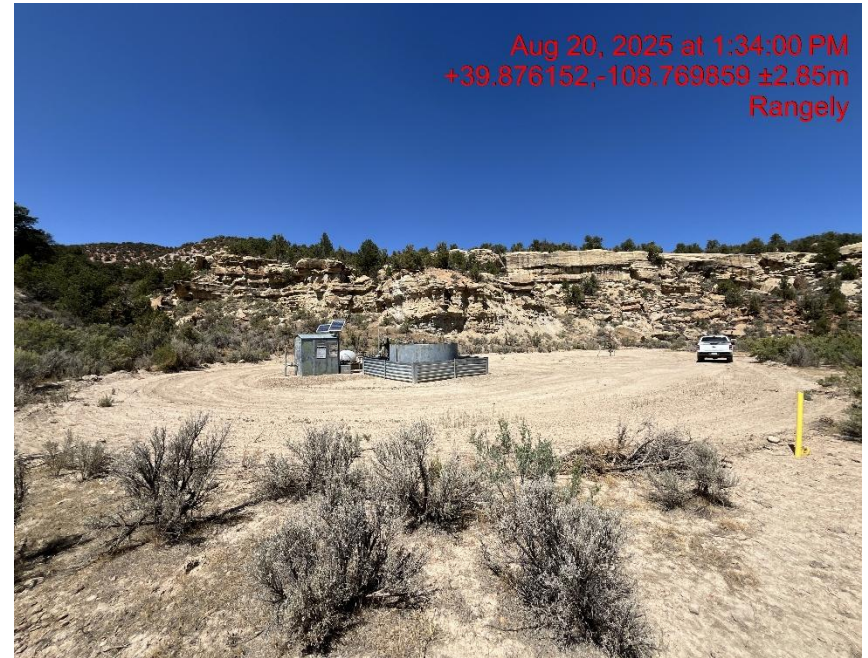
Photo # 2387 SE corner of location

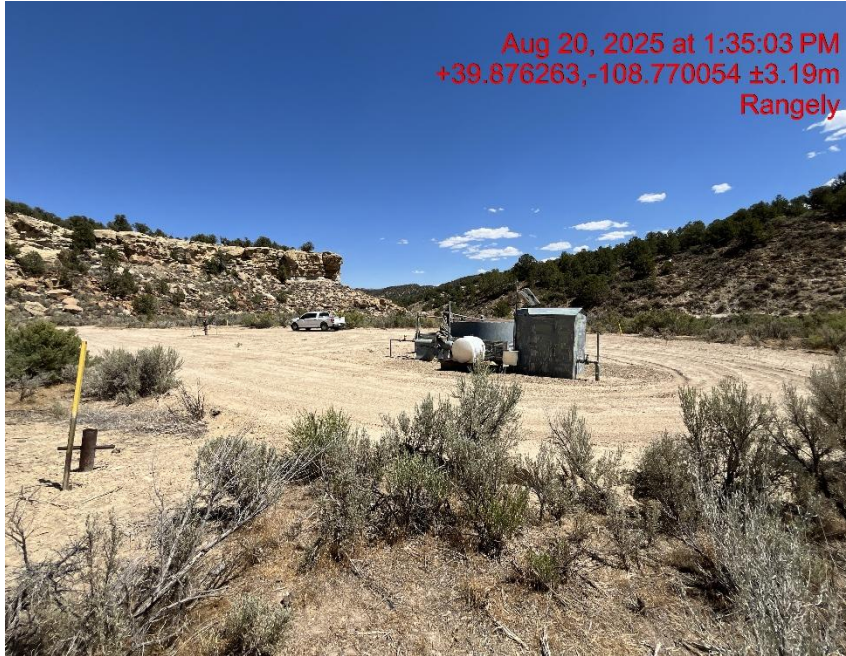
Photo # 2388 SW corner of location

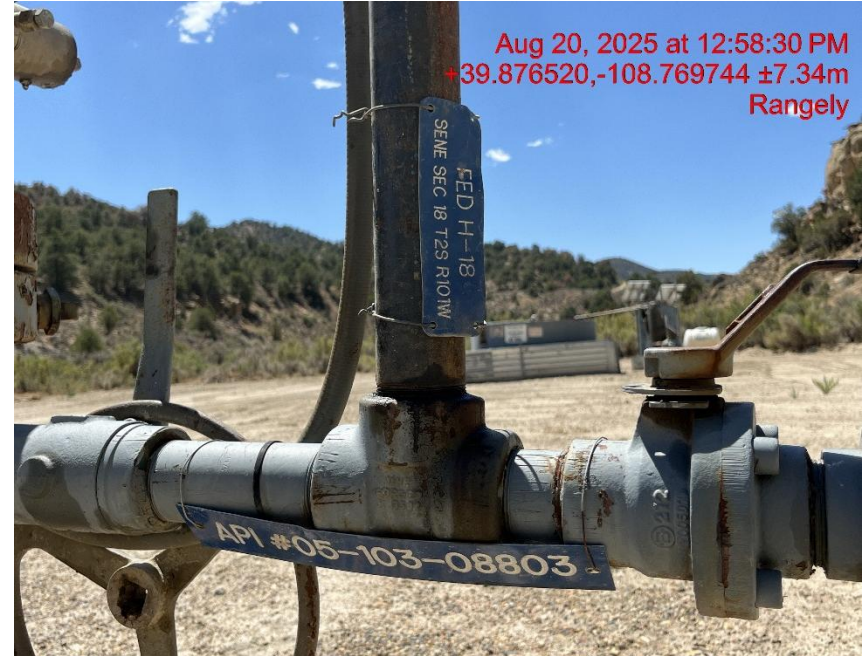
Photo # 2350 Wellhead sign lacks required information

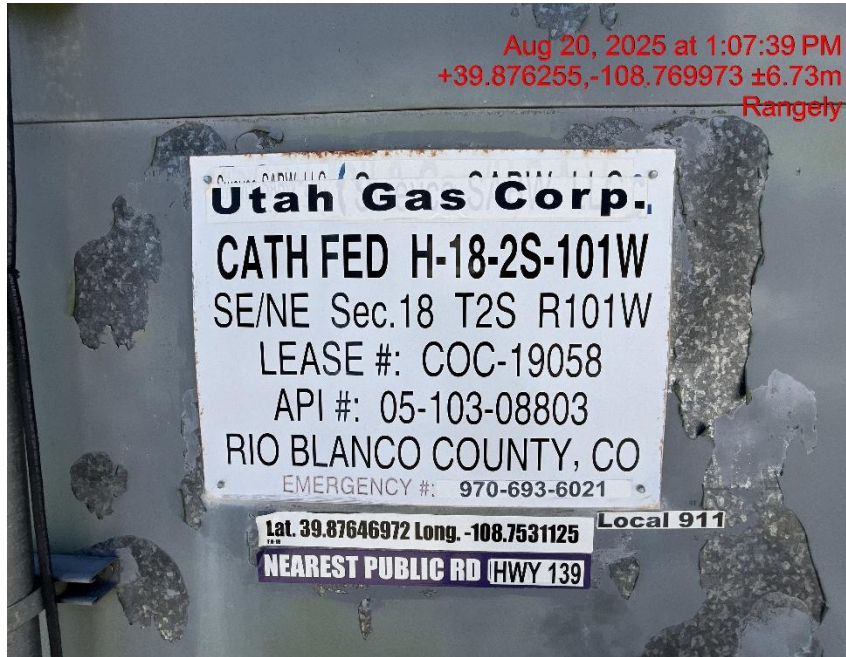
Photo # 2358 Battery sign lacks required information/not in compliance with CECMC rules, also Lat/Long is inaccurate

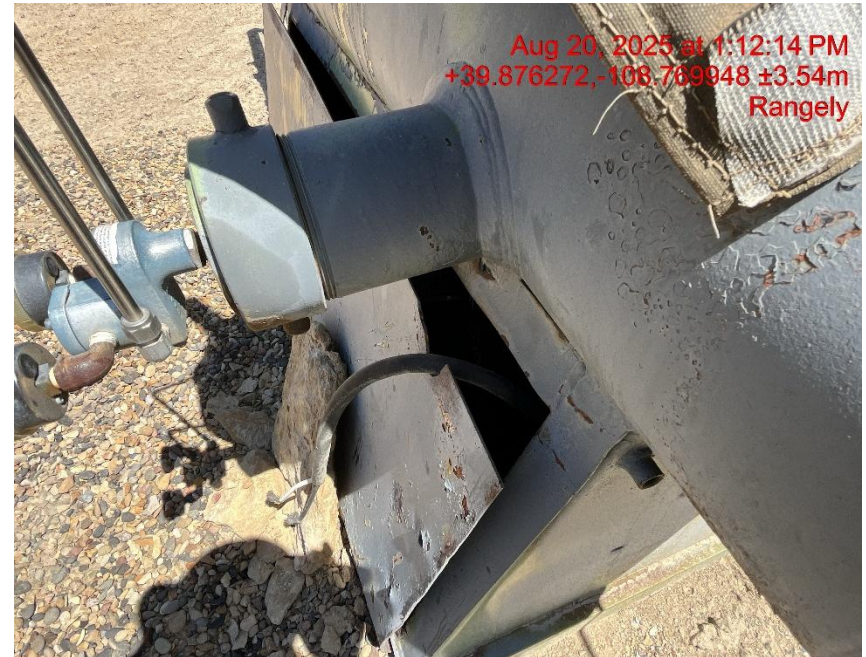
Photo # 2362 Separator door open to wildlife/available for entry by wildlife

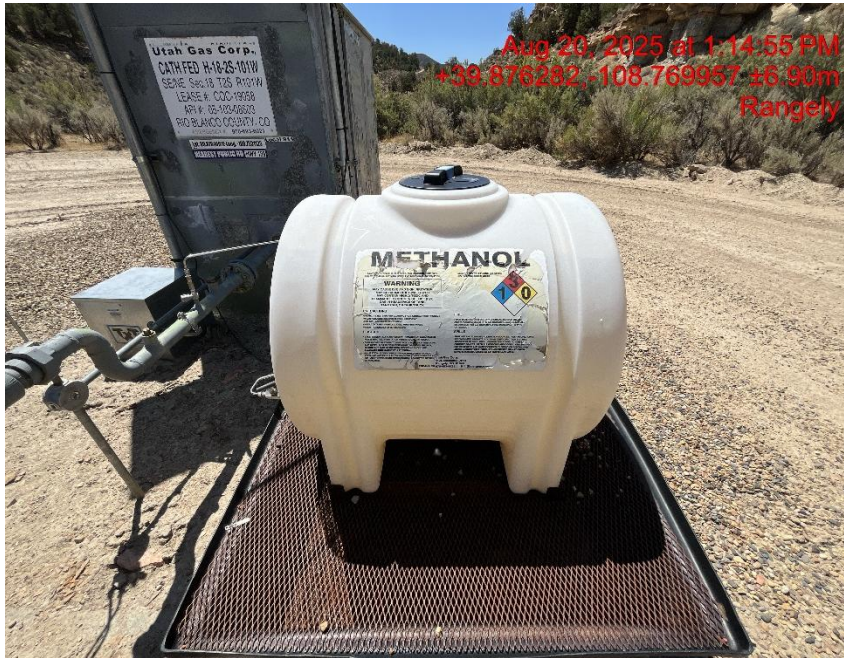
Photo # 2366 Chemical tank label is not legible/not in compliance with CECMC rules

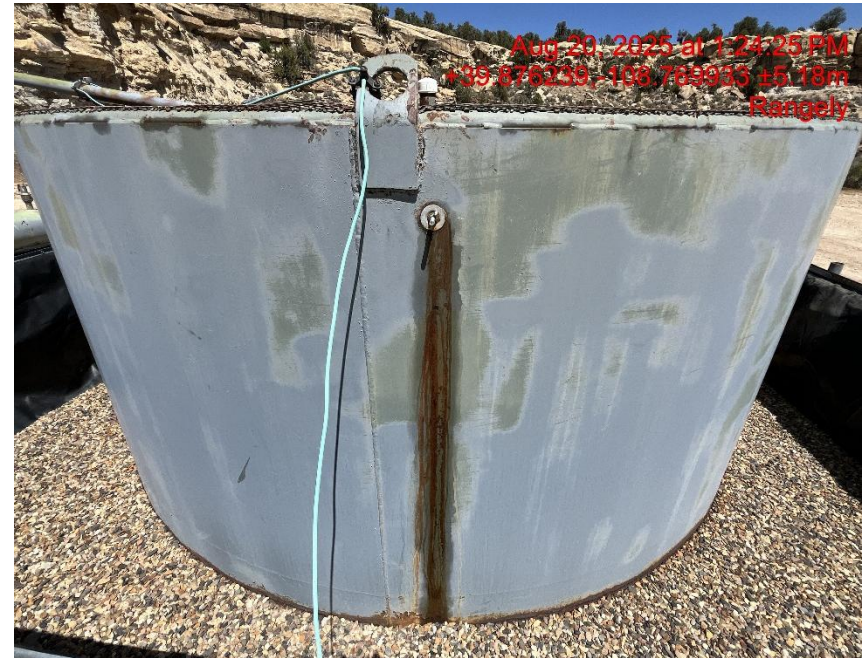
Photo # 2378 Possible leak on production tank/tank appears to lack integrity

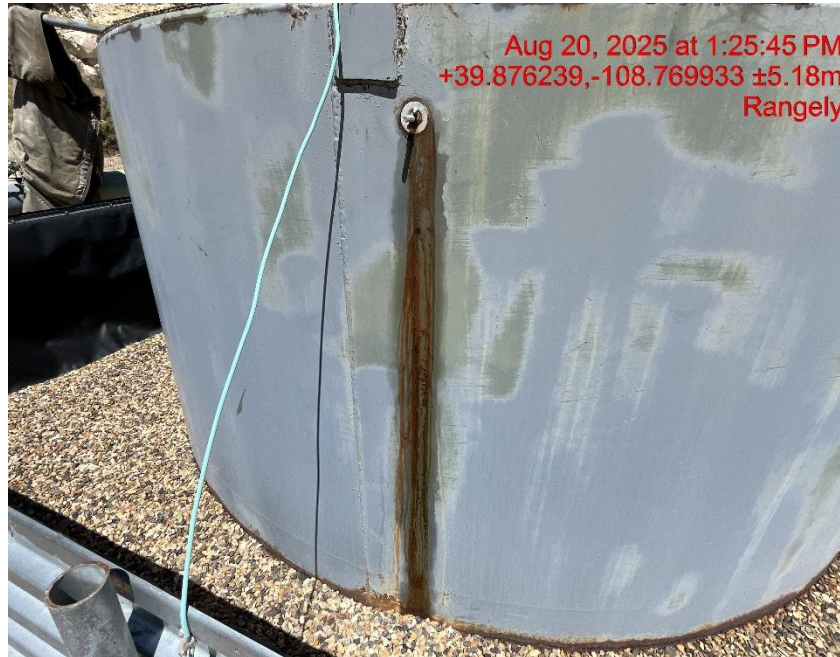
**Photo # 2381 Possible leak on production tank/tank appears to lack integrity**
