WELL NAME: BELARDE 12-34, API #: 071-09005, INSP. # 716301430

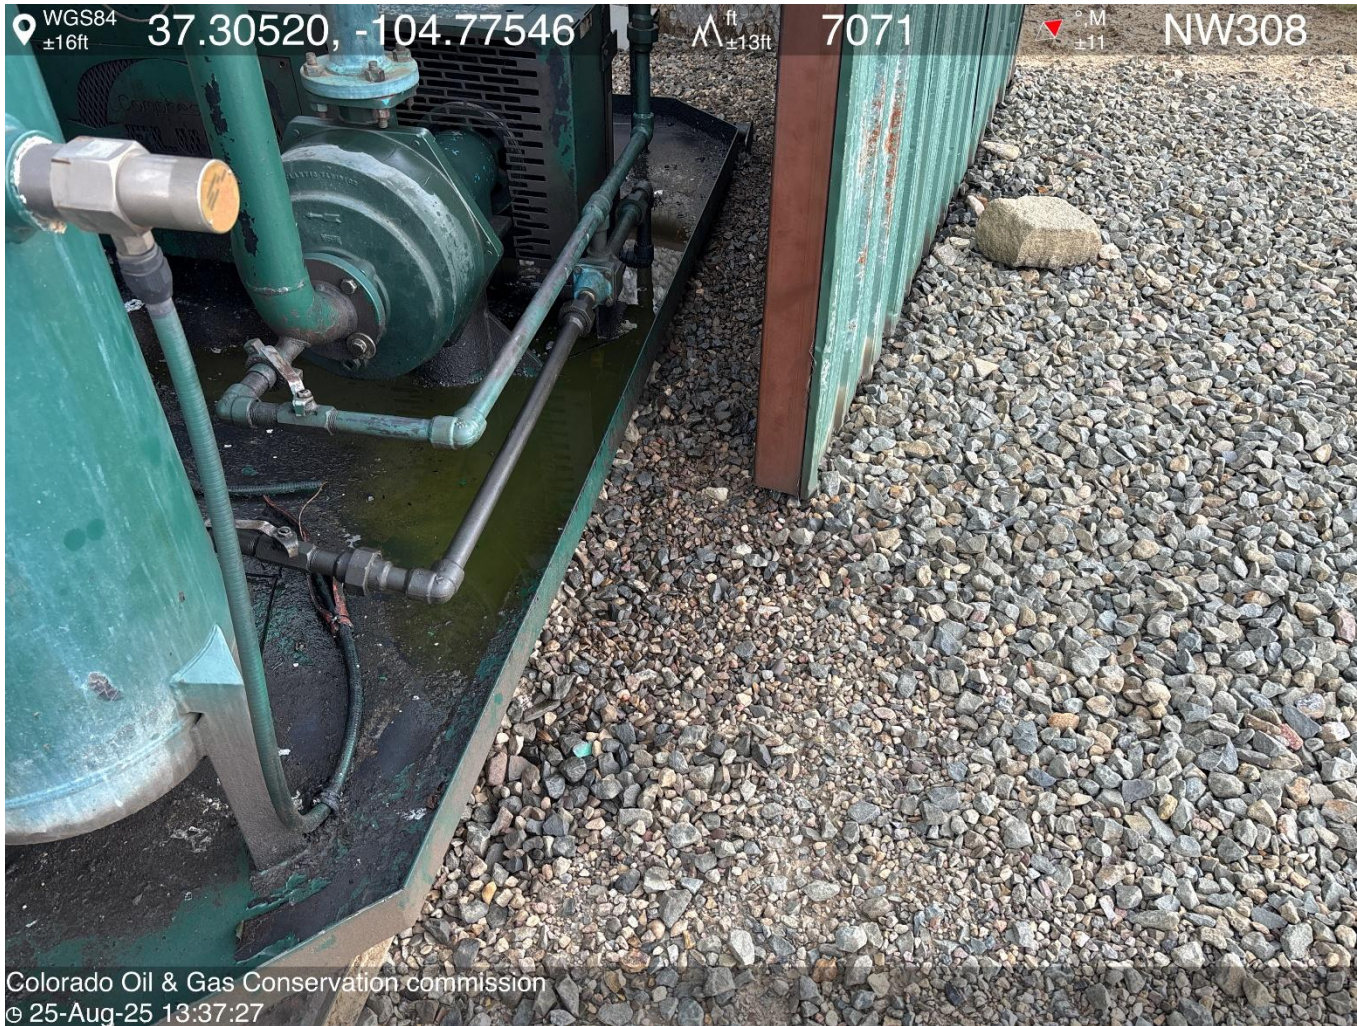
PHOTO 4: AREA OF IMPACTED SOIL NEAR COMPRESSOR SKID. Conduct maintenance on equipment, cleanup stained material and review self inspection processes. COMPLY WITH RULE 1002,(2).D. CA DATE 9-25-2025.

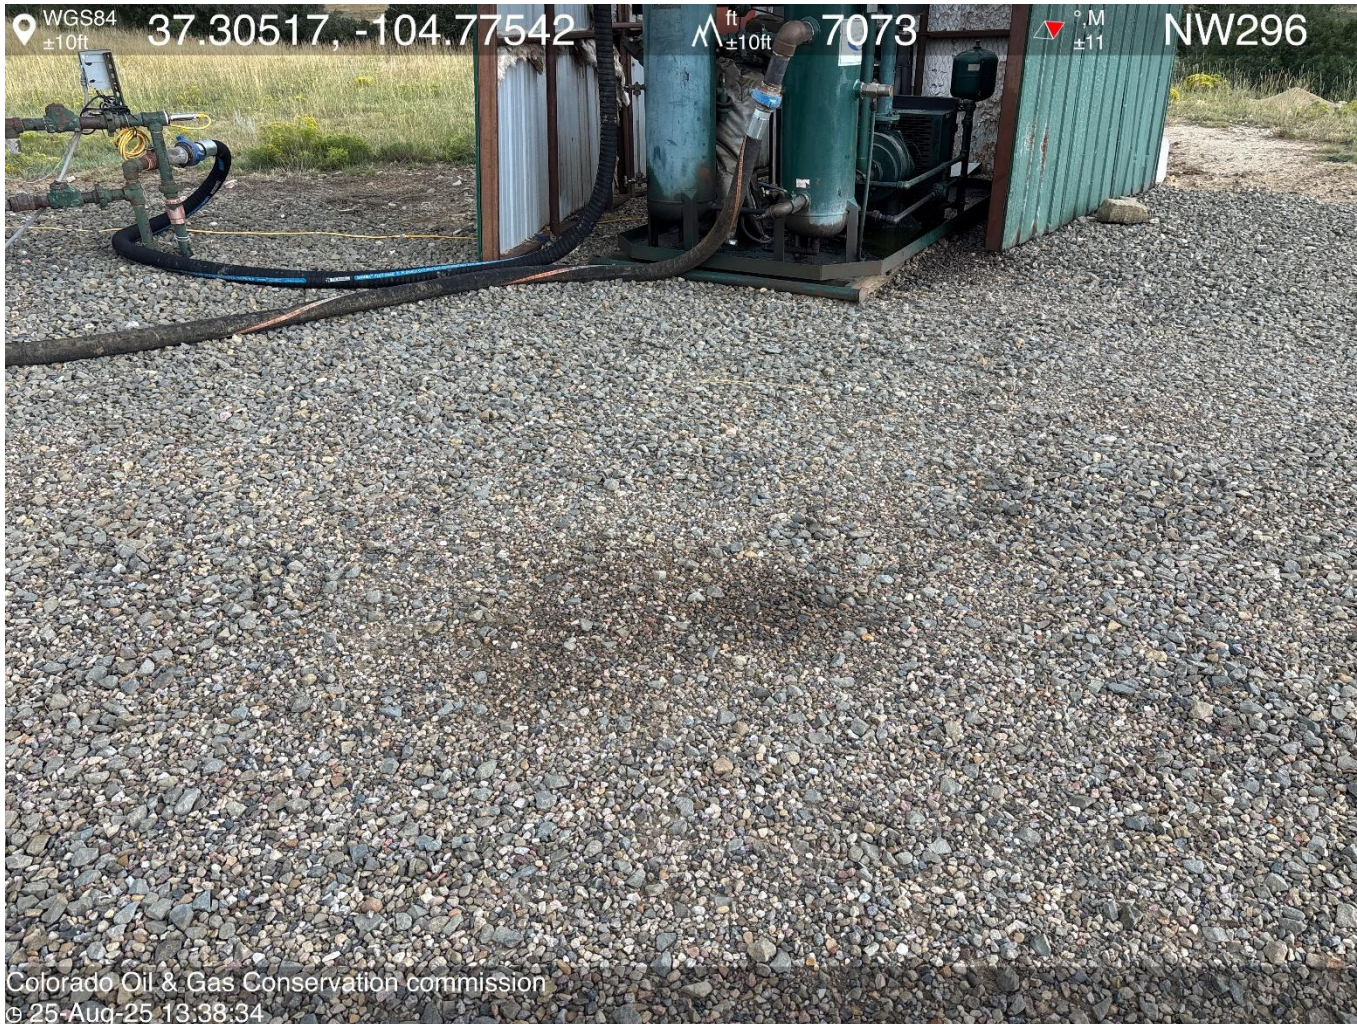
PHOTO 5: AREA OF IMPACTED SOIL NEAR COMPRESSOR SKID. Conduct maintenance on equipment, cleanup stained material and review self inspection processes. COMPLY WITH RULE 1002,(2).D. CA DATE 9-25-2025.

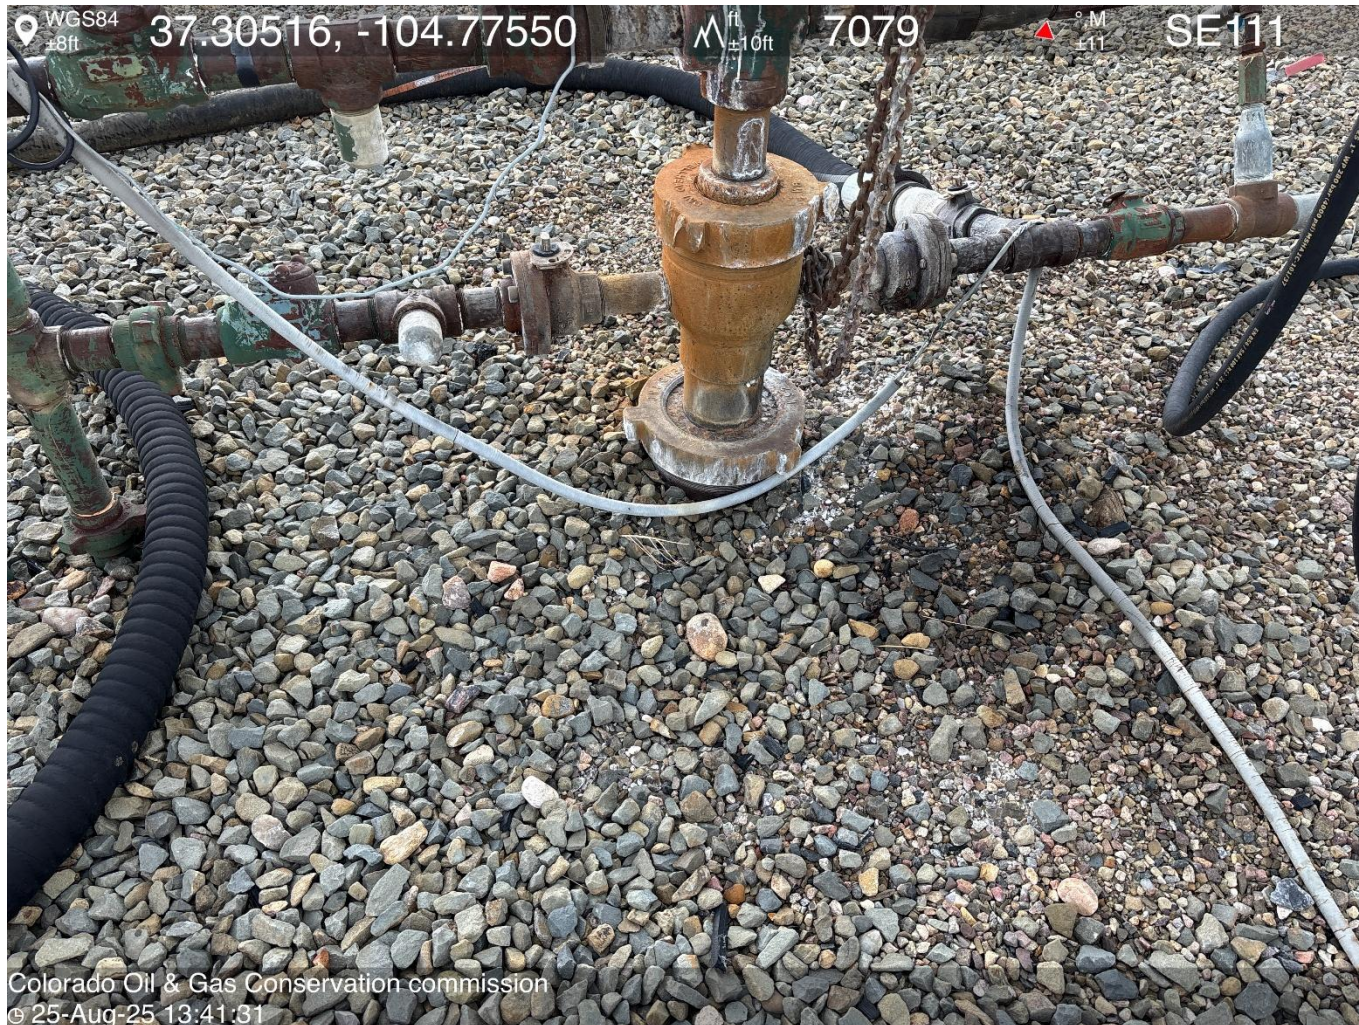
**PHOTO 8: Bradenhead inaccessible. Install appropriate fittings to allow bradenhead visual inspection as per Rule 419.a.(1), (2)
THIS IS THE SECOND NOTICE FOR THIS CORRECTIVE ACTION, IMMEDIATE ACTION IS REQUIRED.**

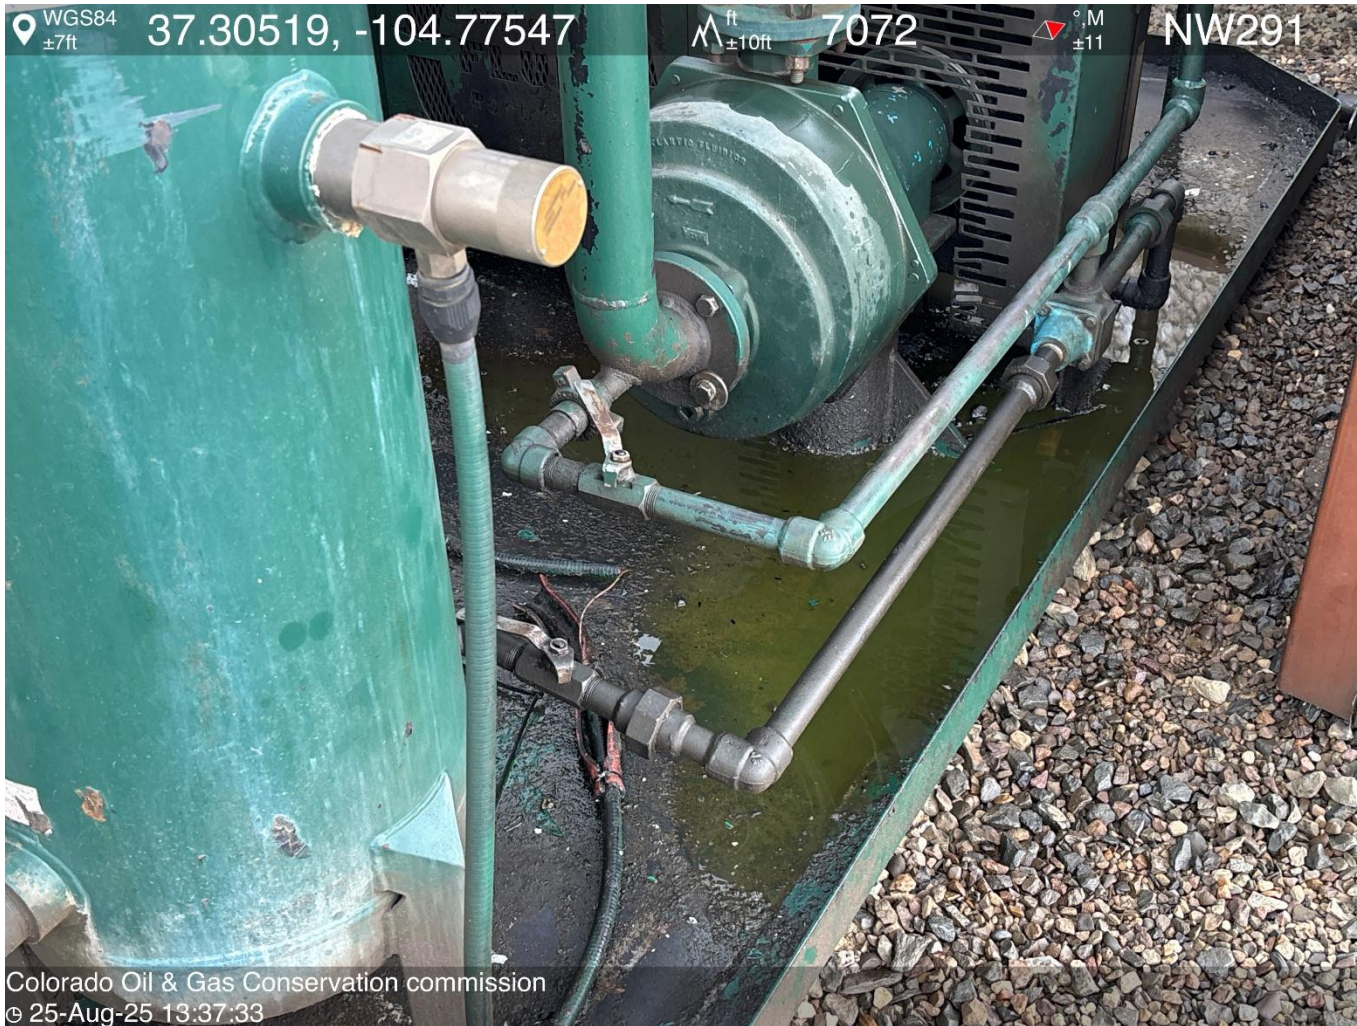
PHOTO 9: APPEARS TO BE ANTIFREEZE AND OILY WASTE IN COMPRESSOR SKID. DRAIN OILY WASTE REPAIR ALL LEAKS AND REMOVE IMPACTED SOIL PER RULE 1002..(2).D & 1002.f.(2)B, Comply with general provisions of the oil and gas act for wildlife protection AND SB-181. THIS IS THE SECOND NOTICE FOR THIS CORRECTIVE ACTION, IMMEDIATE ACTION IS REQUIRED.
