Final Reclamation Inspection

Operator: STRACHAN EXPLORATION INC - 83130

Location ID: 330667

Inspection Photos
Location Name: D.O.C. SHOWERS #32-12-10
Location ID: 330667

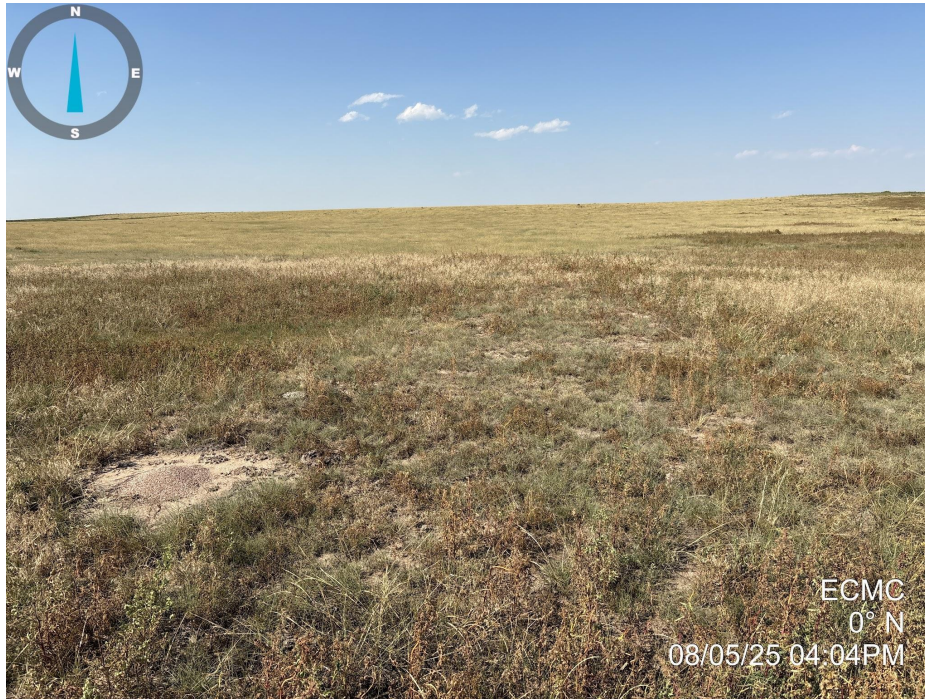
Photo 1. Photo taken of the well location, facing north. Photo illustrates that final reclamation activities have taken place, but the location does not meet Rule 1004 standards. Weedy annual vegetation including kochia (*Bassia scoparia*) and cheatgrass (*Bromus tectorum*) were observed across the location.

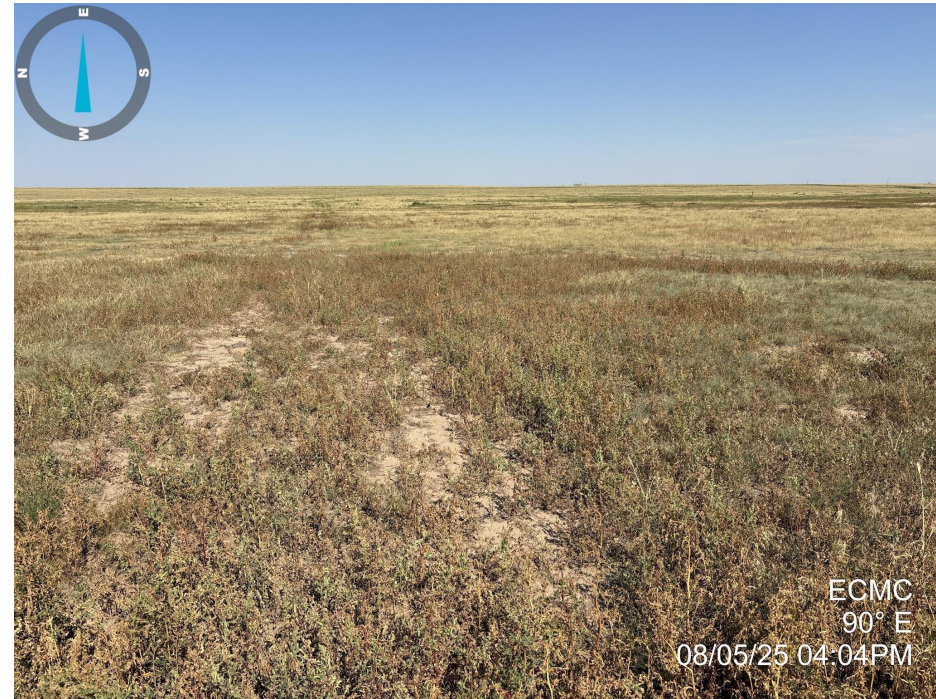
Photo 2. Photo taken of the well location, facing East. See comments under Photo 1.

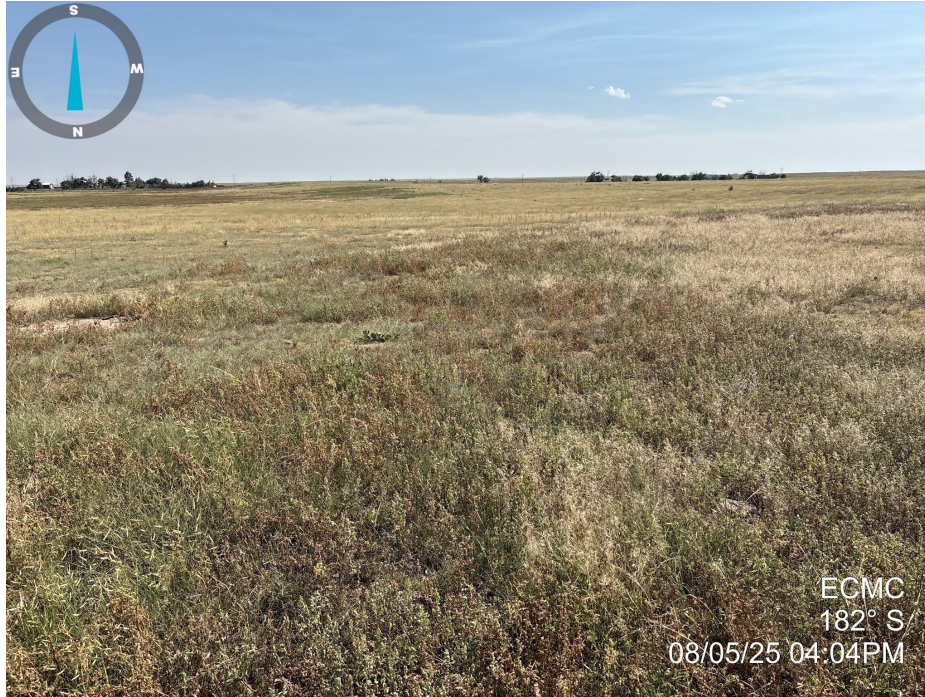
Photo 3. Photo taken of the well location, facing South. See comments under Photo 1.

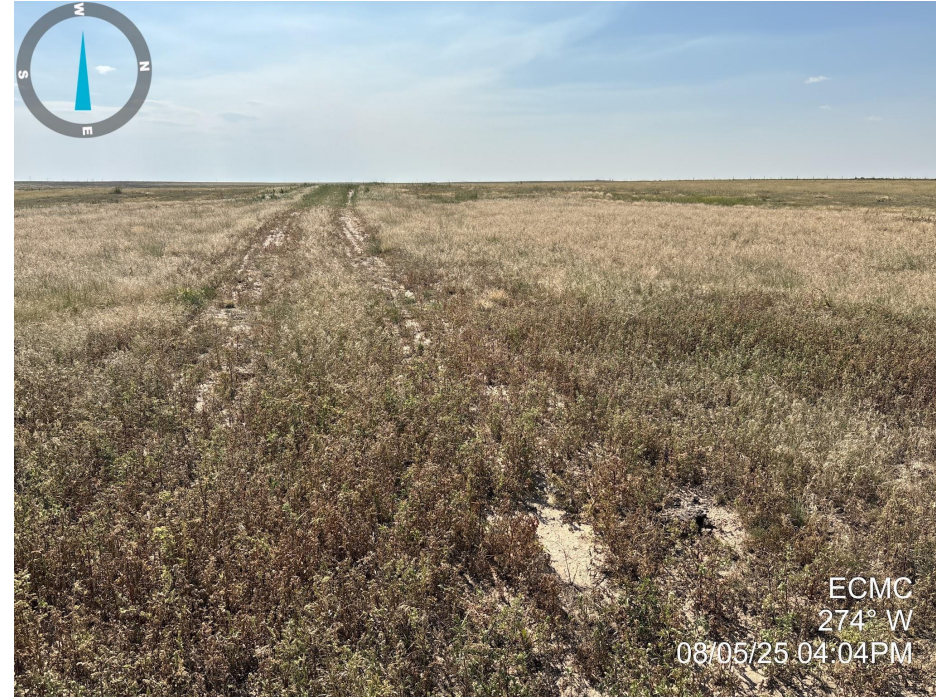
Photo 4. Photo taken of the well location, facing West. See comments under Photo 1.

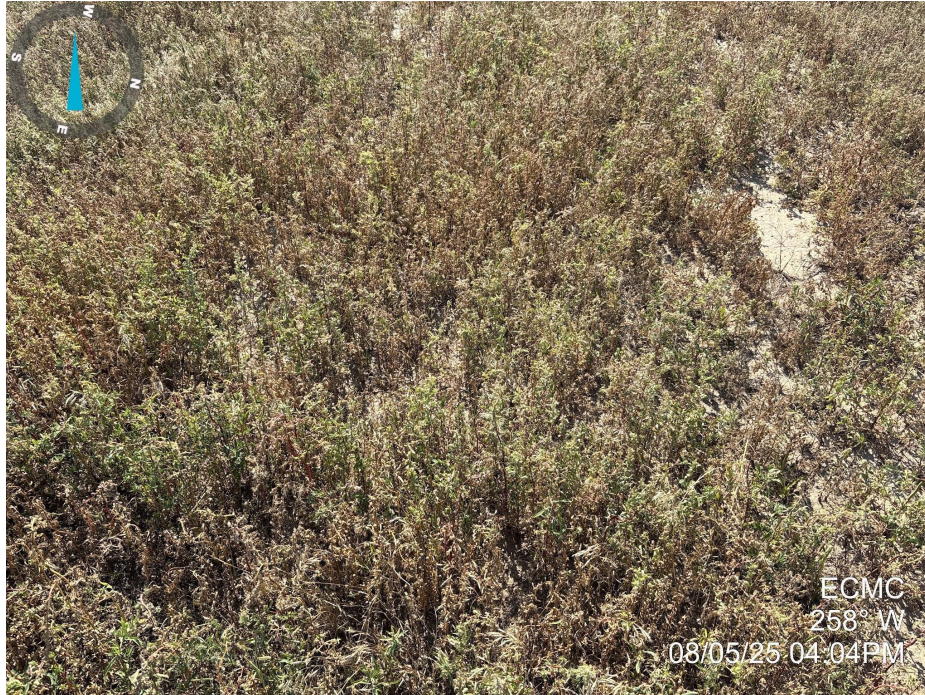
Photo 5. Photo taken of ground cover at the well location. Photo illustrates weedy annual vegetation including kochia (*Bassia scoparia*) and cheatgrass (*Bromus tectorum*), a List C Noxious Weed species.

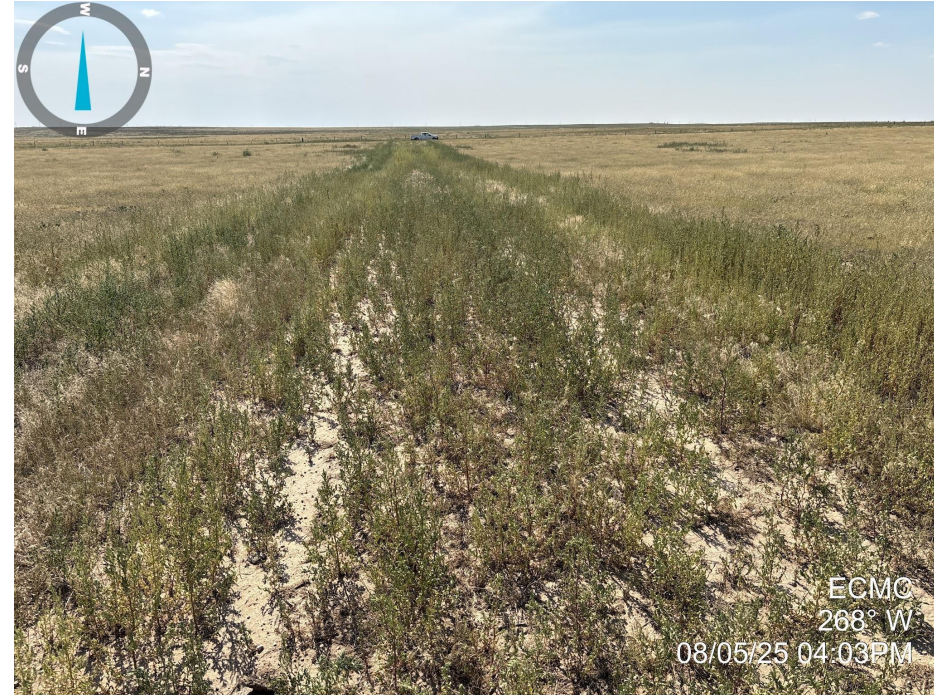
Photo 6. Photo taken of the access road to the well location, facing west. Photo illustrates that the access road fails to meet Rule 1004 standards as gravel remains and weedy annual vegetation was observed across the location.

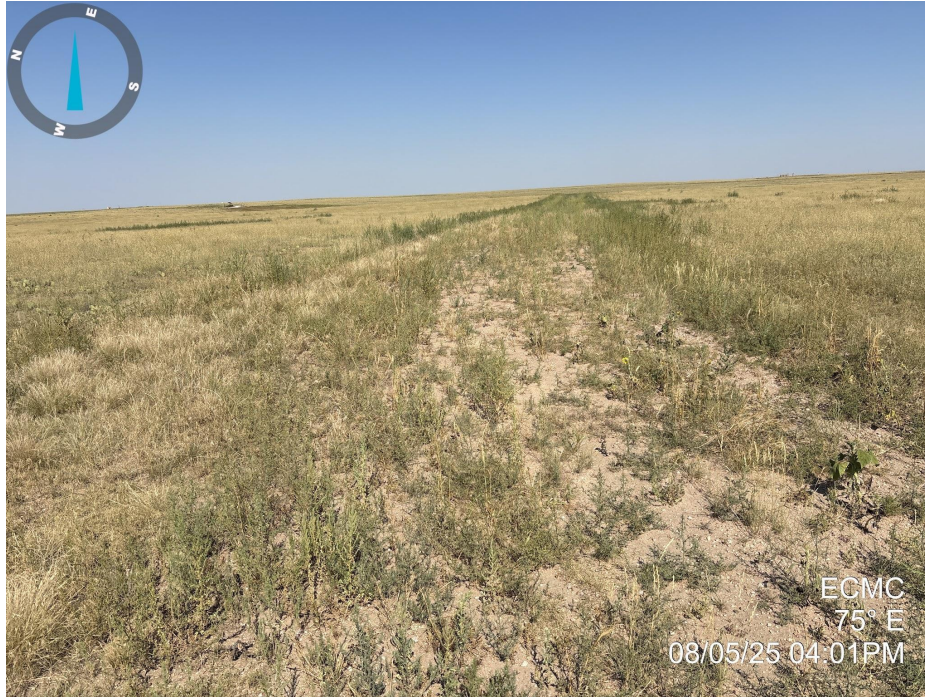
Photo 7. Photo taken of the access road to the well location, facing east. See comments under Photo 6.

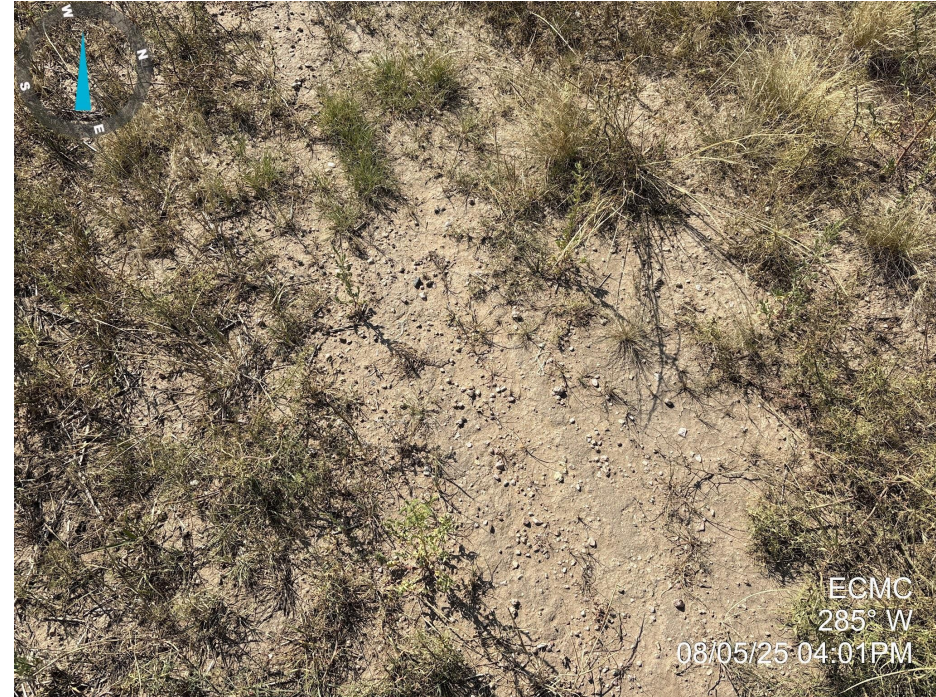
Photo 8. Photo taken of ground cover along the access road. Photo illustrates gravel and weedy annual vegetation including cheatgrass (*Bromus tectorum*), a List C Noxious Weed species.

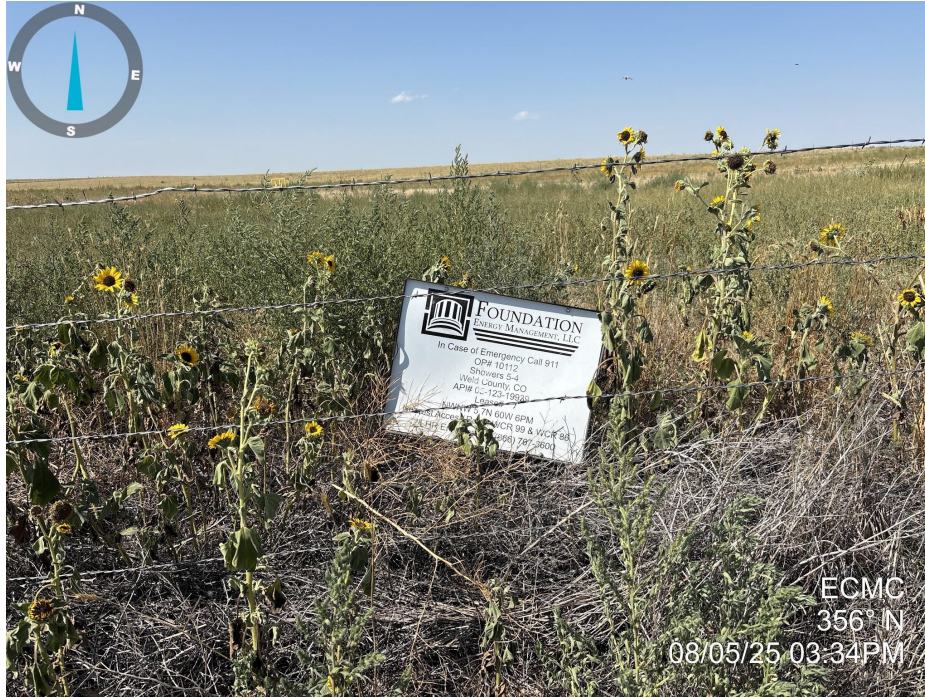
Photo 9. Photo taken of the tank battery location, facing north. Photo illustrates the operator sign and fencing at the entrance to the location.

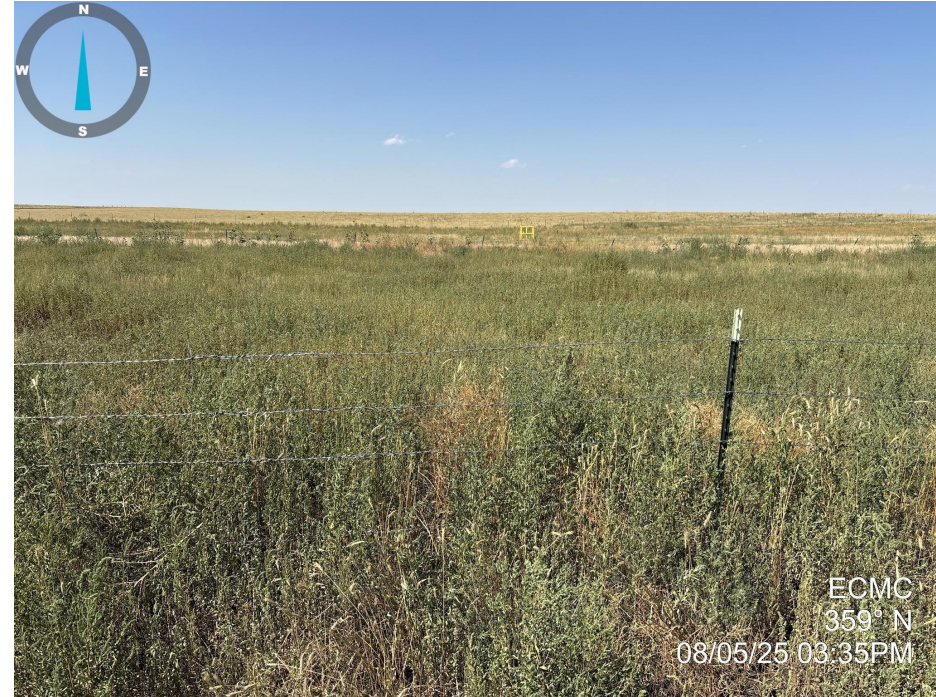
Photo 10. Photo taken of the tank battery location, facing north. Photo illustrates that final reclamation activities have taken place, but vegetation establishment does not meet Rule 1004 standards. Gravel and weedy annual vegetation were observed across the location.

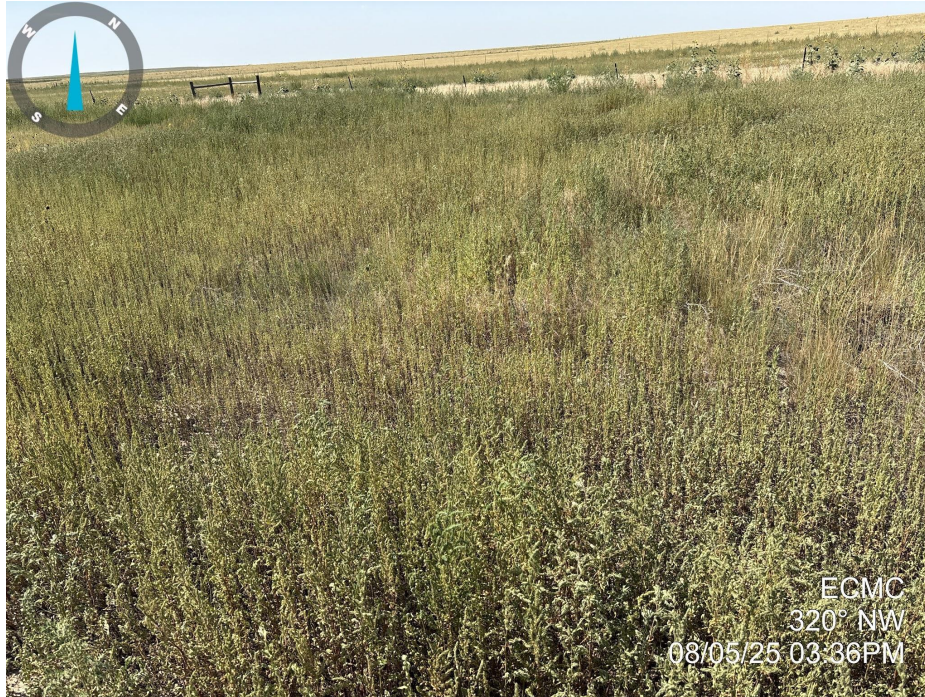
Photo 11. Photo taken of the tank battery location facing northwest. See comments under Photo 10.

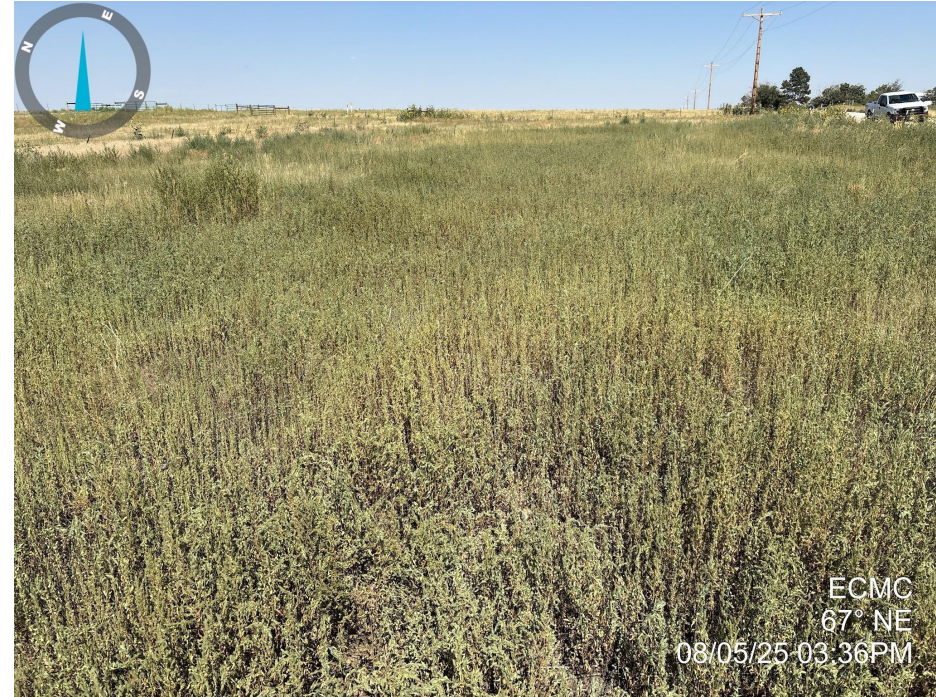
Photo 12. Photo taken of the tank battery location, facing northeast. See comments under Photo 10.

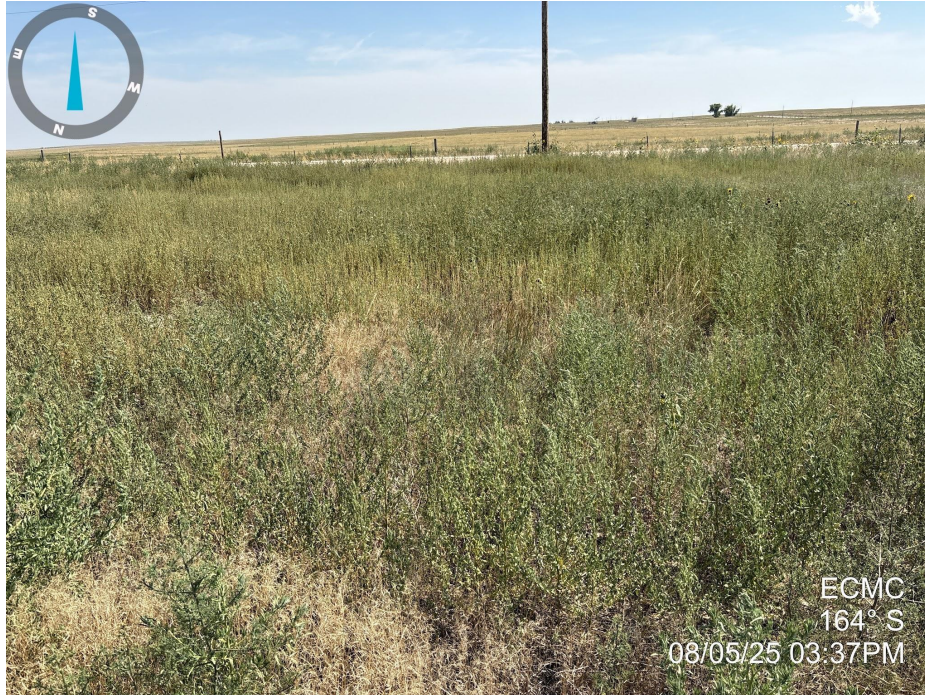
Photo 13. Photo taken of the tank battery location, facing south. See comments under Photo 10.

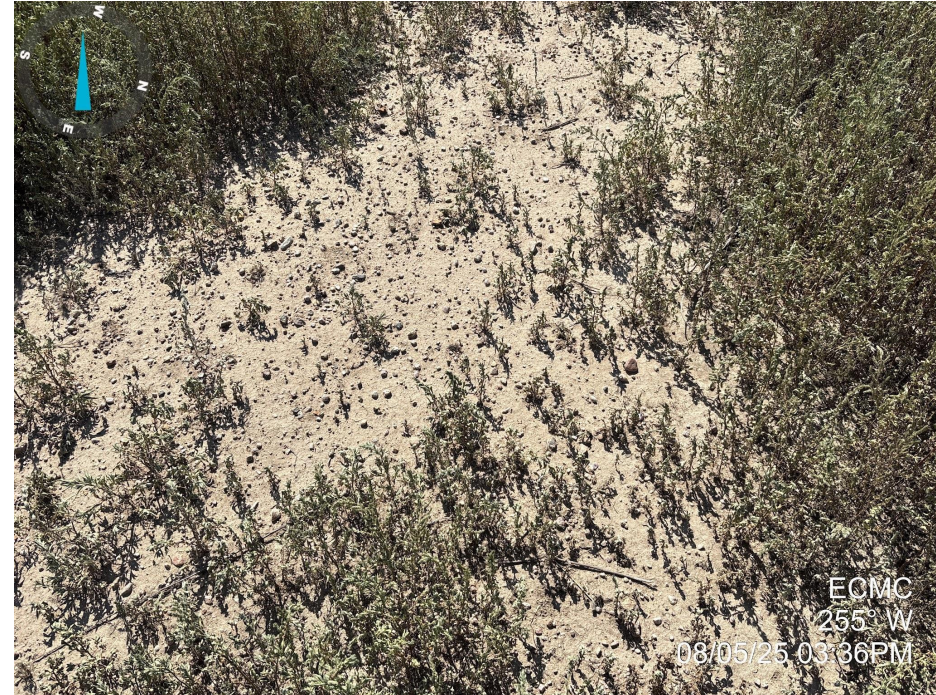
Photo 14. Photo taken of ground cover at the tank battery location. Photo illustrates gravel and weedy annual vegetation including kochia (*Bassia scoparia*).

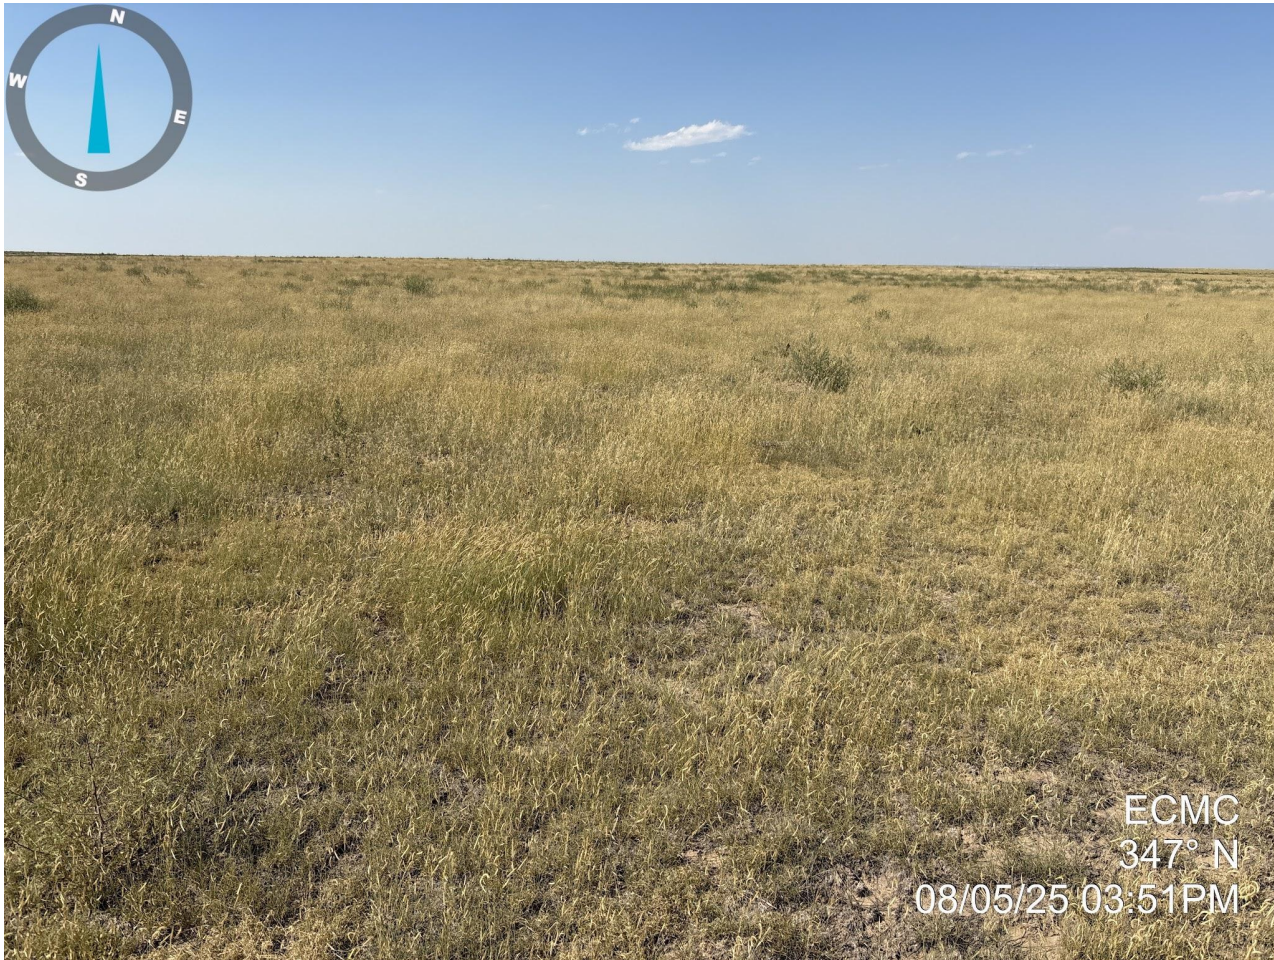
Photo 15. Photo taken of the reference area to the location, north of the location, facing north. Photo illustrates perennial grass vegetation.
