ECMC  
Environmental  
Field Inspection

Aristocrat 11-21 TB  
© 25-Aug-25 12:15:45  
ECMC Environmental Inspection

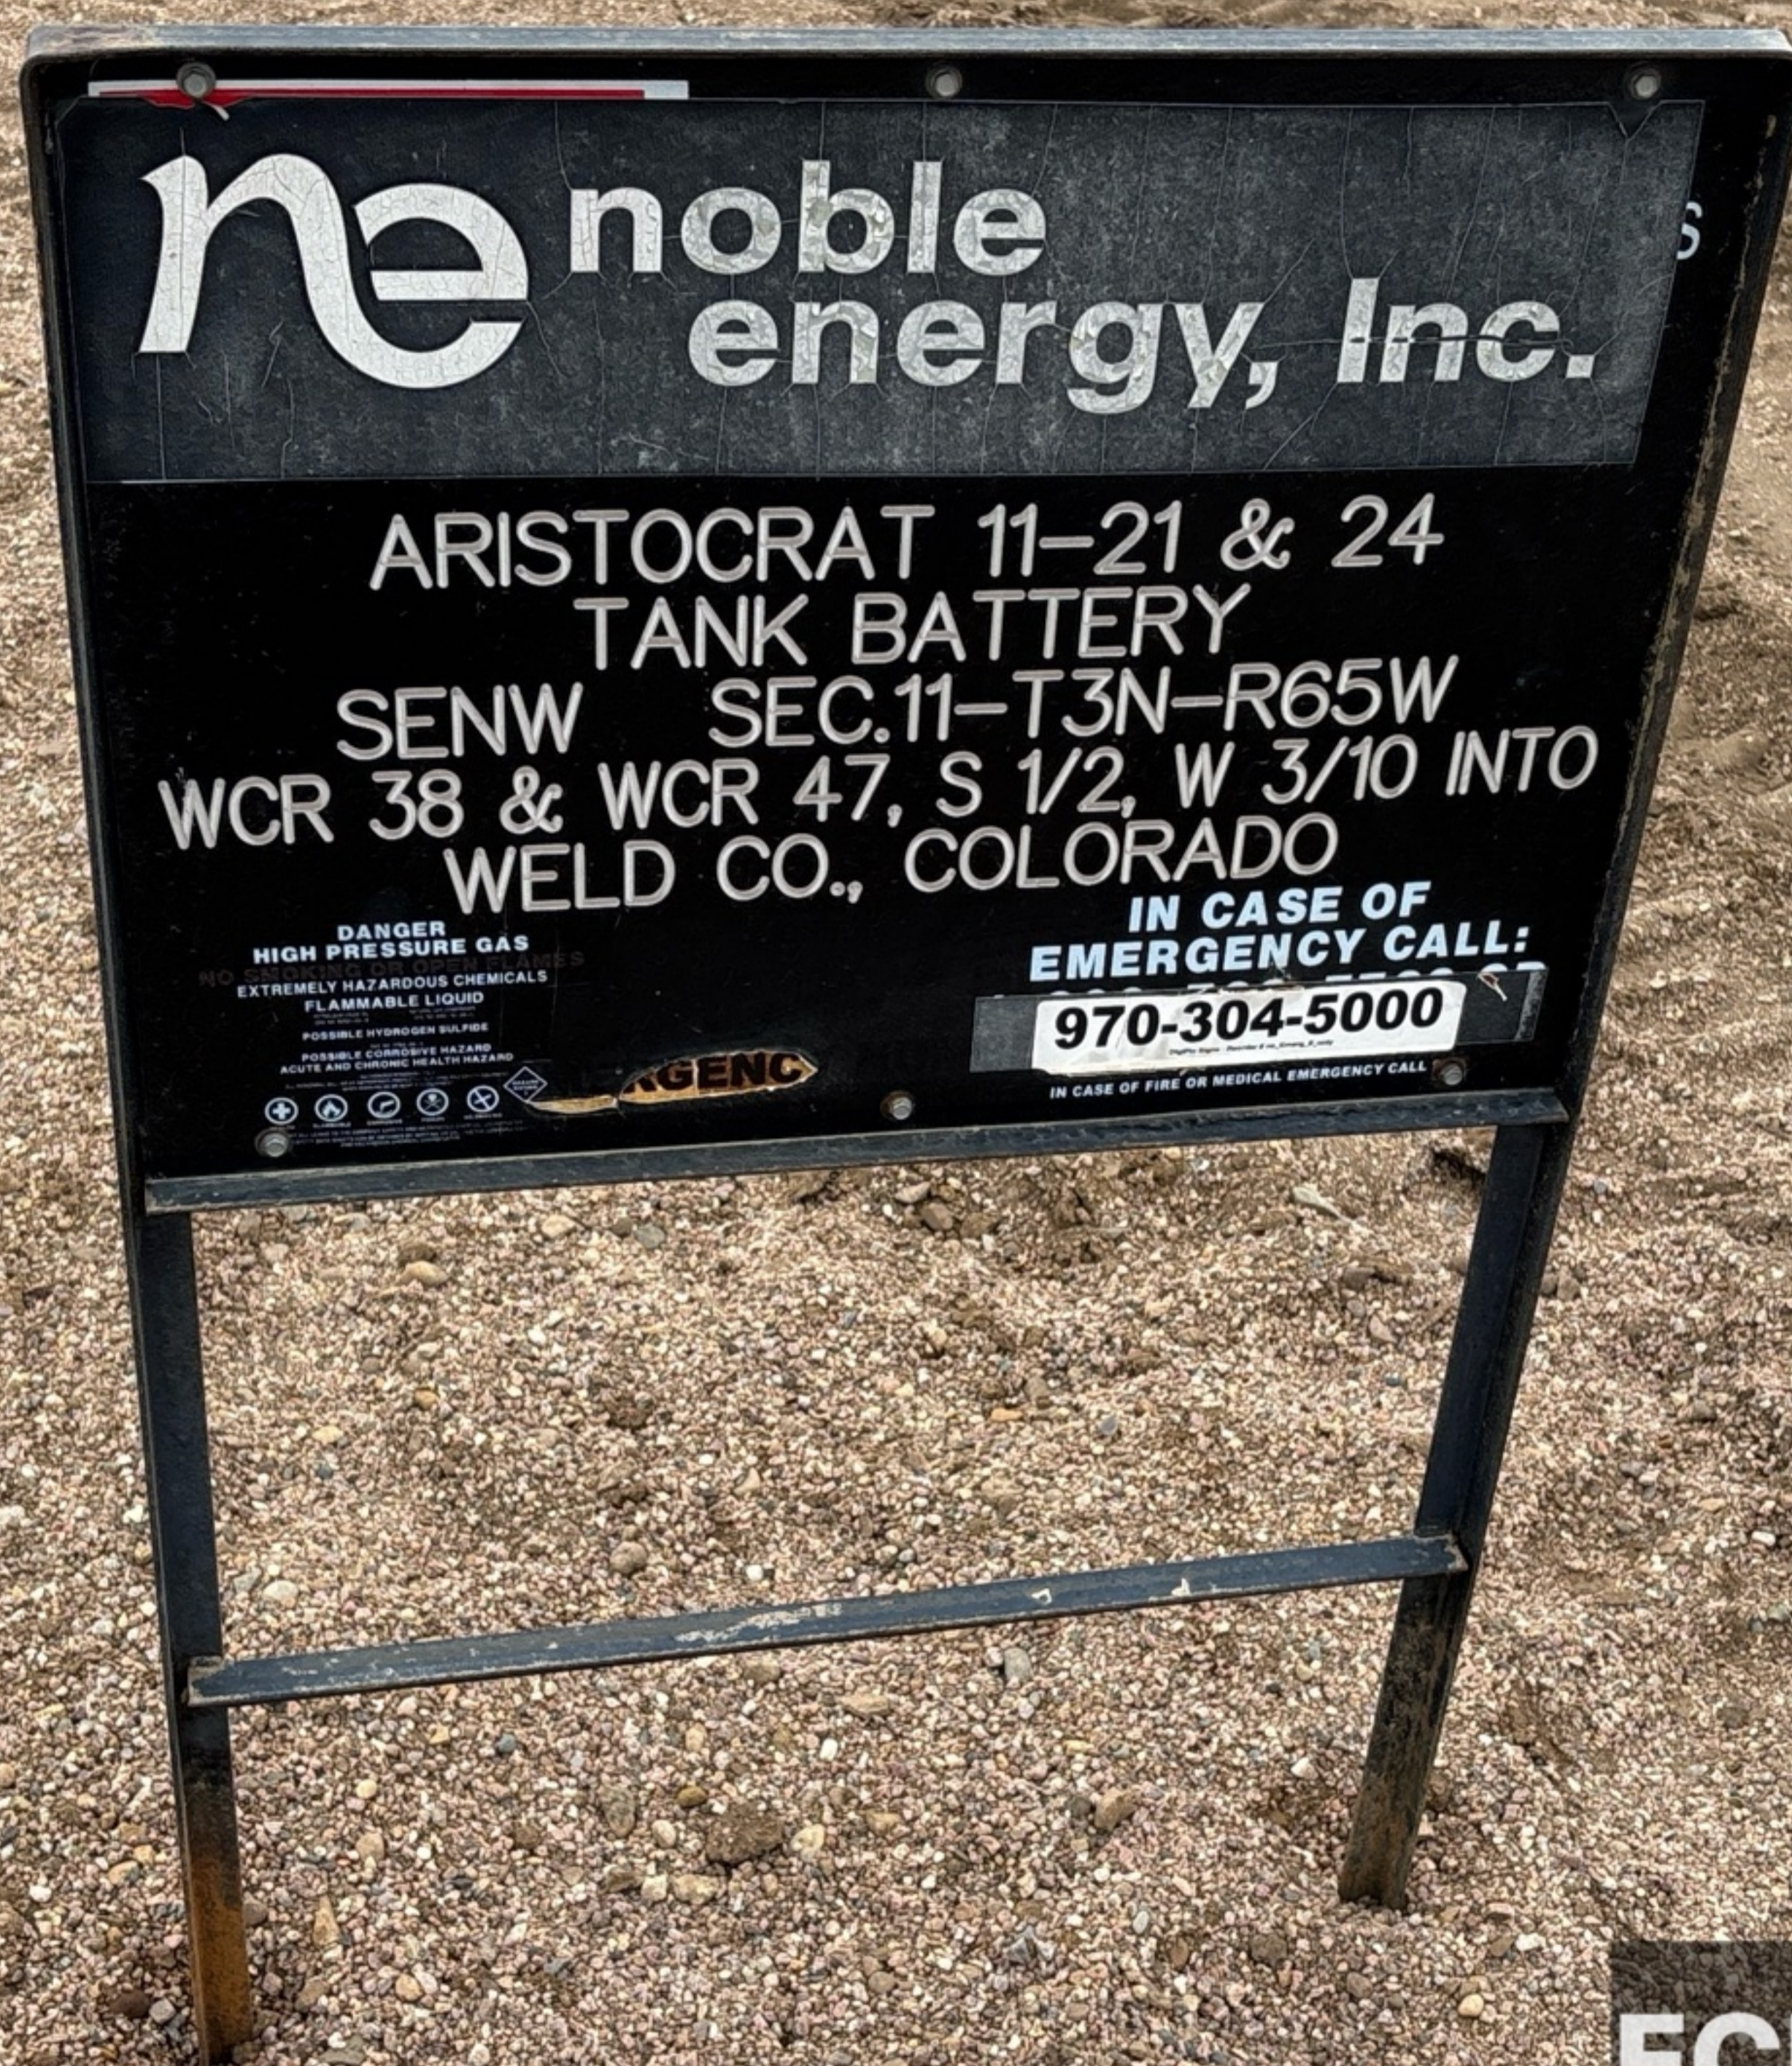
Signage with emergency contact number is visible.

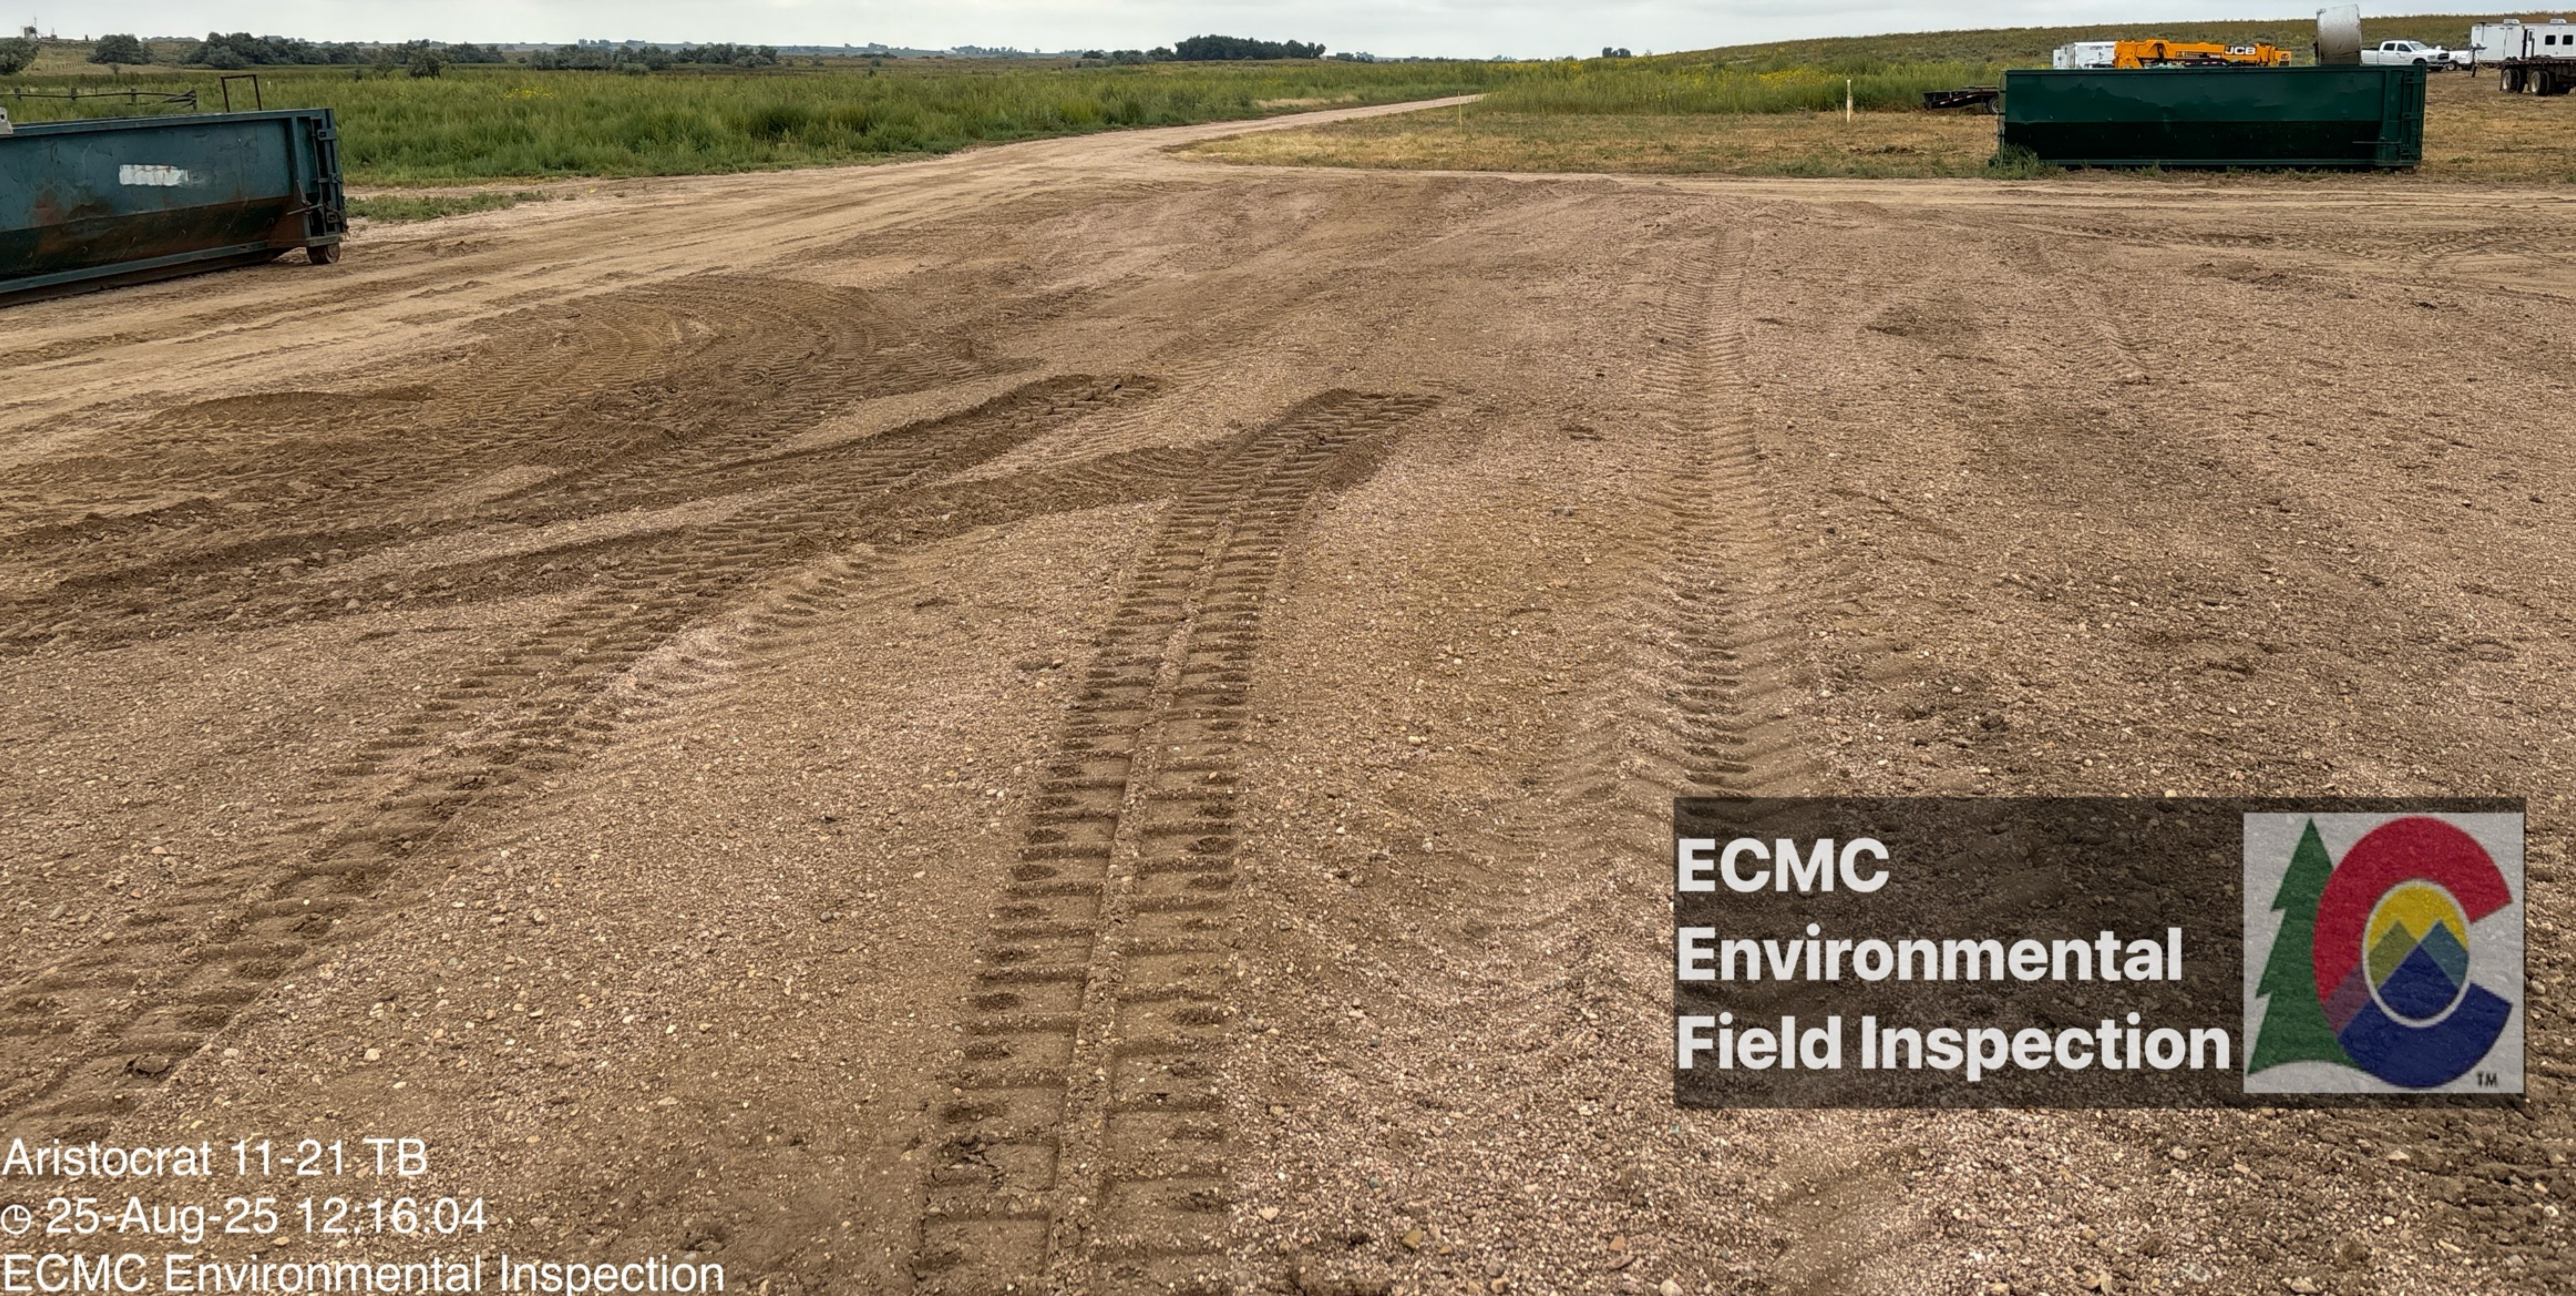
Looking at the approximate spill location. The excavation at the spill location has been backfilled to a grade above that of the surrounding location.

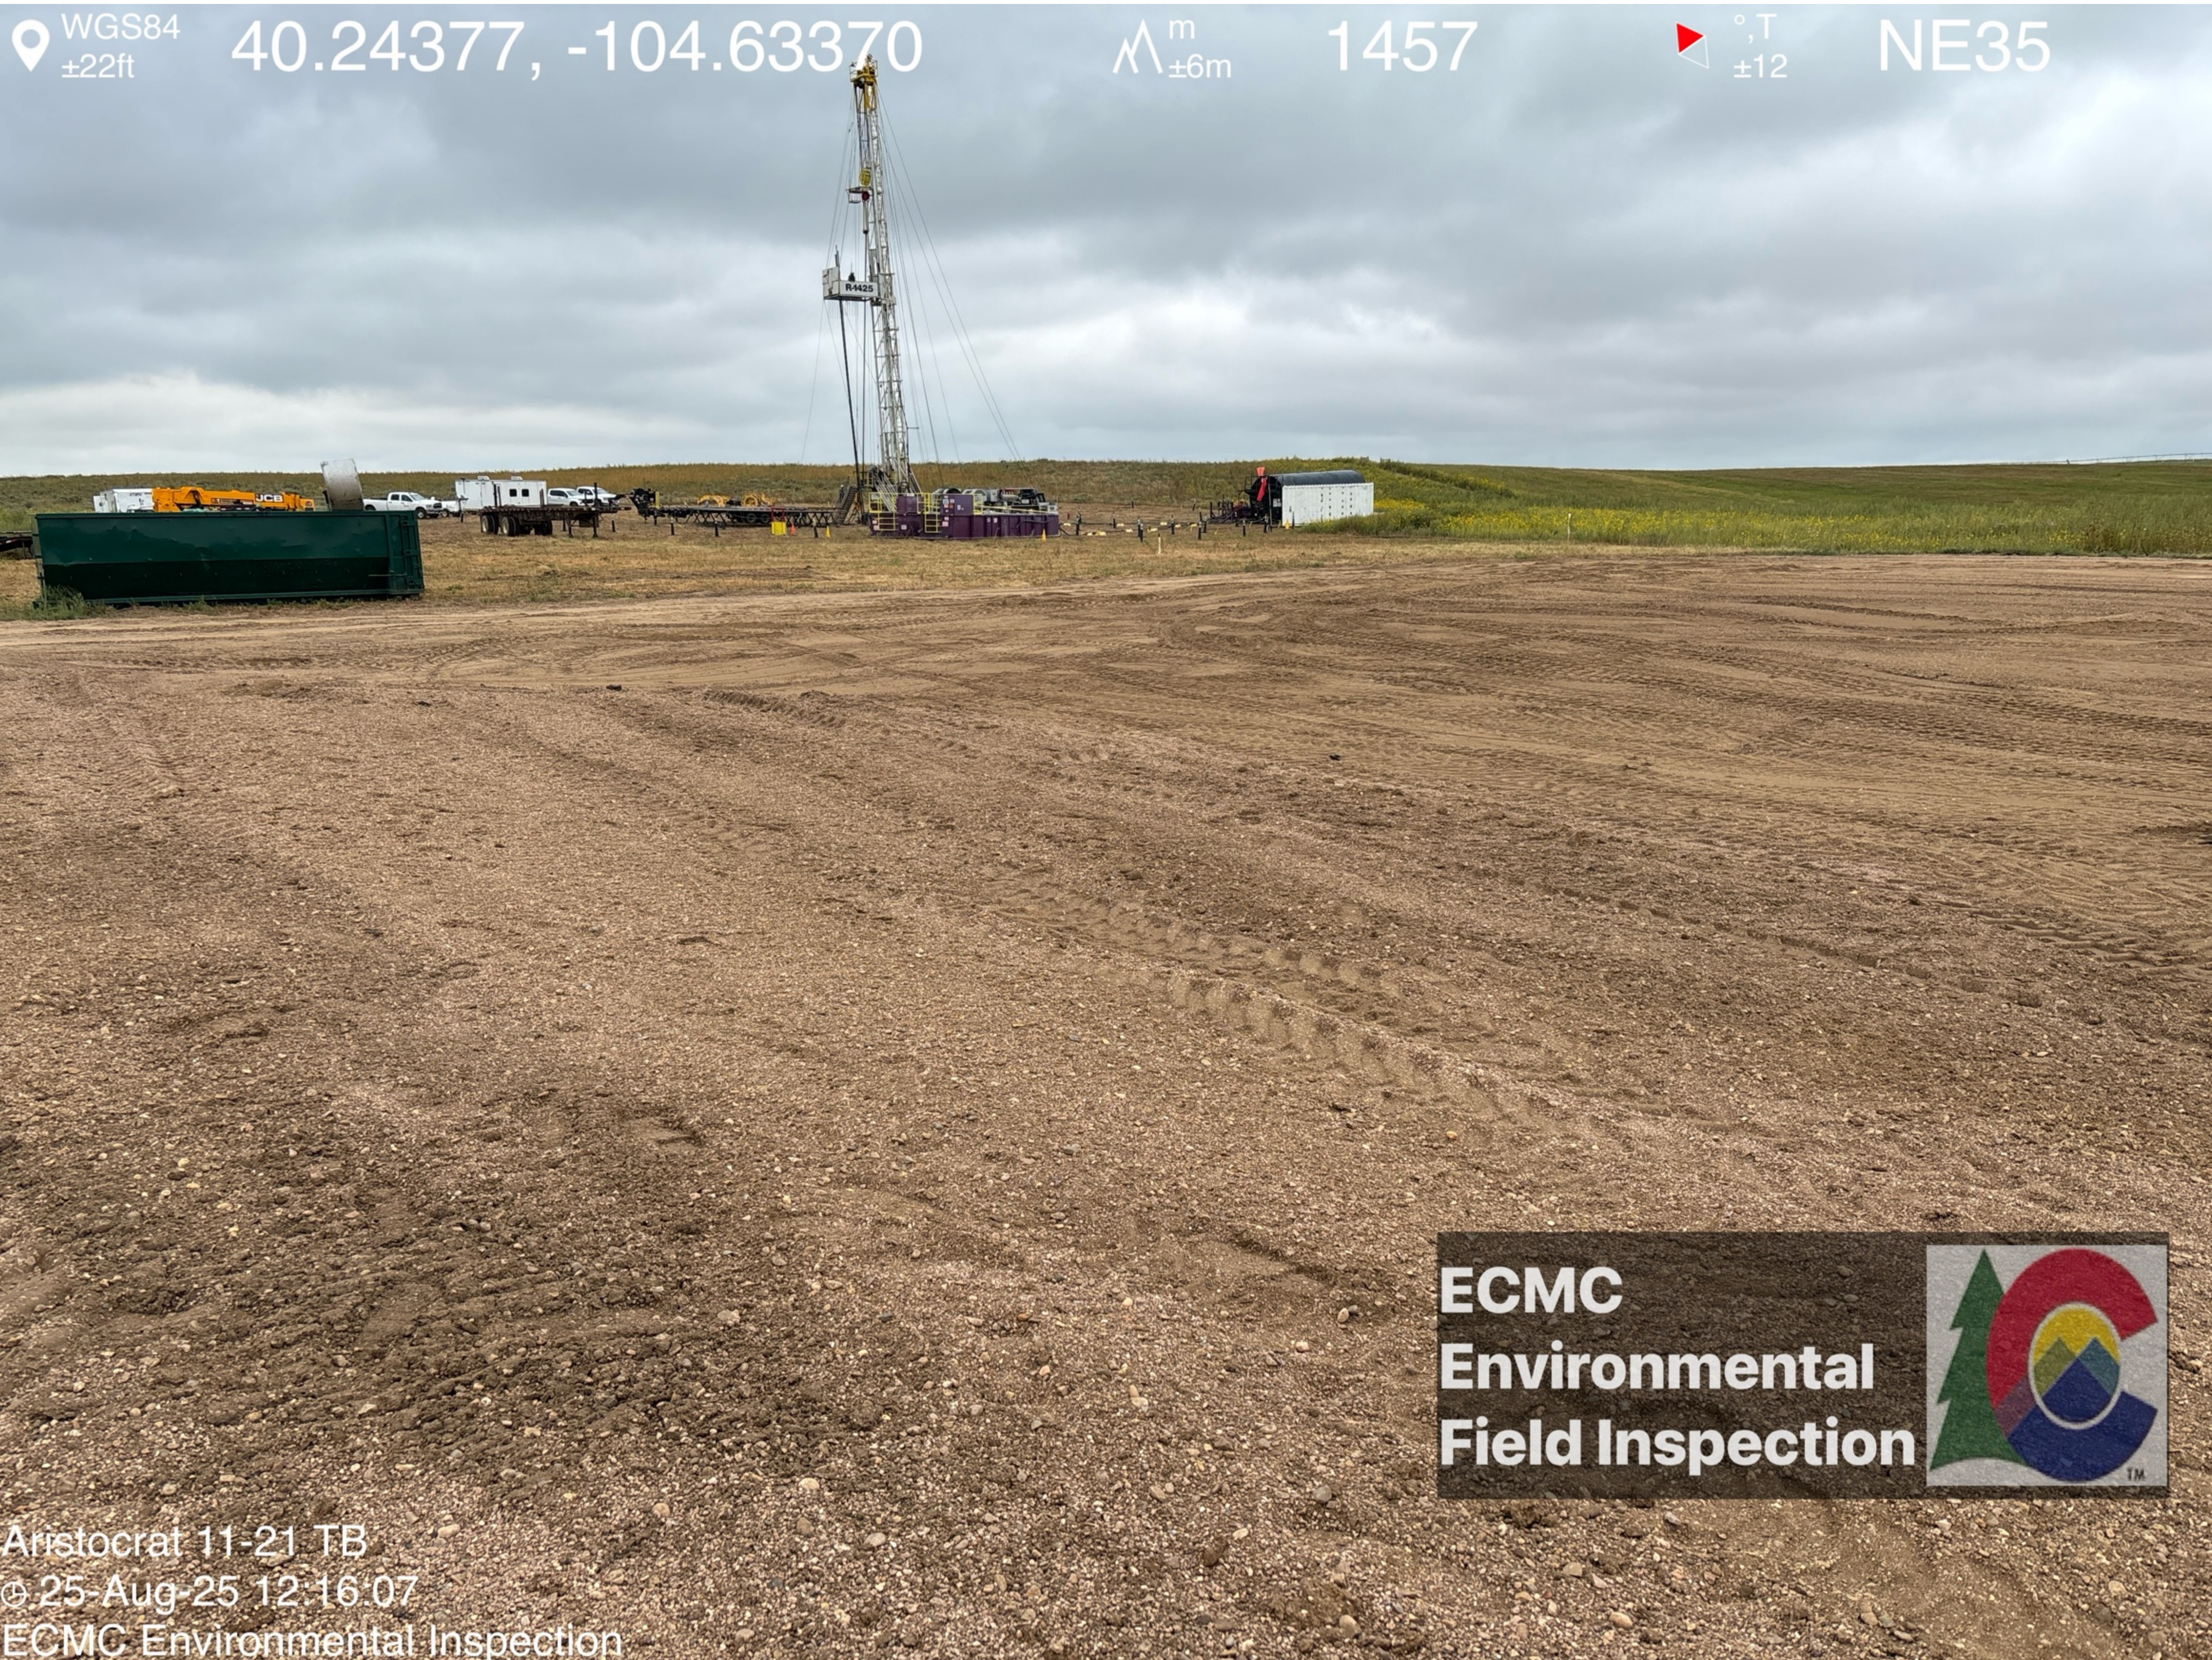
Looking at the former facility. The tank battery has been decommissioned. A work-over rig is visible in the background at the adjacent Aristocrat 11-21 well (API # 05-123-15805).

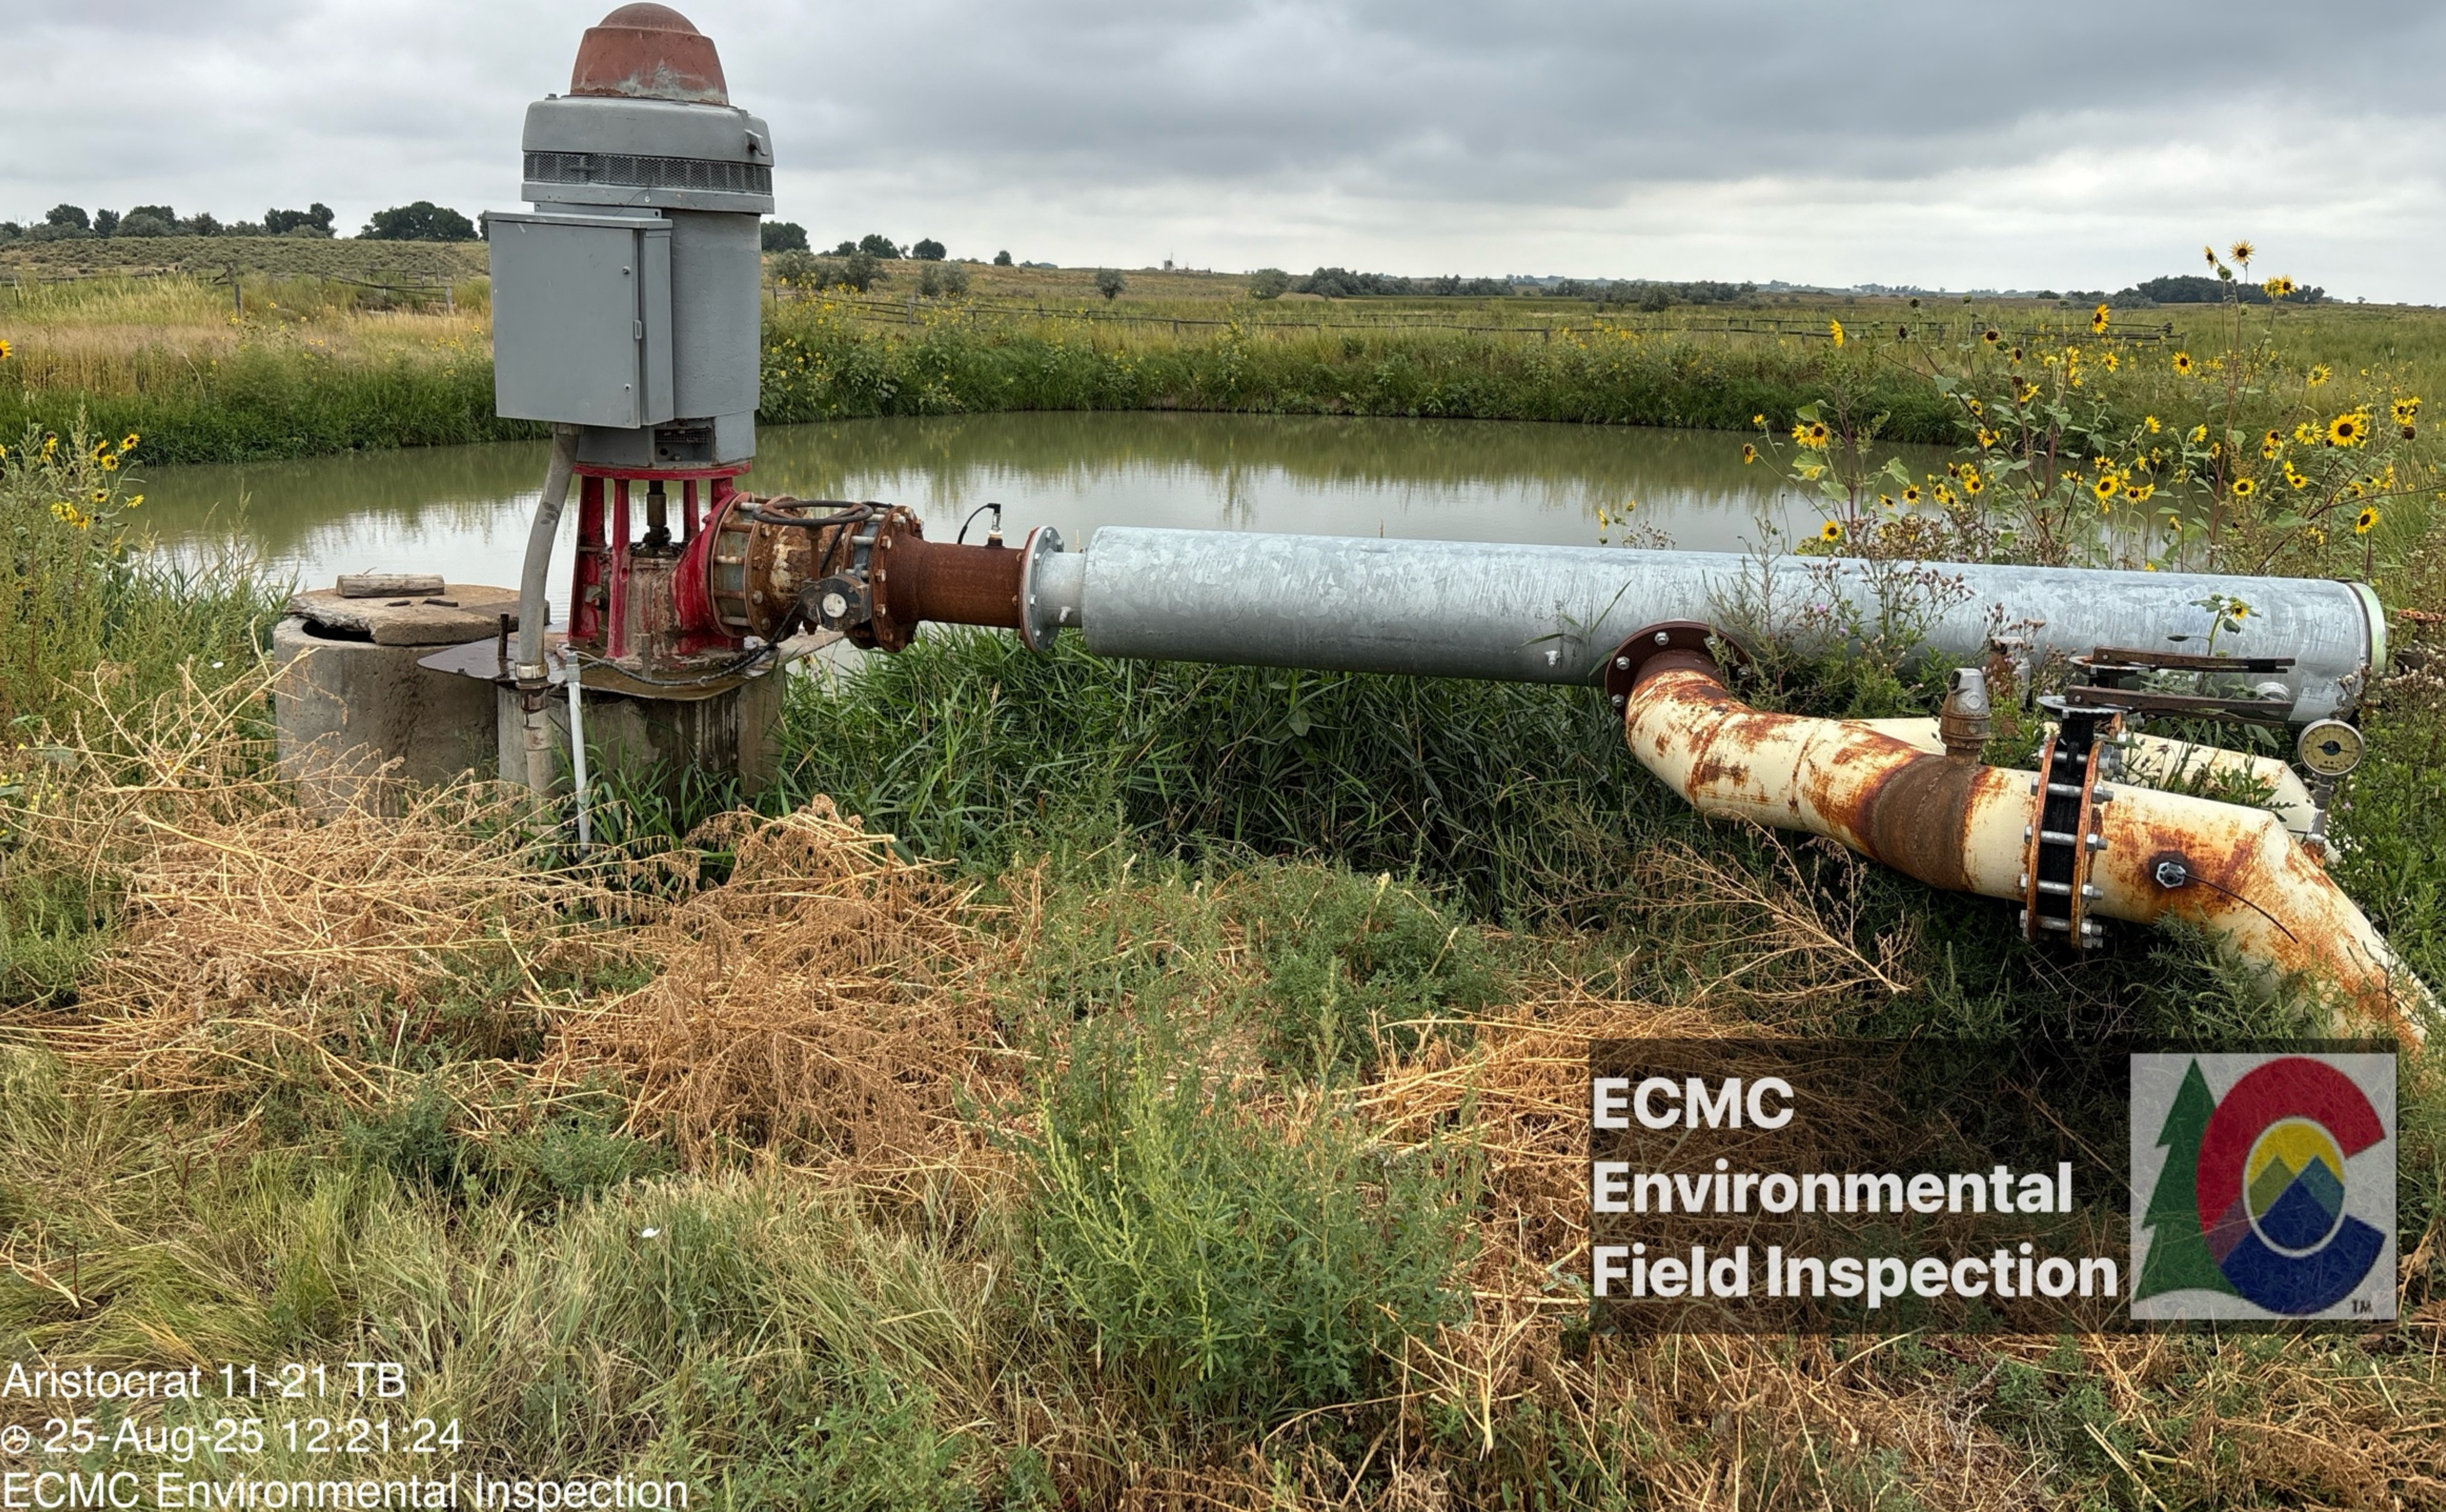
A pump was observed running at the pond southwest of the spill location.
