Inspection/Audit Photos

Location Name: QB ENERGY OPERATING LLC PUCKETT 246-1 Pad

Location #: 324324

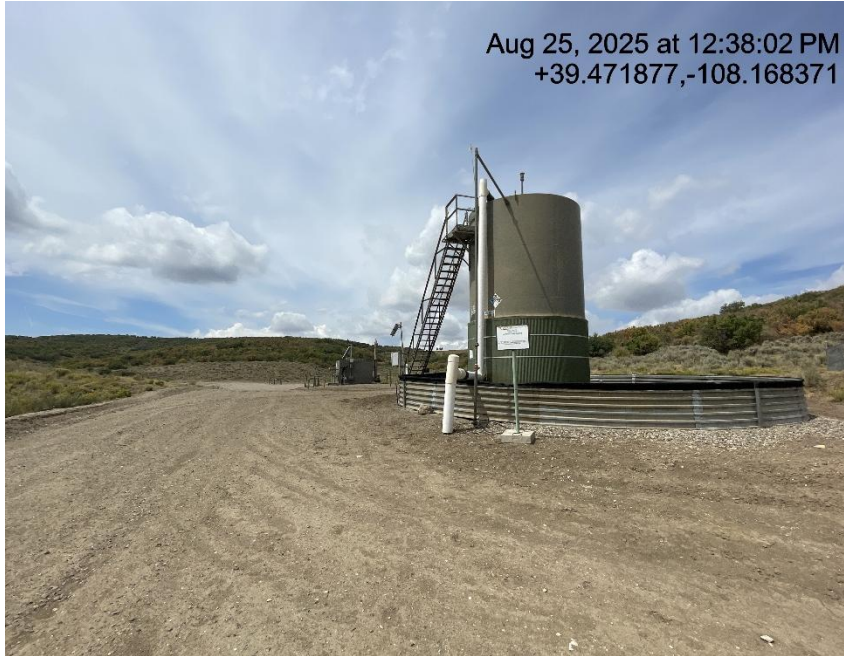
Photo # 3717 From entrance to location

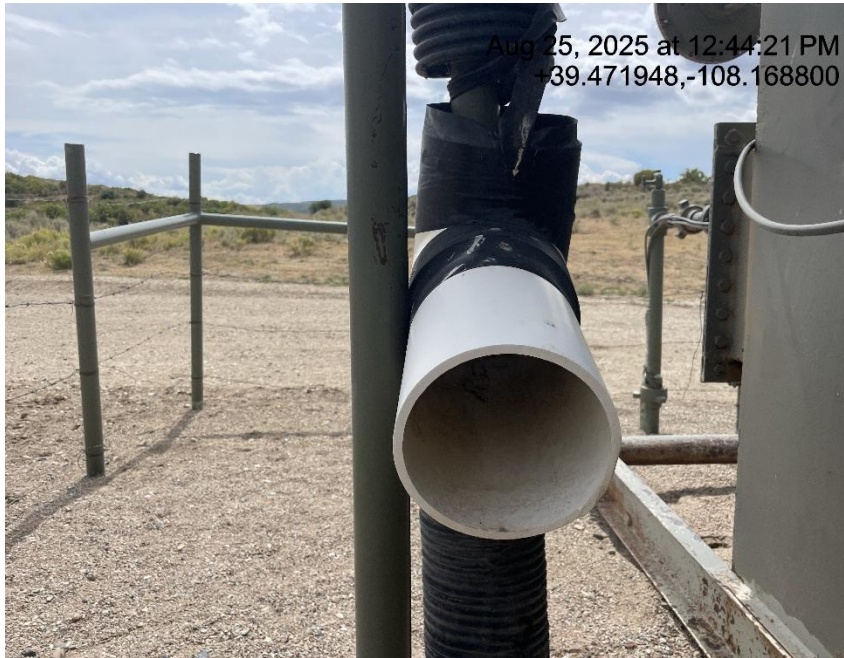
**Photo # 3723 Flowline heating insulation open ended
/wildlife hazard/available for entry by wildlife**

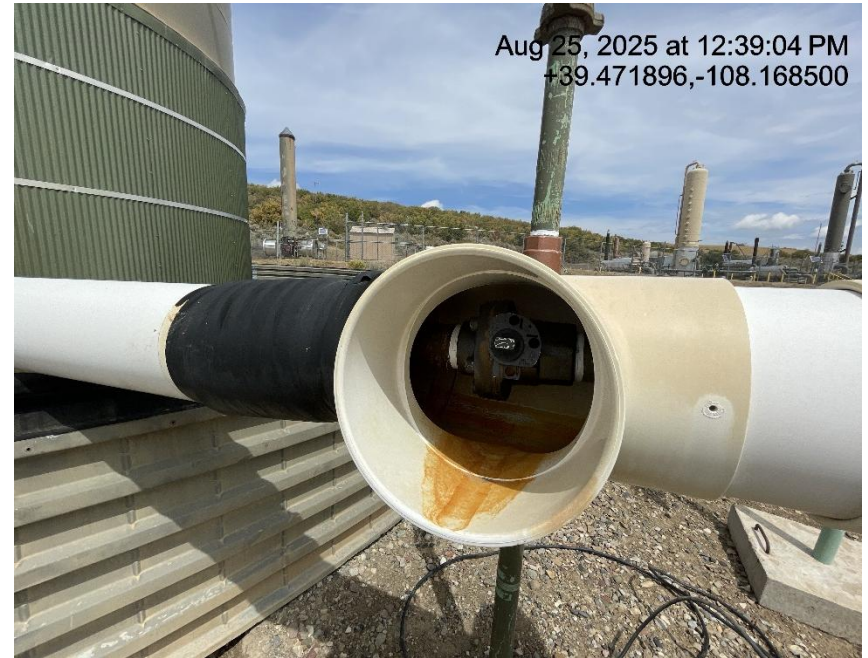
**Photo # 3724 Flowline heating insulation open ended
/wildlife hazard/available for entry by wildlife**

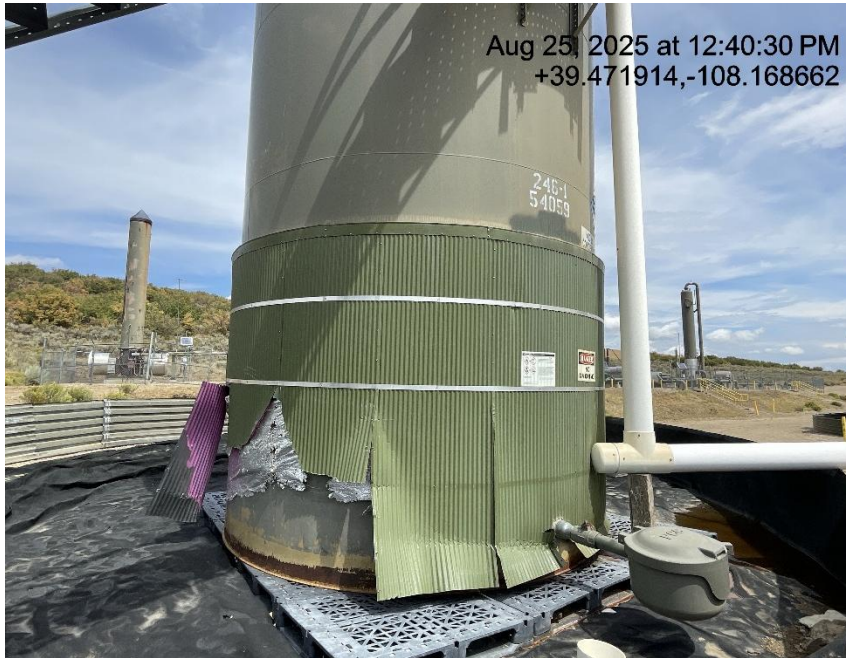
Photo # 3725 Tank lacks required labeling

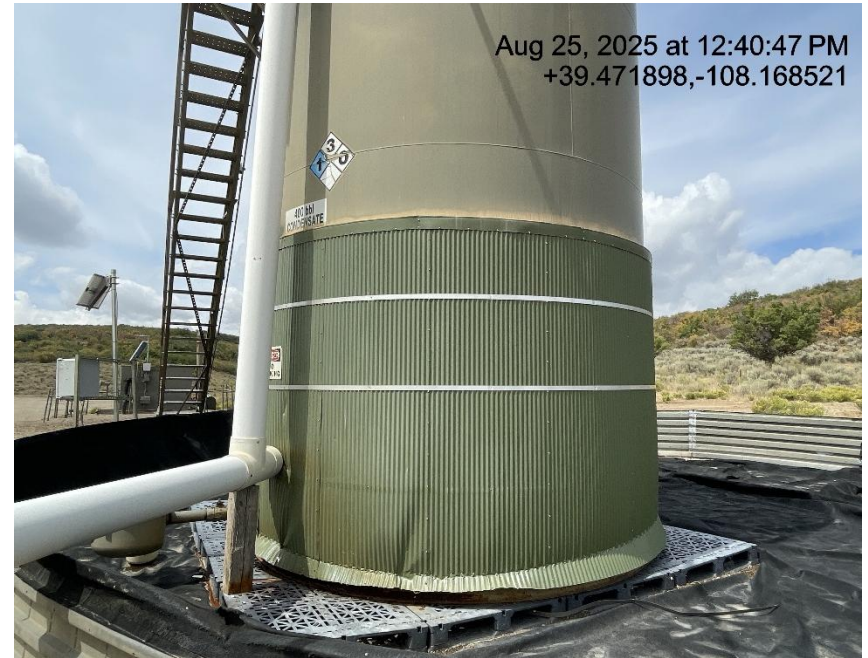
Photo # 3726 Tank lacks required labeling

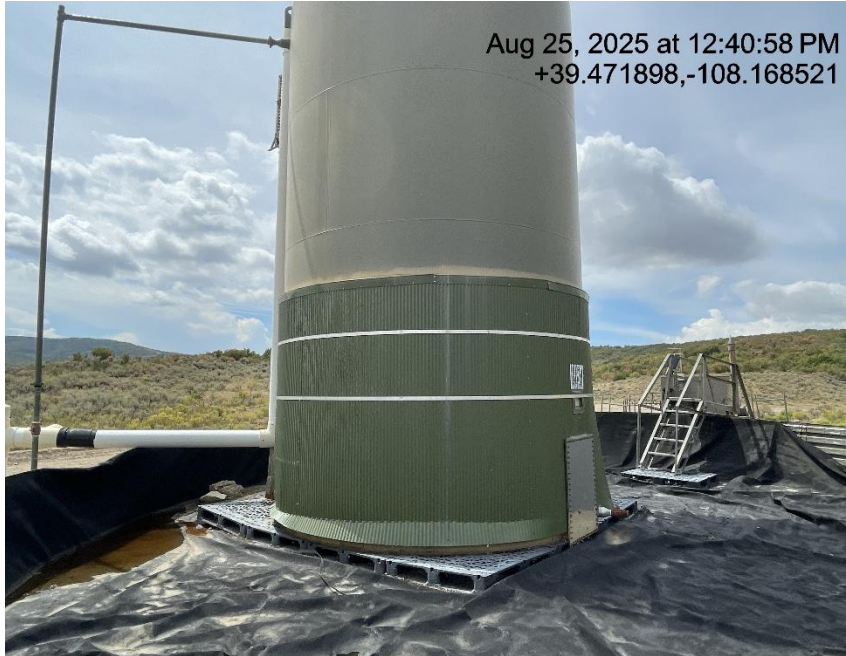
Photo # 3727 Tank lacks required labeling

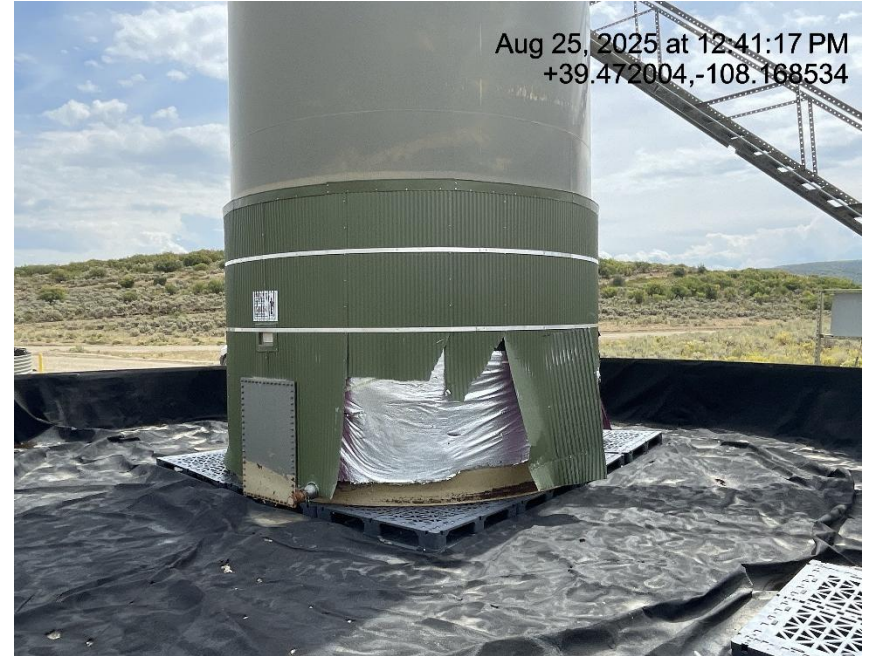
Photo # 3728 Tank lacks required labeling

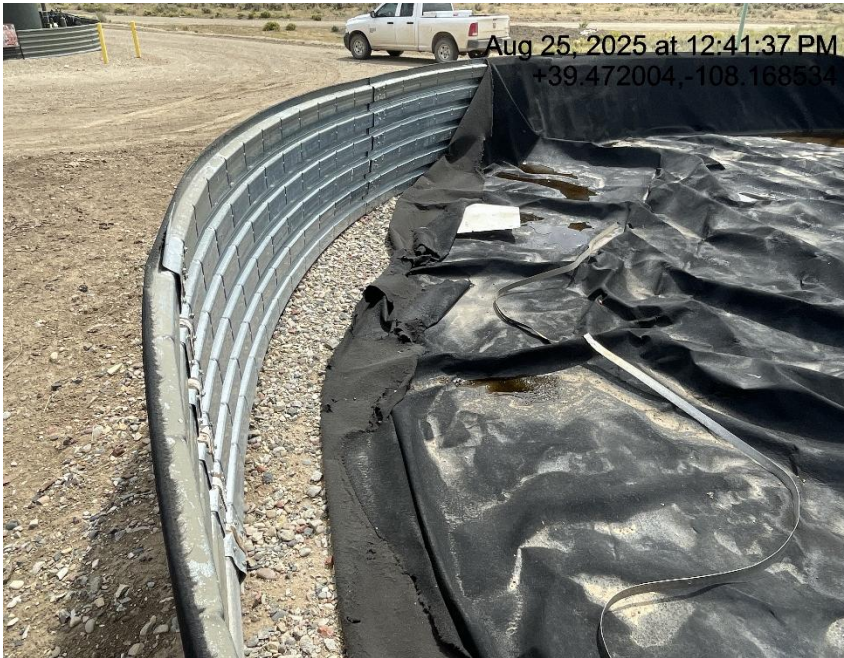
Photo # 3729 Secondary containment liner needs maintenance

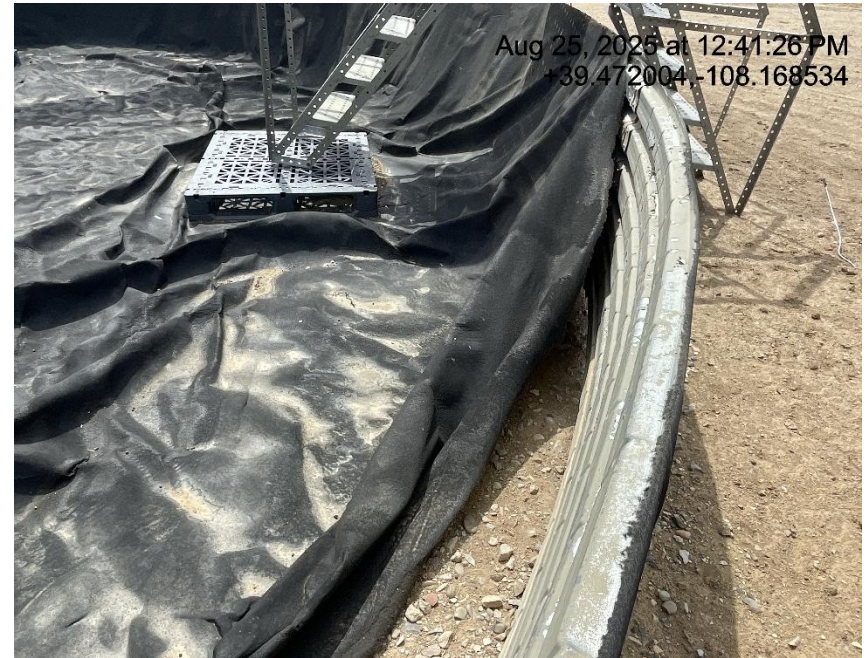
Photo # 3730 Secondary containment liner needs maintenance

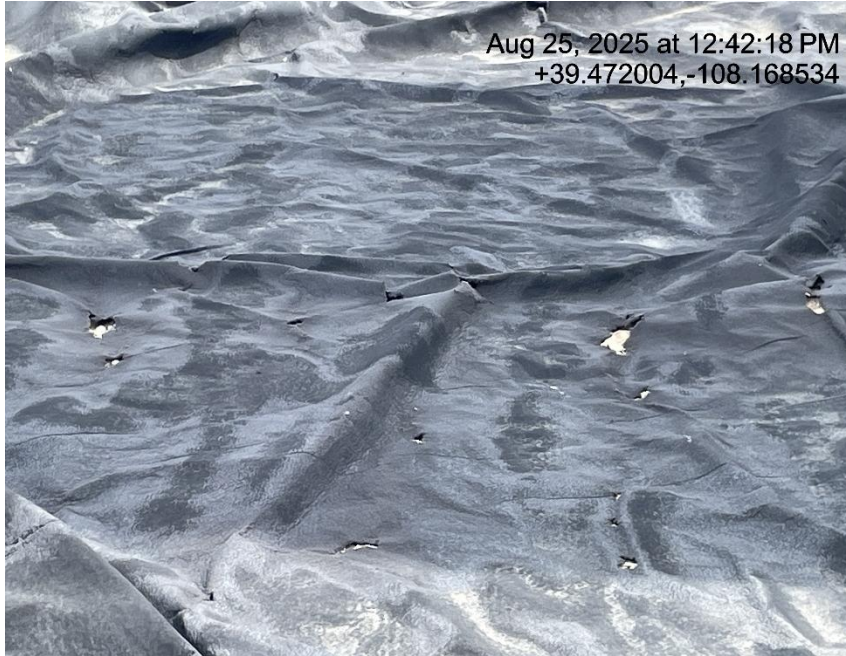
Photo # 3731 Holes in liner/liner needs maintenance

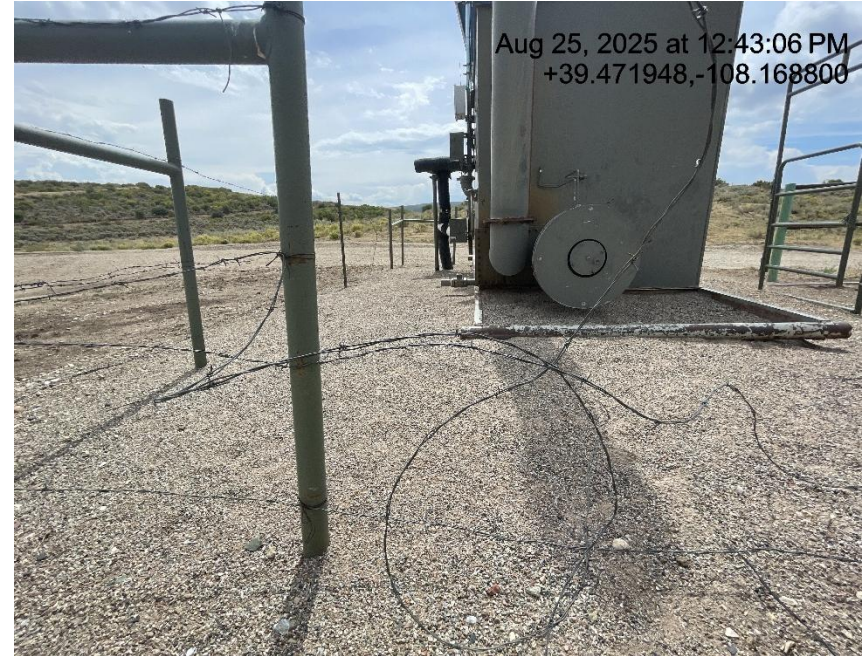
Photo # 3732 Barbed wire fence around separator needs maintenance/wildlife hazard

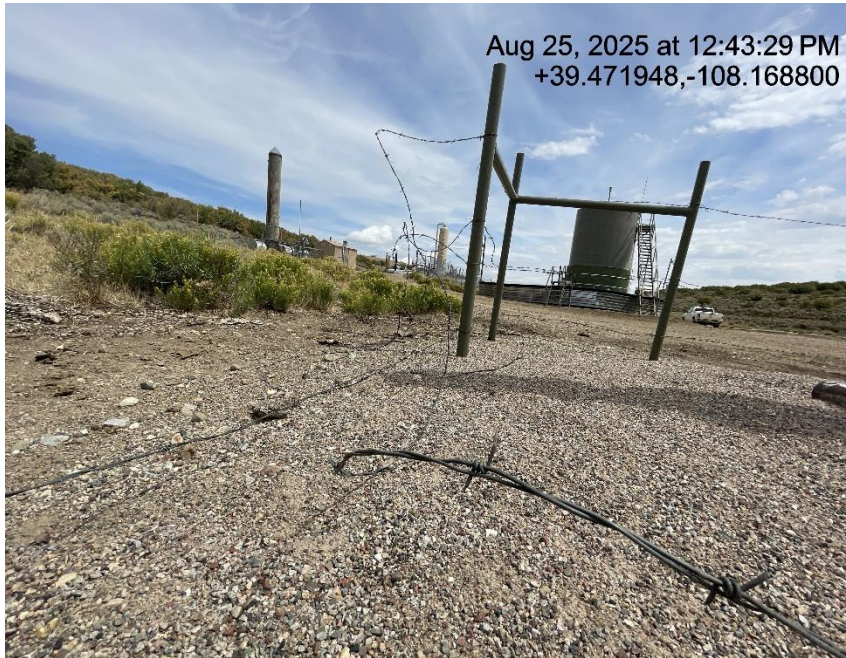
Photo # 3733 Barbed wire fence around separator needs maintenance/wildlife hazard

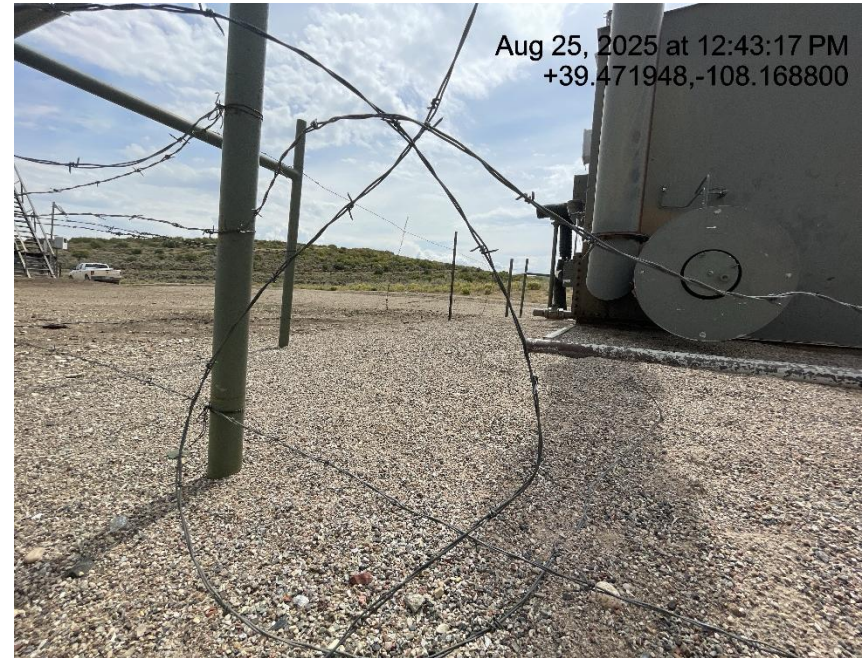
Photo # 3734 Barbed wire fence around separator needs maintenance/wildlife hazard

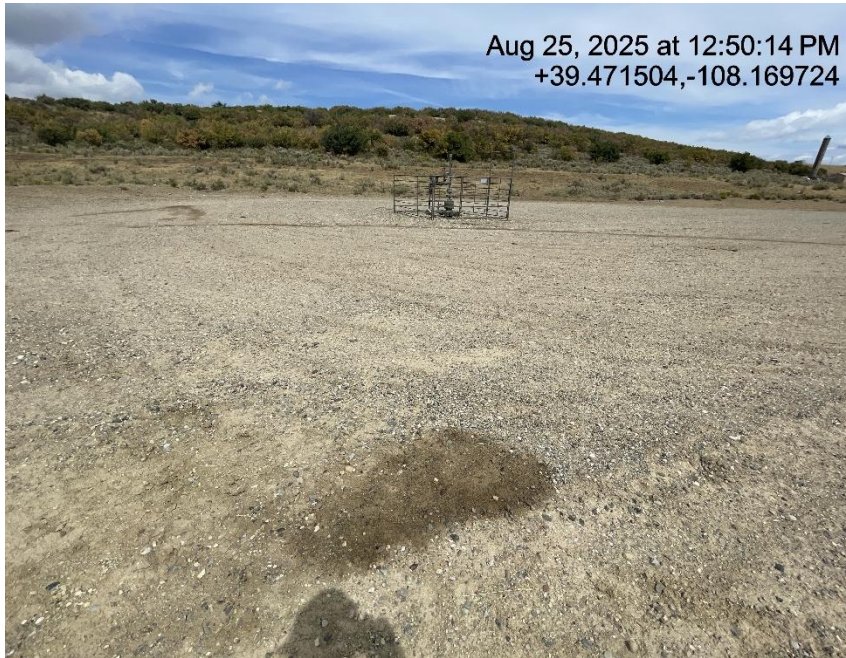
Photo # 3735 Stained soils

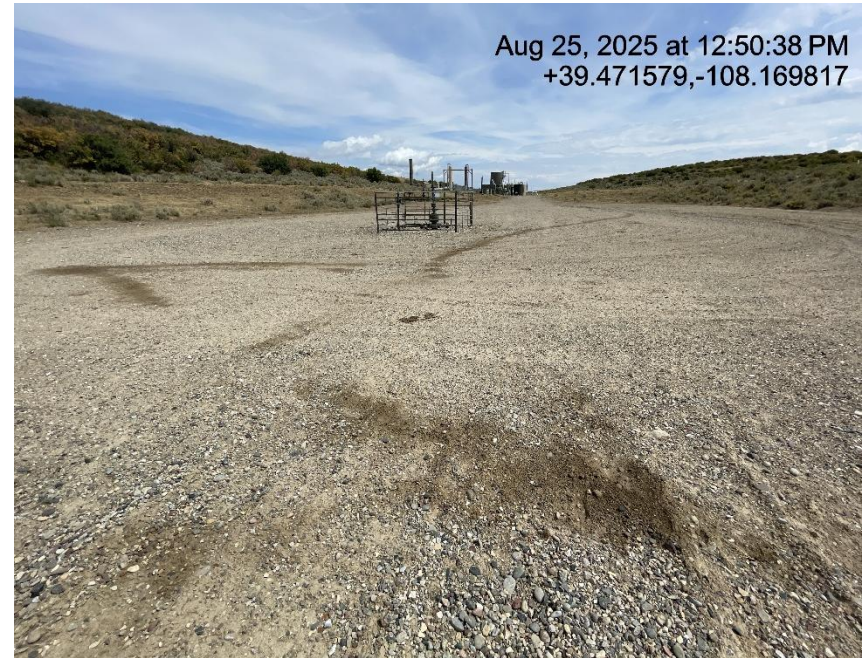
Photo # 3736 Stained soils

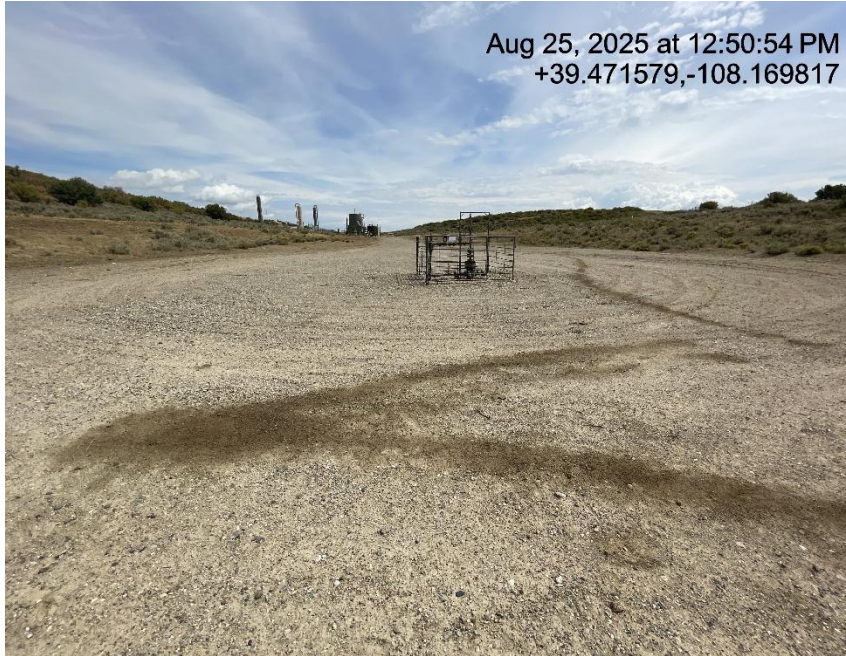
Photo # 3737 Stained soils

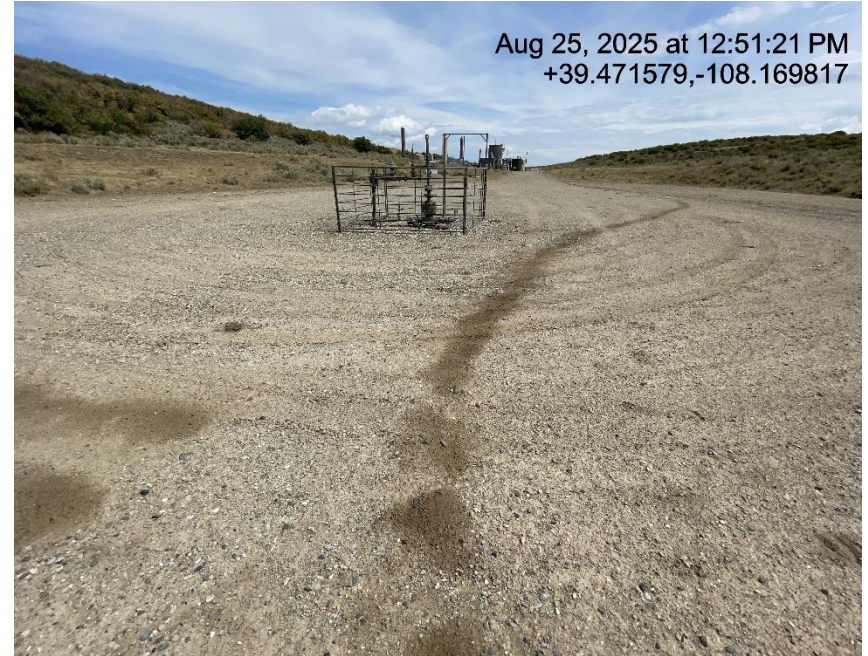
Photo # 3738 Stained soils

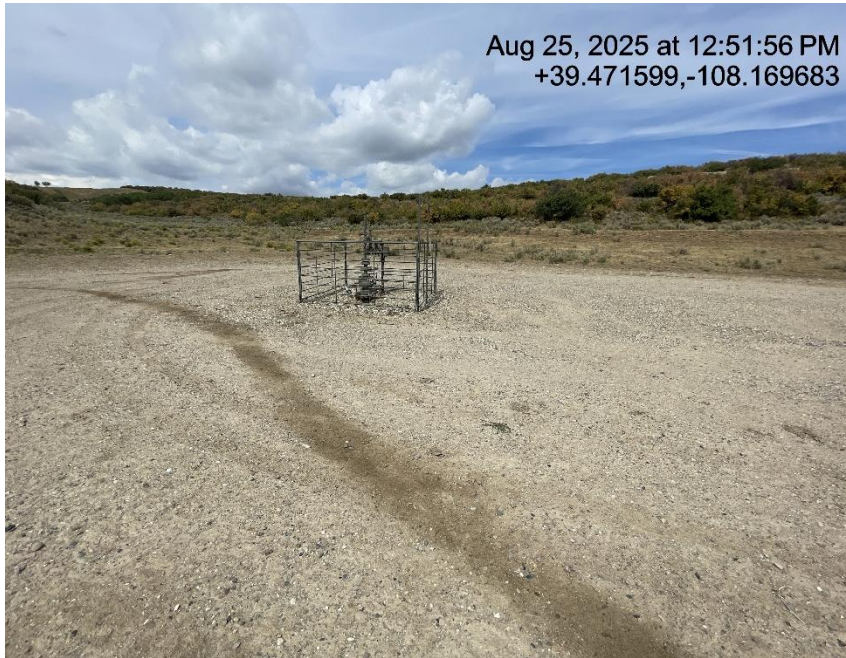
Photo # 3739 Stained soils

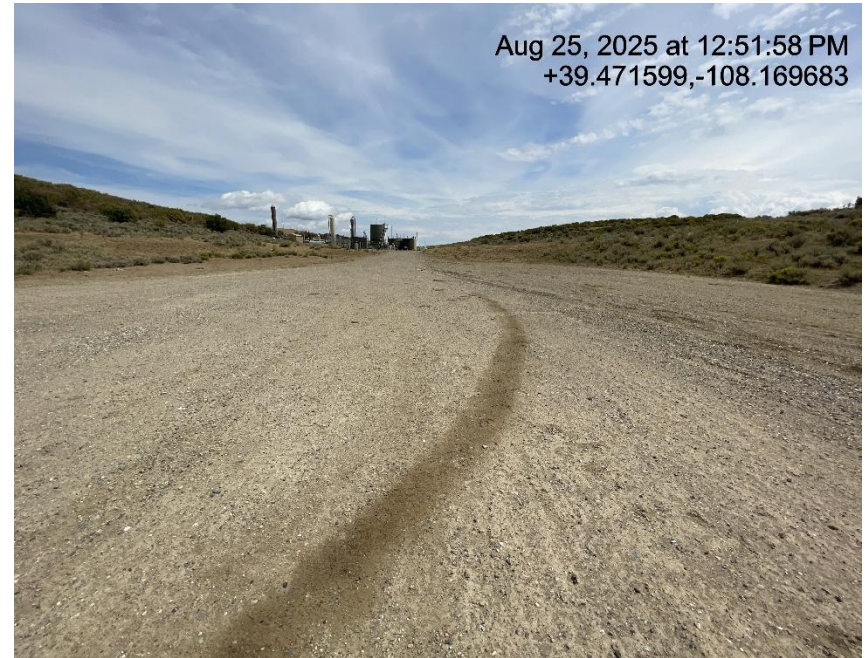
Photo # 3740 Stained soils
