UPRC 13-06J  
© 25-Aug-25 13:03:05  
ECMC Environmental Inspection

**ECMC  
Environmental  
Field Inspection**

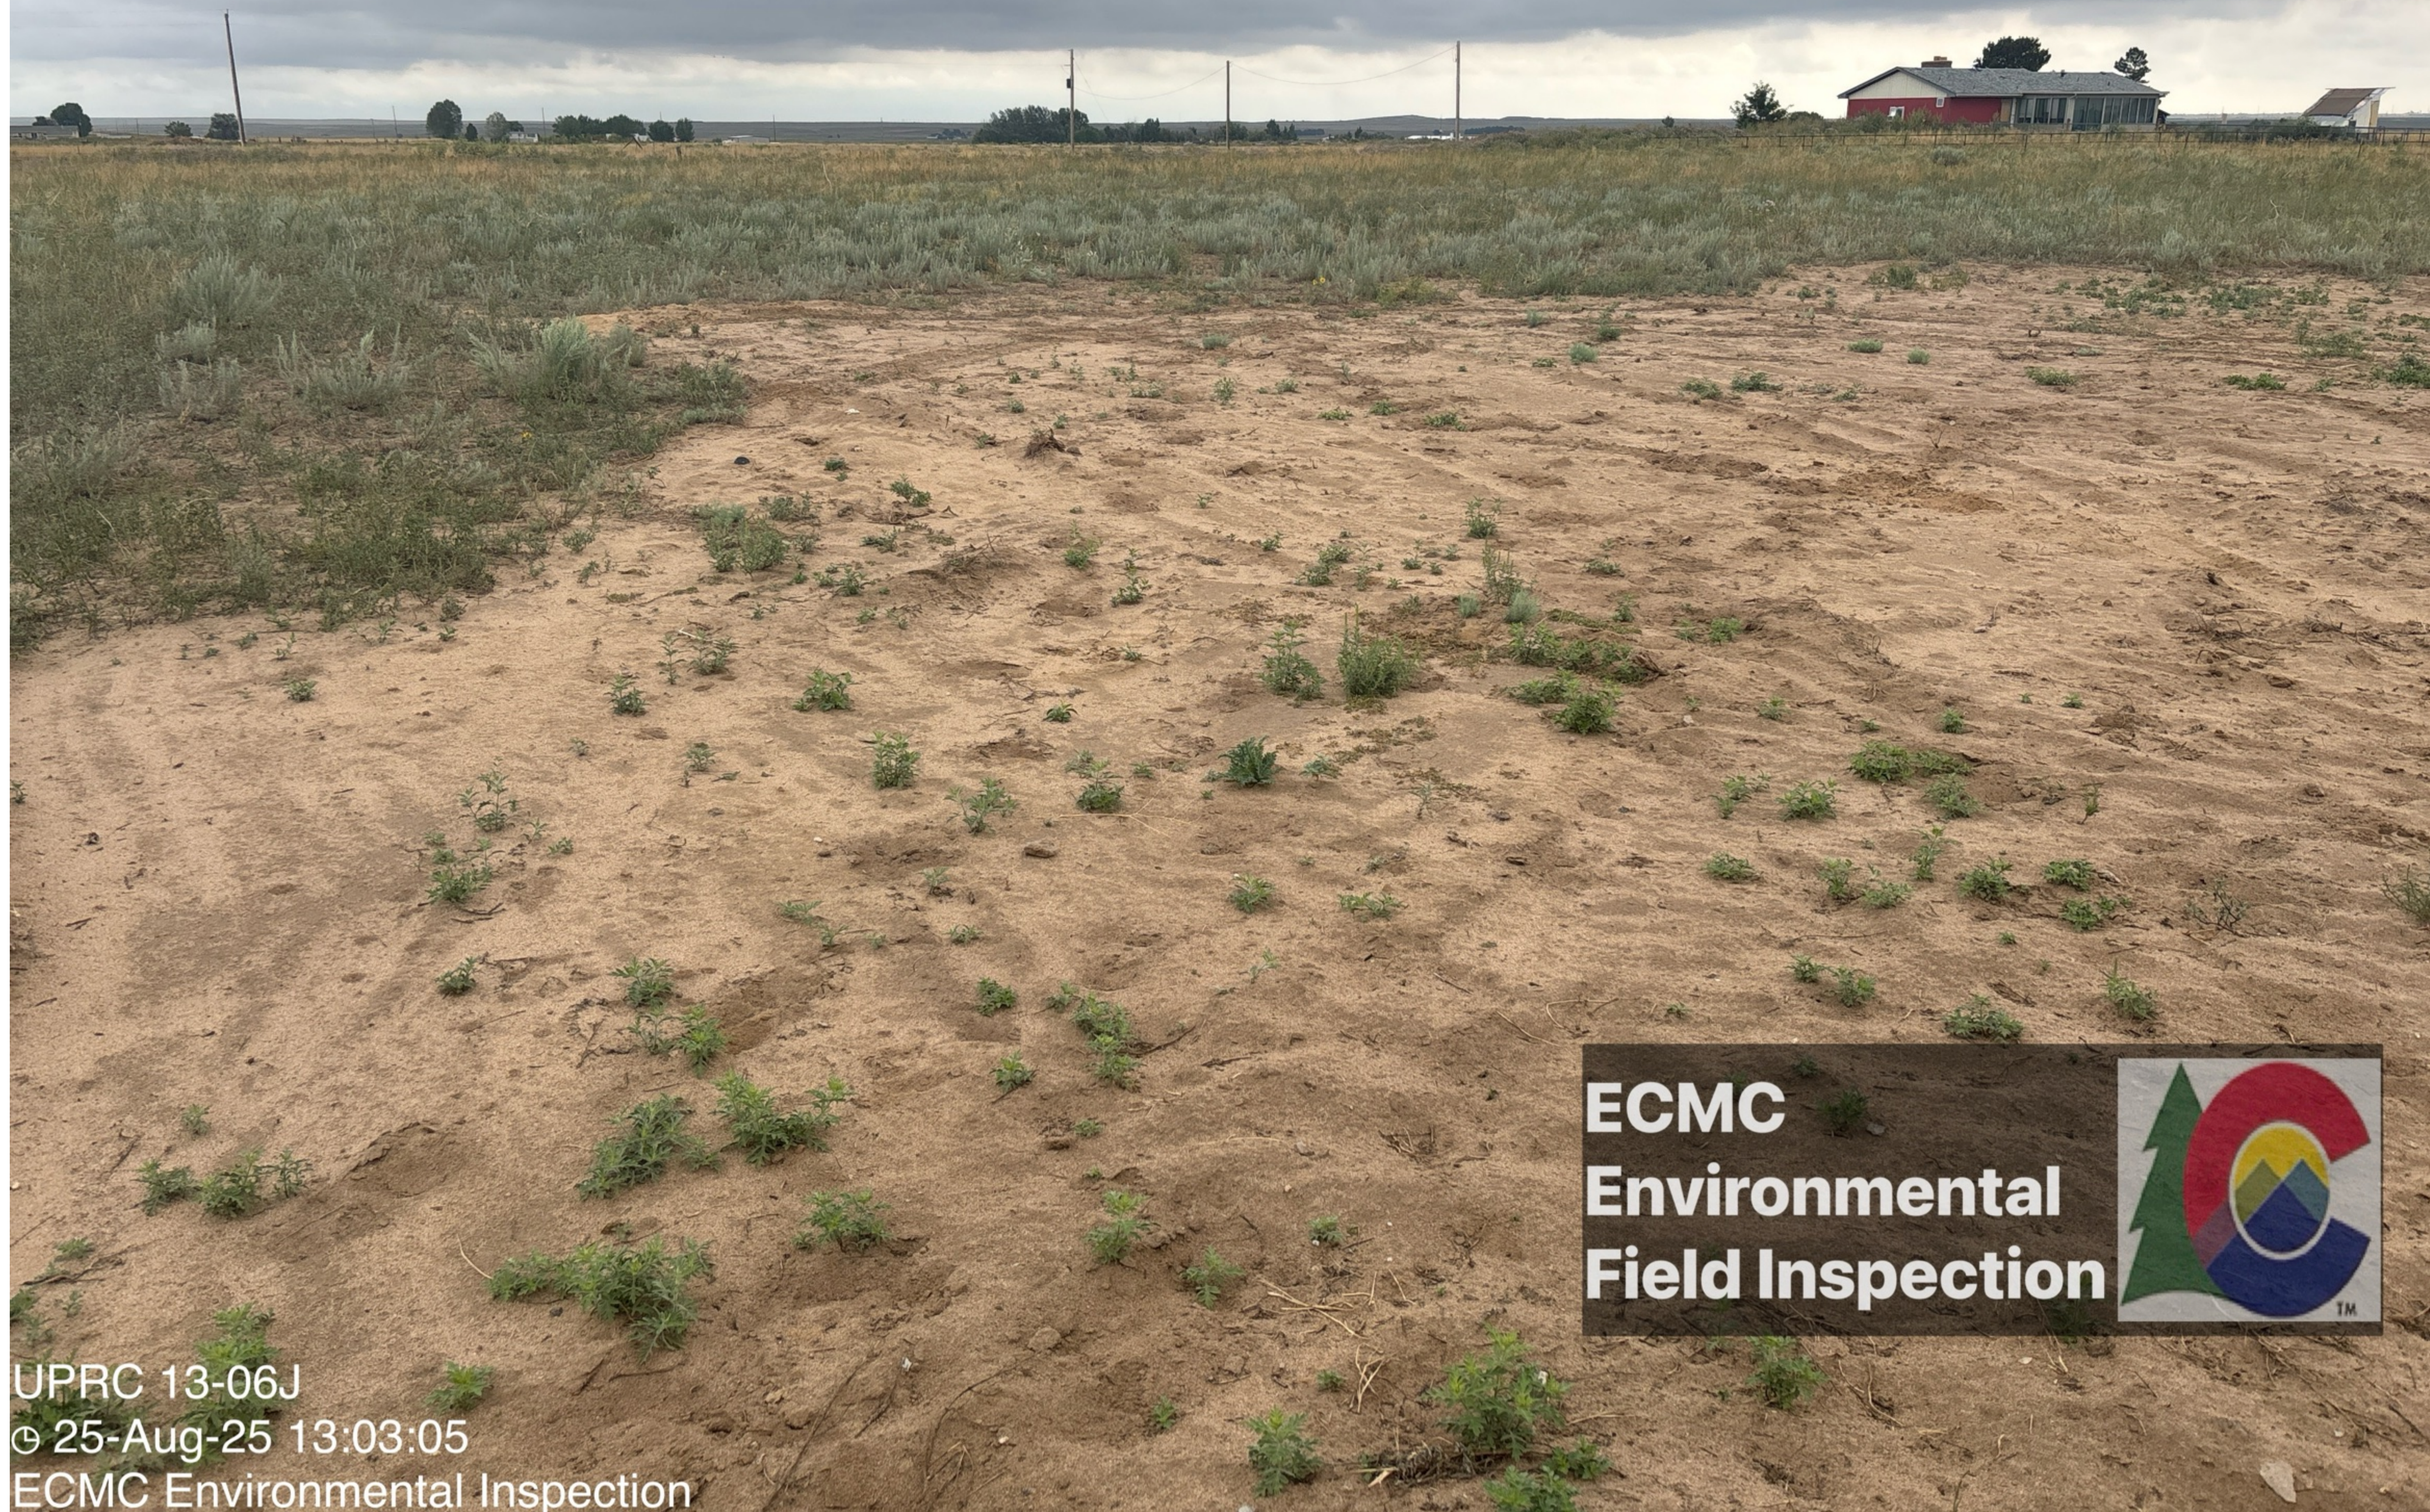
Looking at the approximate spill location. The excavation has been backfilled.
