Inspection/Audit Photos

Location Name: QB ENERGY OPERATING LLC PUCKETT 216-25 Pad

Location #: 324202

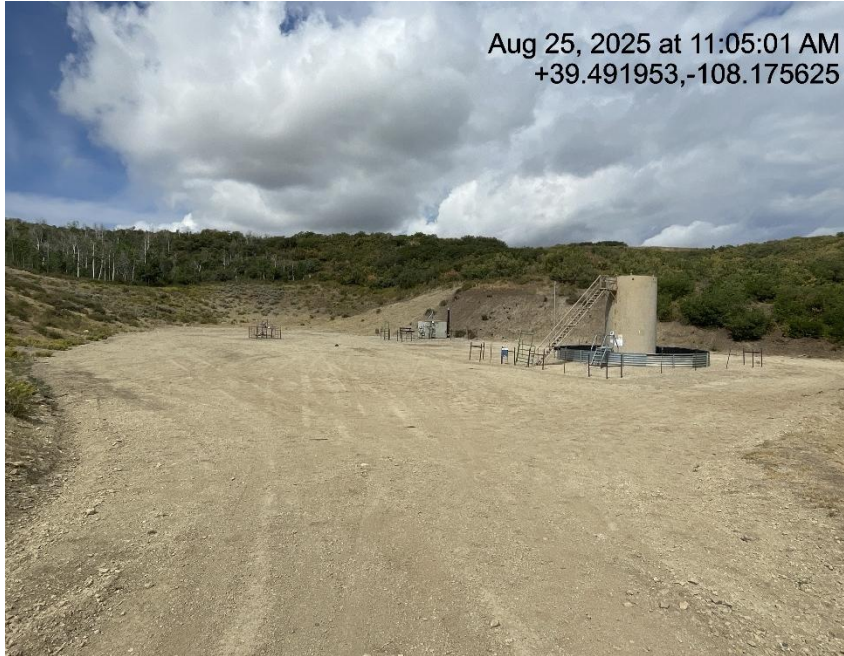
Photo # 3452 From entrance to location

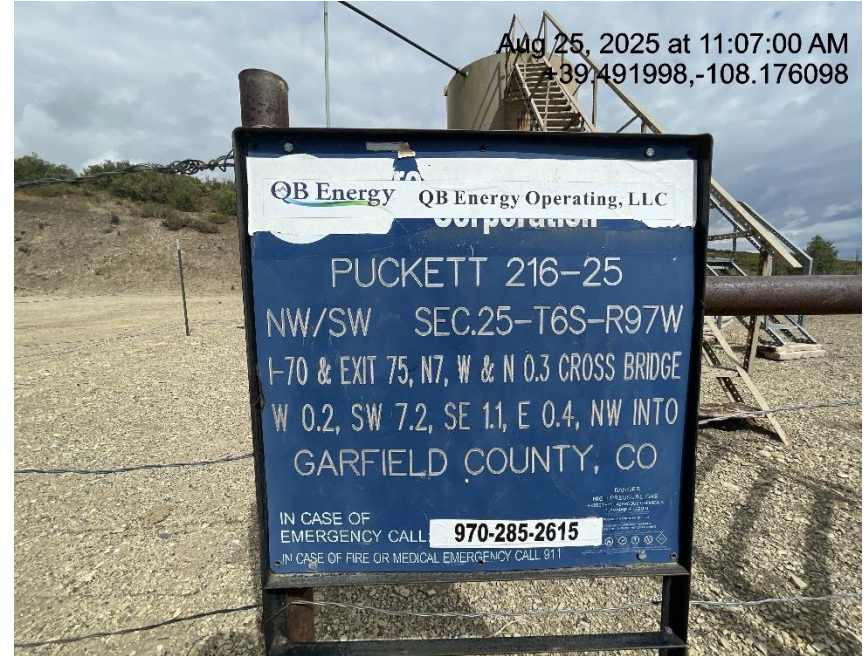
Photo # 3453 Location

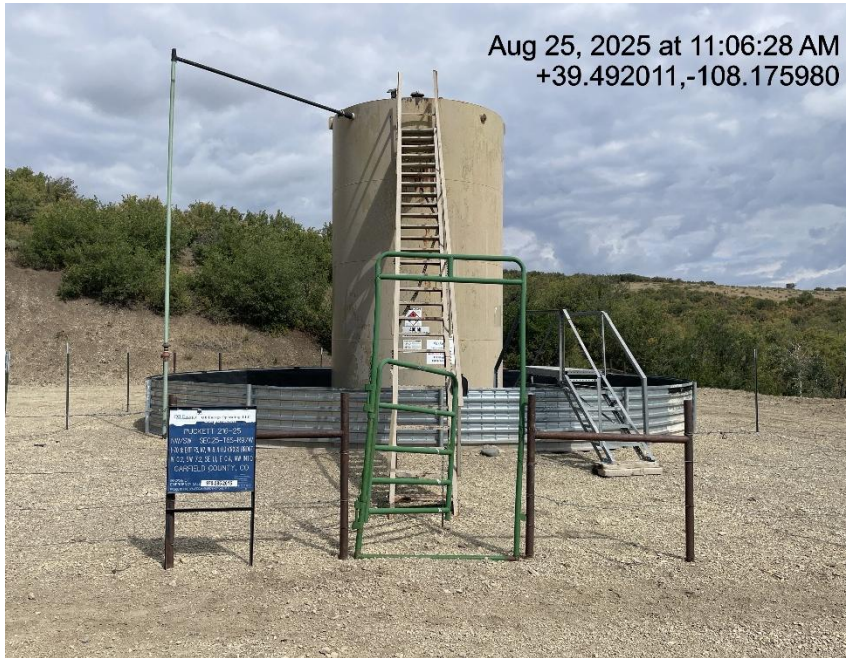
Photo # 3454 Location

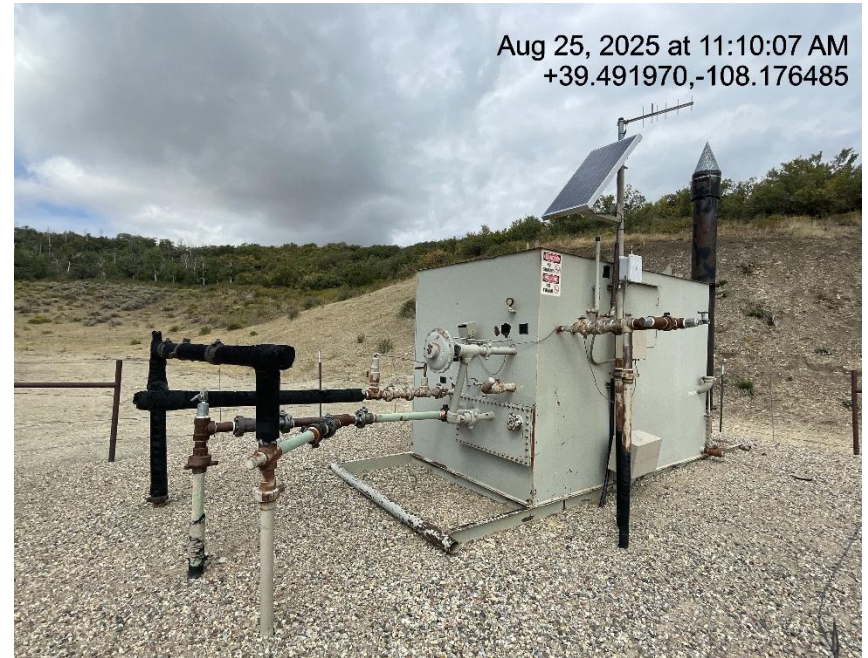
Photo # 3455 Location

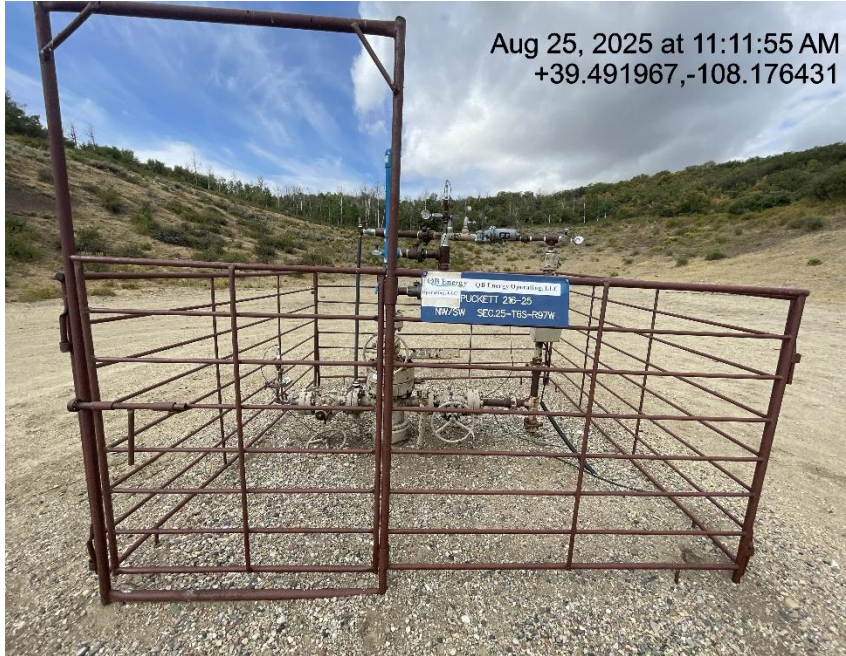
Photo # 3456 Location

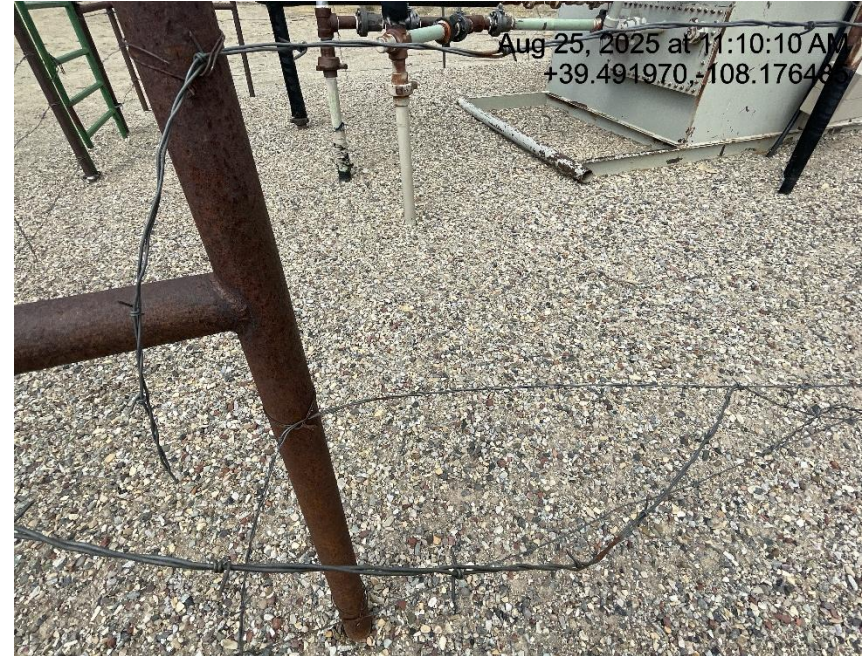
Photo # 3457 Fencing needs maintenance/wildlife hazard

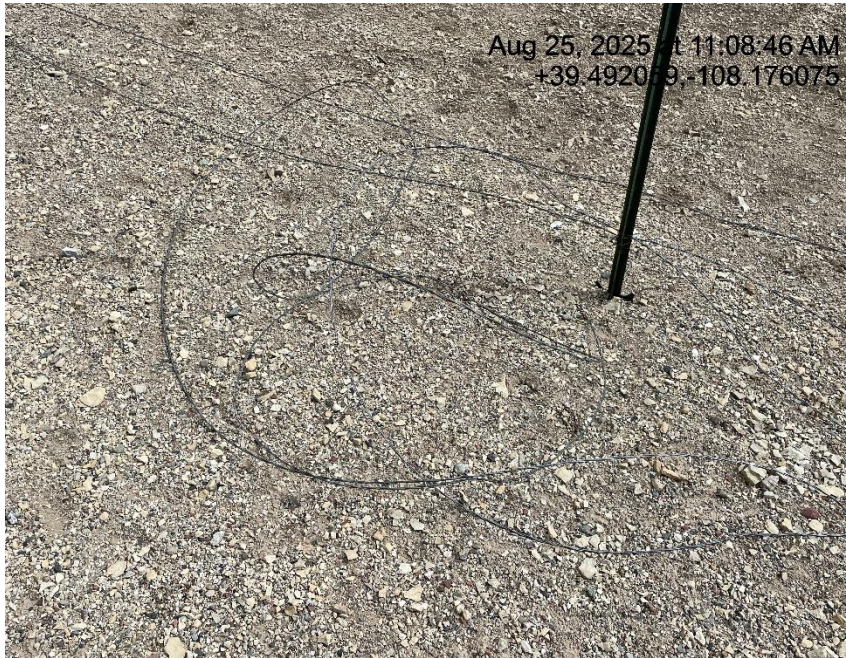
Photo # 3458 Fencing needs maintenance/wildlife hazard

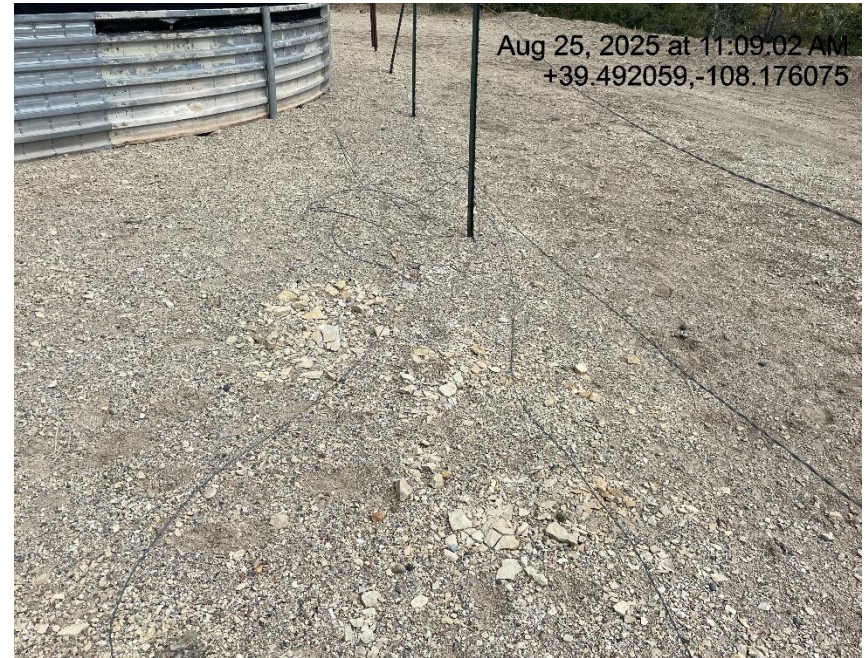
Photo # 3459 Fencing needs maintenance/wildlife hazard

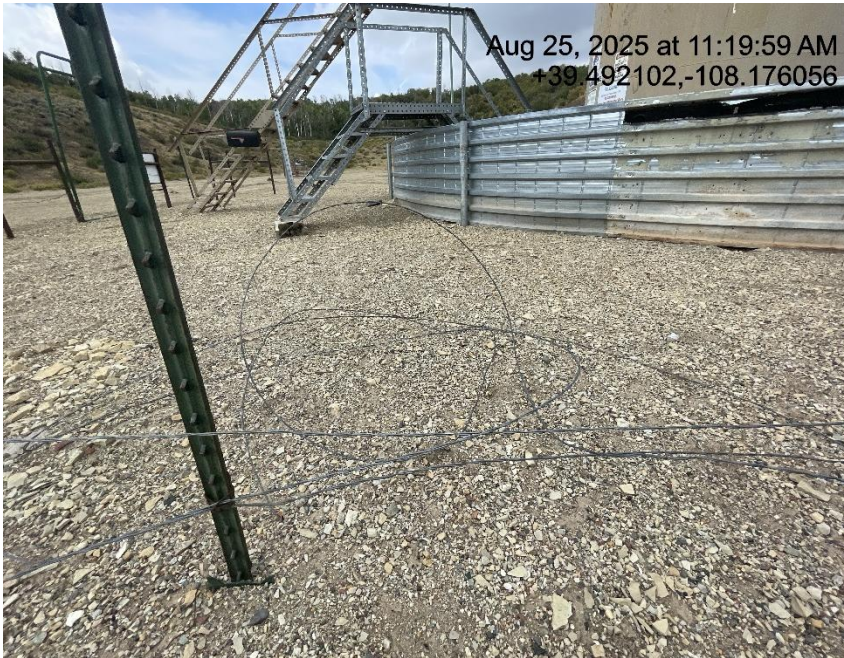
Photo # 3460 Fencing needs maintenance/wildlife hazard

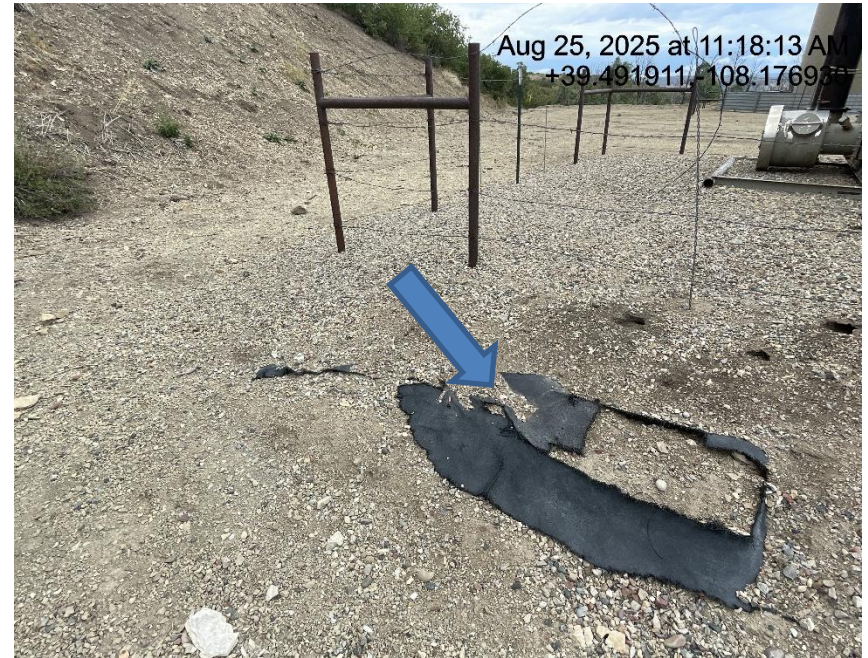
Photo # 3461 Debris

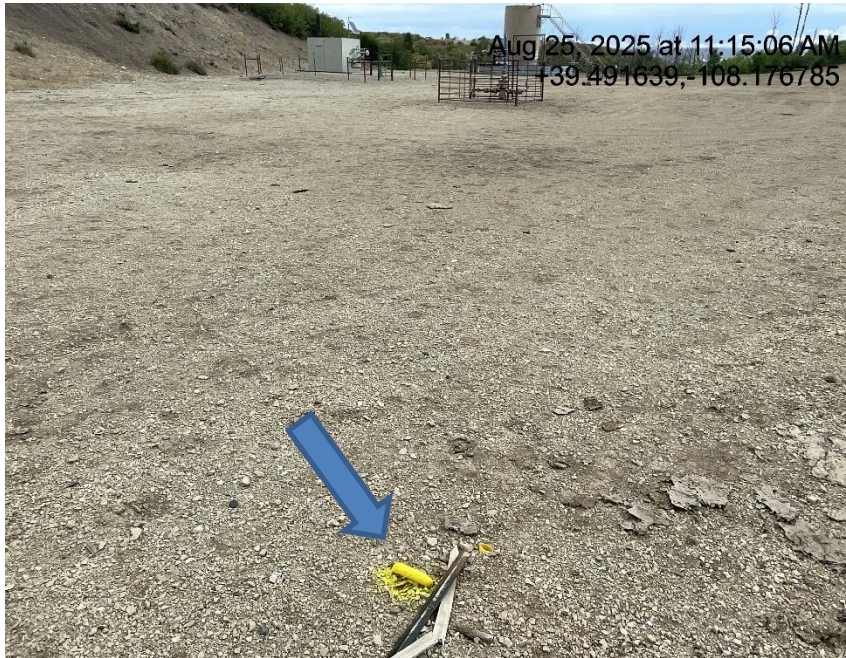
Photo # 3462 Unmarked deadman

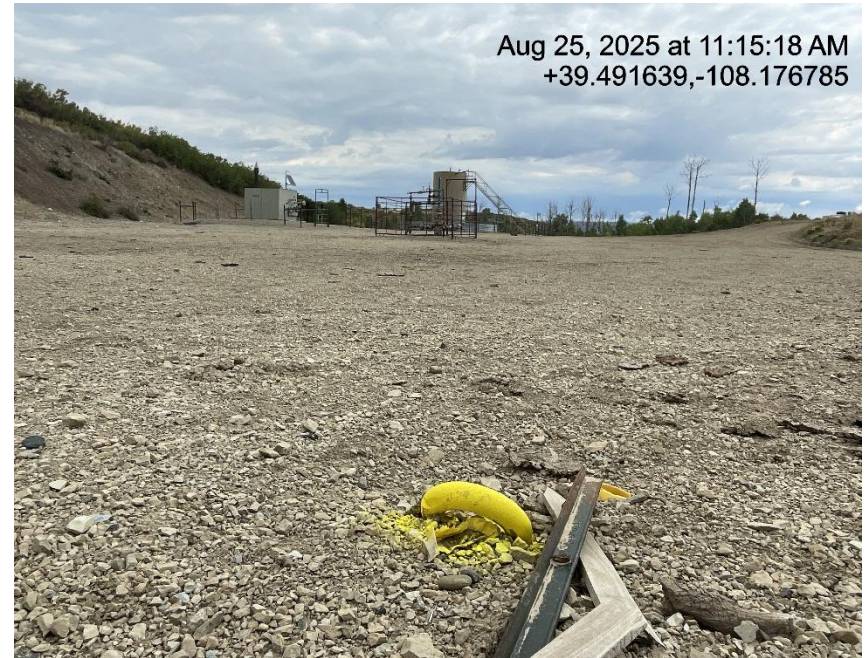
Photo # 3463 Same unmarked deadman

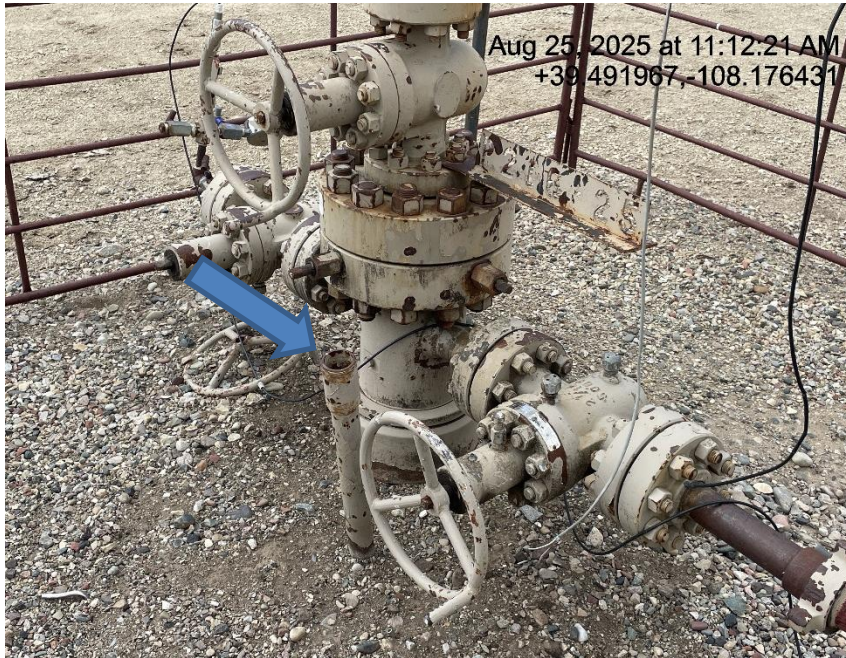
Photo # 3464 Open ended piping near wellhead/wildlife hazard

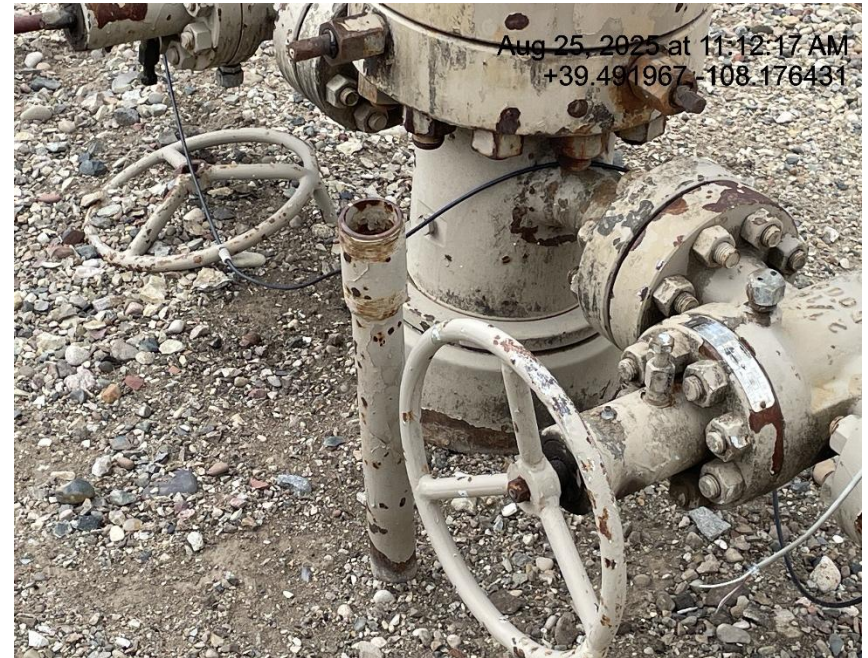
Photo # 3465 Open ended piping near wellhead/wildlife hazard

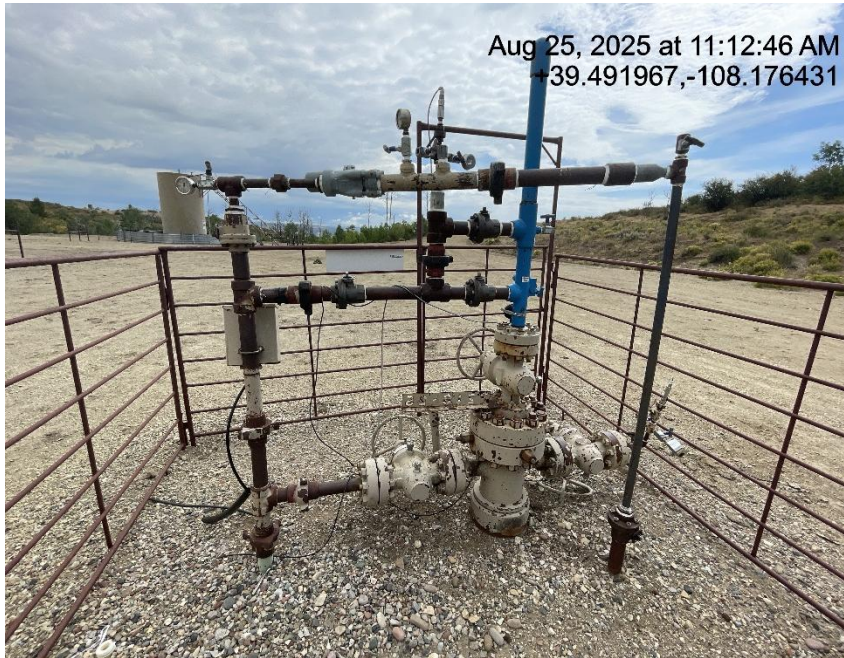
Photo # 3466 PUCKETT 216-25 Bradenhead line tied into flowline/no FORM 4 SUNDRY – Additionally the line lacks a check valve

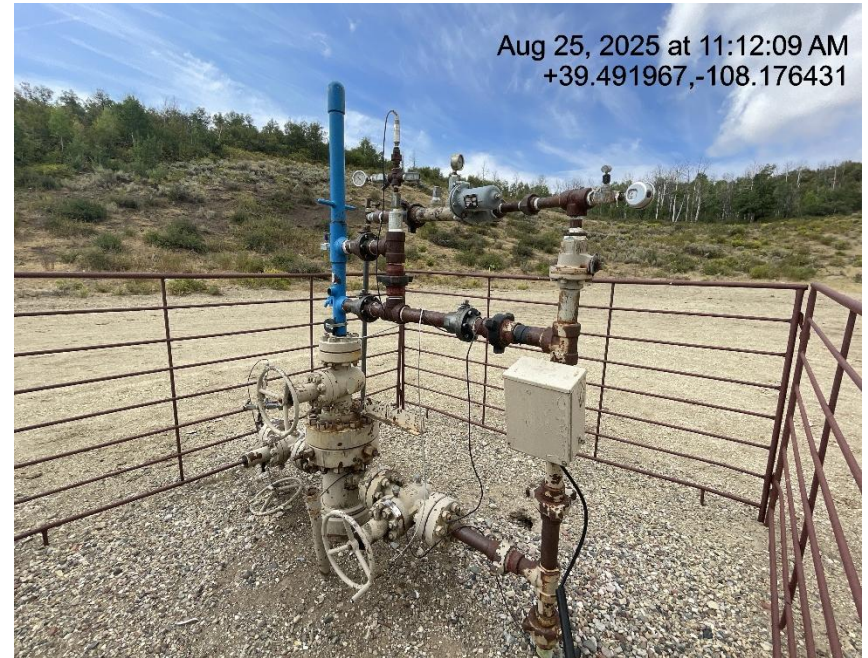
Photo # 3467 PUCKETT 216-25 Bradenhead line tied into flowline/no FORM 4 SUNDRY – Additionally the line lacks a check valve

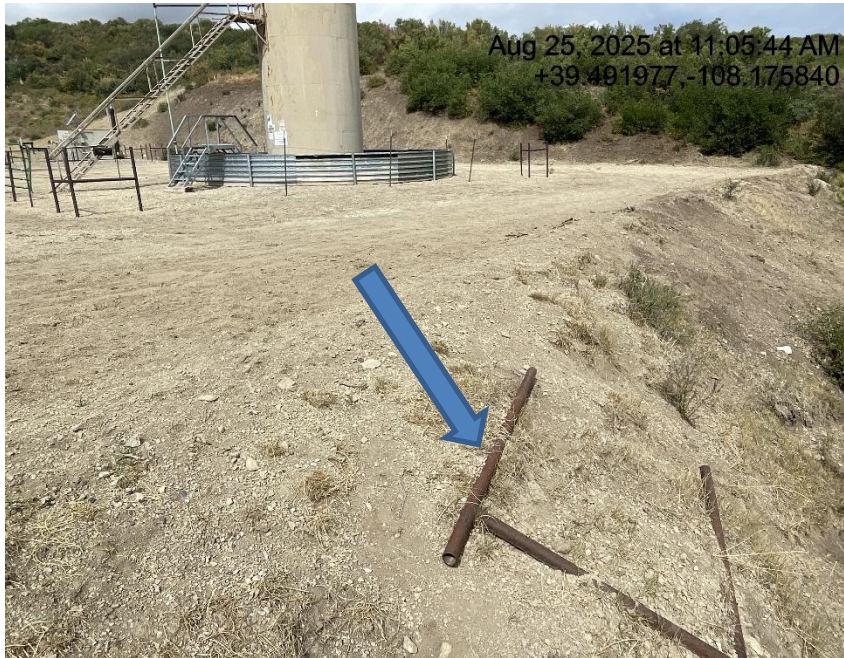
Photo # 3468 Debris
