Inspection/Audit Photos

Location Name: QB ENERGY OPERATING LLC PUCKETT 262-25 Pad

Location ID: 335086

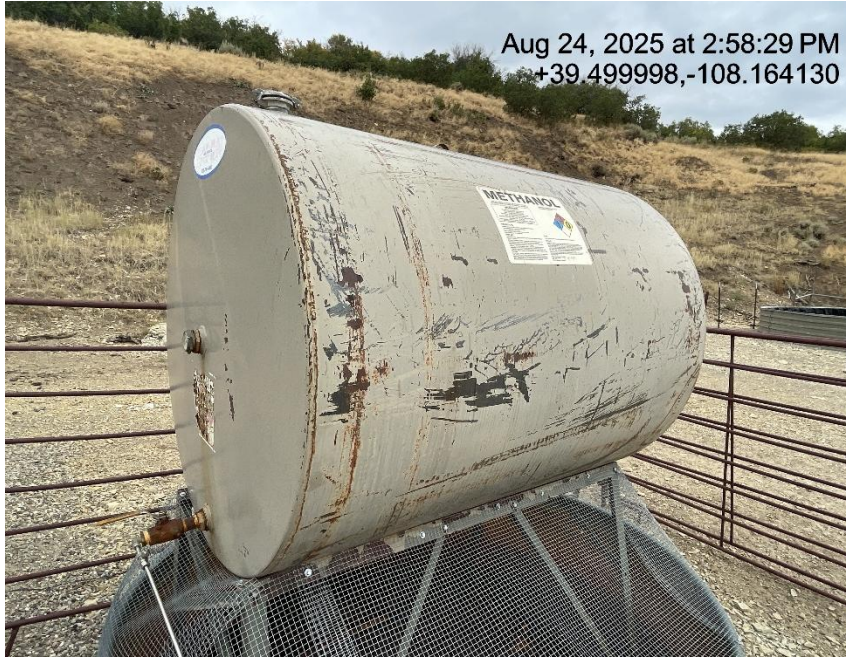
Photo # 3380 Methanol tank lacks required labeling

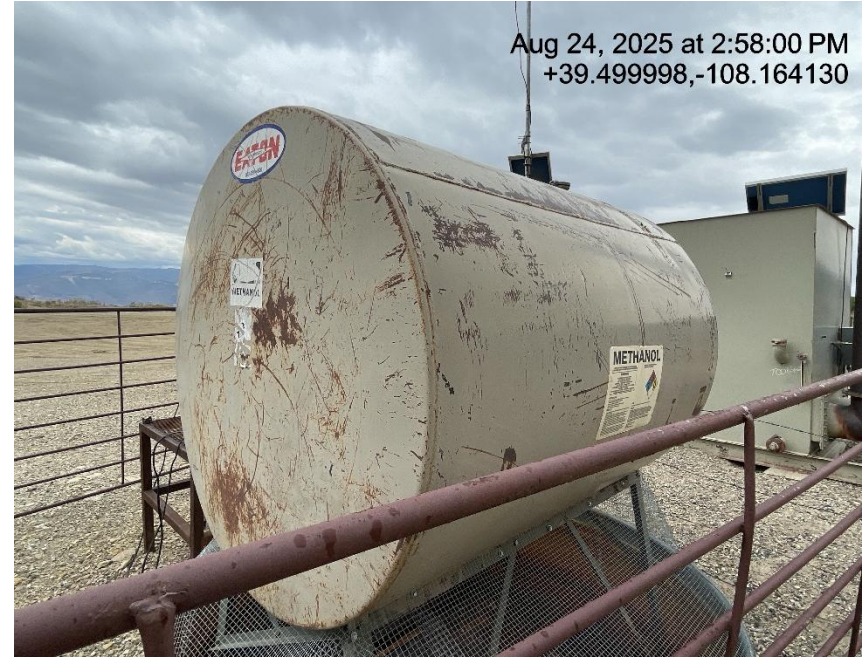
Photo # 3381 Methanol tank lacks required labeling

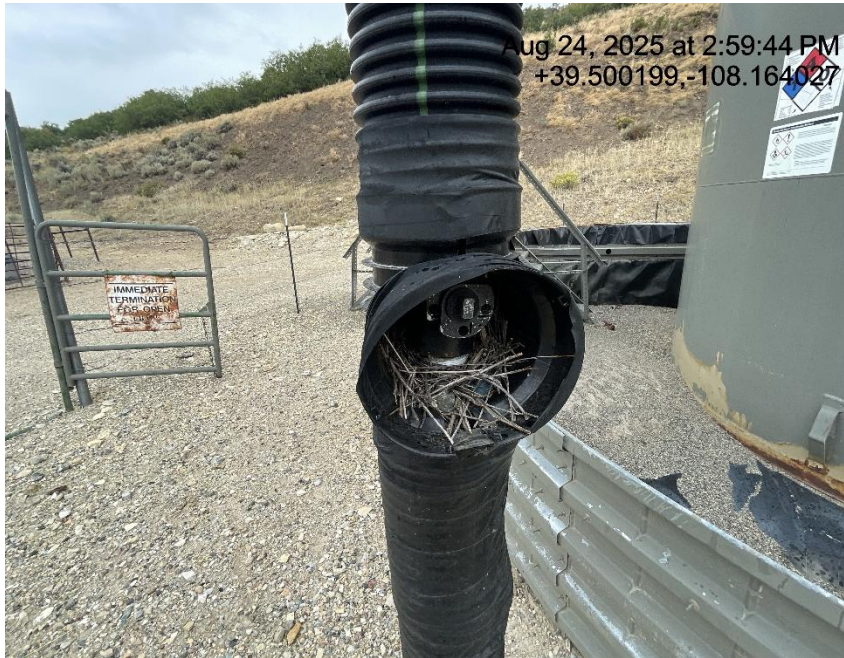
**Photo # 3382 Flowline heating insulation open ended/
wildlife hazard – additionally there appears to be a possible
nest inside**

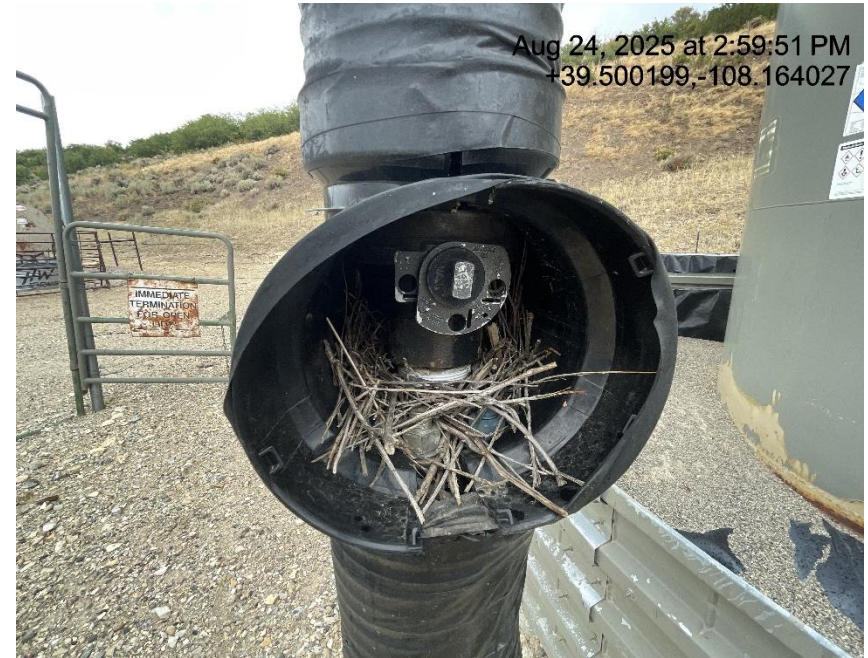
**Photo # 3383 Flowline heating insulation open ended/
wildlife hazard – additionally there appears to be a possible
nest inside**

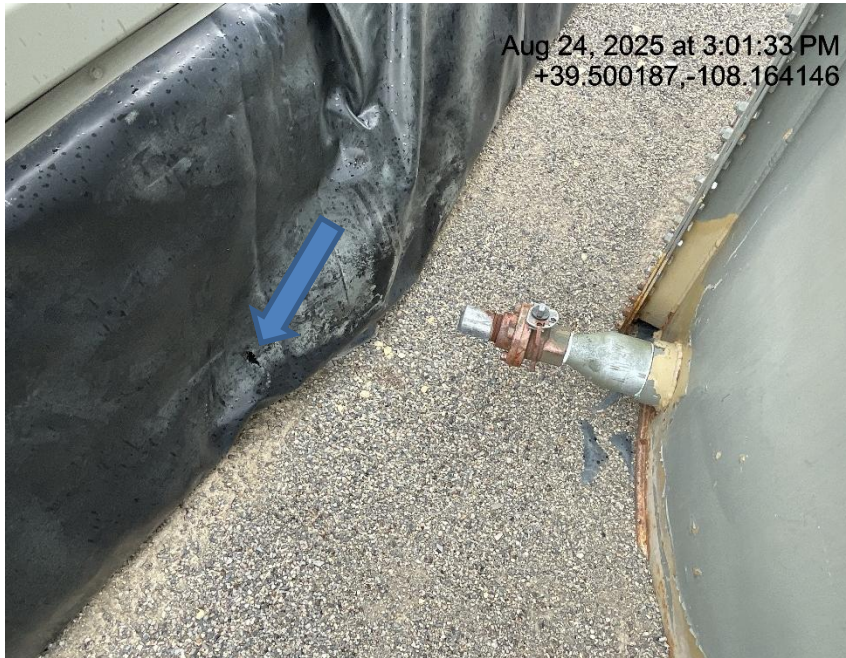
Photo # 3384 Hole in secondary containment liner/liner needs maintenance

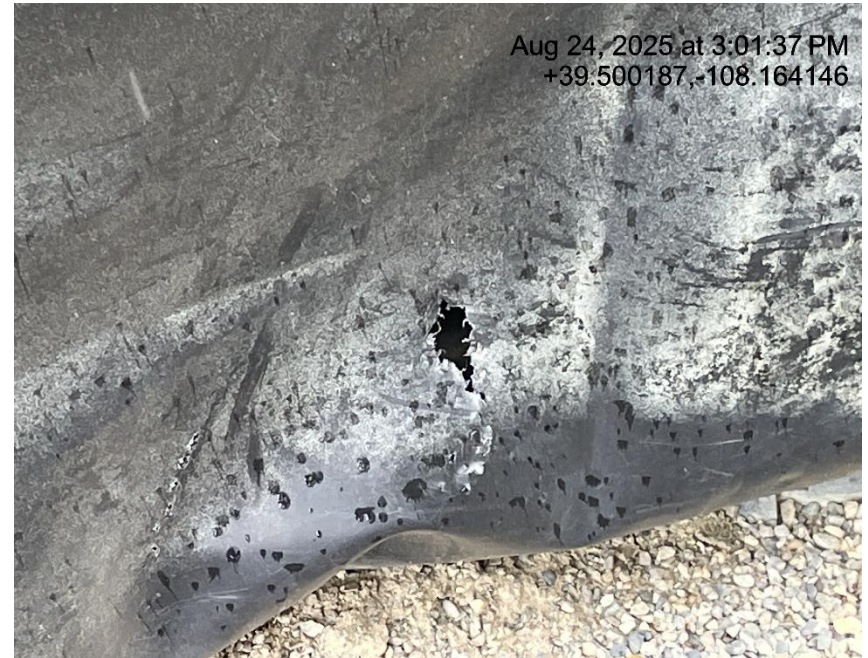
Photo # 3385 Hole in secondary containment liner/liner needs maintenance

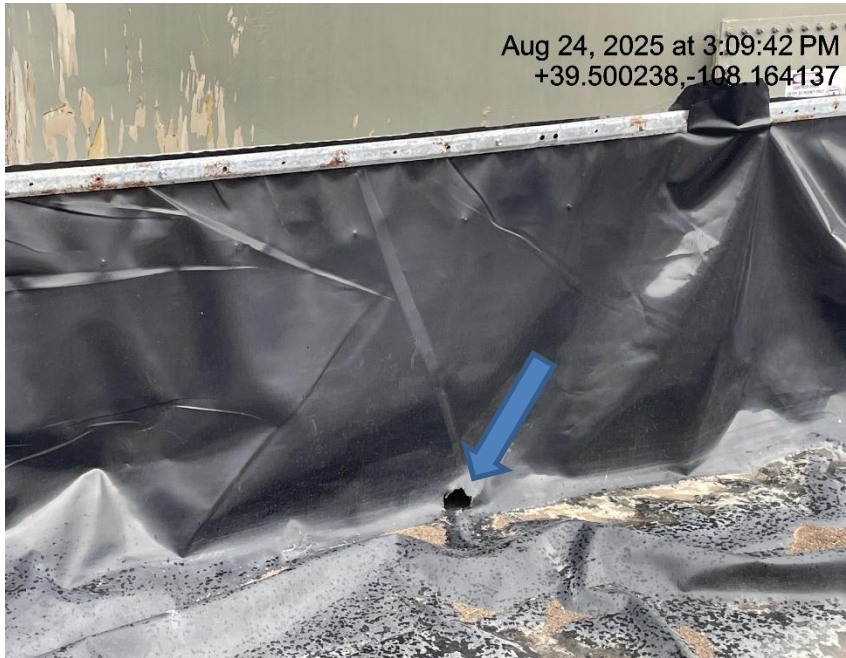
Photo # 3386 Hole in secondary containment liner/liner needs maintenance

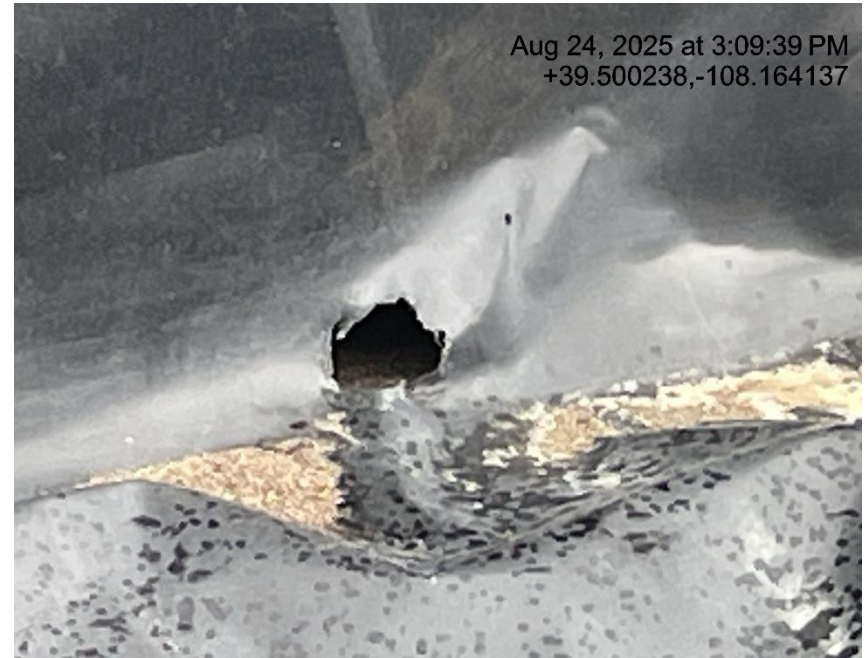
Photo # 3387 Hole in secondary containment liner/liner needs maintenance

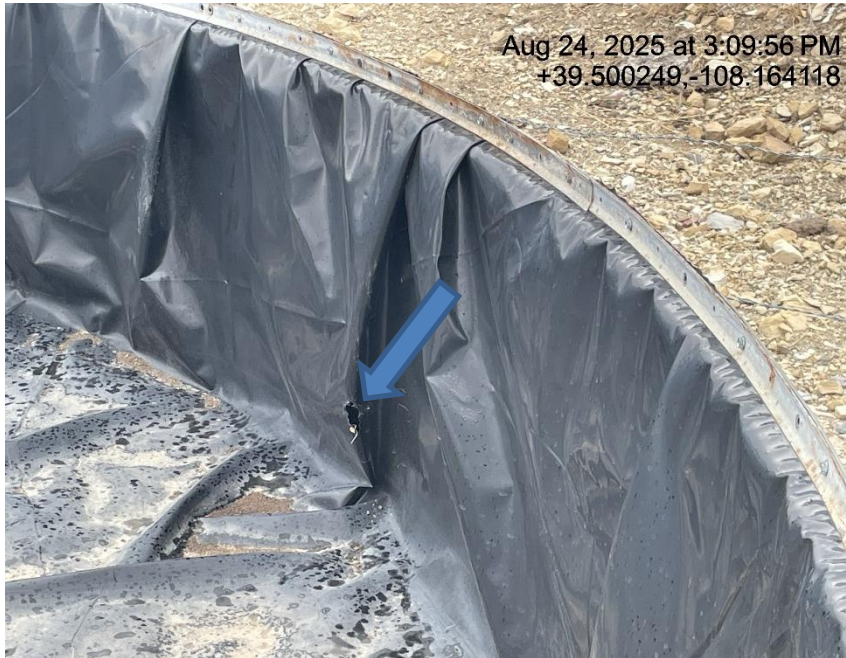
Photo # 3388 Hole in secondary containment liner/liner needs maintenance

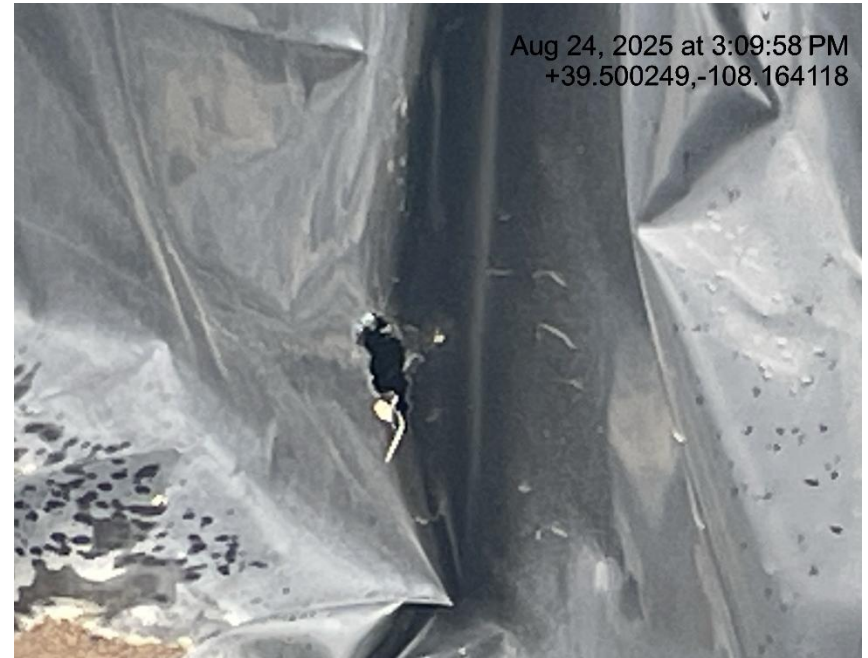
Photo # 3389 Hole in secondary containment liner/liner needs maintenance

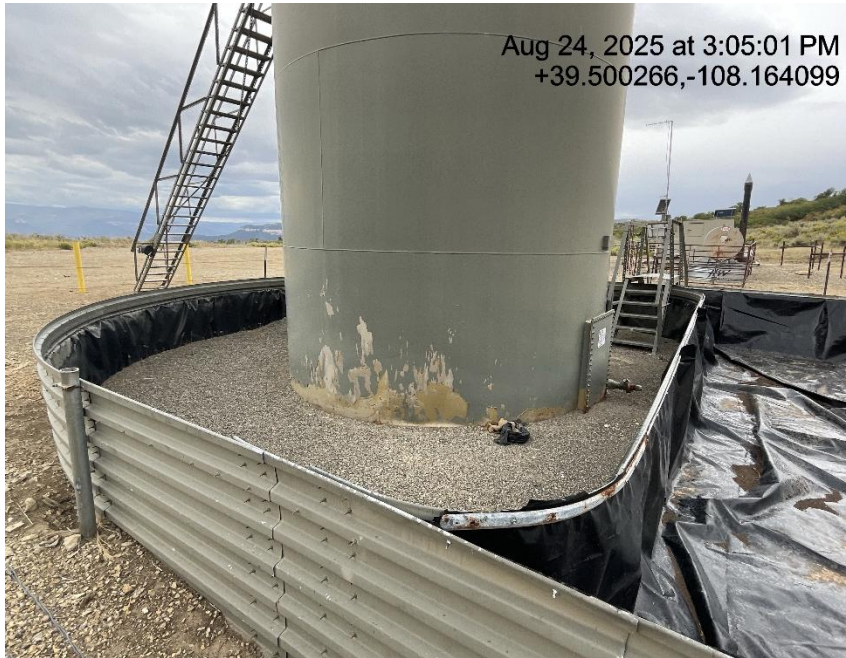
**Photo # 3390 Secondary containment inadequately sized
/not in compliance with CECMC rules**
