Inspection/Audit Photos

Location Name: QB ENERGY OPERATING LLC CHEVRON/TEXACO 24C-12D Pad

Location #: 335774

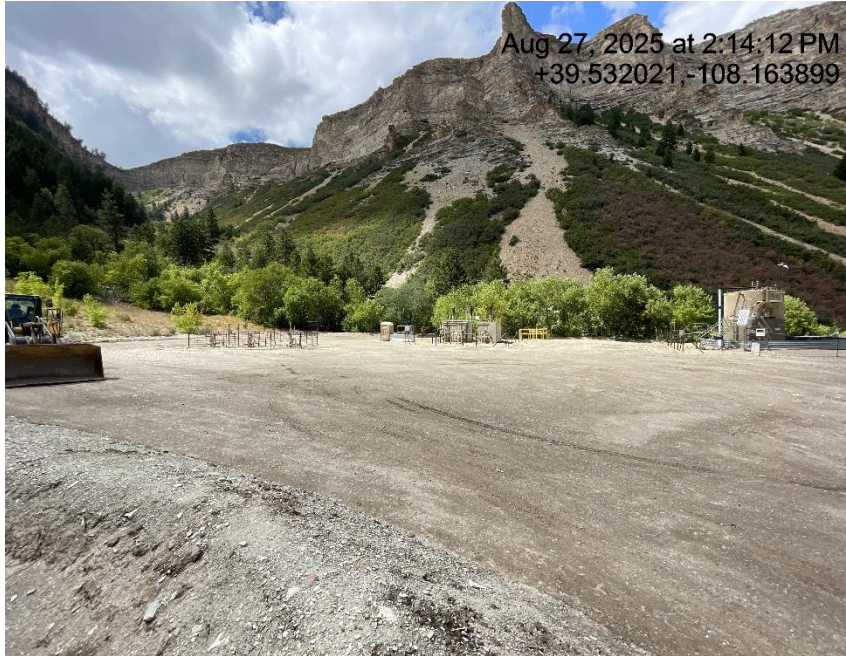
Photo # 4466 From entrance to location

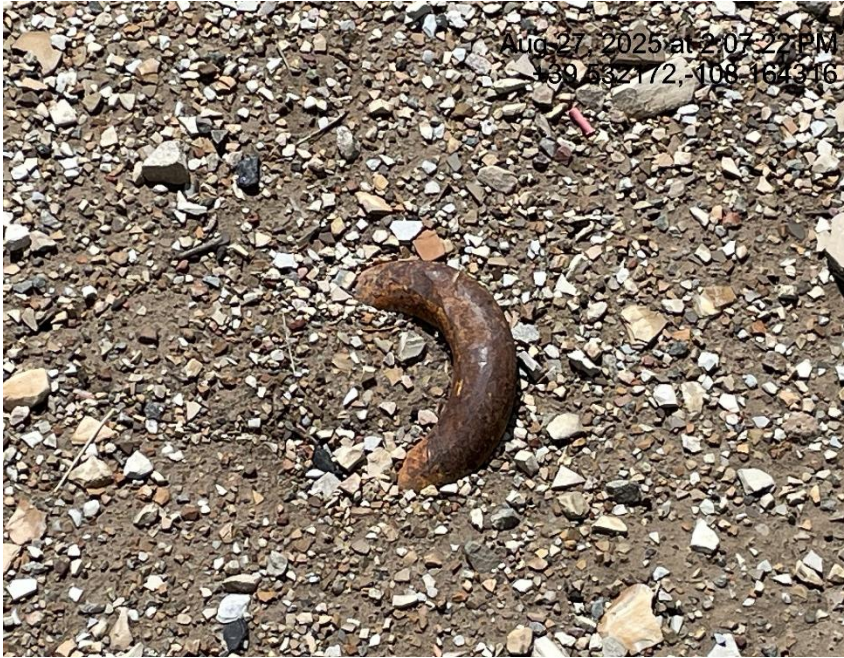
Photo # 4474 Unmarked deadman

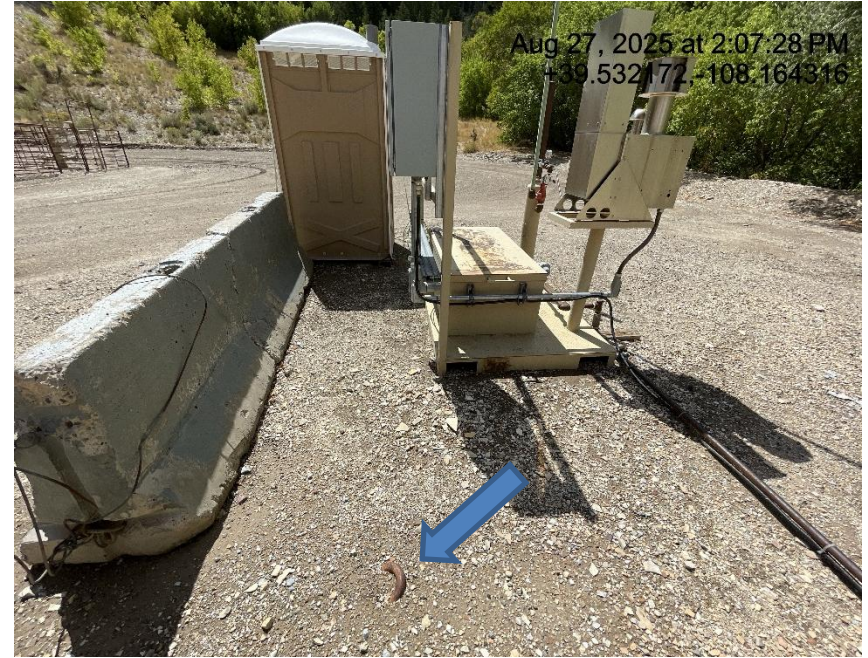
Photo # 4475 Same unmarked deadman

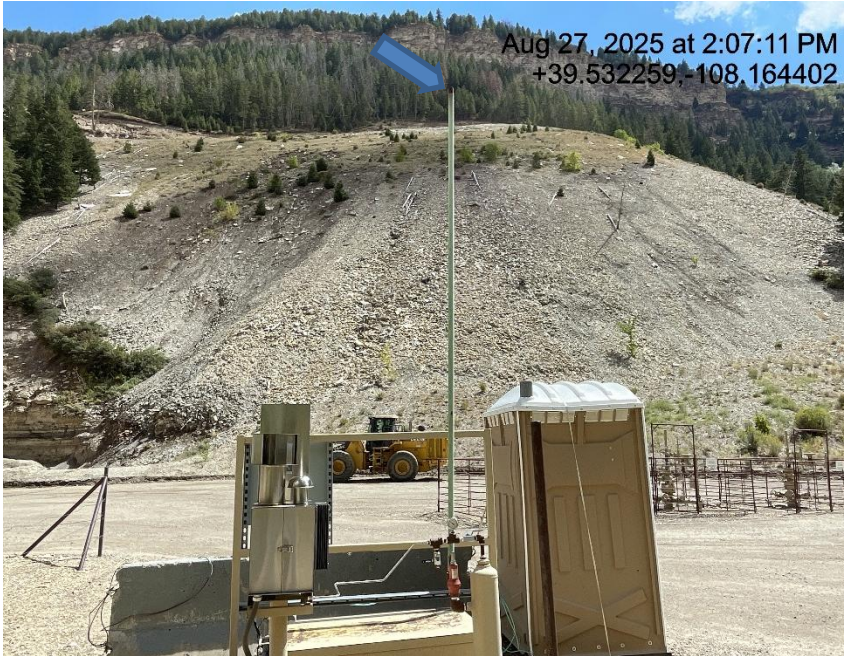
Photo # 4476 PRV vent line on fluid knockout for thermogen does not comply with CECMC pressure safety device rules

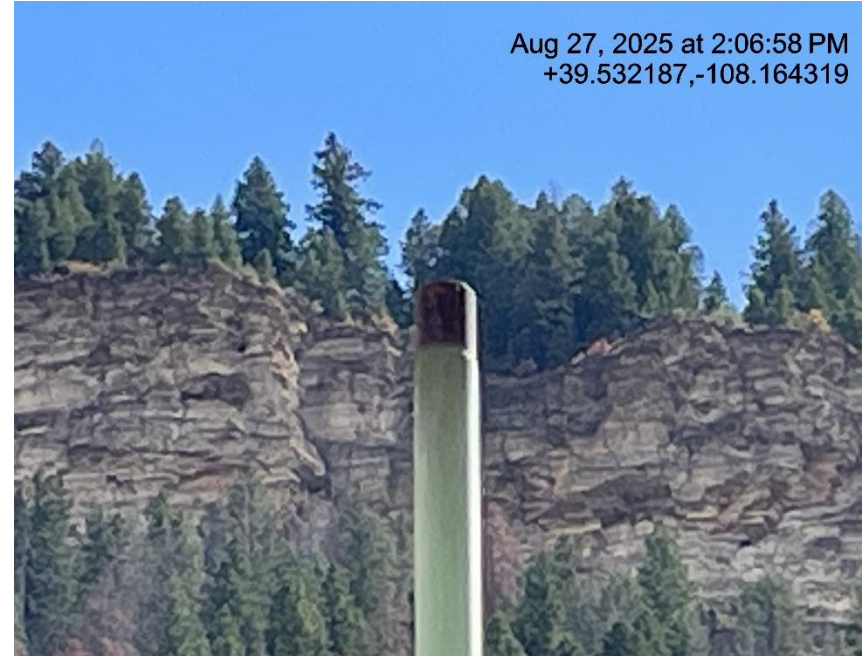
Photo # 4477 PRV vent line on fluid knockout for thermogen does not comply with CECMC pressure safety device rules
