## Inspection/Audit Photos

Location: SCOUT ENERGY MANAGEMENT LLC UNION PACIFIC #126 X 32 PAD

Location ID: 311821

Date: 08/26/2025

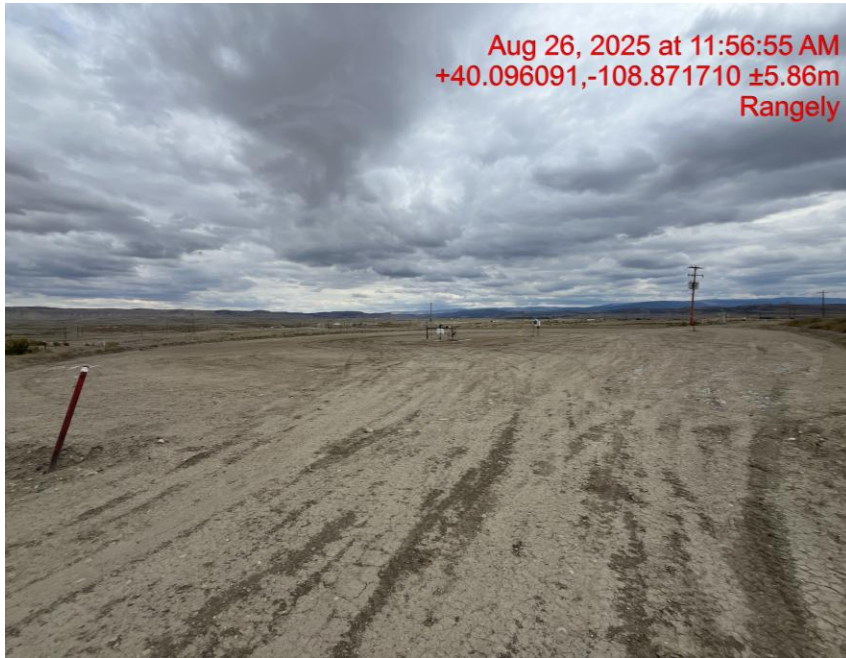
Photo # 2596 Entrance to location

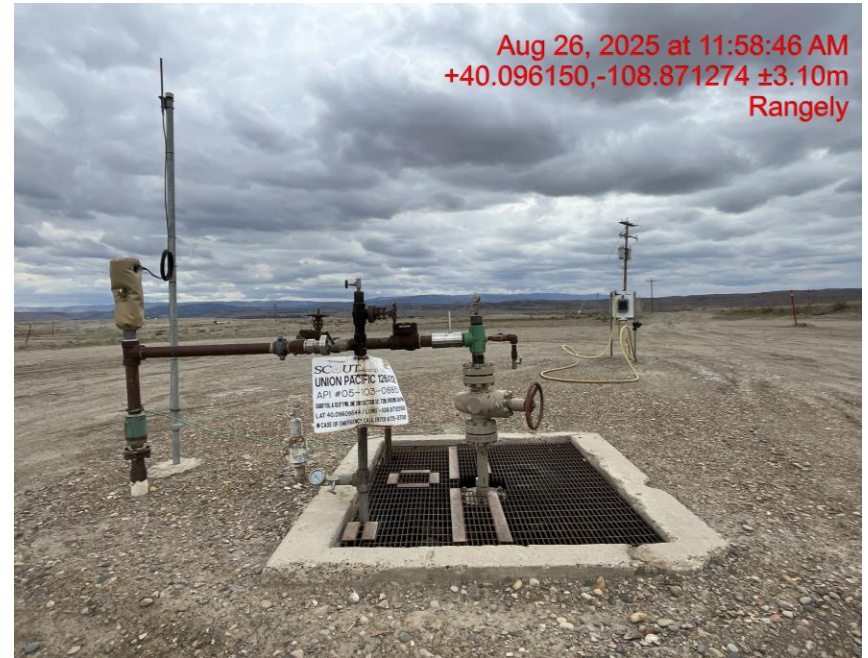
Photo # 2597 Location

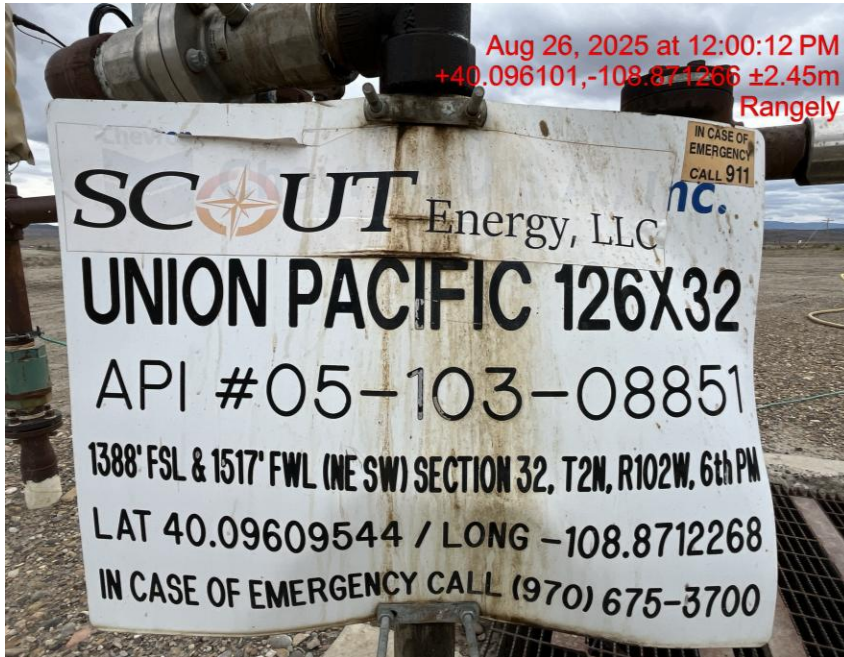
Photo # 2598 Location

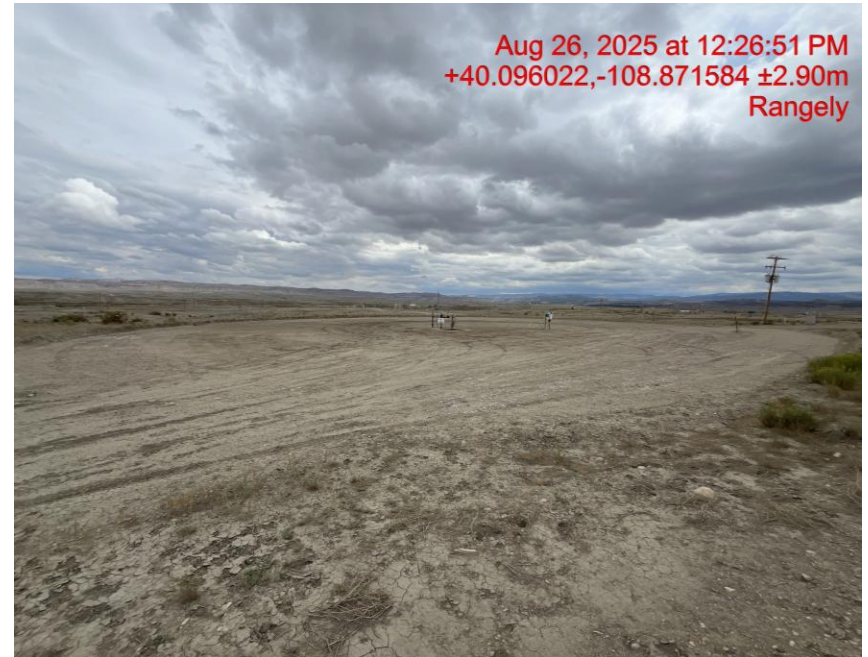
Photo # 2621 SE corner of location

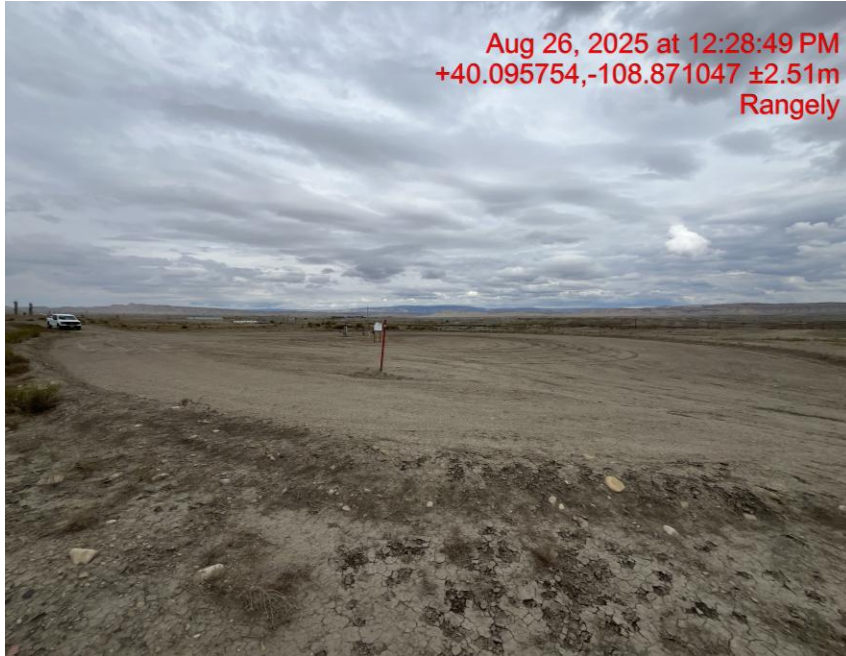
Photo # 2622 SW corner of location

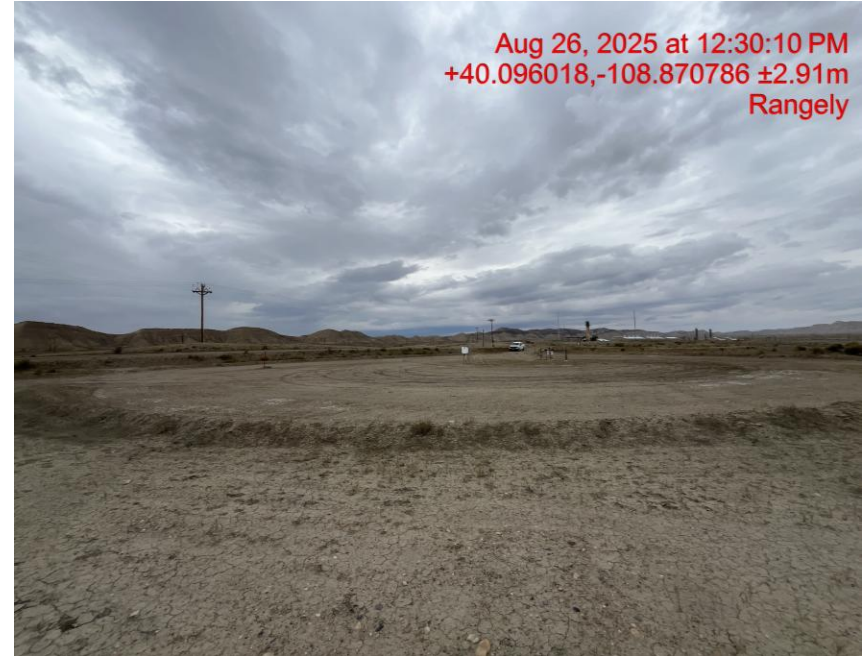
Photo # 2623 NE corner of location

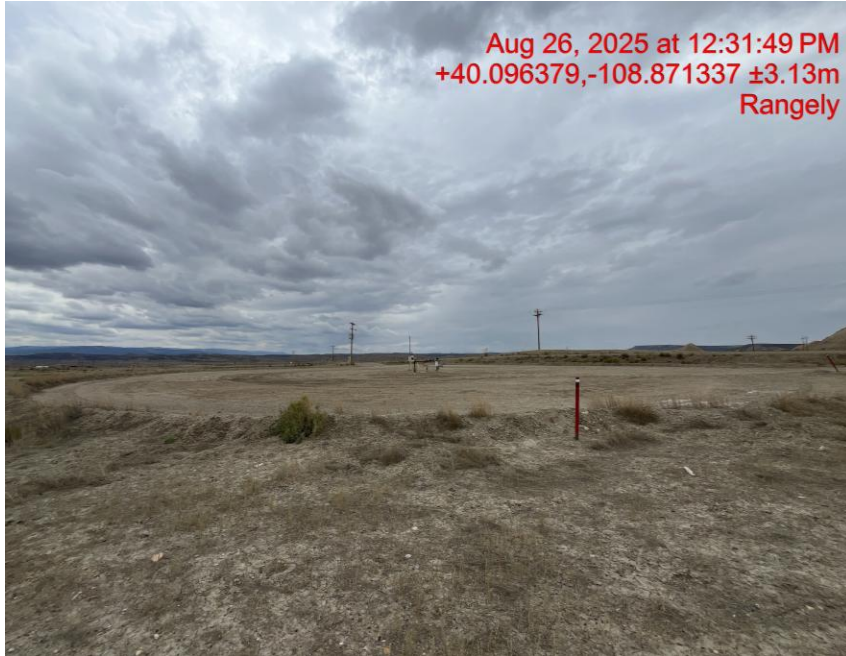
Photo # 2624 NW corner of location

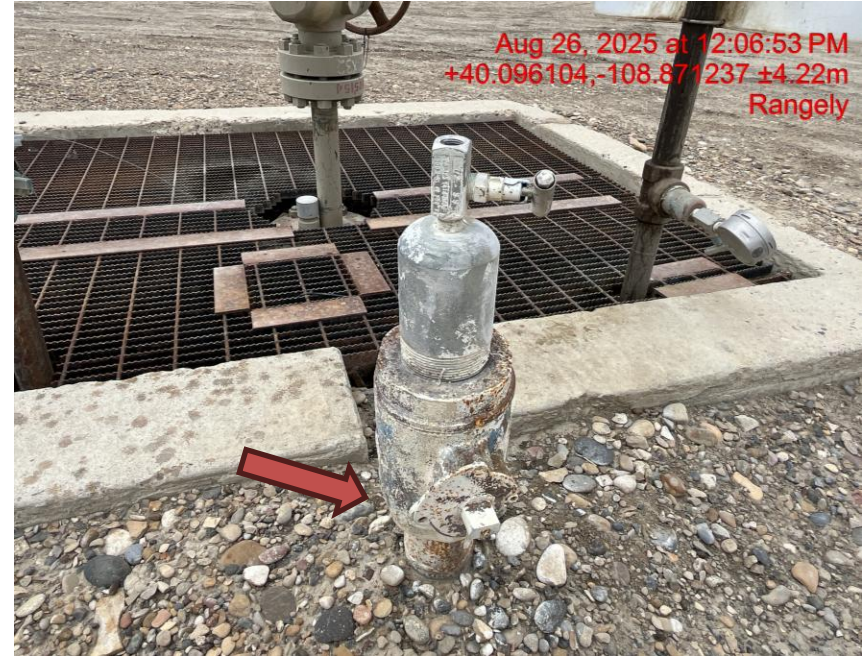
Photo # 2603 Unused flowline lacks lockout tagout (OOSLAT)

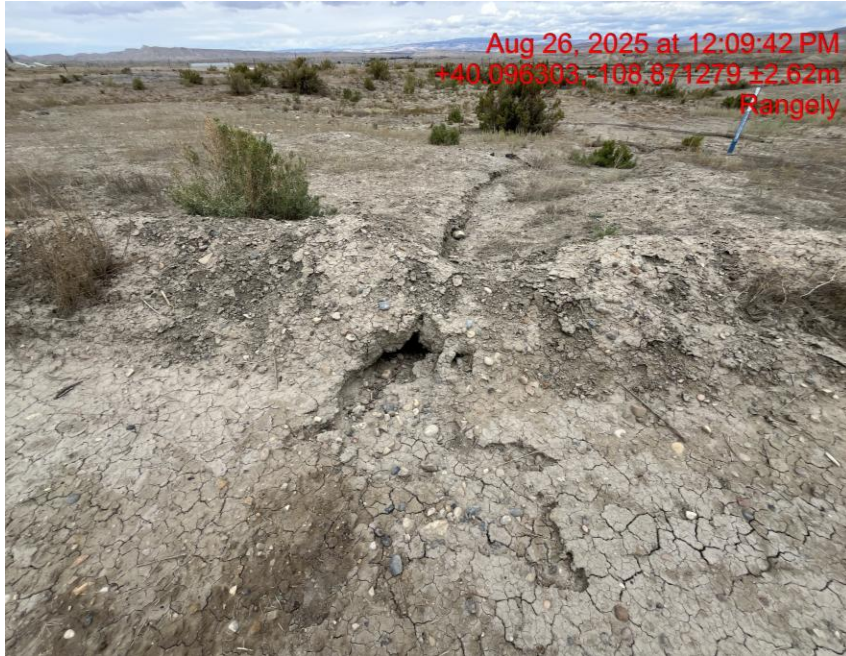
Photo # 2605 Berm needs maintenance

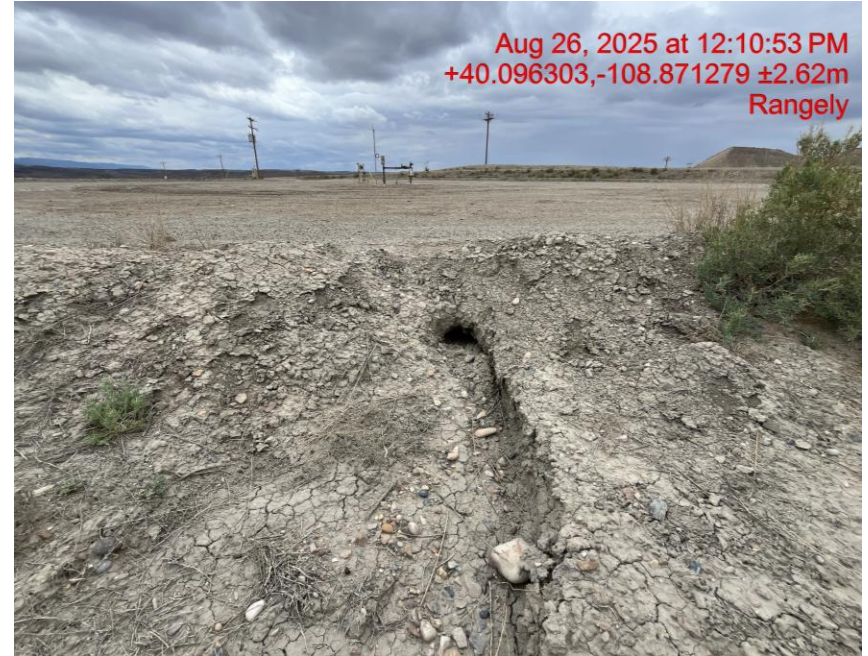
Photo # 2608 Berm needs maintenance

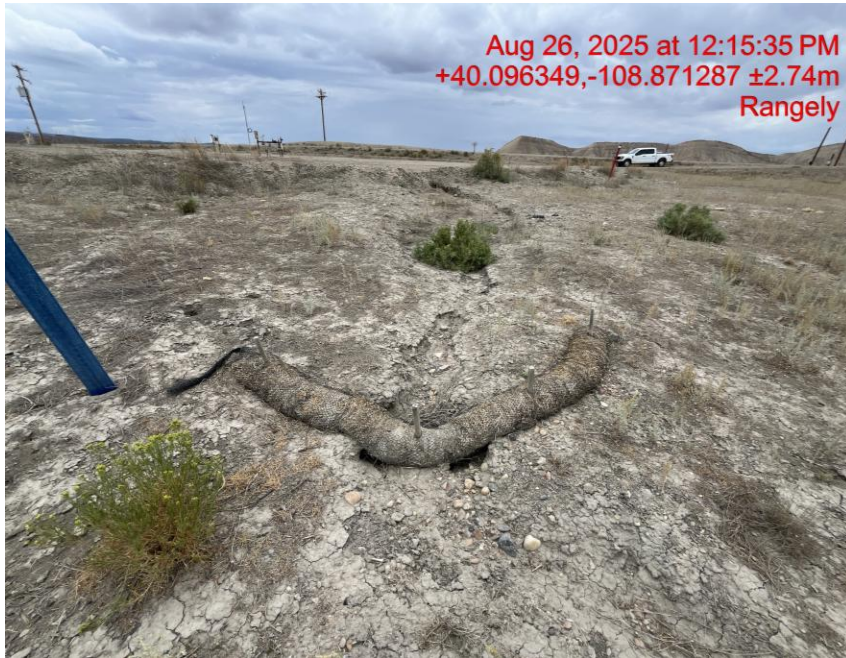
Photo # 2612 Wattles need maintenance

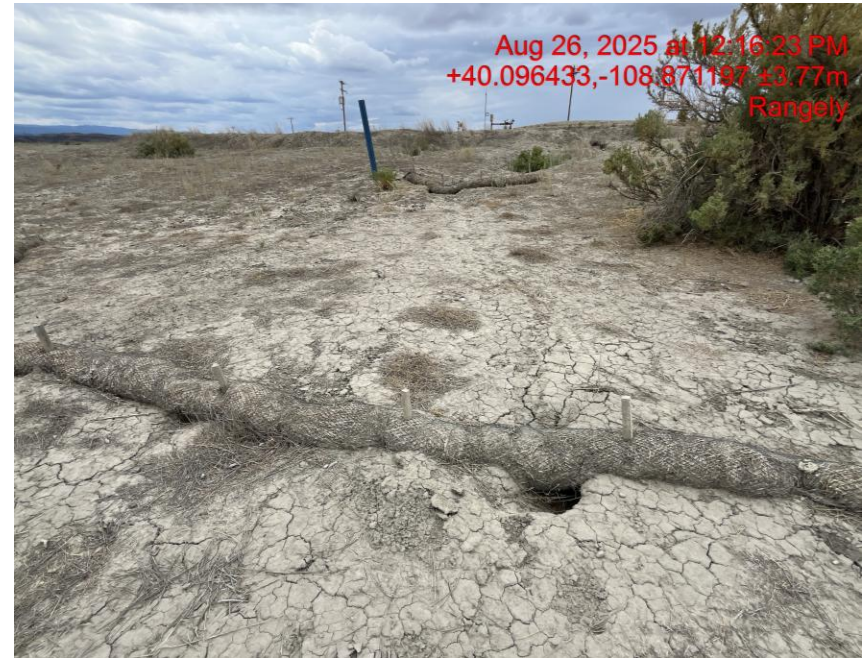
Photo # 2613 Wattles need maintenance

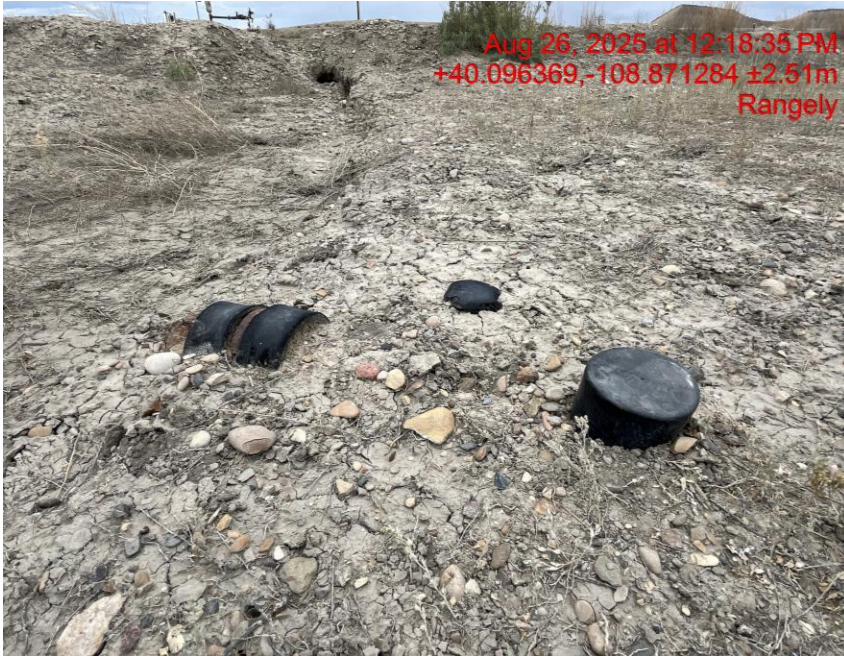
Photo # 2614 Debris

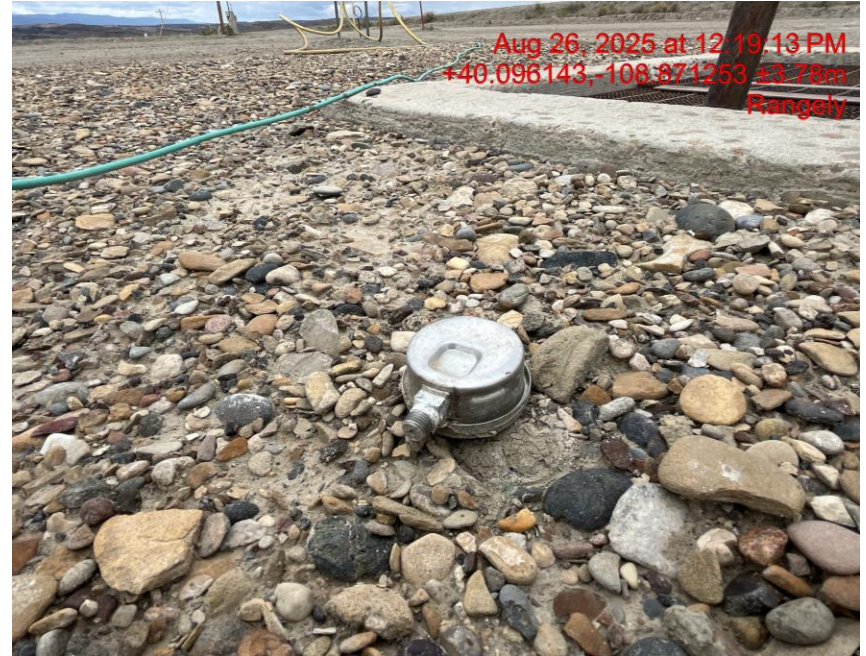
Photo # 2615 Debris

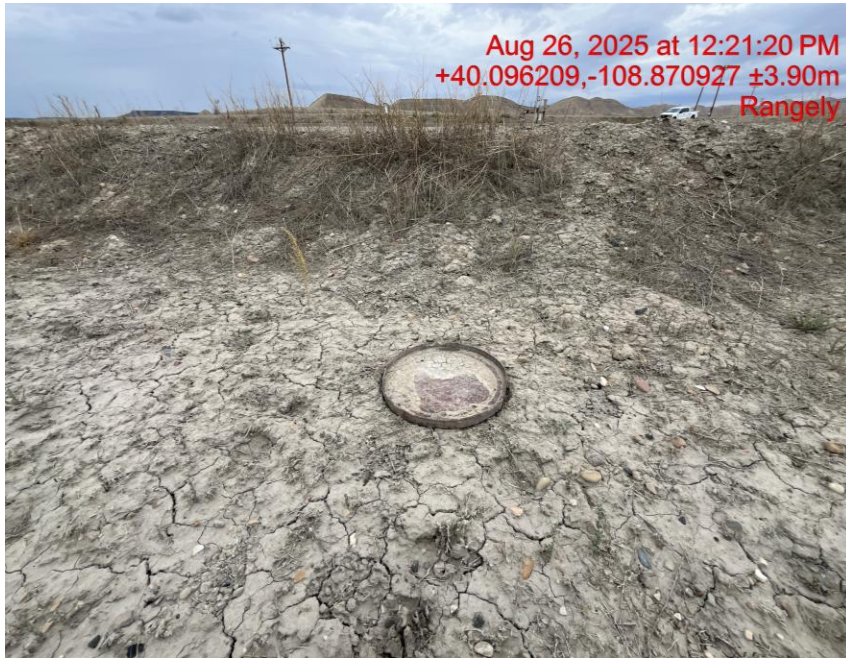
Photo # 2617 Debris

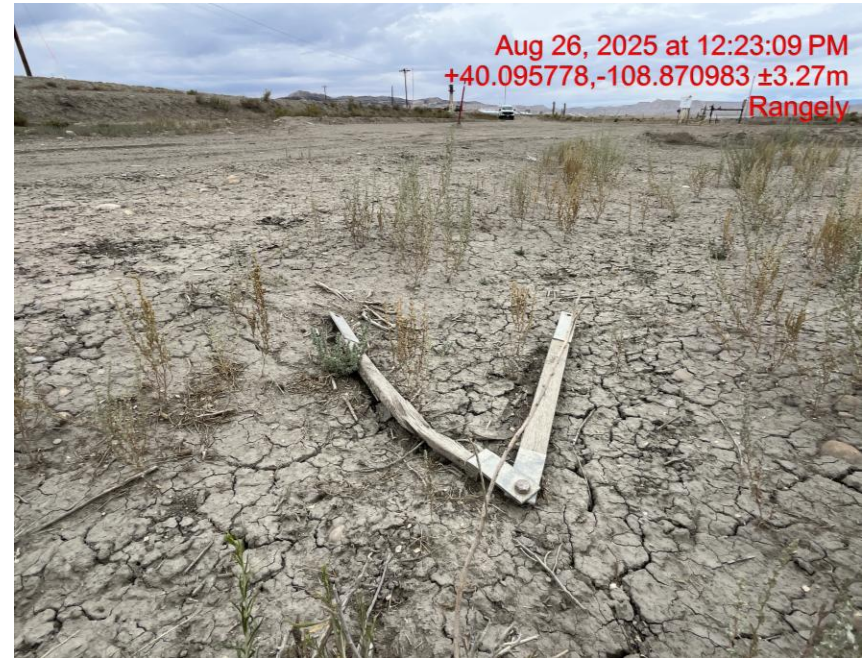
Photo # 2618 Debris

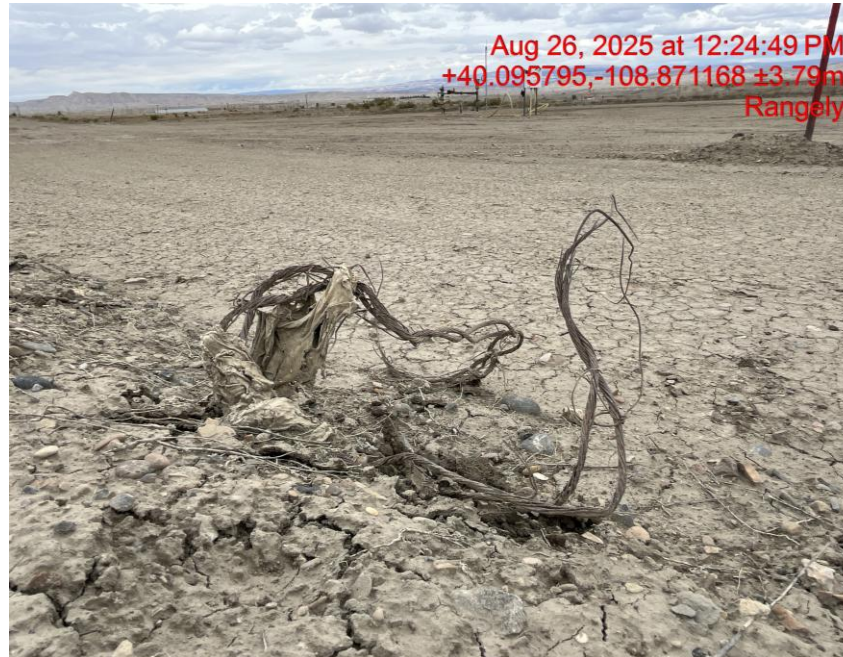
Photo # 2620 Debris
