SITE-SPECIFIC QUALITY ASSURANCE & QUALITY CONTROL AUDIT

PERMIT CLOSURE REPORT – DESIGNATION LAND USE CHANGE

Location ID: 320331

Location Name: PERGOLA-61S68W/15NWNE

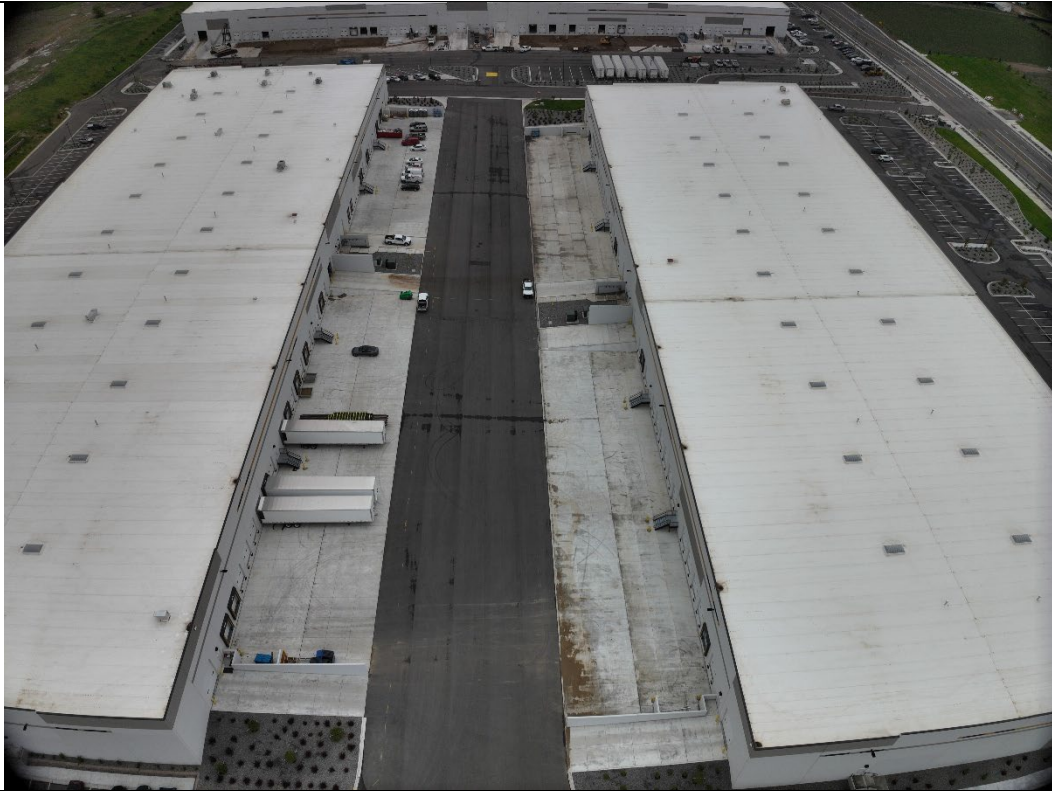
NORTH – 39.968363 / -104.983523

In View – Well, Tank Battery, Access Road, Flowline

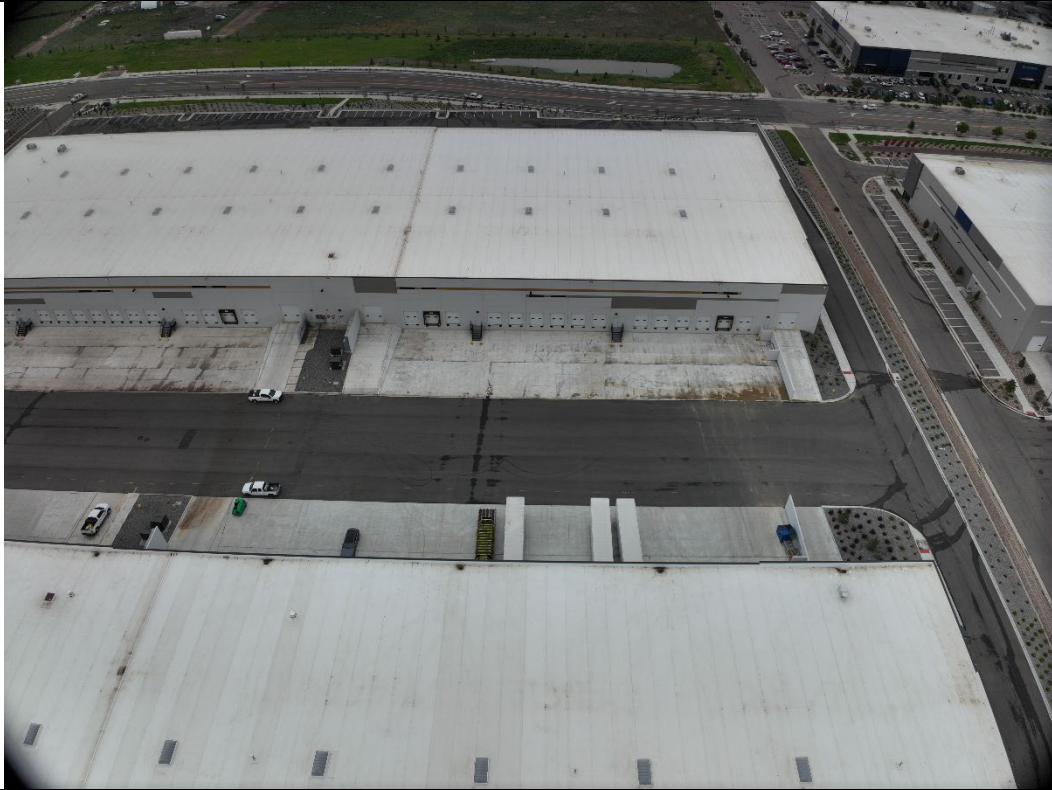
EAST – 39.969095 / -104.984534

In View – Well, Tank Battery, Access Road, Flowline

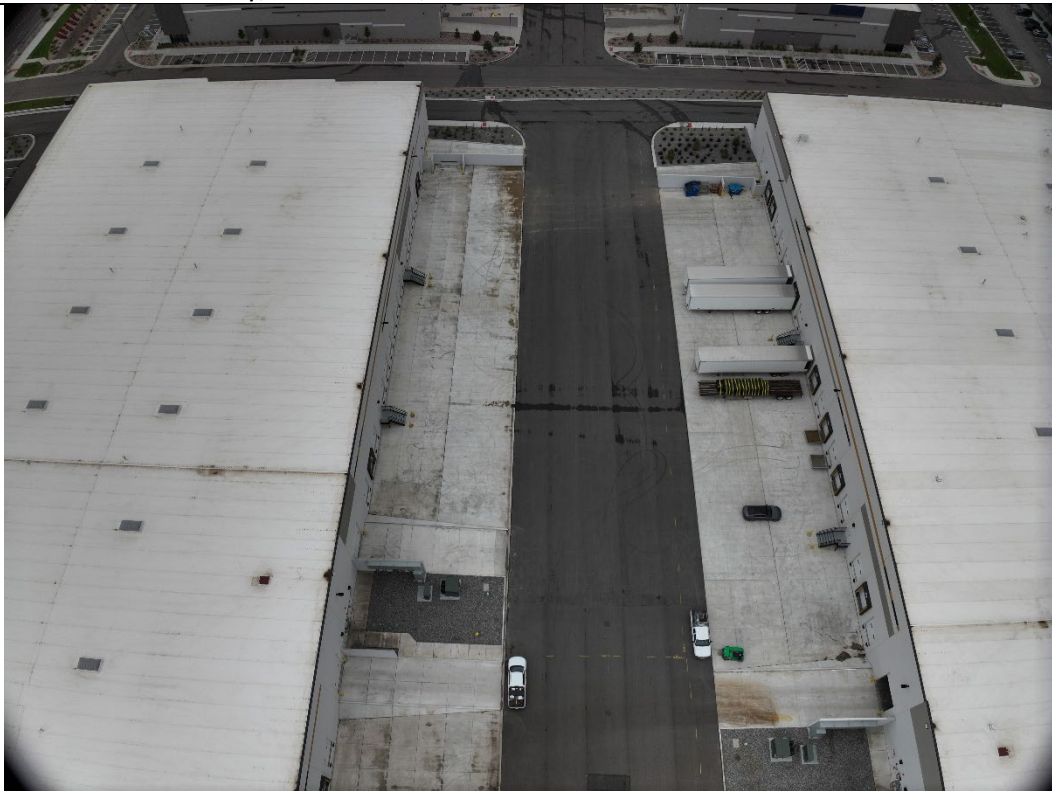
SOUTH – 39.969700 / -104.983486

In View – Well, Tank Battery, Access Road, Flowline

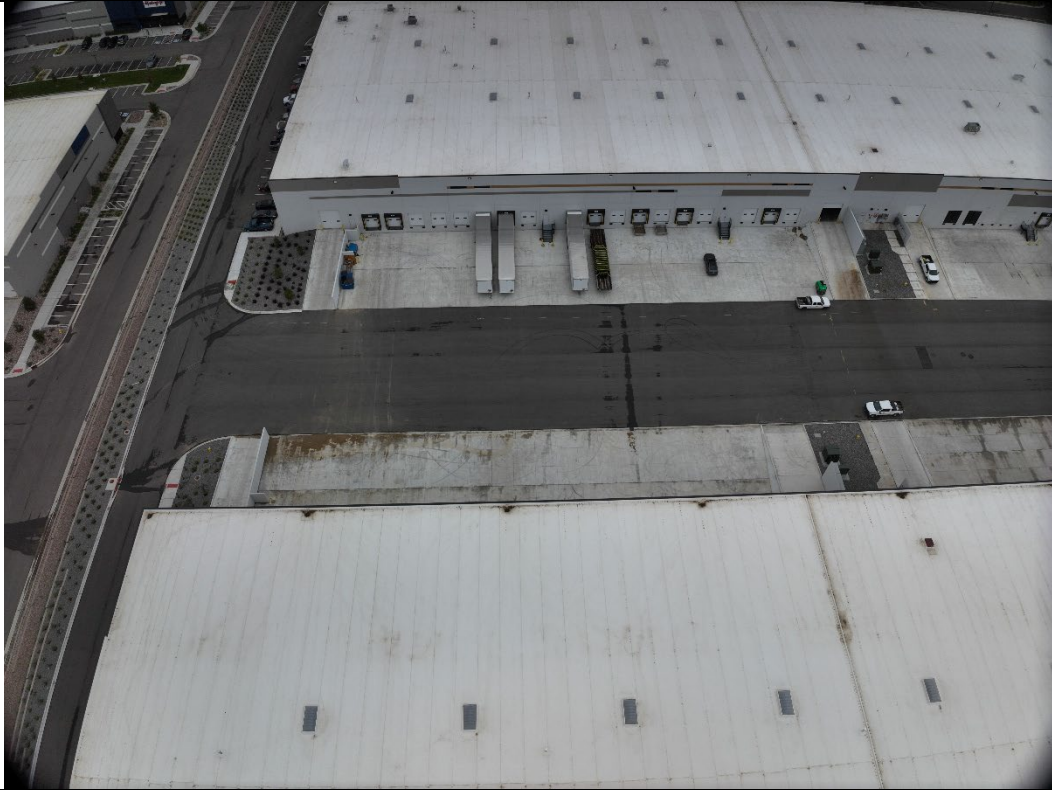
WEST – 39.969027 / -104.982733

In View – Well, Tank Battery, Access Road, Flowline

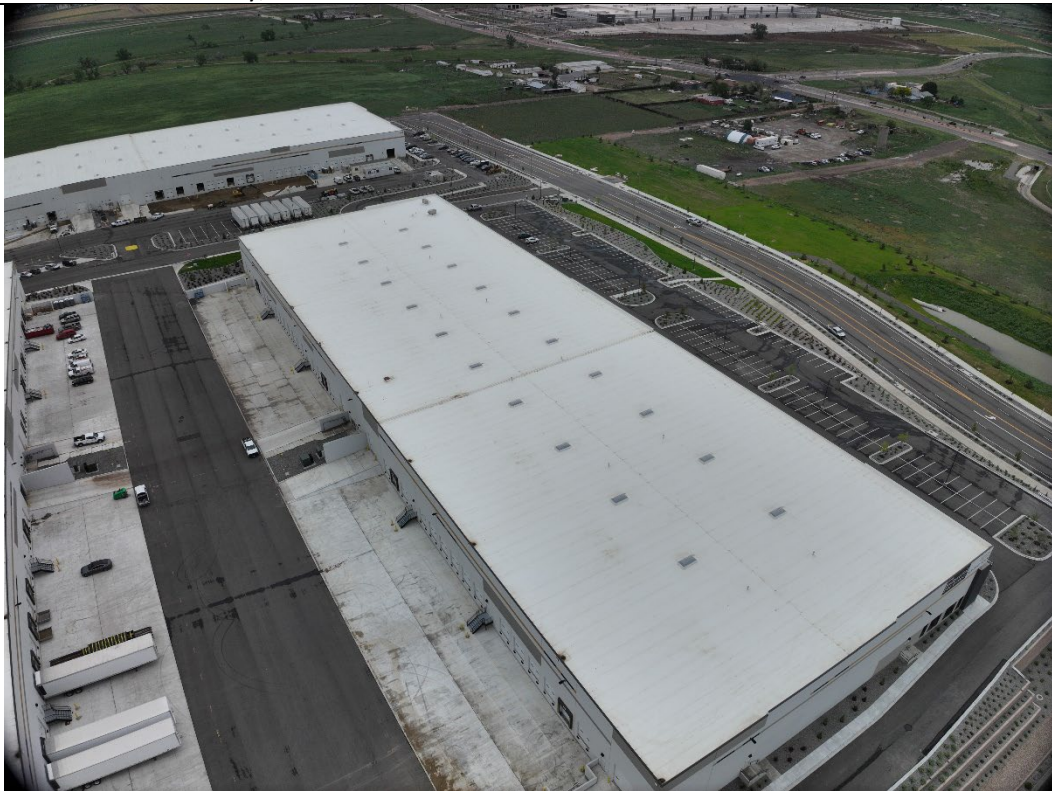
NORTHEAST – 39.968372 / -104.983627

In View – Well, Tank Battery, Access Road, Flowline

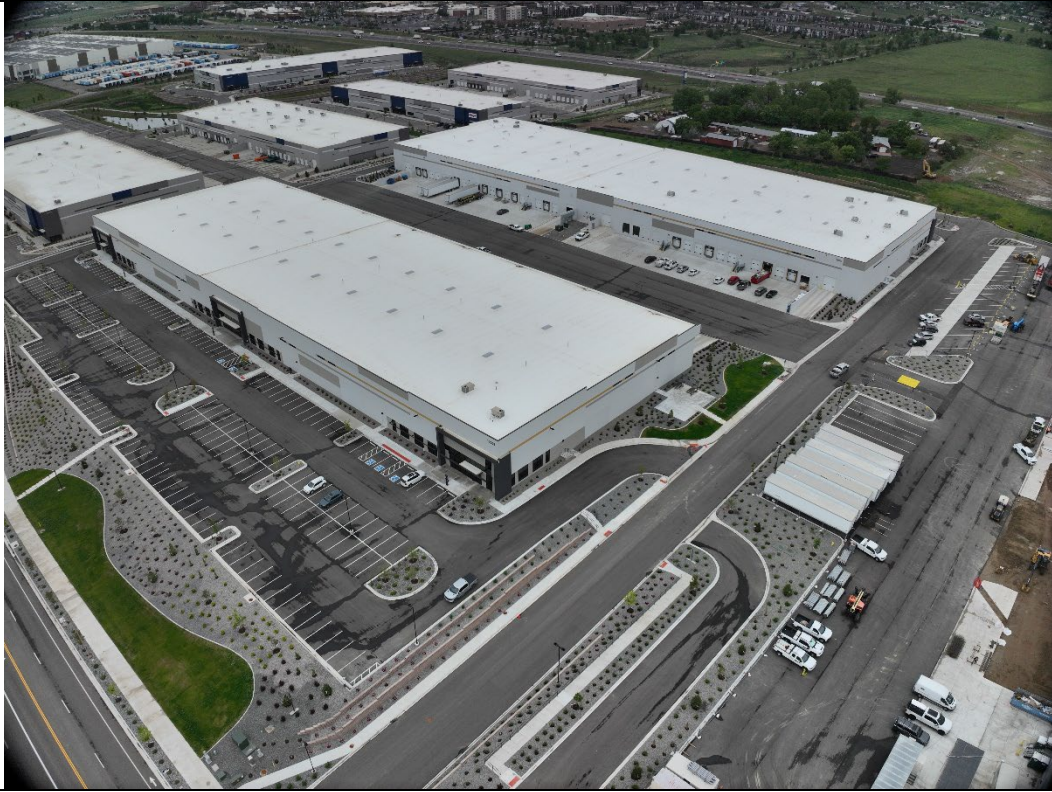
SOUTHWEST – 39.970981 / -104.981627

In View – Well, Tank Battery, Access Road, Flowline

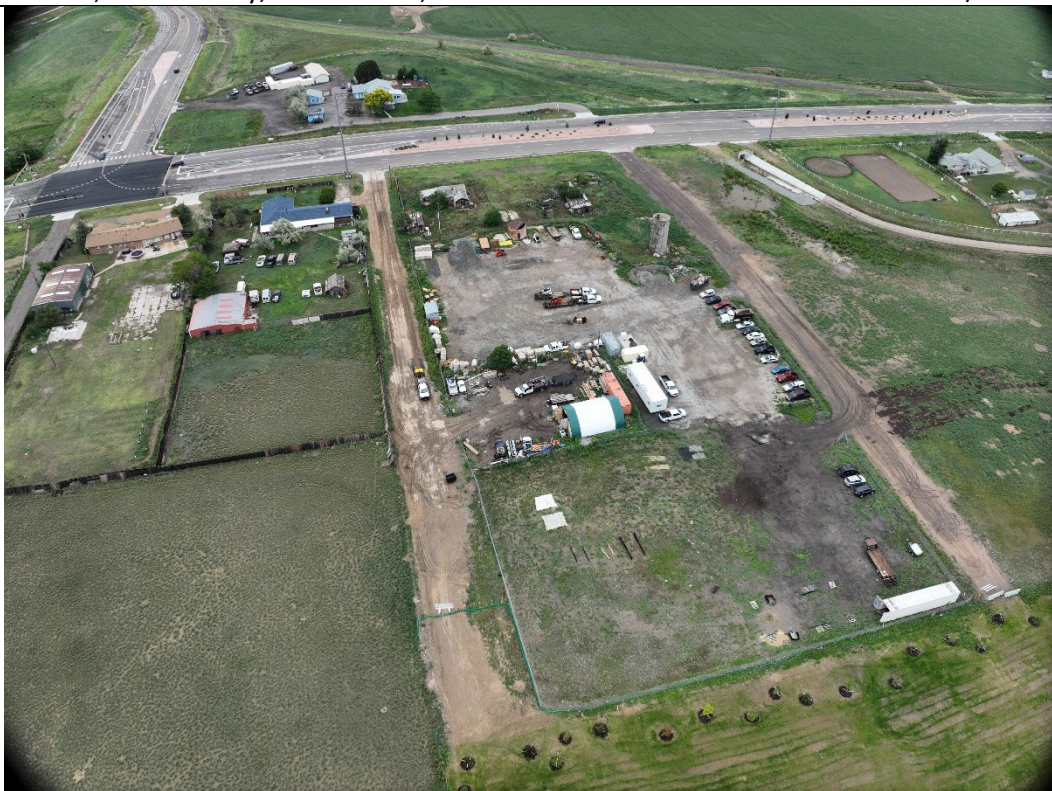
EAST – 39.971192 / -104.981430

In View – Pre-Existing Access Road

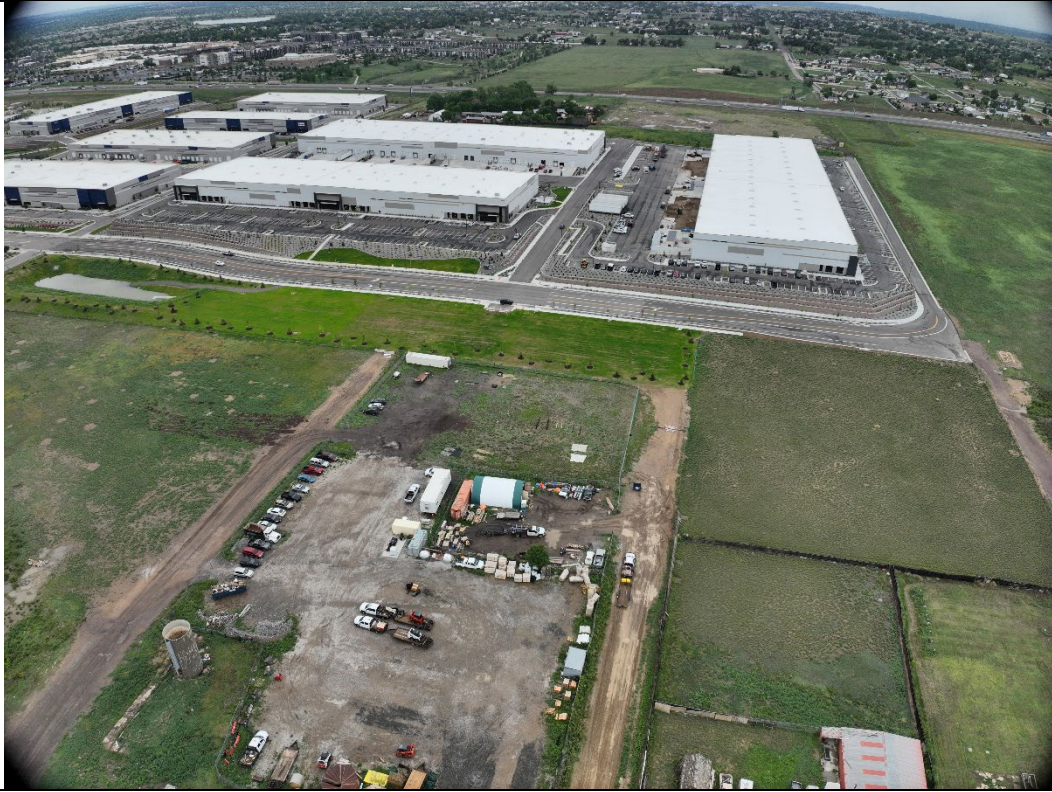
WEST – 39.971204 / -104.978511

In View – Pre-Existing Access Road

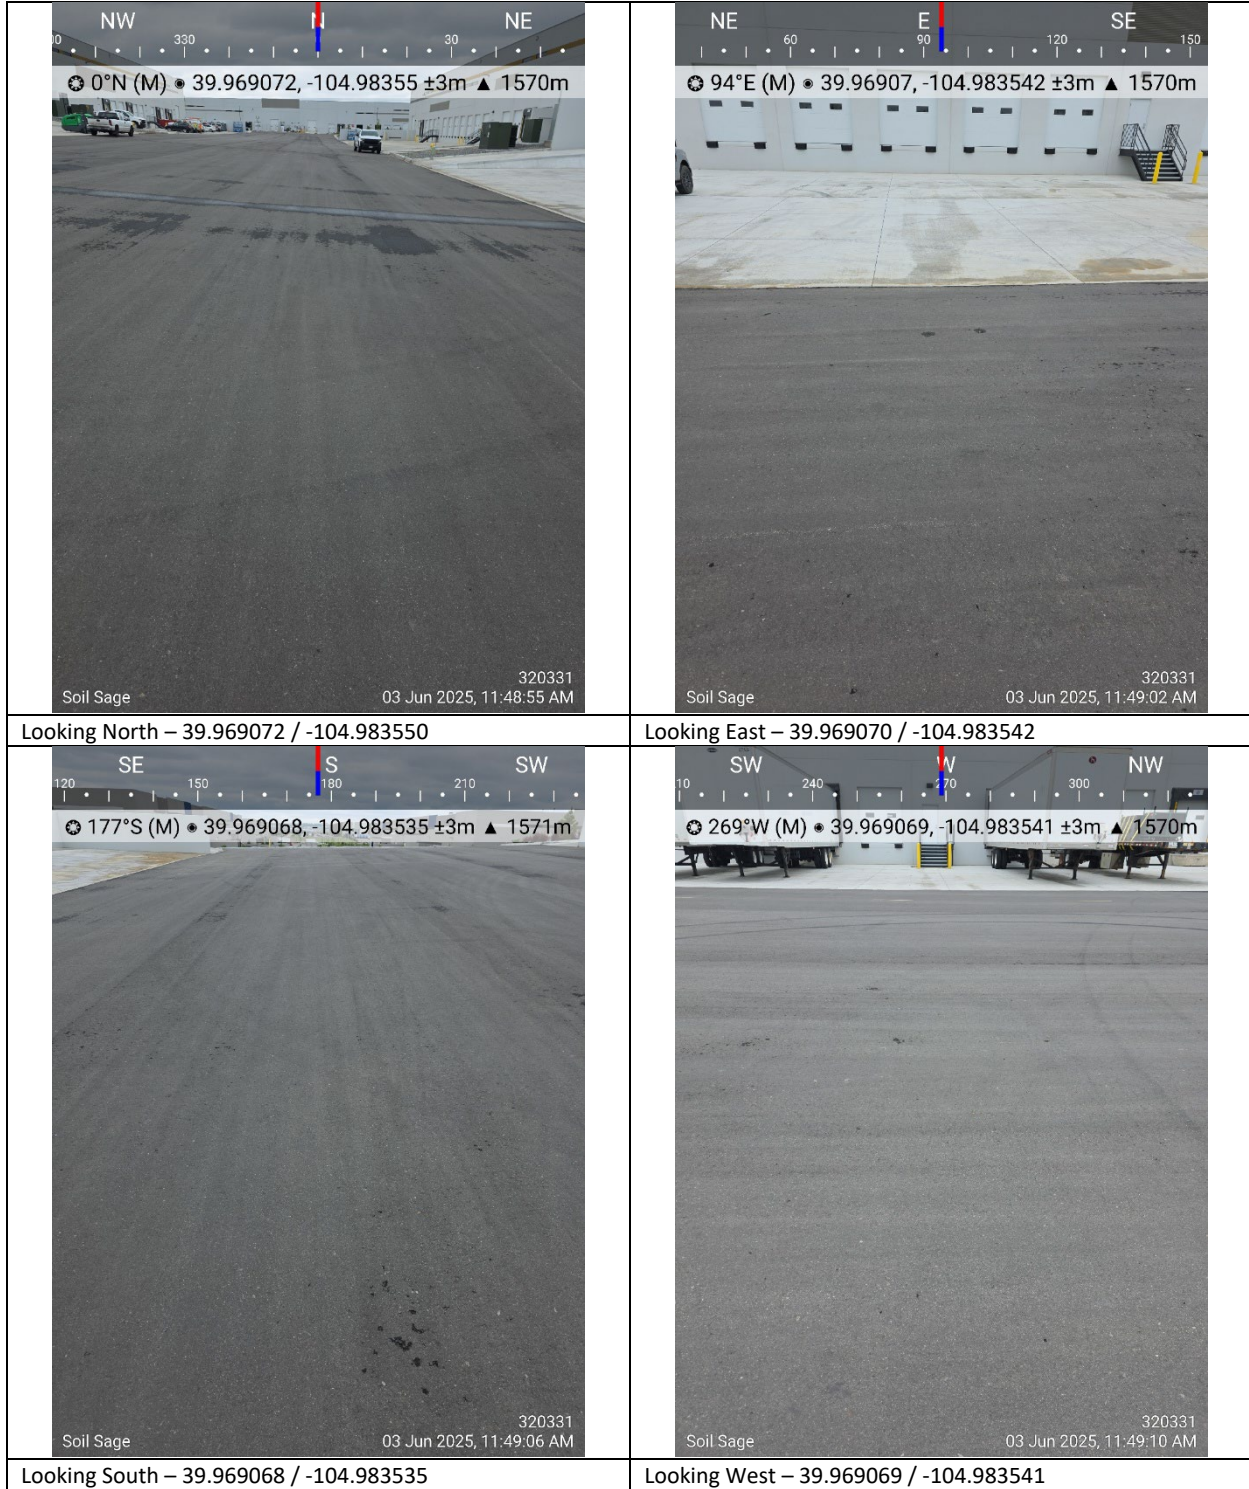
Soil Sage drone imagery confirms that no equipment was left on site at this location after reclamation activities occurred.

Handheld photos taken from PERGOLA #2-15 wellhead (API #05-001-09024).
