SITE-SPECIFIC QUALITY ASSURANCE & QUALITY CONTROL AUDIT

PERMIT CLOSURE REPORT – DESIGNATION LAND USE CHANGE

Location ID: 320428

Location Name: HSR-VAN SCHAACK-62S66W/10NWSE

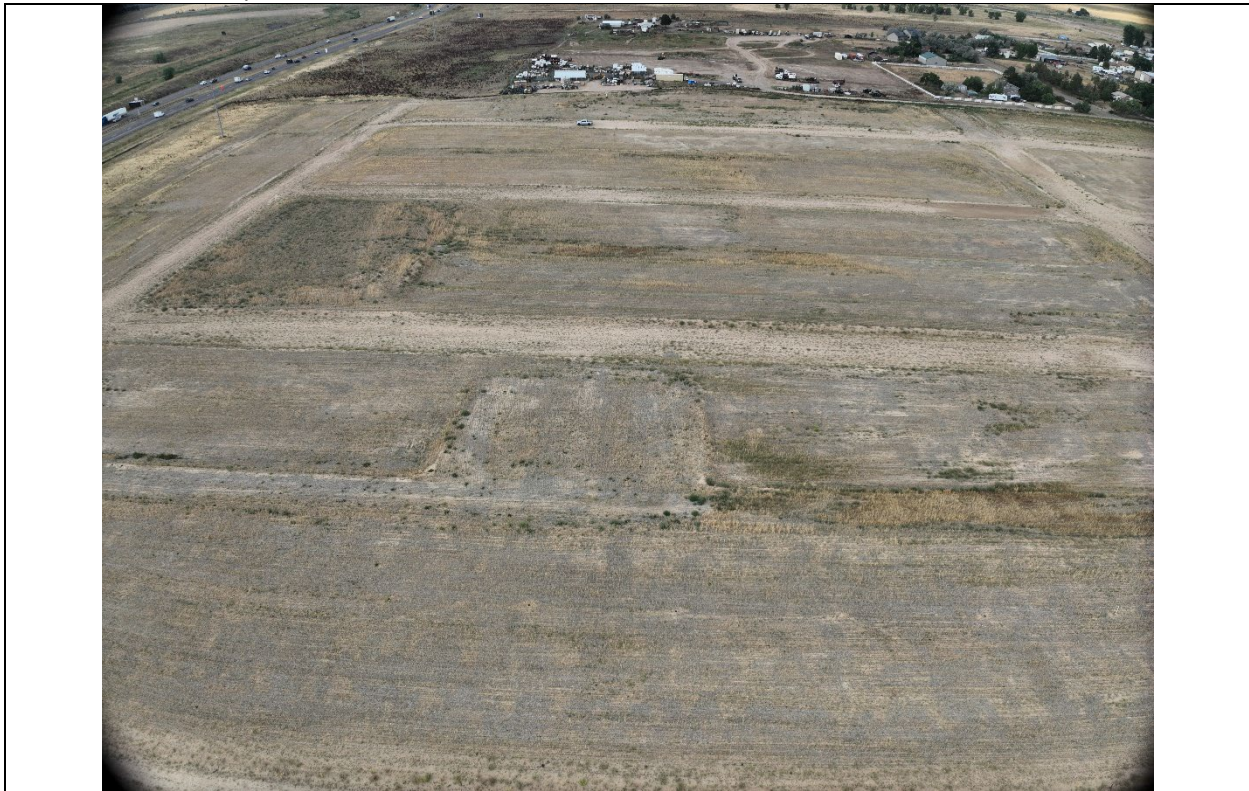
In View – Well, Tank Battery (Loc ID [452734](#)), Access Road, Flowline **NORTH** – 39.889731 / -104.758947

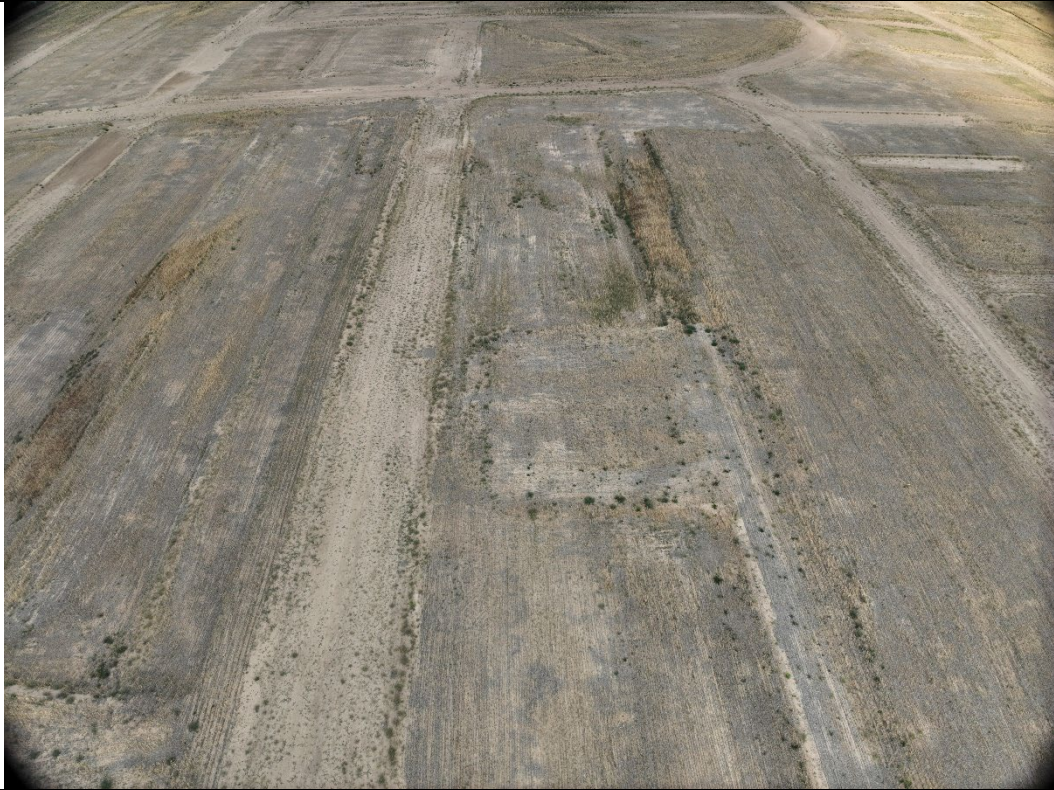
EAST – 39.890555 / -104.759858

In View – Well, Access Road, Flowline

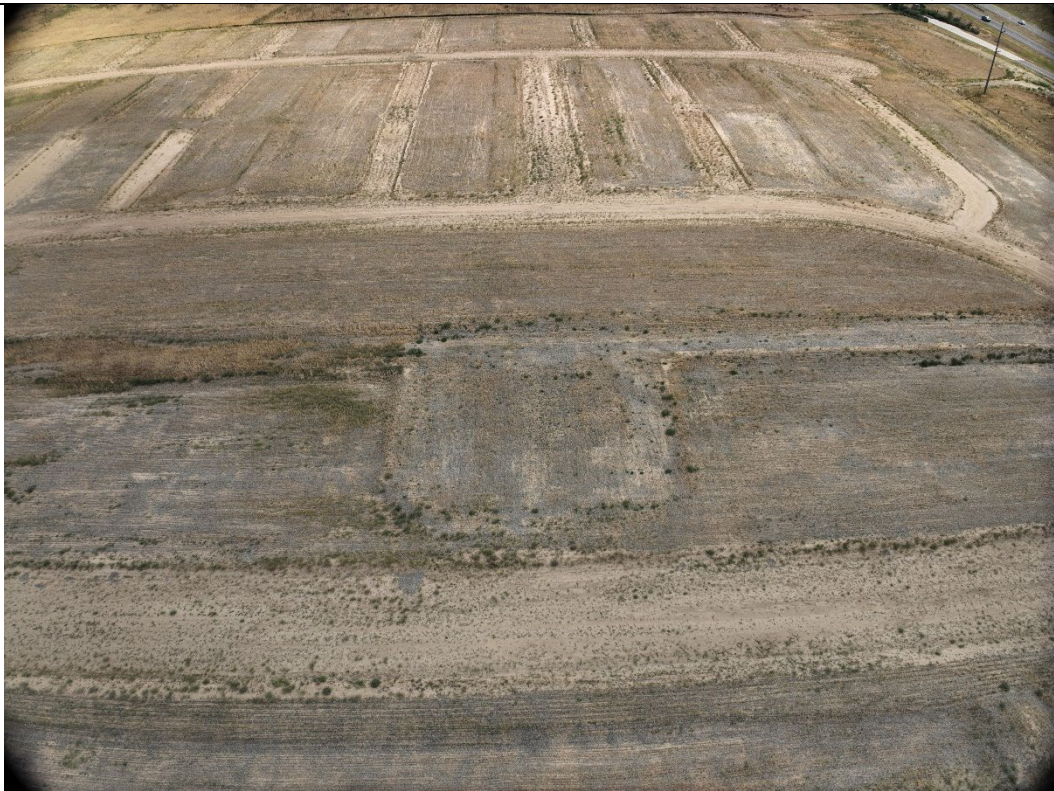
SOUTH – 39.891066 / -104.759027

In View – Well, Access Road, Flowline

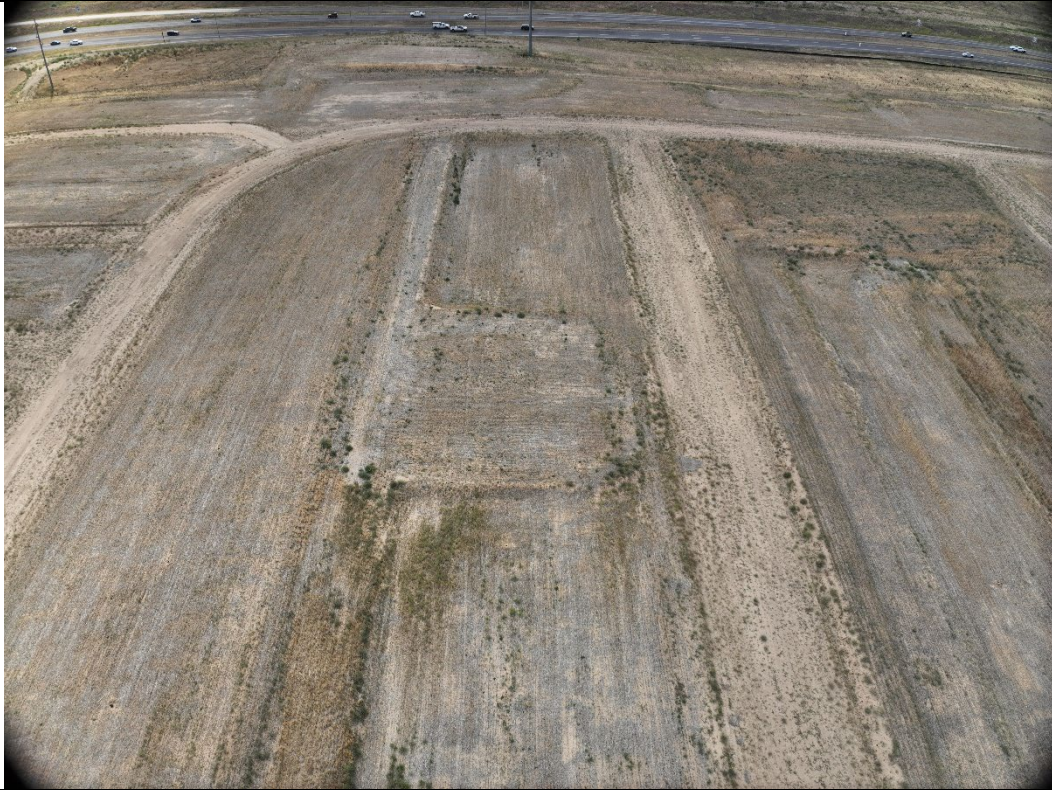
WEST – 39.890499 / -104.758195

In View – Well, Access Road, Flowline

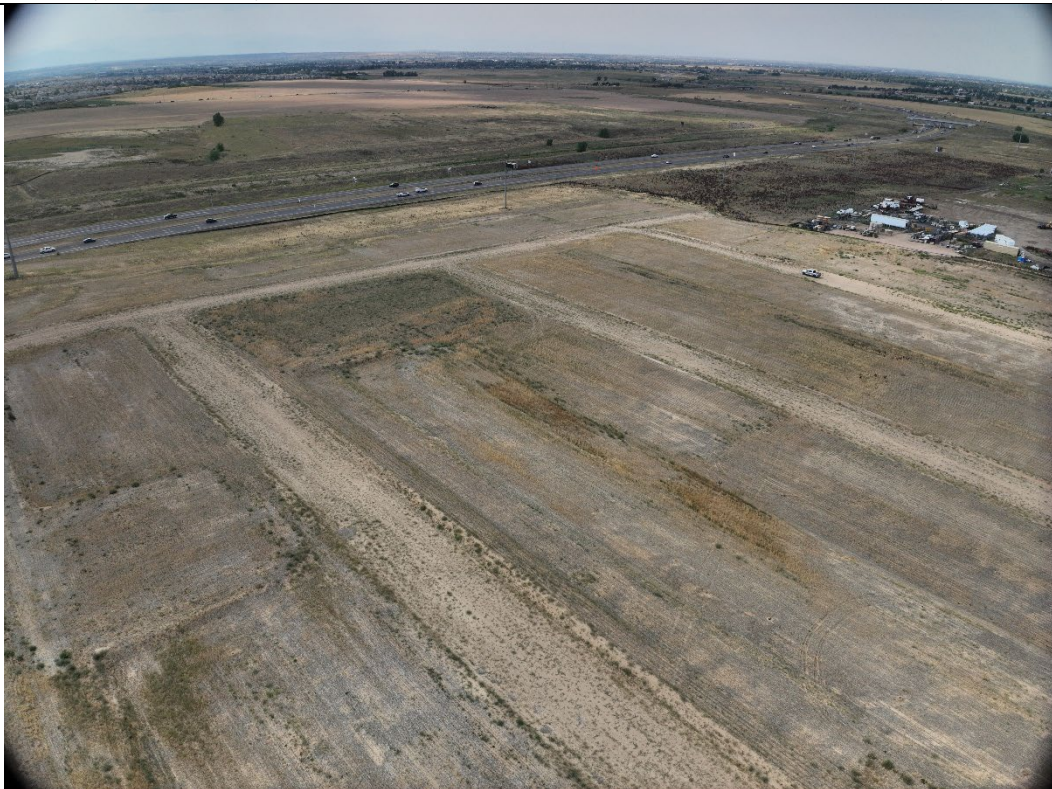
NORTHWEST – 39.890351 / -104.758002

In View – Well, Tank Battery (Loc ID [452734](#)), Access Road, Flowline

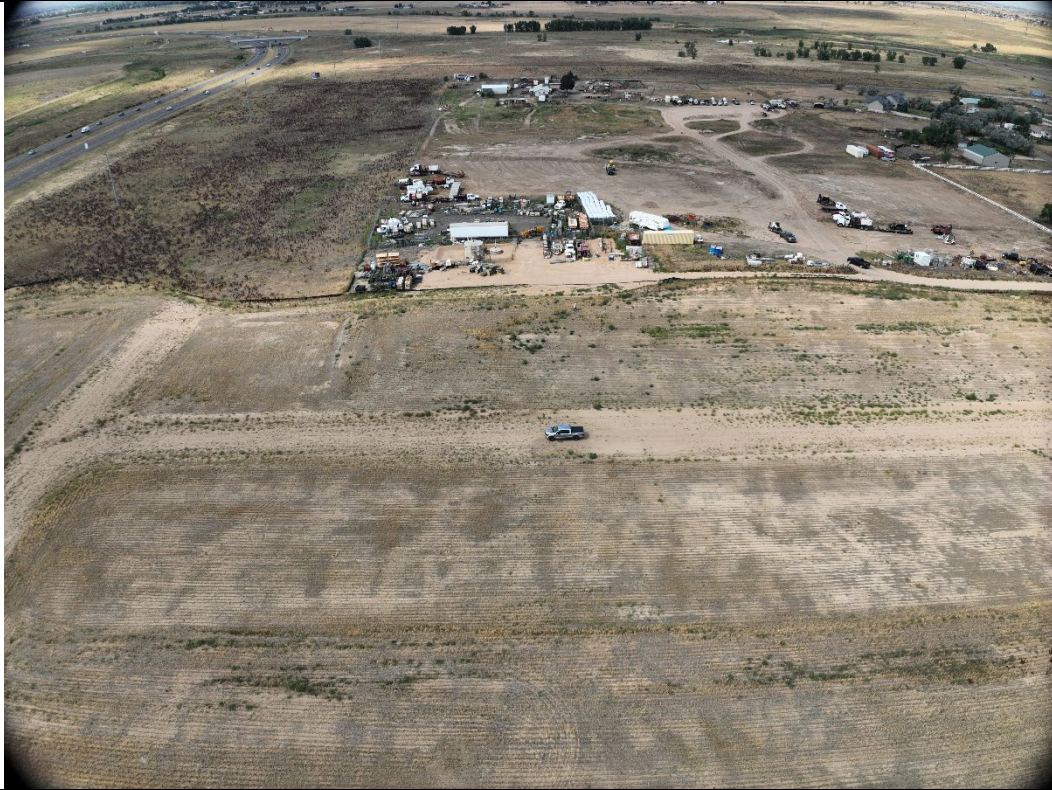
NORTH – 39.891403 / -104.759340

In View – Tank Battery (Loc ID [452734](#)), Access Road, Flowline

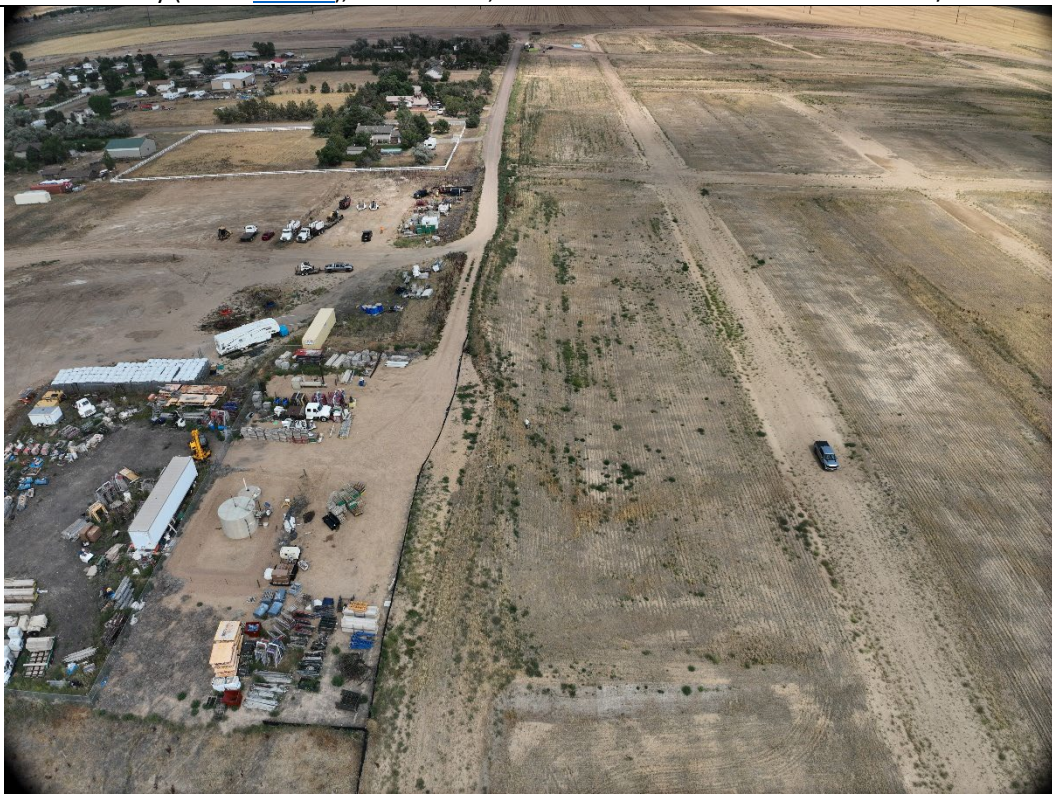
EAST – 39.892607 / -104.760217

In View – Tank Battery (Loc ID [452734](#)), Access Road, Flowline

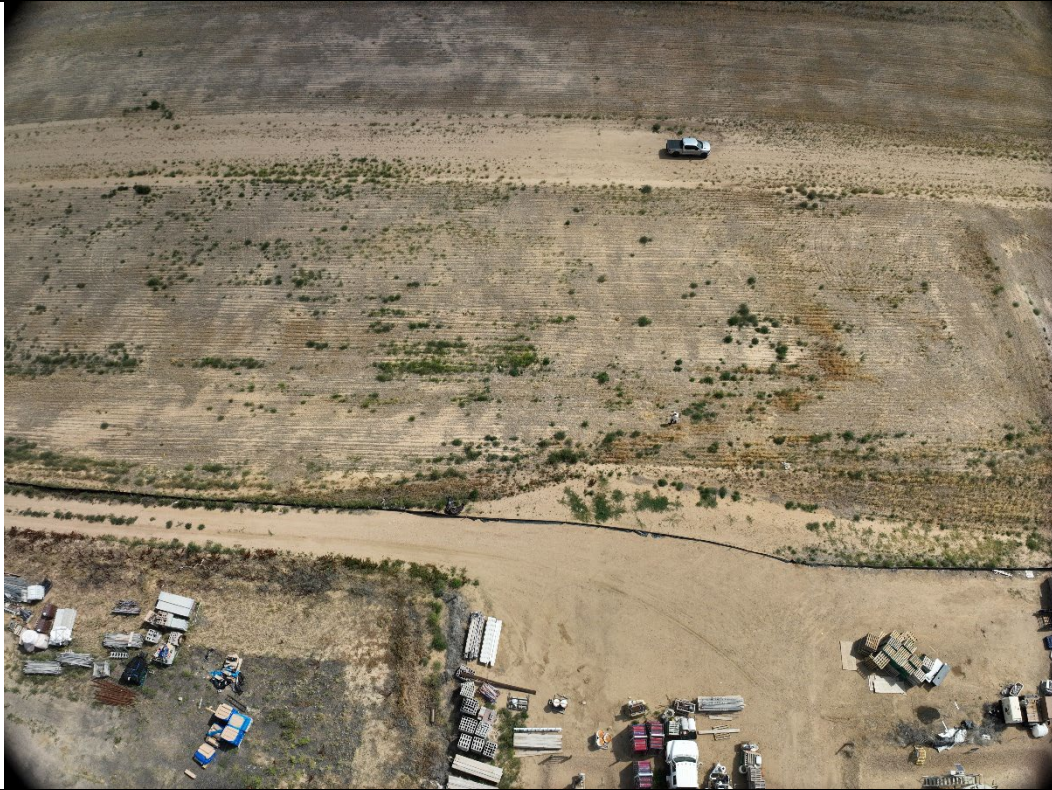
In View – Well, Tank Battery (Loc ID [452734](#)), Access Road, Flowline **SOUTH** – 39.892960 / -104.759024

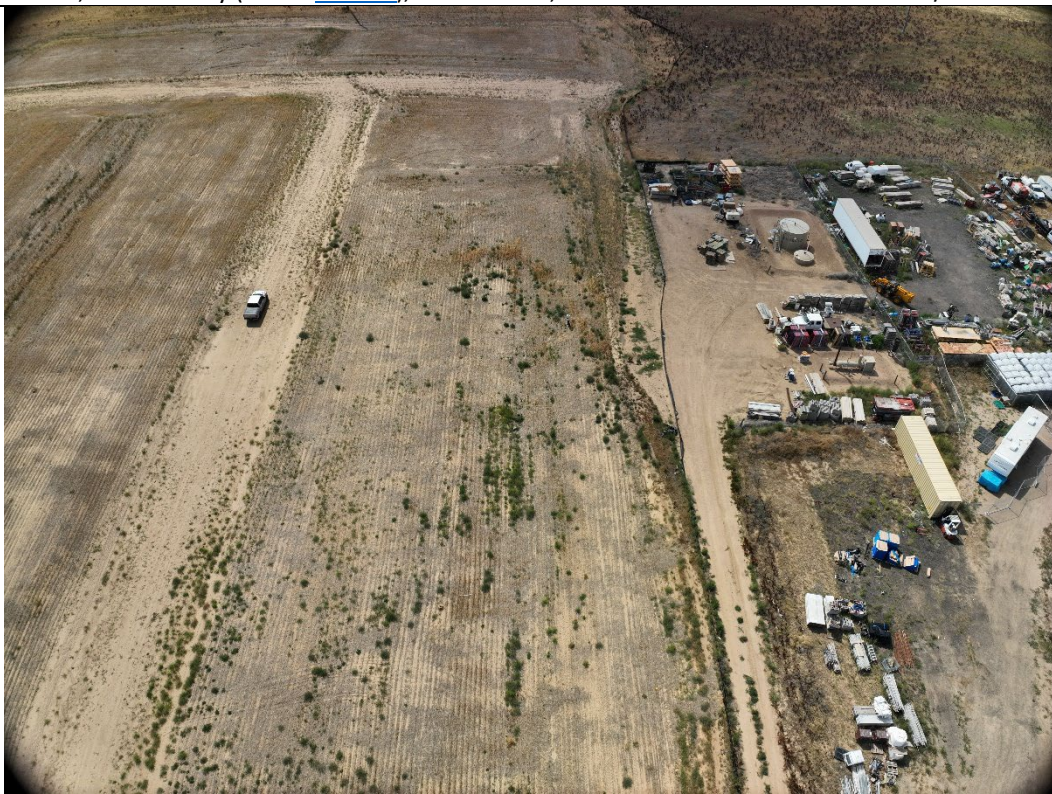
In View – Well, Tank Battery (Loc ID [452734](#)), Access Road, Flowline **WEST** – 39.892573 / -104.758298

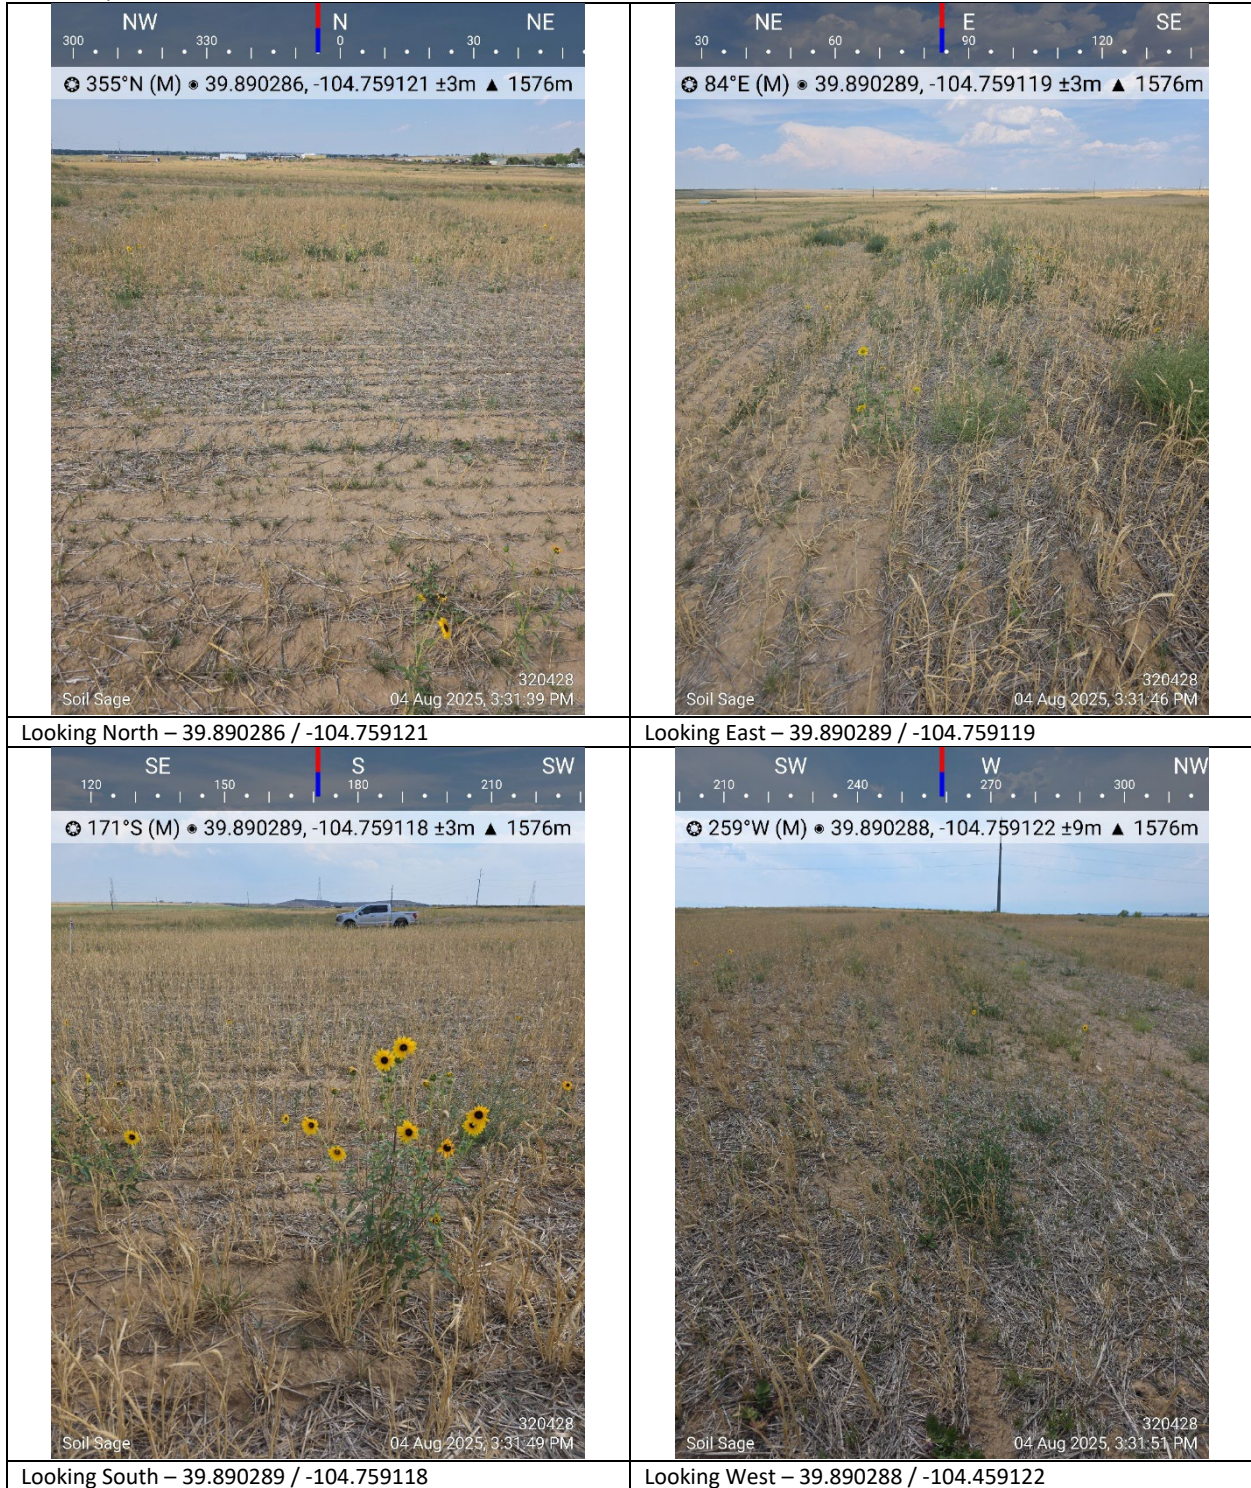
Well – Ground Photos

Soil Sage drone imagery confirms that no equipment was left on site at this location after reclamation activities occurred.

Handheld photos taken from HSR-Van Schaack #10-10 wellhead.

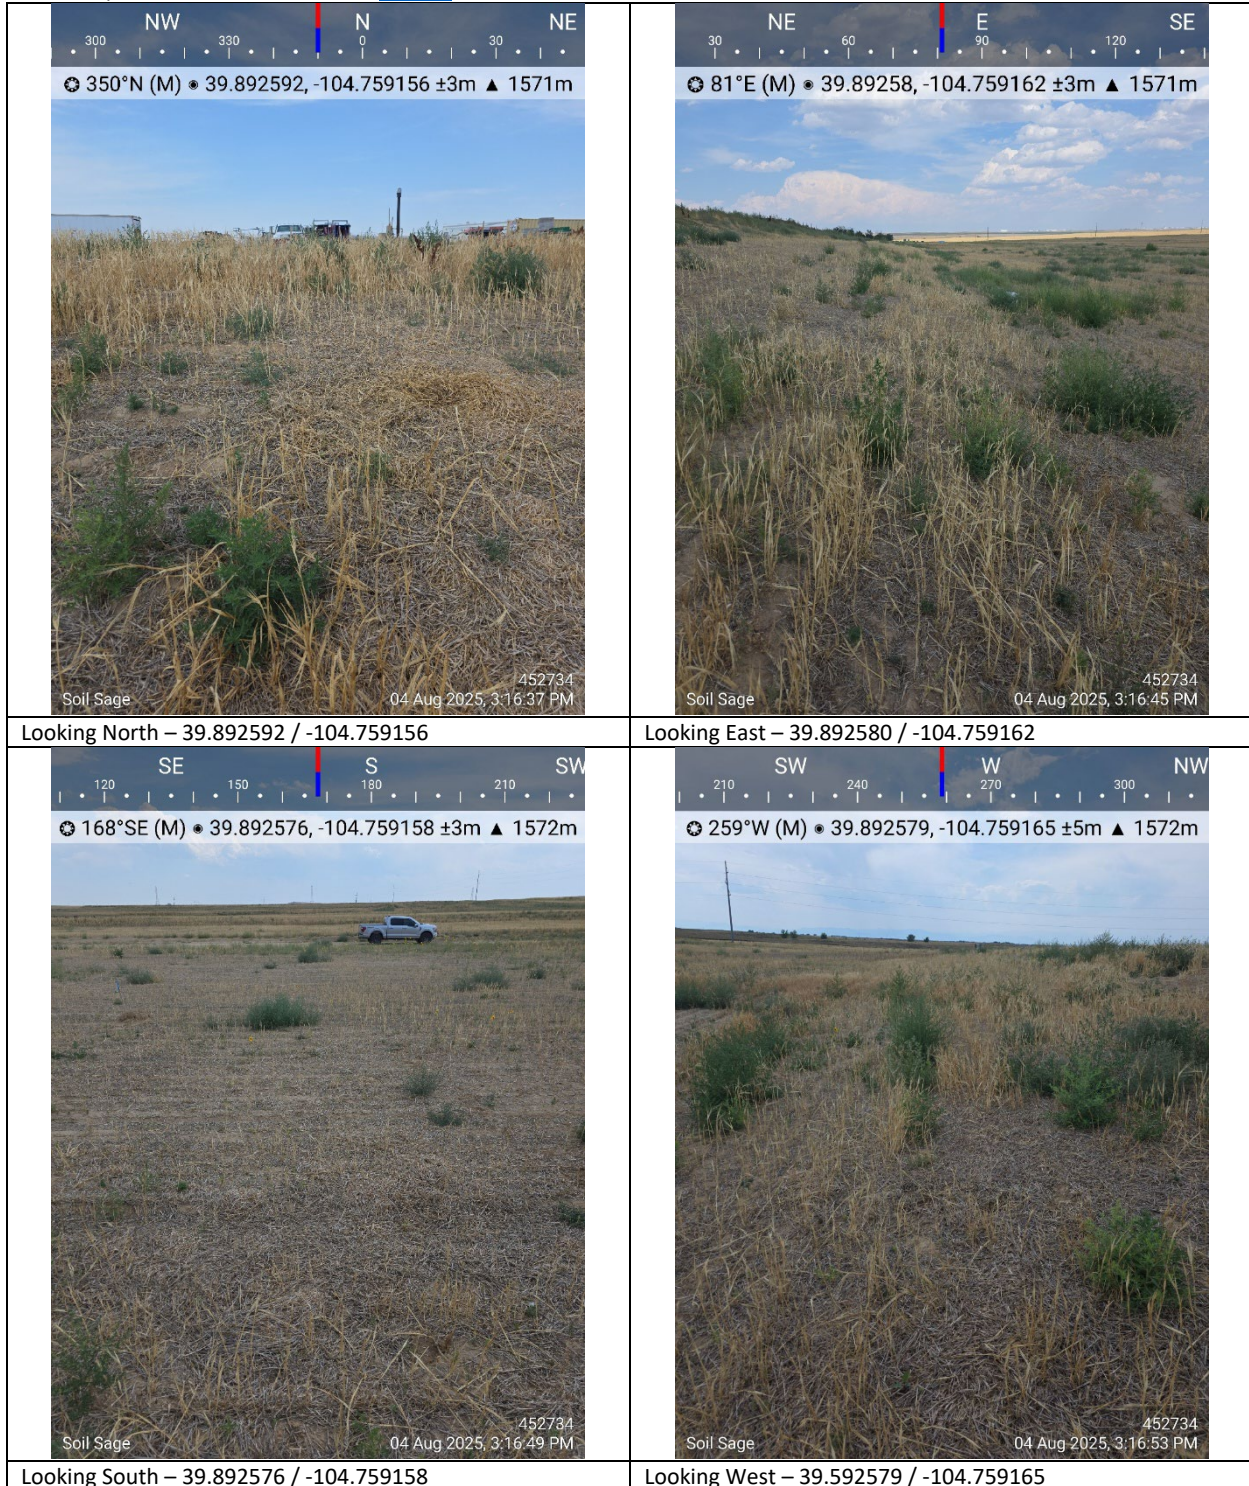
Tank Battery – Ground Photos

Handheld photos taken at Location ID [452734](#) Production Facilities.
