# Inspection Photos

**Operator:** QB Energy Operating LLC #10844

**Location ID:** 421020

**Inspection Doc:** 719200139

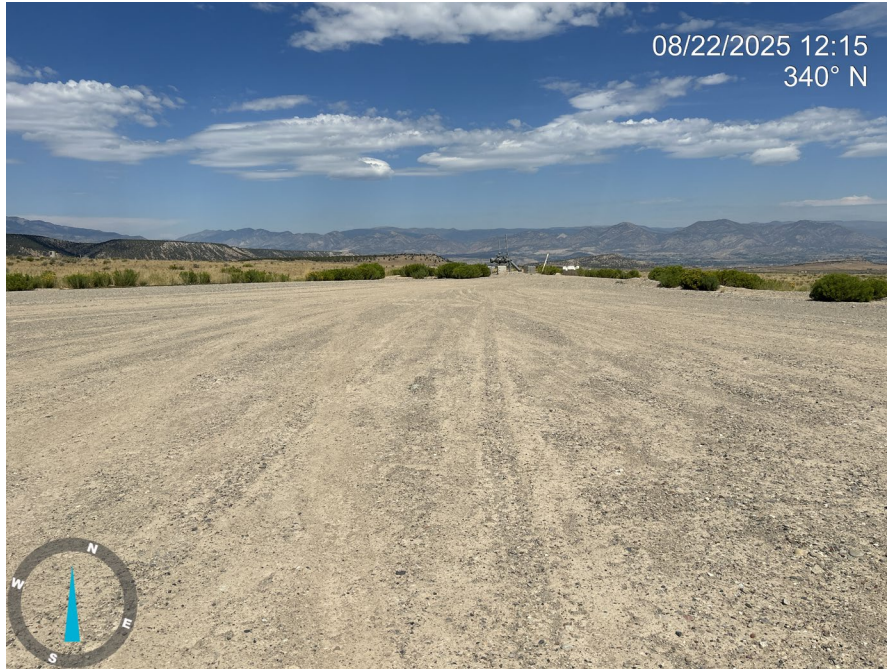
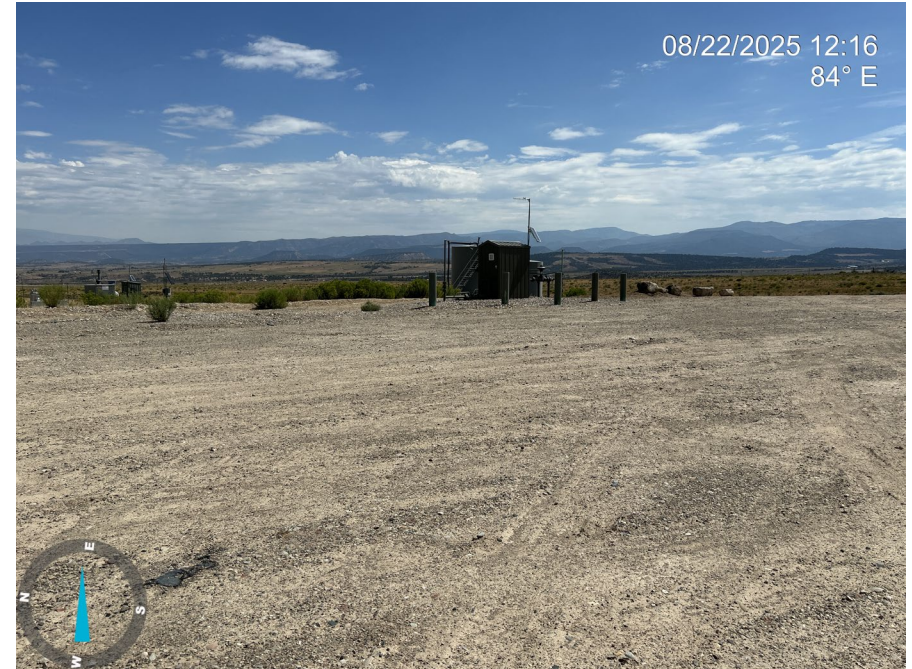
**Photo 1:** Photos show an overview of the location looking north and east, respectively.

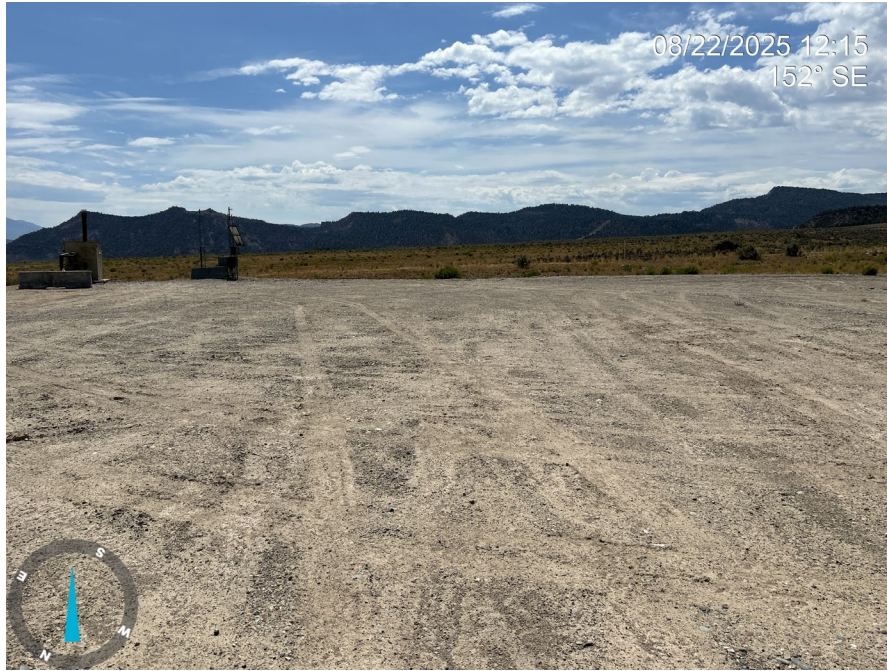
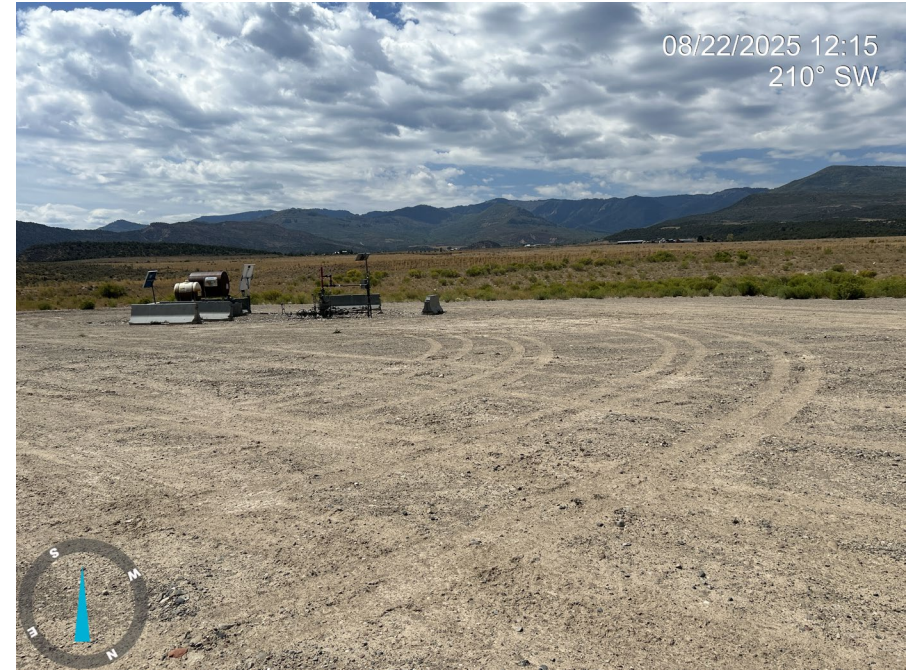
**Photo 2:** Photos show an overview of the location looking southeast and southwest, respectively.

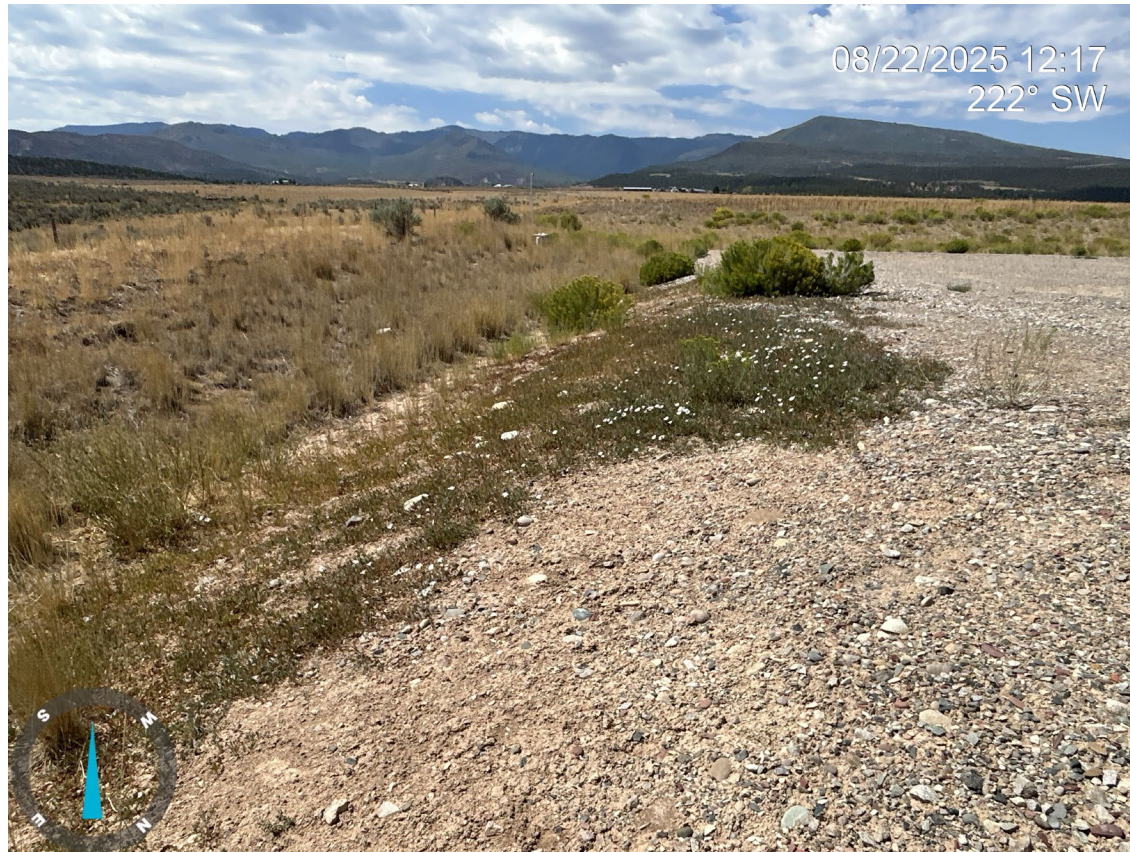
**Photo 3:** Photo showing bindweed is present on the southeastern edge of the upper working pad surface. Comply with Rules 1003.f. and 606.c.

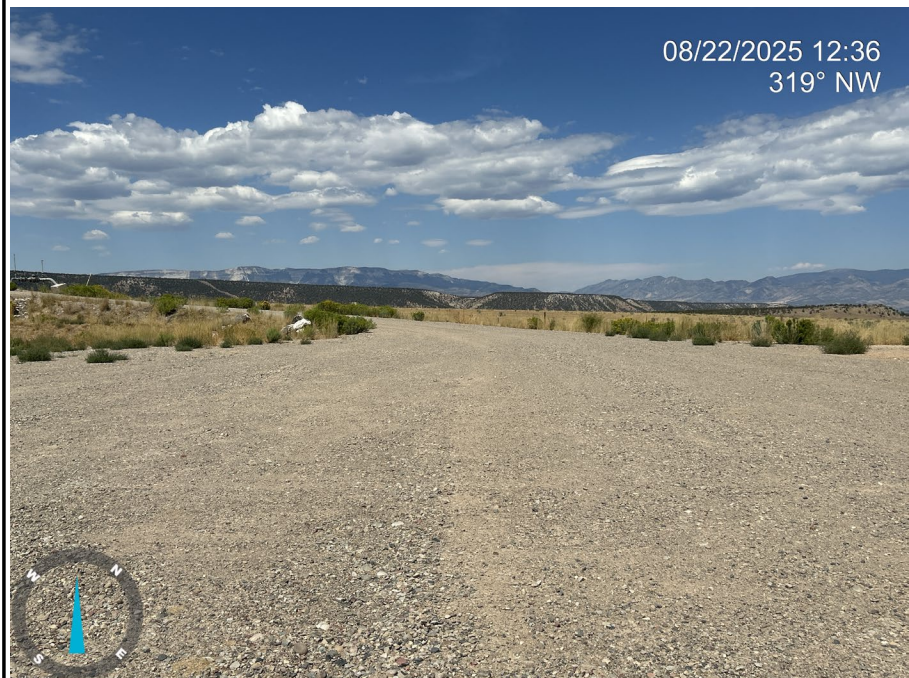
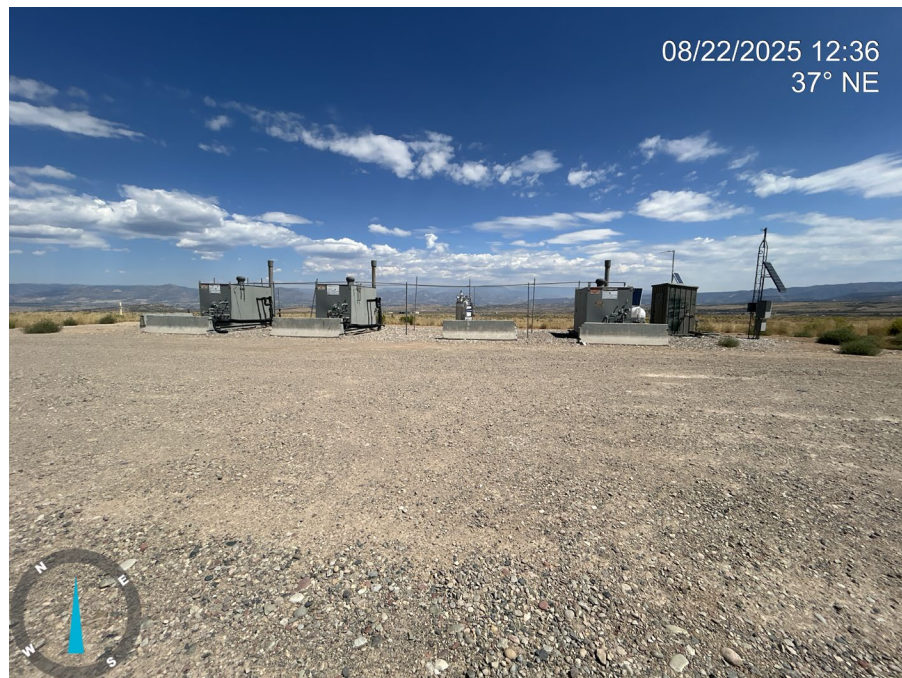
**Photo 4:** Photos show an overview of the lower working pad surface of the location looking northwest and northeast, respectively.

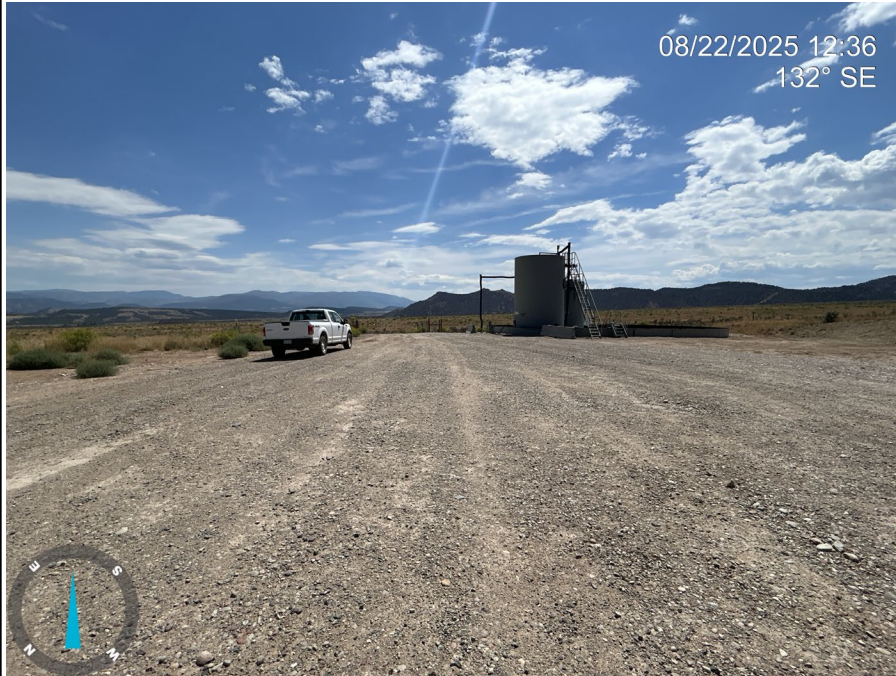
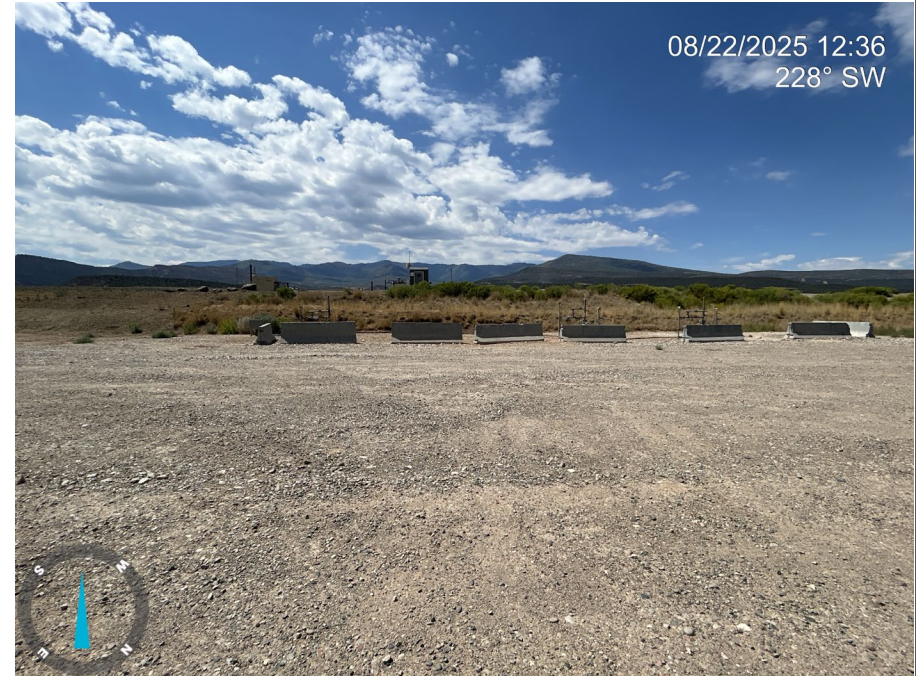
**Photo 5:** Photos show an overview of the lower working pad surface of the location looking southeast and southwest, respectively.

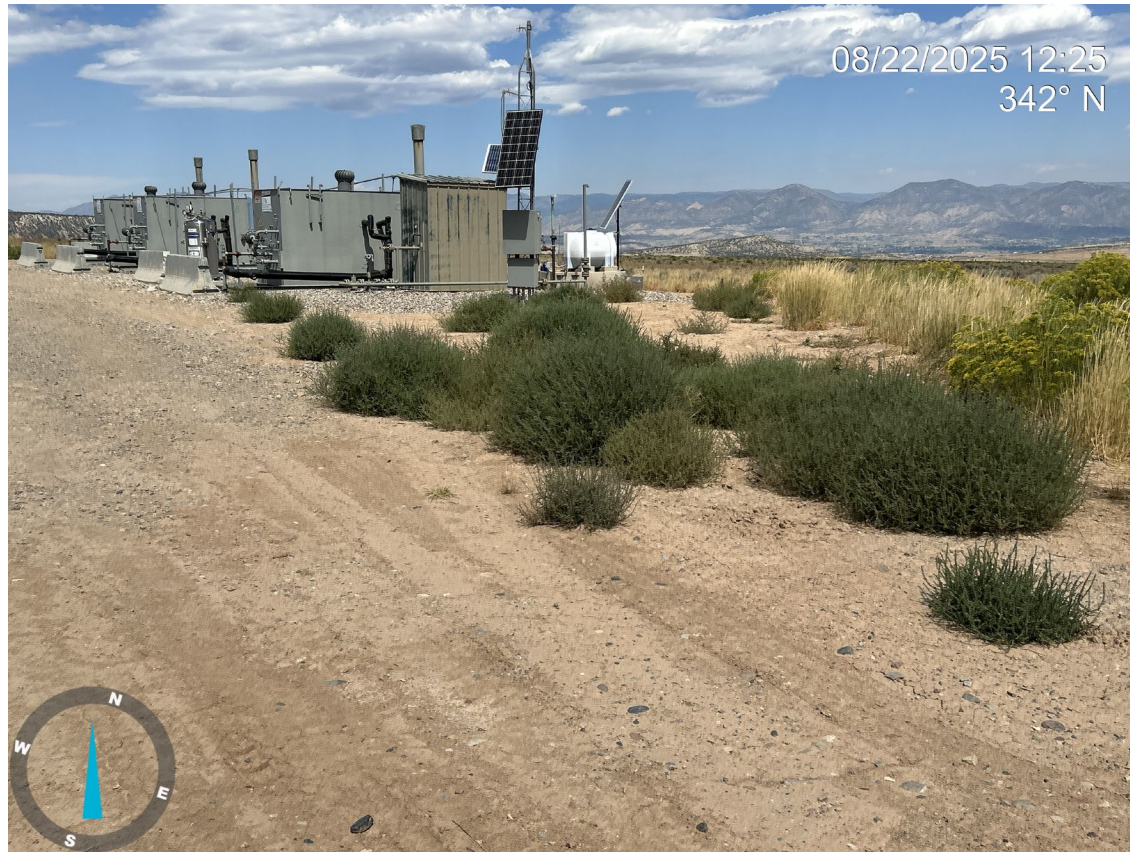
**Photo 6:** Photo showing kochia is present on the northeastern edge of the lower working pad surface. Comply with Rule 606.c.

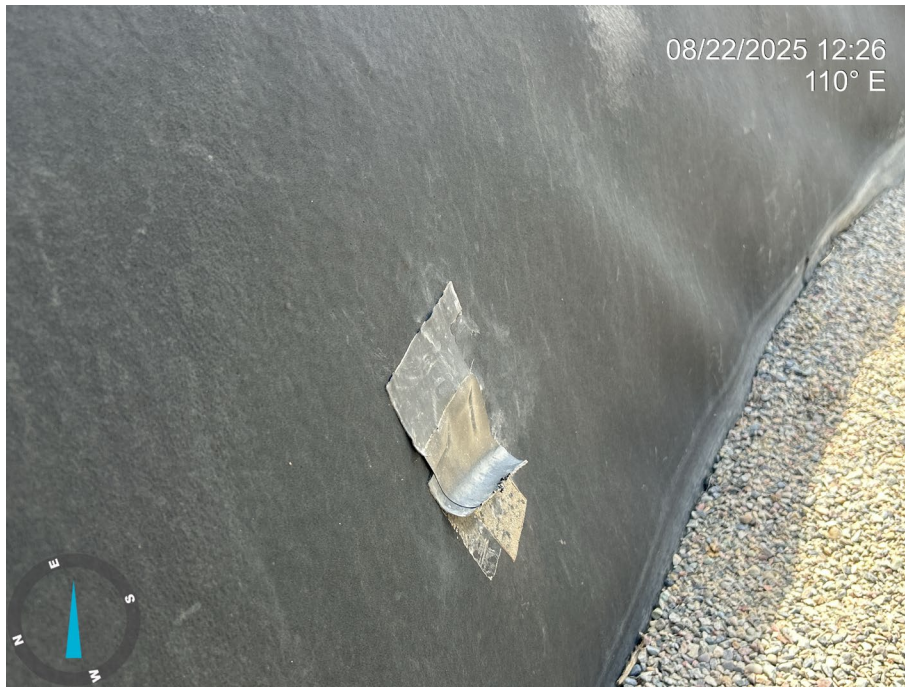
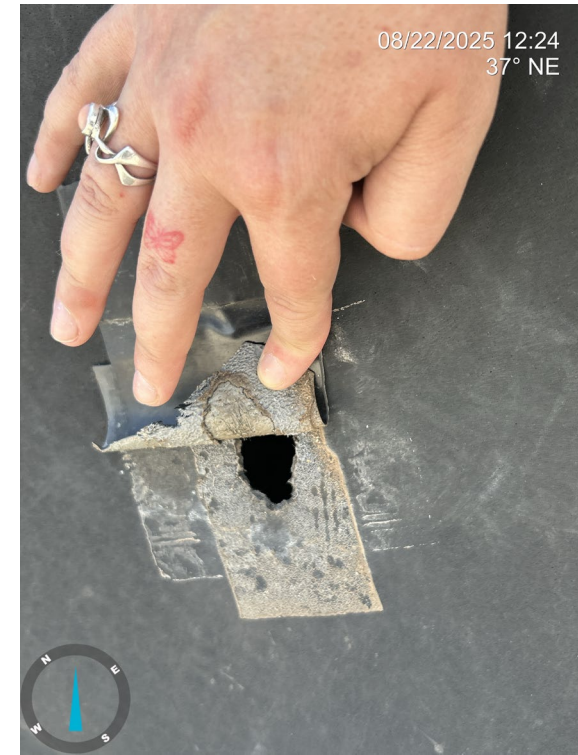
**Photo 7:** Photos showing that some patches on the secondary containment liner are in disrepair and are not sufficiently impervious to contain a spill or release. Refer to previous inspections for Corrective Action.

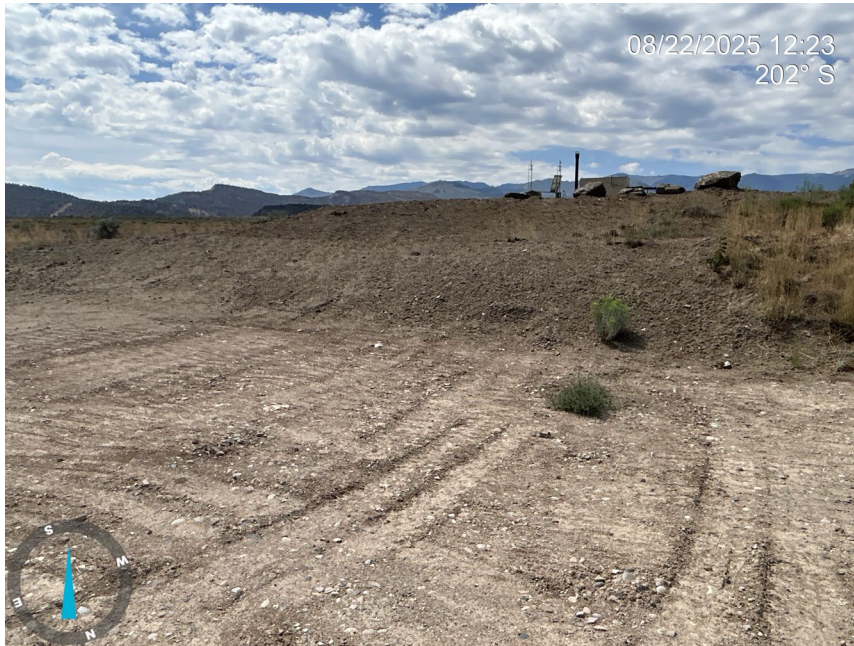
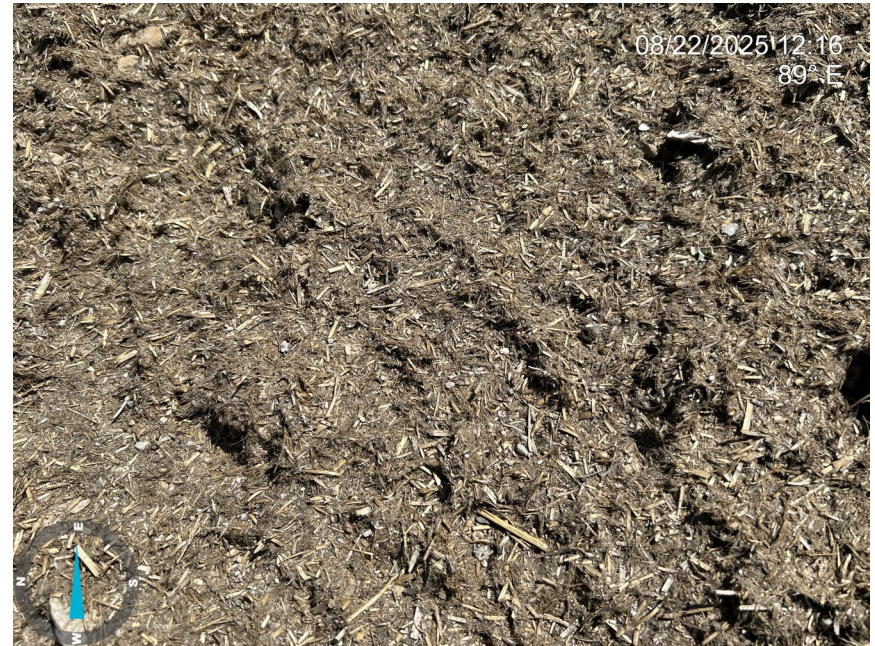
**Photo 8:** Photos showing a cut slope in between the upper and lower working pad surface that appears to have been hydromulched recently.

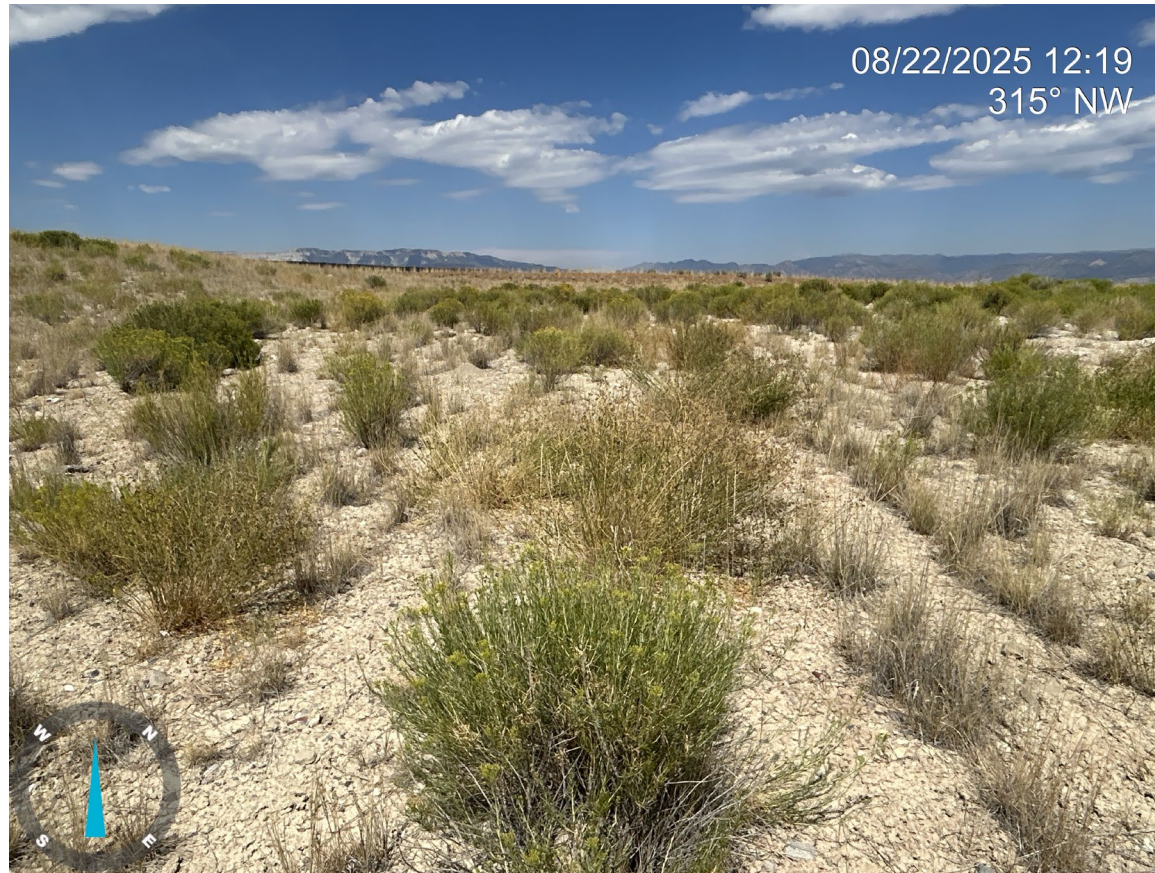
**Photo 9:** Photo showing an overview of the western interim area. Interim areas appear to be progressing towards 1003 reclamation standards.
