## Inspection/Audit Photos

Location Name: QB ENERGY OPERATING LLC Logan Dehydration Facility

Facility #: 449282

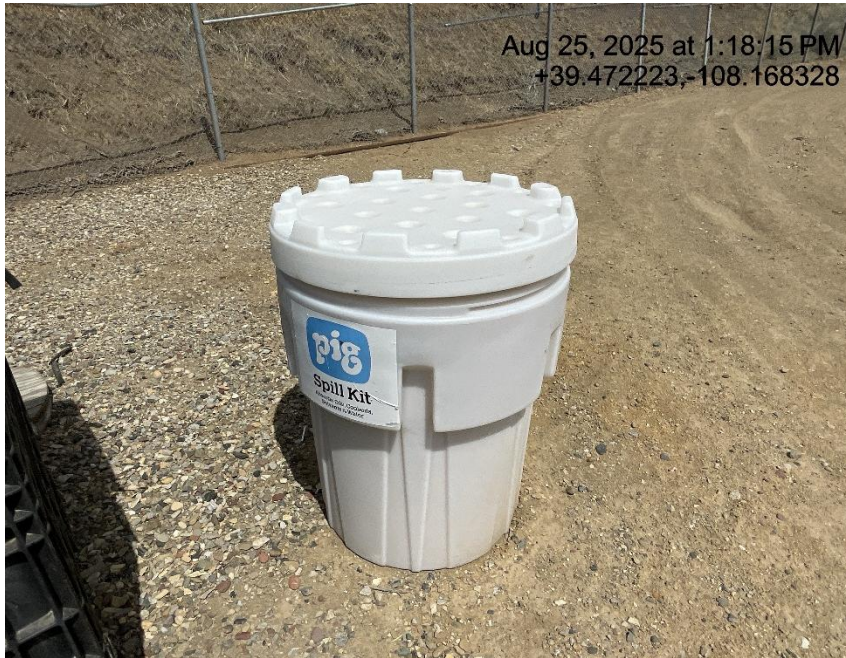
Photo # 3844 Spill kit

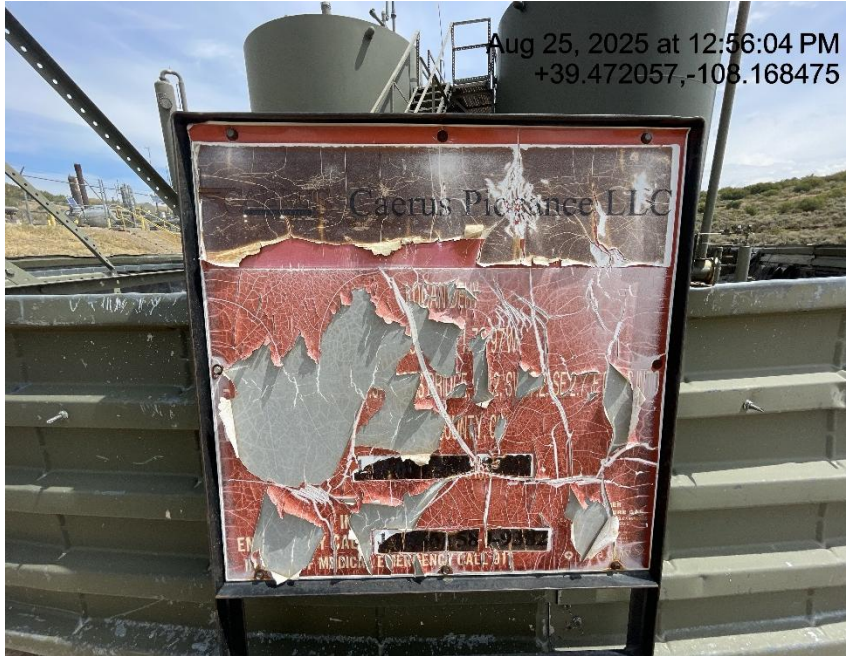
Photo # 3846 Battery sign damaged & illegible

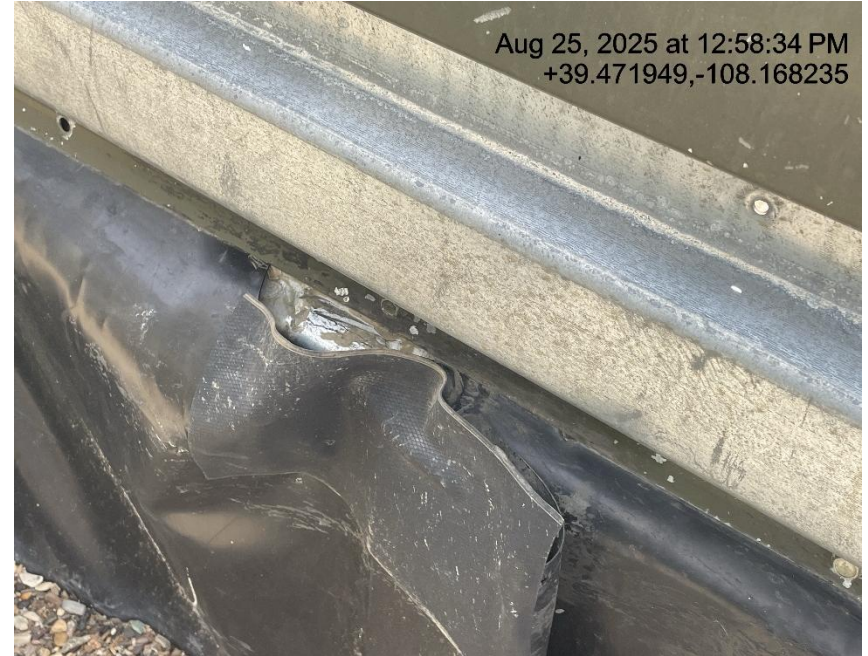
Photo # 3847 Secondary containment liner damaged/needs maintenance

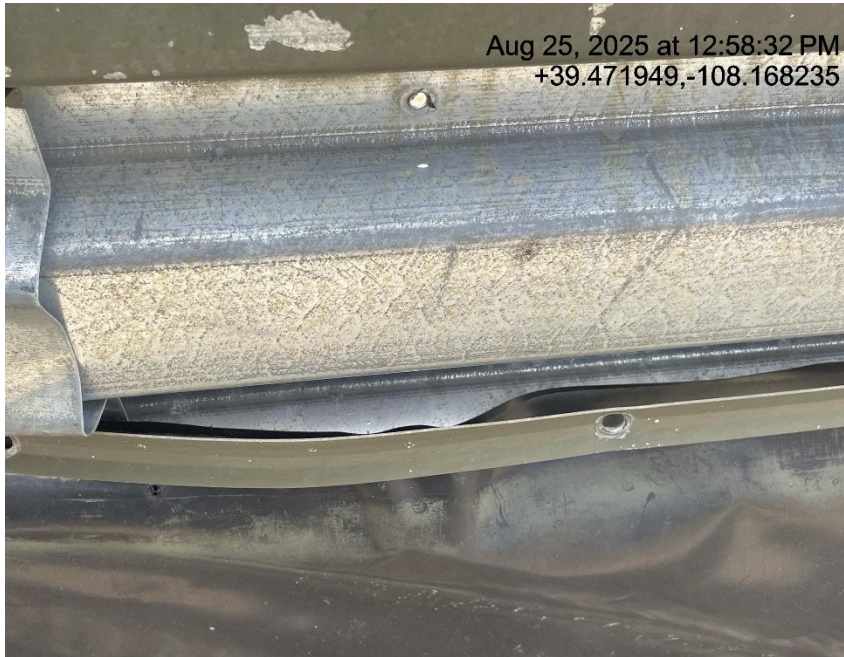
**Photo # 3848 Secondary containment liner damaged/needs maintenance**

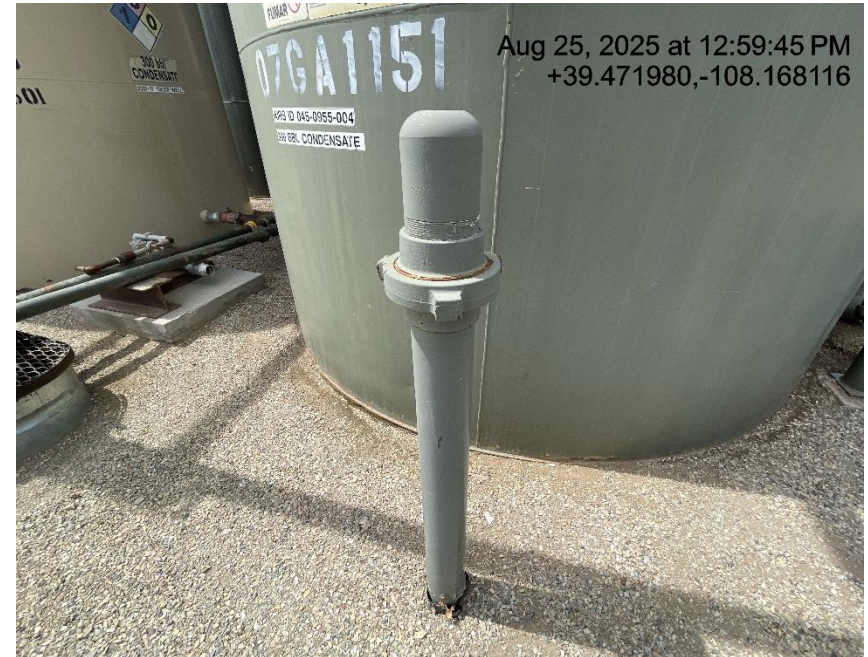
**Photo # 3849 Unused flowline lacks lockout tagout (OOSLAT)**

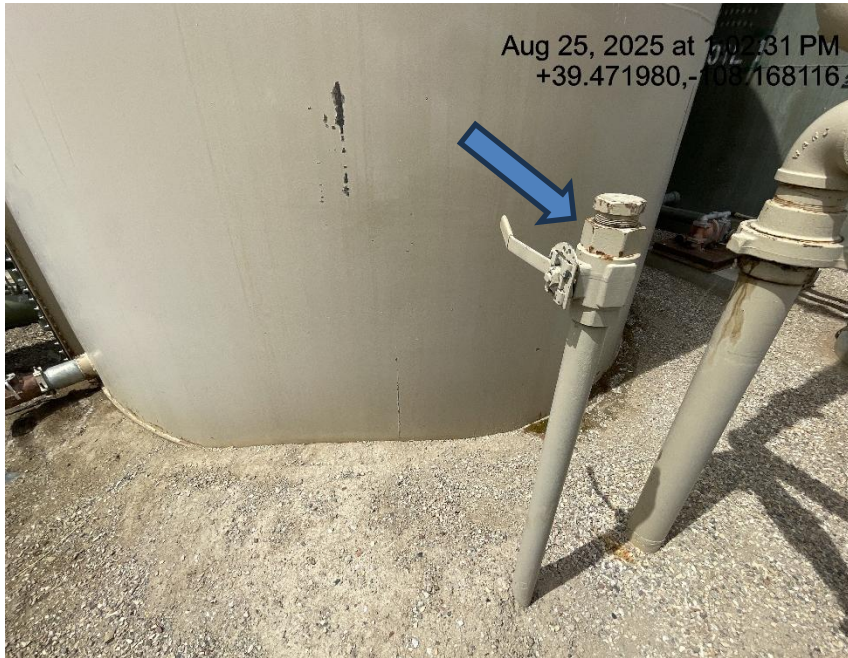
Photo # 3850 Unused flowline lacks lockout tagout (OOSLAT)

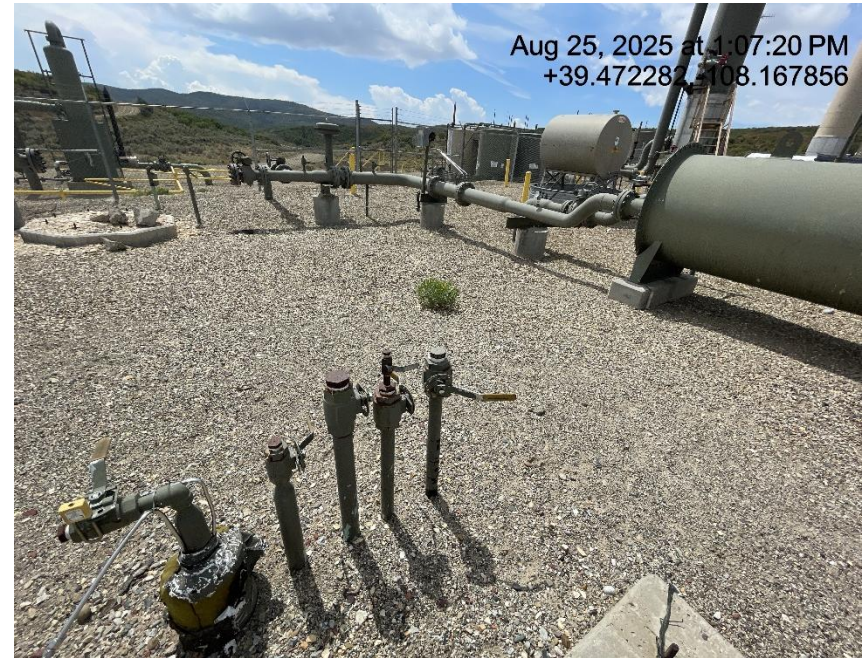
Photo # 3851 Unused flowlines lack lockout tagout (OOSLAT)

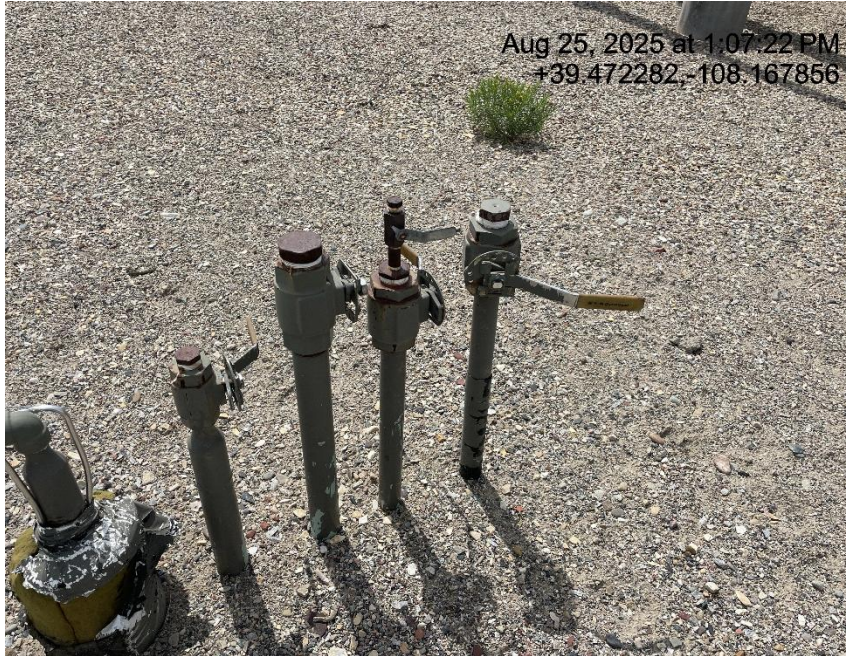
Photo # 3852 Unused flowlines lack lockout tagout (OOSLAT)

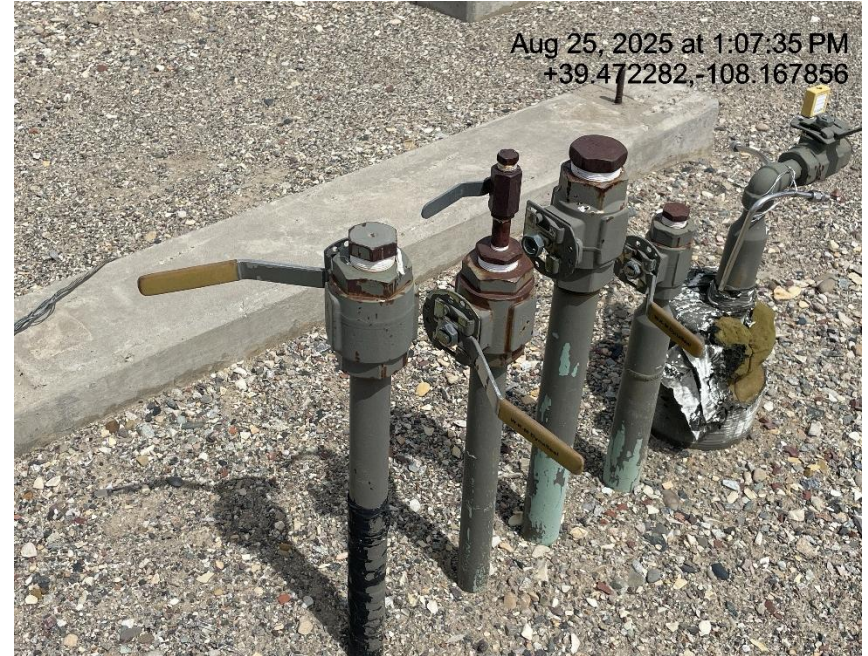
Photo # 3853 Unused flowlines lack lockout tagout (OOSLAT)

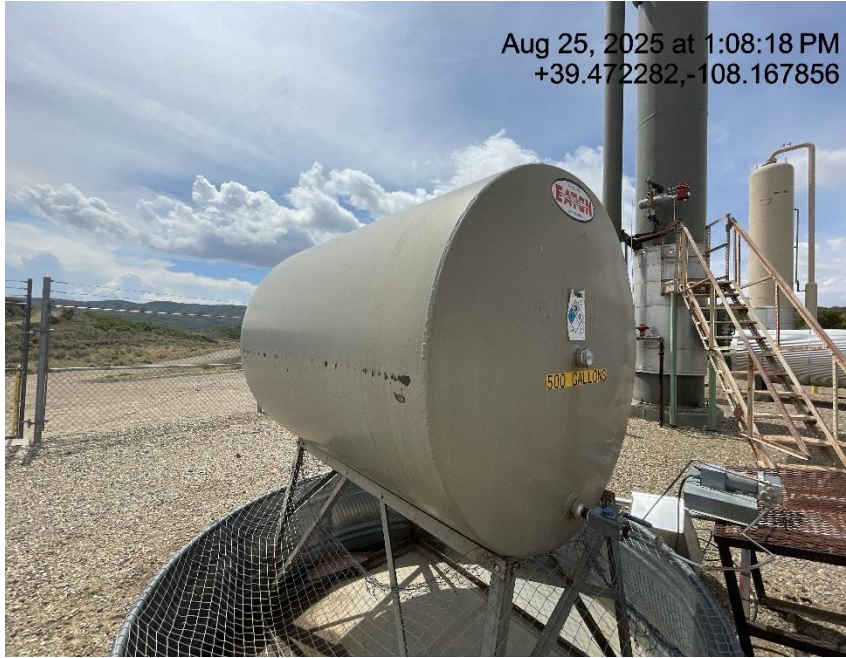
Photo # 3854 Chemical tank lacks required labeling

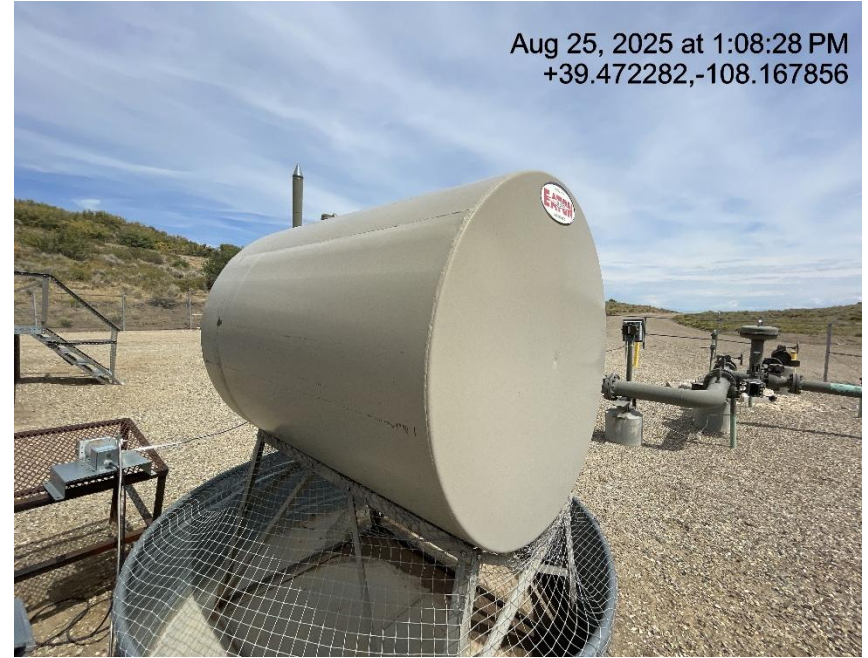
Photo # 3855 Chemical tank lacks required labeling

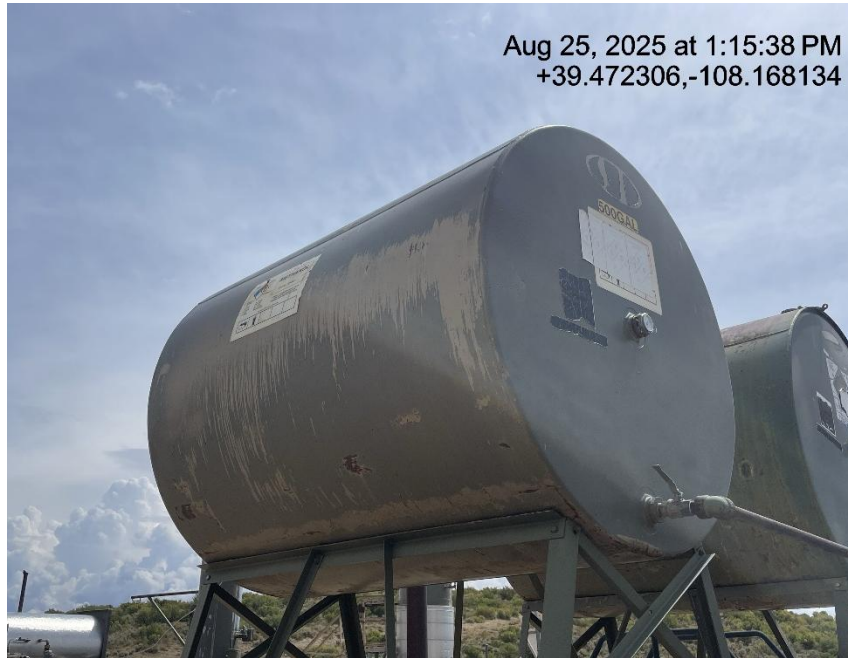
Photo # 3856 Chemical tank lacks required labeling

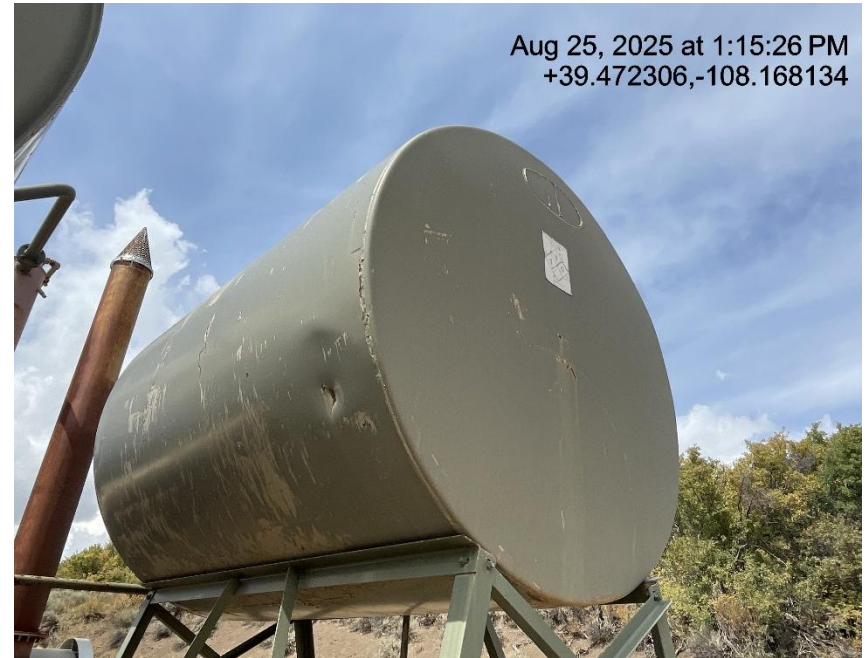
Photo # 3857 Chemical tank lacks required labeling

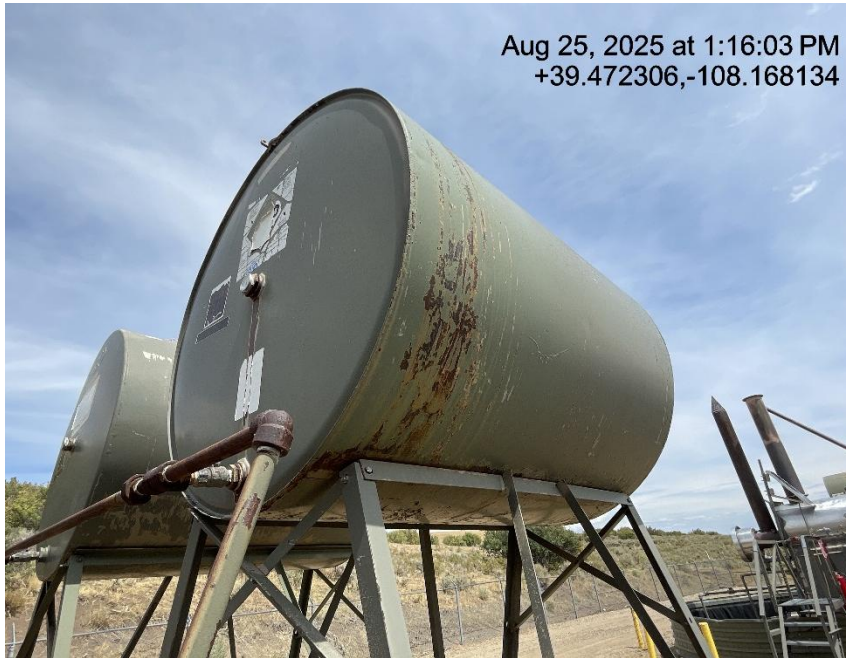
Photo # 3858 Chemical tank lacks required labeling

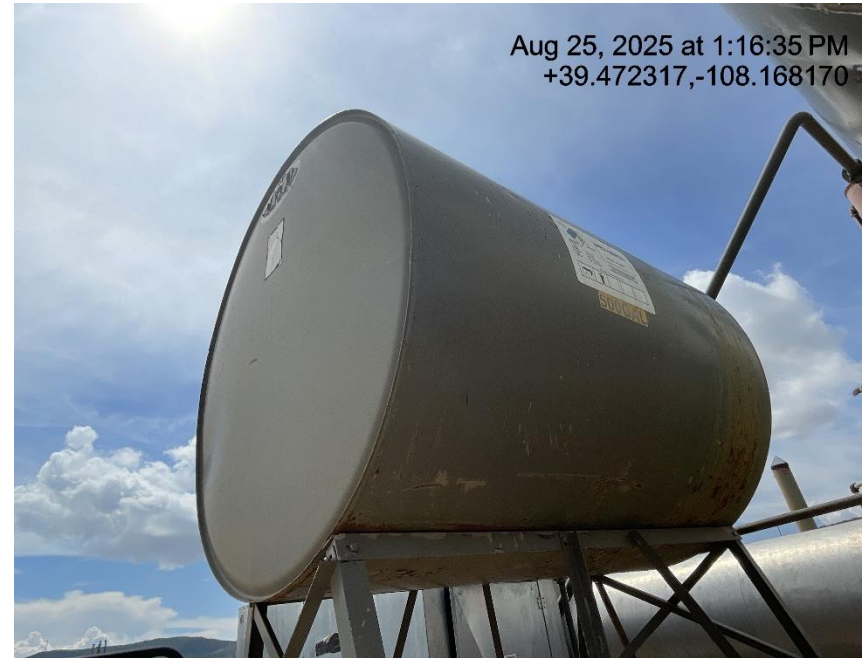
Photo # 3859 Chemical tank lacks required labeling

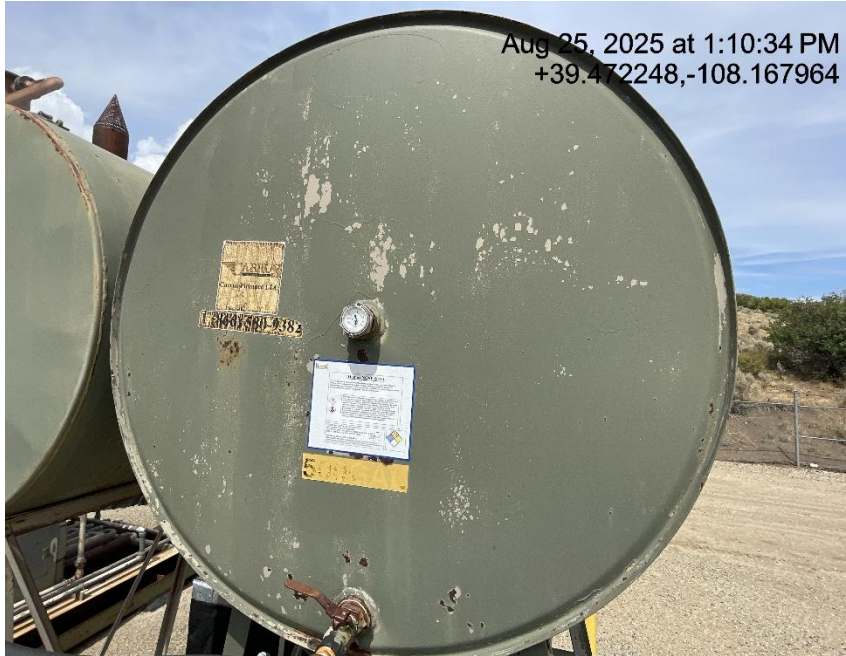
**Photo # 3860 Chemical tank lacks required labeling**

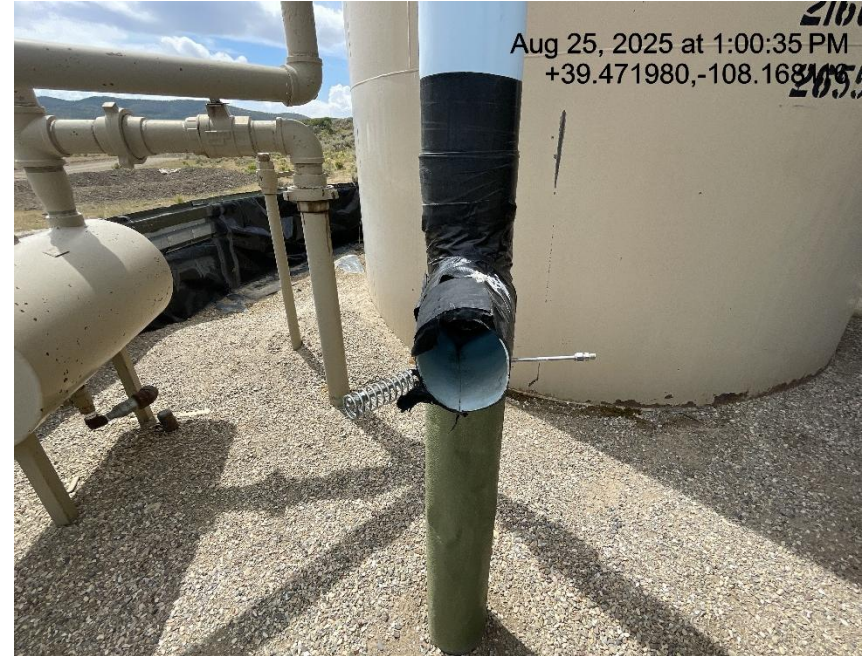
**Photo # 3861 Flowline heating insulation open ended  
/wildlife hazard/available for entry by wildlife**

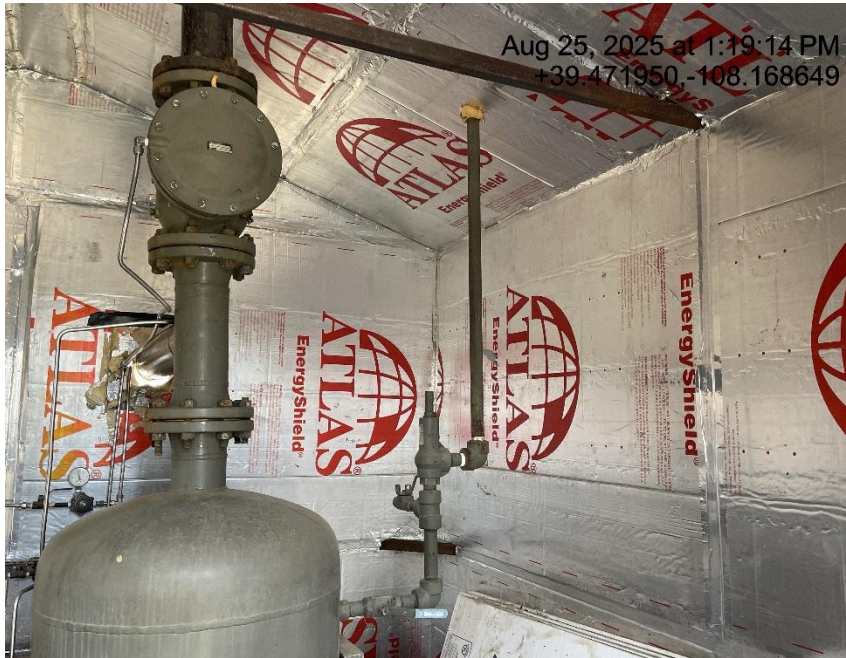
Photo # 3862 PRV vent line does not comply with CECMC pressure safety device rules

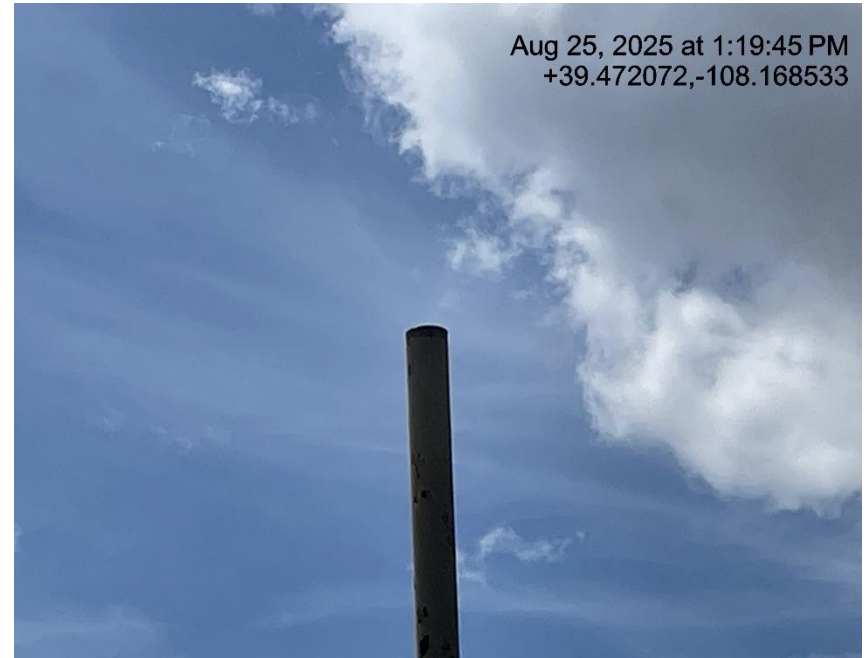
Photo # 3863 PRV vent line does not comply with CECMC pressure safety device rules

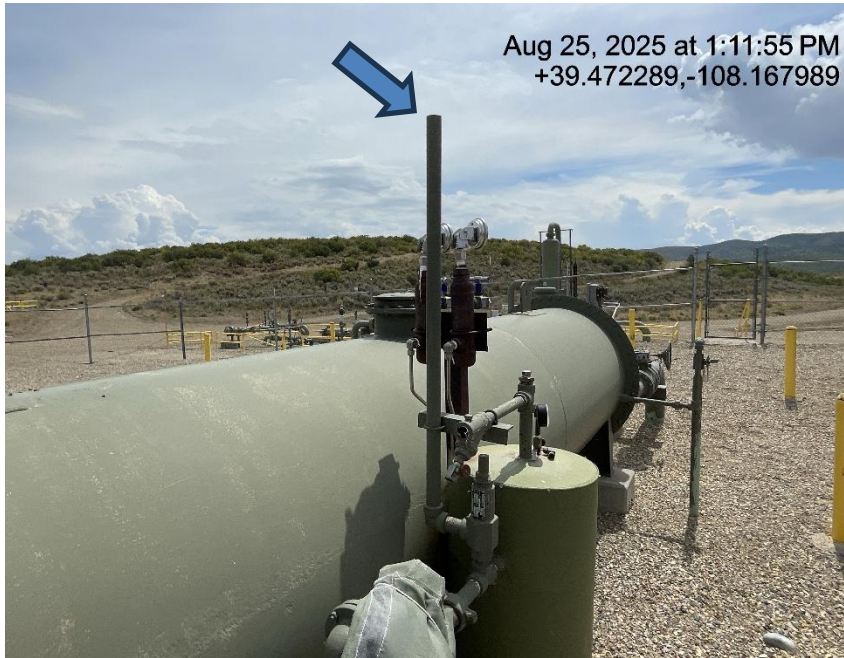
**Photo # 3864 PRV vent line does not comply with CECMC pressure safety device rules**

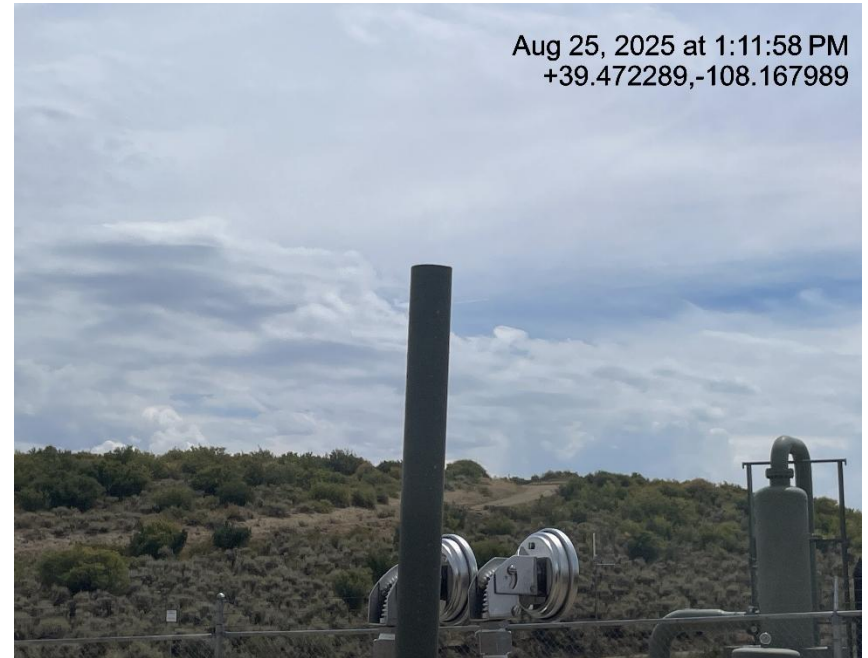
**Photo # 3865 PRV vent line does not comply with CECMC pressure safety device rules**

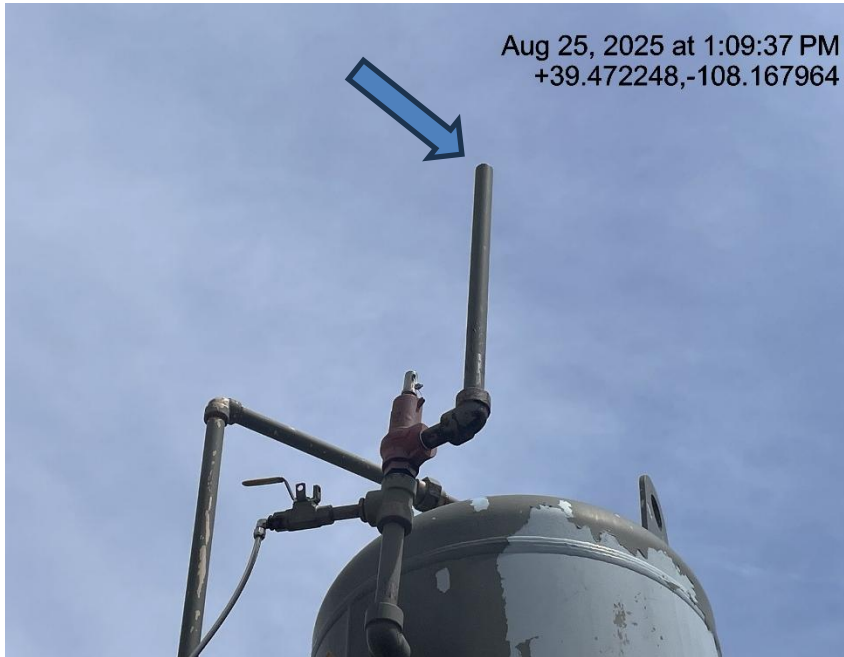
Photo # 3866 PRV vent line does not comply with CECMC pressure safety device rules

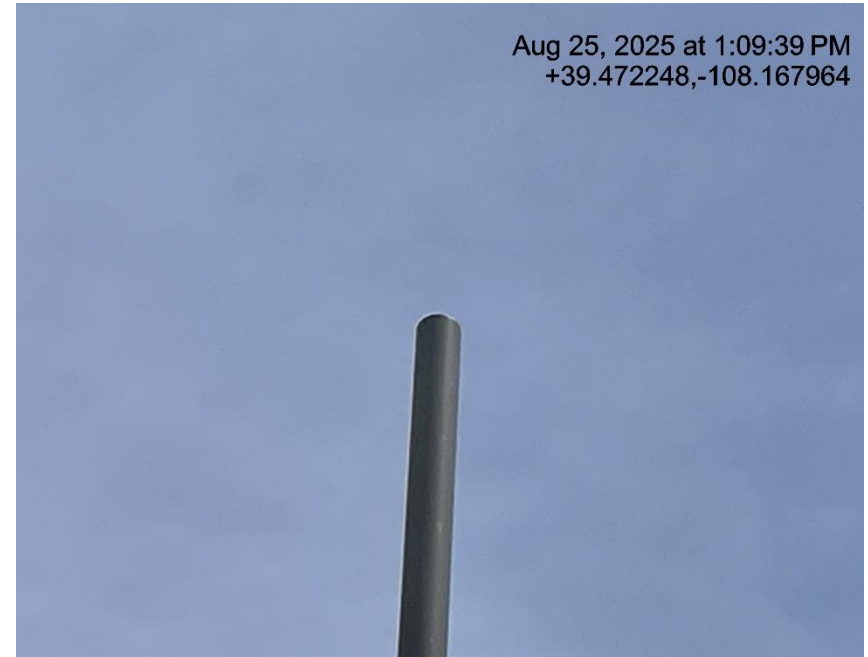
Photo # 3867 PRV vent line does not comply with CECMC pressure safety device rules

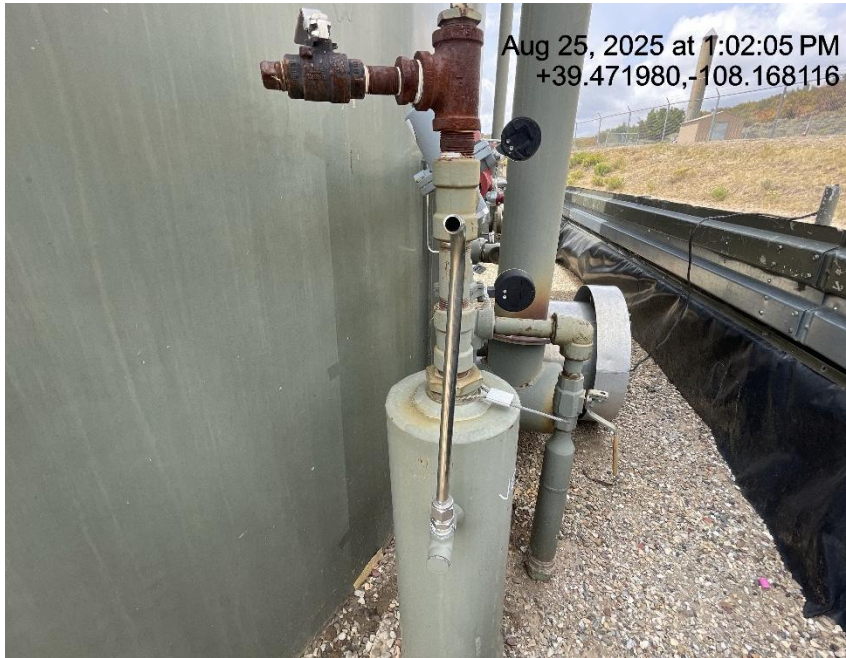
**Photo # 3868 PRV vent line does not comply with CECMC pressure safety device rules**

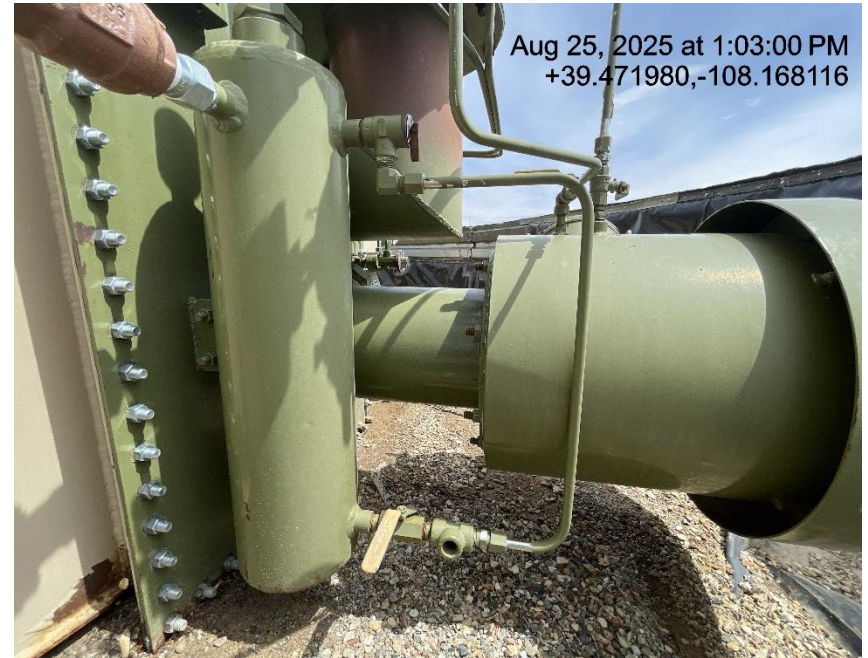
**Photo # 3869 PRV vent line does not comply with CECMC pressure safety device rules**

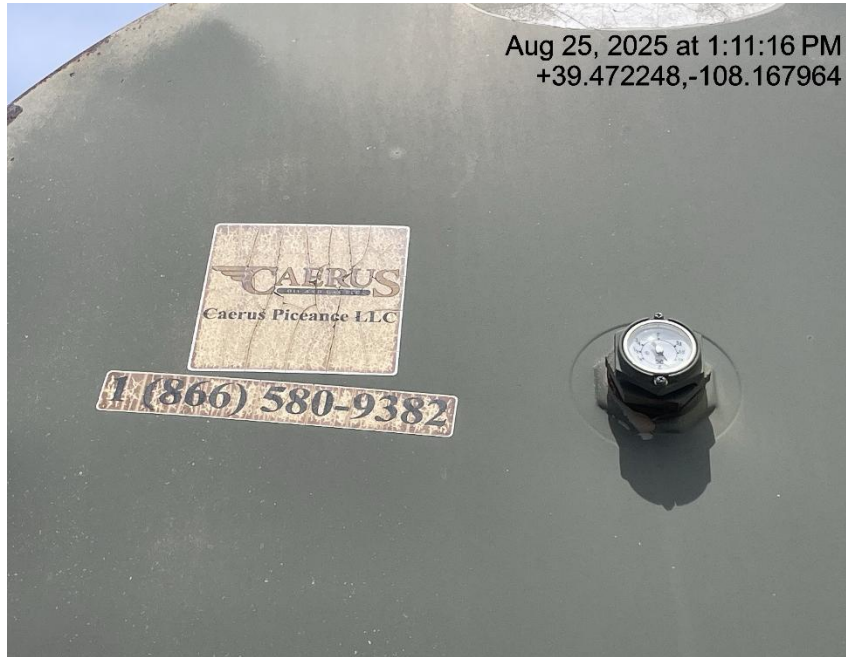
Photo # 3870 Tank label has previous operators name

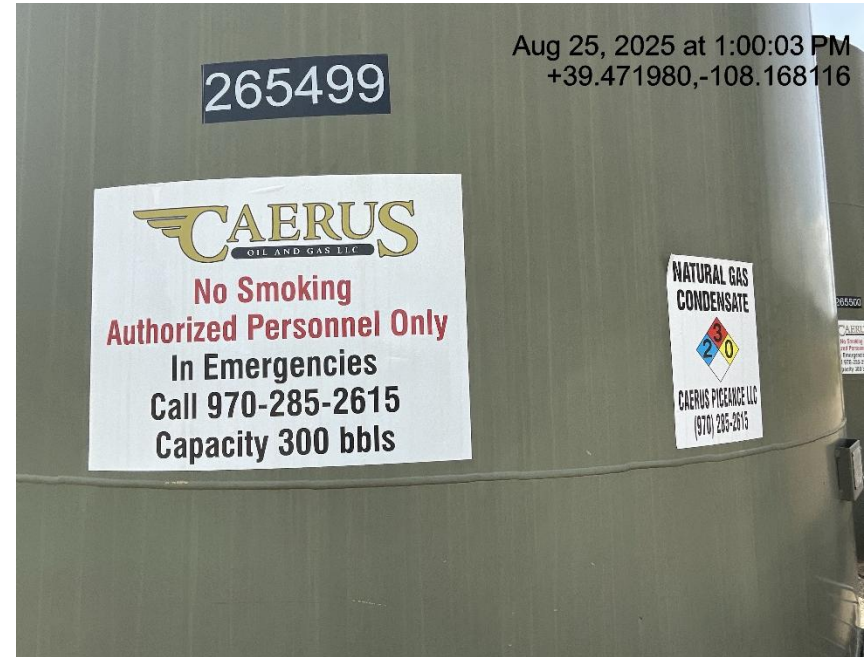
Photo # 3871 Tank label has previous operators name

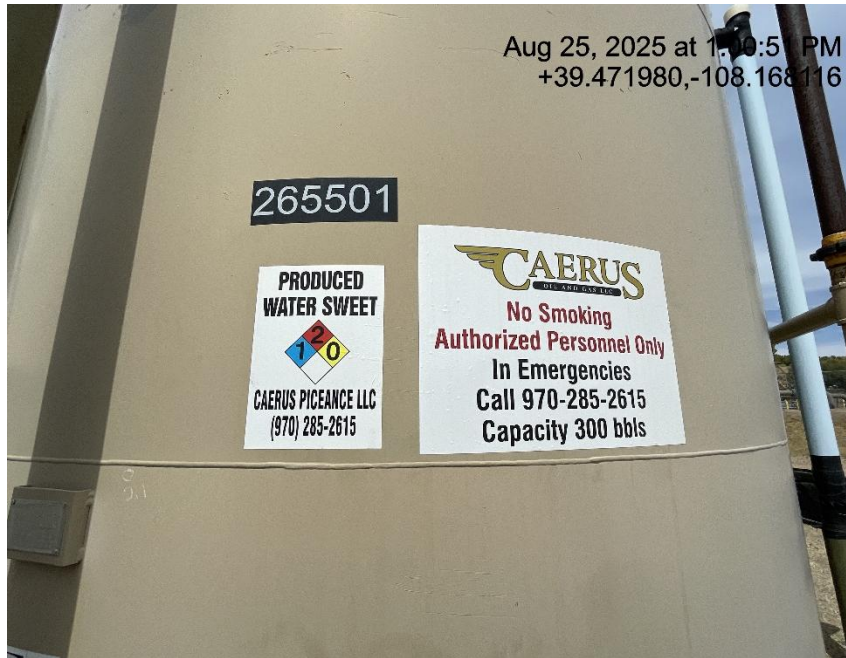
Photo # 3872 Tank label has previous operators name

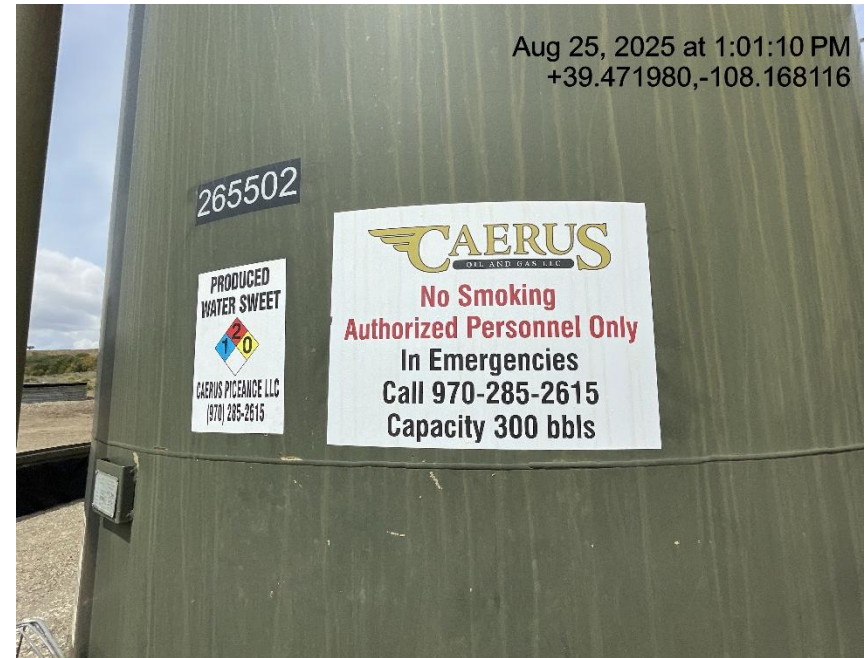
Photo # 3873 Tank label has previous operators name

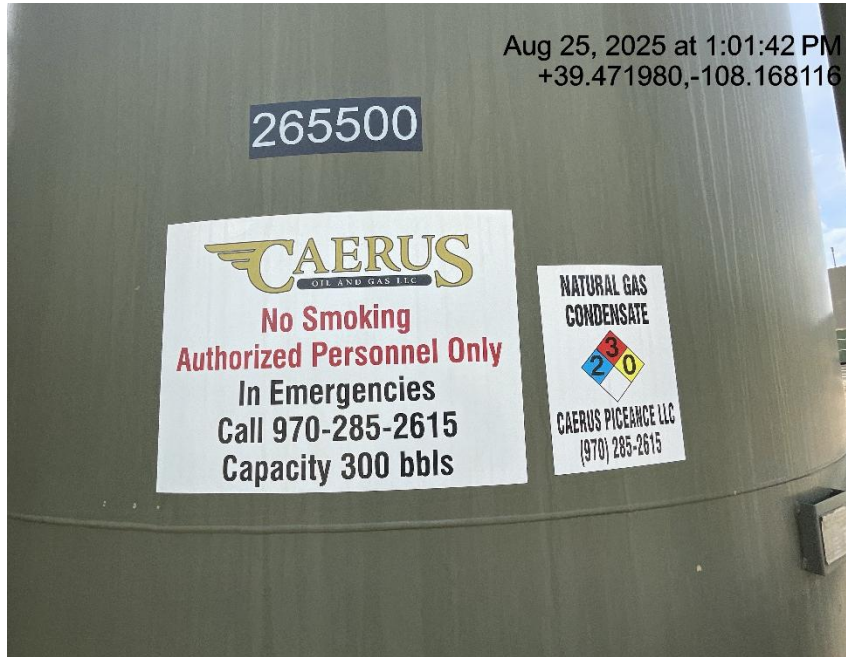
Photo # 3874 Tank label has previous operators name

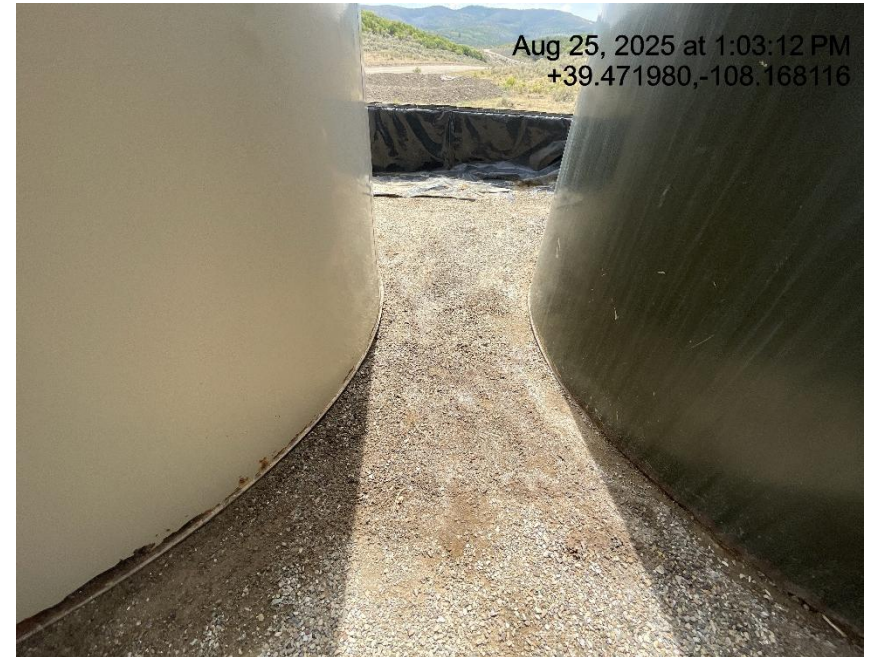
Photo # 3875 Staining in secondary containment
