Inspection/Audit Photos

Location Name: QB ENERGY OPERATING LLC CHEVRON E13 697

Location #: 311623

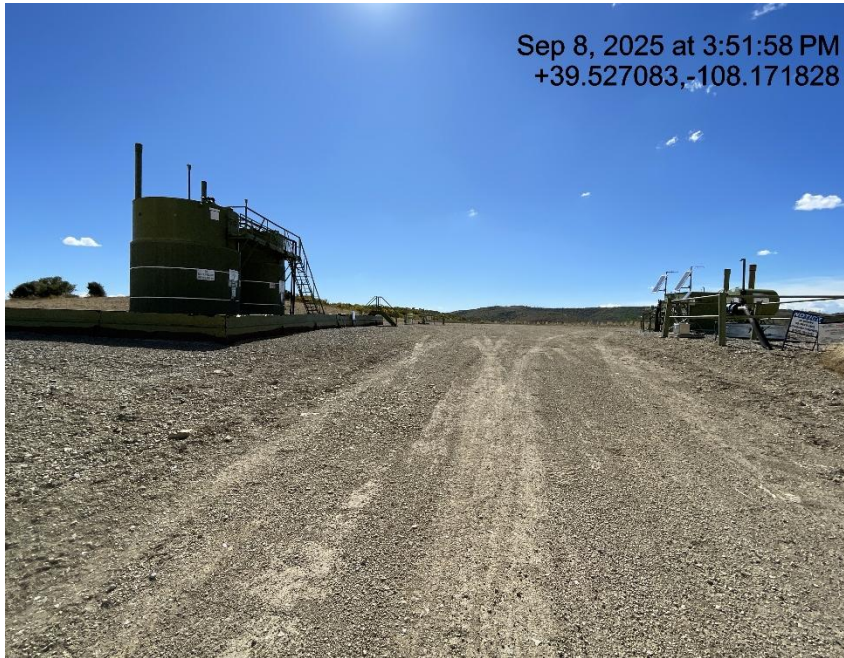
Photo # 6883 From entrance to location

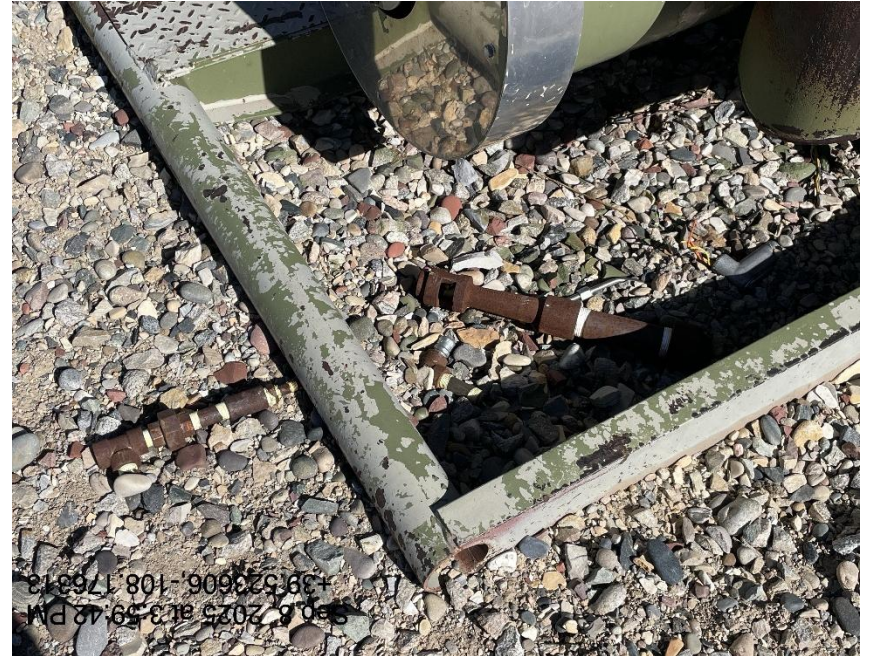
Photo # 6888 Debris

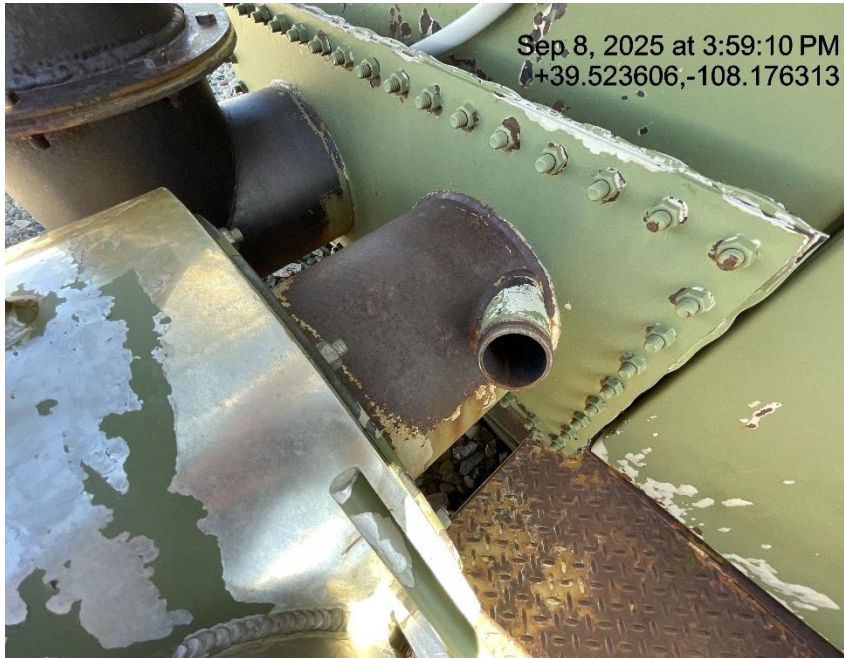
Photo # 6889 Open ended pipe on fire tube/wildlife hazard

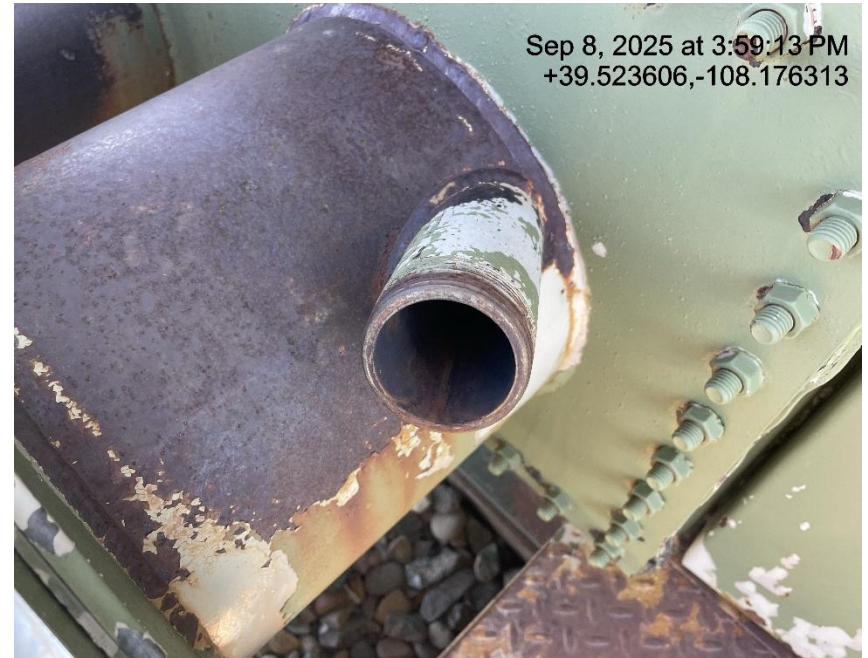
Photo # 6890 Open ended pipe on fire tube/wildlife hazard

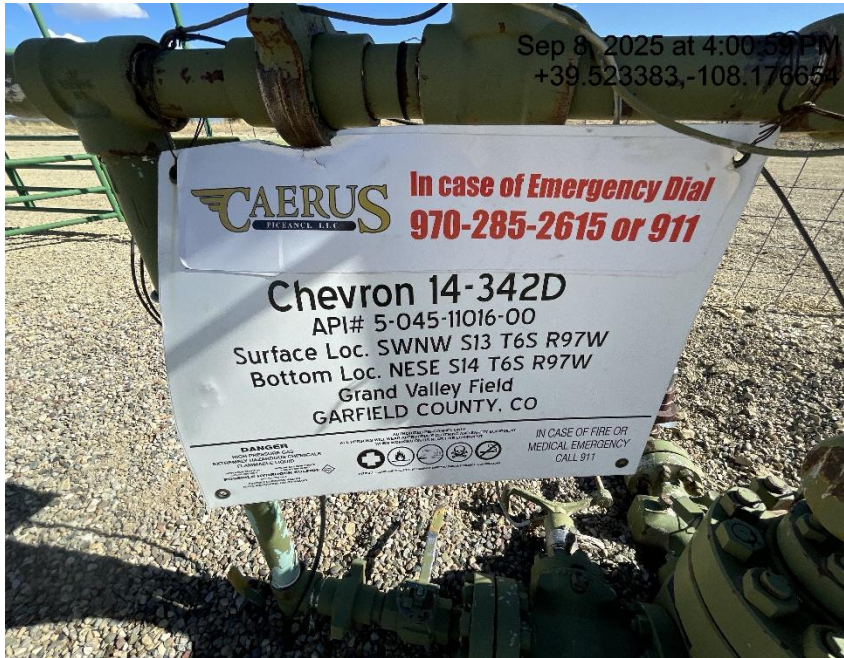
Photo # 6891 Wellhead sign has previous operators name

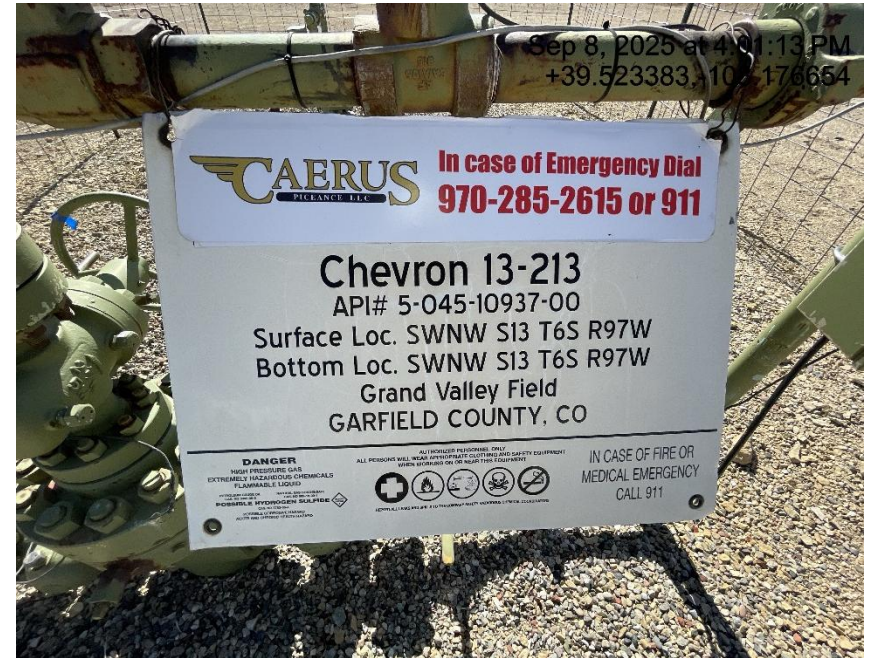
Photo # 6892 Wellhead sign has previous operators name

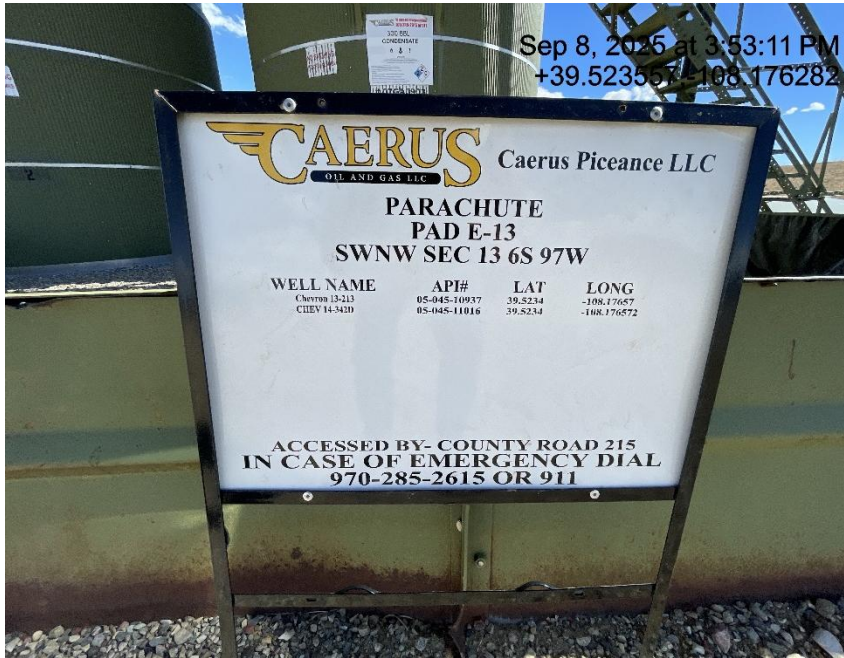
Photo # 6893 Battery sign has previous operators name

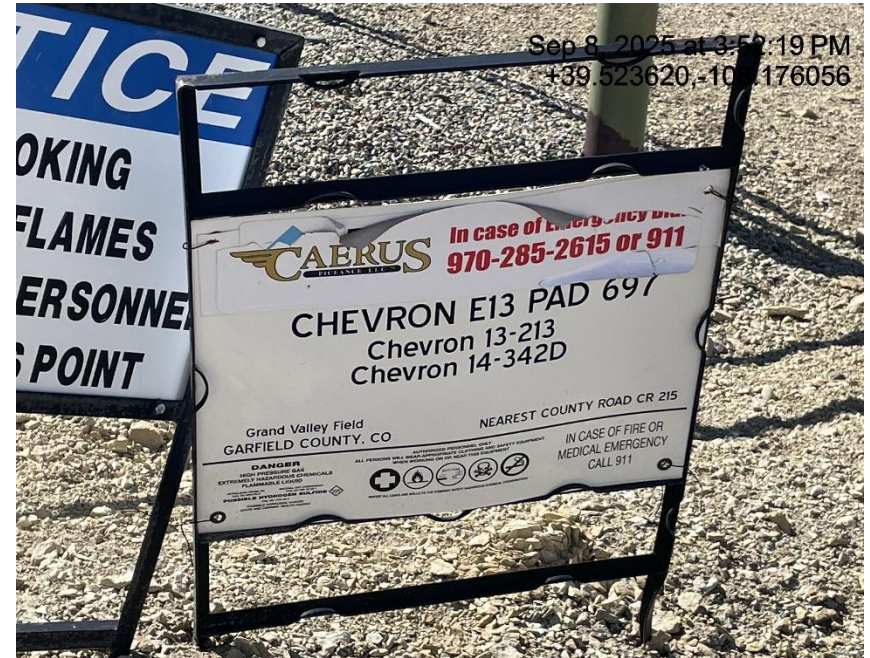
Photo # 6894 Sign at entrance to location has previous operators name

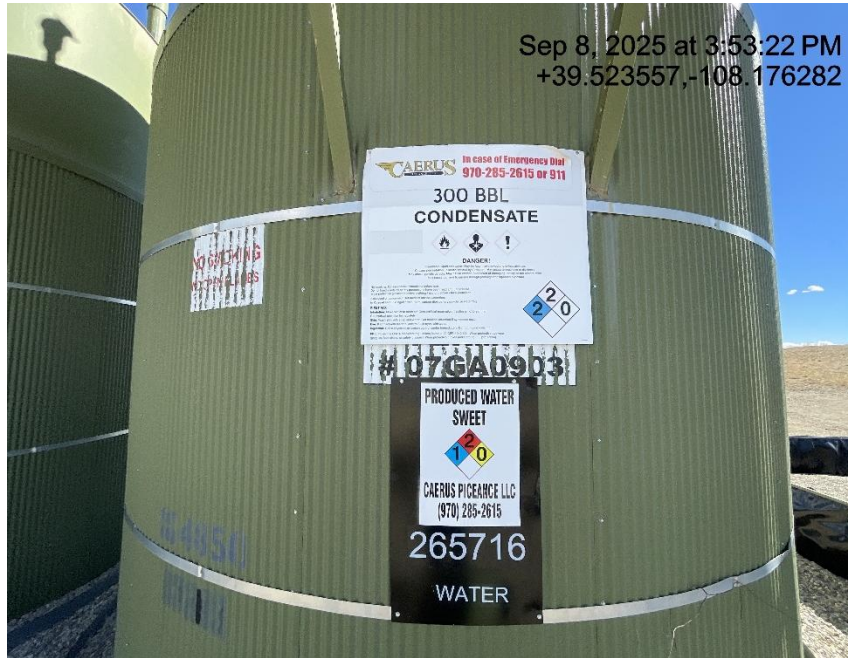
Photo # 6895 Tank labels have previous operators name

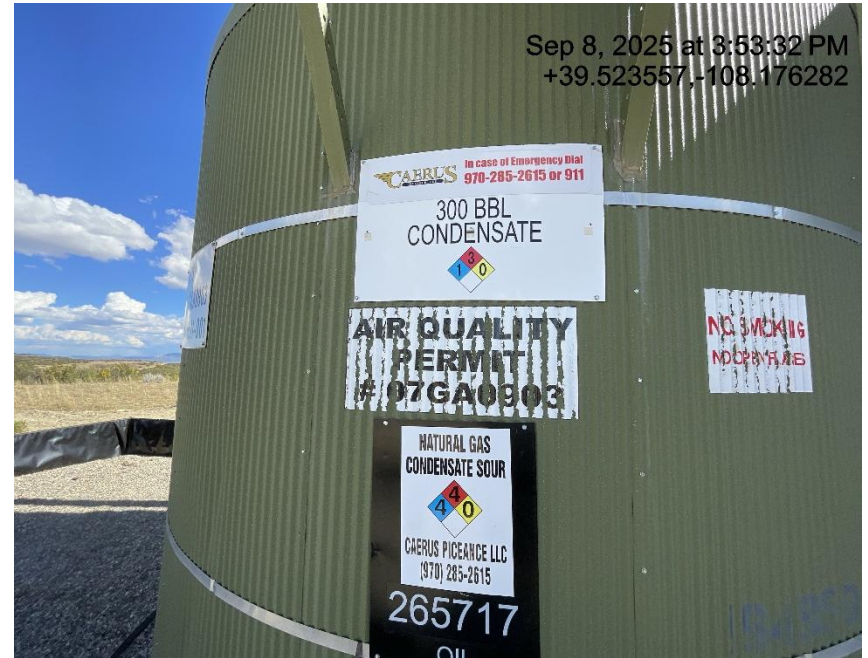
Photo # 6896 Tank labels have previous operators name

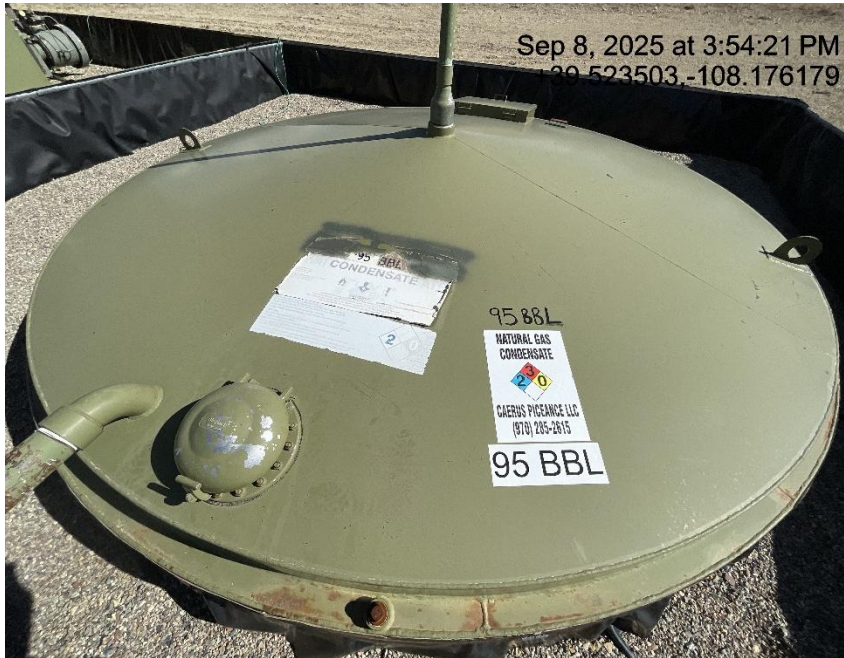
Photo # 6897 Tank label has previous operators name

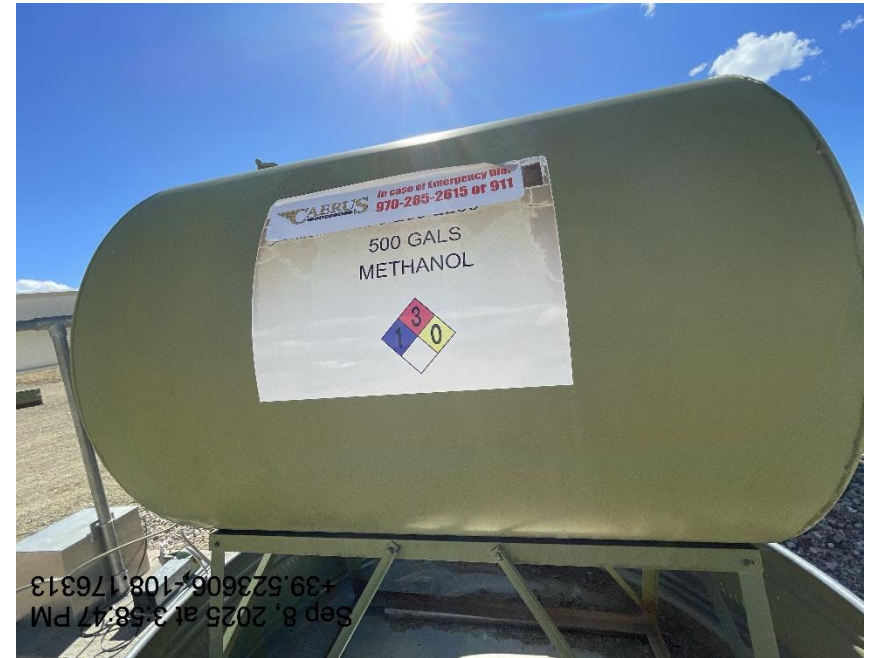
Photo # 6898 Tank label has previous operators name

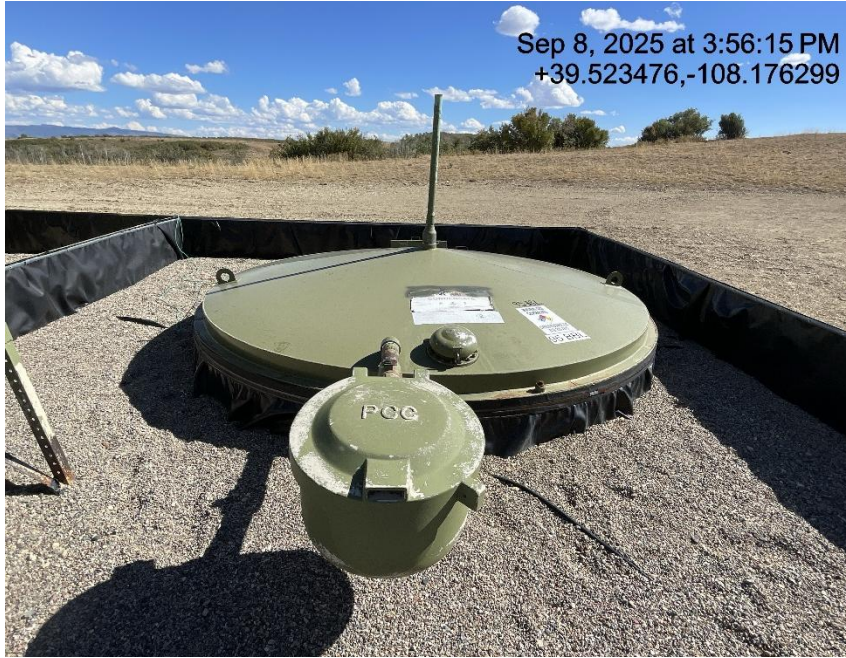
Photo # 6899 Unused equipment

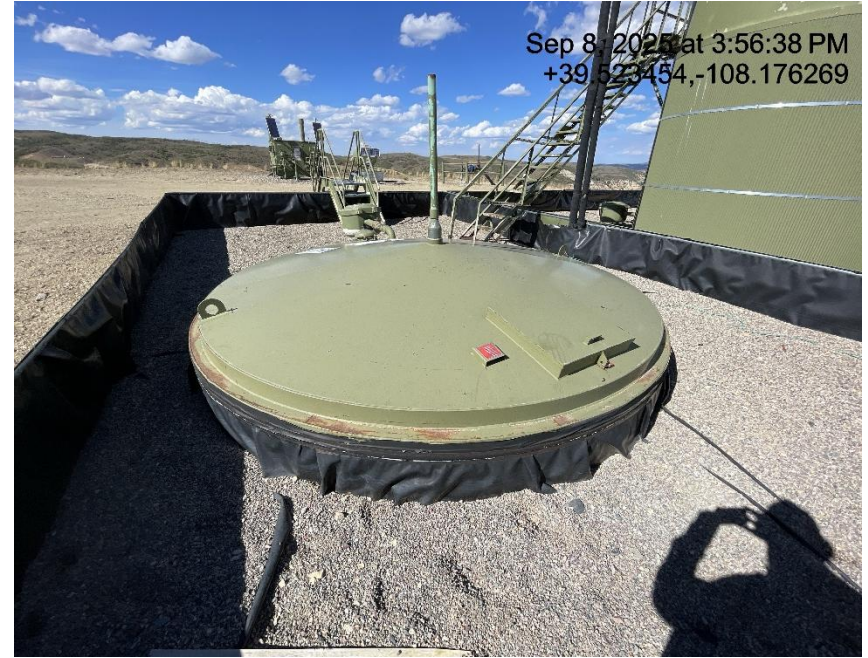
Photo # 6900 Unused equipment

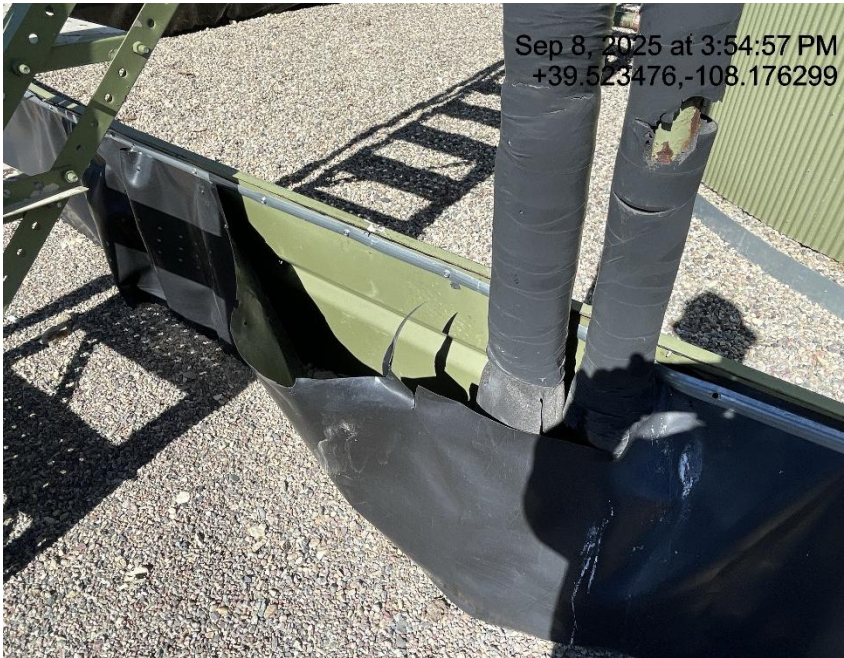
Photo # 6901 Secondary containment liner damaged/needs maintenance
