Inspection Photos
Location Name: Hein 2
Location ID: 332959

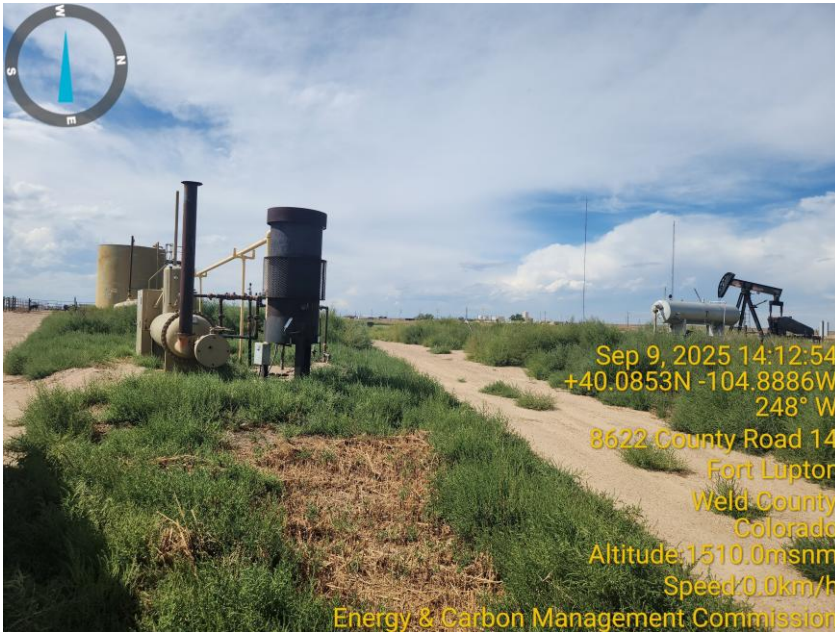
Photo 1 Location has overgrown vegetation throughout.

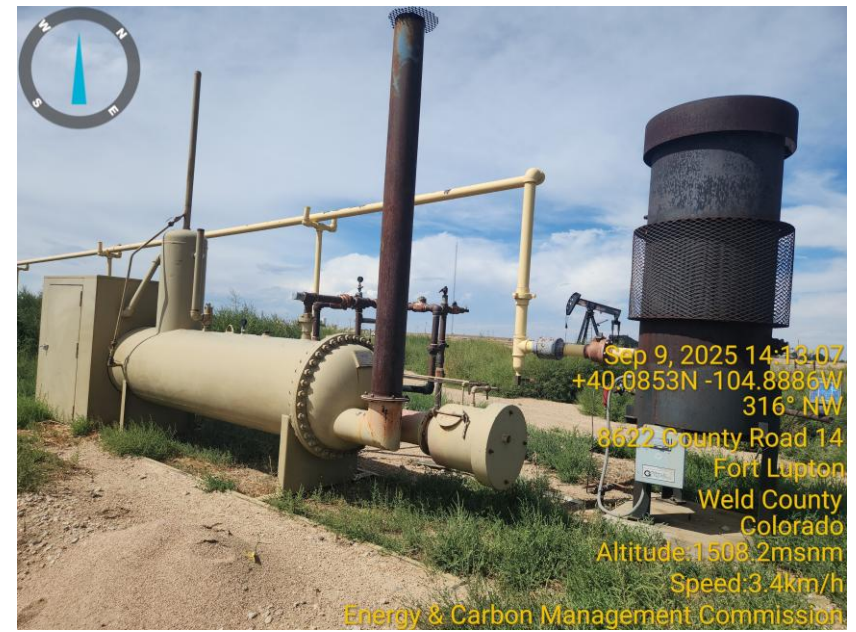
Photo 2 ECD, Horizontal Heated Separator.

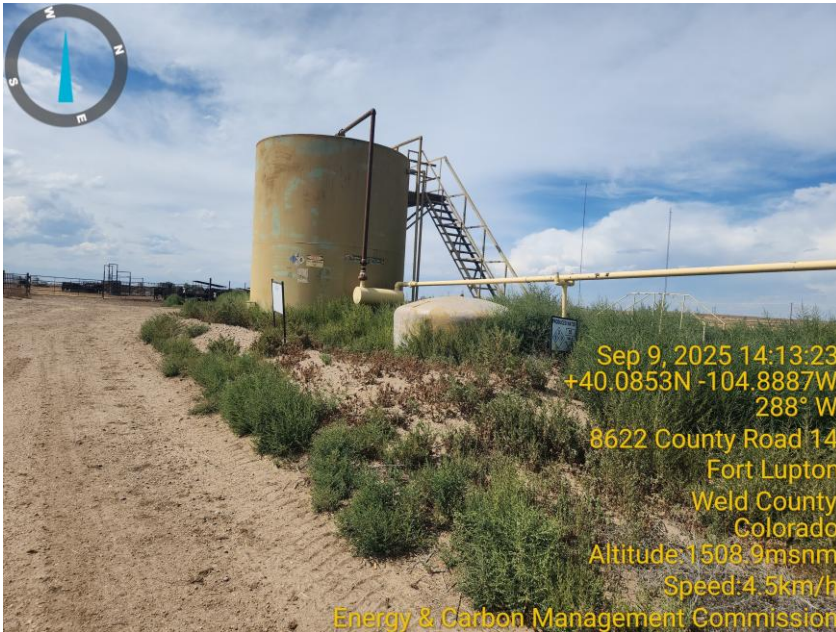
Photo 3 Tank Battery is overrun with vegetation .

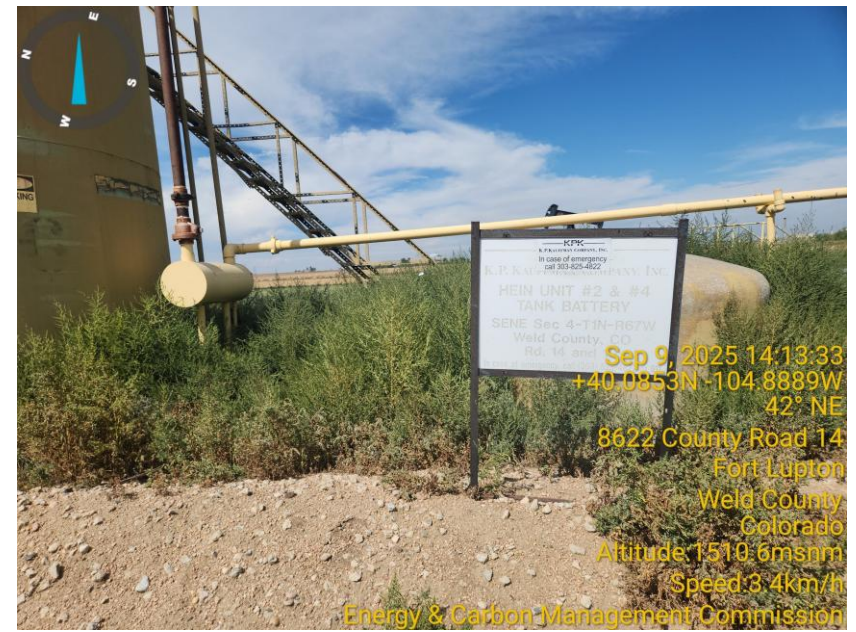
Photo 4 Tank Battery sign.

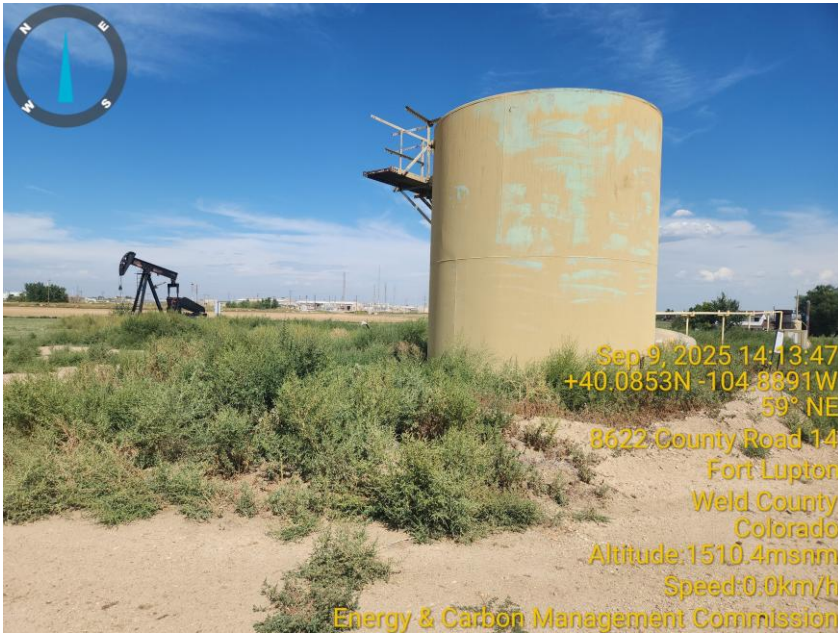
Photo 5 Tank Battery is overrun with vegetation .

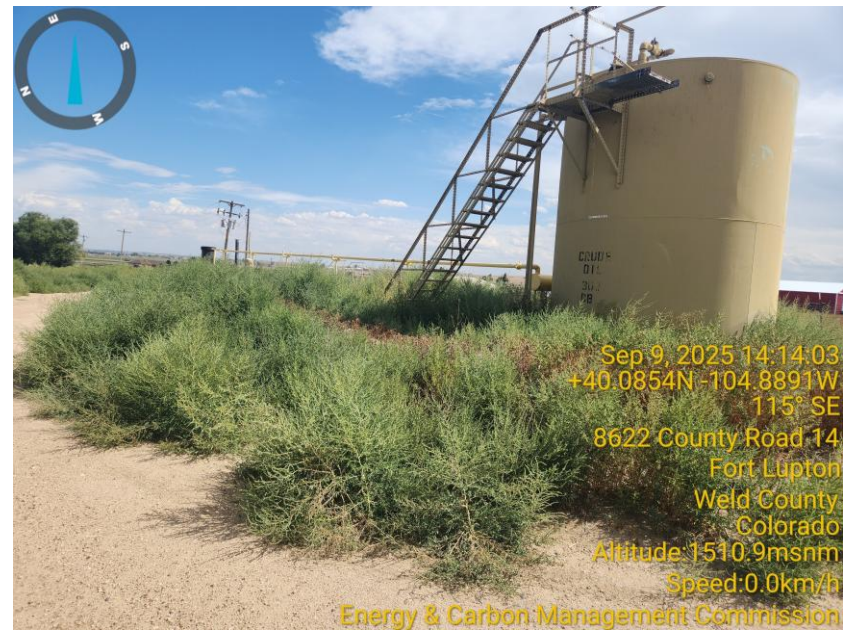
Photo 6 Tank Battery is overrun with vegetation ..

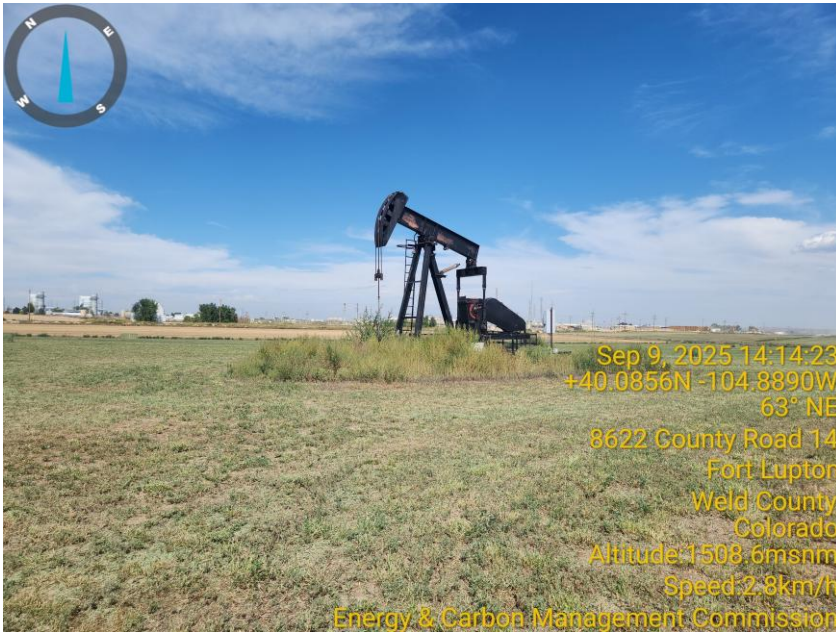
Photo 7 Wellsite is overrun with vegetation .

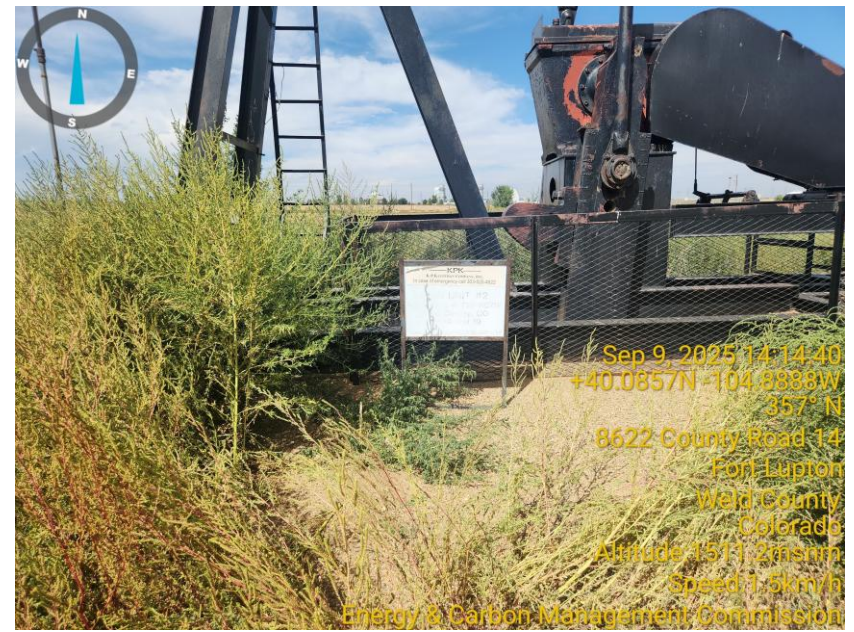
Photo 8 Wellsite sign.

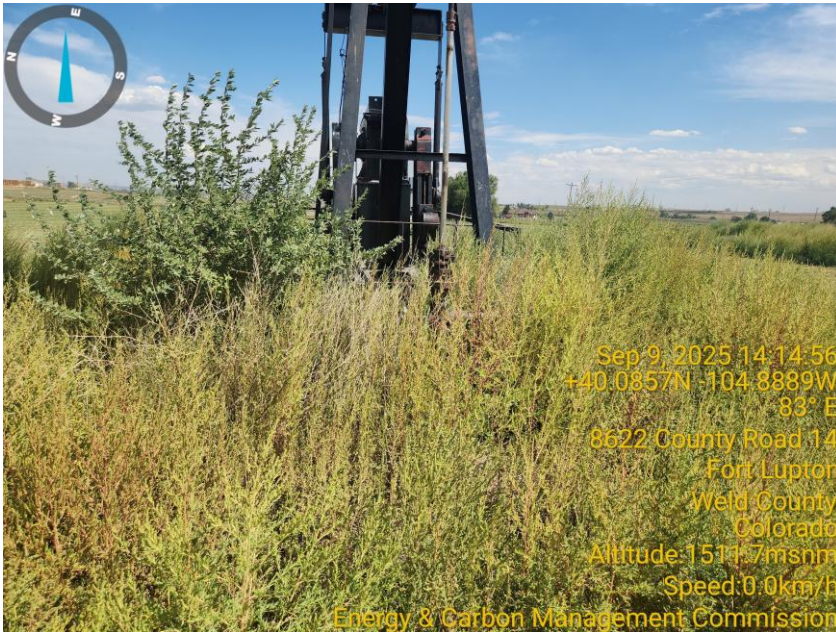
Photo 9 Wellhead is overrun with vegetation .

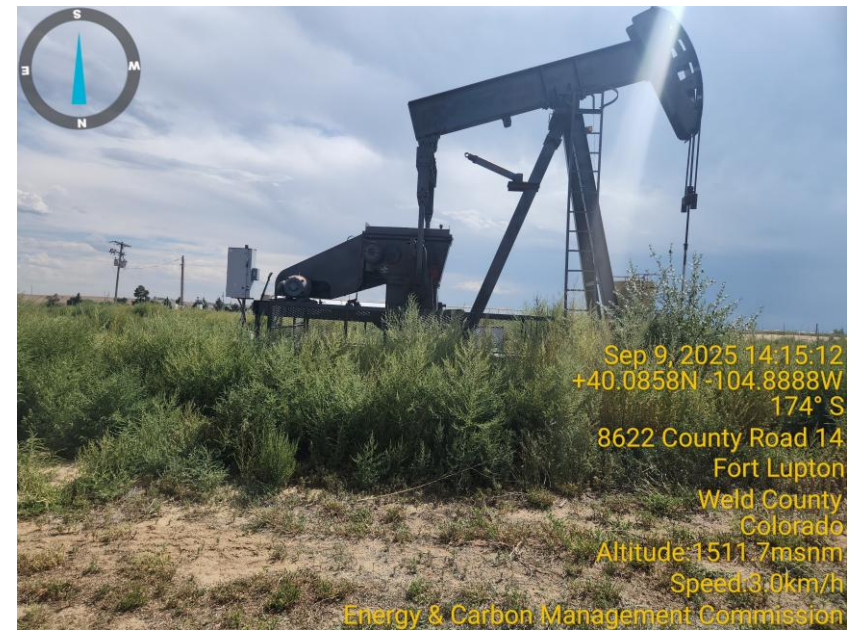
Photo 10 Wellsite is overrun with vegetation.

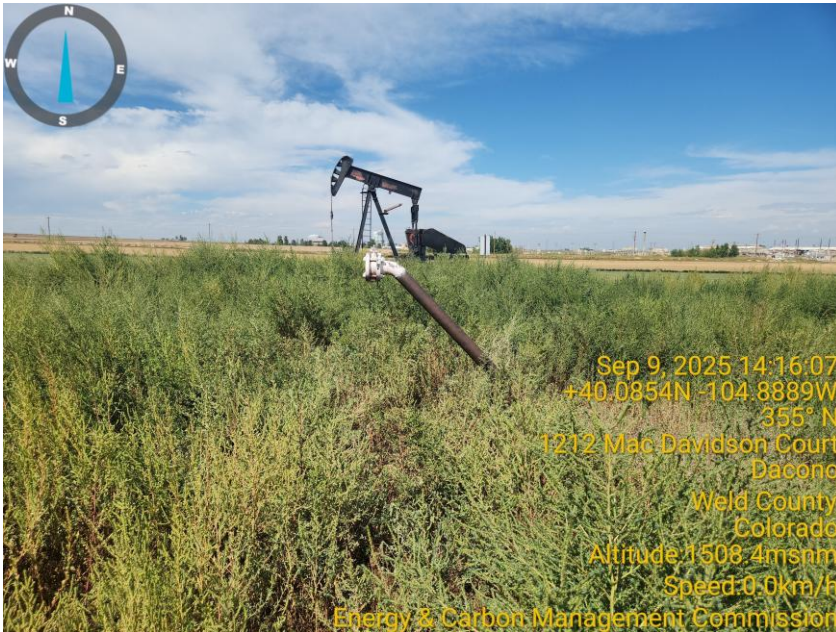
Photo 11 Unmarked flow line is overrun with vegetation.

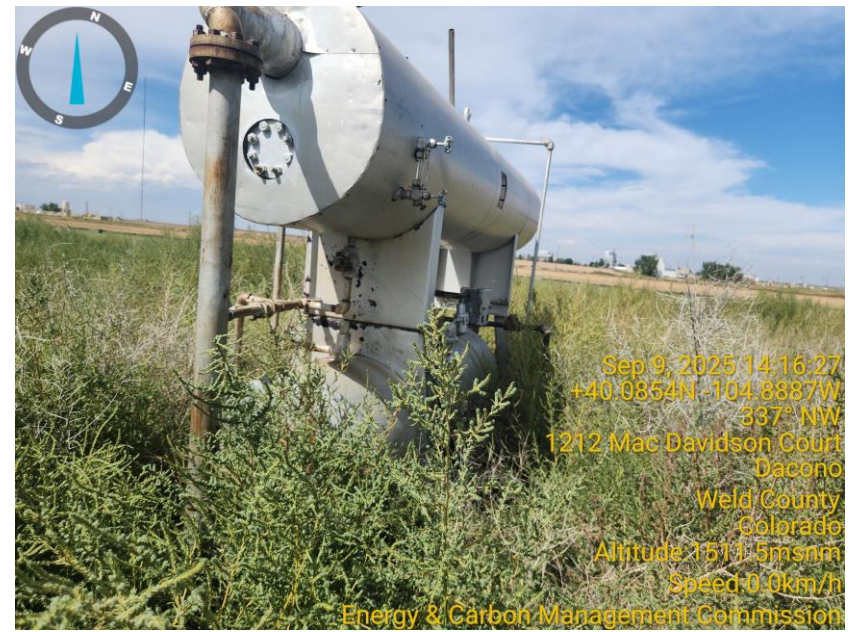
Photo 12 Horizontal separator is overrun with vegetation.

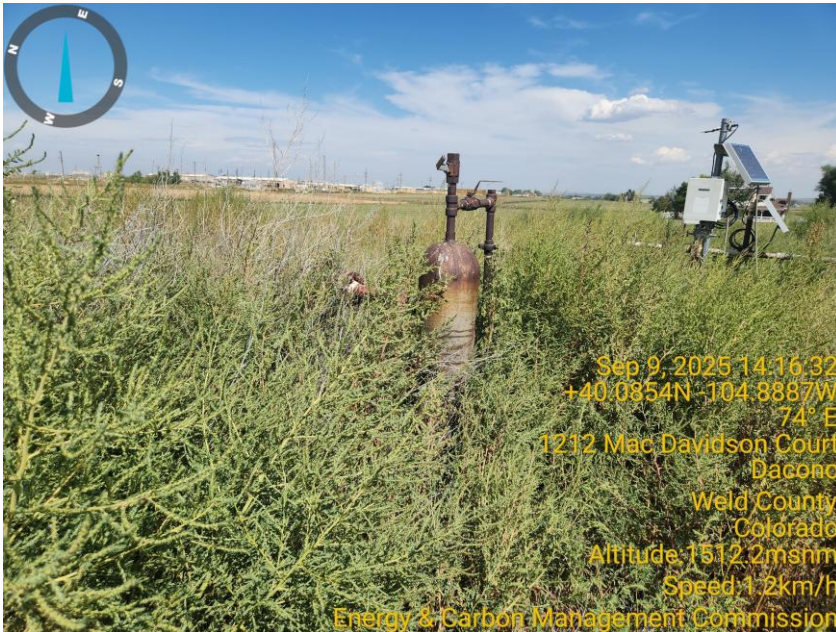
Photo 13 vertical separator is overrun with vegetation.

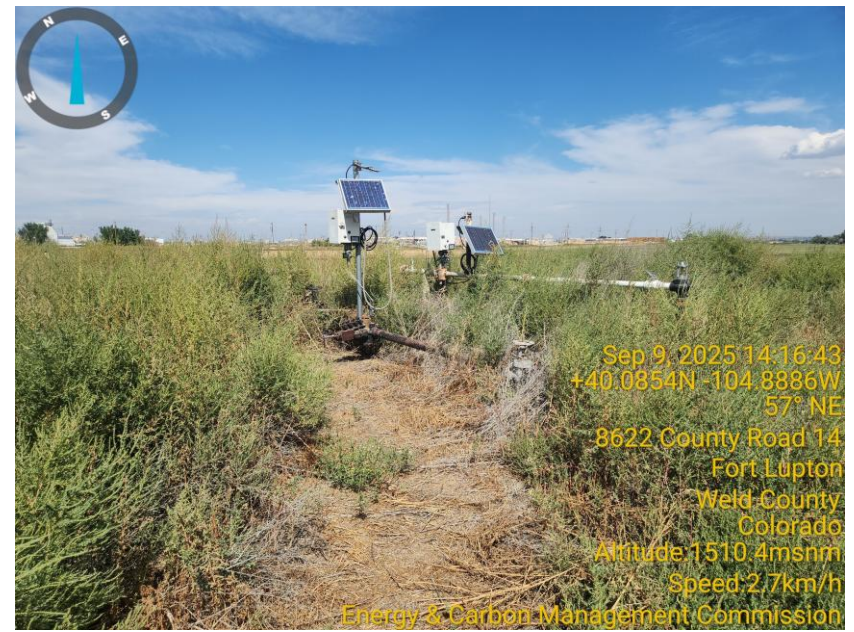
Photo 14 Gas Meter Run is overrun with vegetation.
