Inspection/Audit Photos

Location Name: QB ENERGY OPERATING LLC CHEVRON I01 697

Location #: 335693

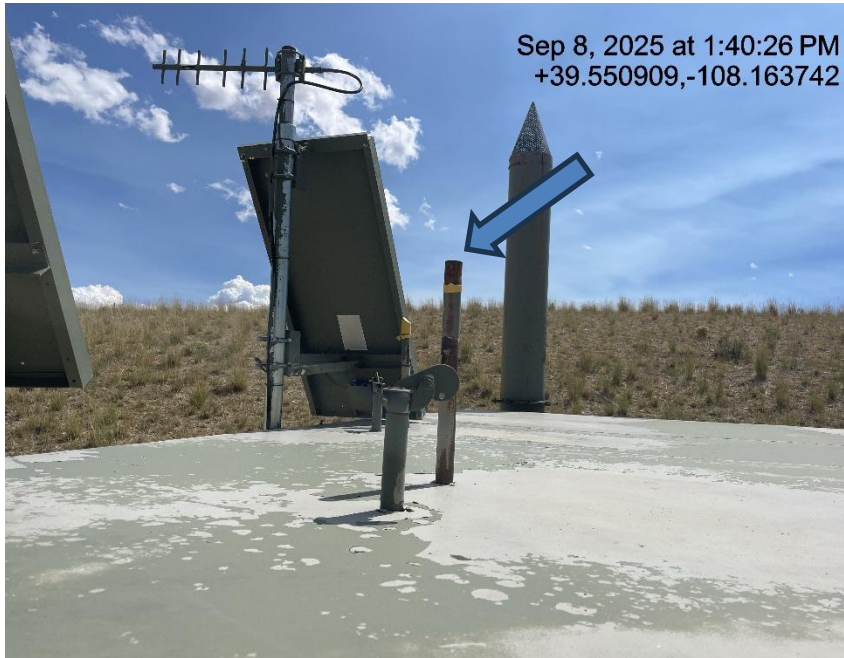
Photo # 6638 PRV vent line does not comply with CECMC pressure safety device rules

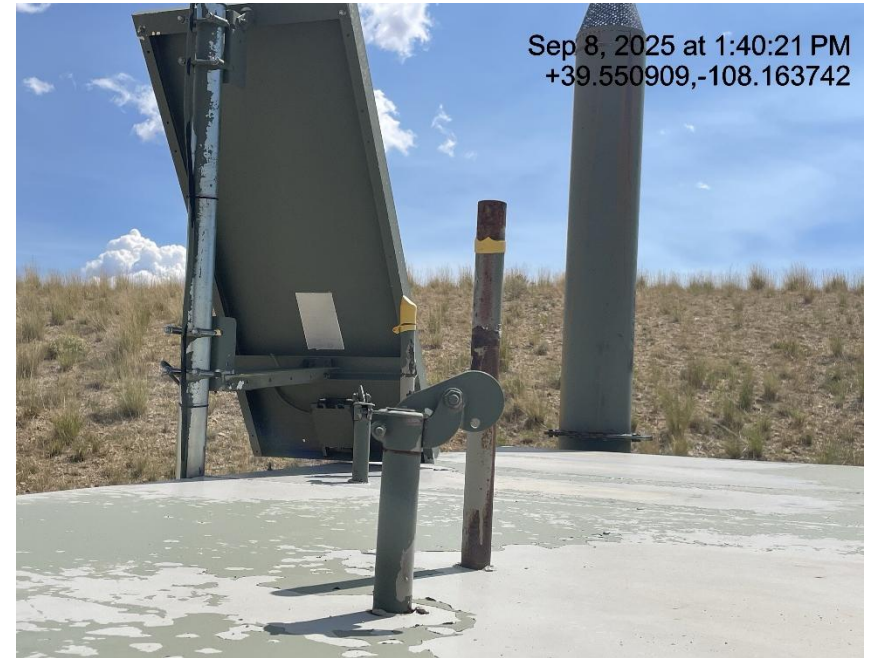
Photo # 6639 PRV vent line does not comply with CECMC pressure safety device rules

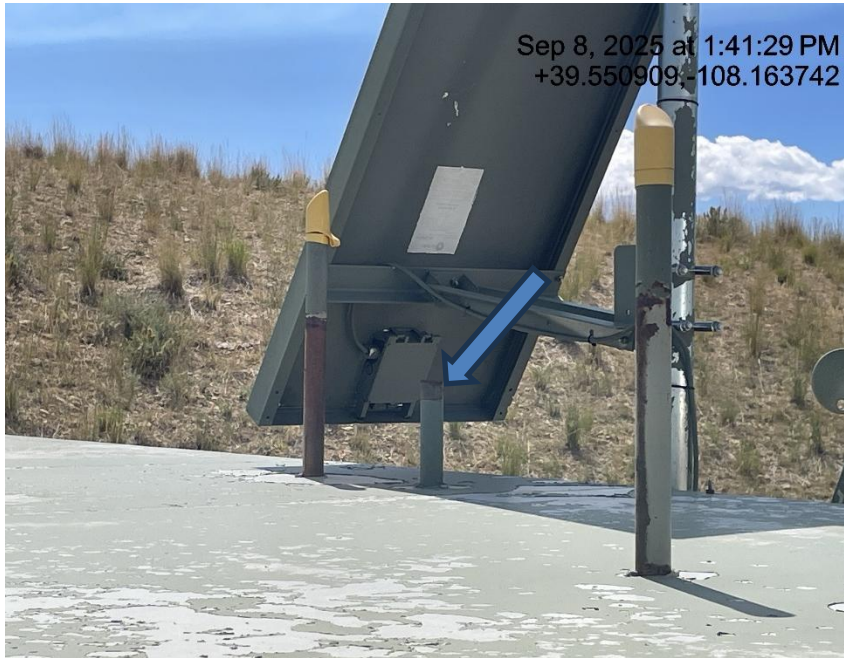
Photo # 6640 Rupture disc vent line does not comply with CECMC pressure safety device rules

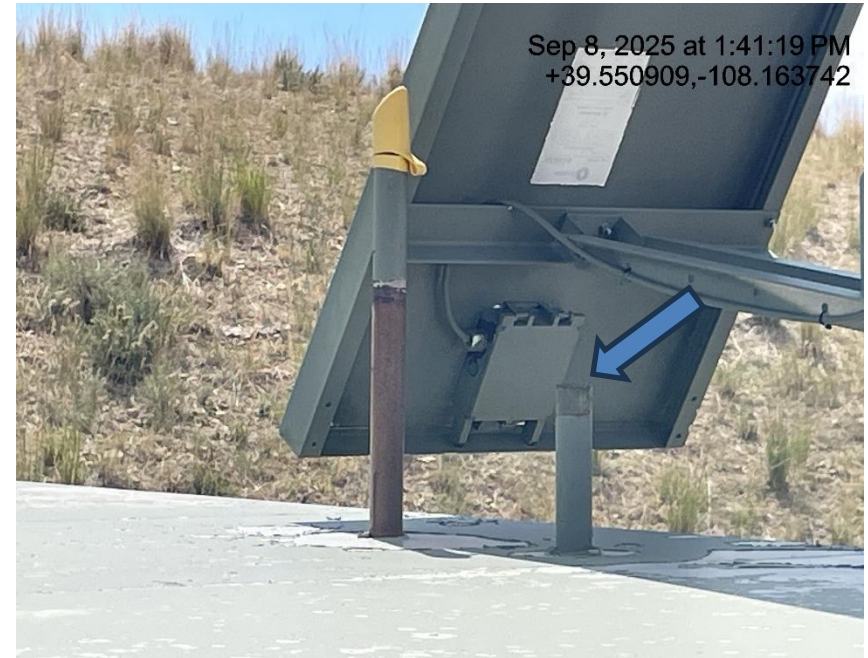
Photo # 6641 Rupture disc vent line does not comply with CECMC pressure safety device rules

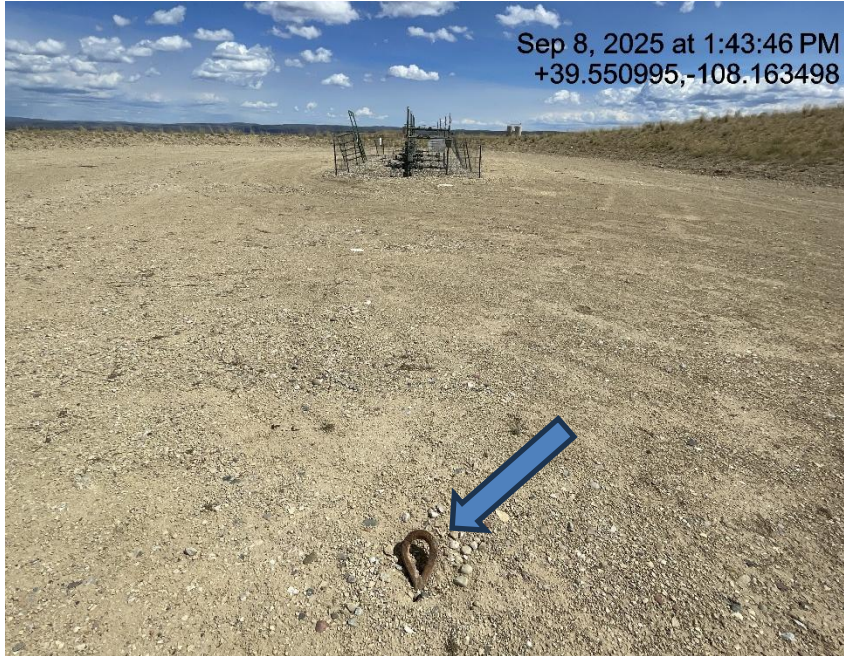
Photo # 6642 Unmarked deadman

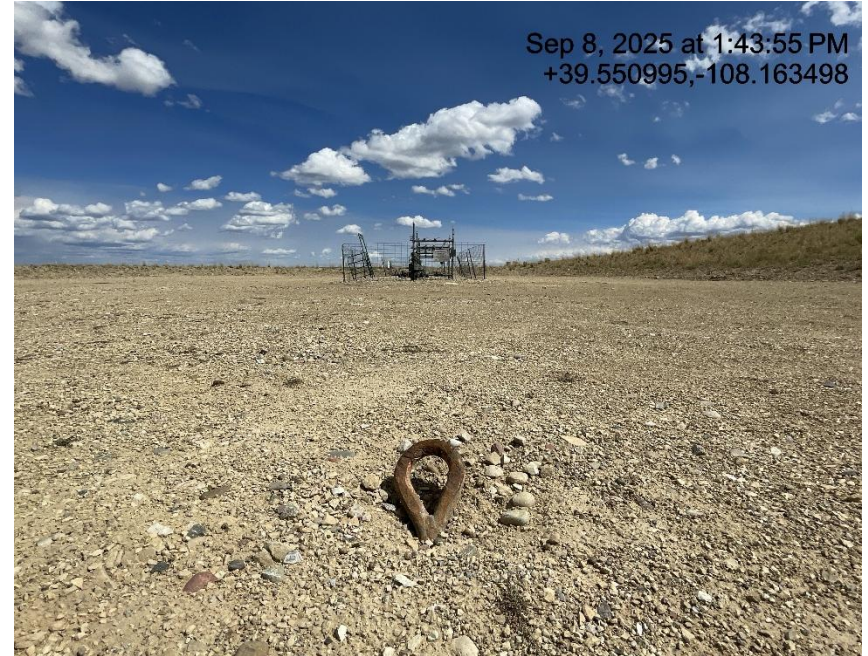
Photo # 6643 Same unmarked deadman

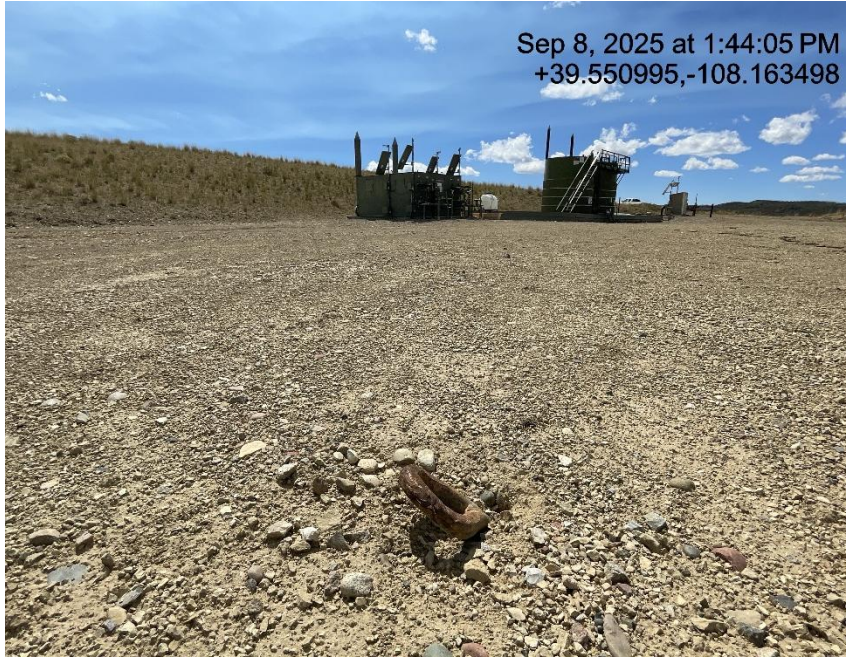
Photo # 6644 Same unmarked deadman

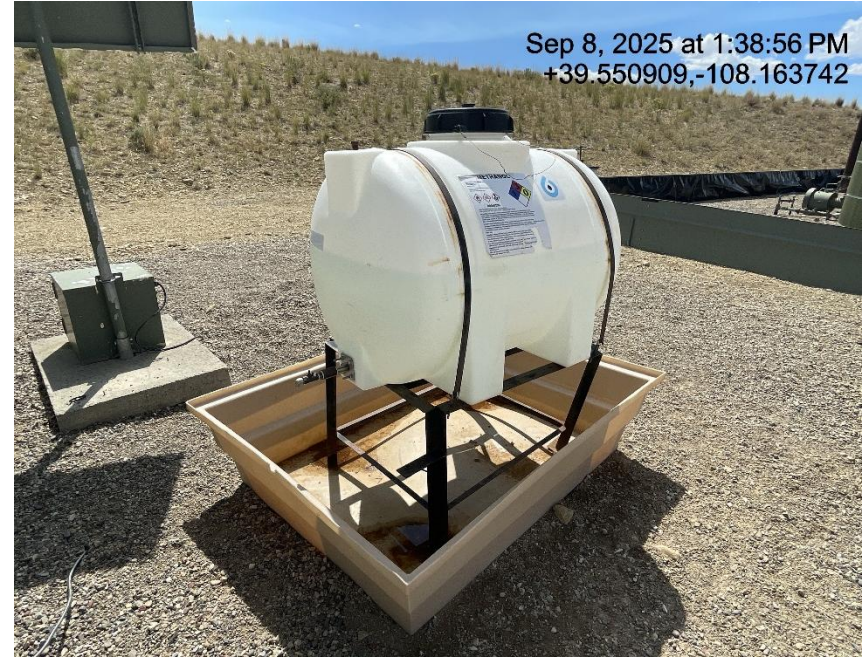
Photo # 6645 Unused equipment

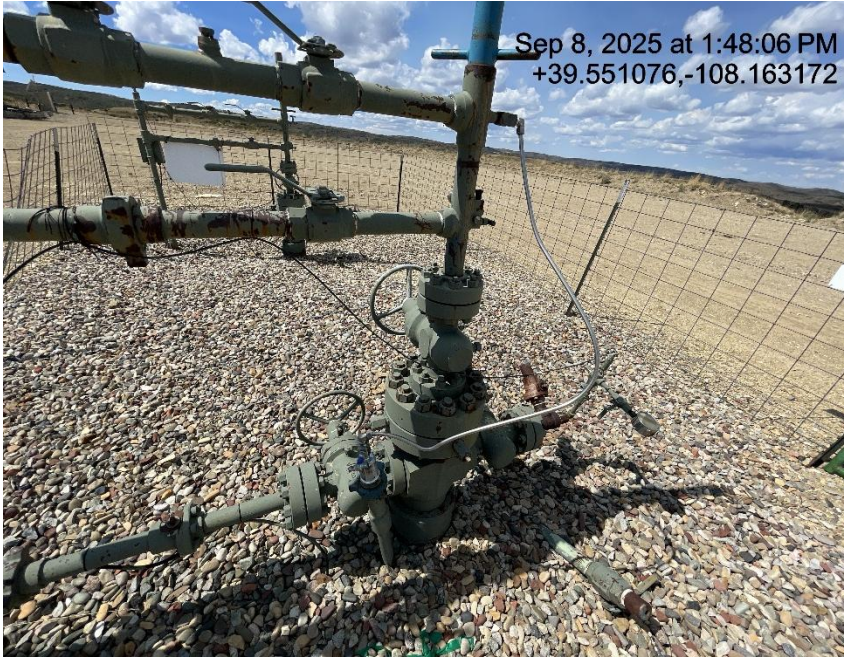
Photo # 6646 CHEVRON 275-1 BH line tied into flowline/no FORM 4 SUNDRY & no check valve

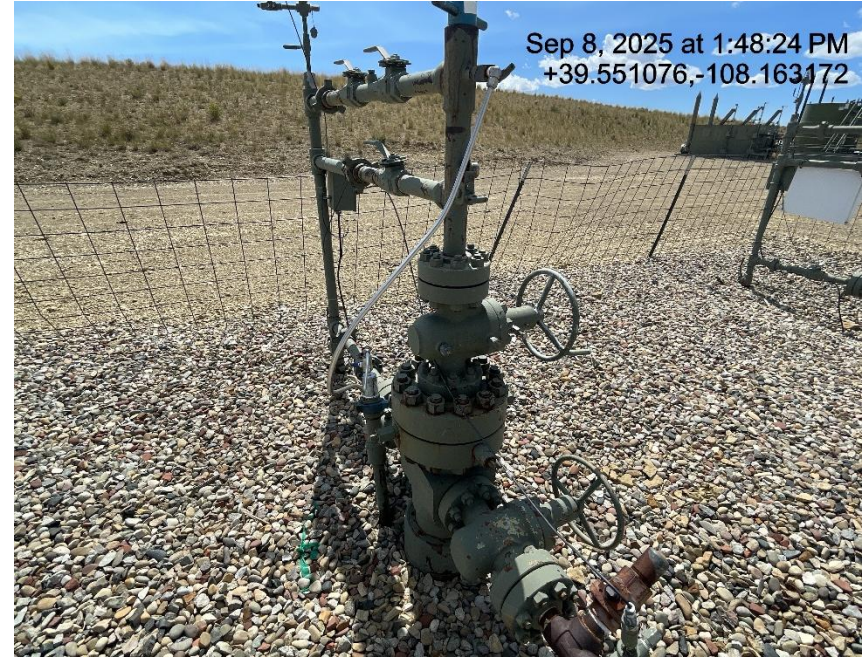
Photo # 6647 CHEVRON 275-1 BH line tied into flowline/no FORM 4 SUNDRY & no check valve

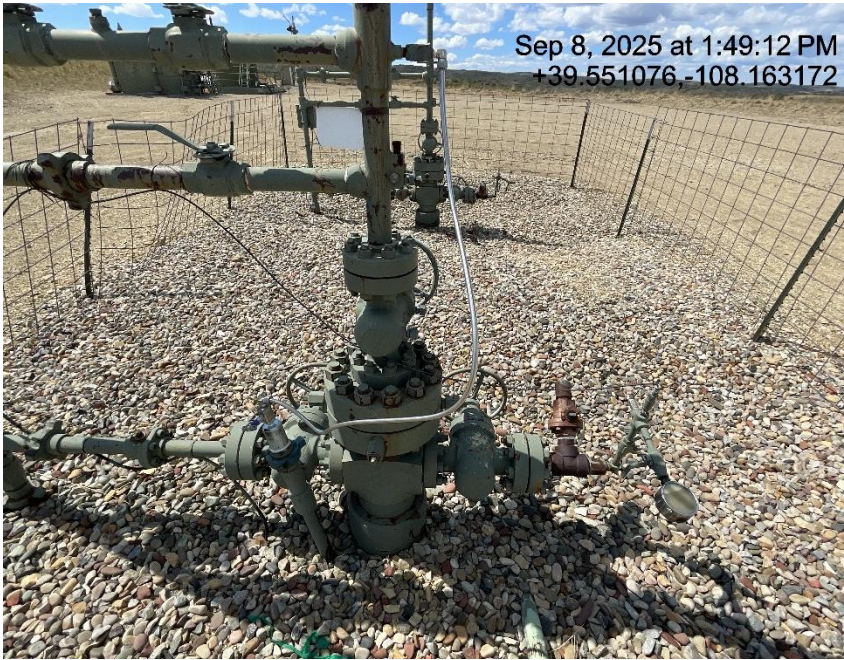
Photo # 6648 CHEVRON 275-1 BH line tied into flowline/no FORM 4 SUNDRY & no check valve

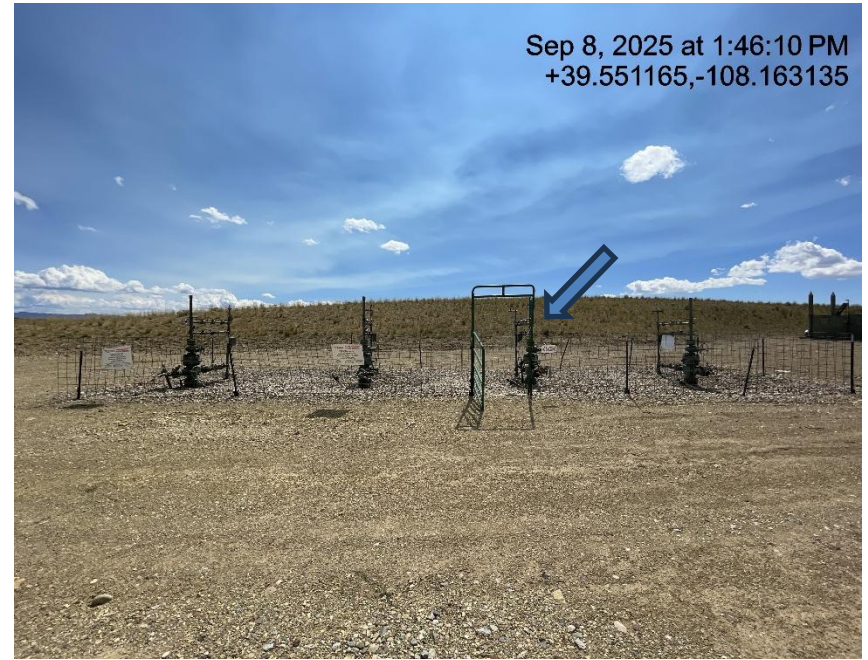
Photo # 6649 CHEVRON 275-1 well lacks required signage

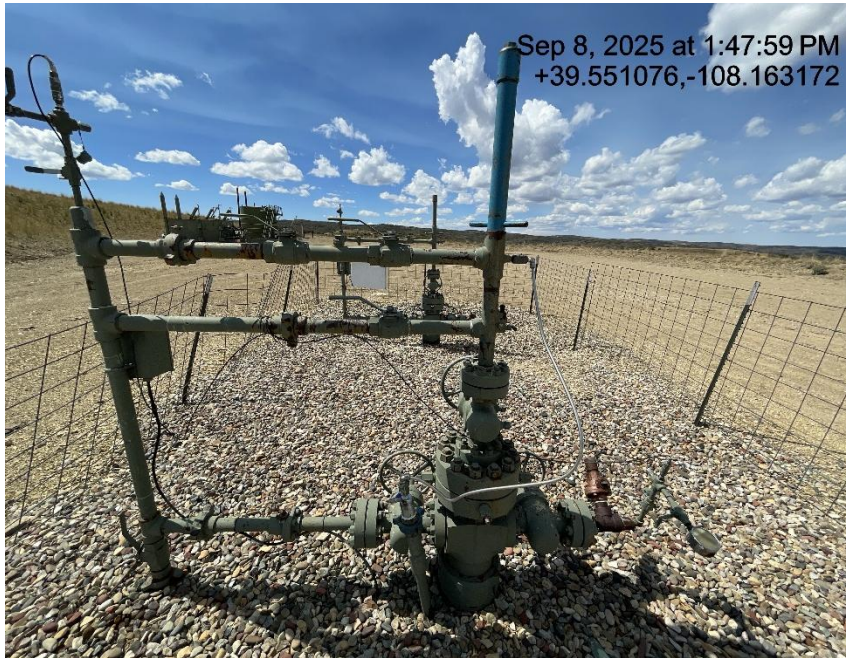
Photo # 6650 CHEVRON 275-1 well lacks required signage

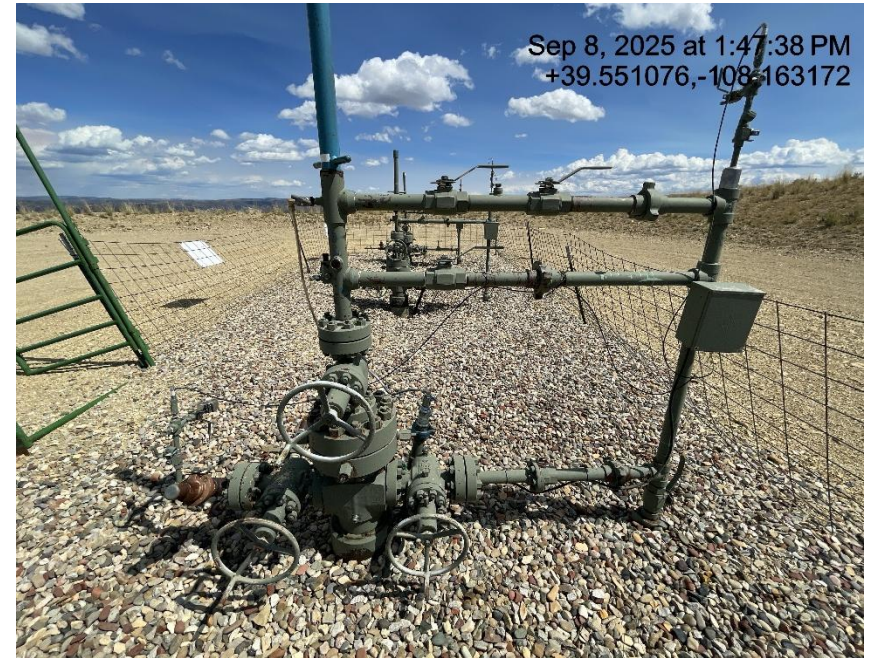
Photo # 6651 CHEVRON 275-1 well lacks required signage

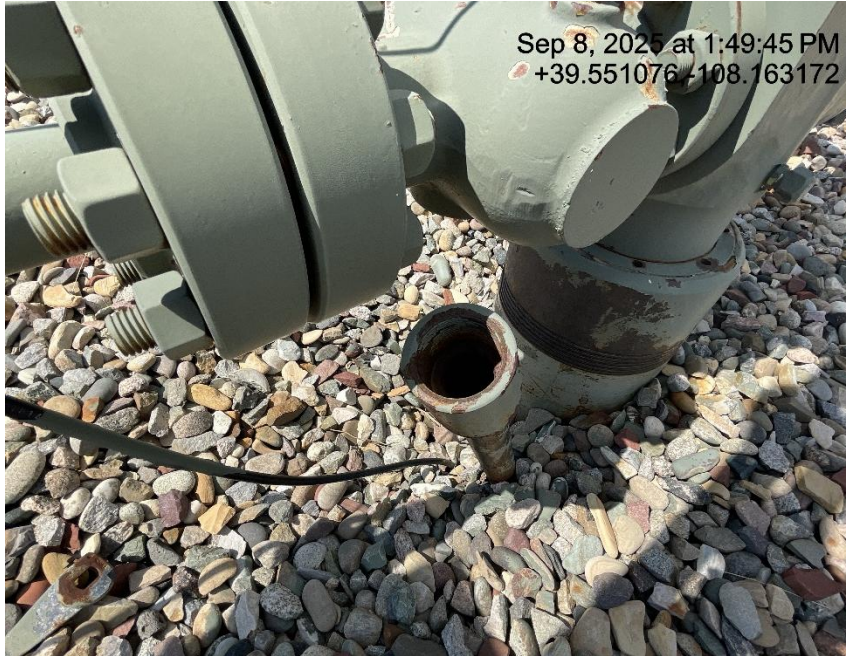
Photo # 6652 Open ended piping near wellhead/wildlife hazard

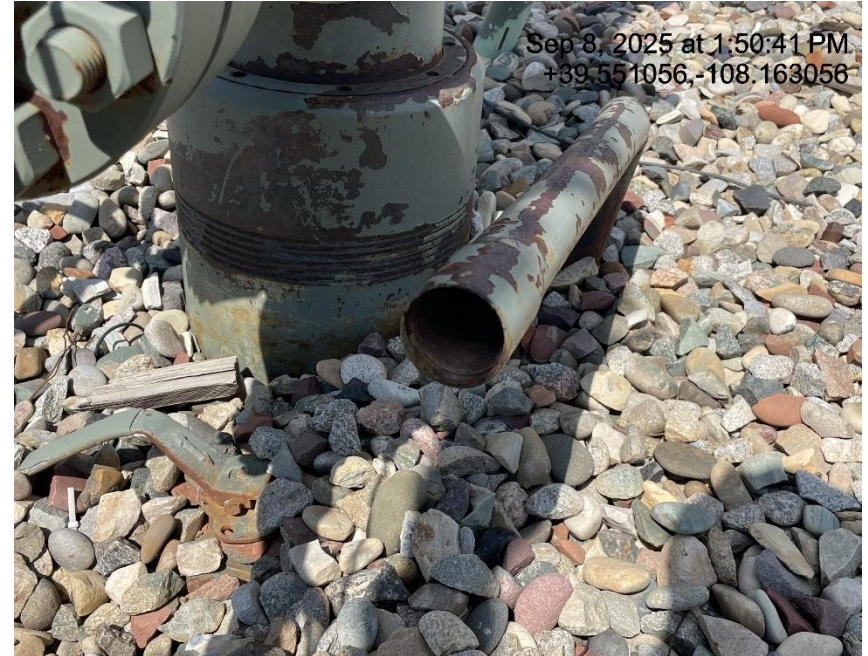
Photo # 6653 Open ended piping near wellhead/wildlife hazard

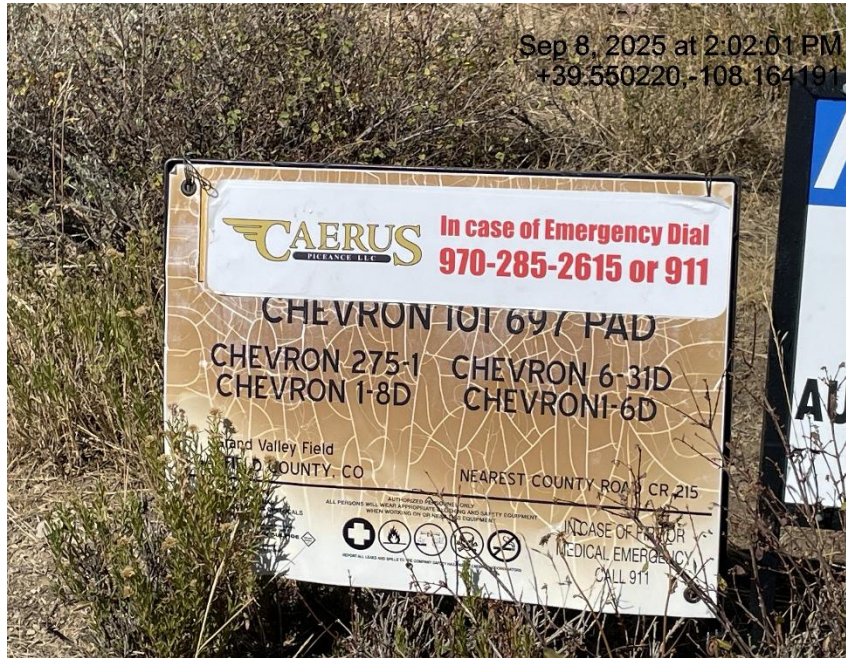
Photo # 6654 Sign at start of spur road to location has previous operators name

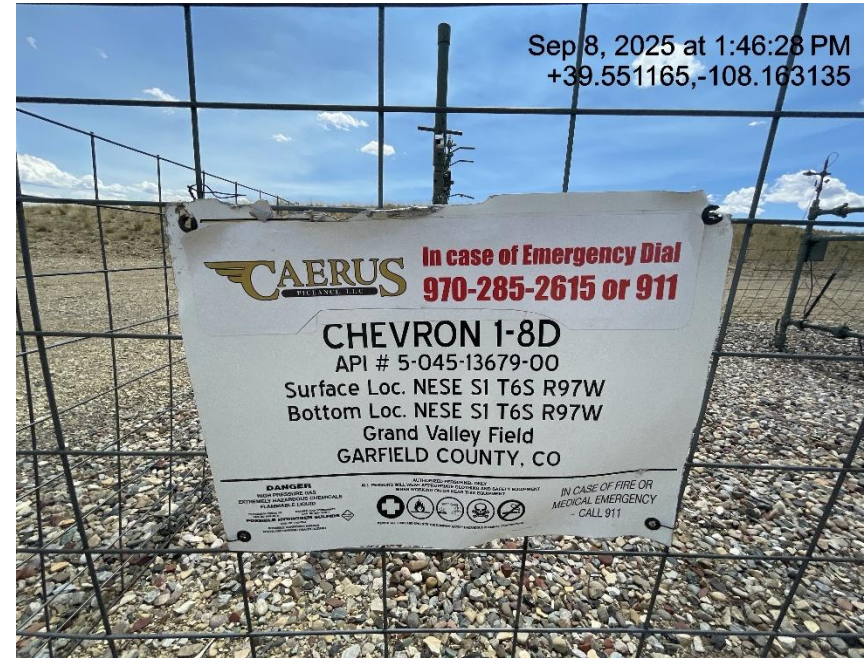
Photo # 6655 Wellhead sign has previous operators name

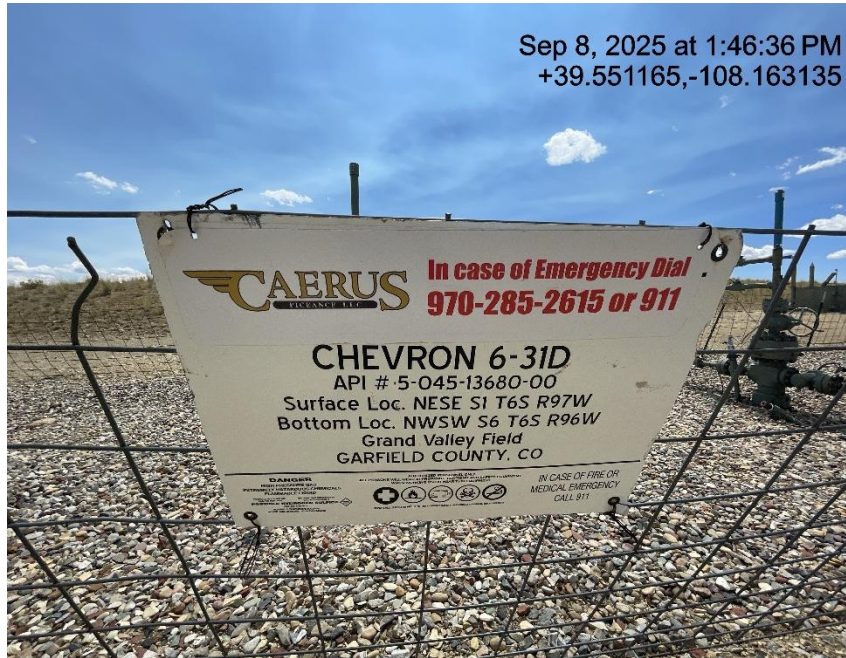
Photo # 6656 Wellhead sign has previous operators name

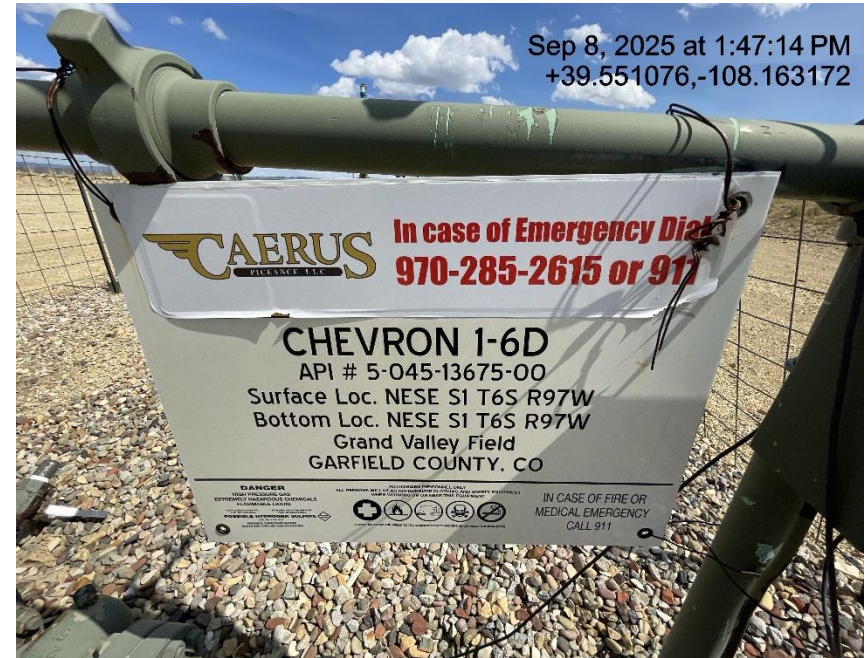
Photo # 6657 Wellhead sign has previous operators name

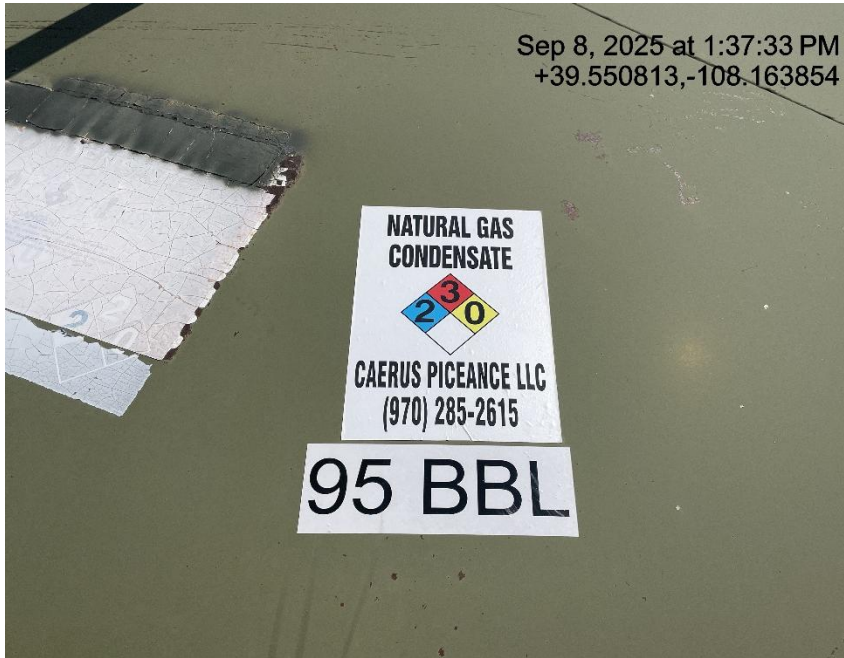
Photo # 6658 Tank label has previous operators name

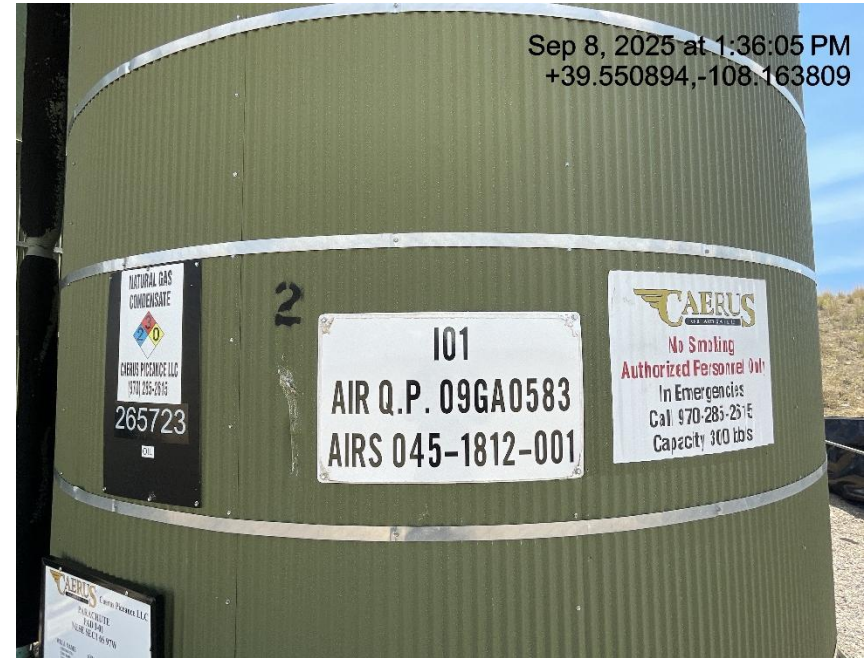
Photo # 6659 Tank labels have previous operators name

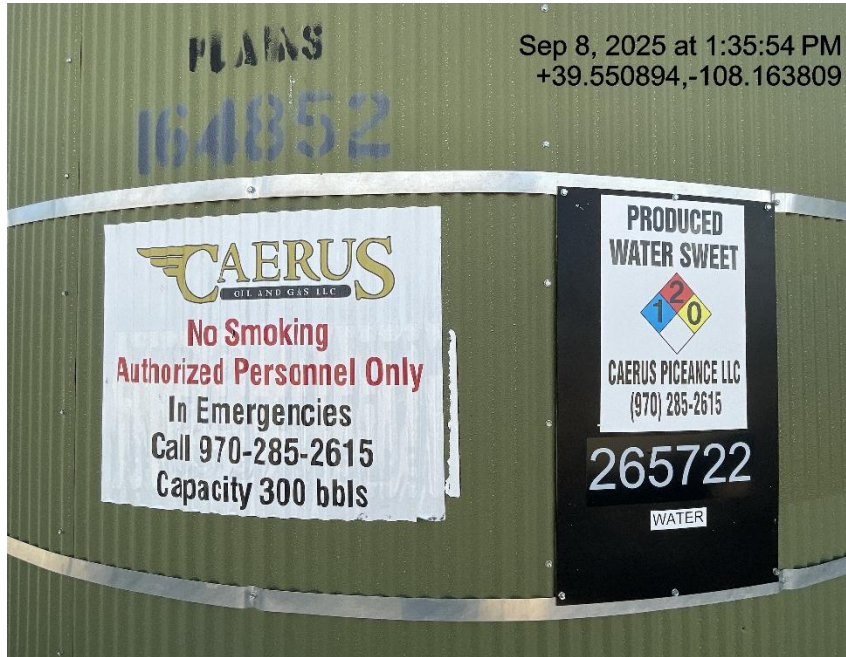
Photo # 6660 Tank labels have previous operators name

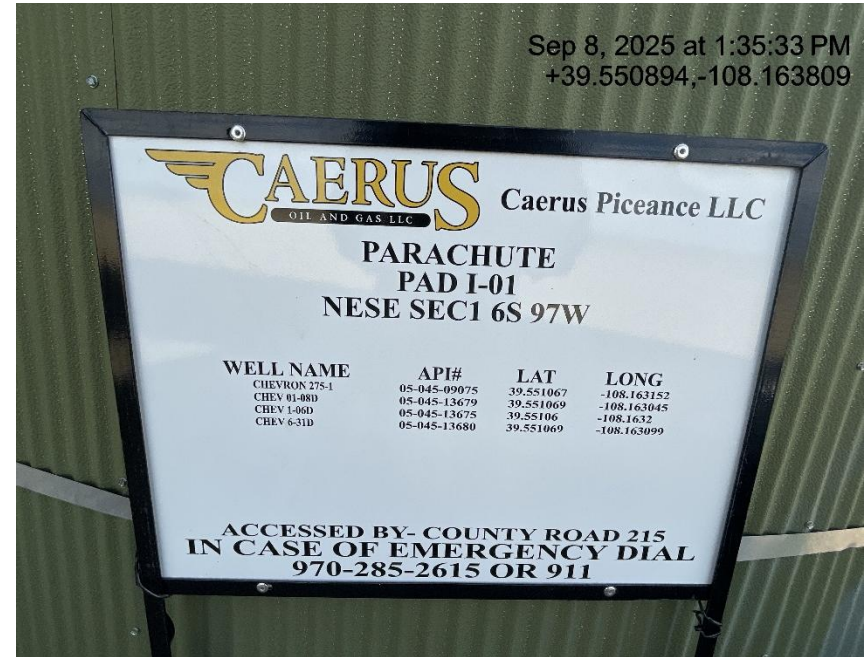
Photo # 6661 Battery sign has previous operators name

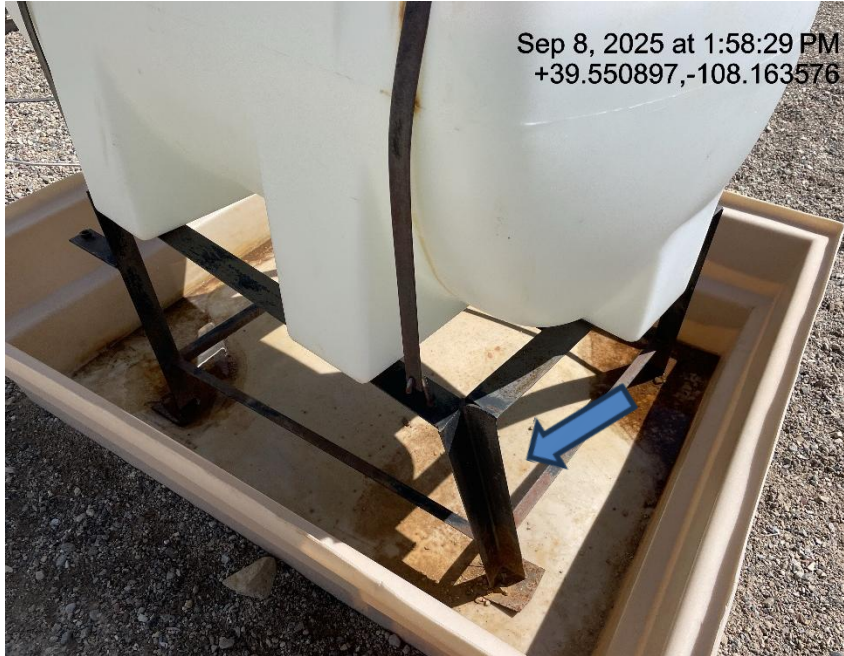
Photo # 6662 Leg on metal stand for chemical tank appears to be starting to buckle

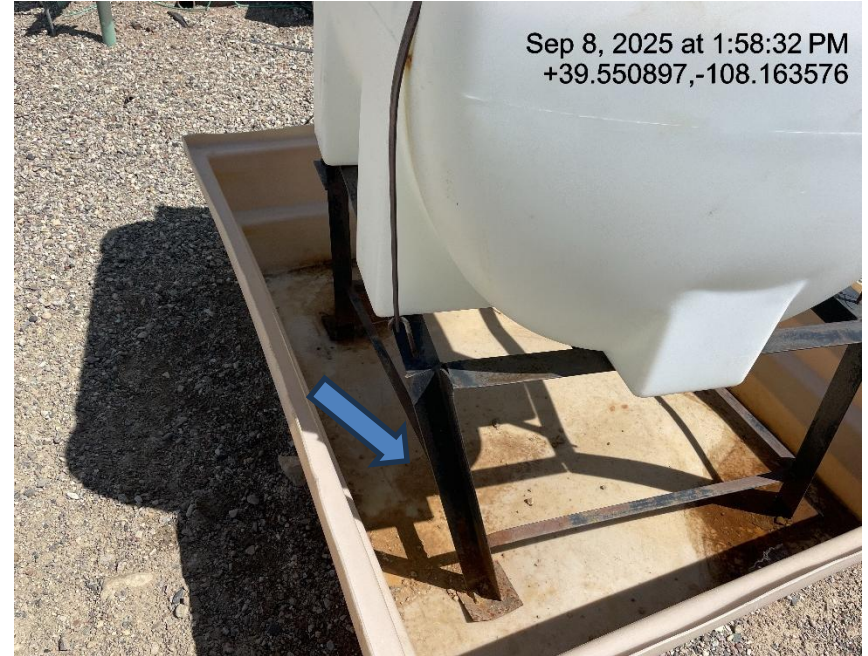
Photo # 6663 Leg on metal stand for chemical tank appears to be starting to buckle
