Inspection Photos

API: 017-06622

Operator: **WILLIFORD ENERGY COMPANY**

Inspection Date: 9/5/2025

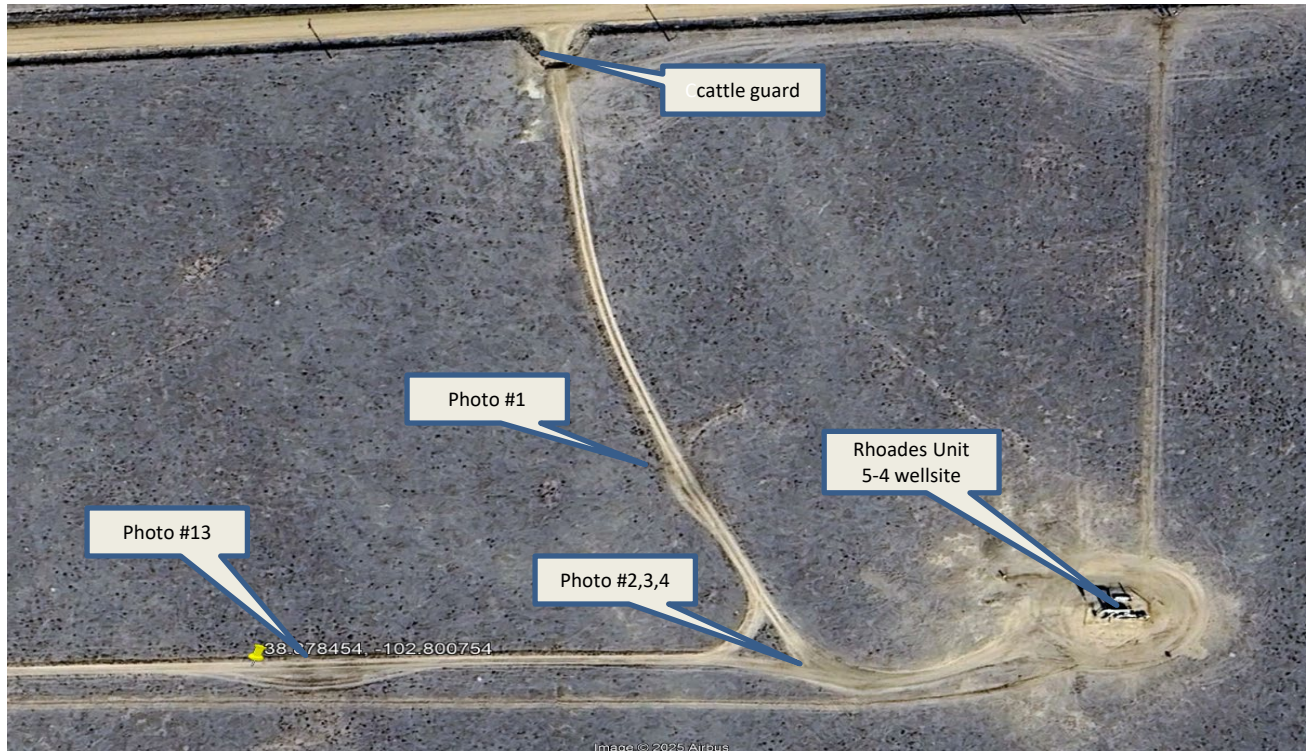
2025 aerial image of the wellsite and access road.

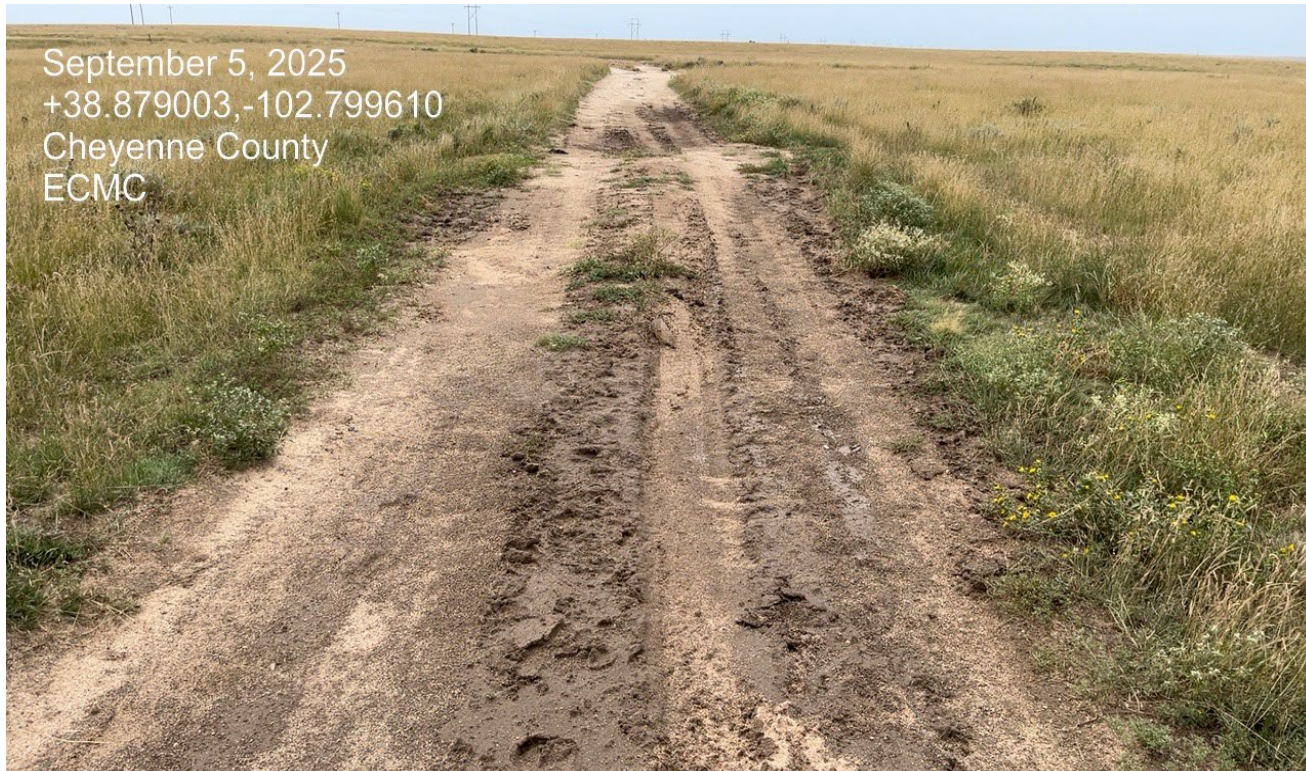
Photo 1. Facing south along the access road. It appears stormwater is still accumulating along the area of the road and there is vehicle rutting. BMP's have not been installed in this area per good engineering practice.

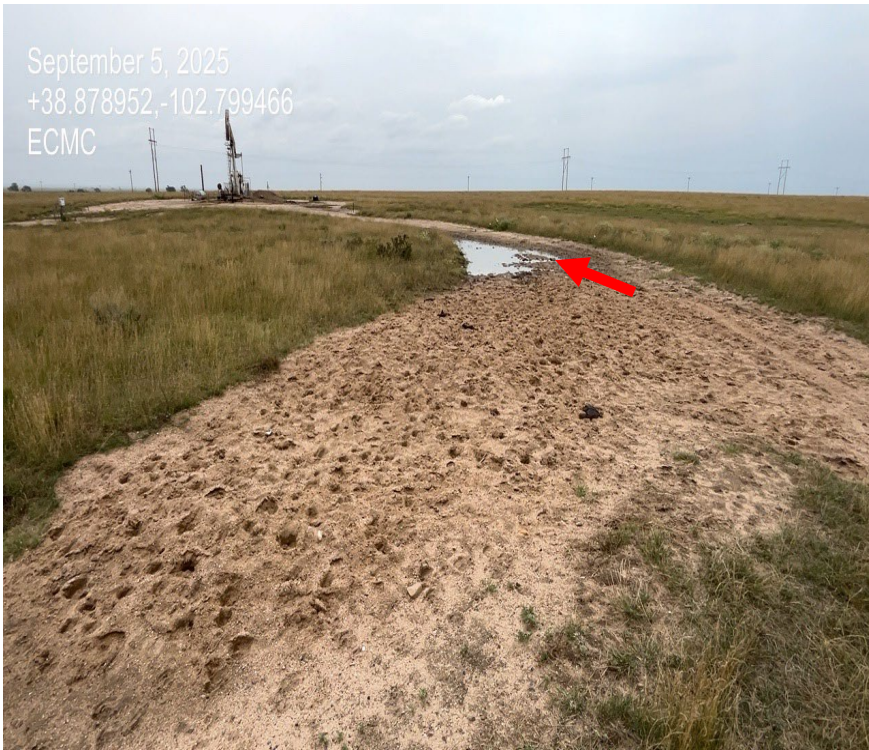
Photo 2. Facing southeast along the access road. There has been a load of road base sand material placed in this area but was not properly installed by crowning and compacting.

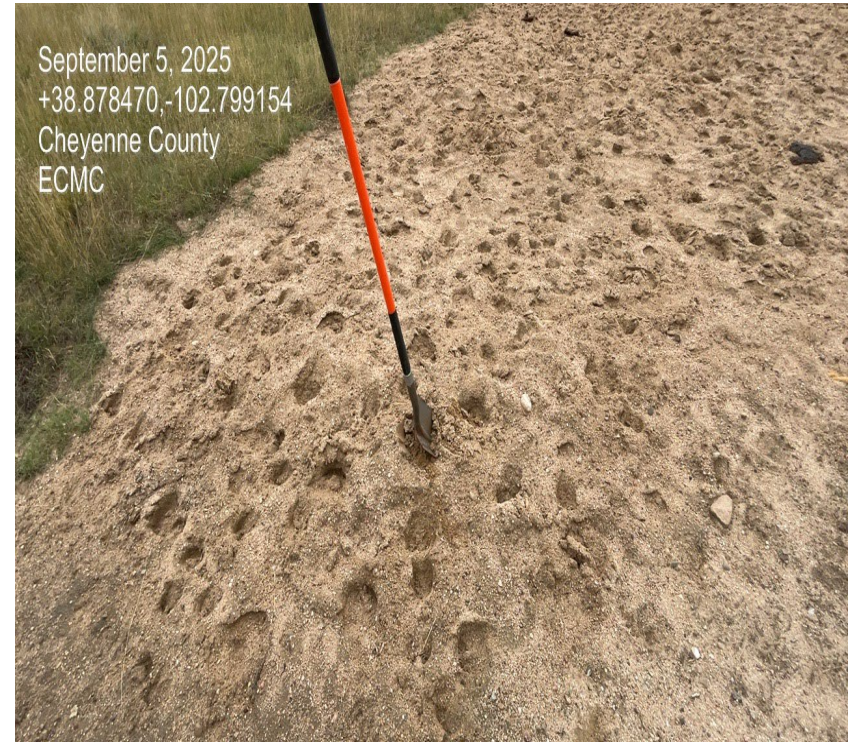
Photo 3. View of material placed on the road is not compacted. Cattle hoof marks and shove show the material is loose and susceptible to vehicle rutting and erosion.

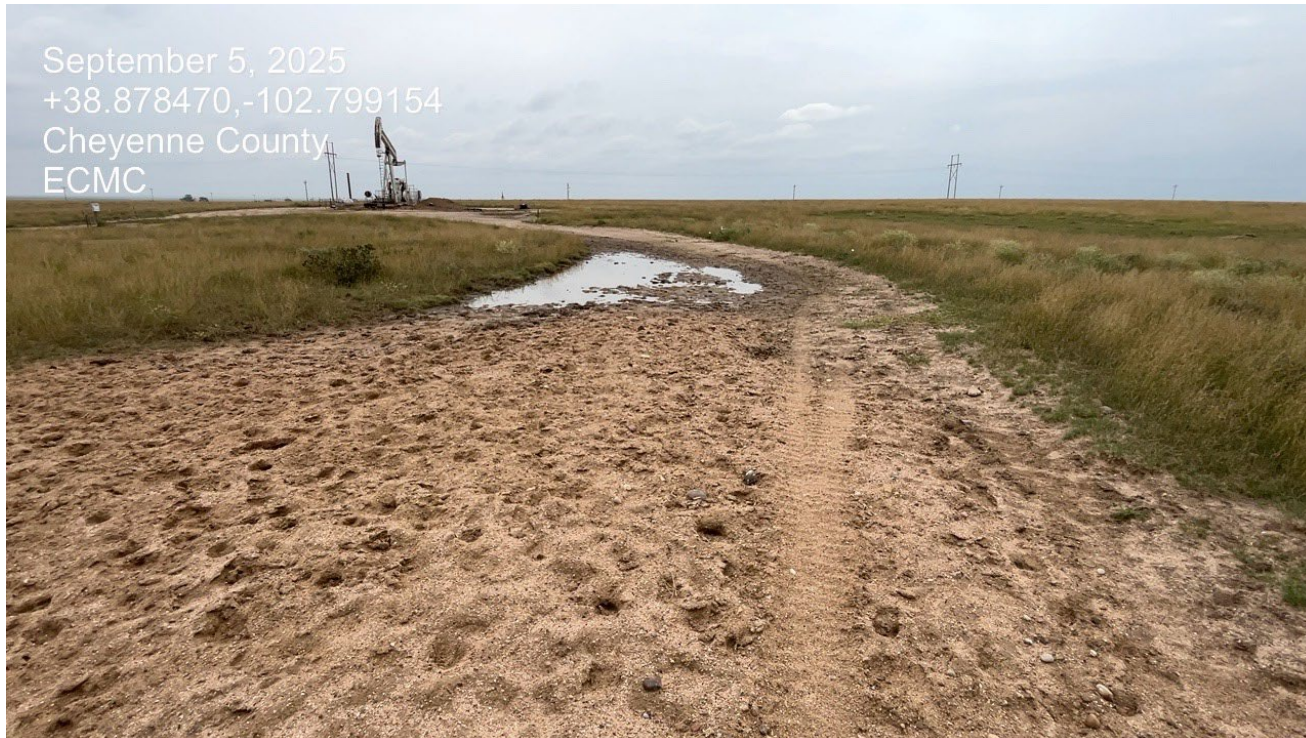
Photo 4. Facing east toward the wellsite. Stormwater is still pooling on the road causing vehicles to drive around the damaged area of the road. BMP's have not been installed to stabilize and maintain the road.

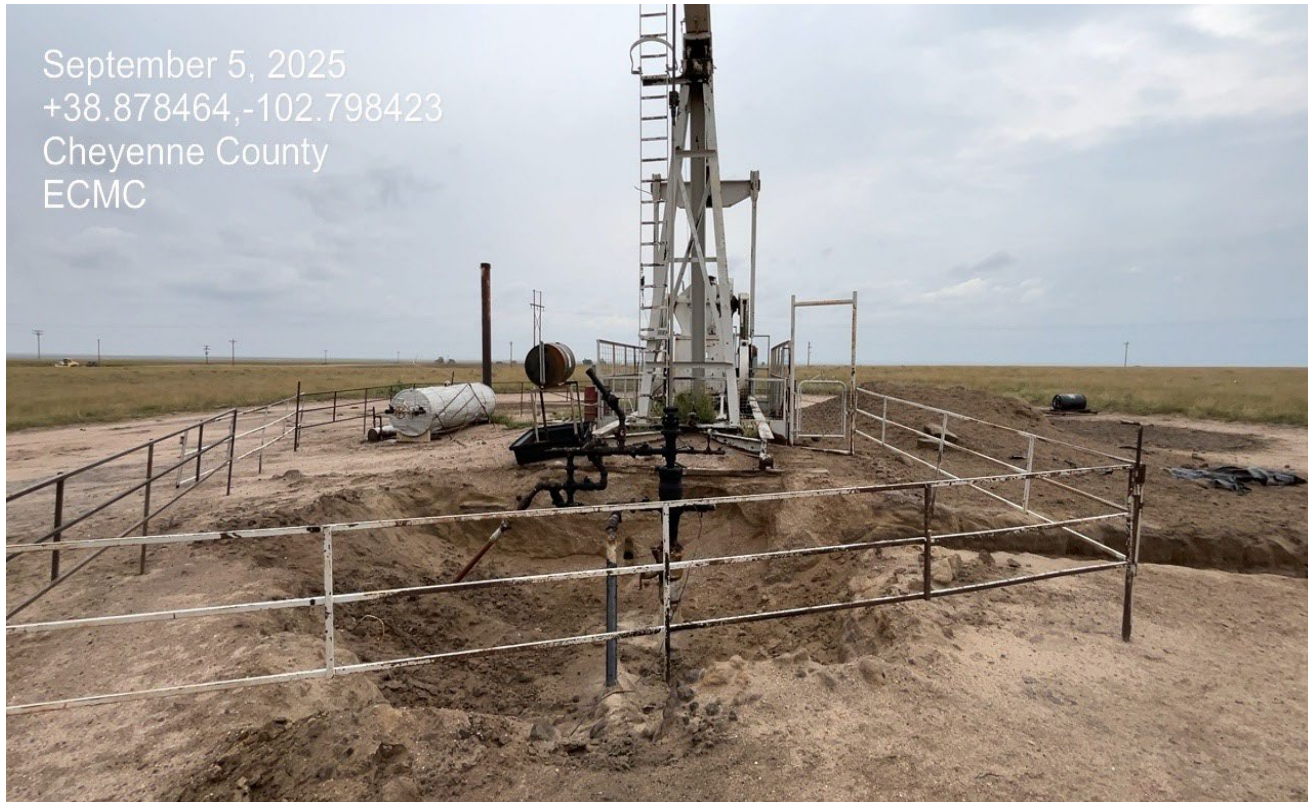
Photo 6. The impacted area around the wellhead has been excavated .

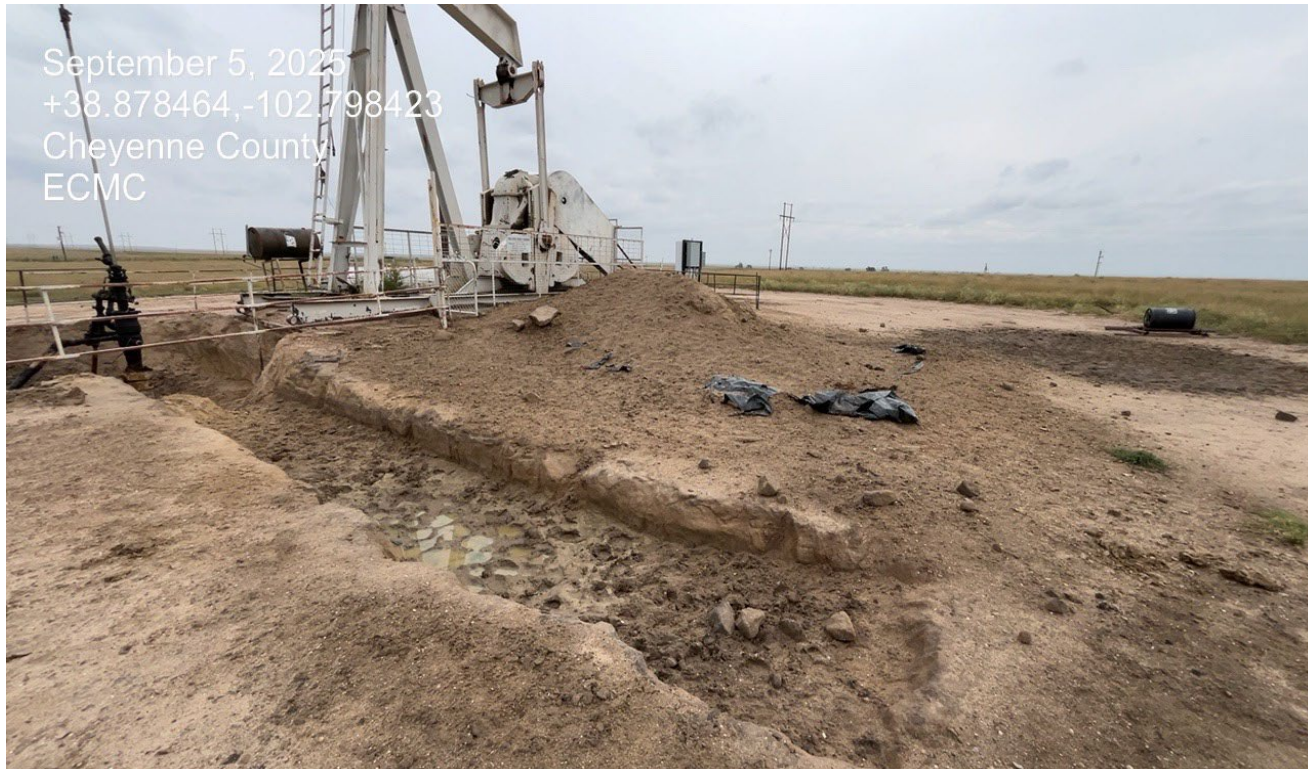
Photo 7. Facing northeast toward the excavated area where impacted material was identified.

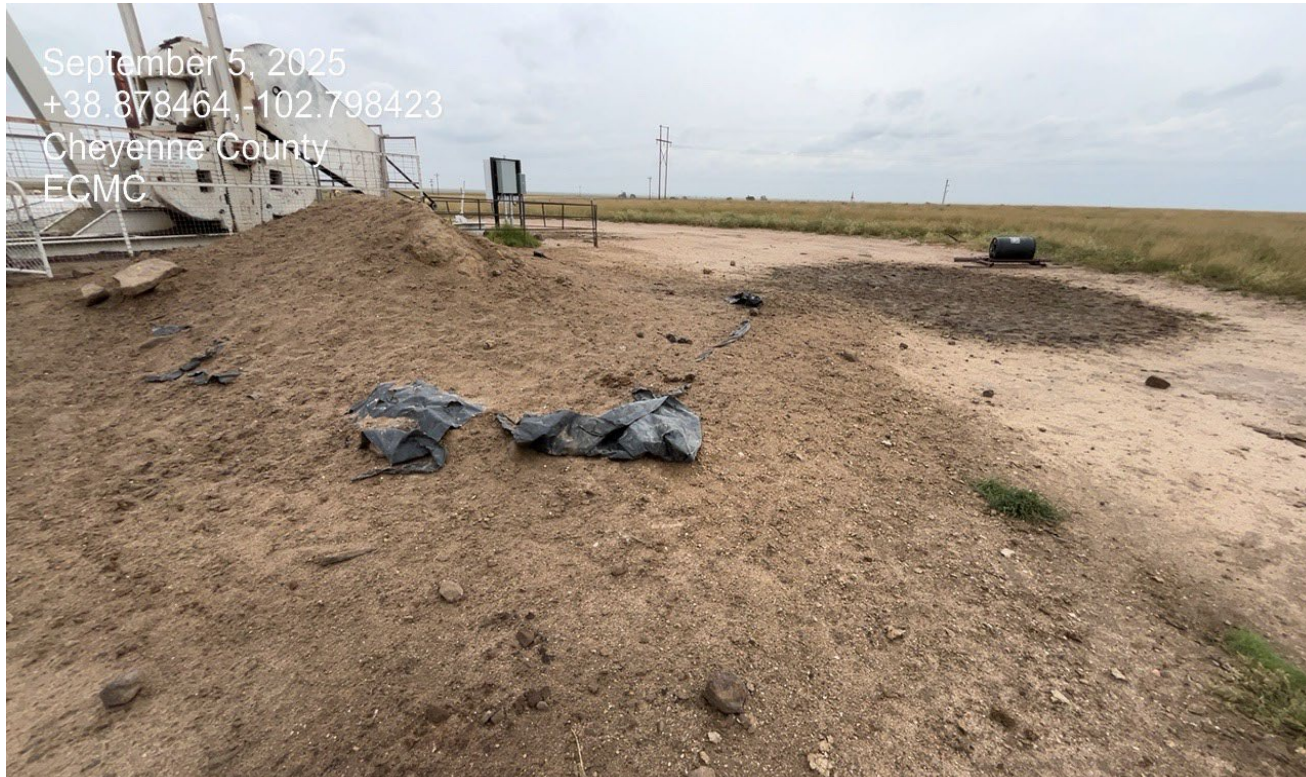
Photo 8. The excavated material was stored on plastic liner but has no secondary containment. Much of the material fallen off the liner. The liner appears to be torn and may be compromised.

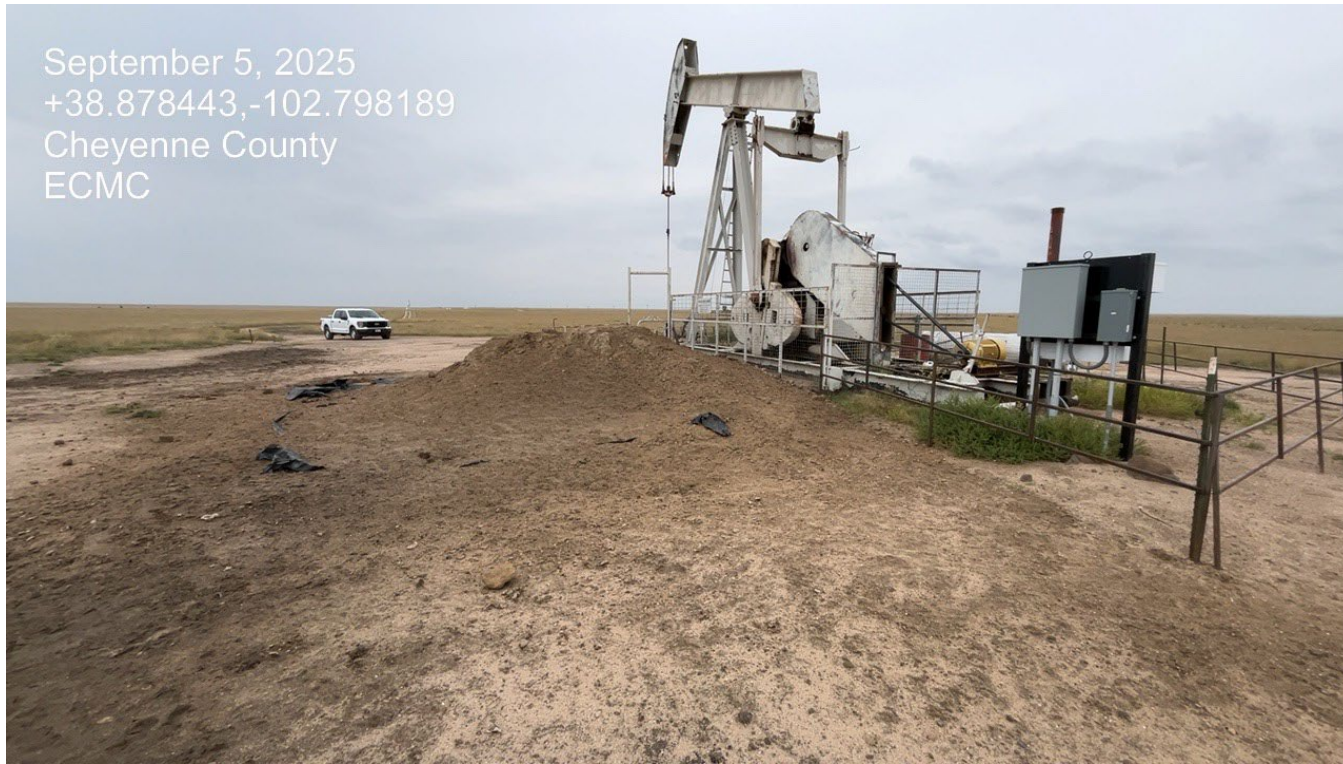
Photo 9. Facing northwest at the wellsite. The excavated material was stored on plastic liner but has no secondary containment. Much of the material fallen off the liner. The liner appears to be torn and may be compromised.

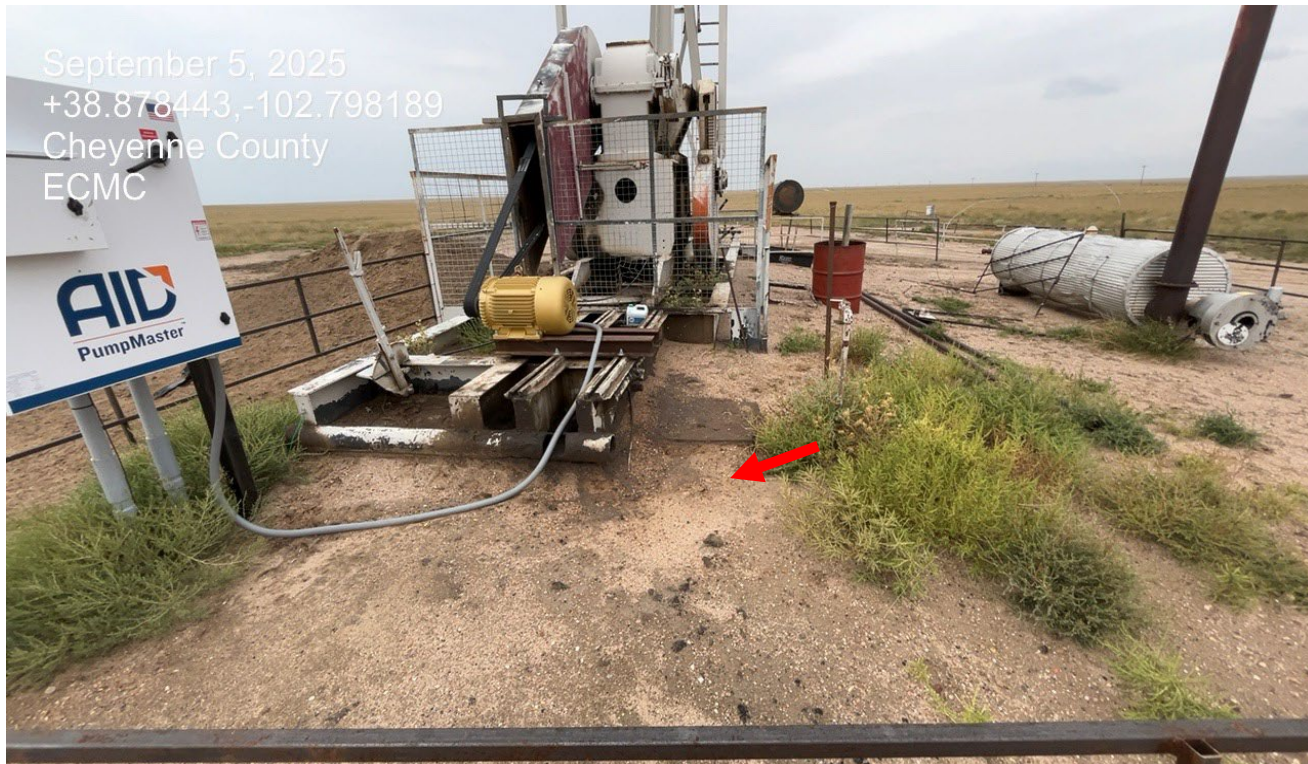
Photo 10. There is oil staining at the base of the pump jack that has not been cleaned up.

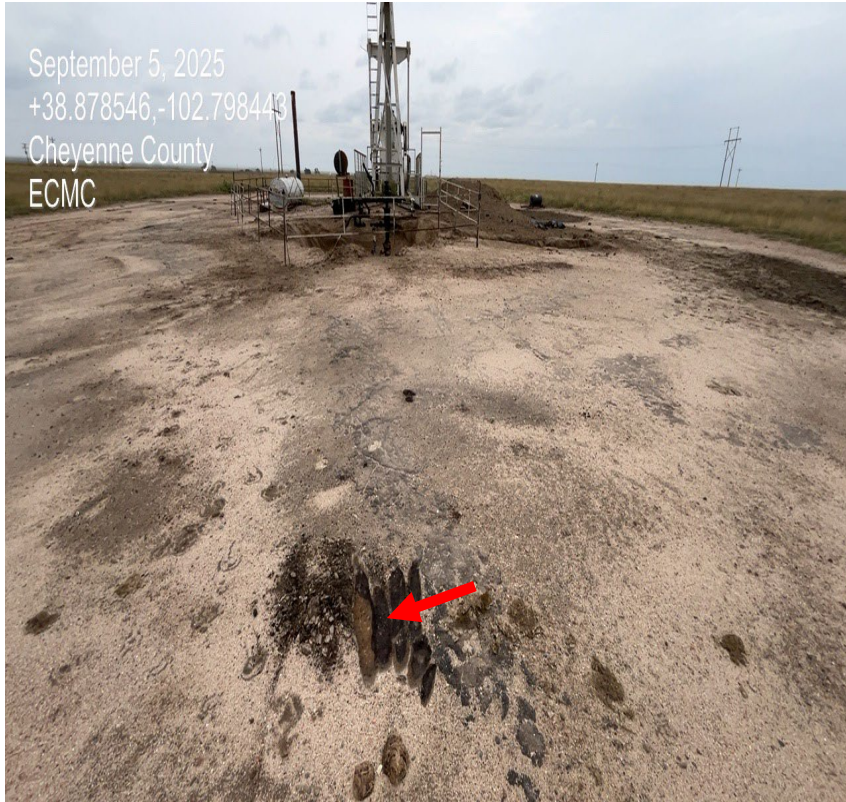
Photo 11. Facing east at the wellsite. There is black hardened hydrocarbon material shown at red arrow.

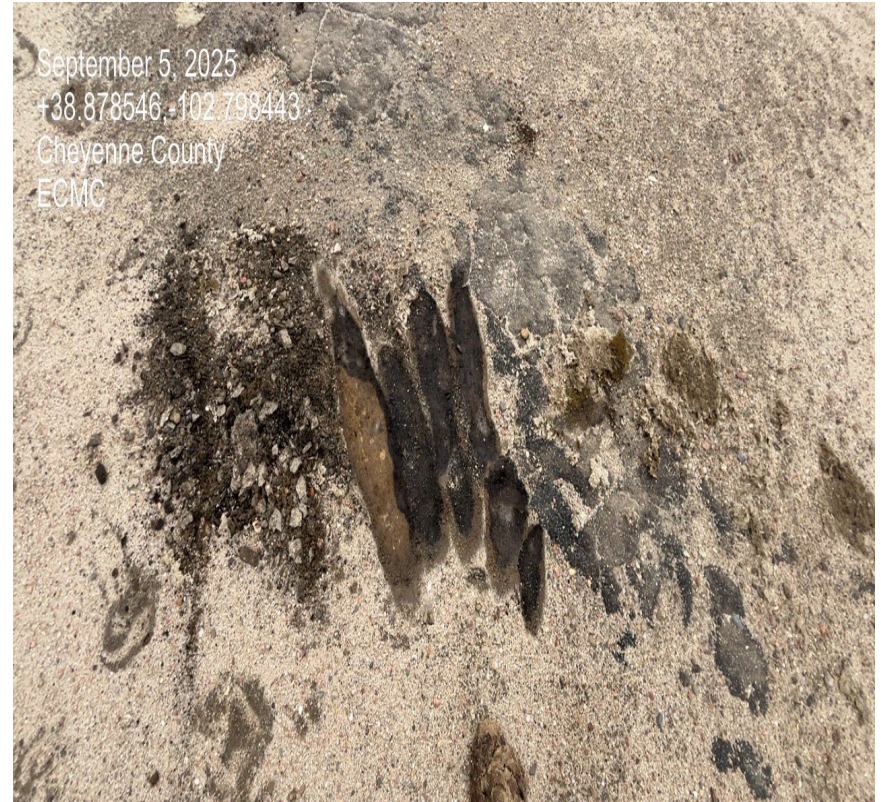
Photo 12. Closer view of the stained black material which appears to be impacted soils.

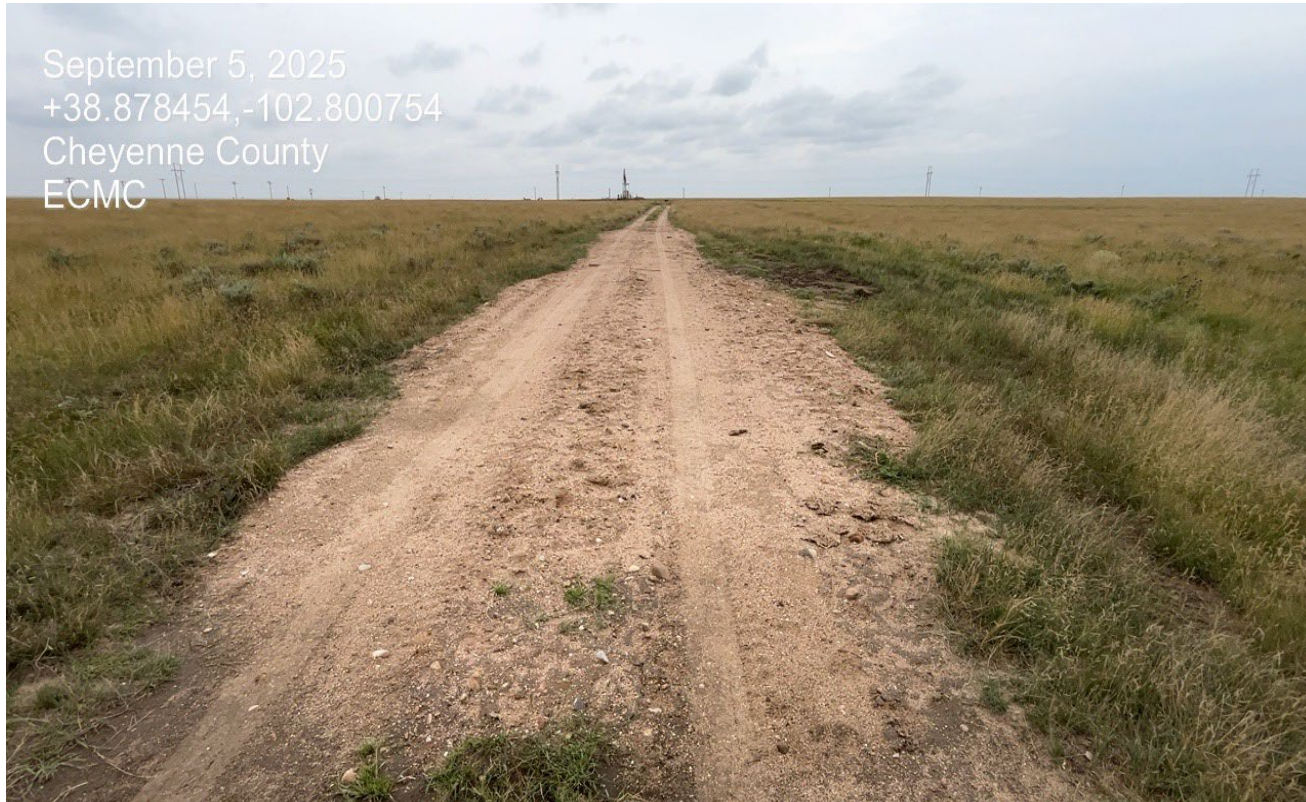
Photo 13. Facing east along the access road. There is a load of road base material but this material has not be graded and crowned.
