Inspection Photos
Location Name: State 14-32
Location ID: 320756

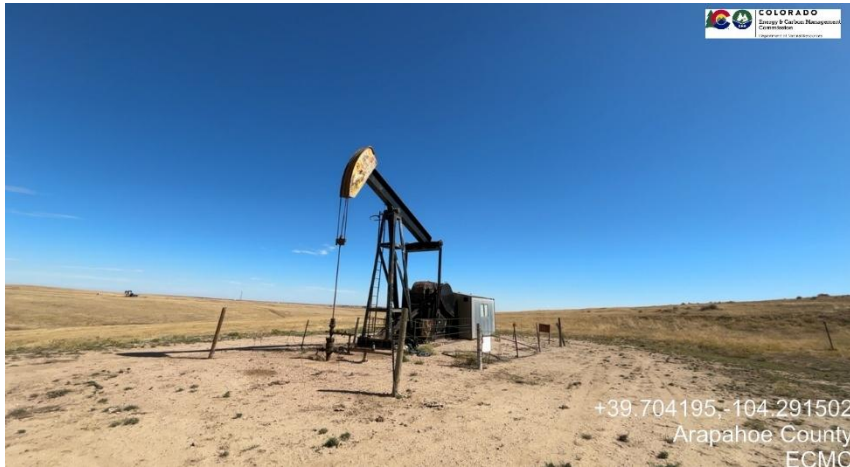
Pic 1 wellhead / pumpjack

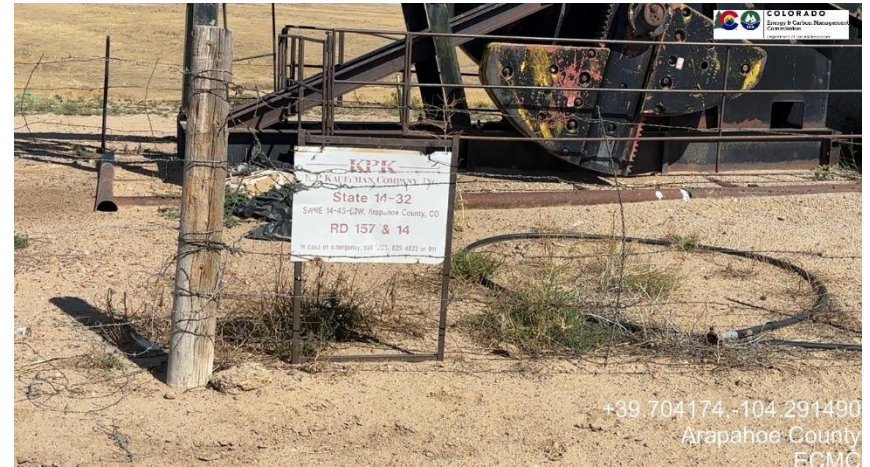
Pic 2 wellhead sign

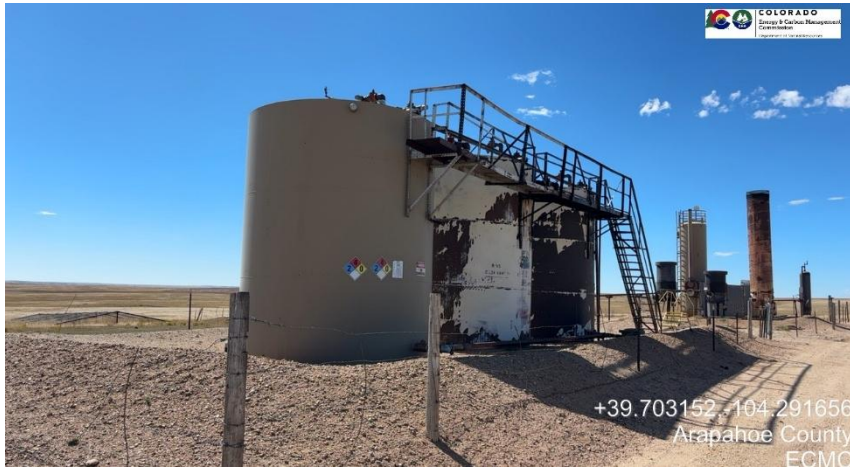
Pic 3 tanks

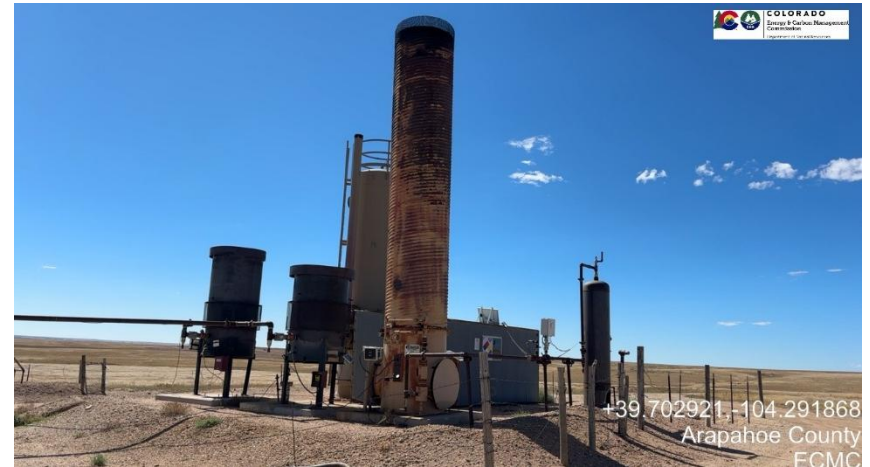
Pic 4 Separators, ECD

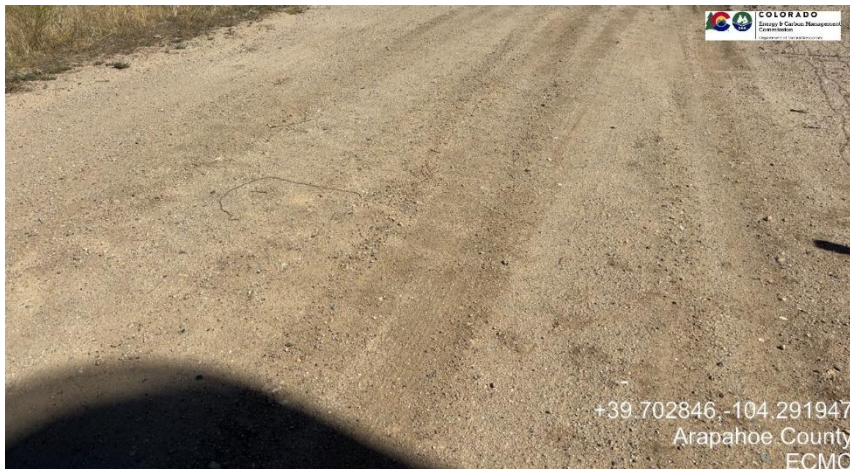
Pic 5 Venting / flaring fumes are visible on ground as shadow

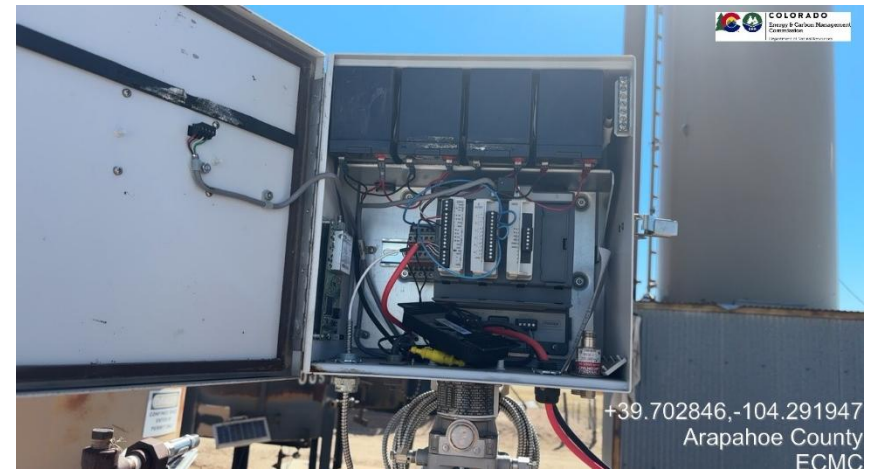
Pic 6 GMR on location is connected from Separator, to ECD's on location

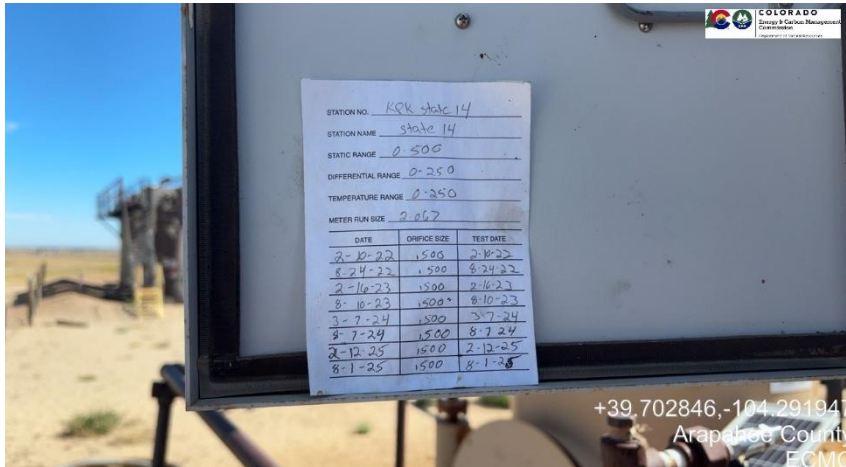
Pic 7 GMR calibration card

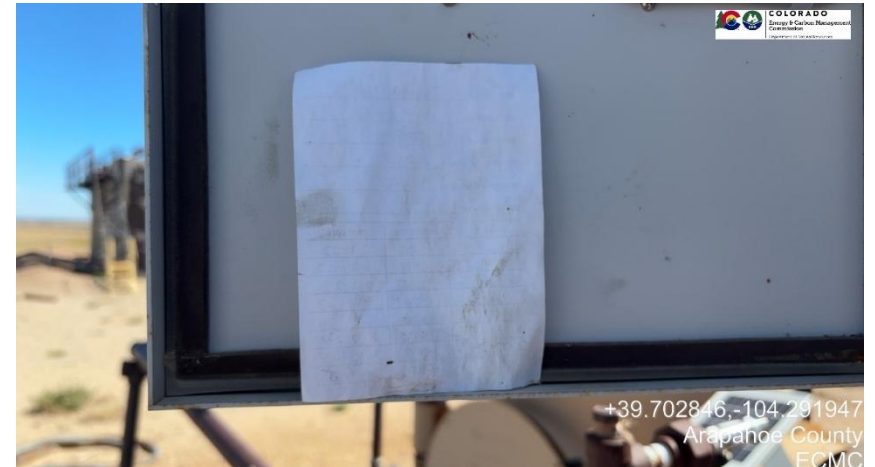
Pic 8 back of card

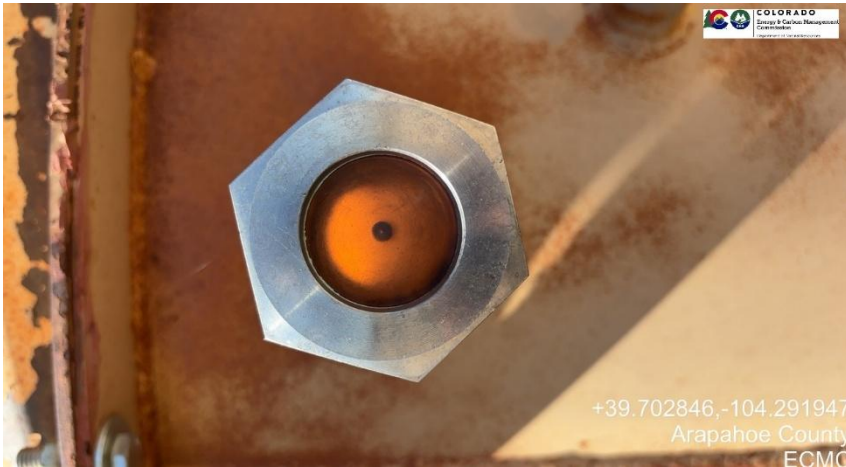
Pic 9 glass with flame inside of ECD

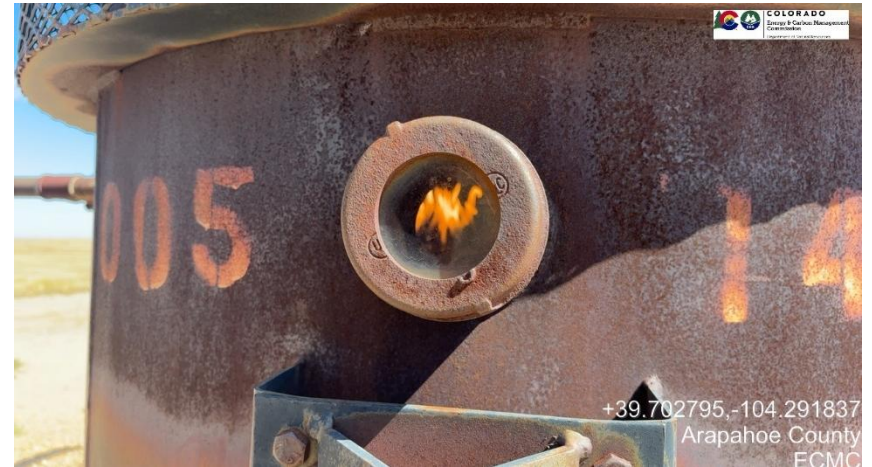
Pic 10 Glass with flame inside ECD

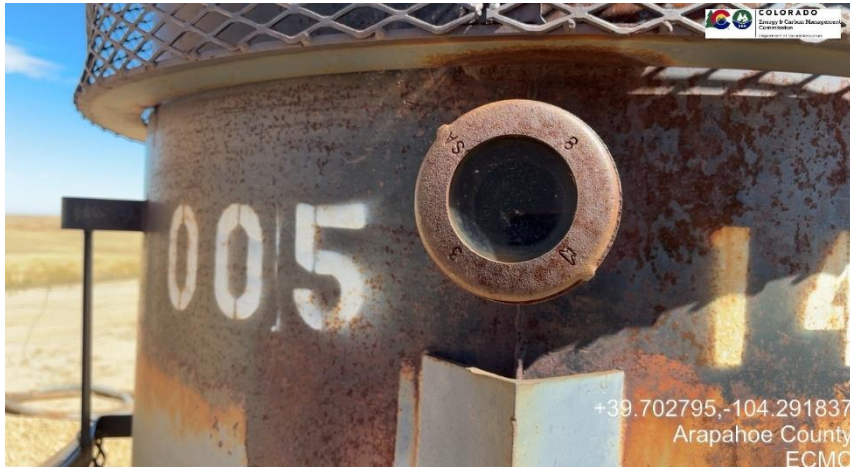
Pic 11 middle ECD on location does not have flame inside of ECD

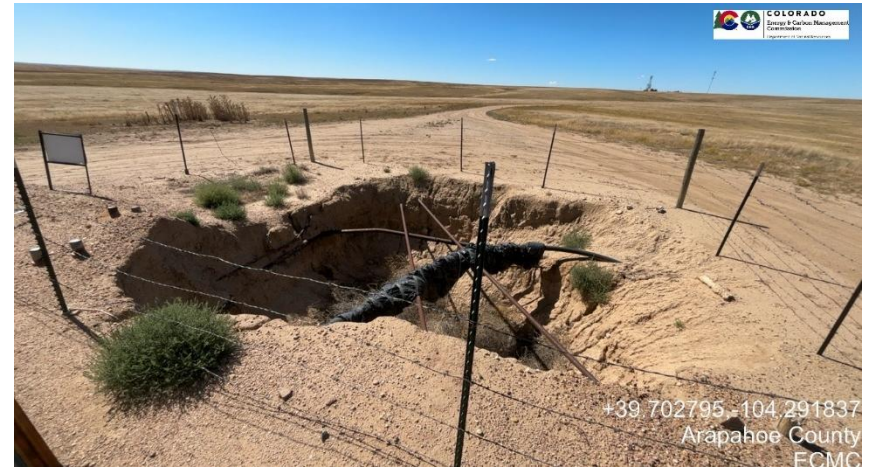
Pic 12 Open excavation on location

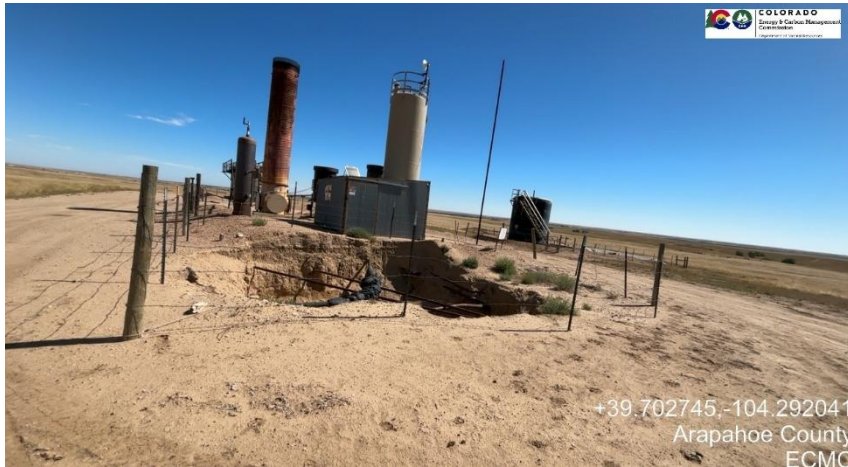
Pic 13 Open excavation

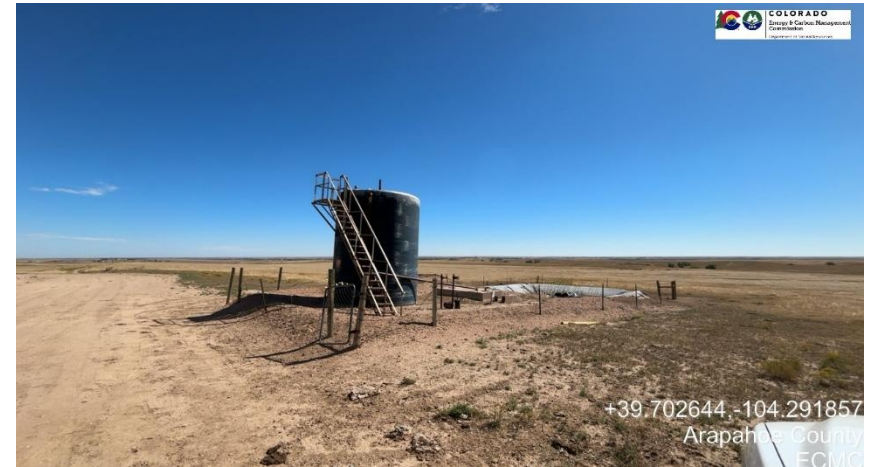
Pic 14 Water tank and Pit

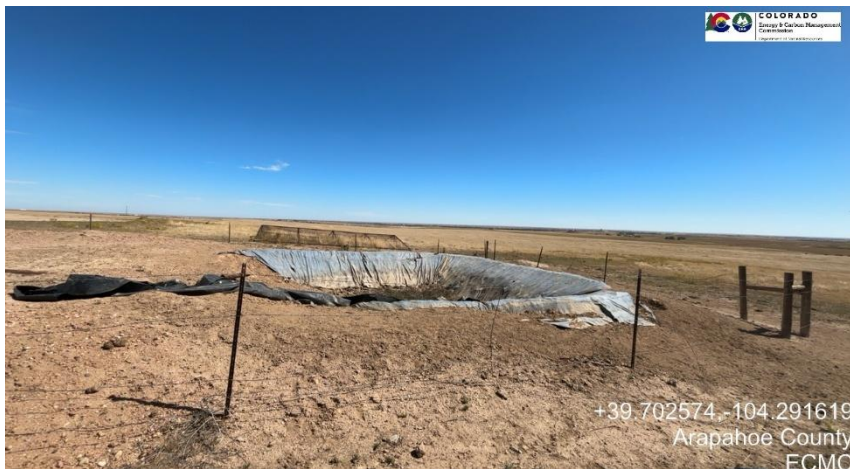
Pic 15 Pit

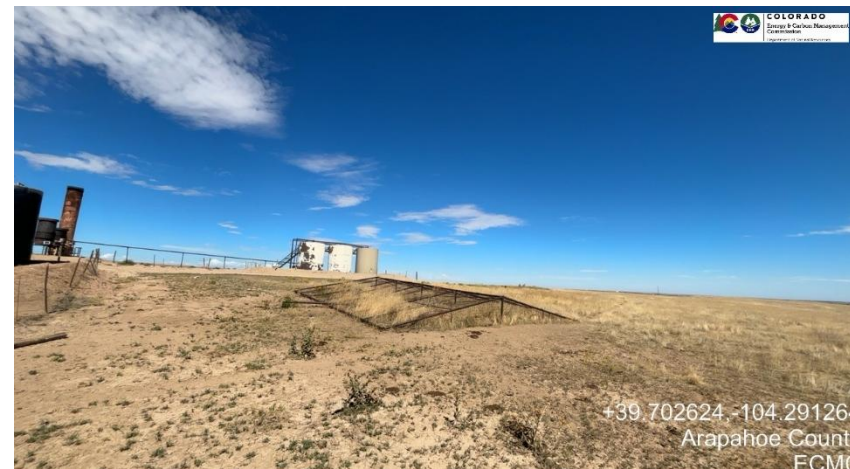
Pic 16 Pit bird cover
