WELL NAME: MONTOYA 11-1 V & R, API #: 071-08141, INSP. # 716301519

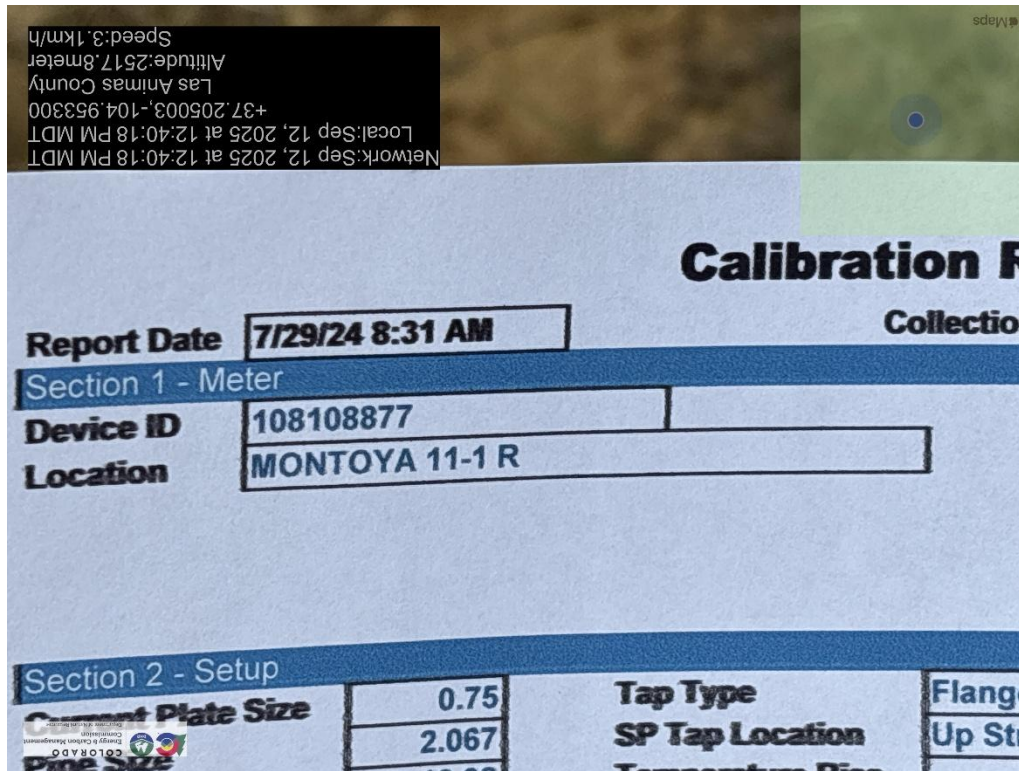
**PHOTO 3: Meter not calibrated annually ON V WELL. Calibrate gas metering equipment annually to comply with rule 430.d.(1). CA DATE 10-12-2025.**

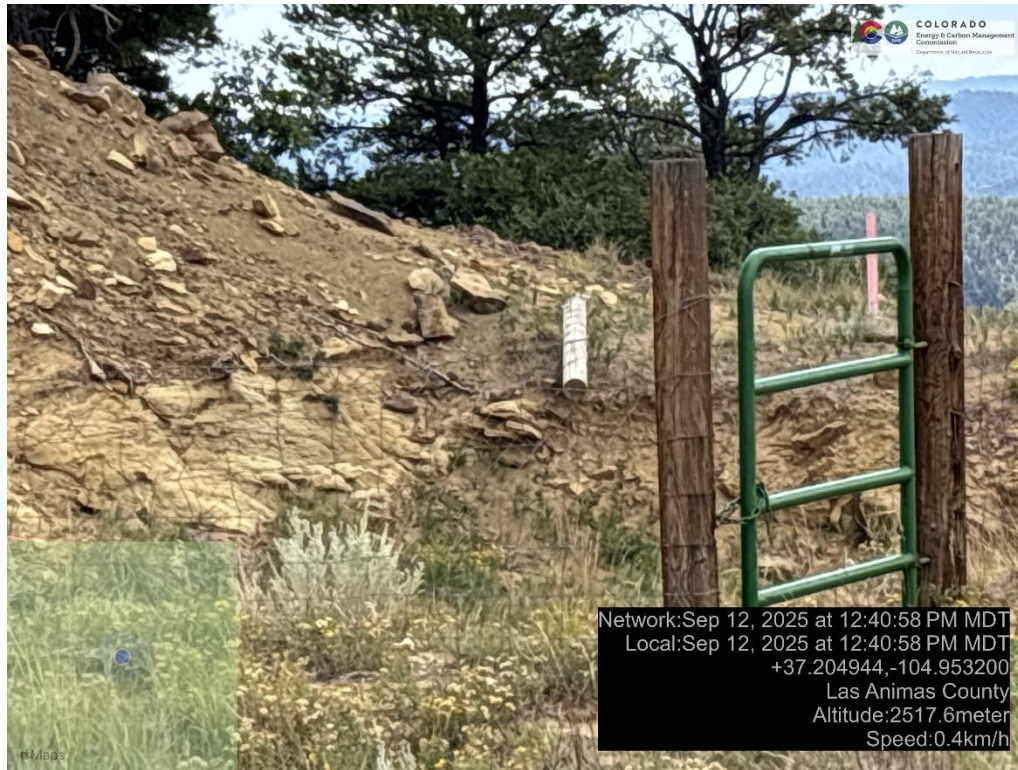
**PHOTO 5: FENCE IS IN DISREPAIR ON V WELL PIT. REPAIR FENCE AROUND PIT PER RULE 1002. CA DATE 10-12-2025.**
