Inspection/Audit Photos

Location Name: QB ENERGY OPERATING LLC PUCKETT 32D-25D (Mesa 22)

Location #: 335506

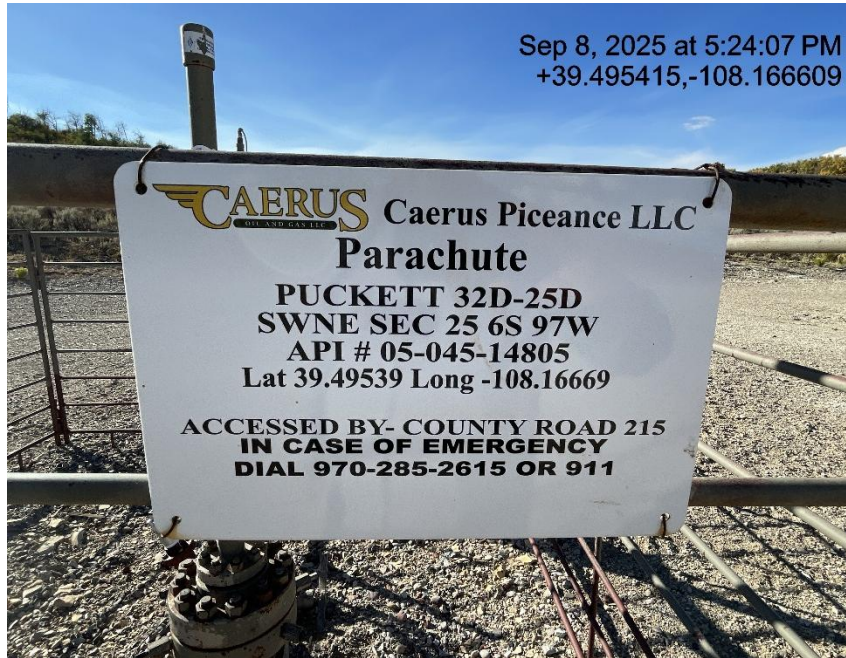
Photo # 7120 Wellhead sign has previous operators name

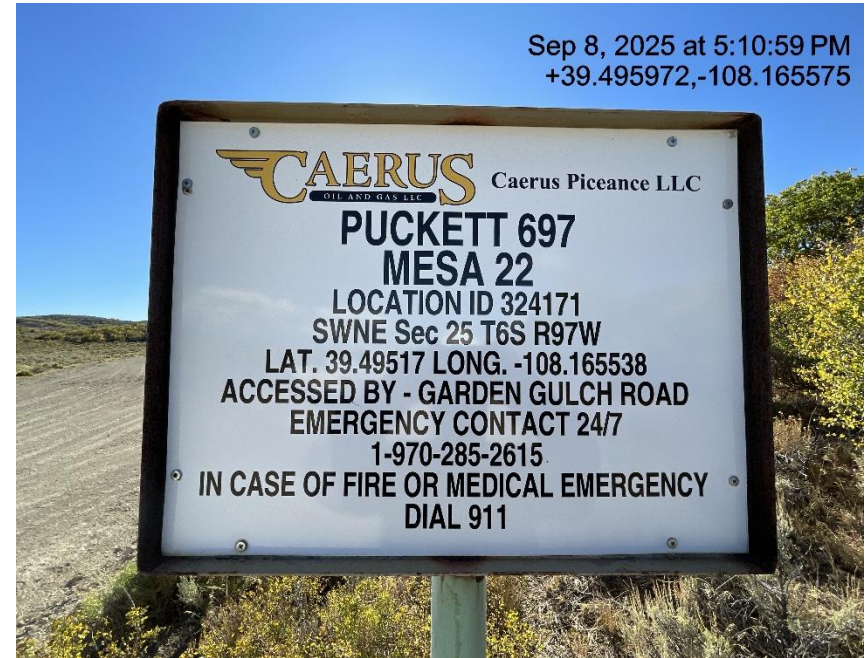
Photo # 7121 Sign at entrance to location has previous operators name

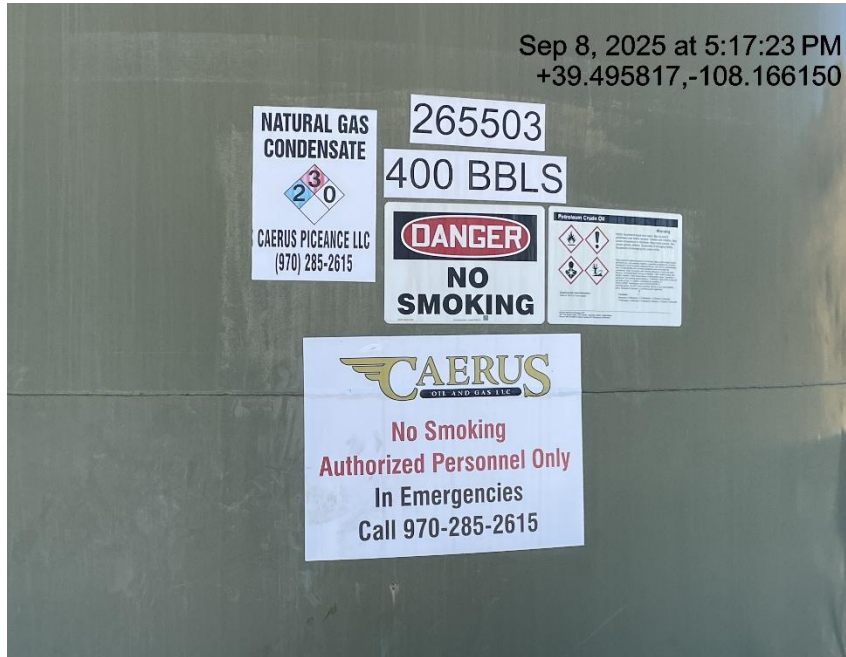
Photo # 7122 Tank labels have previous operators name

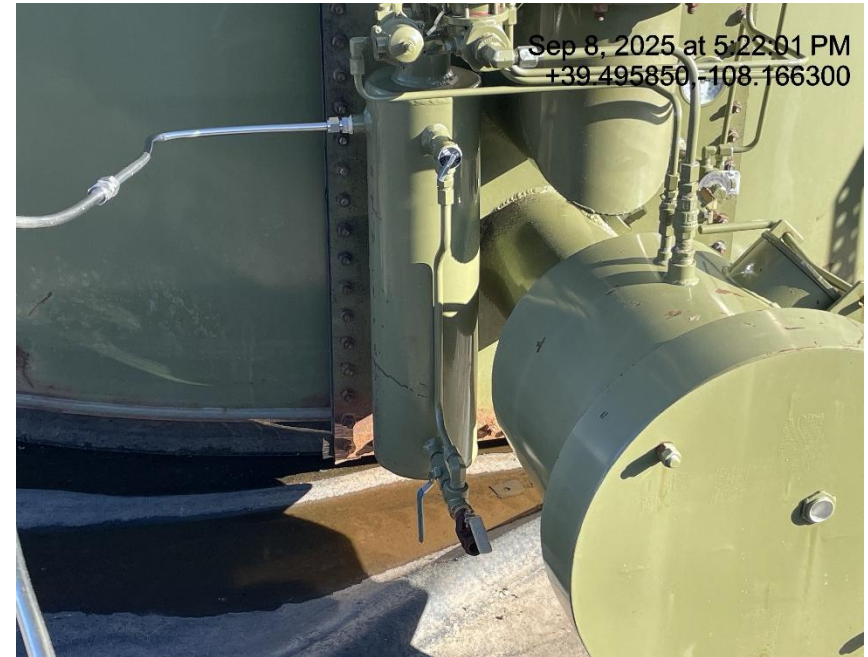
Photo # 7123 PRV vent line on tank burner does not comply with CECMC pressure safety device rules

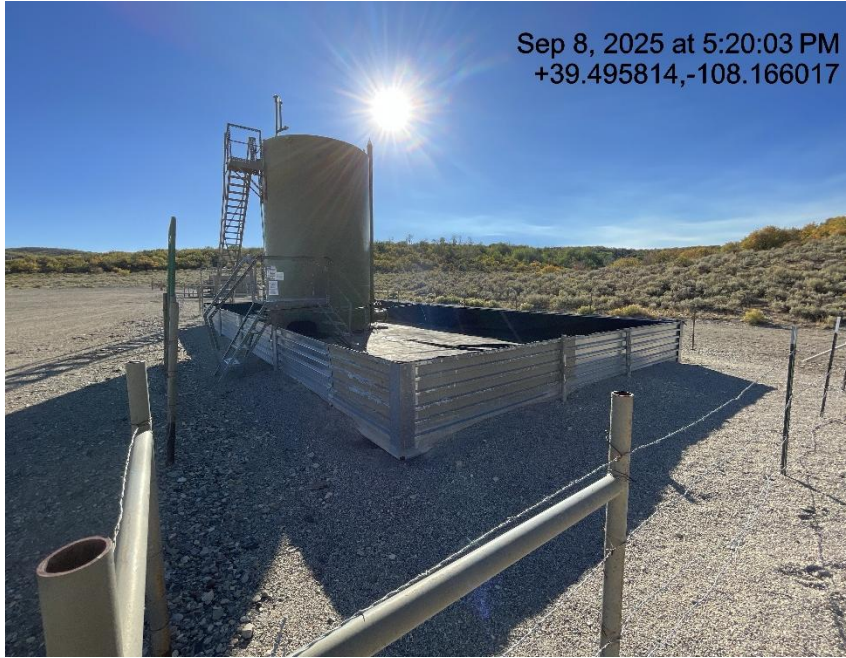
Photo # 7124 Tank battery lacks required signage

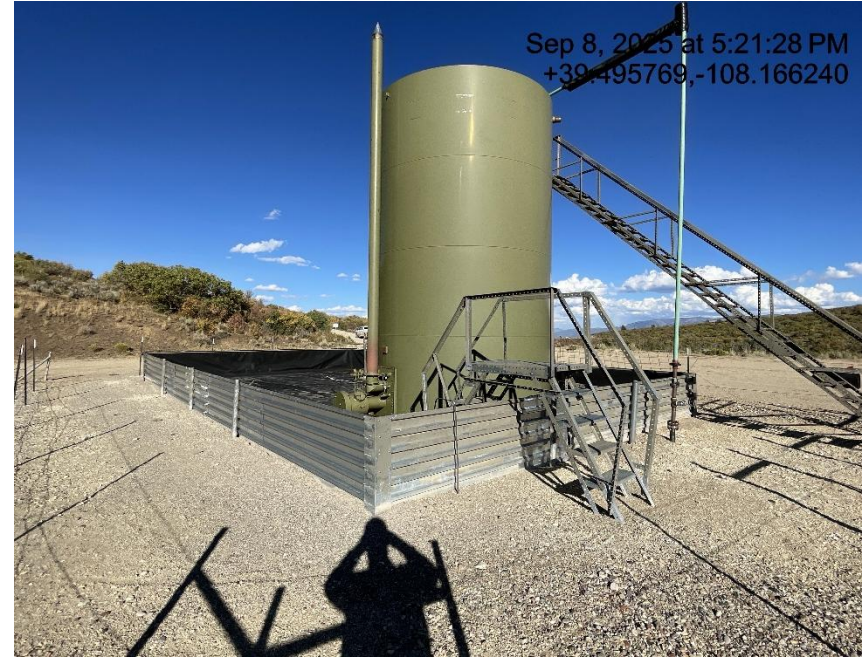
Photo # 7125 Tank battery lacks required signage
