Final Reclamation Inspection

Operator: KERR MCGEE OIL & GAS ONSHORE LP - 47120

Location ID: 336691

Location Name: HSR-KATZEN-63N66W 1SESE

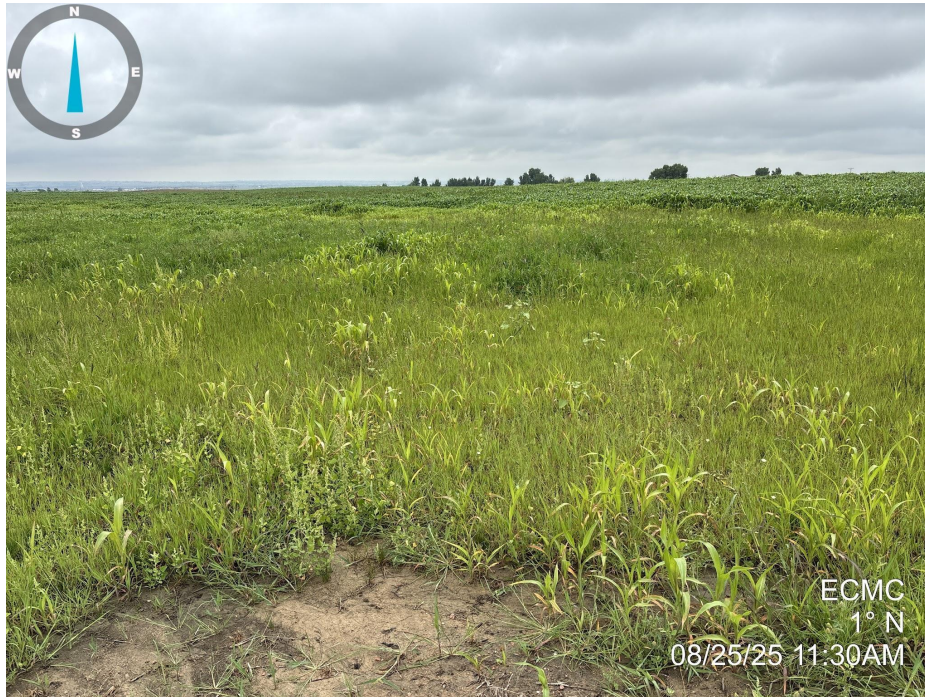
Photo 1. Photo taken from the multi-well location, from HSR-KATZEN #16-1A (API# 123-15101), facing north. Photo illustrates that final reclamation activities have taken place, but vegetation establishment does not meet Rule 1004 standards and bare ground was observed at the well site.

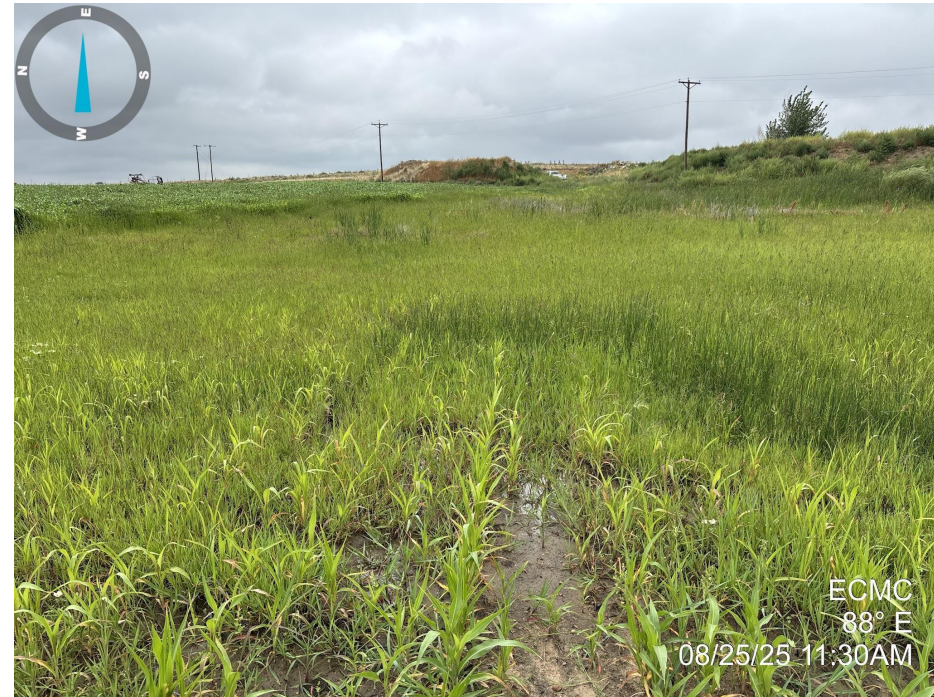
Photo 2. Photo taken from the multi-well location, from HSR-KATZEN #16-1A (API# 123-15101), facing east. See comments under Photo 1.

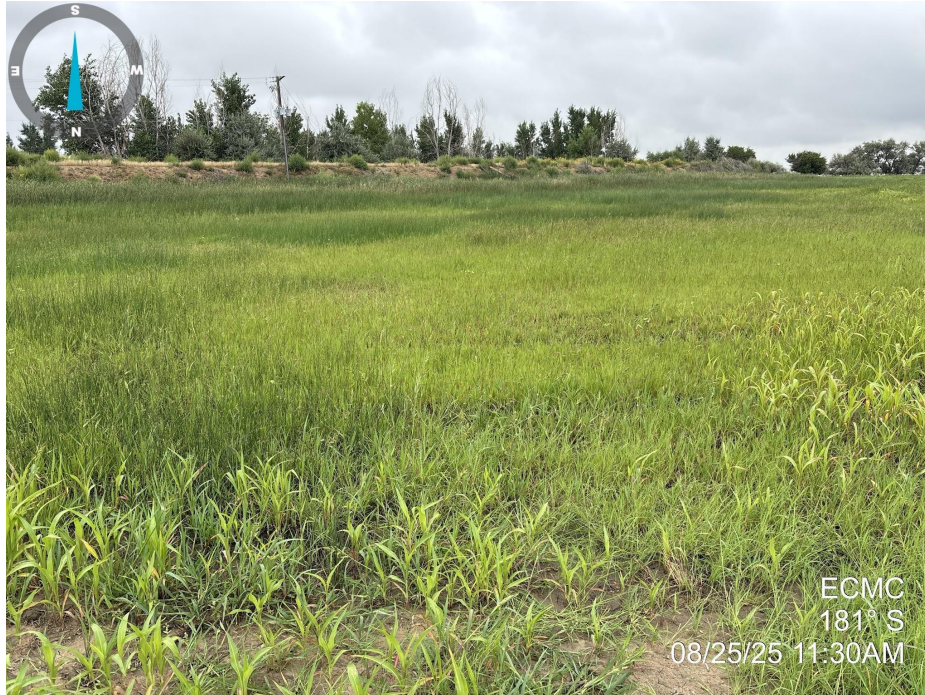
Photo 3. Photo taken from the multi-well location, from HSR-KATZEN #16-1A (API# 123-15101), facing south. See comments under Photo 1.

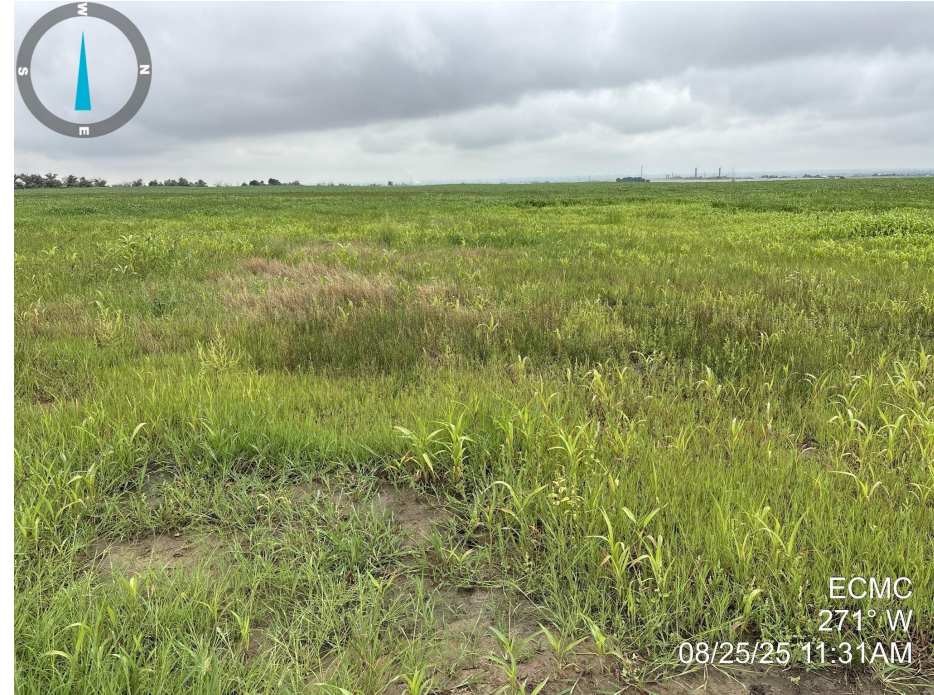
Photo 4. Photo taken from the well location, from HSR-KATZEN #16-1A (API# 123-15101), facing west. See comments under Photo 1.

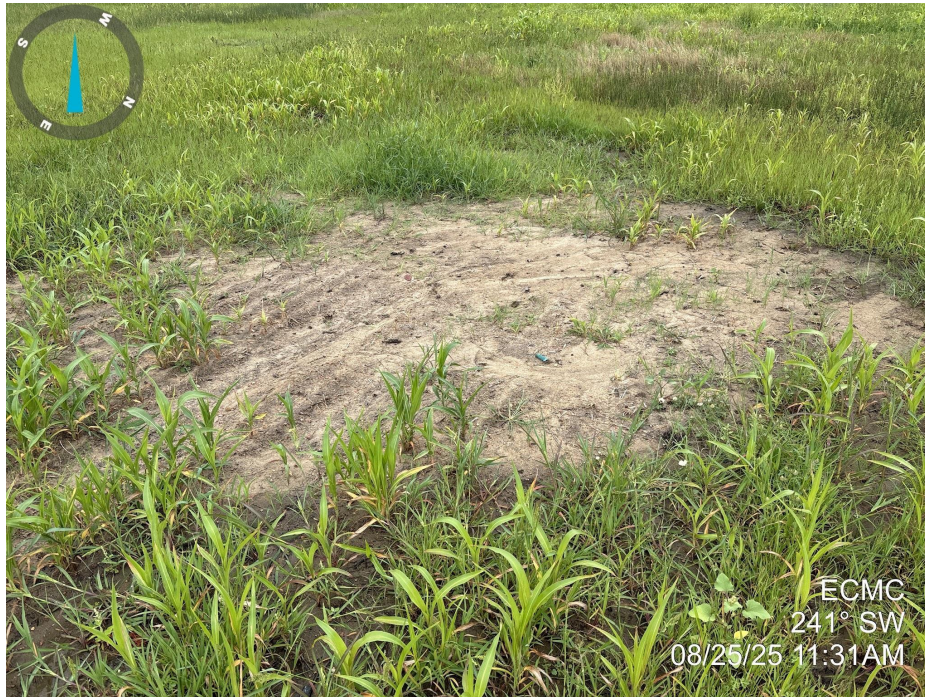
Photo 5. Photo taken of the multi-well location, of HSR-KATZEN #16-1A (API# 123-15101), facing southwest. Photo illustrates that final reclamation activities have taken place, with evidence of drill row seeding, but bare ground remains at the well location.

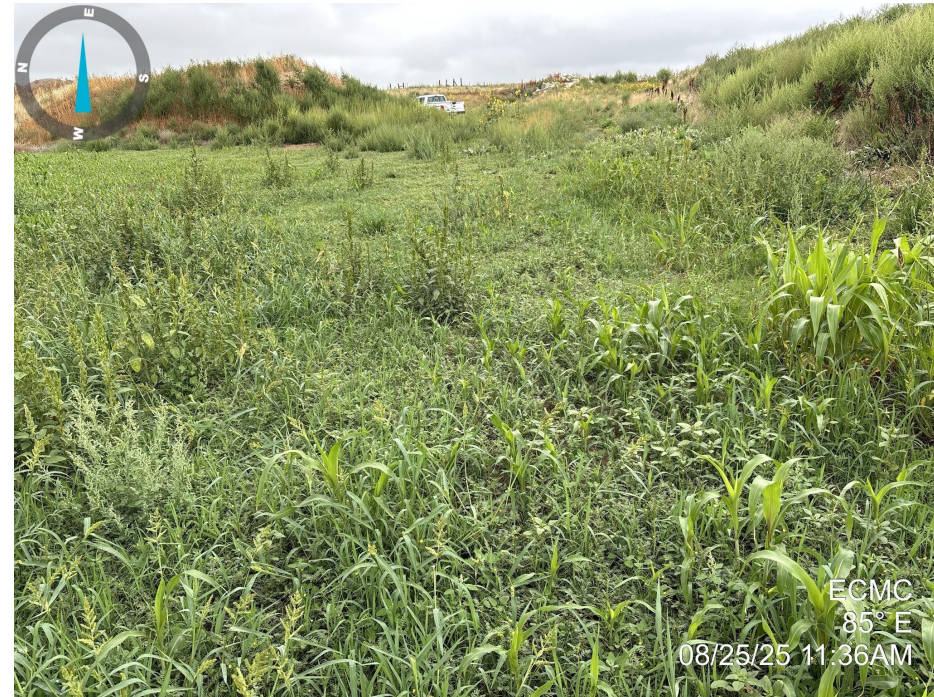
Photo 6. Photo taken of the access road to the multi-well location, facing east, away from the location. Photo illustrates that final reclamation activities have taken place. However, weedy annual vegetation including puncture vine (*Tribulus terrestris*) was observed across the location.

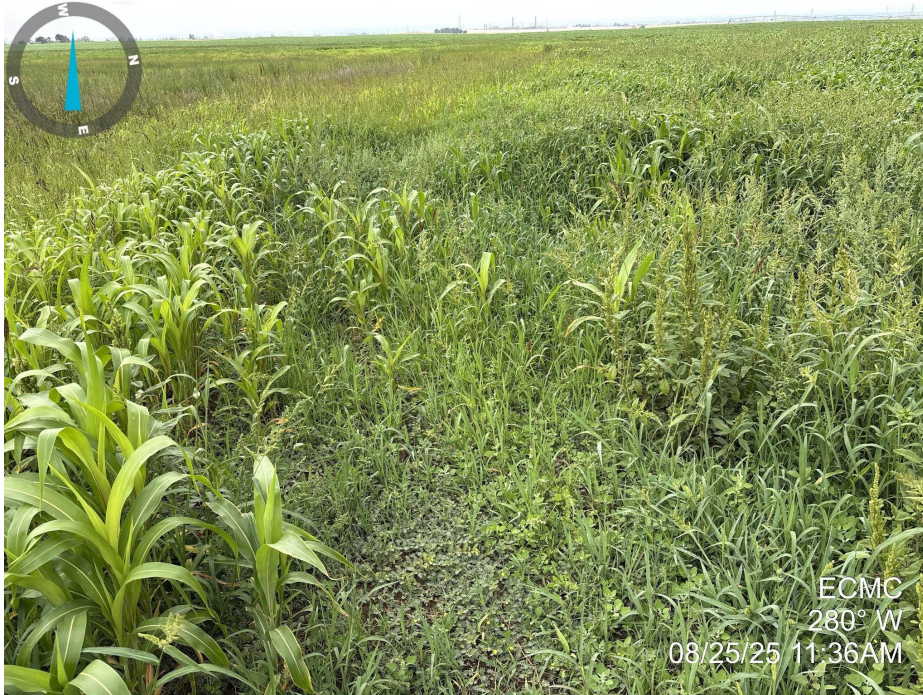
Photo 7. Photo taken of the access road to the multi-well location, facing west, towards the location. See comments under Photo 6.

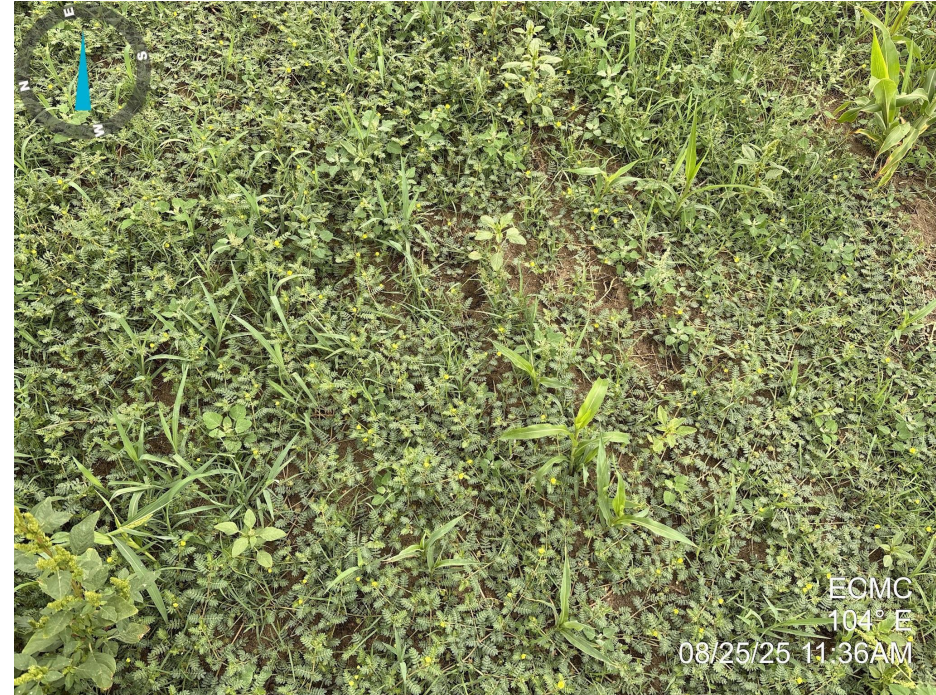
Photo 8. Photo taken of ground cover along the access road. Photo illustrates puncture vine (*Tribulus terrestris*), a List C Noxious Weed species.

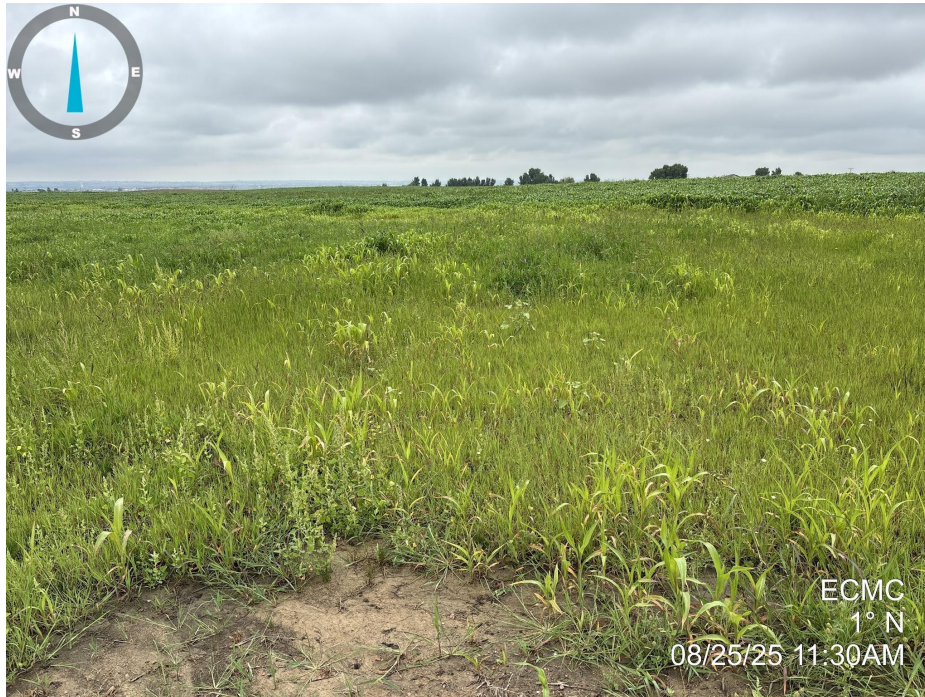
Photo 9. Photo taken from the multi-well location, from ROCKY MOUNTAIN #37-1 (API# 123-24263), facing north. Photo illustrates that final reclamation activities have taken place, but vegetation establishment does not meet Rule 1004 standards and bare ground was observed at the well site.

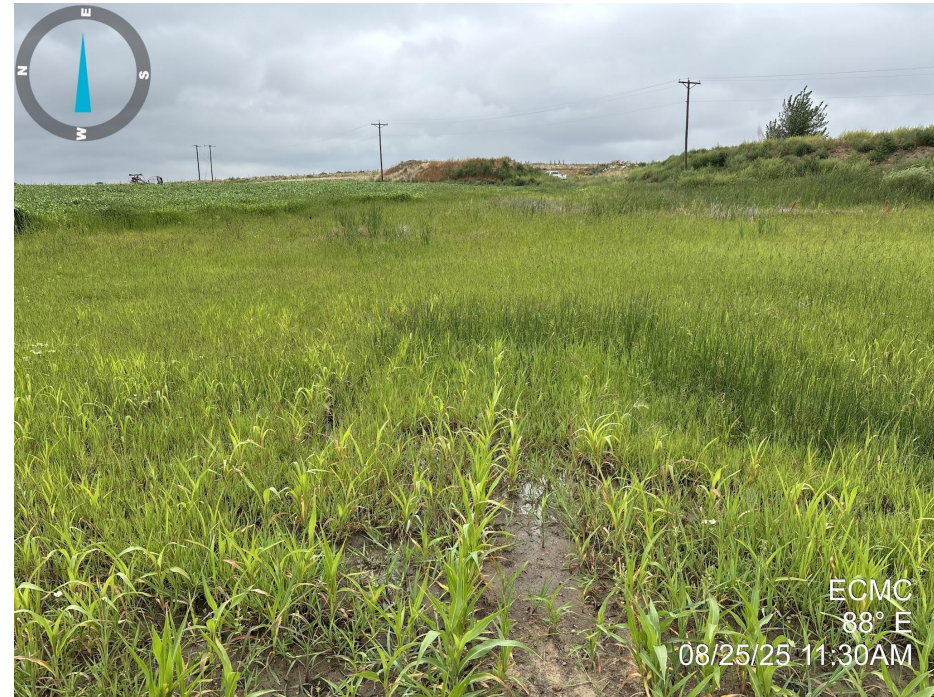
Photo 10. Photo taken from the multi-well location, from ROCKY MOUNTAIN #37-1 (API# 123-24263), facing east. See comments under Photo 9.

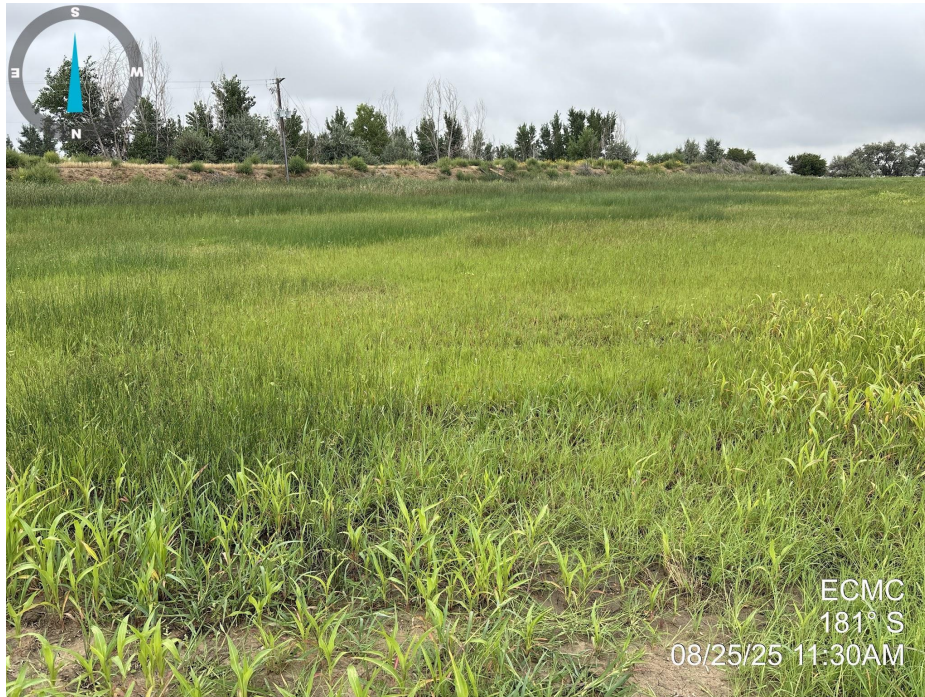
Photo 11. Photo taken from the multi-well location, from ROCKY MOUNTAIN #37-1 (API# 123-24263), facing south. See comments under Photo 9.

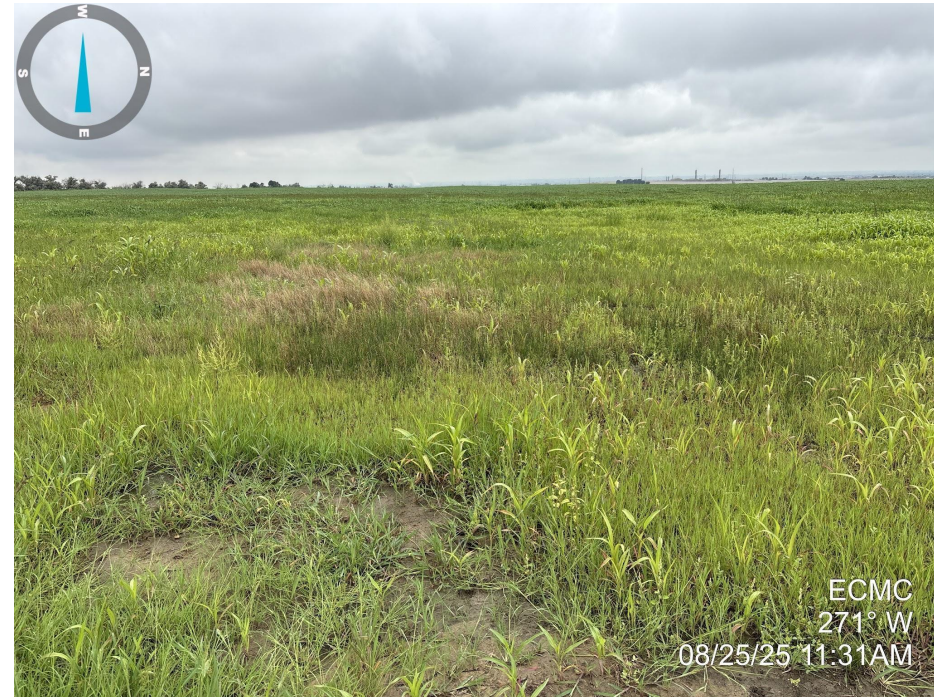
Photo 12. Photo taken from the well location, from ROCKY MOUNTAIN #37-1 (API# 123-24263), facing west. See comments under Photo 9.

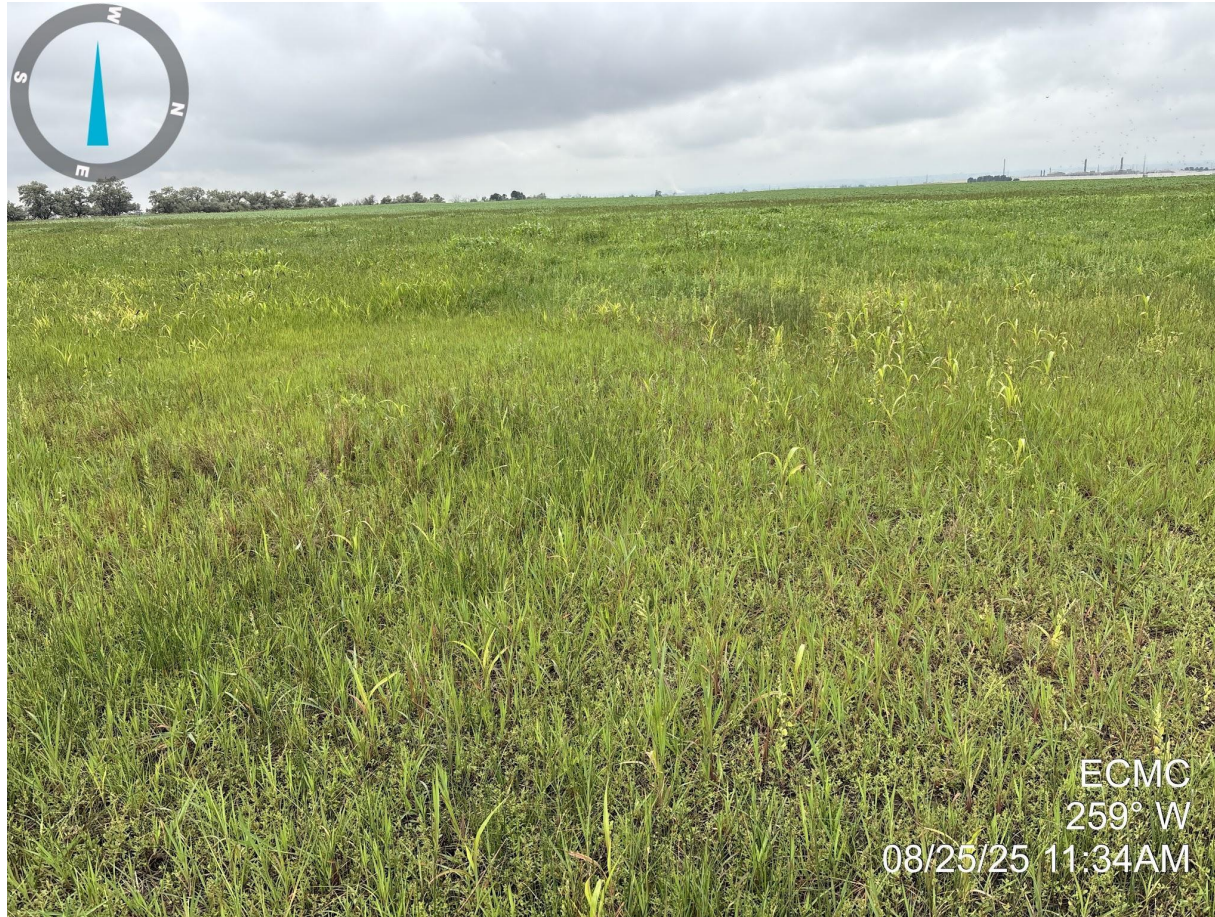
Photo 13. Photo taken of the reference area, west of the location, facing west.
Photo illustrates perennial grass vegetation.
