# Inspection/Audit Photos

Location Name: QB ENERGY OPERATING LLC CHEVRON 42A-8D (PARACHUTE CREEK 6 696)

Location #: 335795

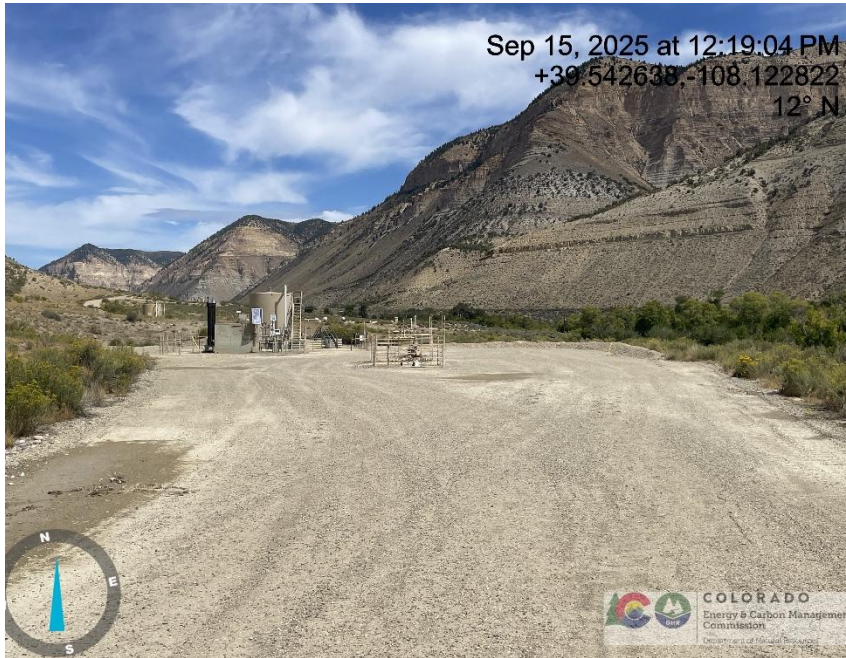
Photo # 8499 From entrance to location

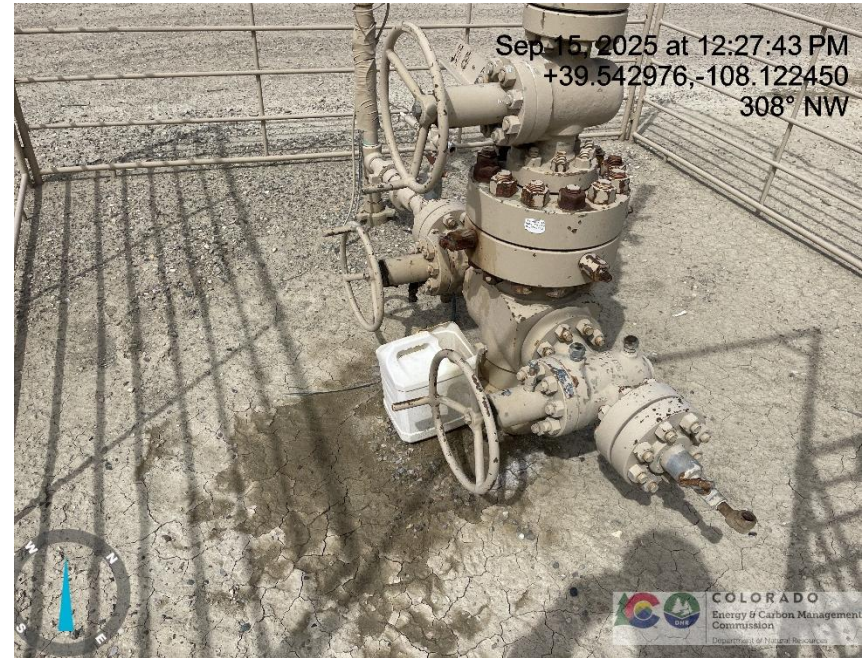
Photo # 8504 Mechanical Condition - Possible leak on tubing hanger lock pin

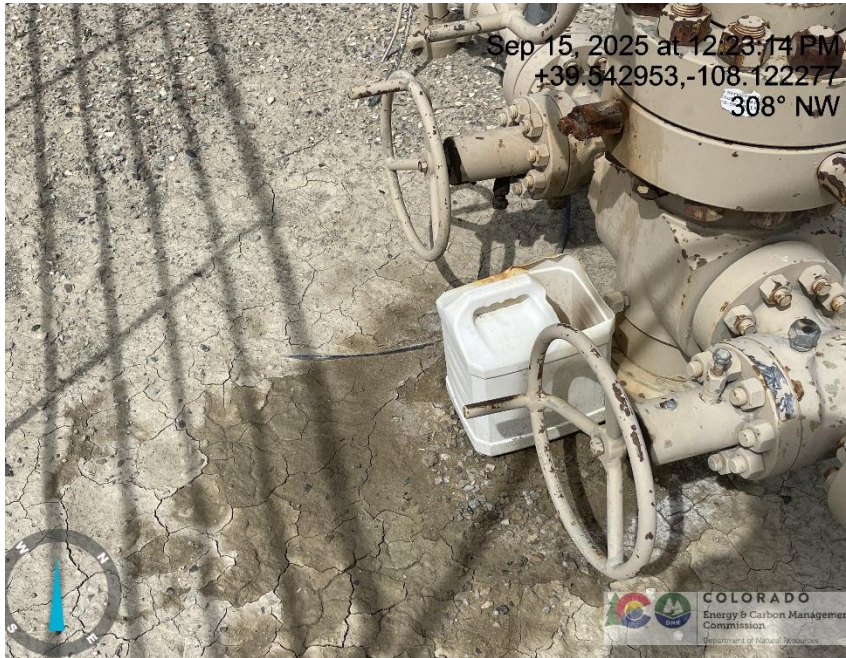
Photo # 8505 Mechanical Condition - Possible leak on tubing hanger lock pin

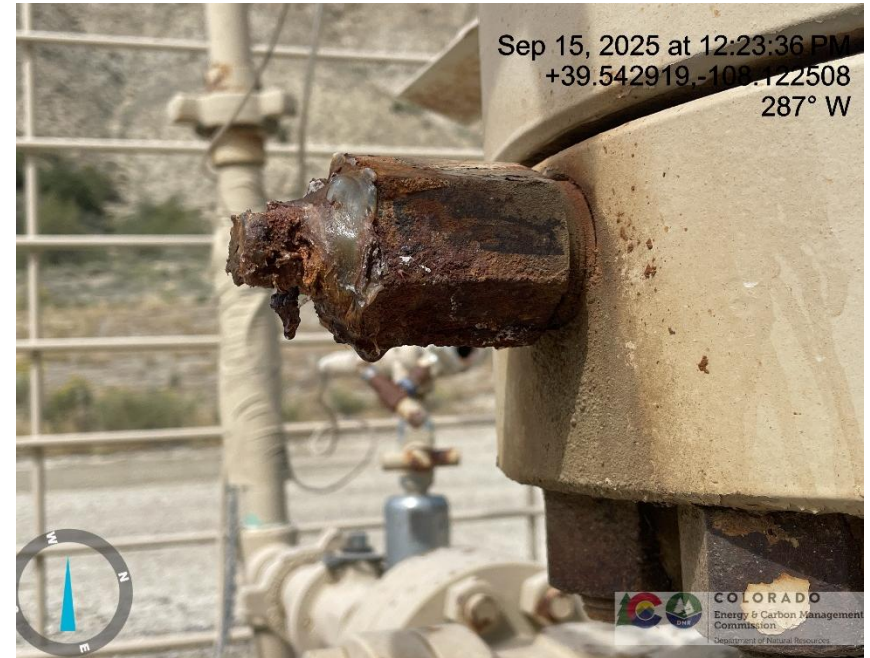
Photo # 8506 Mechanical Condition - Possible leak on tubing hanger lock pin

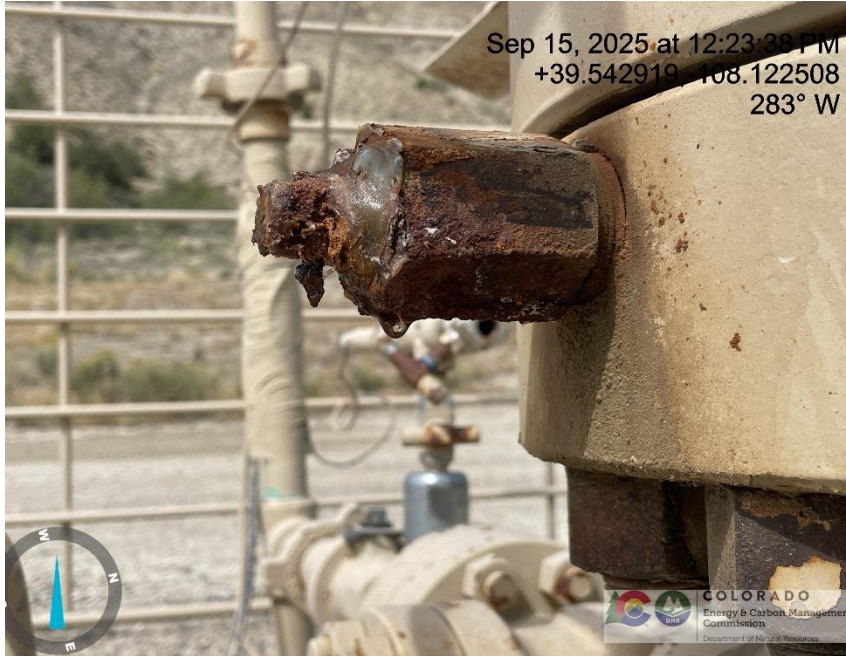
**Photo # 8507 Mechanical Condition - Possible leak on tubing hanger lock pin**

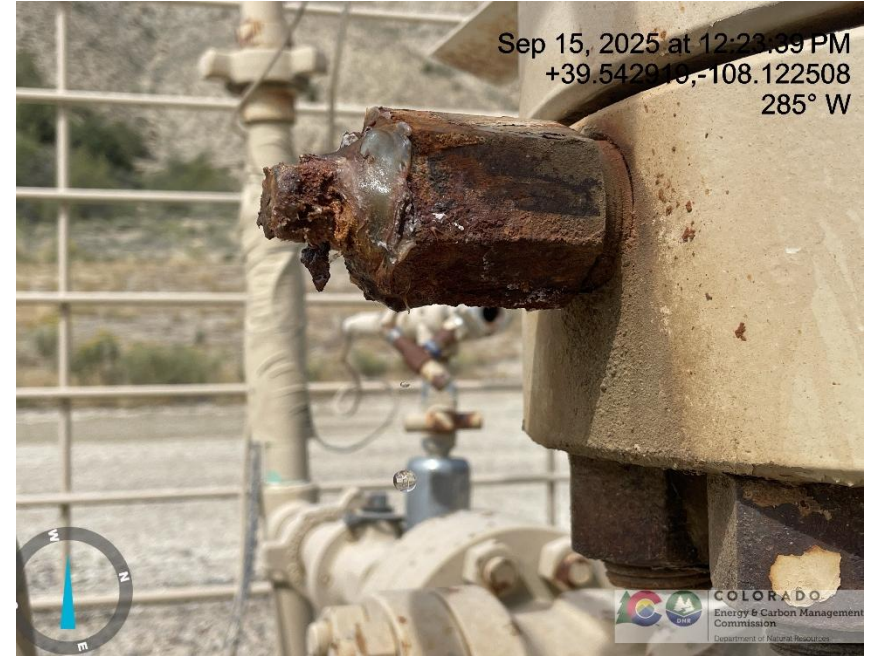
**Photo # 8508 Mechanical Condition - Possible leak on tubing hanger lock pin**

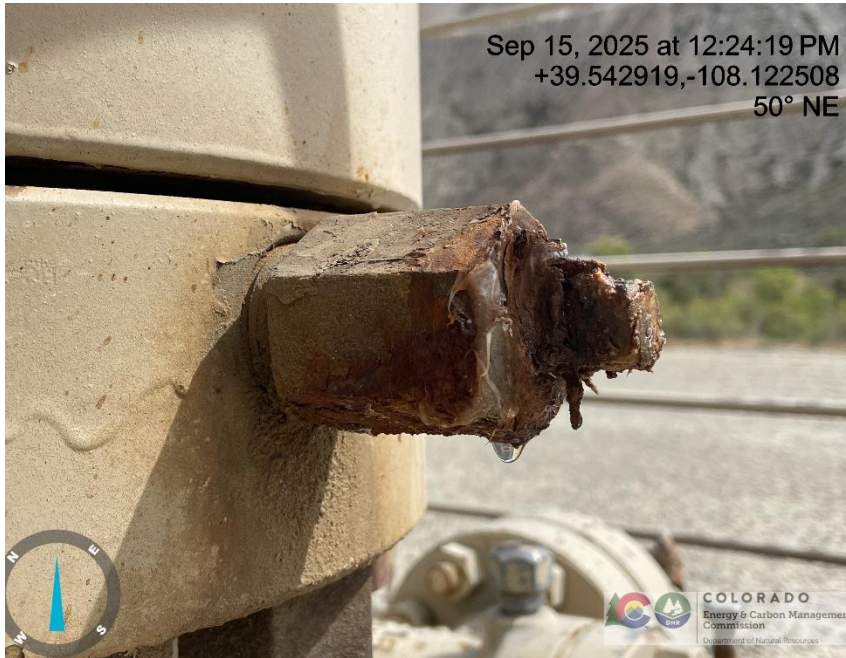
**Photo # 8509 Mechanical Condition - Possible leak on tubing hanger lock pin**

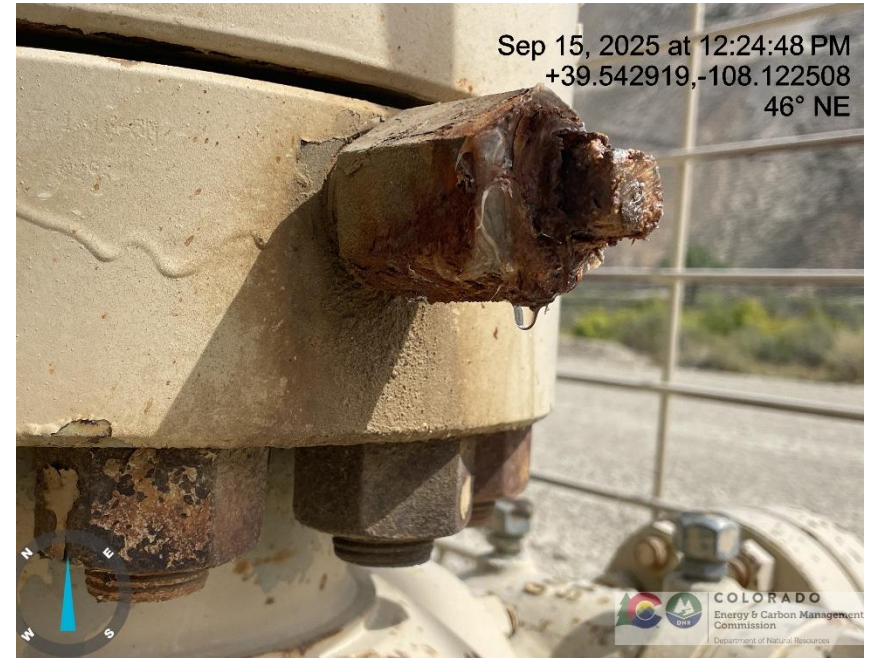
**Photo # 8510 Mechanical Condition - Possible leak on tubing hanger lock pin**

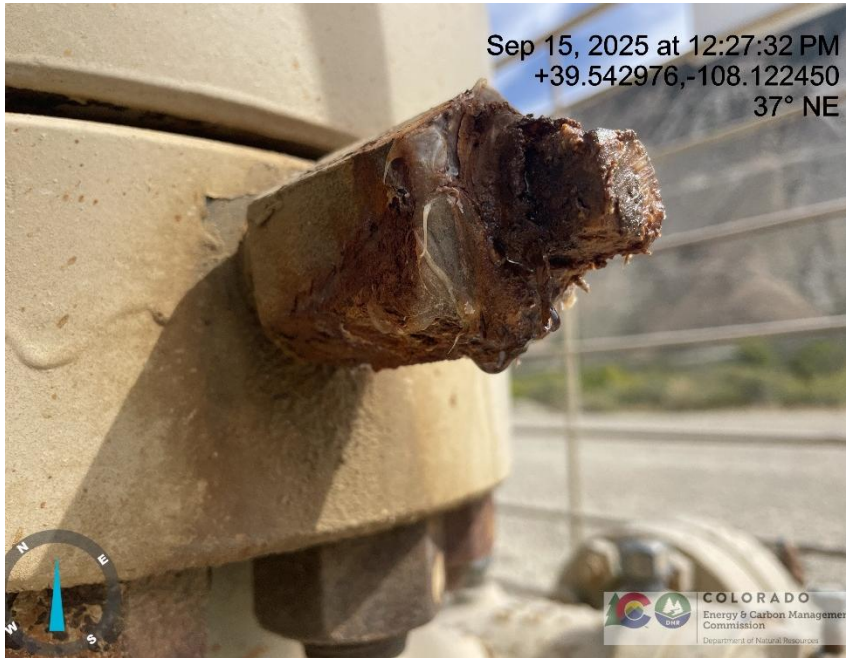
Photo # 8511 Mechanical Condition - Possible leak on tubing hanger lock pin

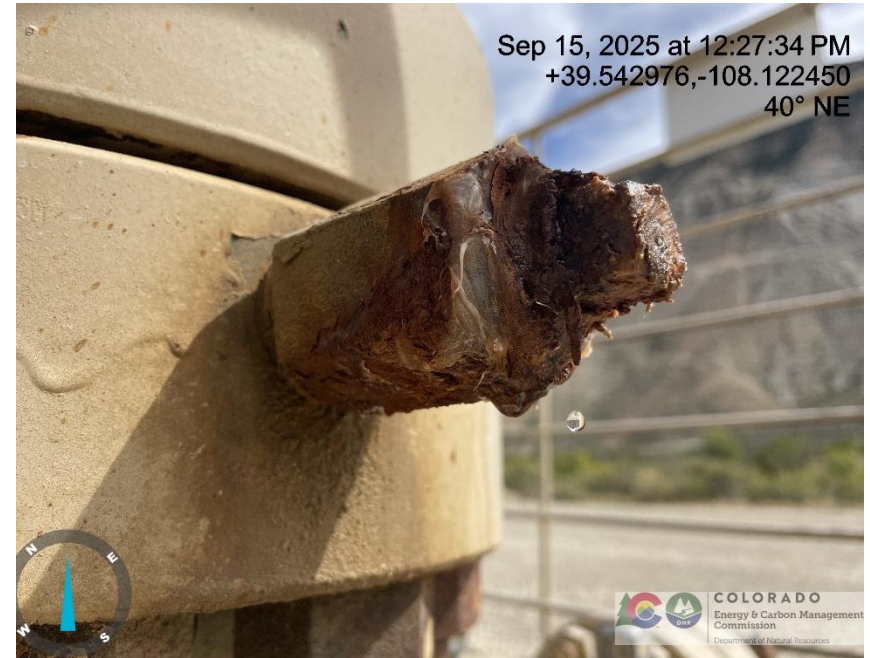
Photo # 8512 Mechanical Condition - Possible leak on tubing hanger lock pin

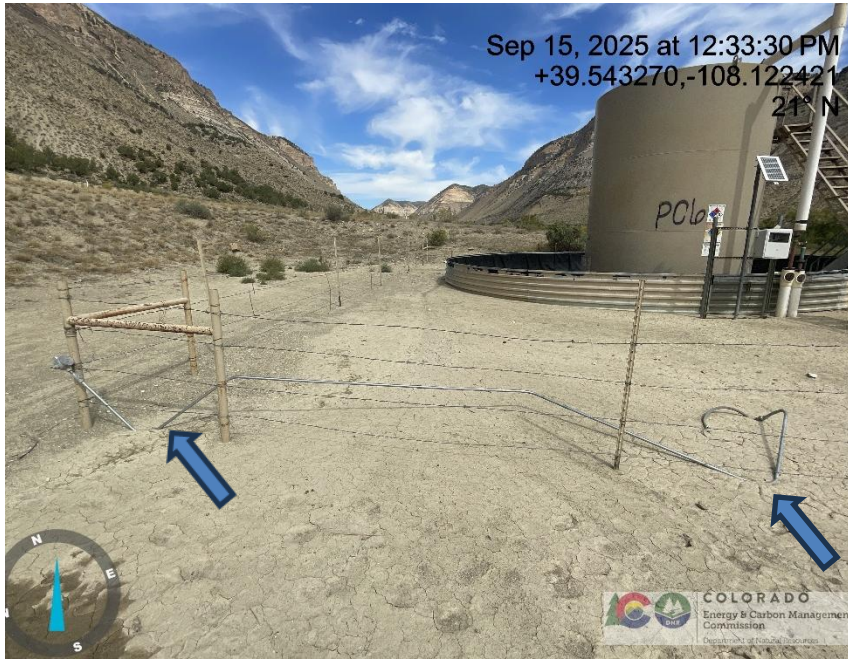
Photo # 8513 Debris

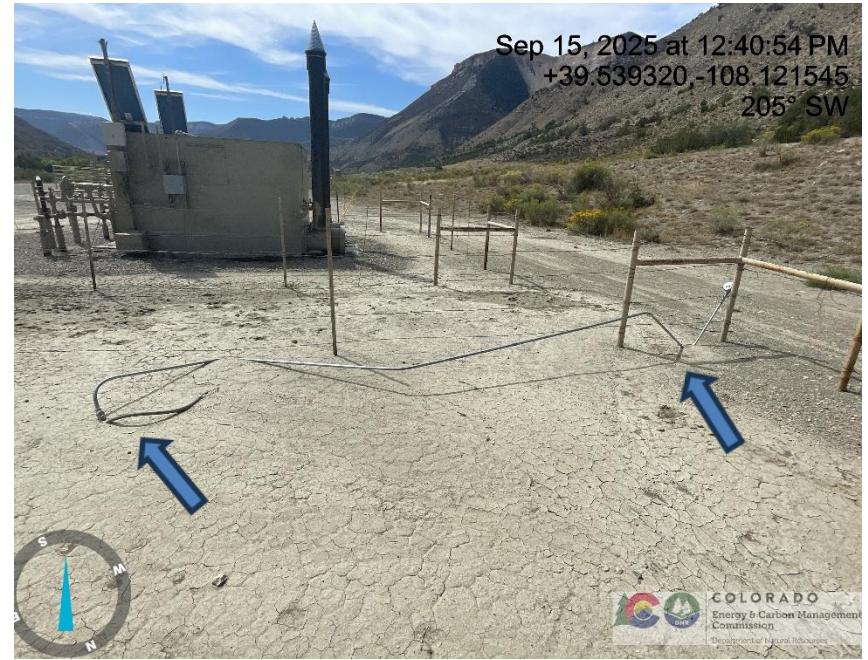
Photo # 8514 Debris
