Frederick, CO, United States

ECMC : Environmental Inspection

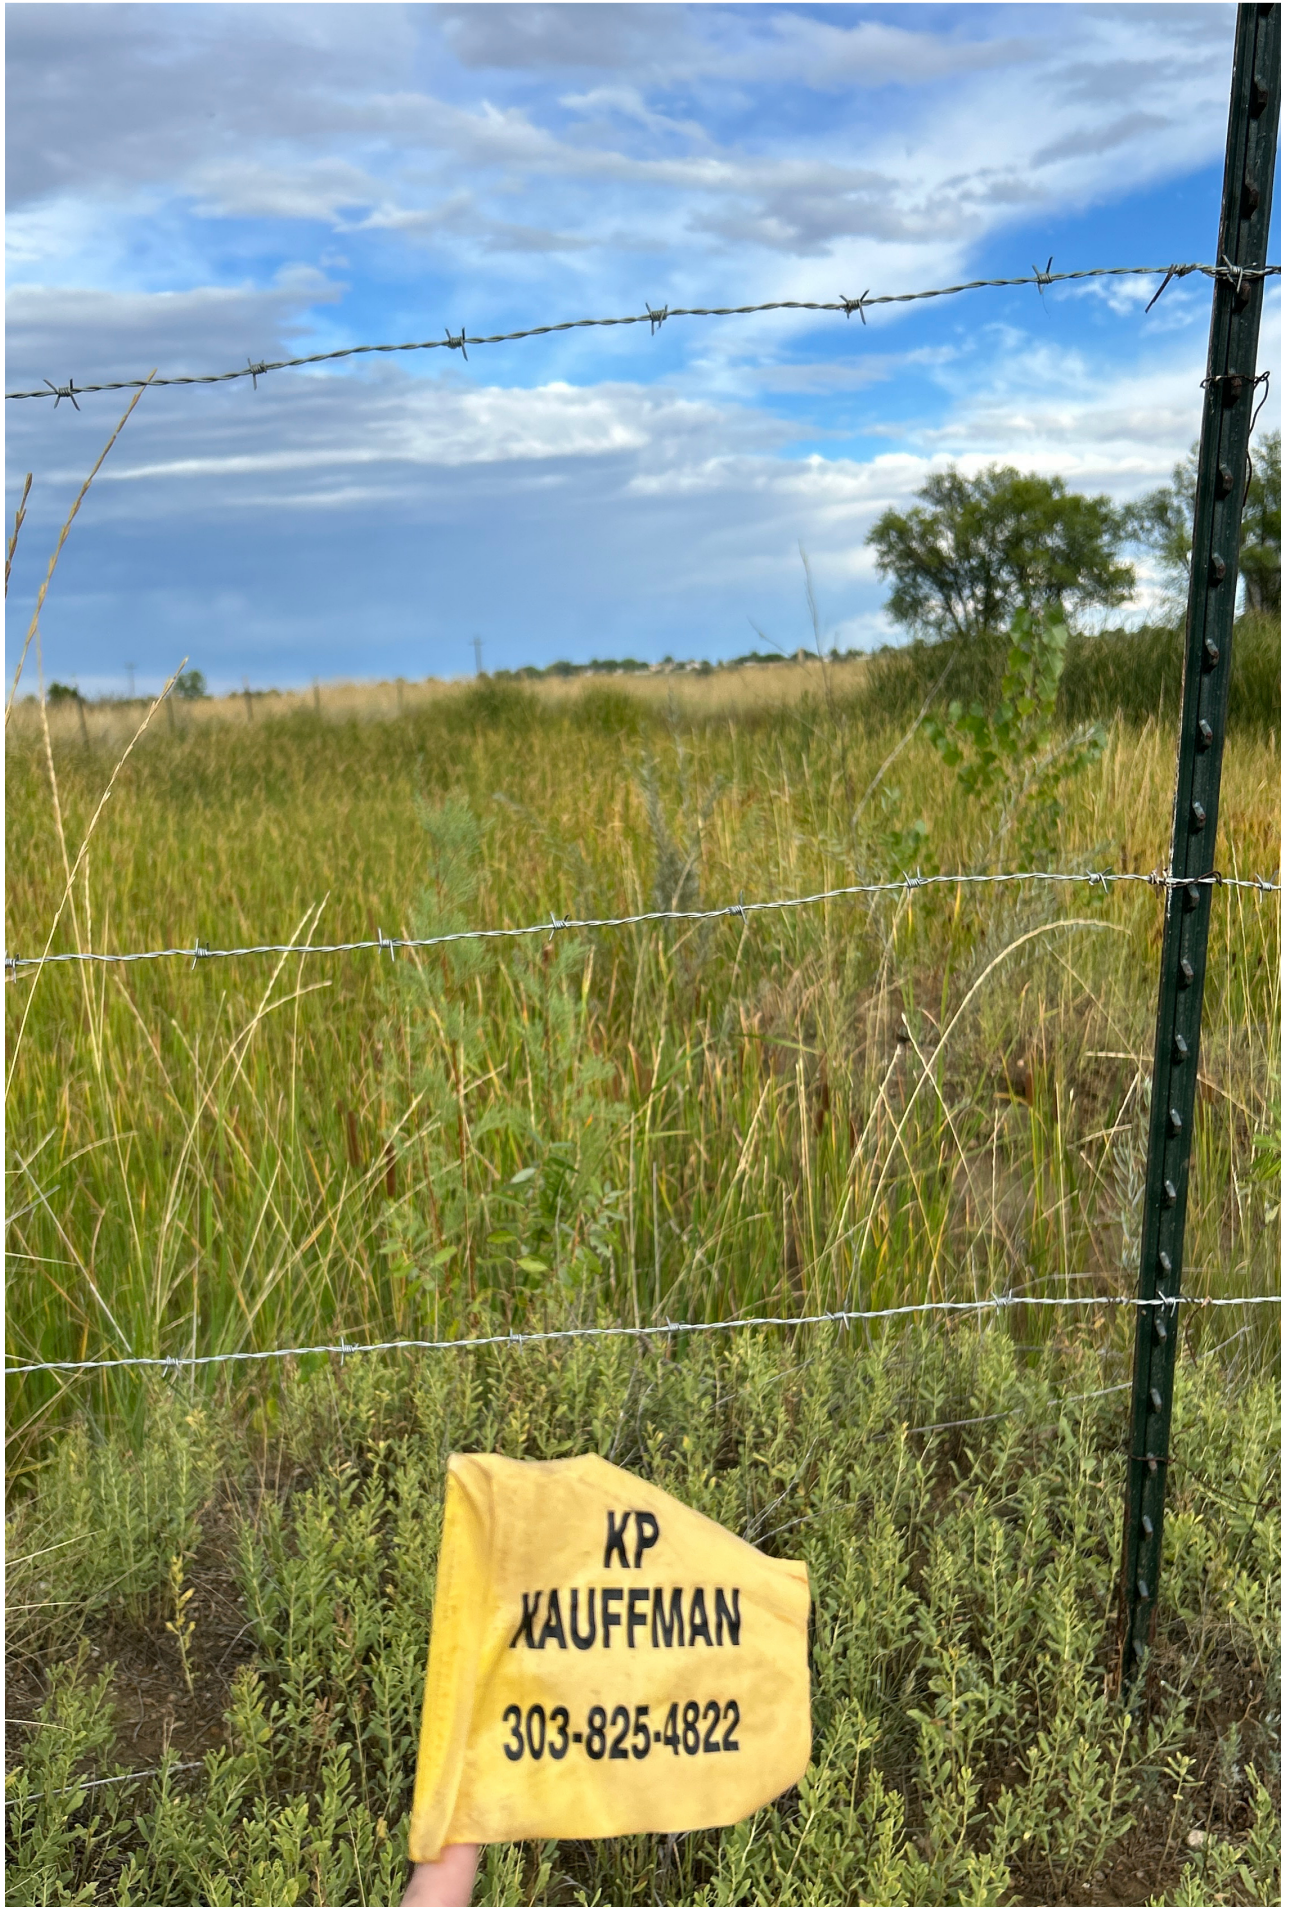
Multiple KP Kauffman underground utility pin flags and pipeline markers were observed east of the spill.

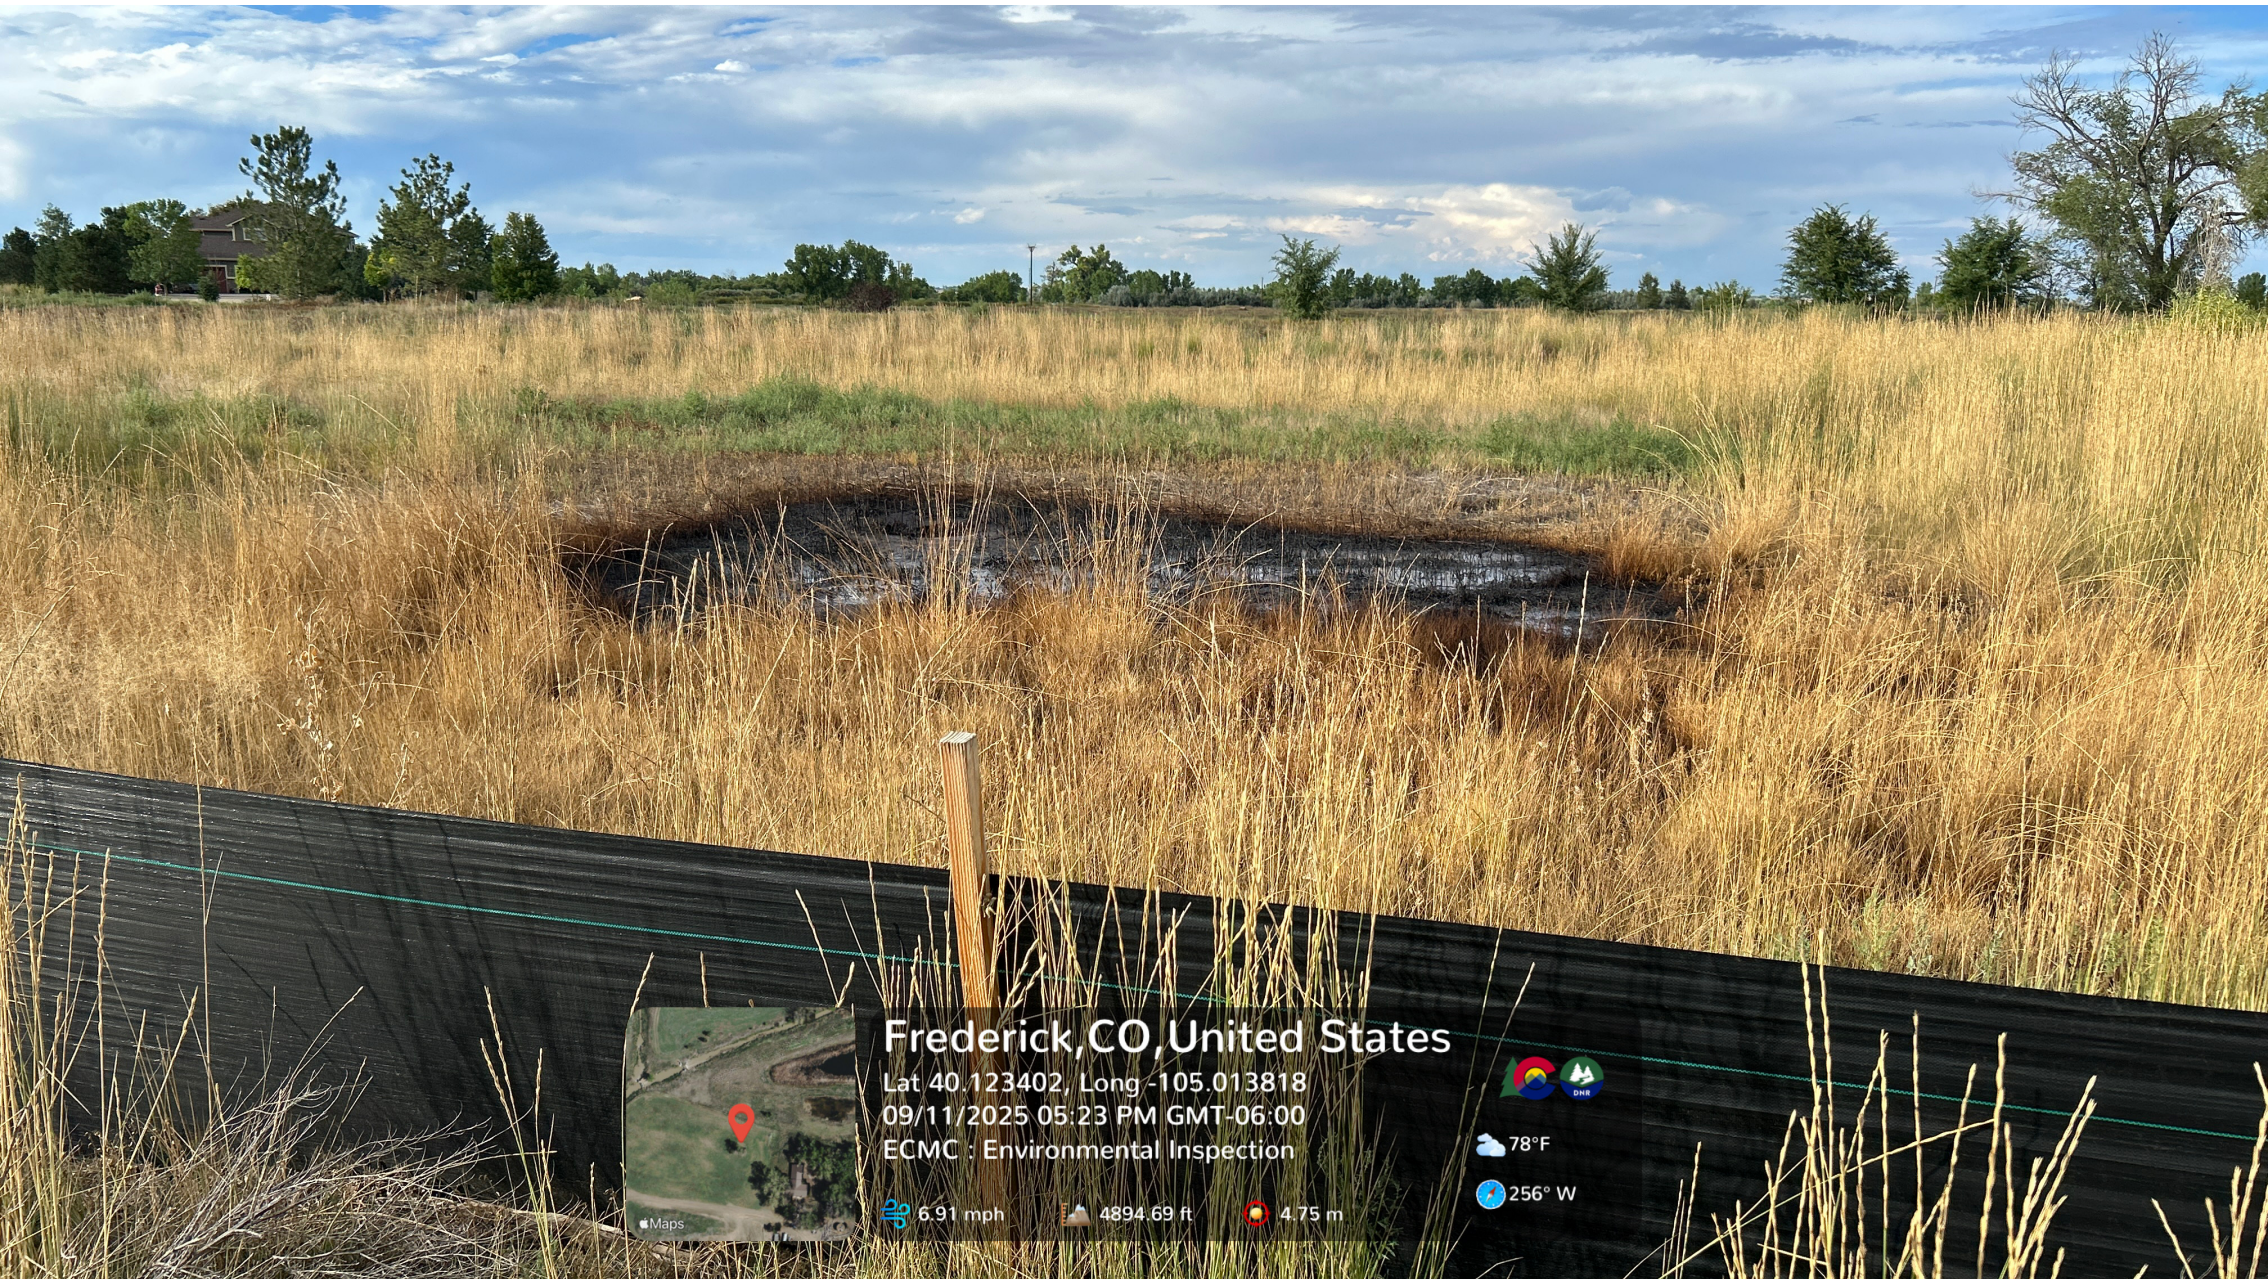
Petroleum hydrocarbon fluid has daylighted to the surface. Petroleum hydrocarbon fluid has pooled on the surface and has saturated vegetation.

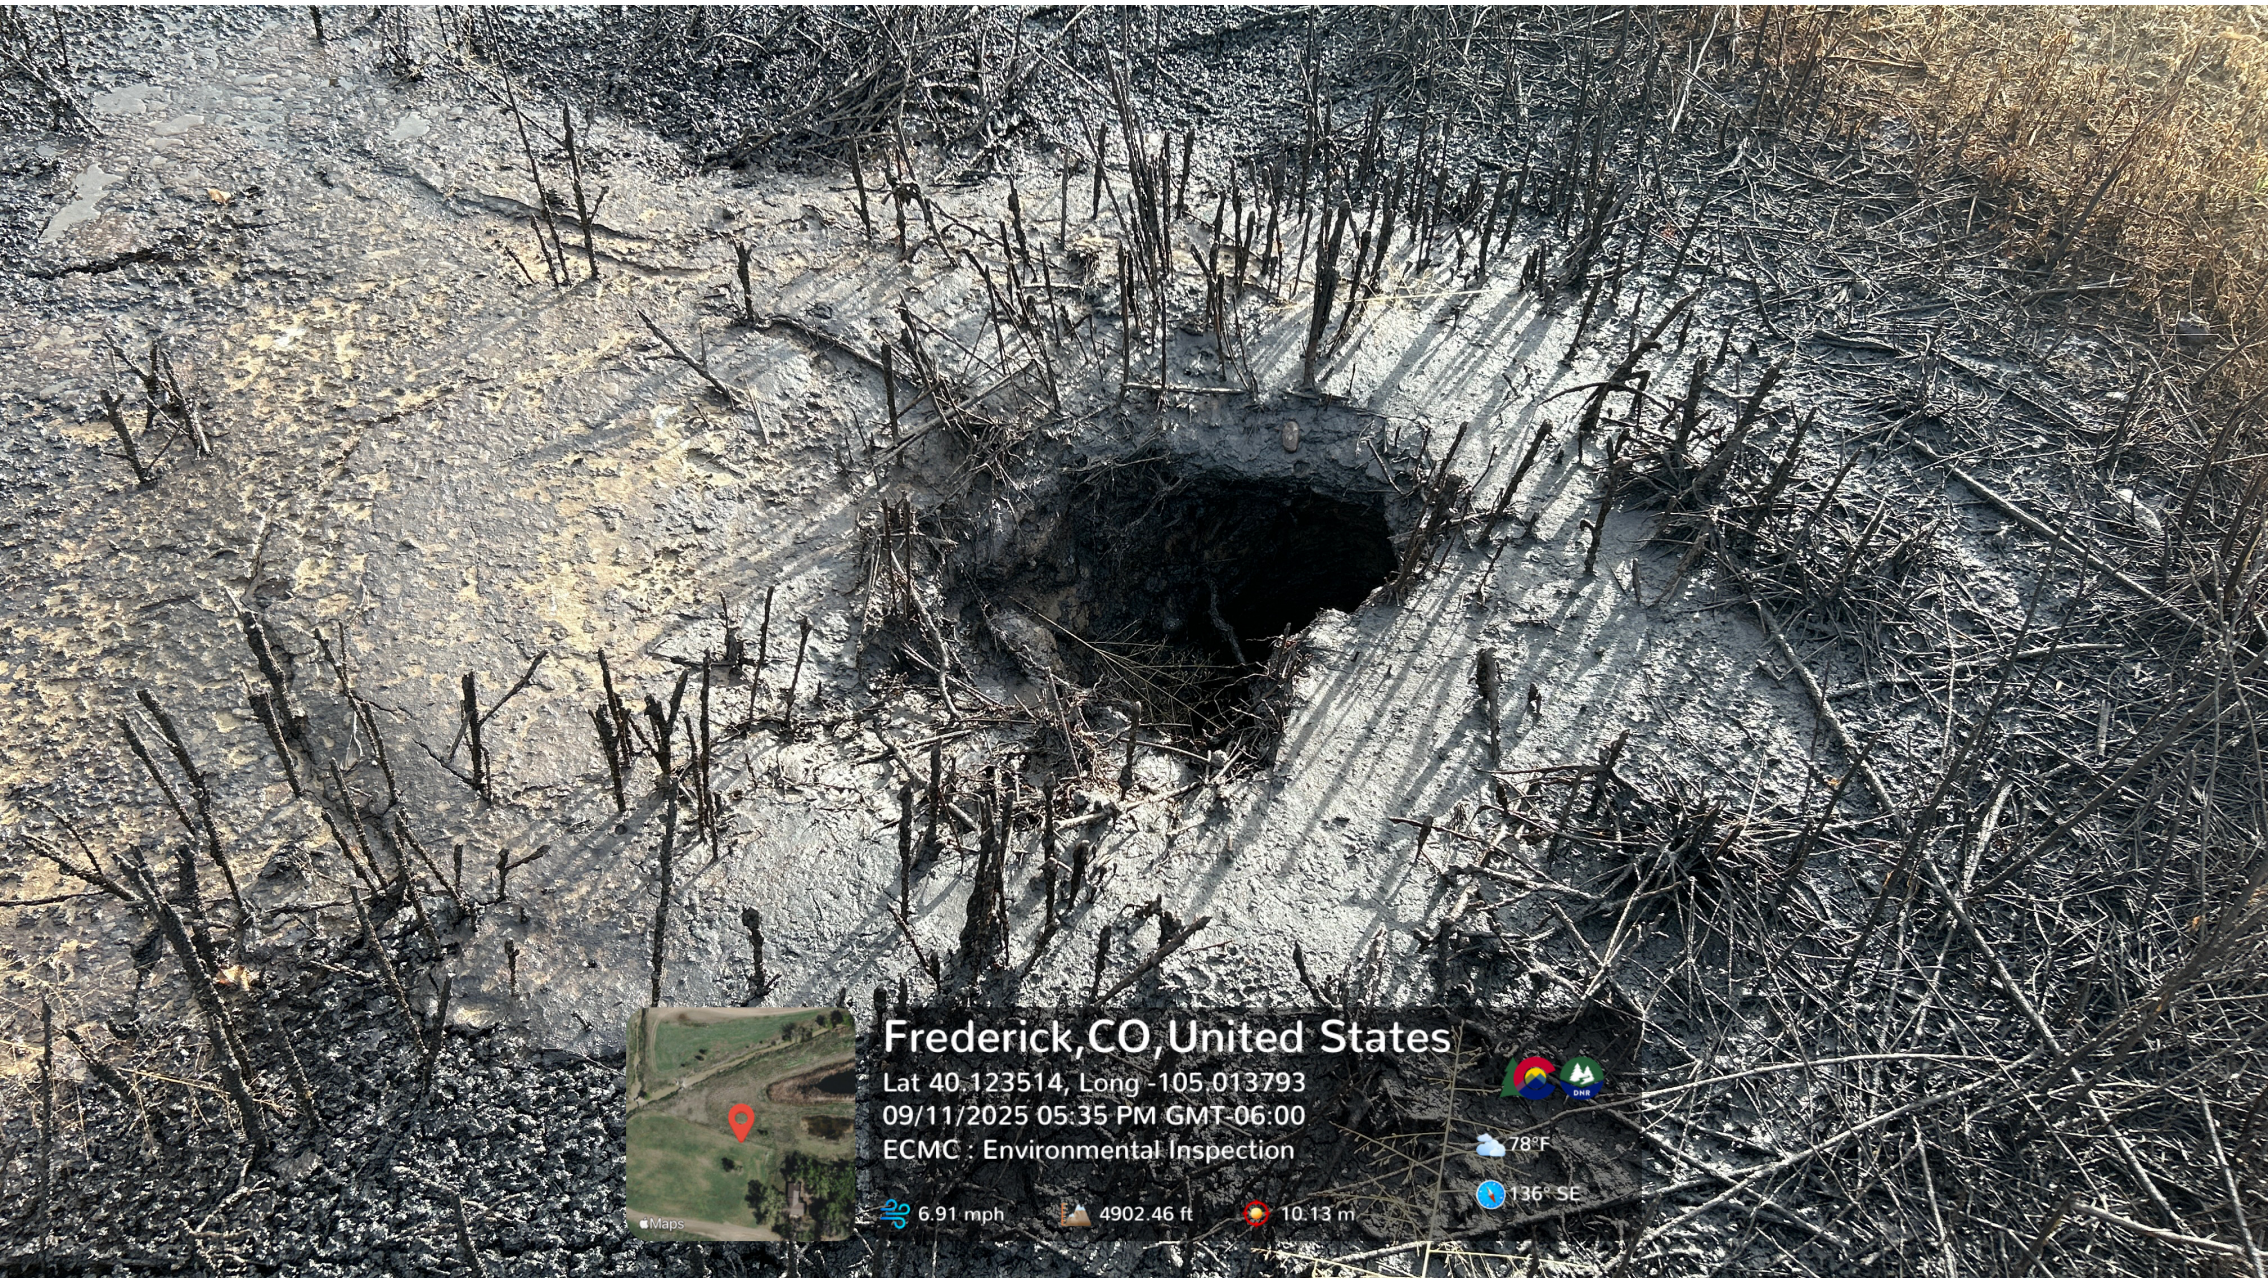
A hole is visible on the ground surface at the source of the spill.

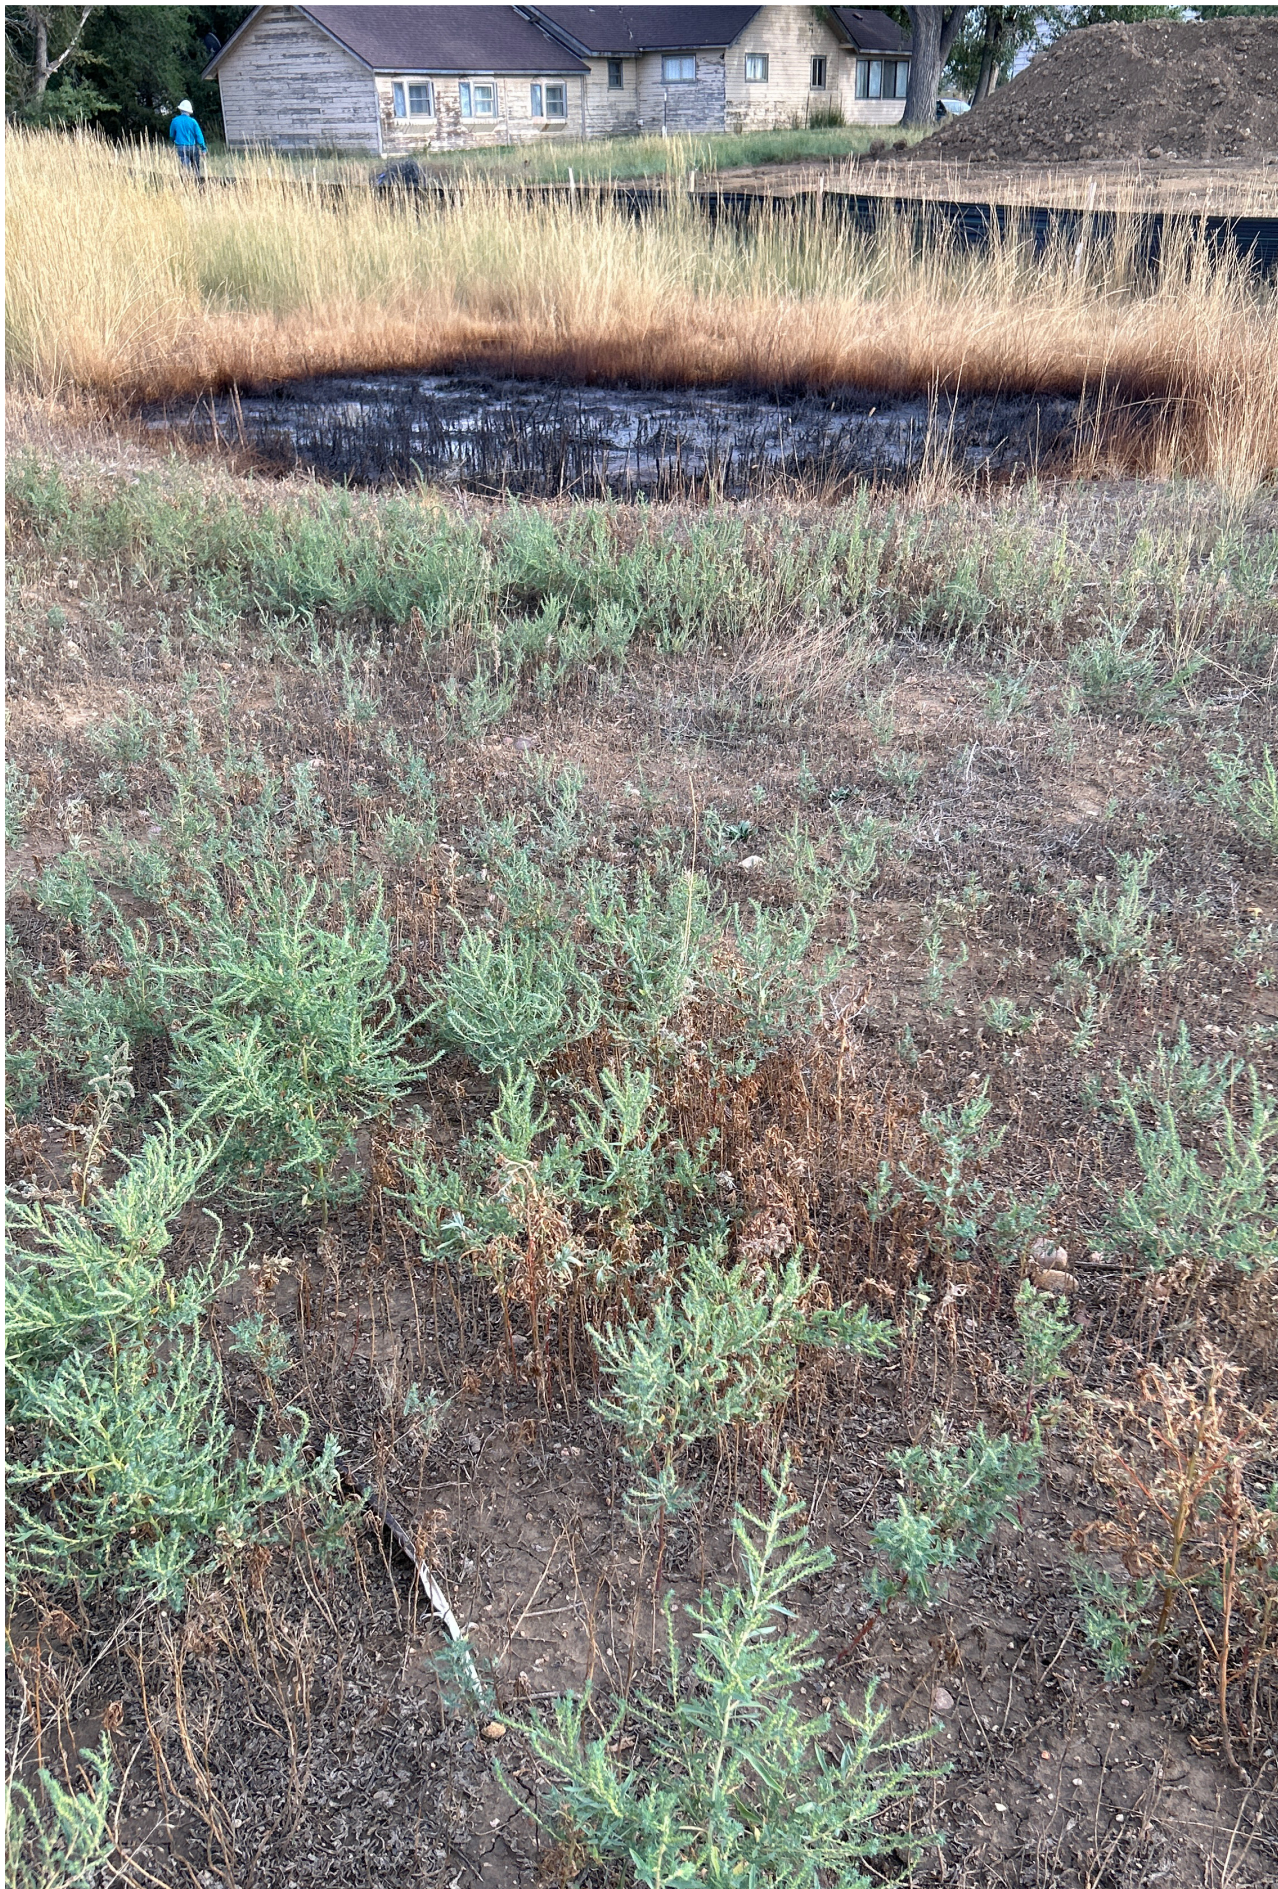
A bird feather is located in close proximity to the spill.

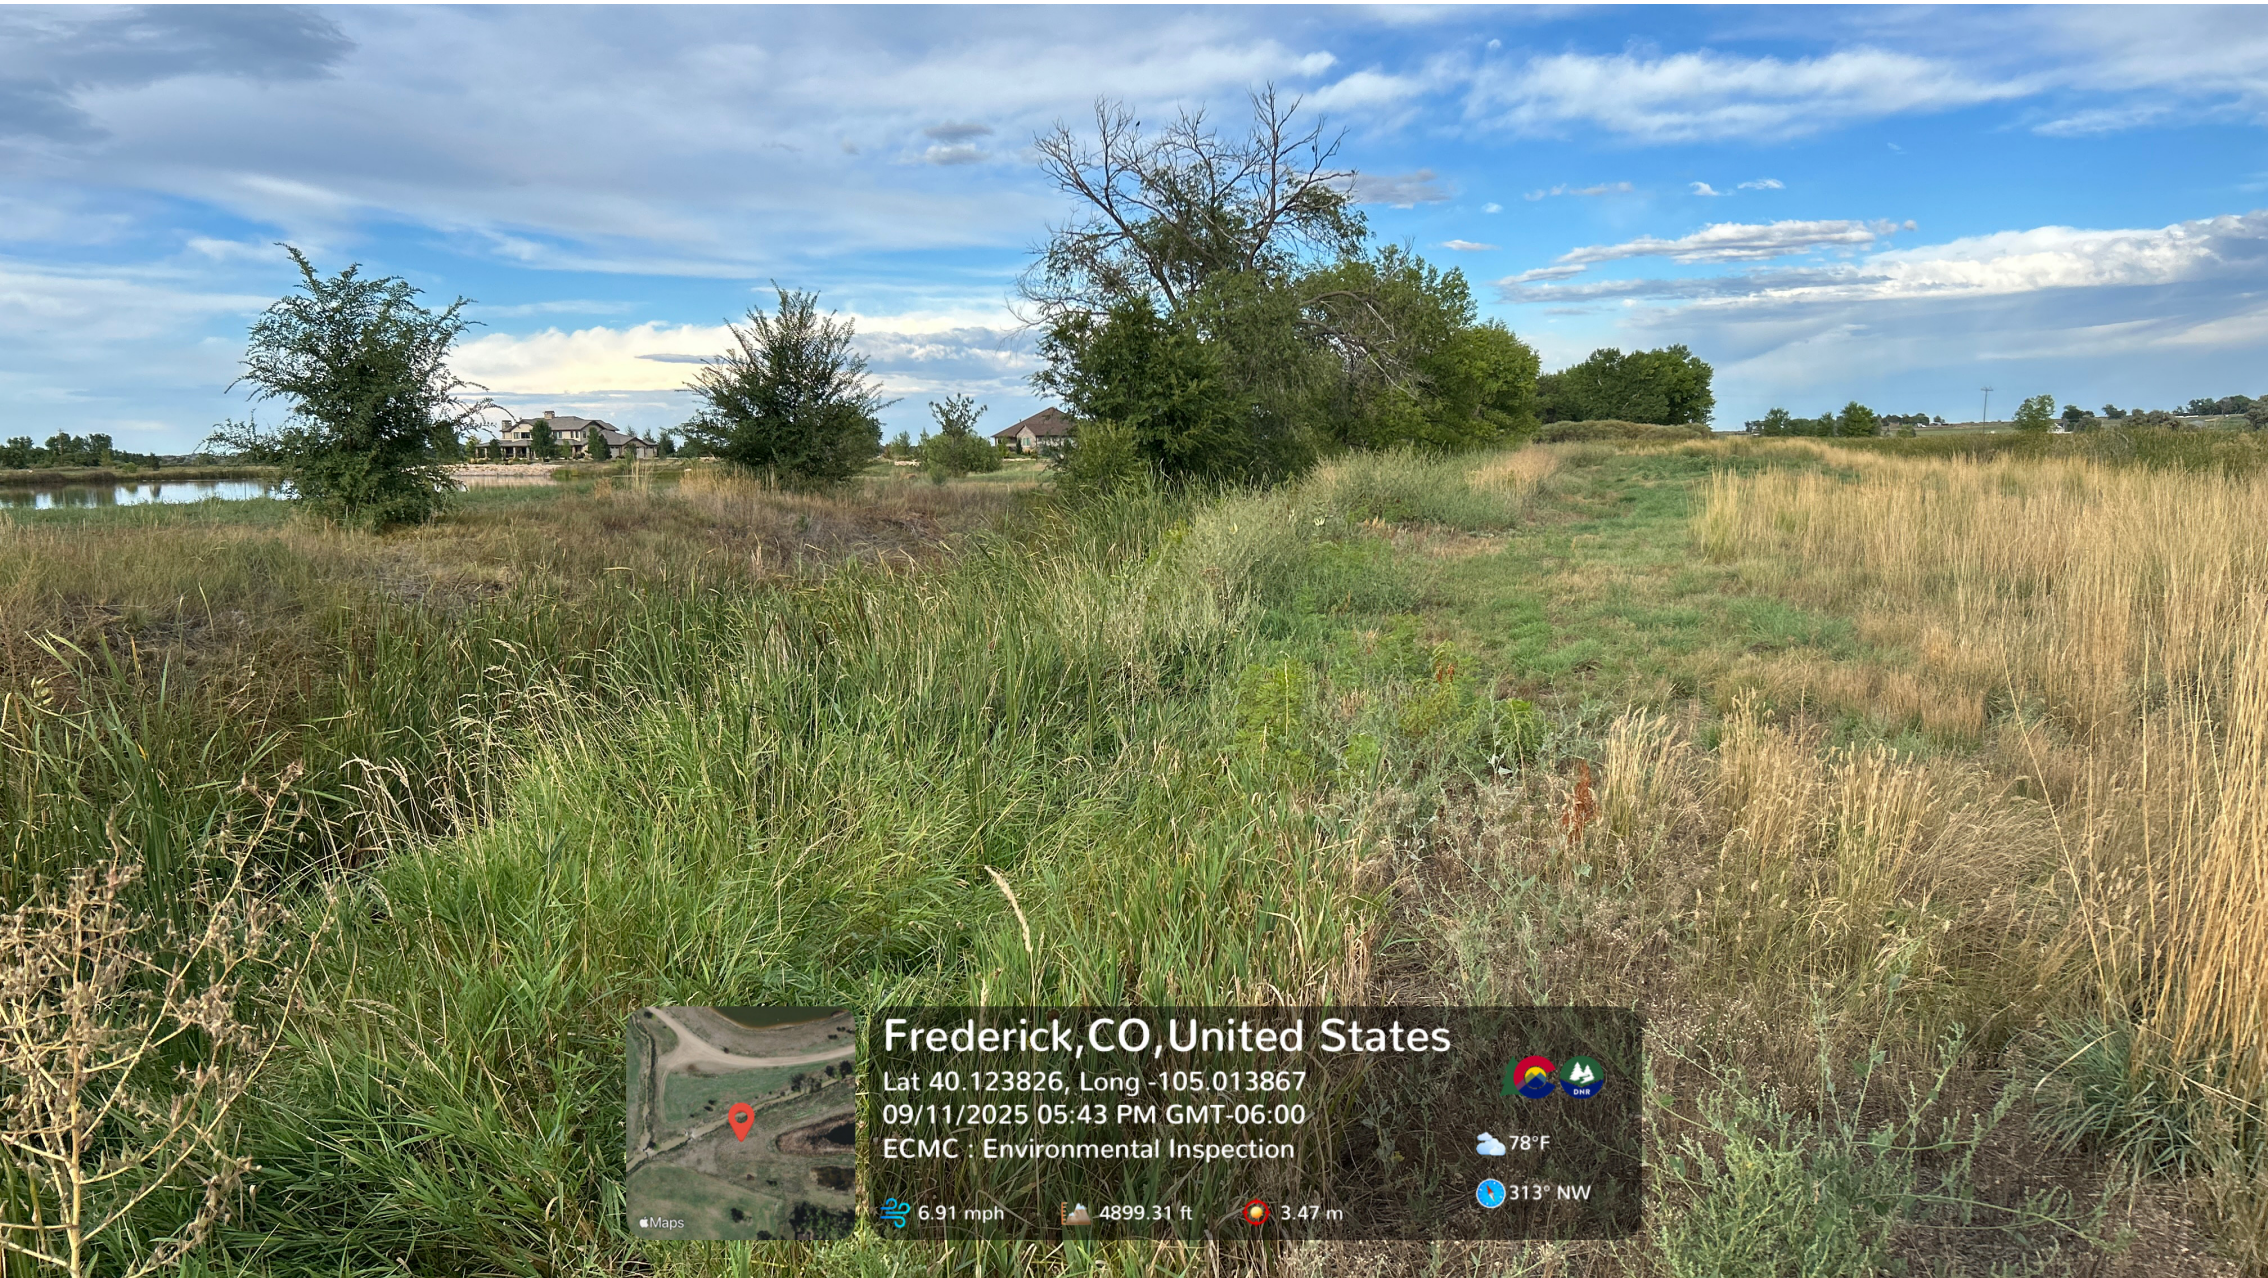
Looking at Idaho Creek and the Riverine Wetland.

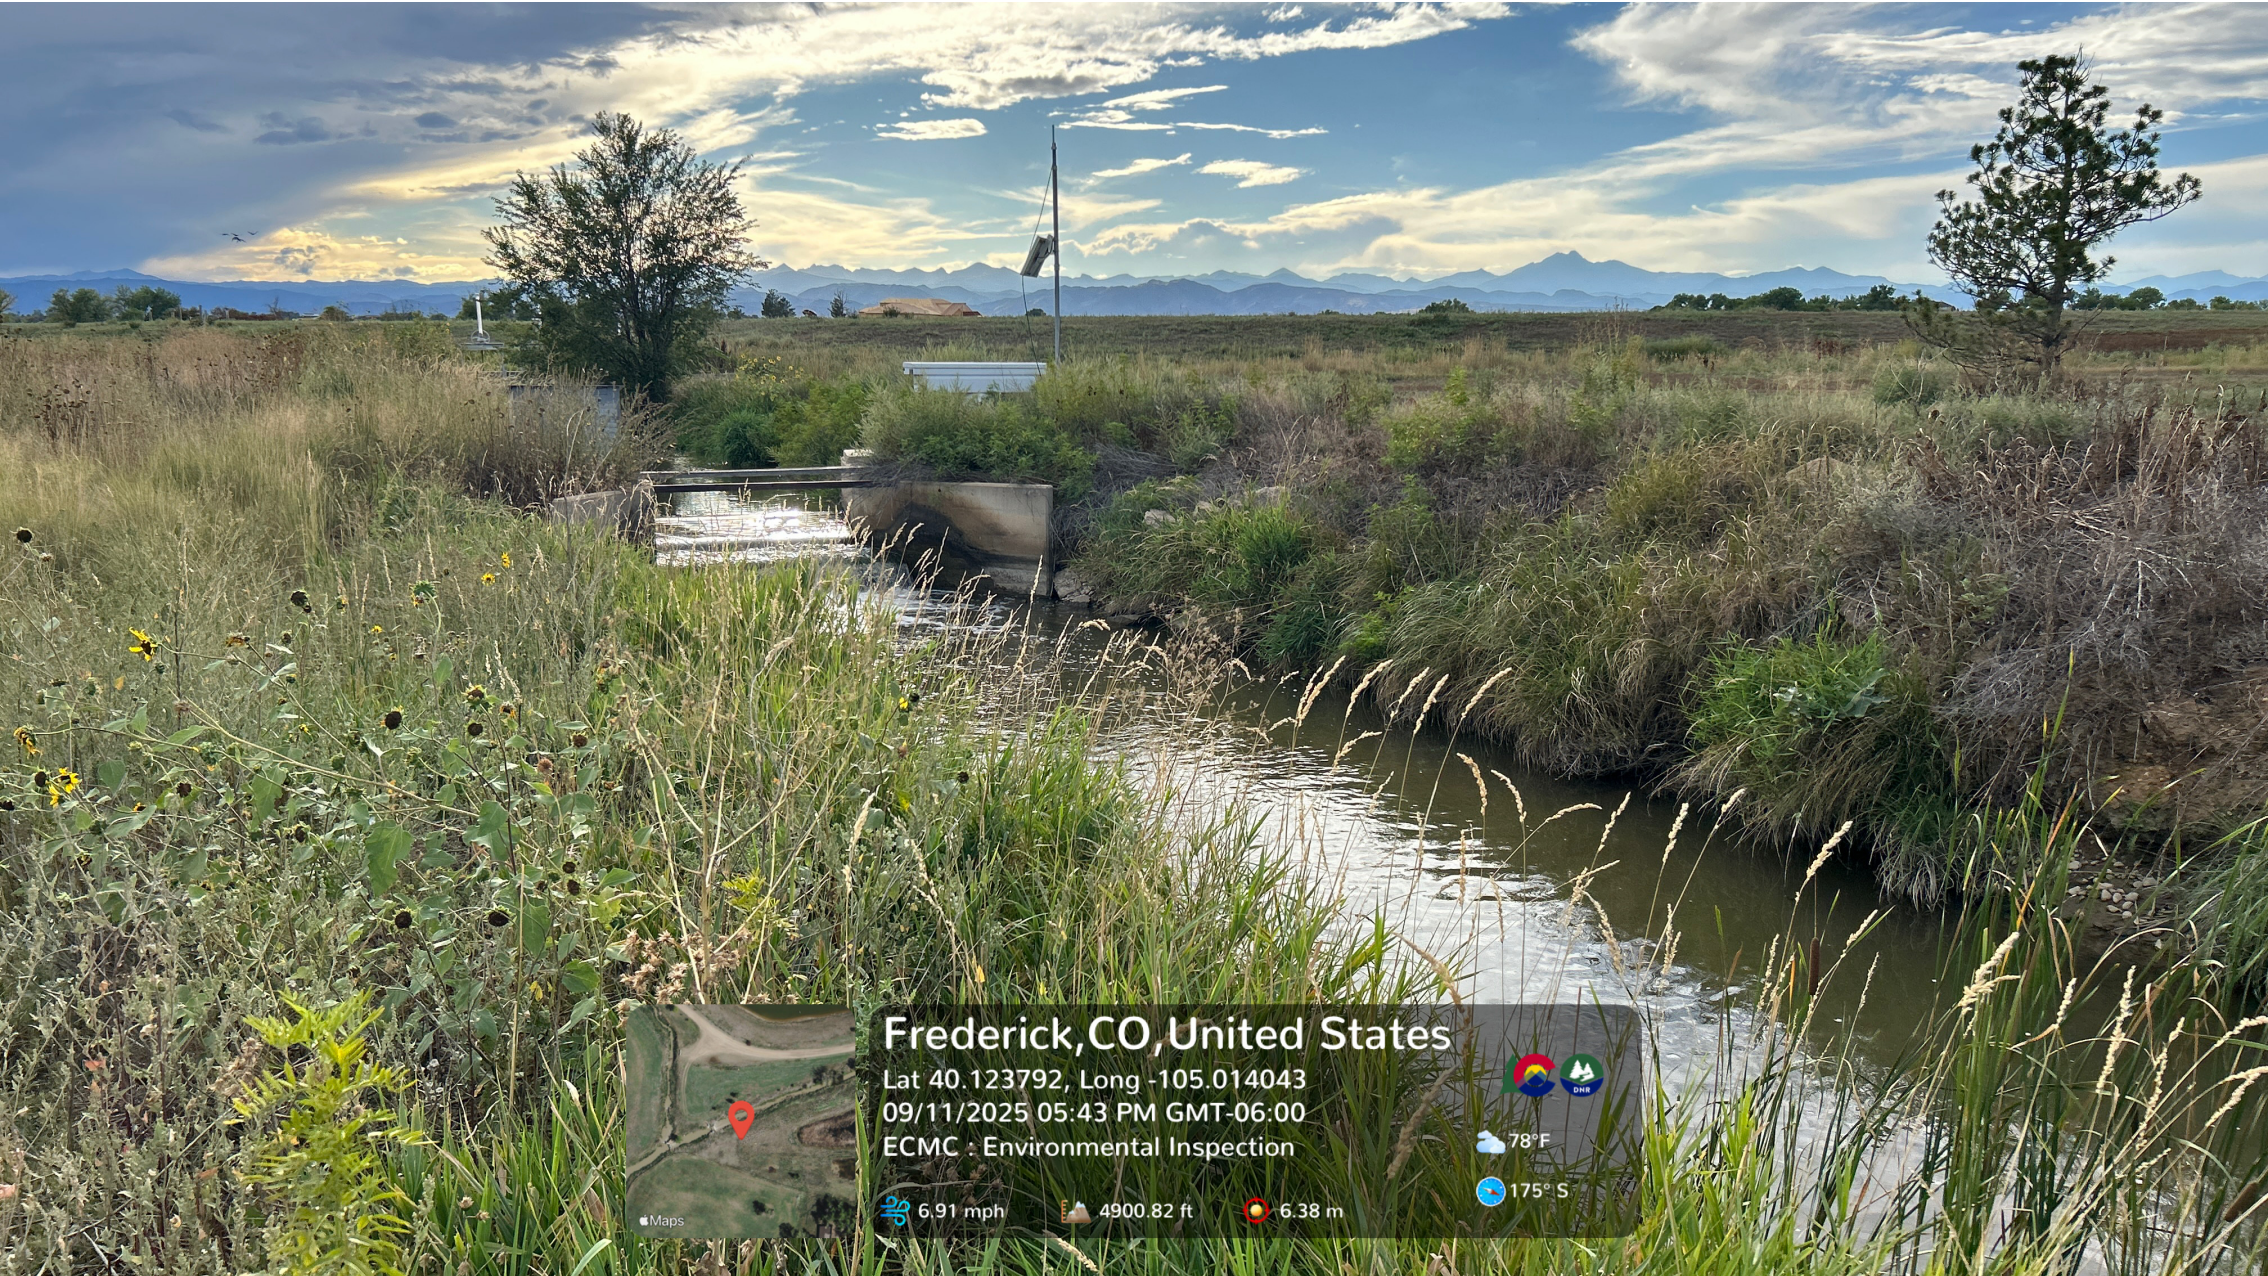
Idaho Creek was flowing at the time of the inspection; the channel appeared to be unlined.

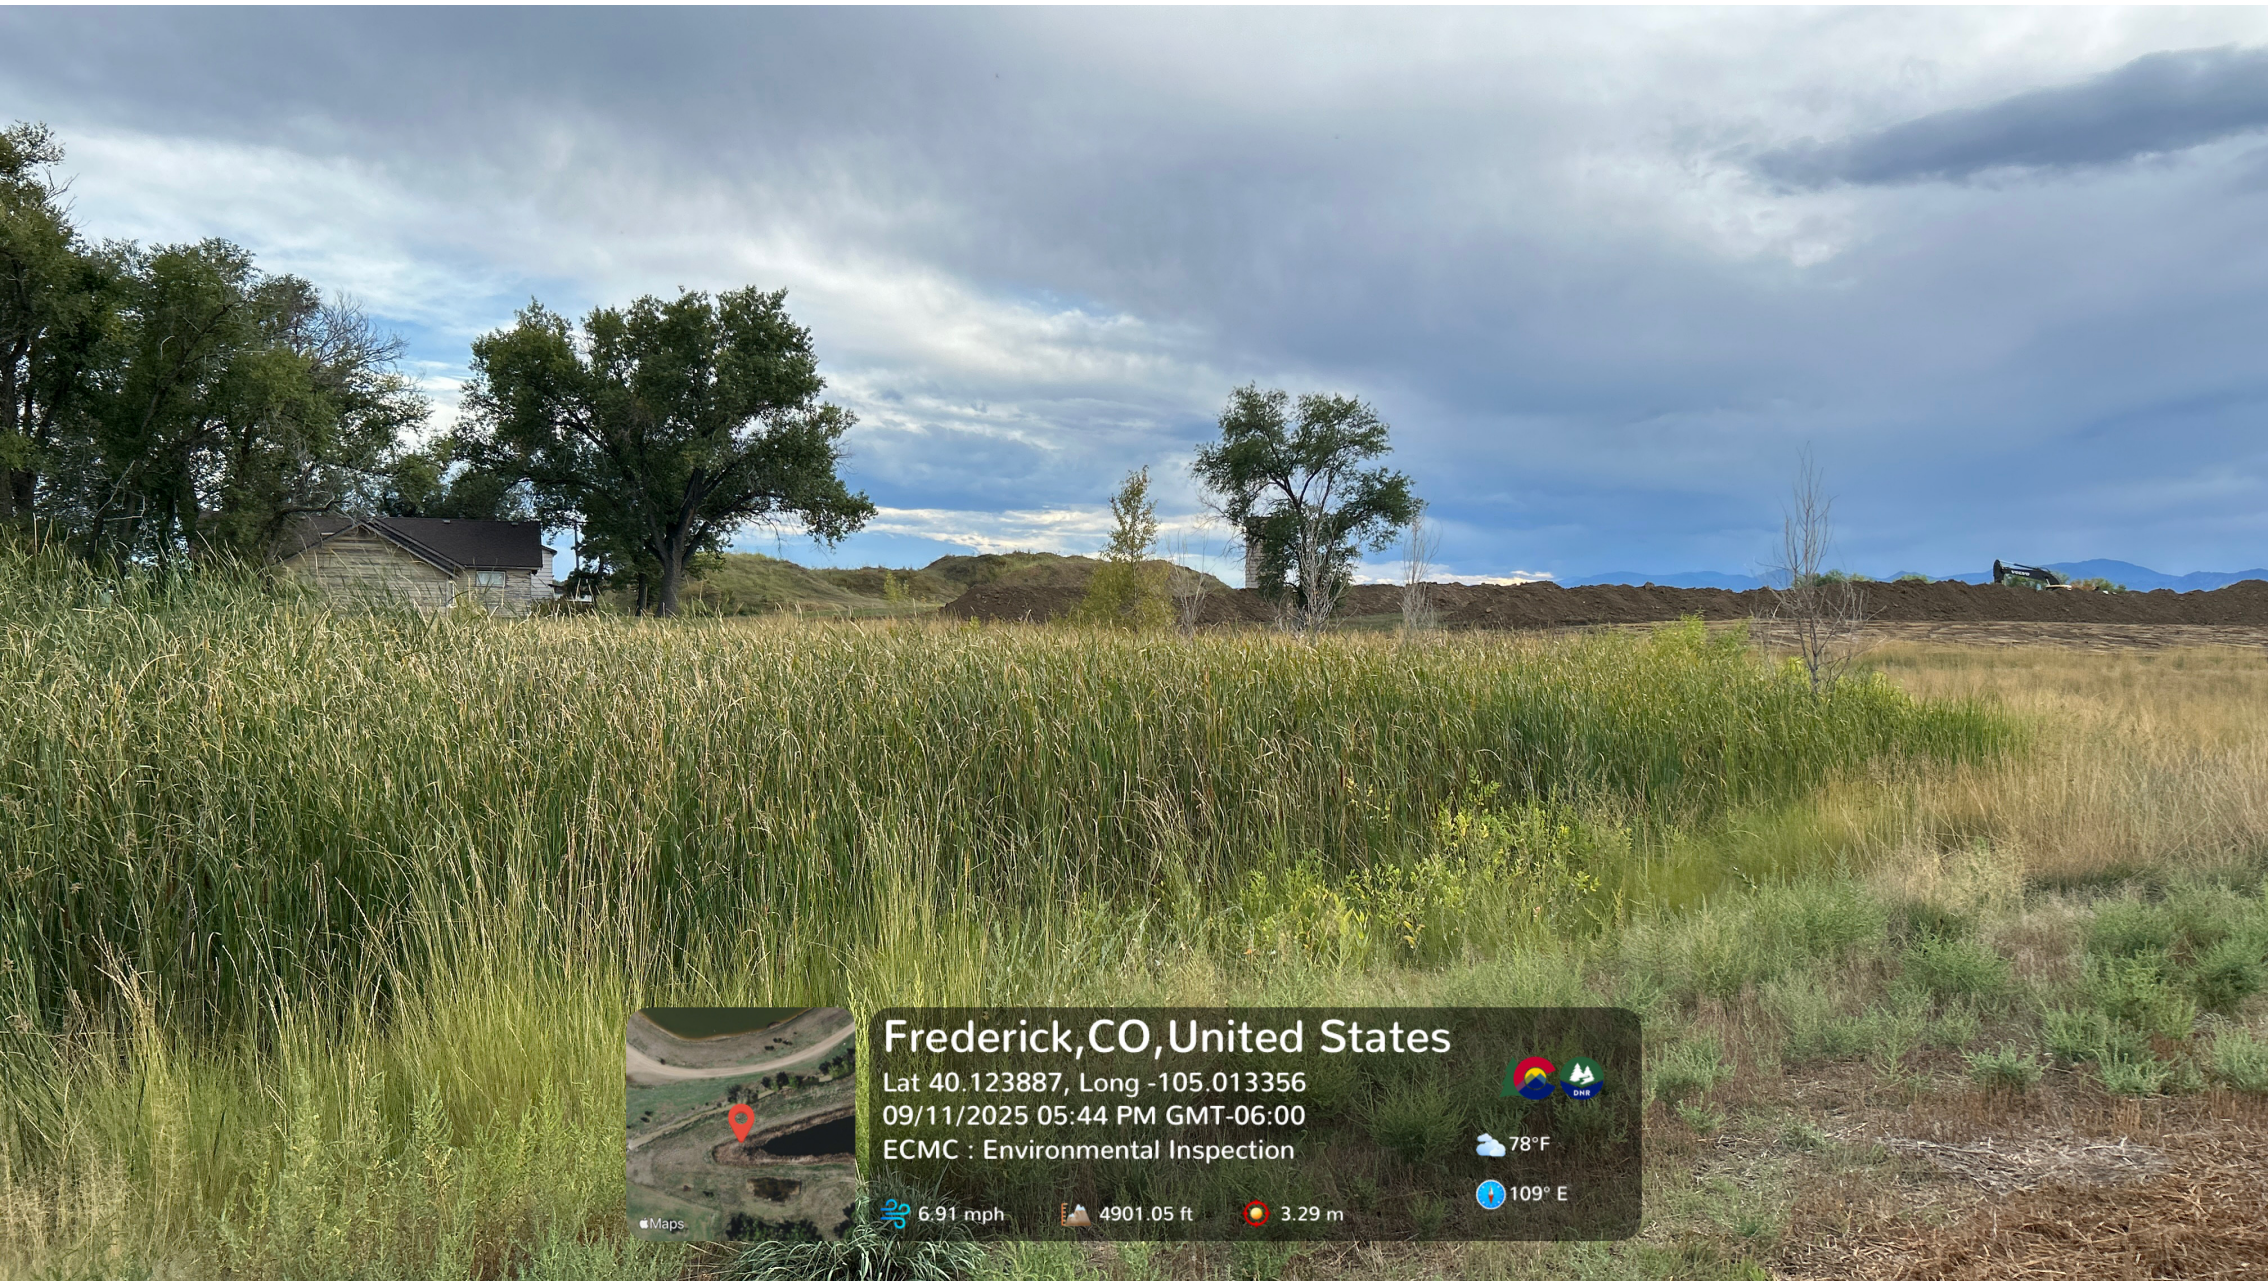
Looking towards the spill location from the western corner of the unmapped surface water/pond. visibility to the portion of the unmapped surface water/pond located closest to the spill was obscured by vegetation.
