# Inspection Photos

**Operator:** PETROLEUM RESOURCE MANAGEMENT  
CORP - #10421

**Location ID:** 485573

Location Name: Duncan Unpermitted Facility

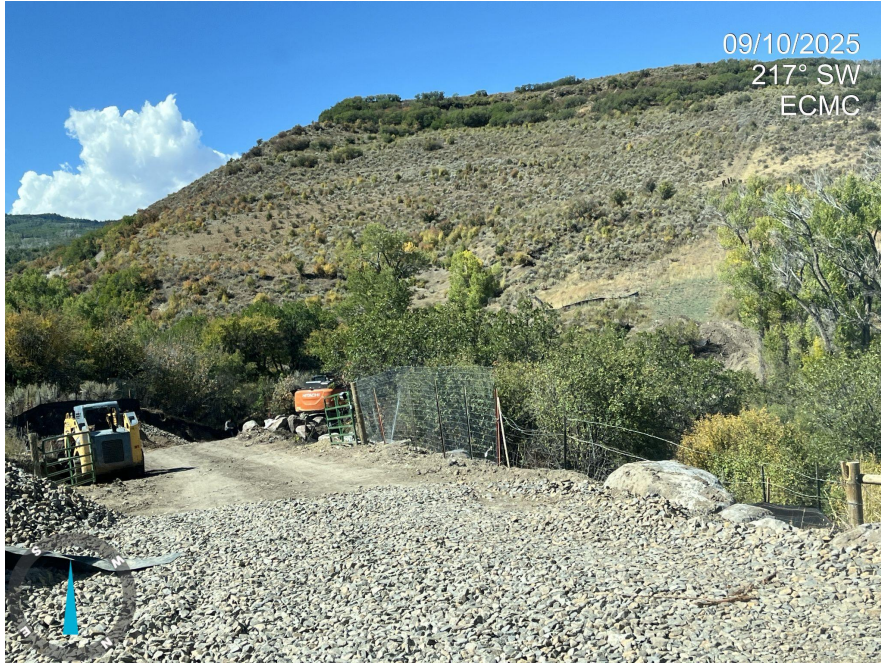
**Photo 1.** Photo taken from the east side of the stream crossing, facing southwest. Photo illustrates that construction of the stream crossing is still occurring at the Location.

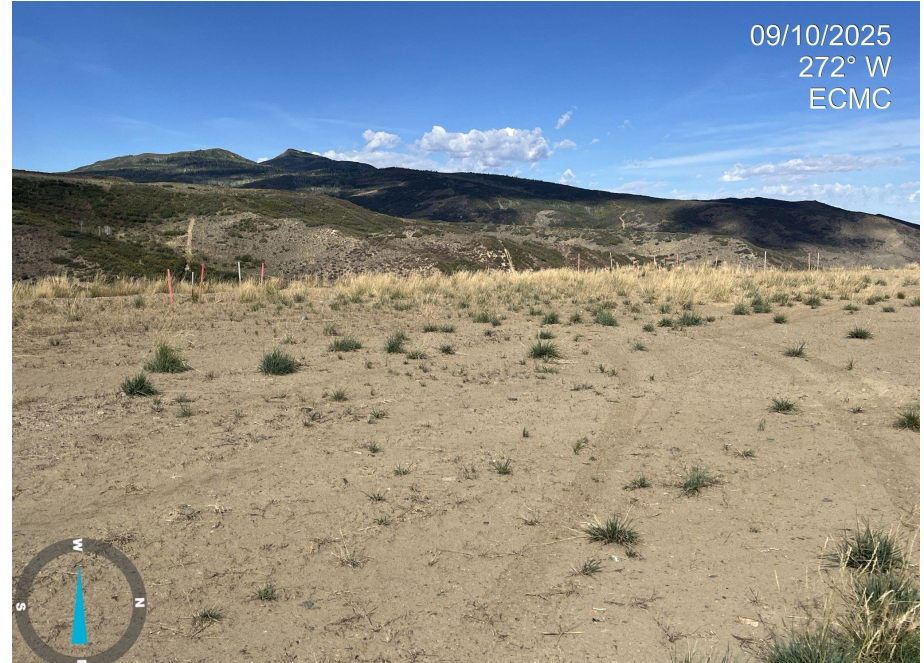
**Photo 2.** Photo taken from the southwestern portion of the location, facing west. Photo illustrates that the surplus material/debris was removed.

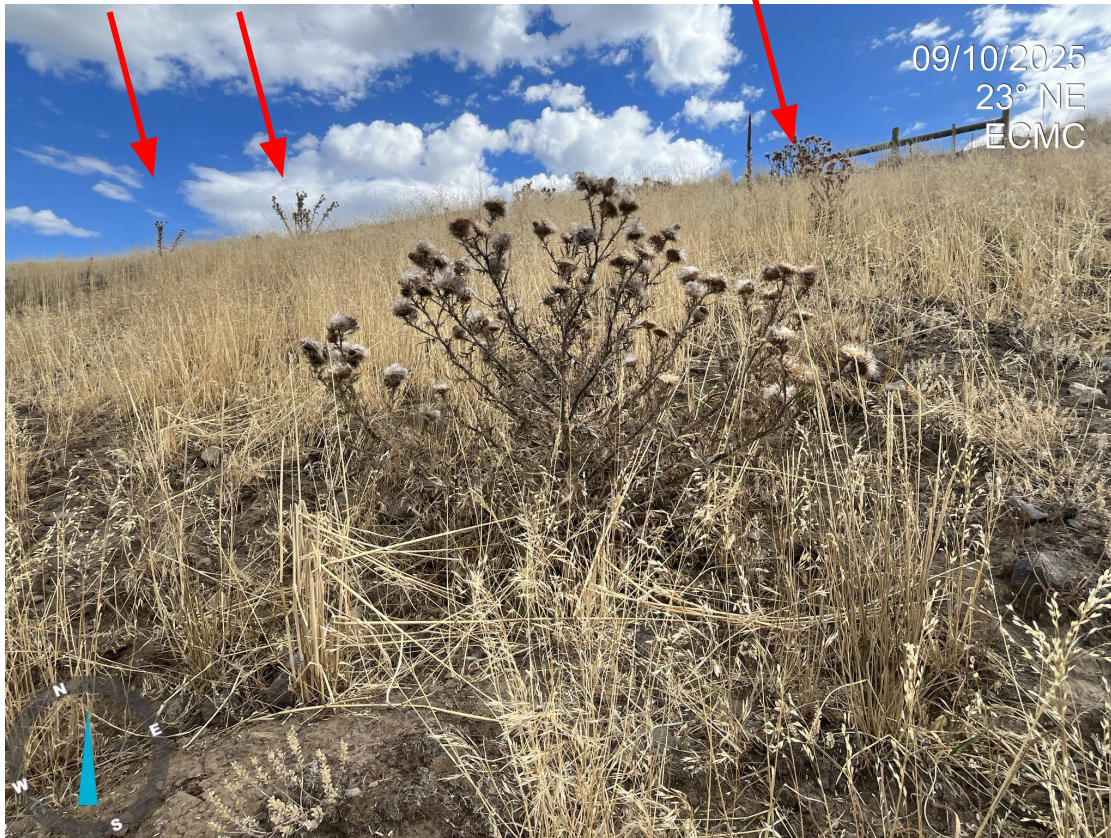
**Photo 3.** Photo taken of the cut slope of the northern portion of the Location, facing northeast. Photo illustrates an example that undesirable weed species are still present on the Location (see also red arrows for the presence of weeds).

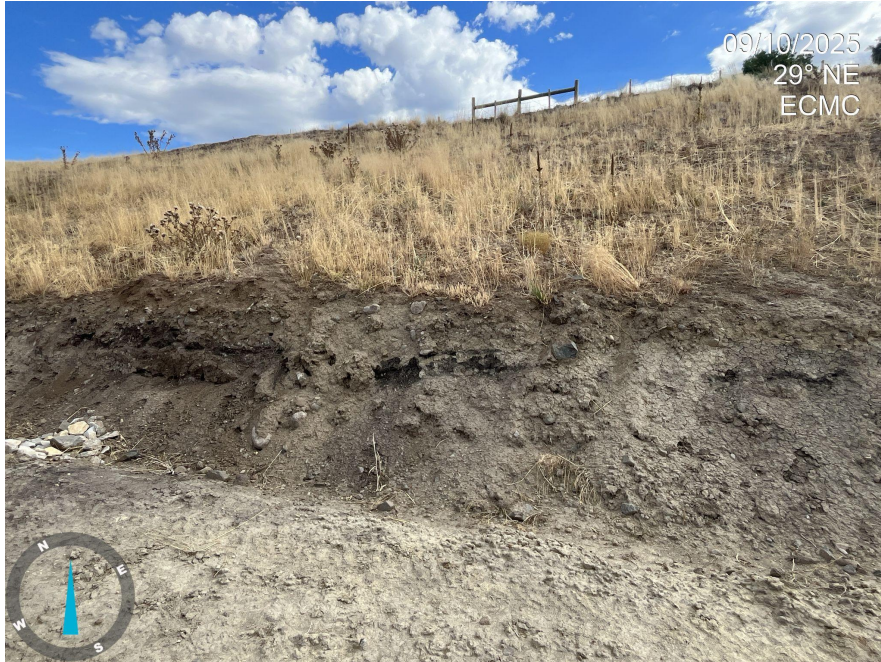
**Photo 4.** Photo taken of the cut slope on the northern portion of the Location, illustrating that some areas remain bare without vegetation.

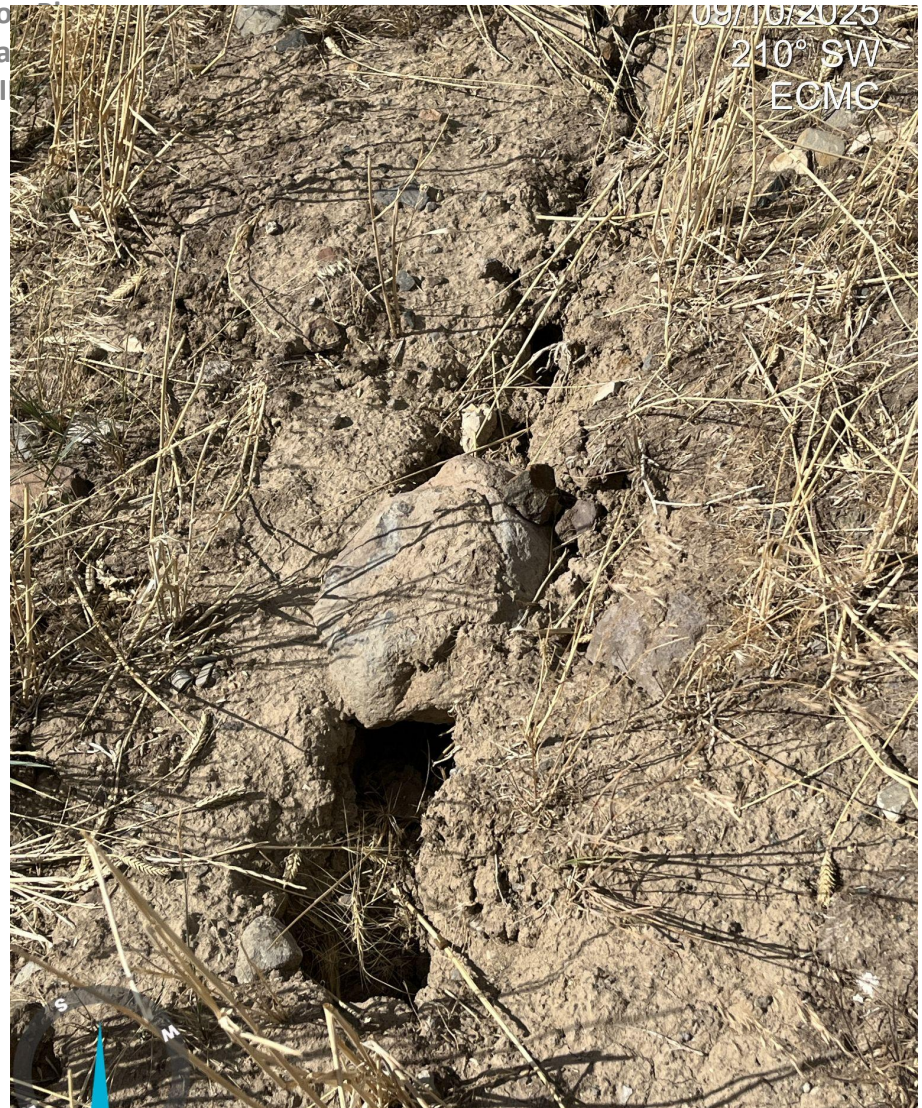
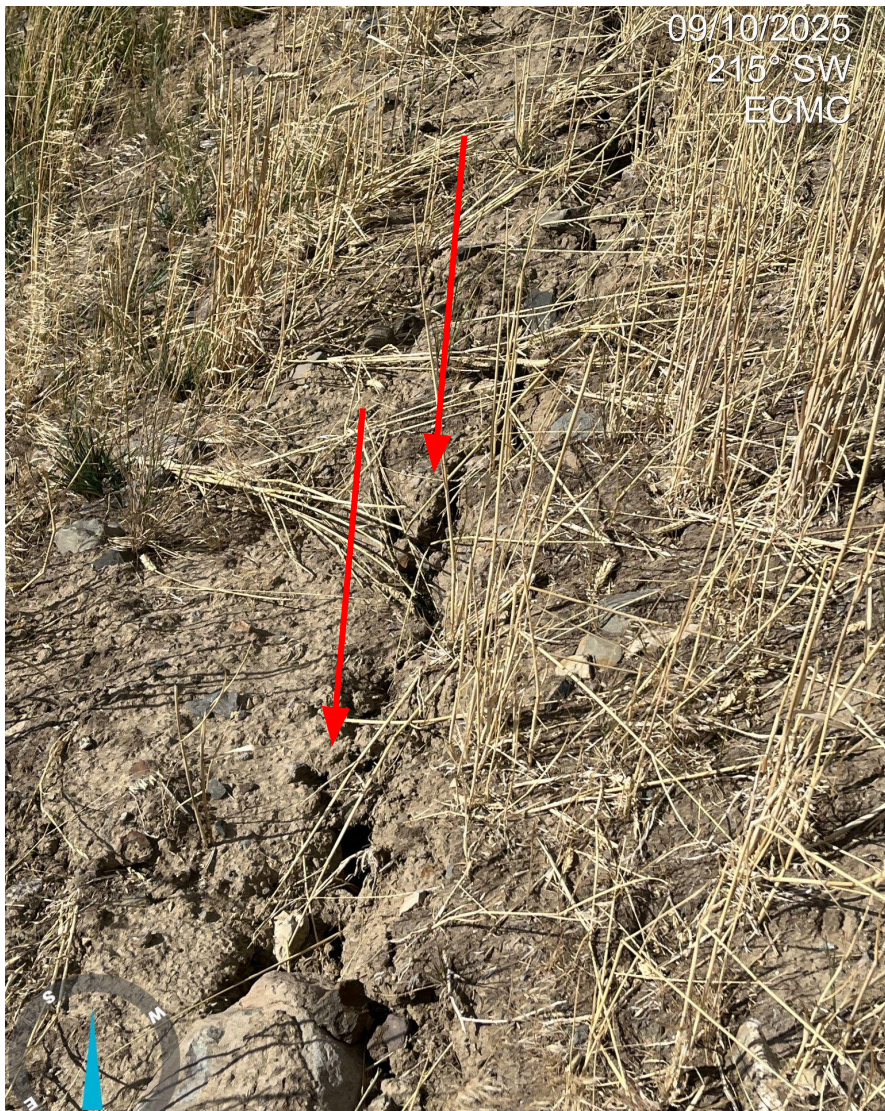
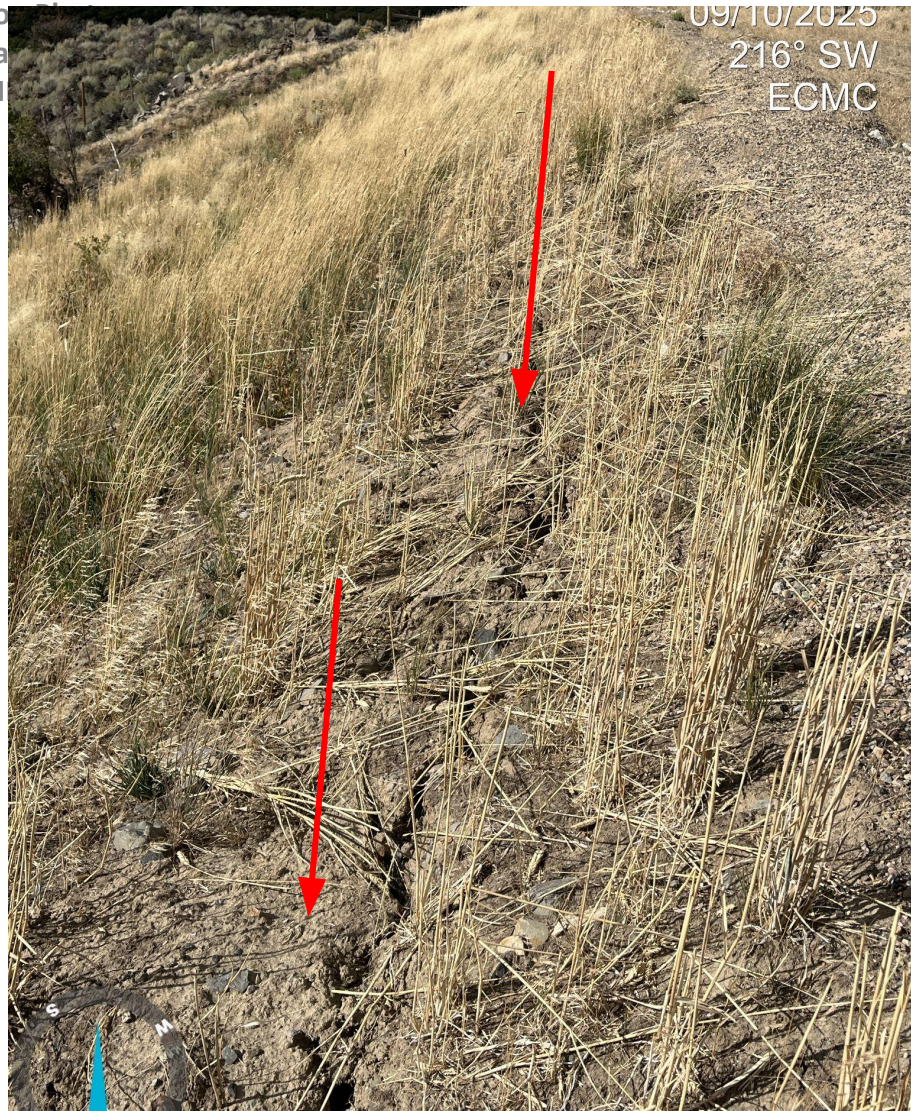
**Photo 5.** Photos 5-7 taken on top of the fill slope, on the eastern portion of the location, illustrating cracking along the fill slopes that are recurring.
