**Frederick, CO, United States**  
**KP Kauffman - Facility 3 @ Rasmussen Flowline**  
**Photo 1**

Lat 40.110244° Long -105.024368°  
06/08/2025 Wednesday, 9:39 AM  
8.0 mph 77%  
76 °F 192° S 4923 ft  
Tag: ECMC Environmental Inspection

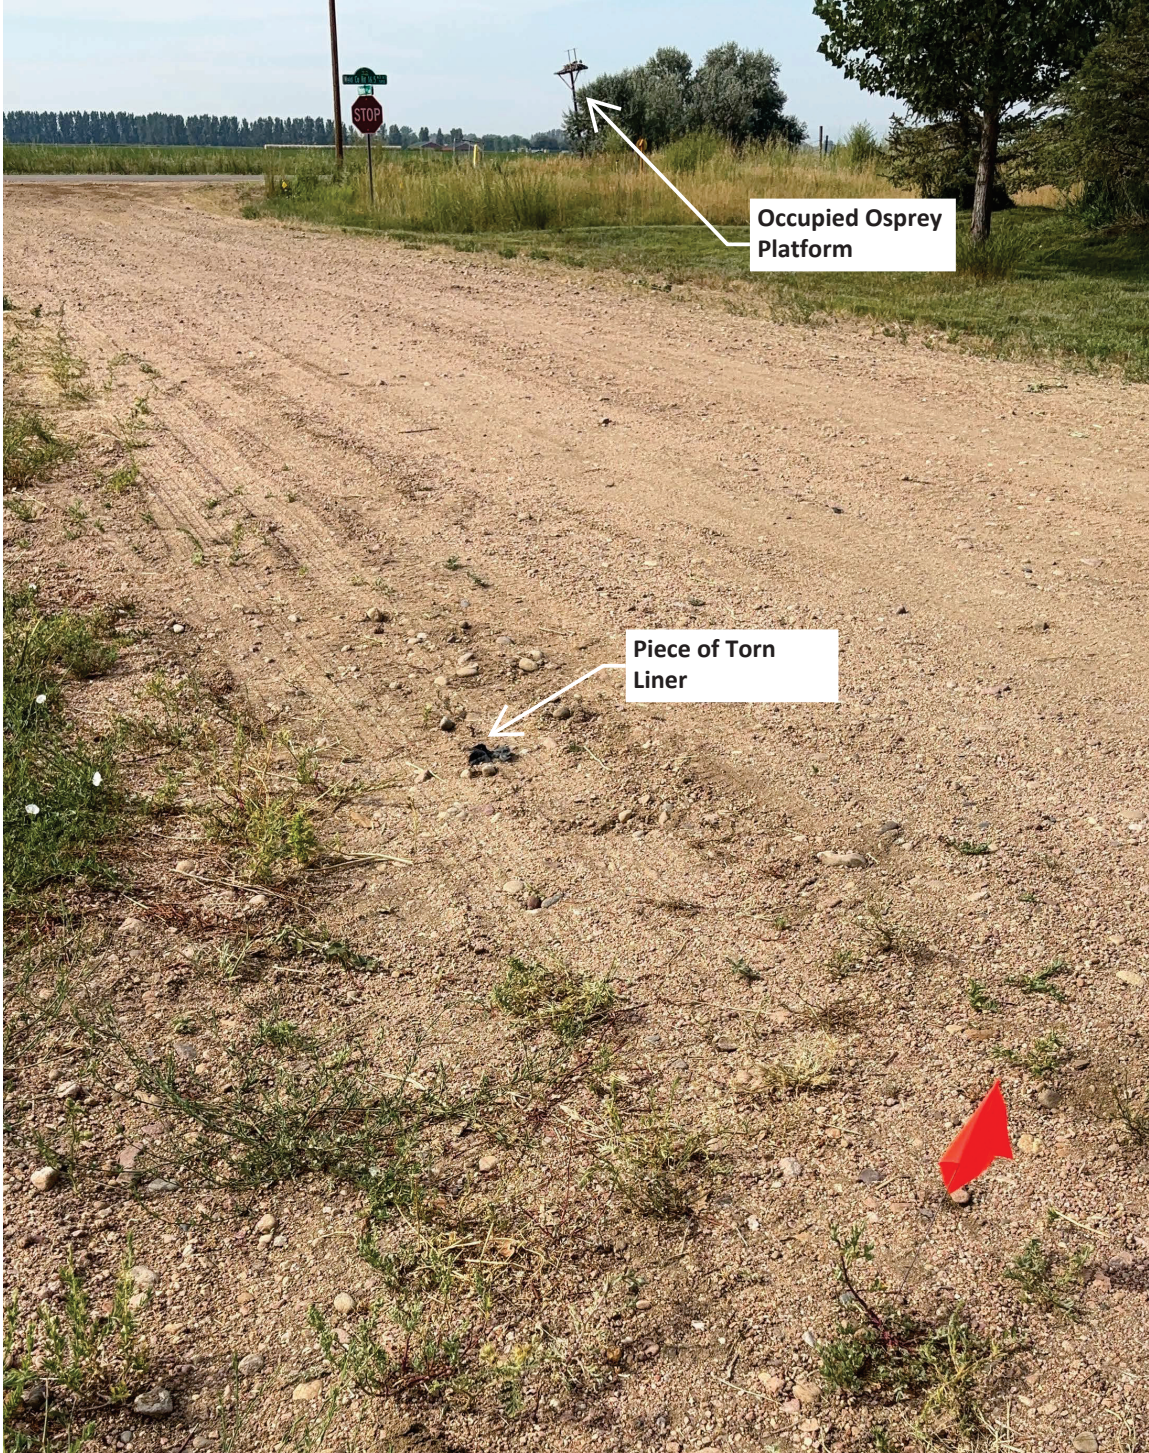
Occupied Osprey Platform

Piece of Torn Liner

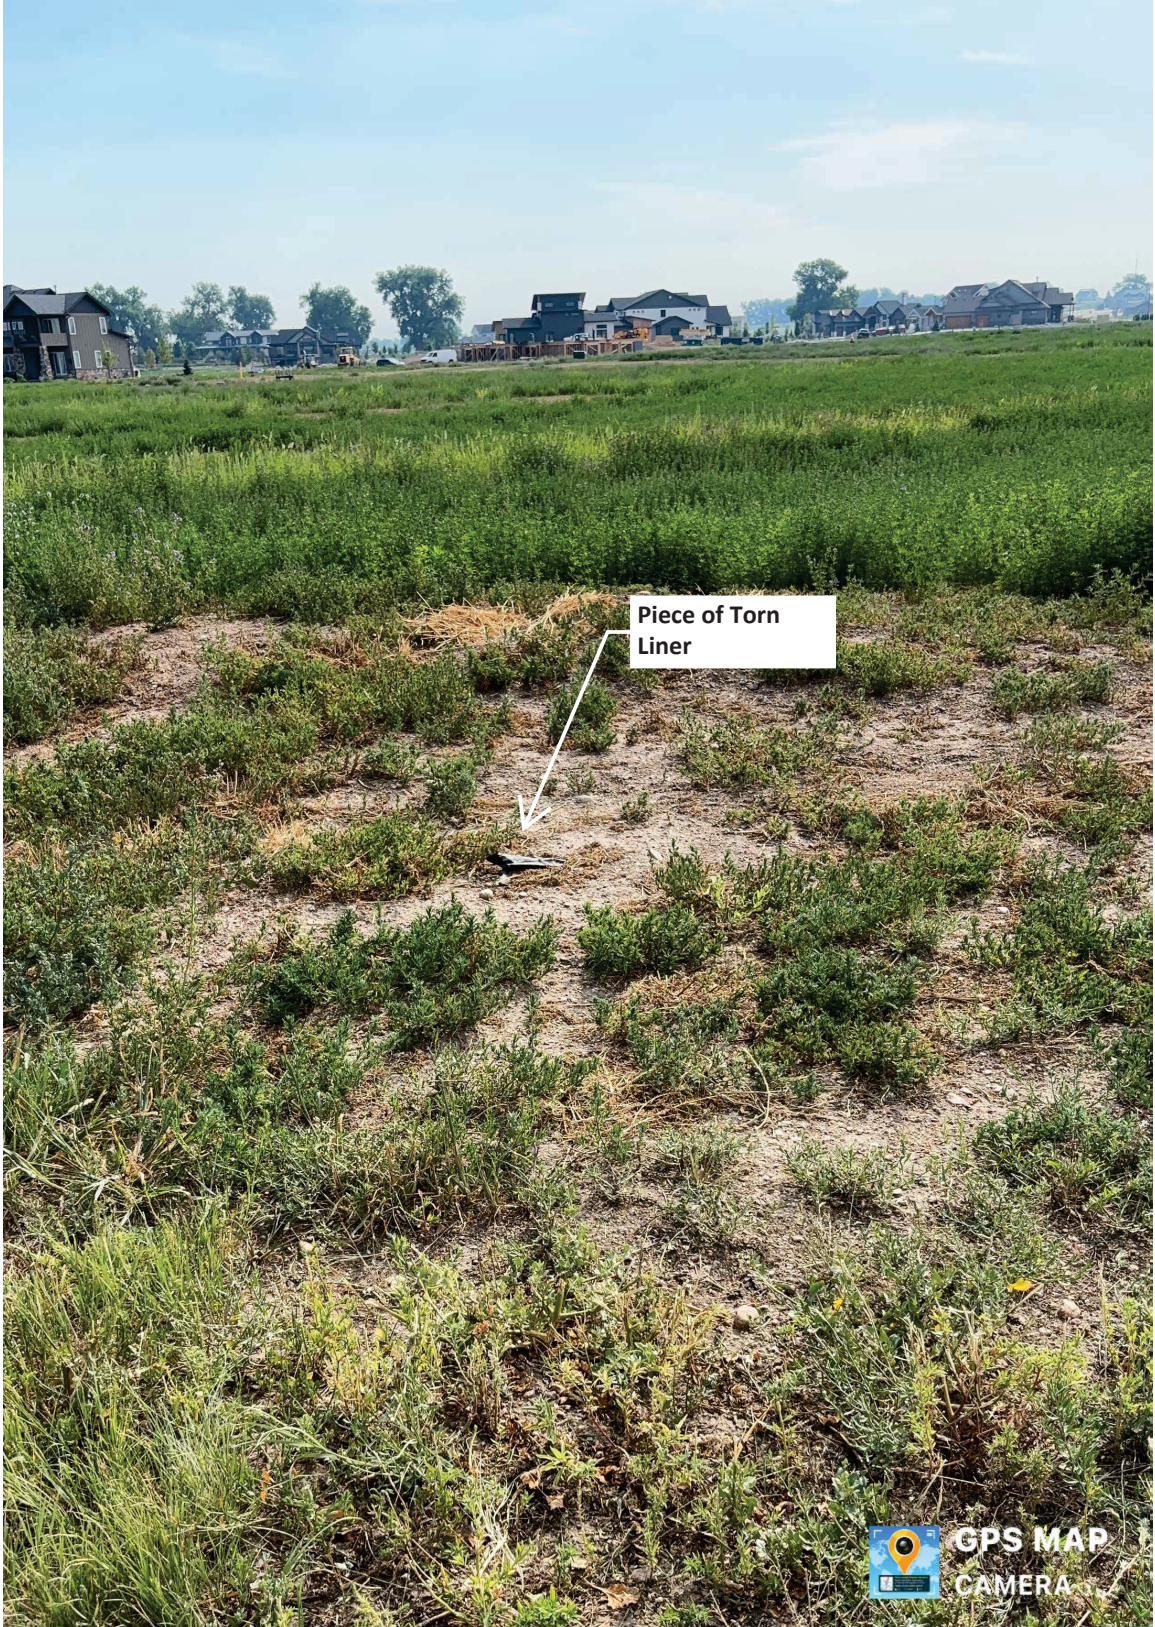
KP Kauffman - Facility 3 @ Rasmussen Flowline  
Photo 2

Piece of Torn Liner

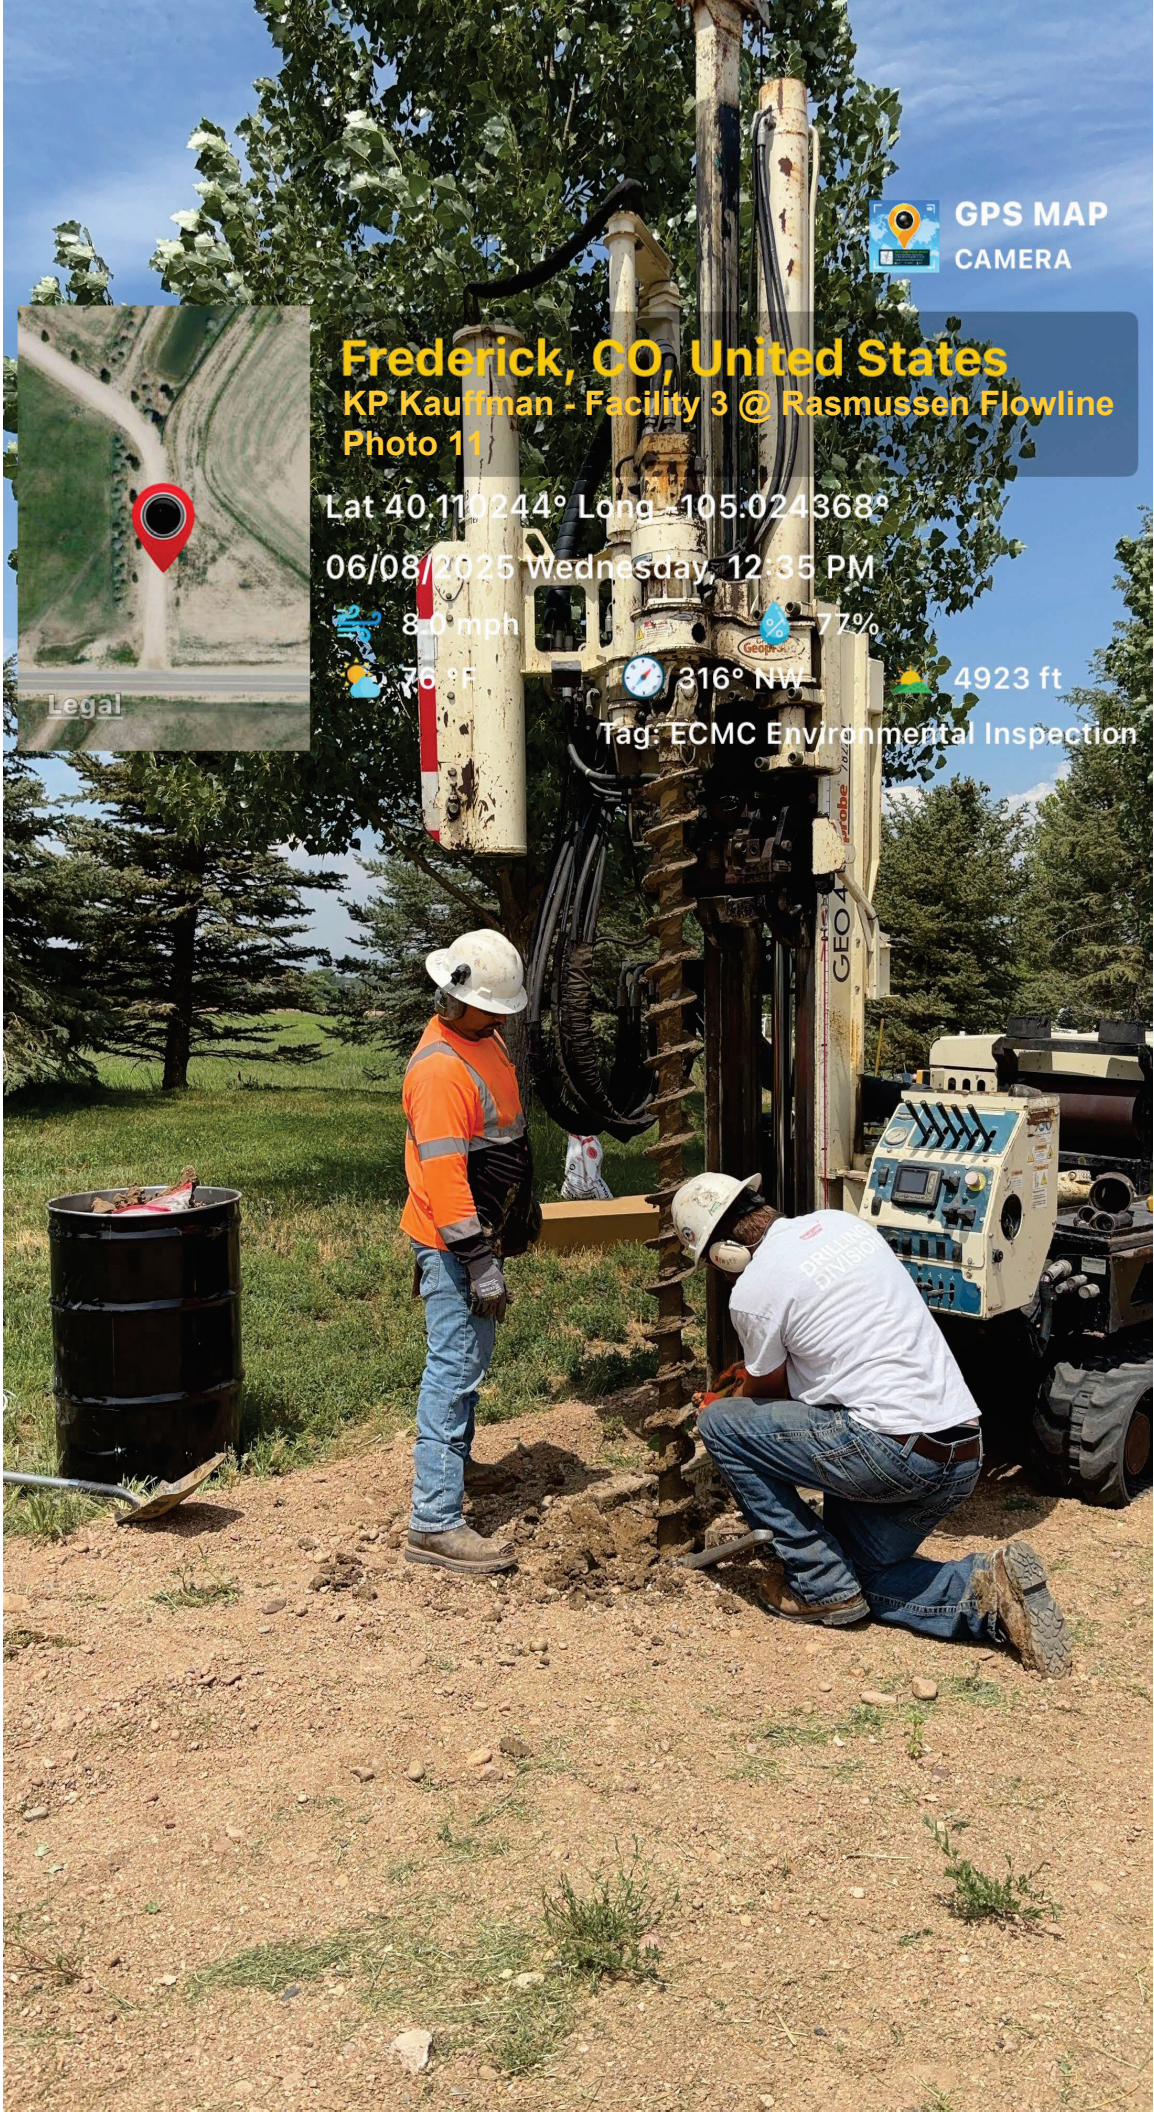
KP Kauffman - Facility 3 @ Rasmussen Flowline  
Photo 12

Piece of torn liner  
embedded along  
Preserve Drive
