# Inspection Photos

API: 017-06625

Operator: **WILLIFORD ENERGY COMPANY**

Inspection Date: 9/5/2025

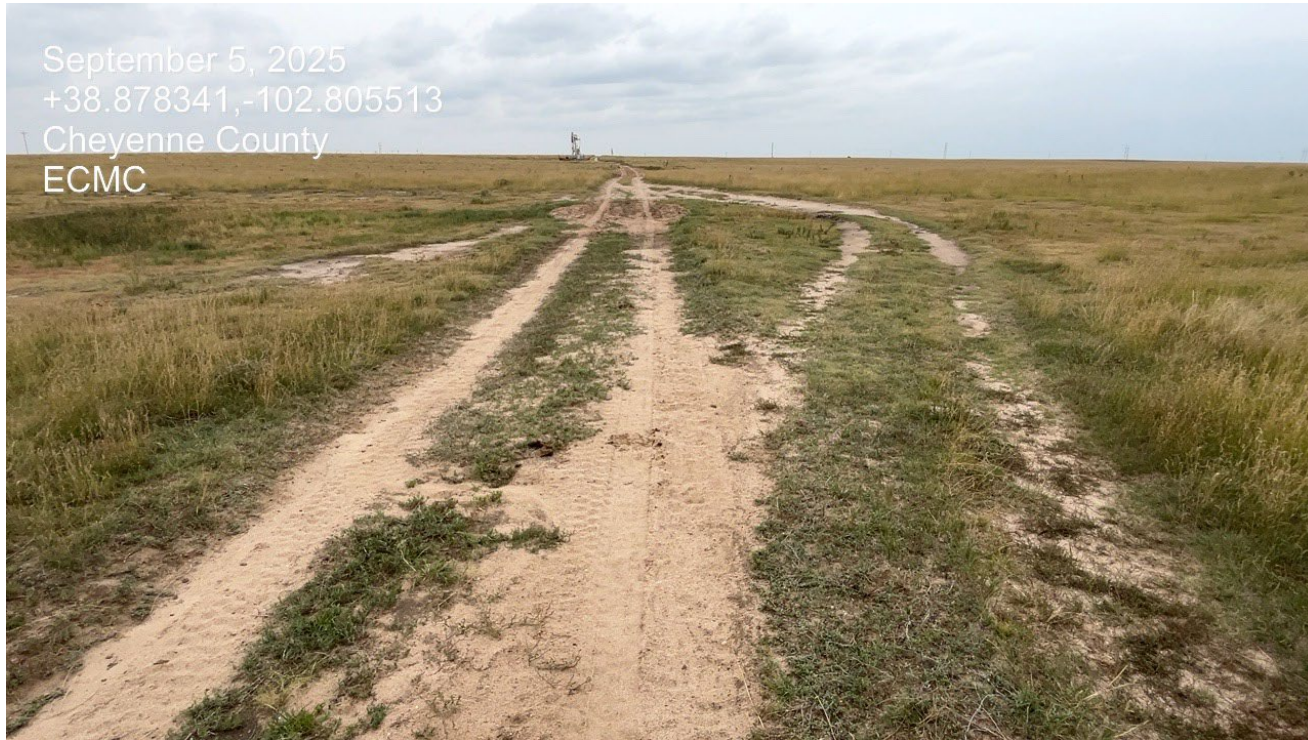
**Photo 1.** Facing east along the access road. There are areas where vehicles caused unnecessary disturbance driving outside of the access road due to stormwater pooling on the road.

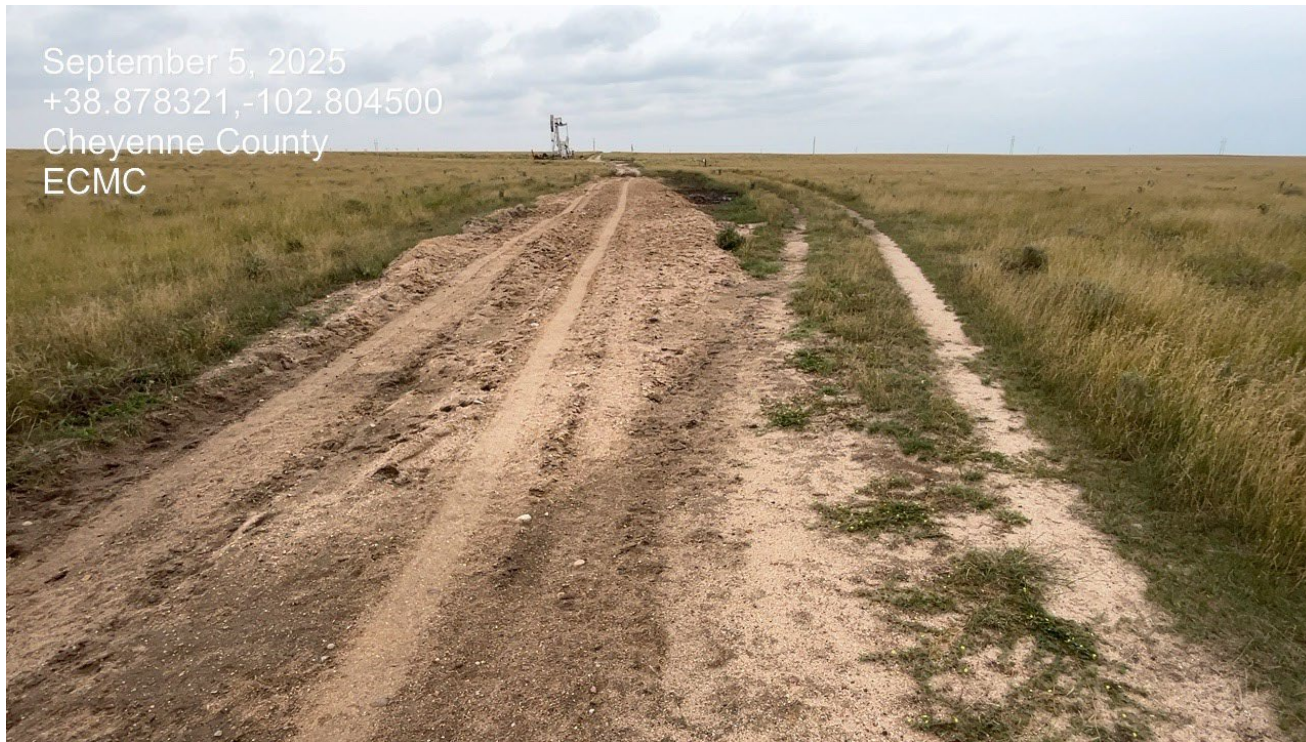
**Photo 2.** Facing east along the access road. There has been a load of road base sand material placed in this area but was not properly installed by crowning and compacting.

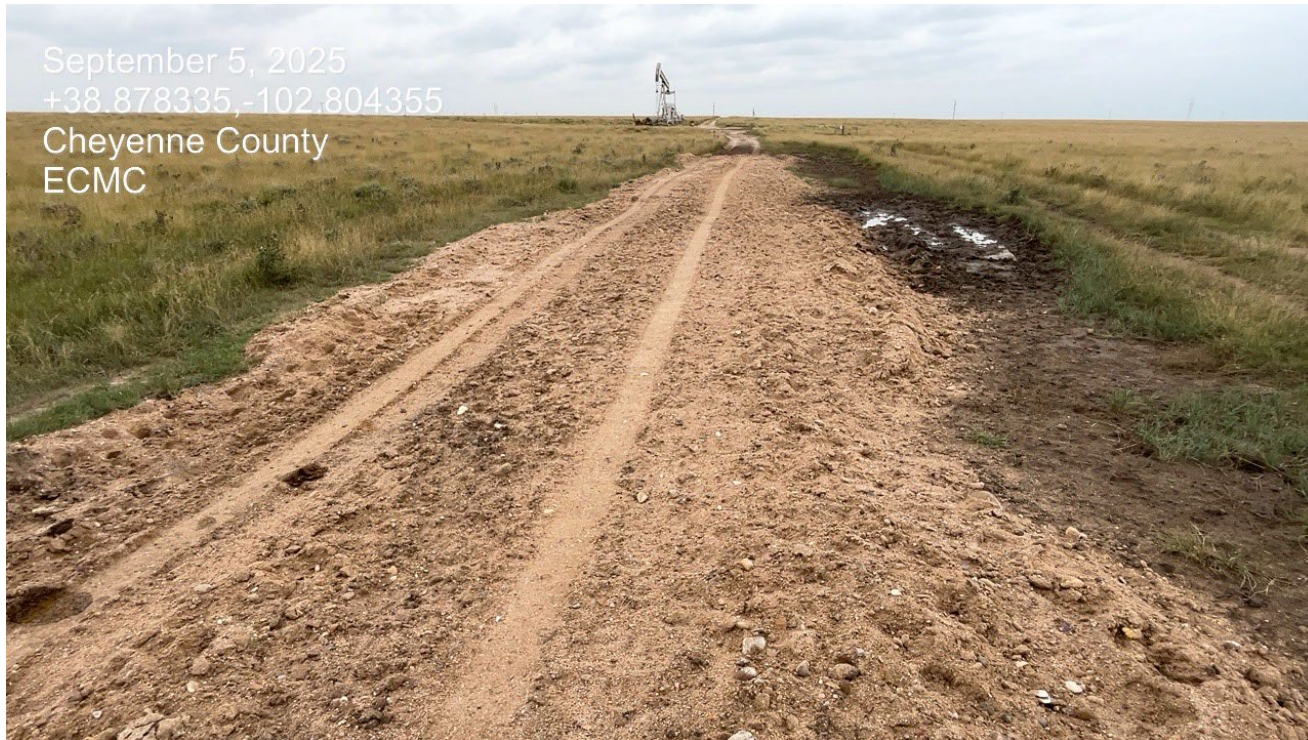
**Photo 3.** Facing east along the access road. There has been a load of road base sand material placed in this area but was not properly installed by crowning and compacting.

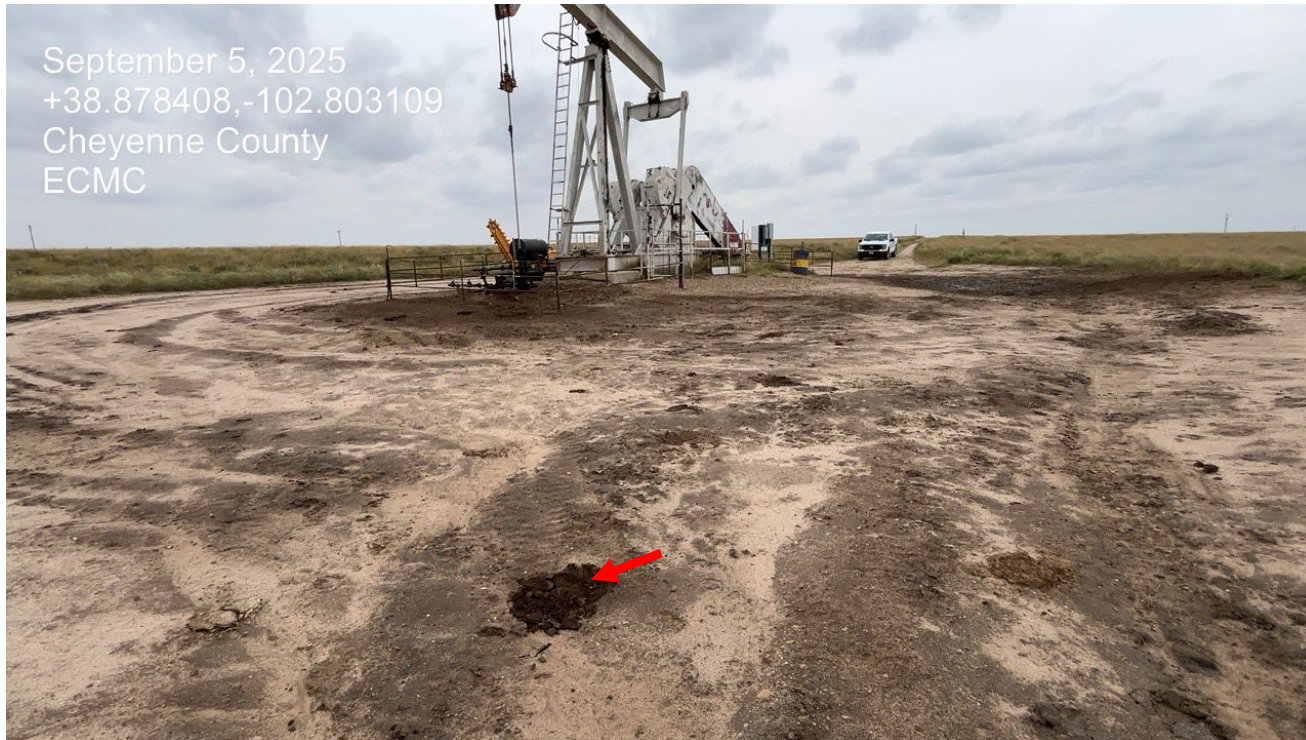
**Photo 4.** Facing northeast toward the wellsite. There are oil stained soils near the wellhead that have not been cleaned up since the previous inspection. The previous leak observed had flowed approximately 50 ft. to the southwest of the wellhead.

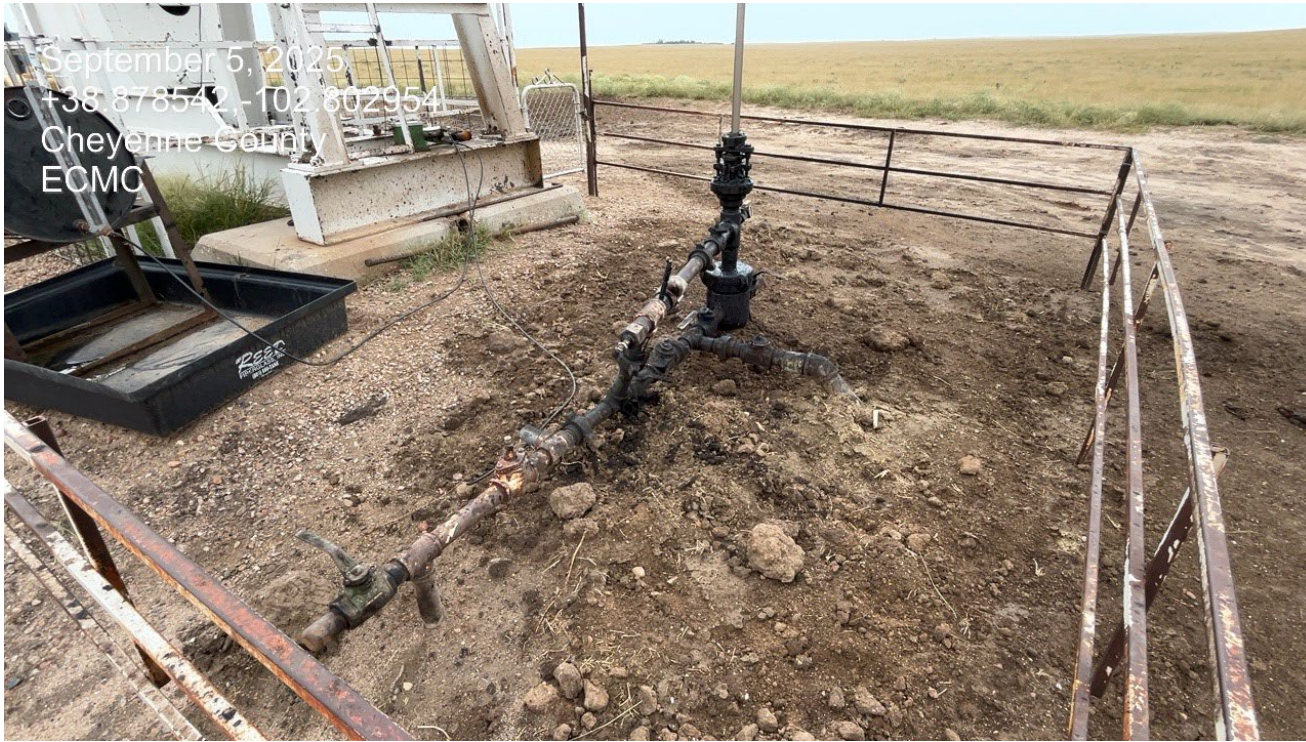
**Photo 5.** There are stained oily soils from a leak at the wellhead. Stained soils have not been cleaned up since the previous inspection.

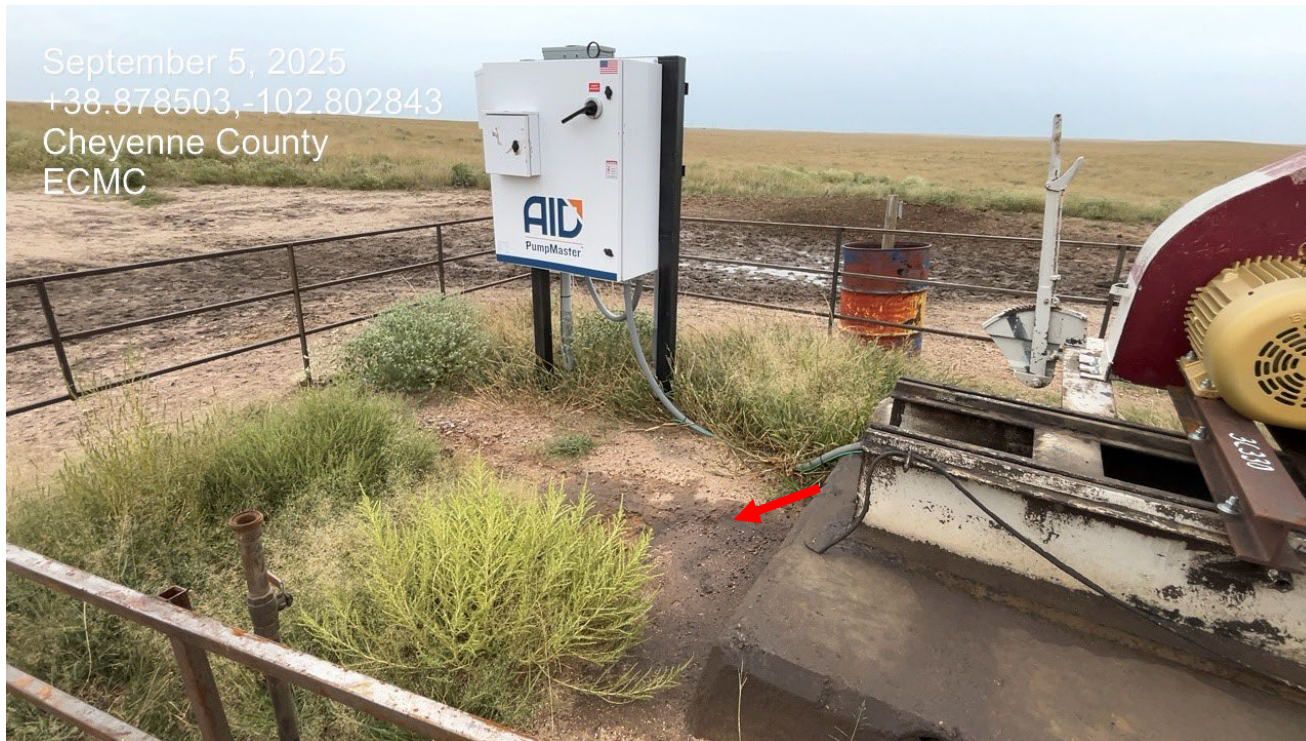
**Photo 6.** There is still oil stained soils at the pumpjack that have not been cleaned up. Previous corrective action was not completed.

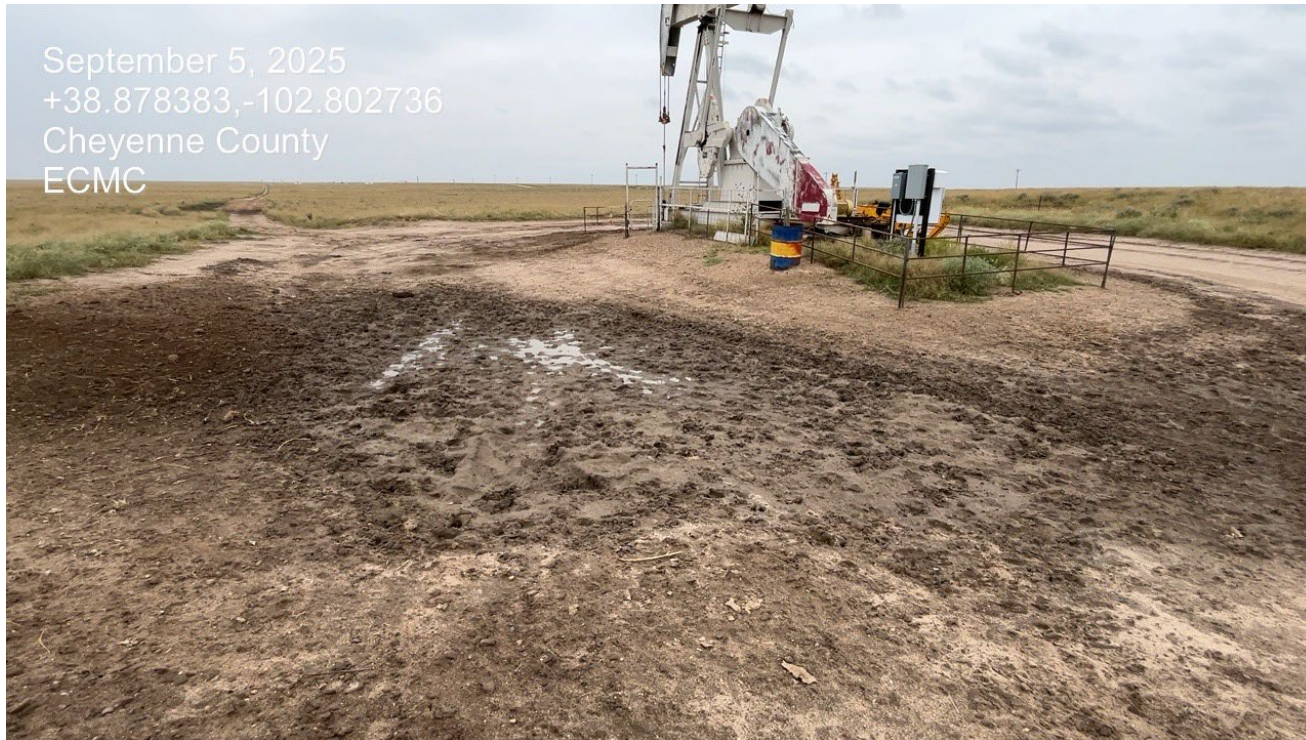
**Photo 5.** This area of the location collects stormwater and should be built up with road base to allow proper drainage.

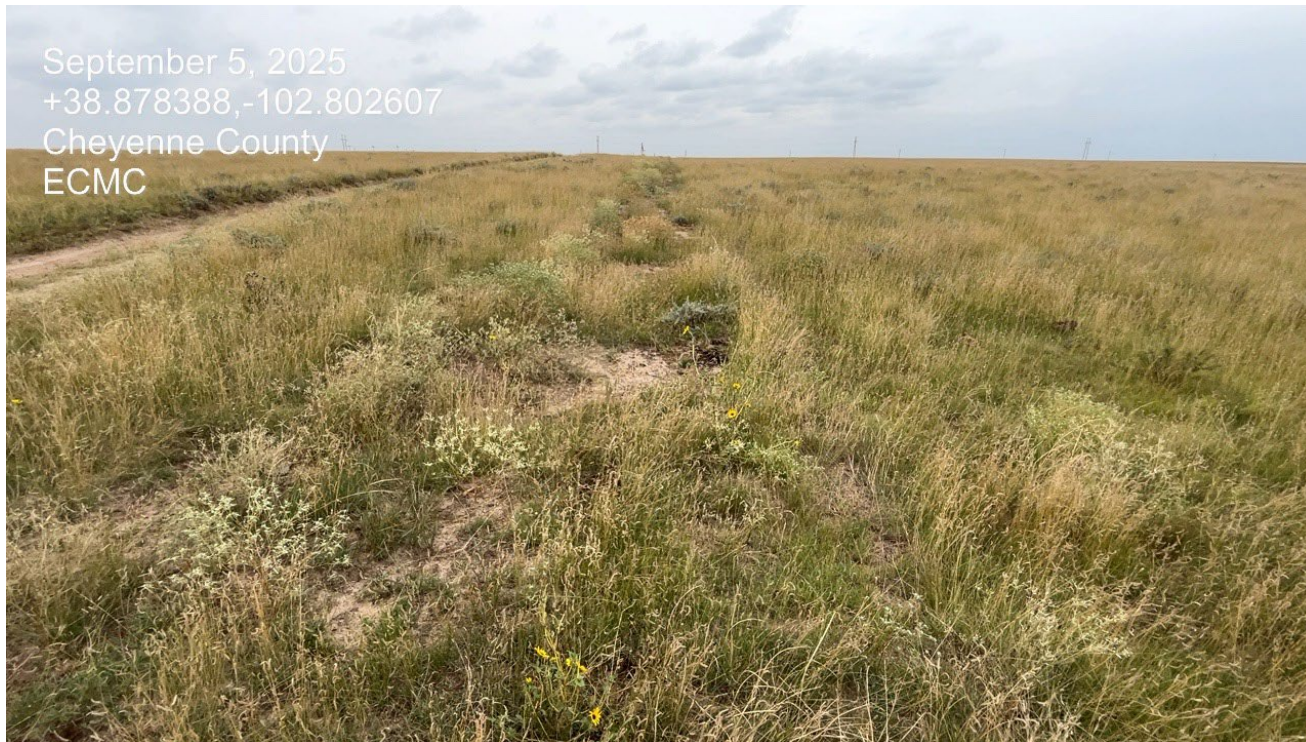
**Photo 9.** The disturbance along the buried electric line has mostly revegetated with the significant moisture summer season.
