Inspection Photos
Location Name: Raisley 21-34
Location ID: 329009

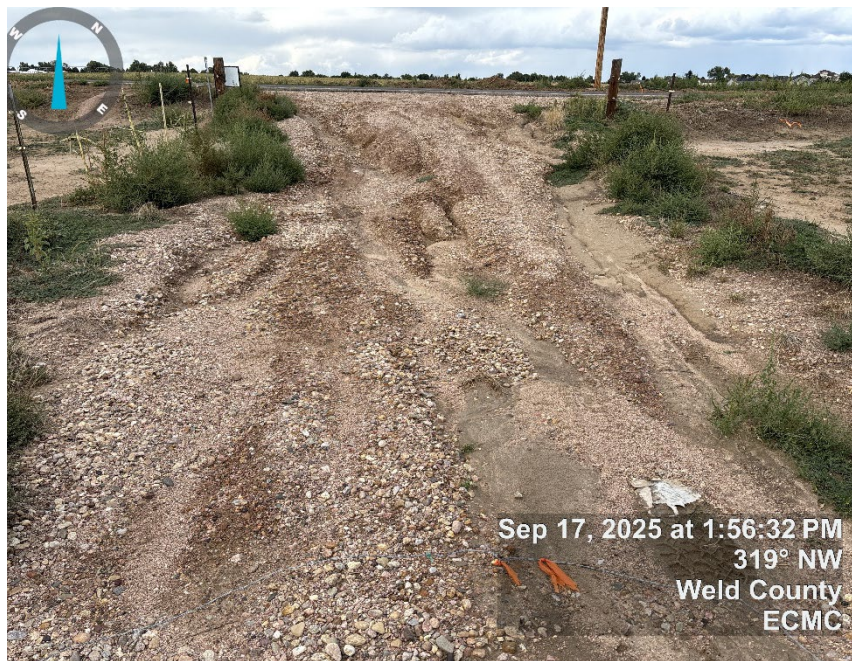
Photo 1: erosion

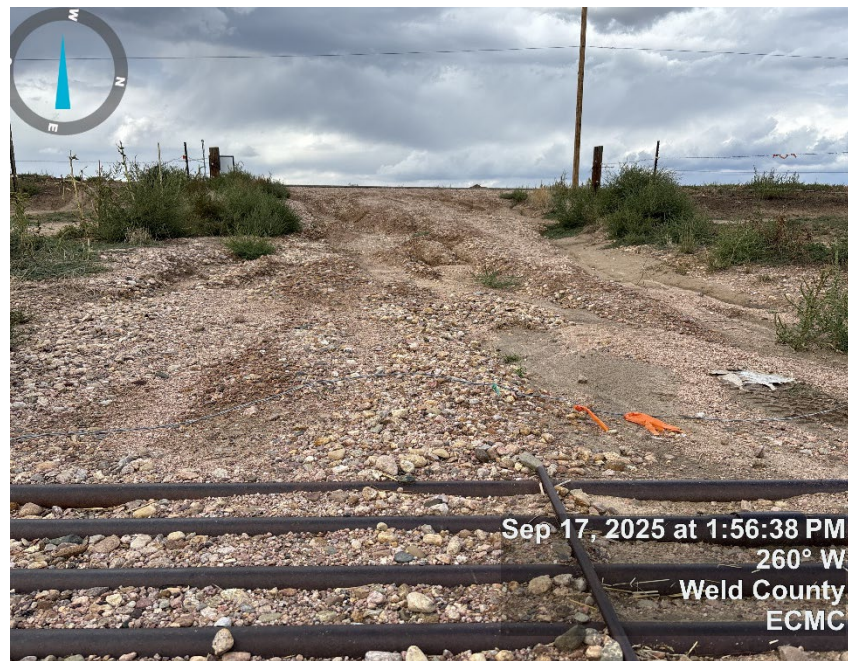
Photo 2: Erosion

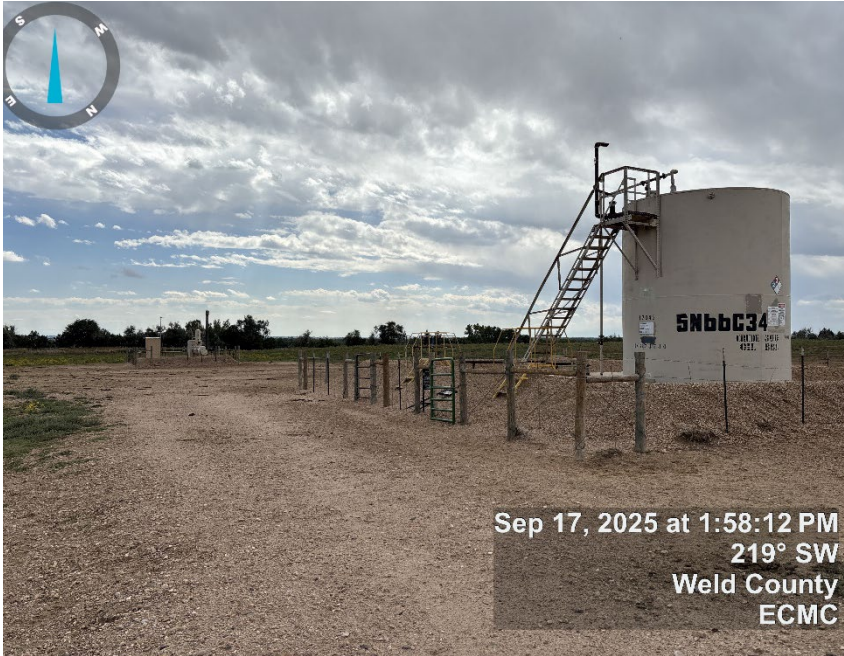
Photo 3: location from entrance

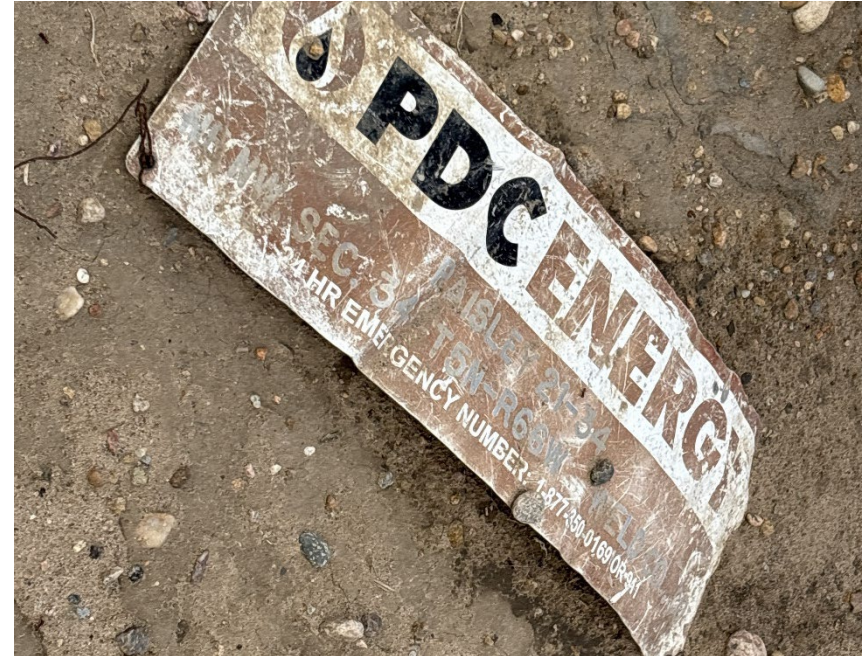
Photo 4: Wellhead sign not legible, damage

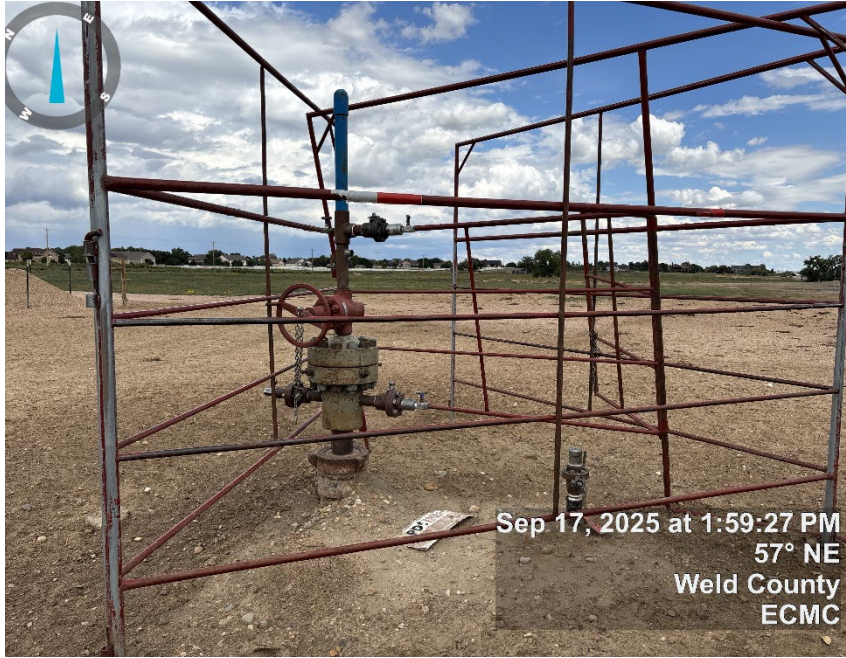
Photo 5: TA Wellhead

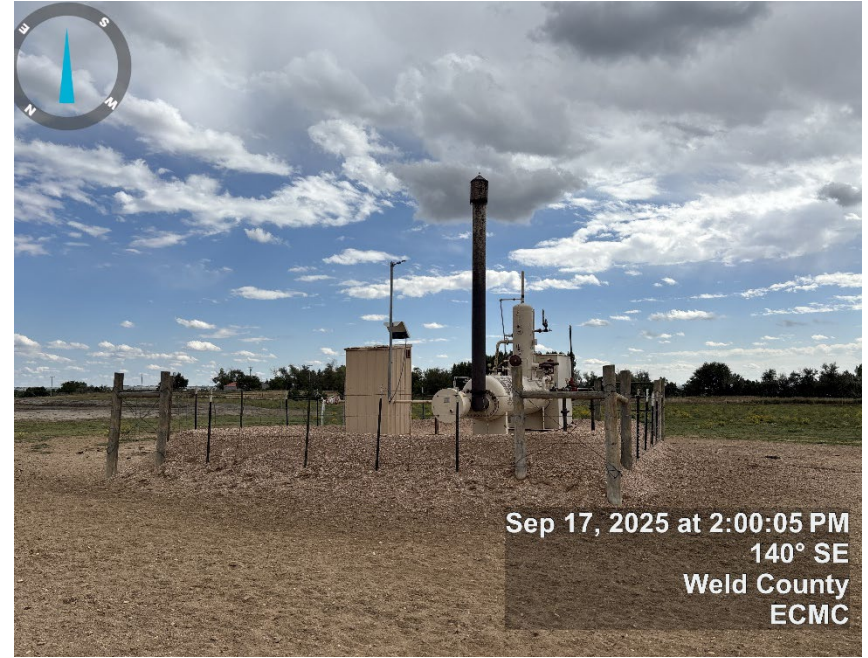
Photo 6: Equipment

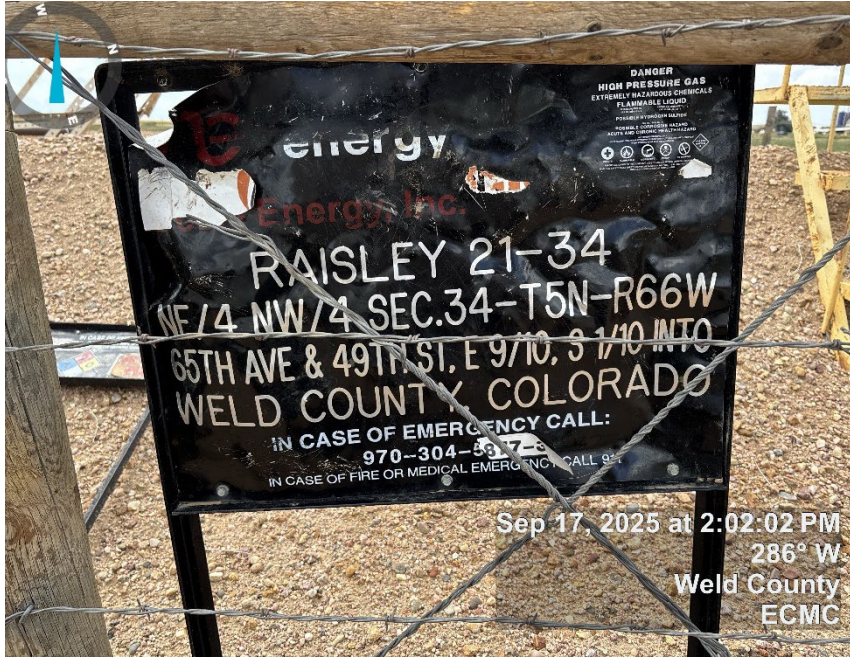
Photo 7: Operator name not displayed, damaged tank battery sign

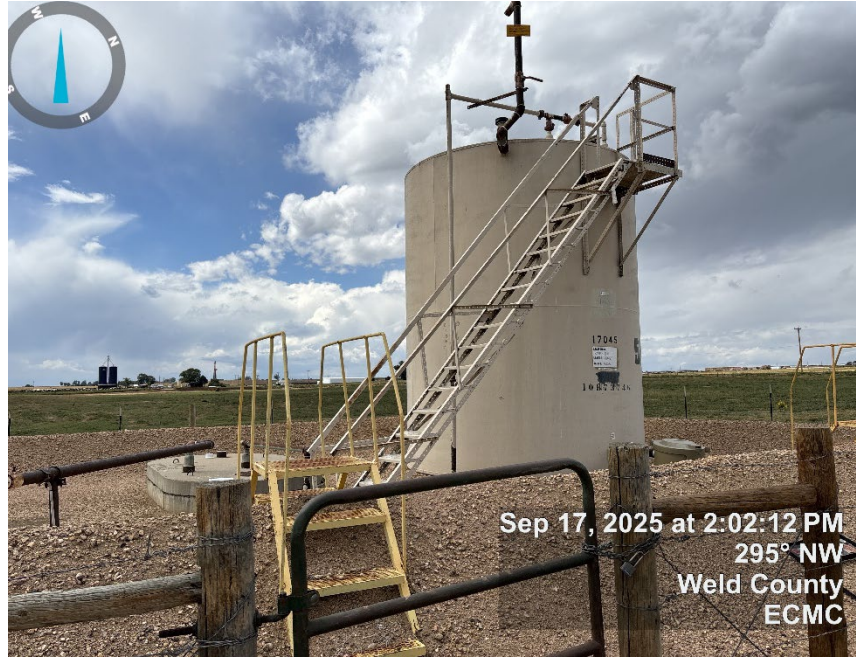
Photo 8: tank battery
