Inspection Photos

Operator: TEP Rocky Mountain LLC #96850

Location ID: 335543

Inspection Doc: 719200181

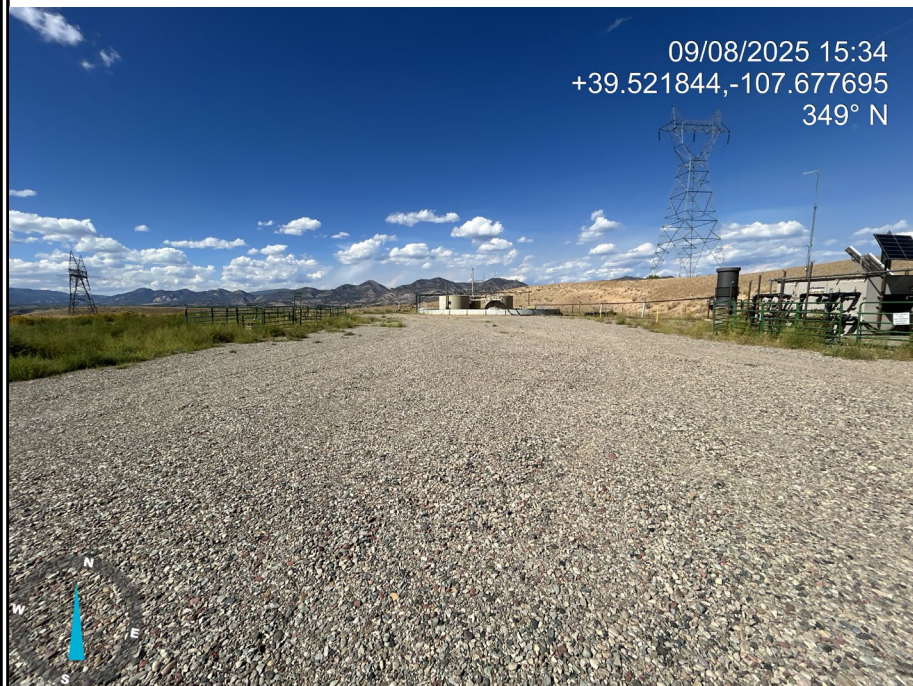
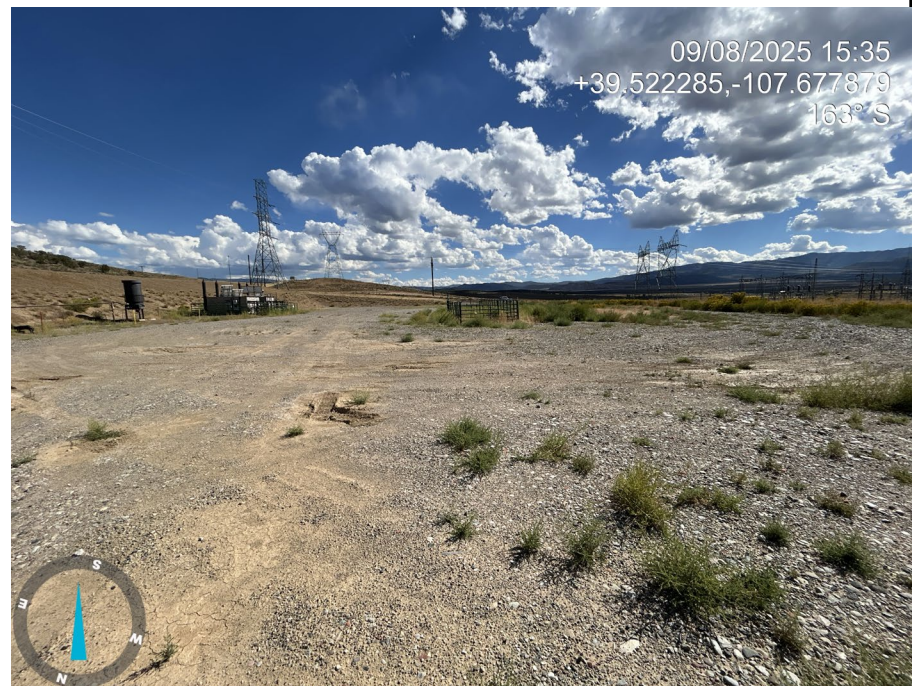
Photo 1: Photos showing an overview of the location looking north and south, respectively.

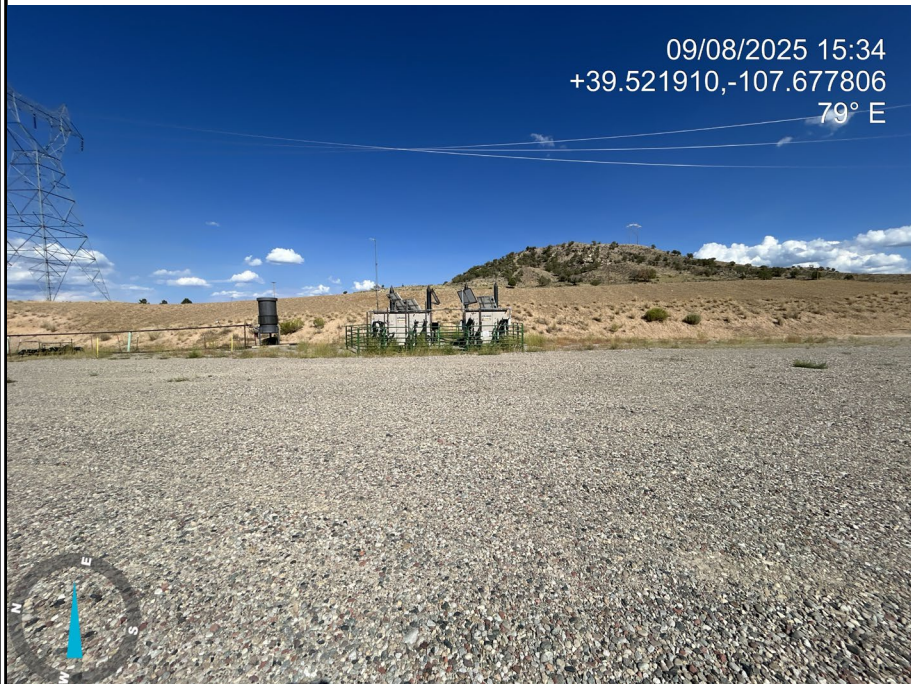
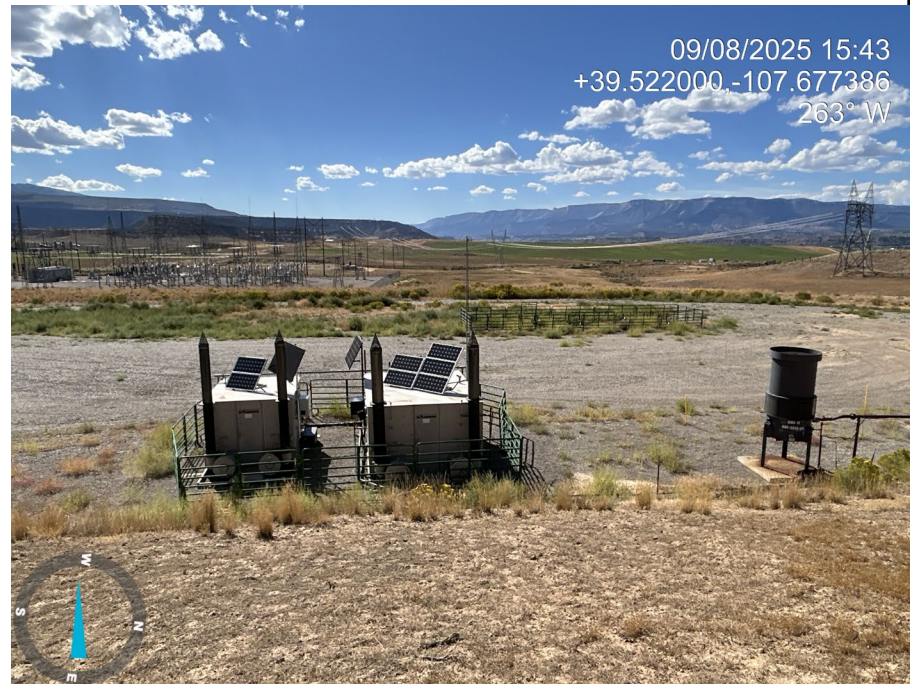
Photo 2: Photos showing an overview of the location looking east and west, respectively.

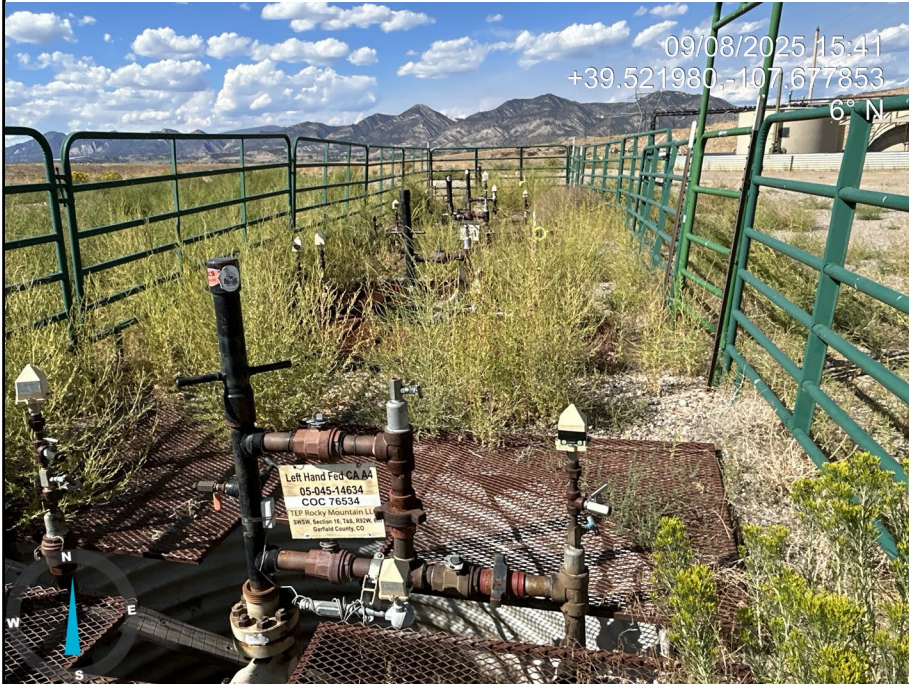
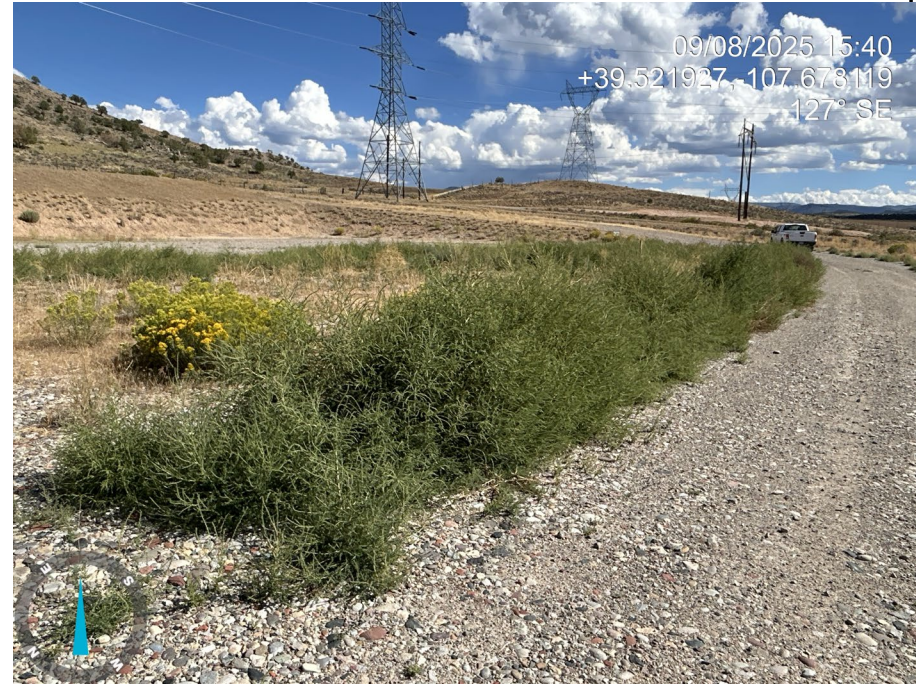
Photo 3: Kochia, cheatgrass, and rubber rabbitbrush is present around the wellheads and on the working pad surface. See previous inspections for Corrective Action. This Corrective Action remains outstanding.

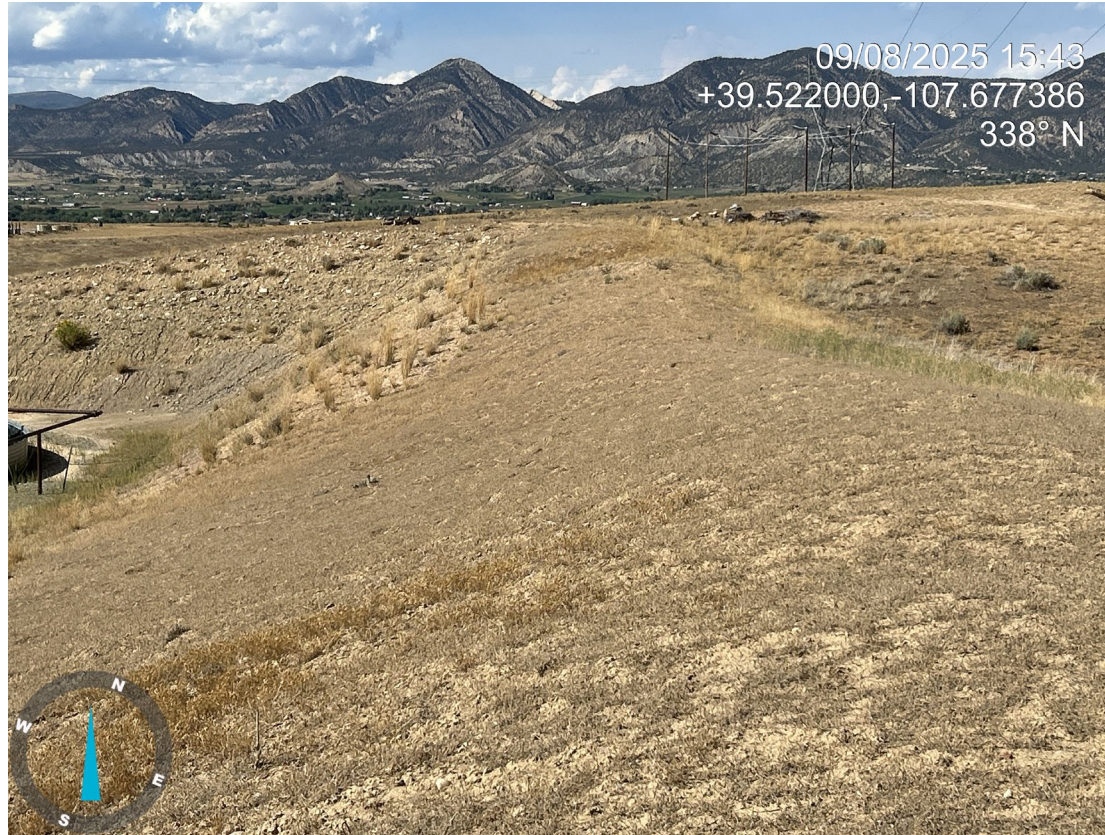
Photo 4: Photo showing the eastern interim area above the cut slope. These areas appear to be dominated by annual pepperweeds and annual false wheatgrass and are not progressing towards 1003 reclamation requirements.

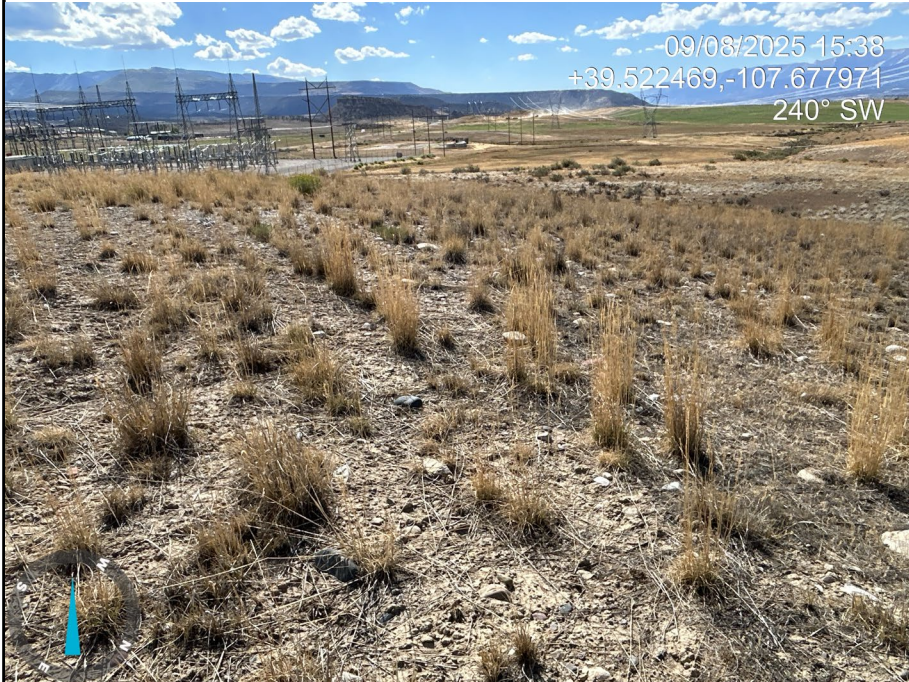
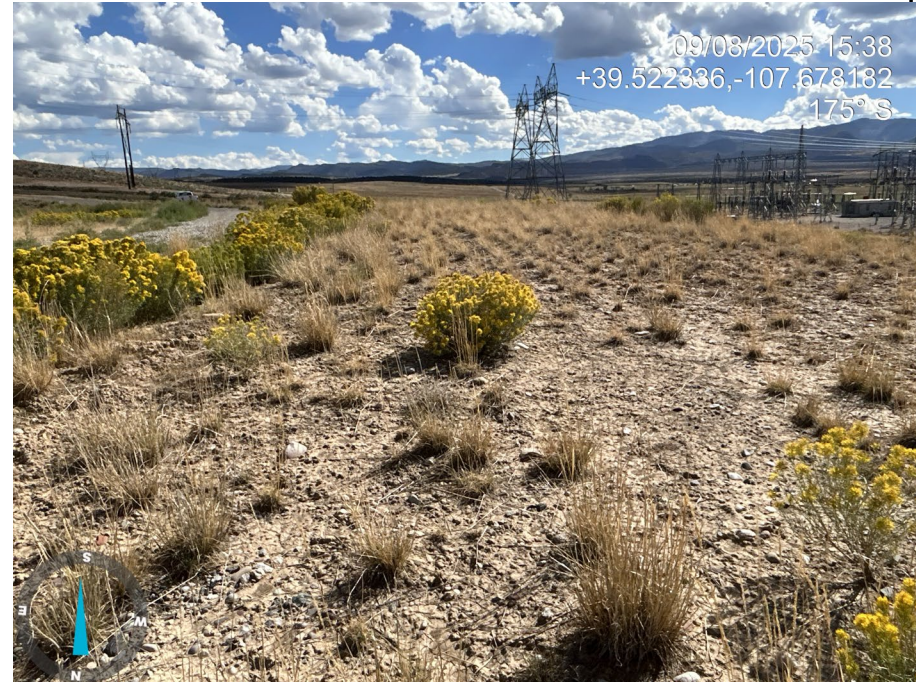
Photo 5: Photos showing the western interim areas are composed of Russian wildrye, intermediate wheatgrass and secondary amounts of rubber rabbitbrush. These portions of the interim areas are progressing towards 1003 reclamation requirements.

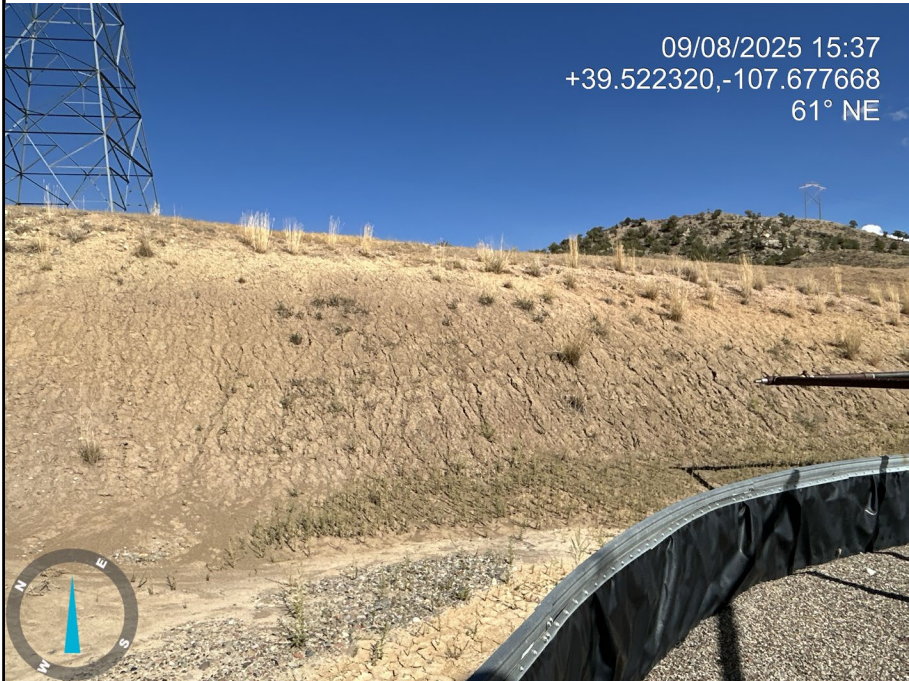
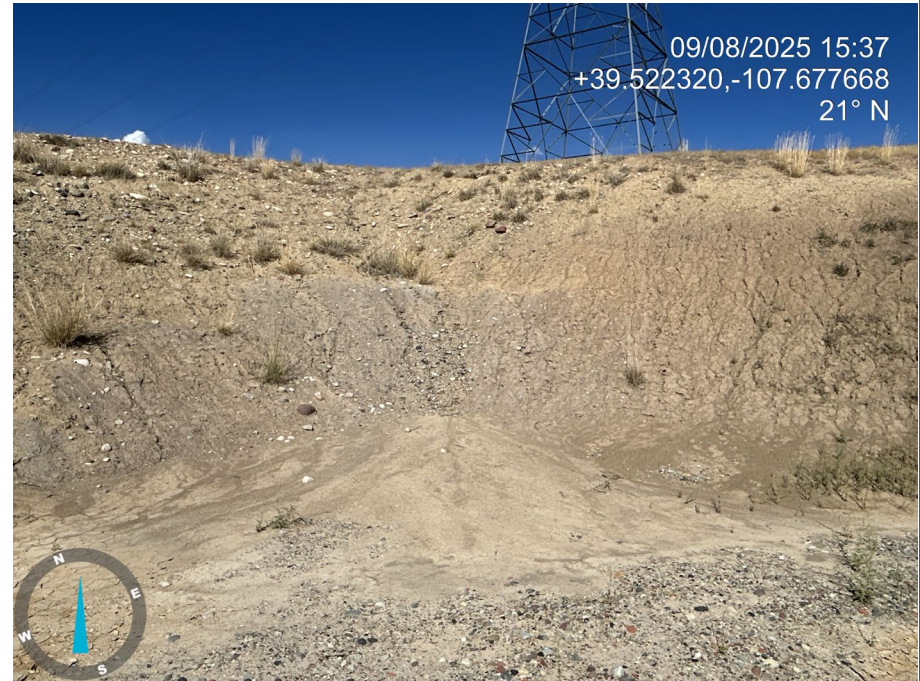
Photo 6: Photo showing the eastern and northeastern cut slopes behind production equipment, respectively. The cut slopes appear to be predominantly bare with rilling and sediment deposition occurring. Implement or maintain stormwater BMP's.

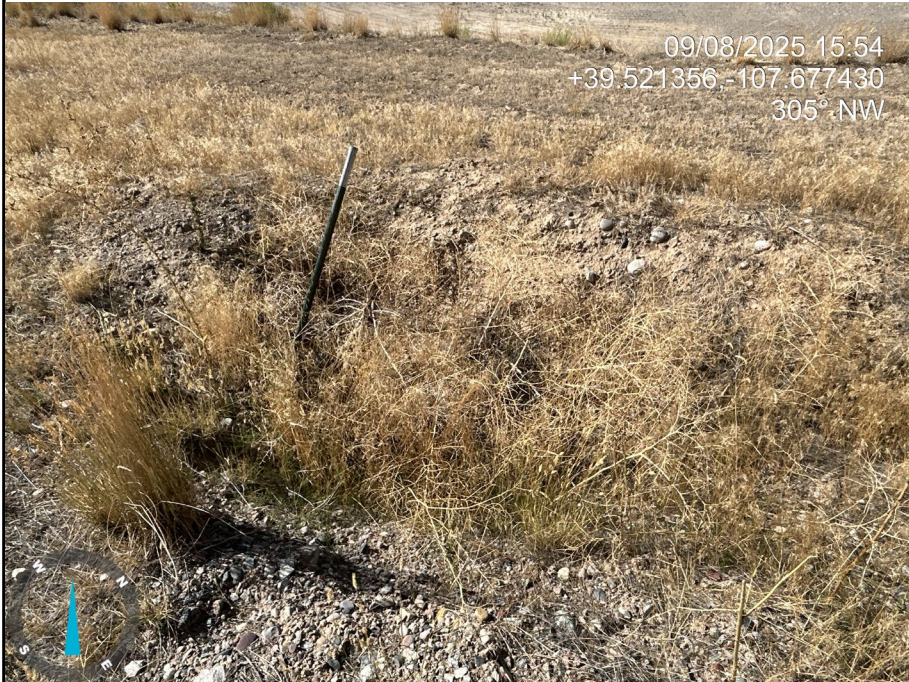
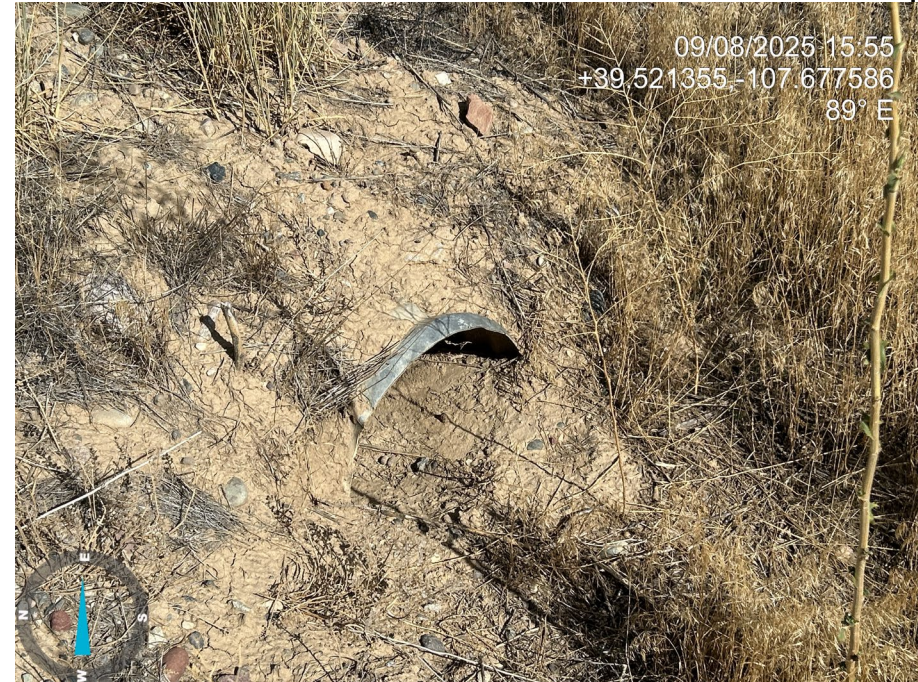
Photo 7: A culvert along the access road appears to have accumulated a build-up of vegetative debris and sediment. Maintain stormwater BMP's.
