# Inspection Photos

**Operator:** TEP Rocky Mountain LLC #96850

**Location ID:** 335271

**Inspection Doc:** 719200201

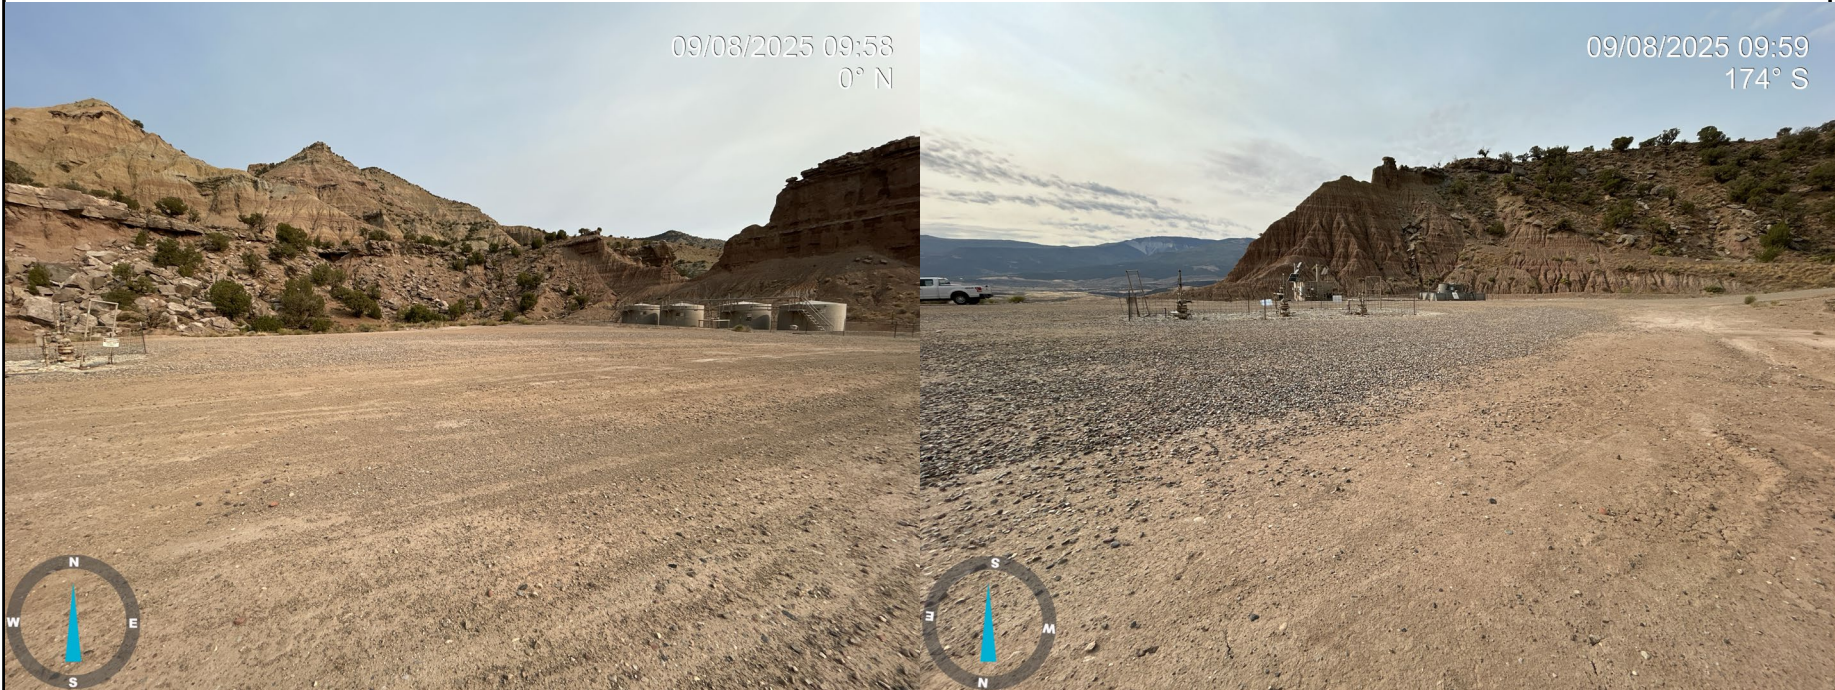
**Photo 1:** Photos show an overview of the location looking north and south, respectively.

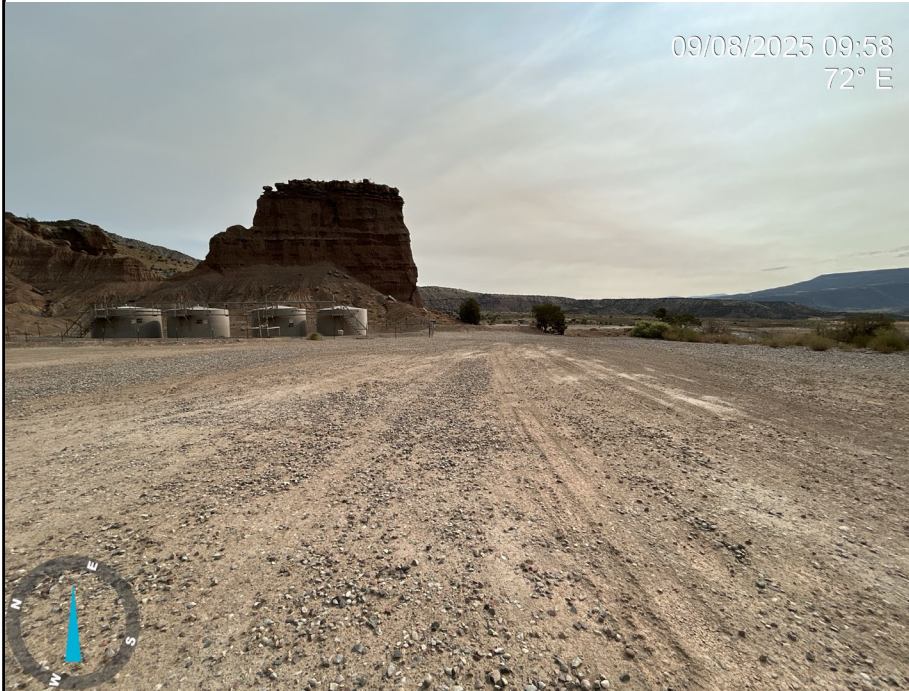
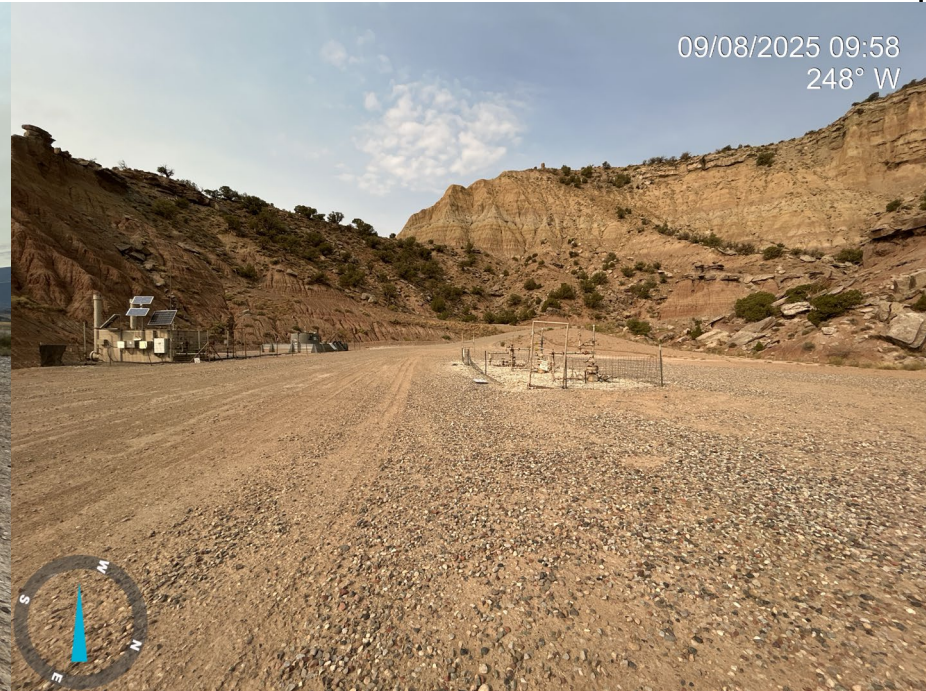
**Photo 2:** Photos show an overview of the location looking east and west, respectively.

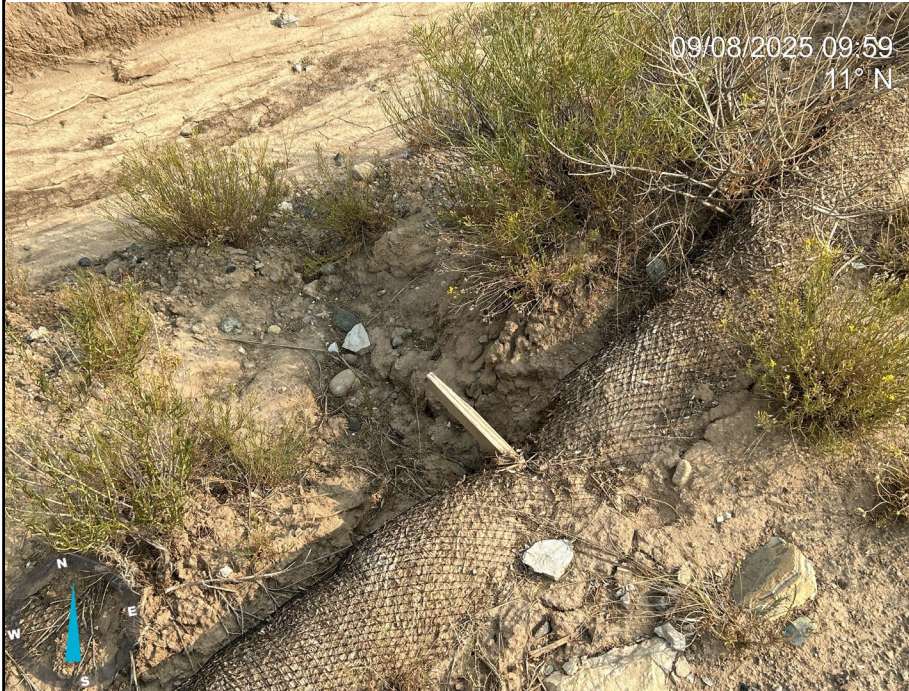
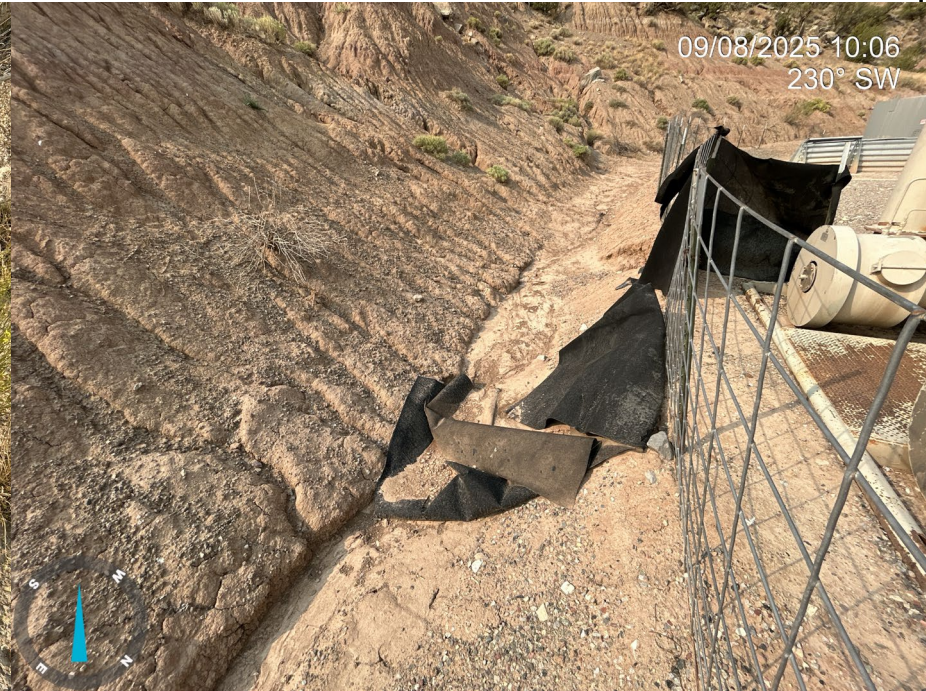
**Photo 3:** Photos showing stormwater controls on the northeastern and southern portions of the location, respectively. Stormwater BMP's are in disrepair. Comply with Rule 1002.f.

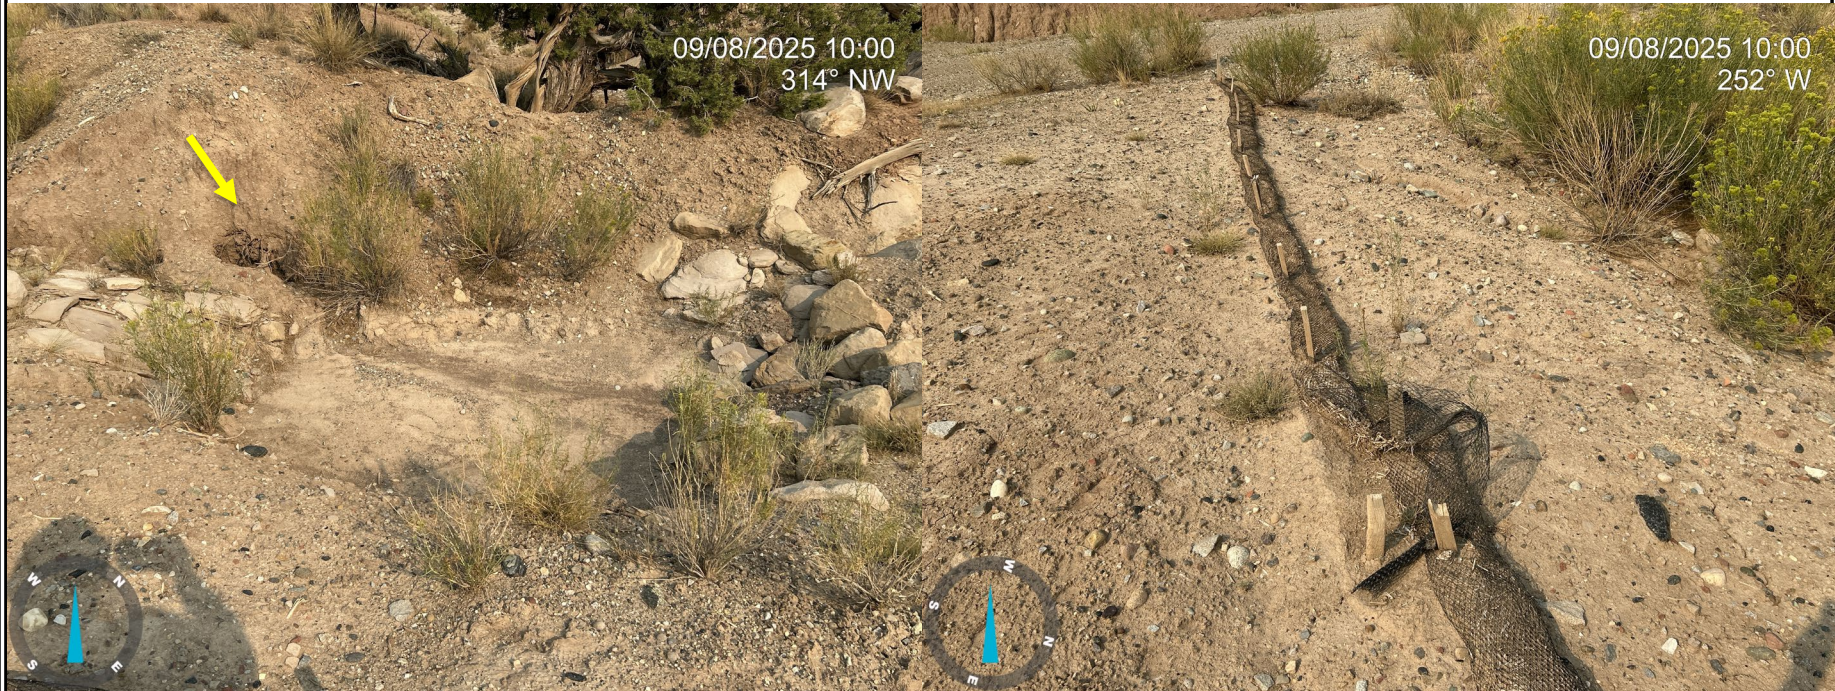
**Photo 4:** Photos showing stormwater controls on the northern portion of the location. Stormwater BMP's are in disrepair or in need of maintenance. Comply with Rule 1002.f.

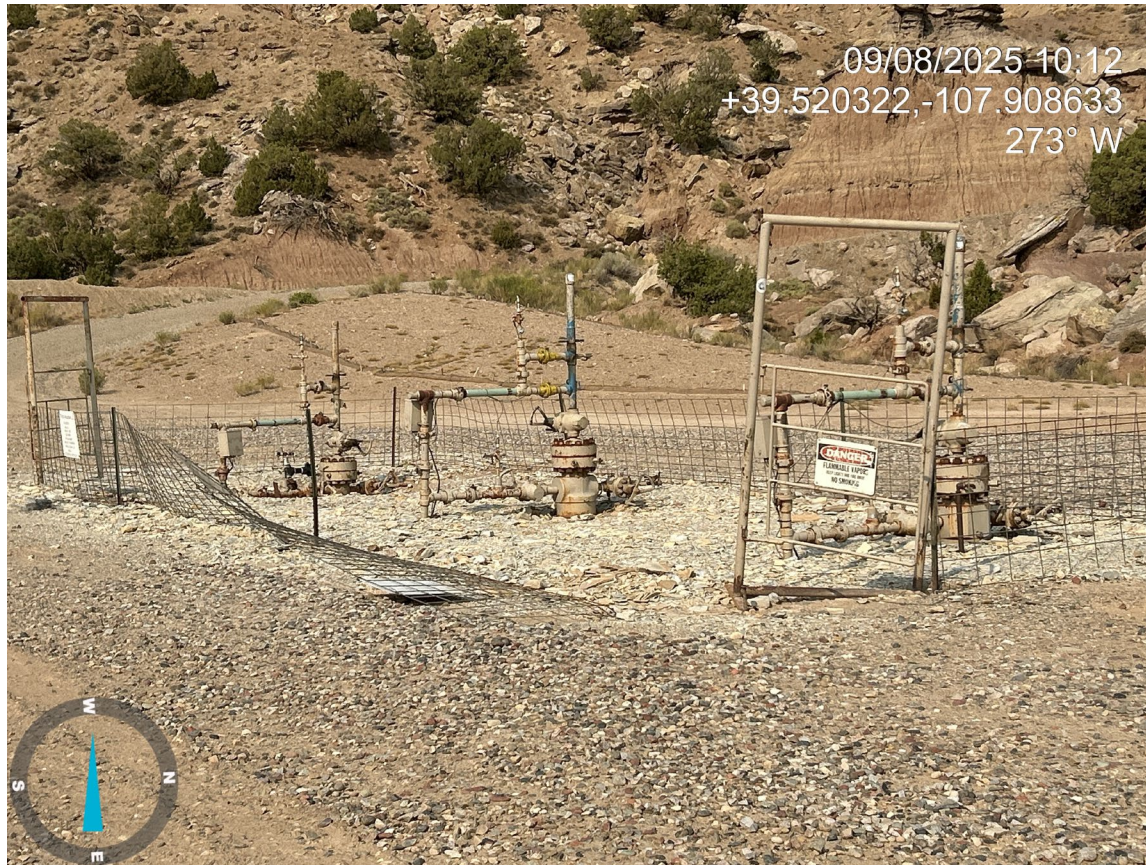
**Photo 5:** Photos showing fencing around the wellheads is in disrepair and insufficient to prevent livestock or wildlife entry. Maintenance is advised.

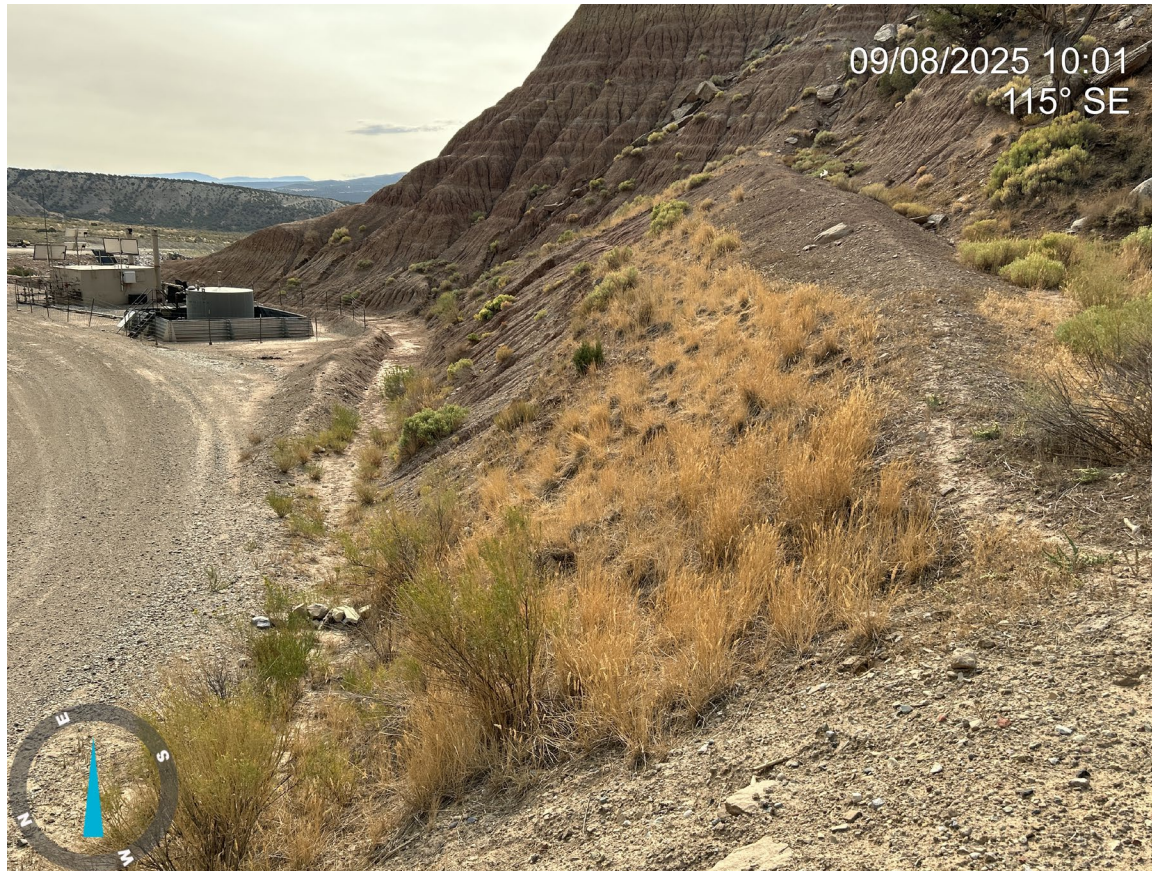
**Photo 6:** Photos showing the southwestern cut slope. Desirable vegetation has established on portions of the cut slope.

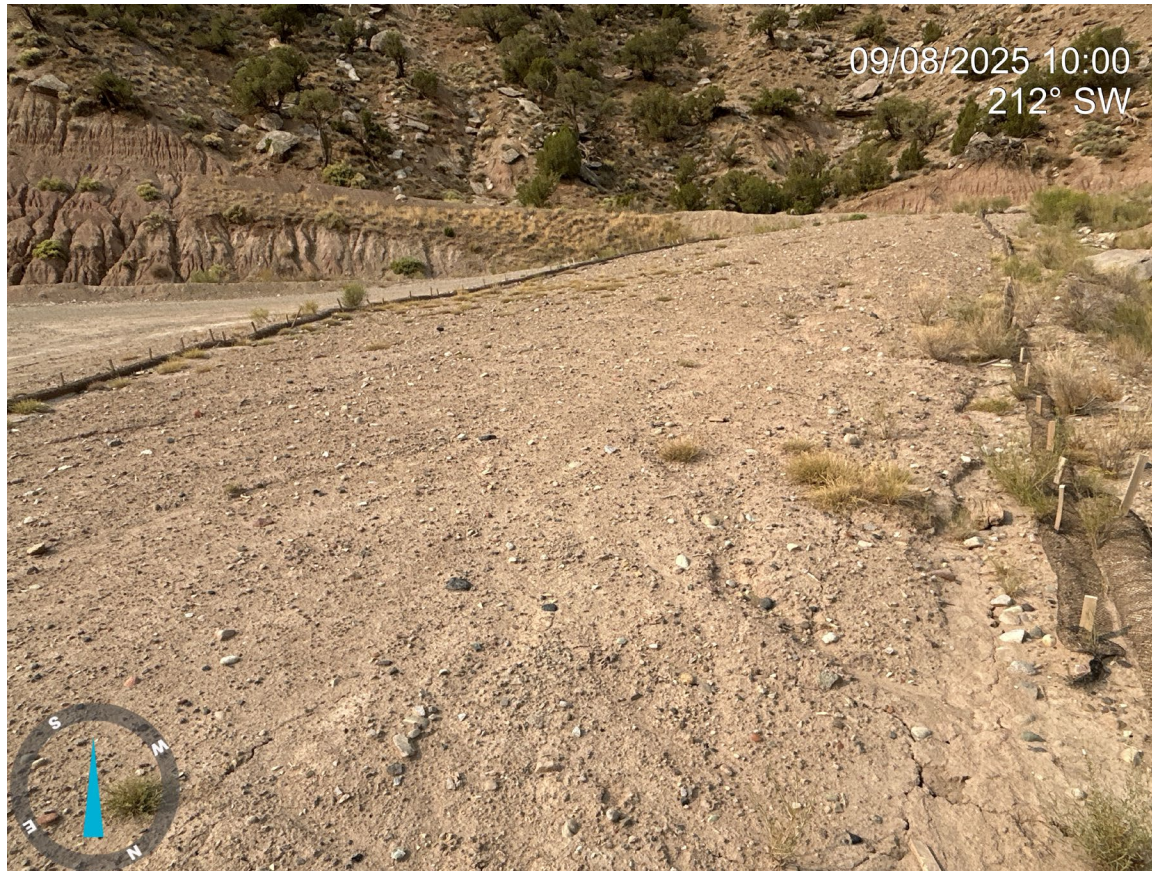
**Photo 7:** Photo showing the northwestern interim area is composed of mostly bare ground. Reseeding and reclamation efforts are not apparent. Comply with 1003 reclamation rules.

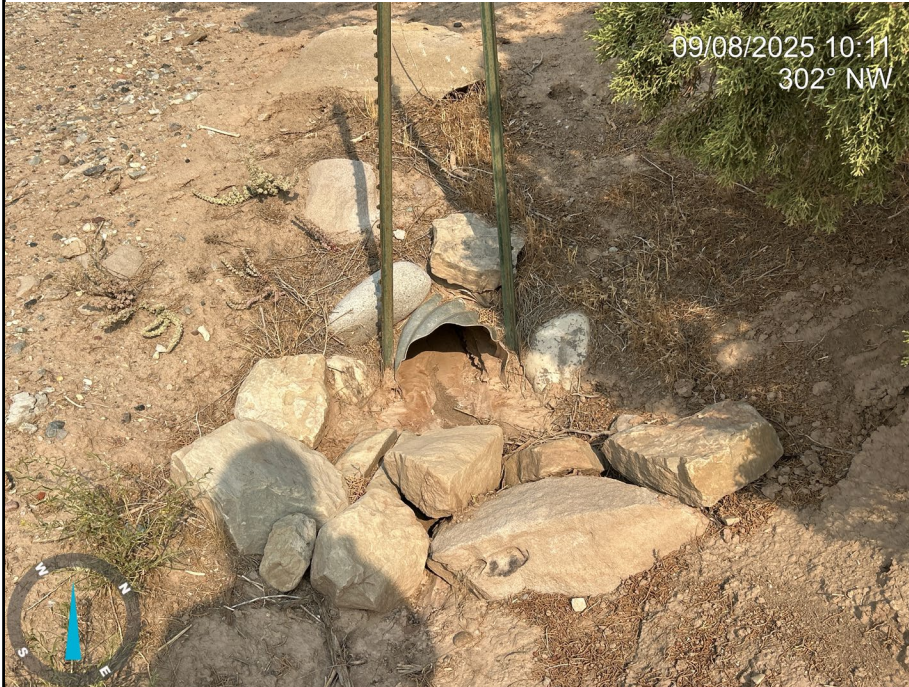
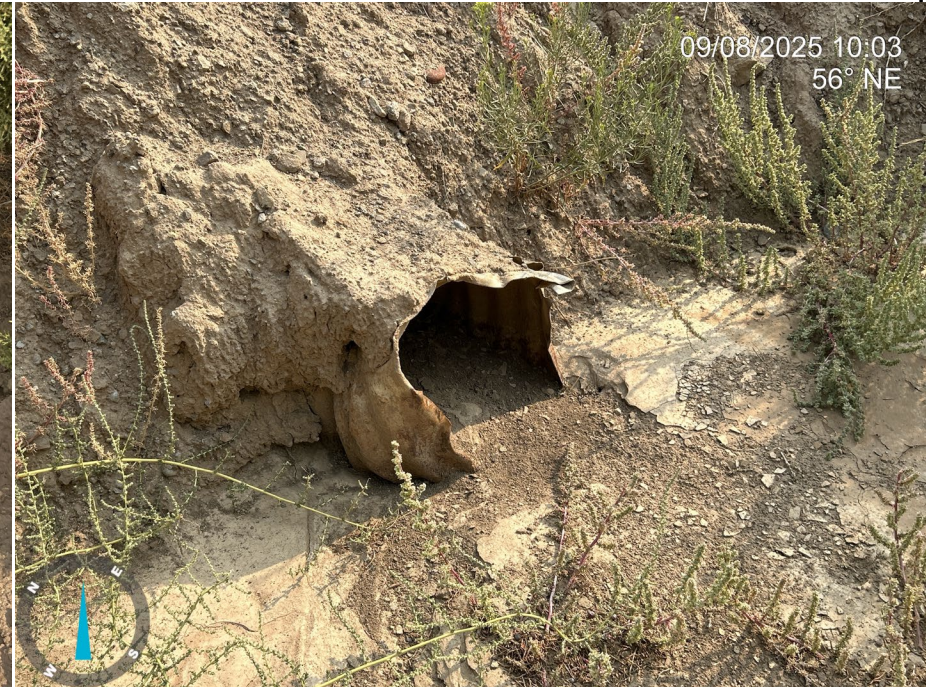
**Photo 8:** Photos showing some culverts at the location appear to have an accumulation of sediment deposition, reducing capacity. Maintenance is required.
