Inspection/Audit Photos

Location: UTAH GAS OP LTD DBA UTAH GAS CORP DOUGLAS CREEK UNIT #50 PAD

Location ID: 311826

Date: 09/17/2025

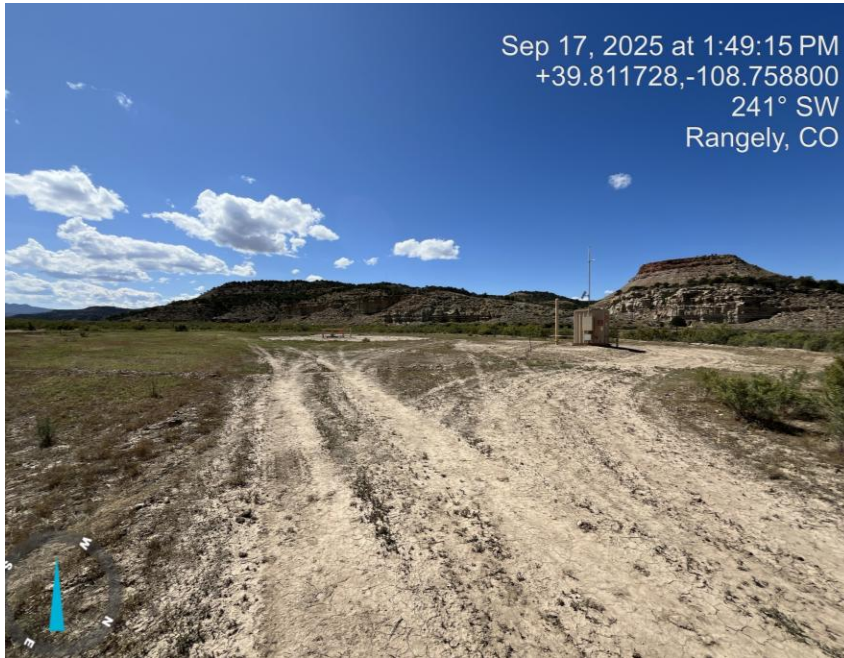
Photo # 3562 Entrance to location

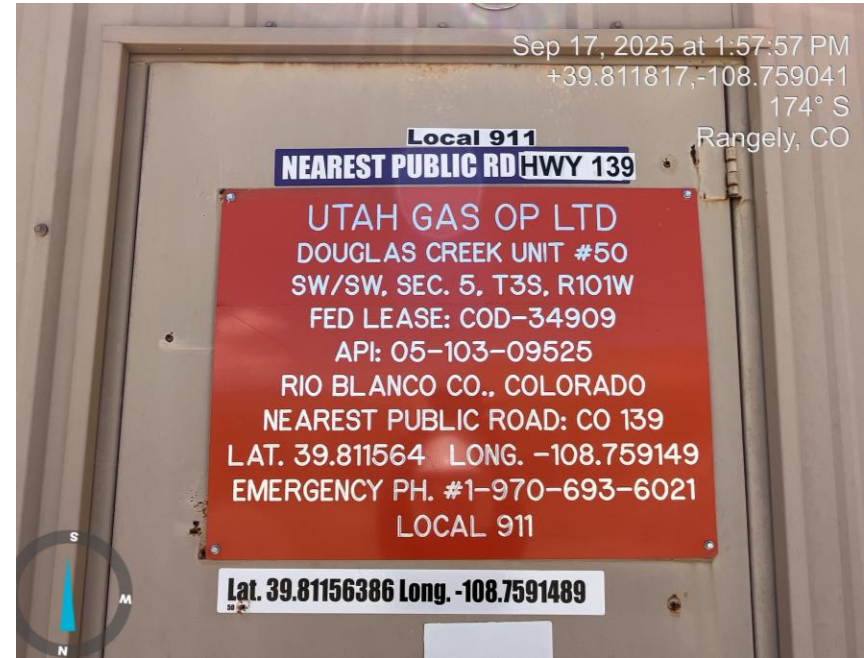
Photo # 3570 Location

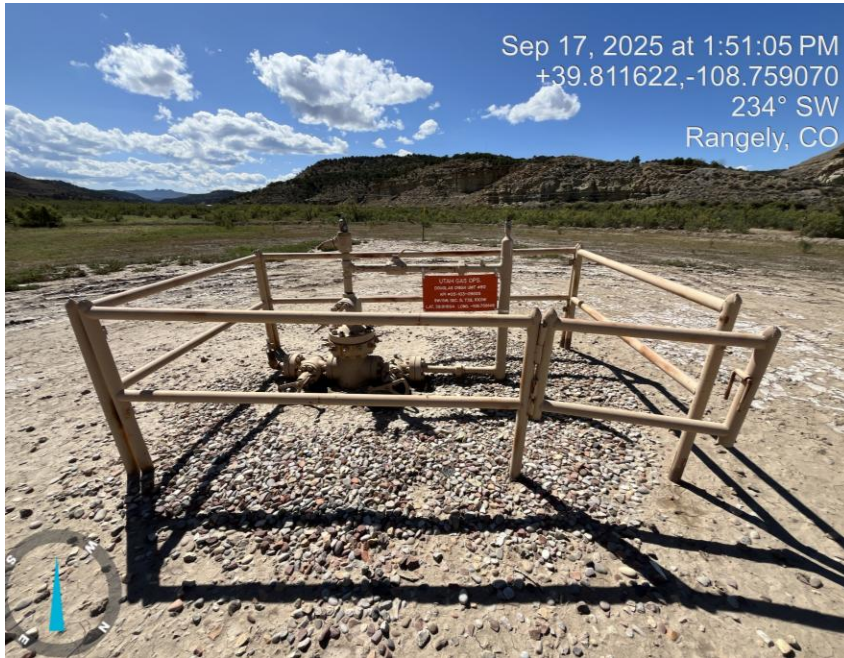
Photo # 3563 Location

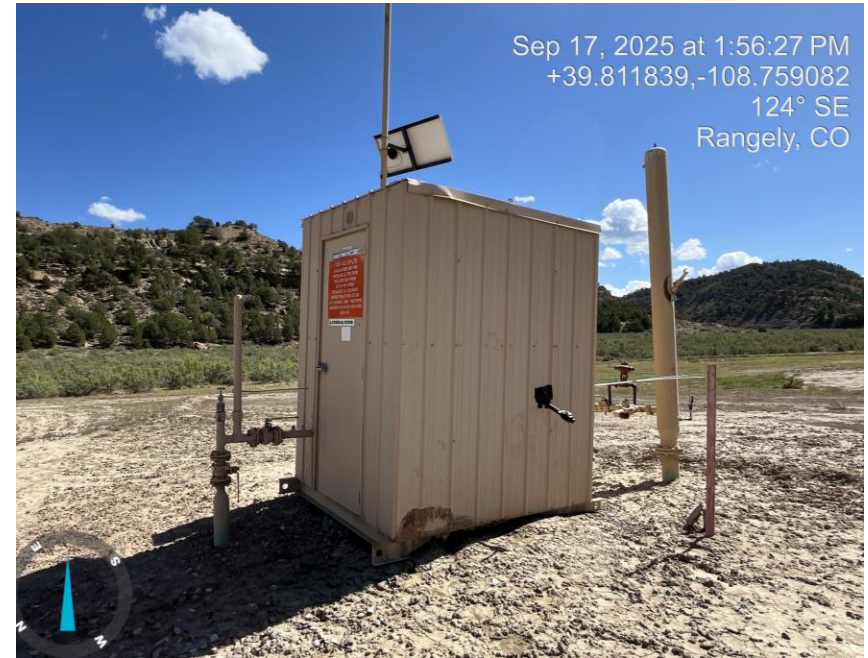
Photo # 3567 Location

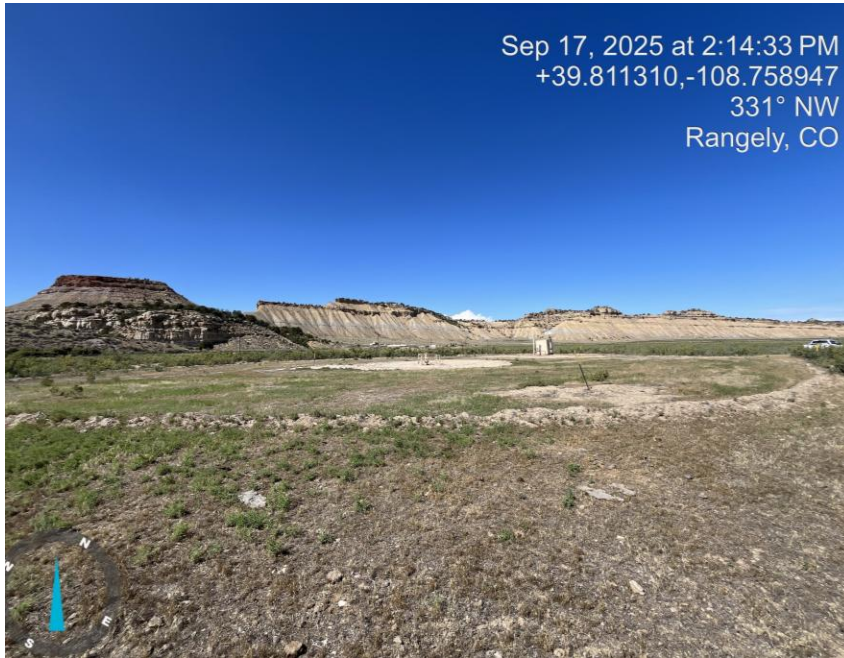
Photo # 3580 SE corner of location

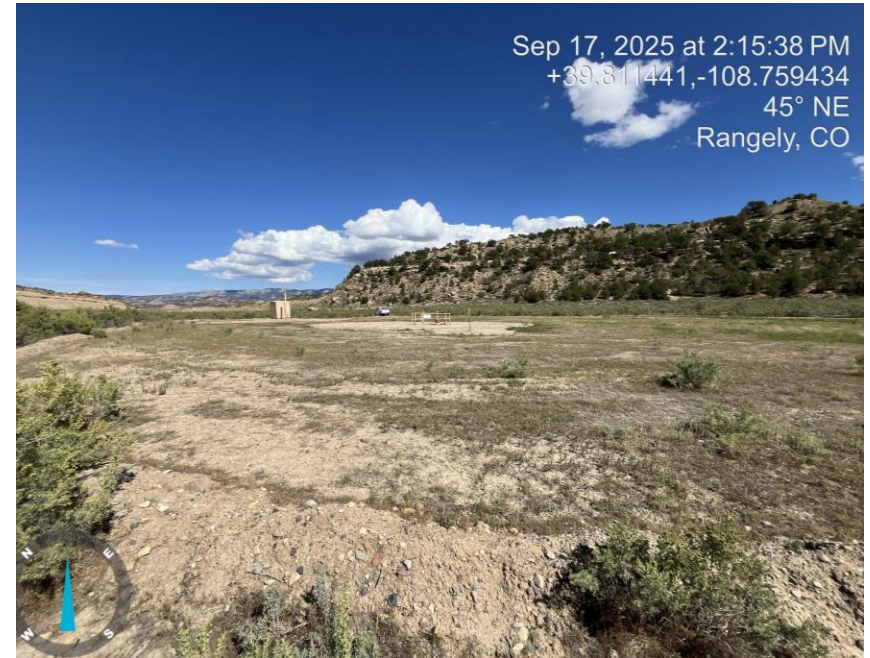
Photo # 3581 SW corner of location

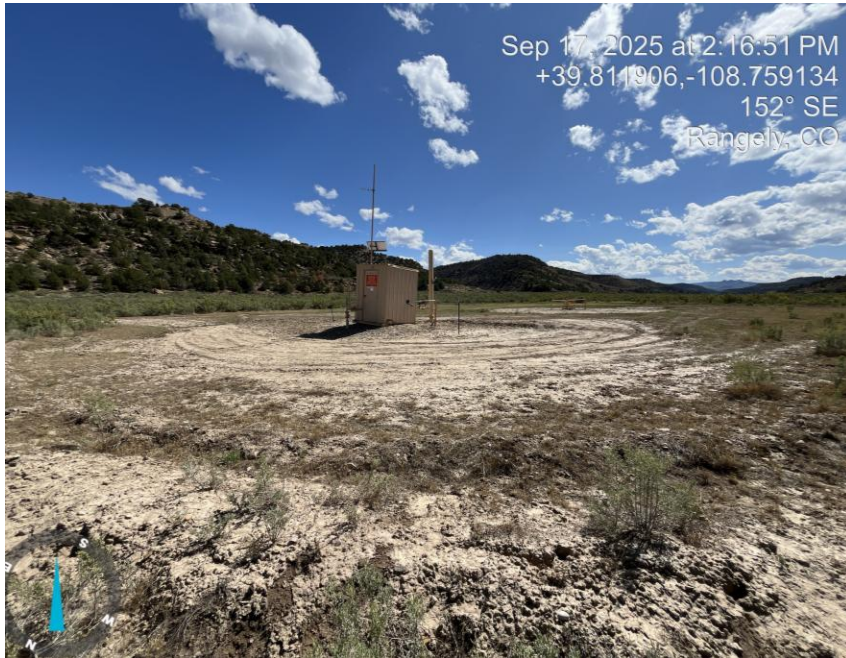
Photo # 3582 NW corner of location

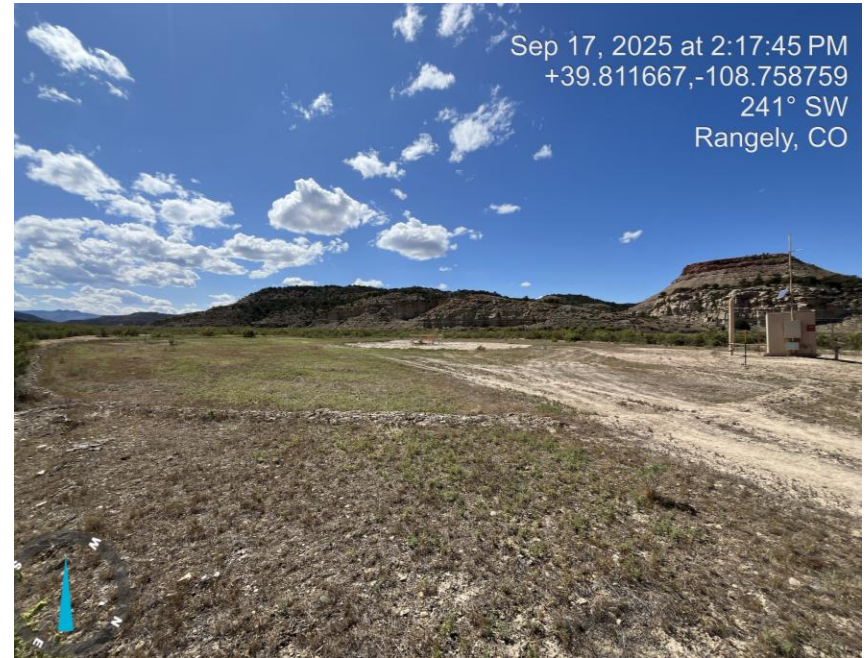
Photo # 3583 NE corner of location

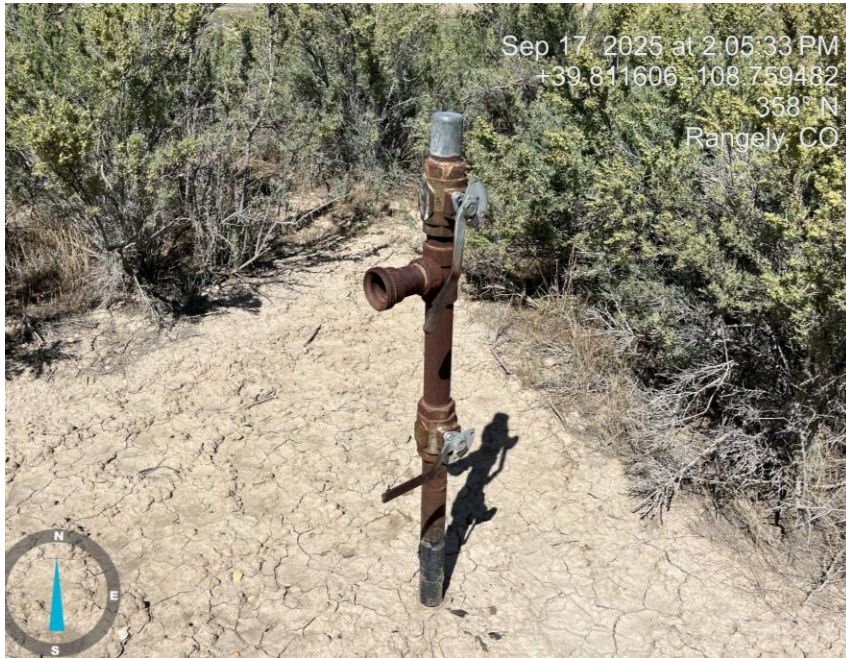
Photo # 3575 Unused flowline lacks lockout tagout (OOSLAT) & has open ended piping/wildlife hazard/available for entry by wildlife

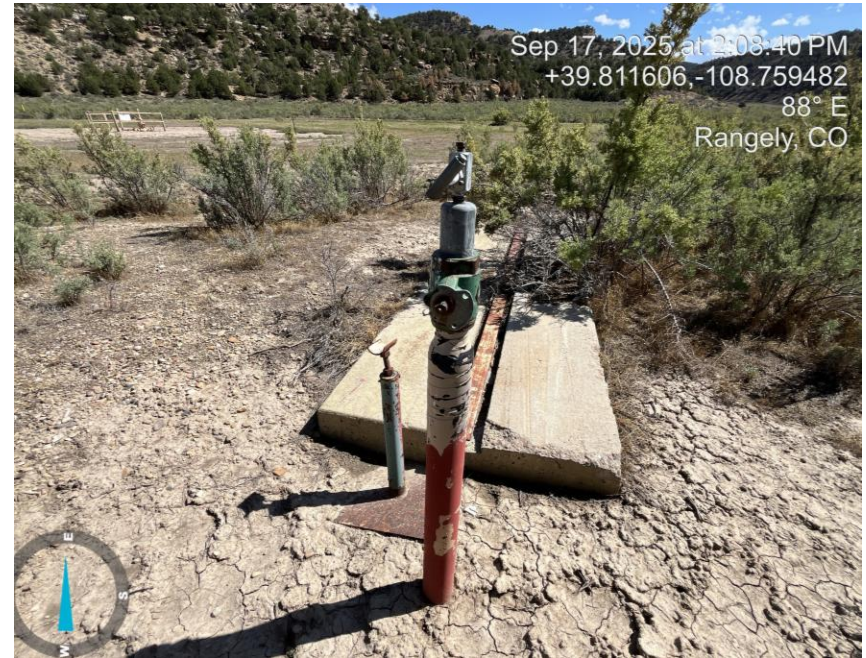
Photo # 3577 Unused flowline lacks lockout tagout (OOSLAT)

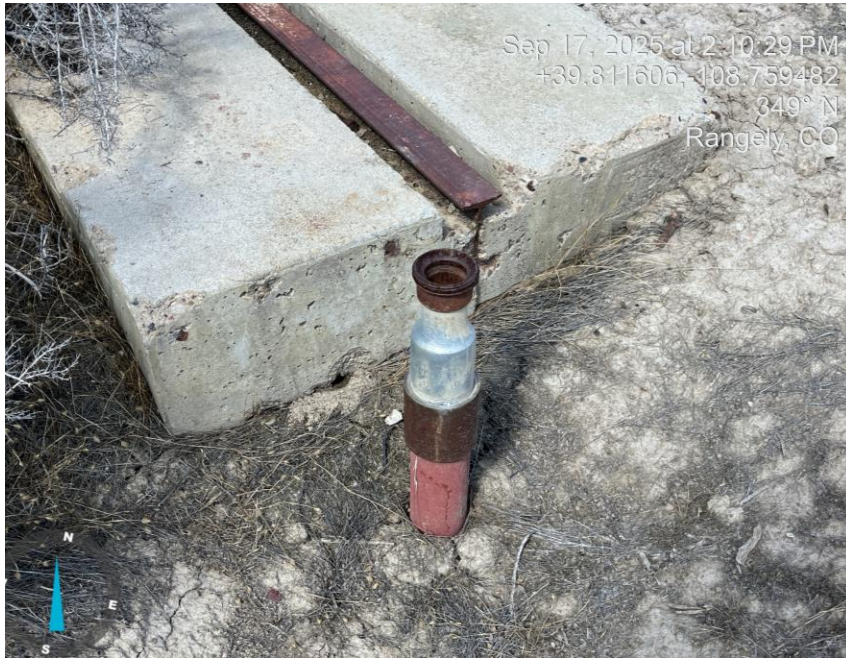
Photo # 3578 Open ended piping/wildlife hazard/available for entry by wildlife

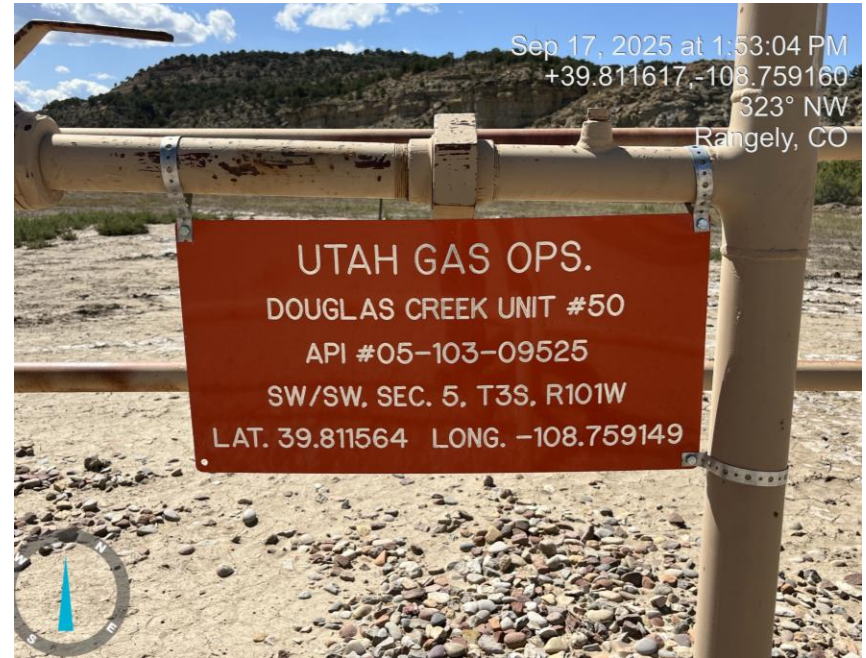
Photo # 3565 Wellhead sign lacks required information/not in compliance with CECMC rules

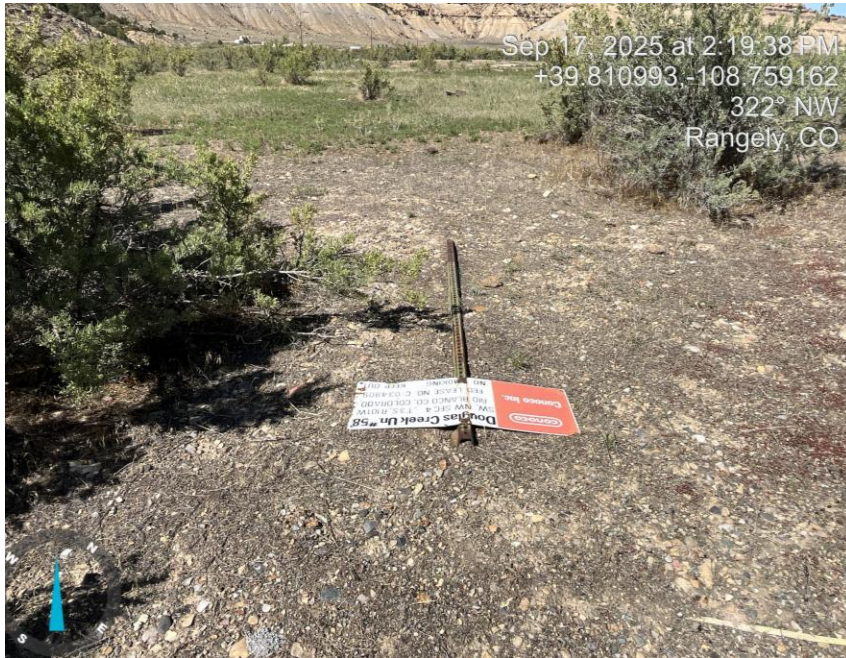
Photo # 3584 Debris

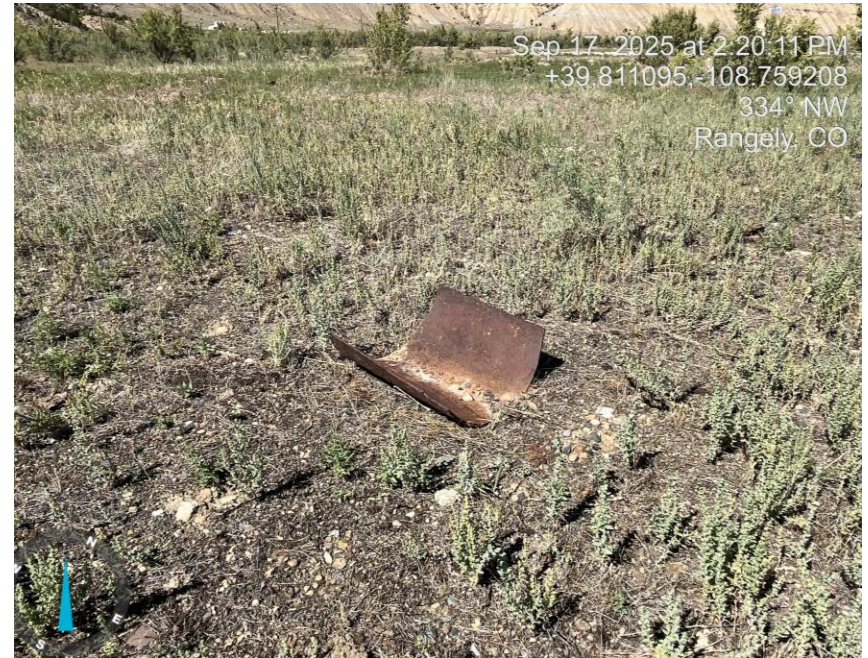
Photo # 3585 Debris

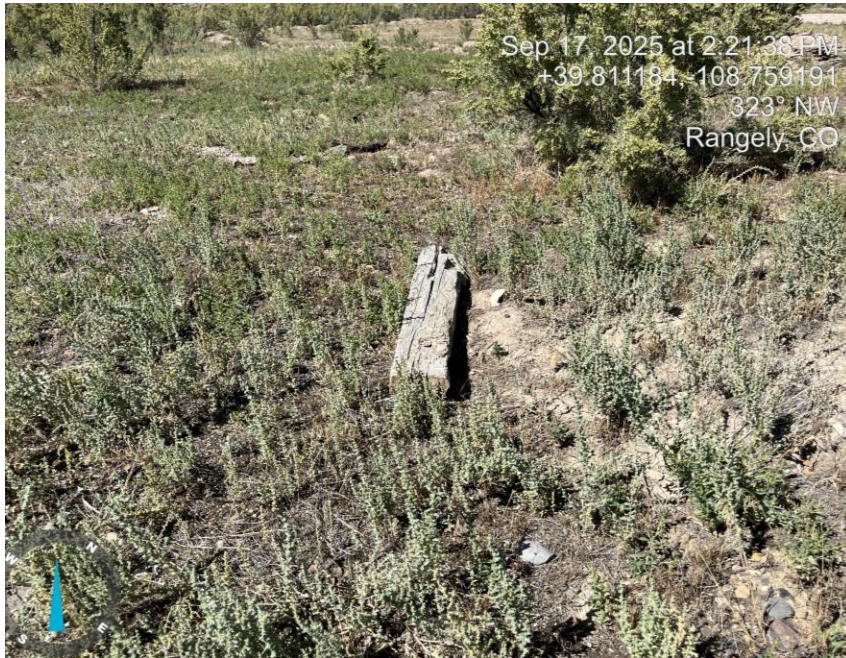
Photo # 3587 Debris

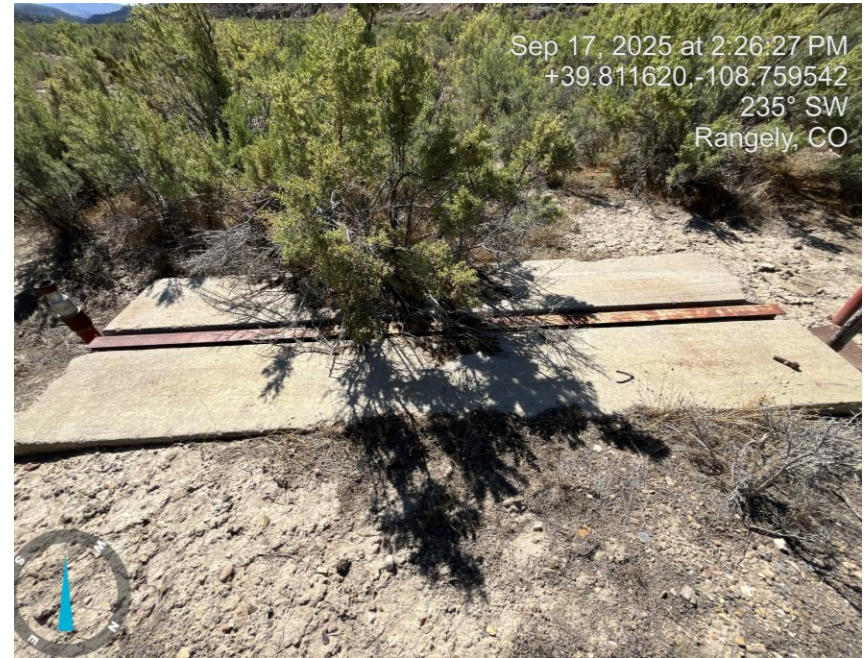
Photo # 3594 Debris
