# Inspection/Audit Photos

Location Name: TEP ROCKY MOUNTAIN LLC AP 41-11-696

Location ID: 335874

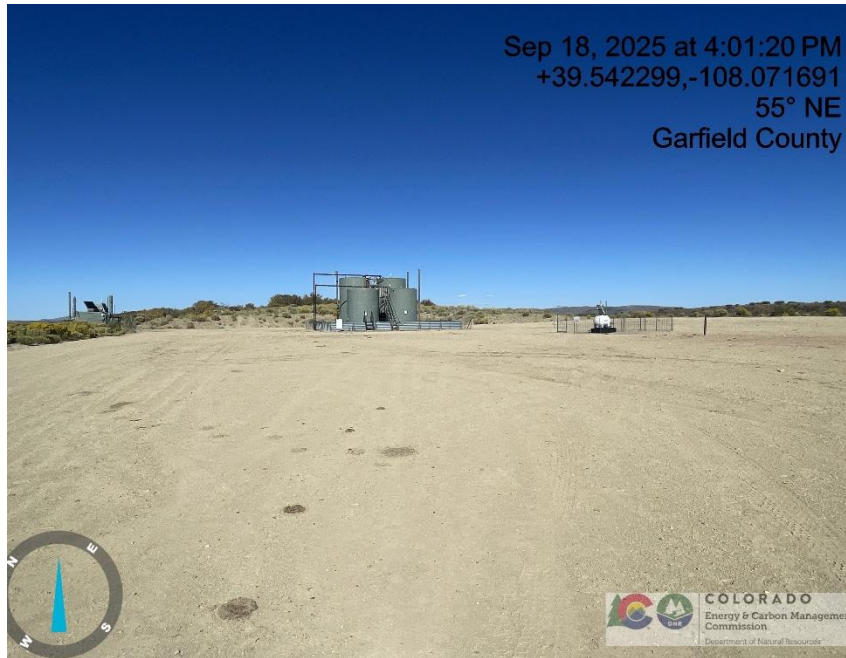
Photo # 1185 From entrance to location

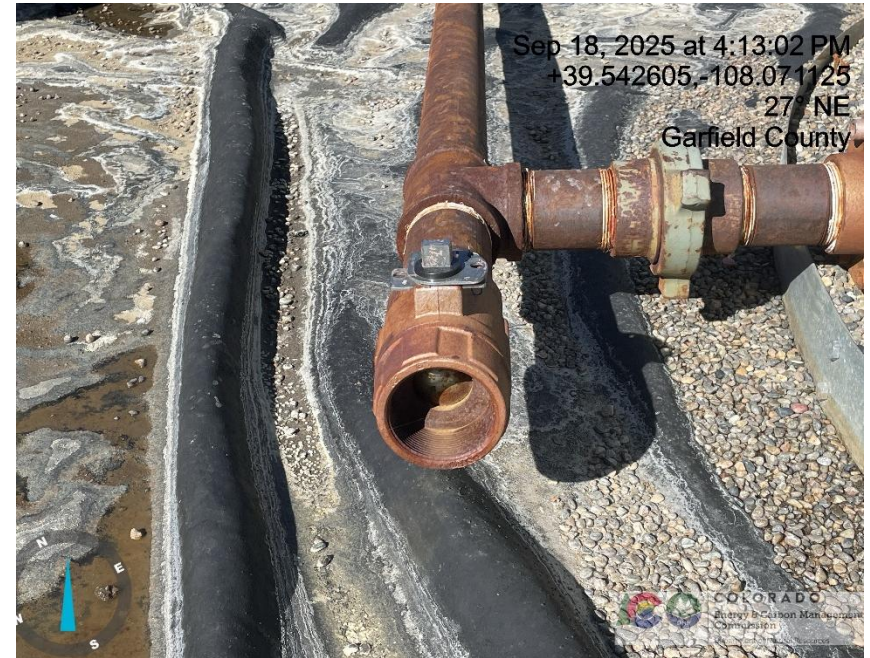
Photo # 1192 Open ended load line

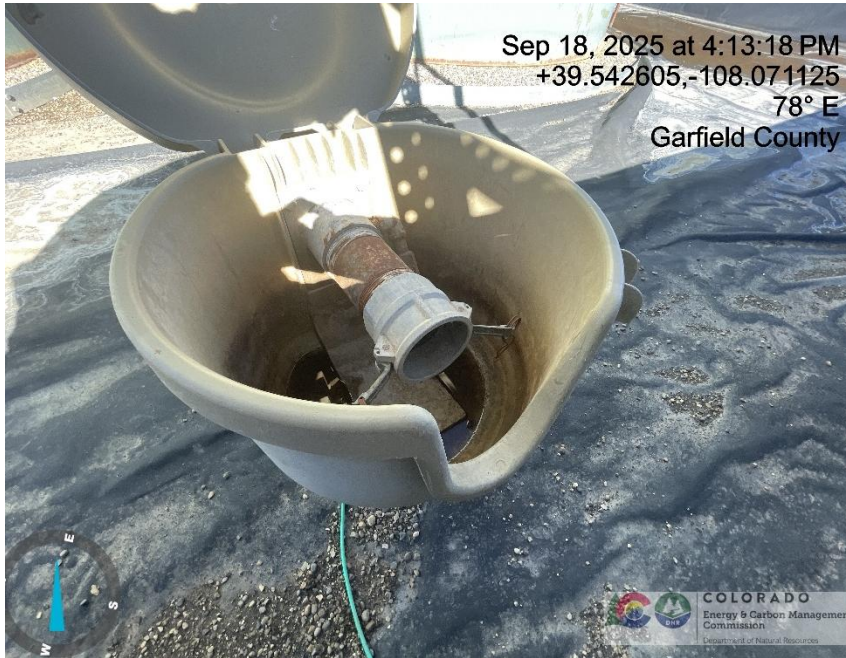
Photo # 1193 Open ended load line

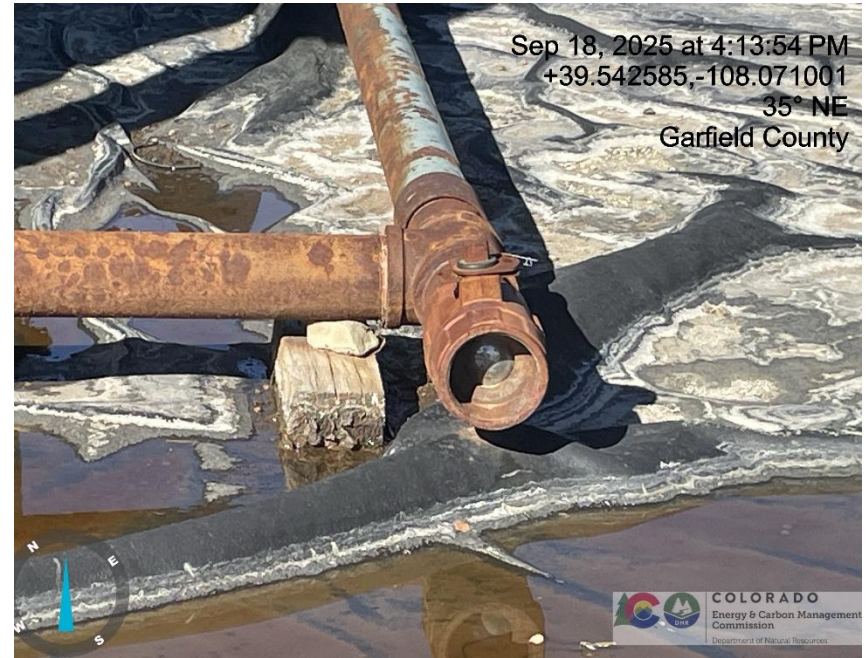
Photo # 1194 Open ended load line

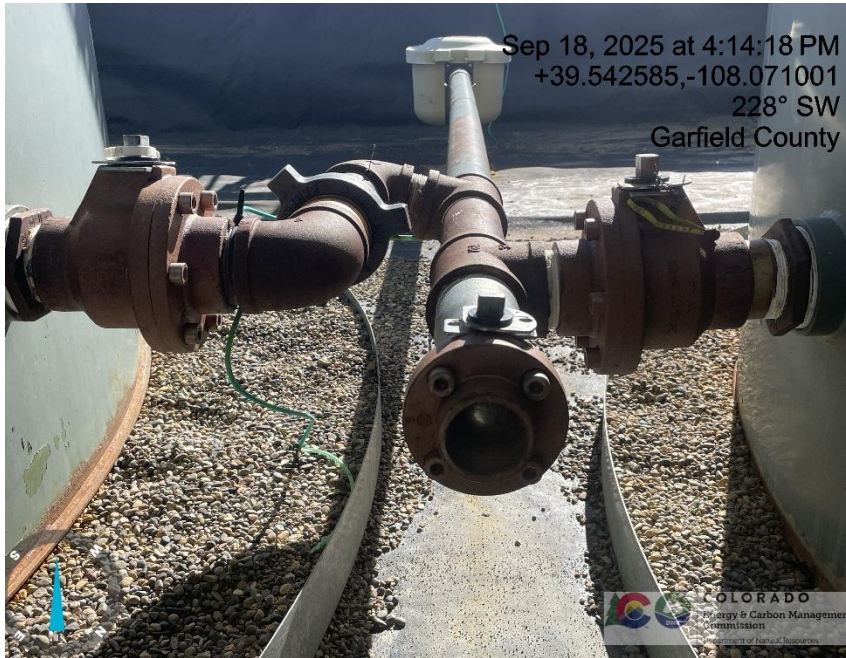
Photo # 1195 Open ended load line

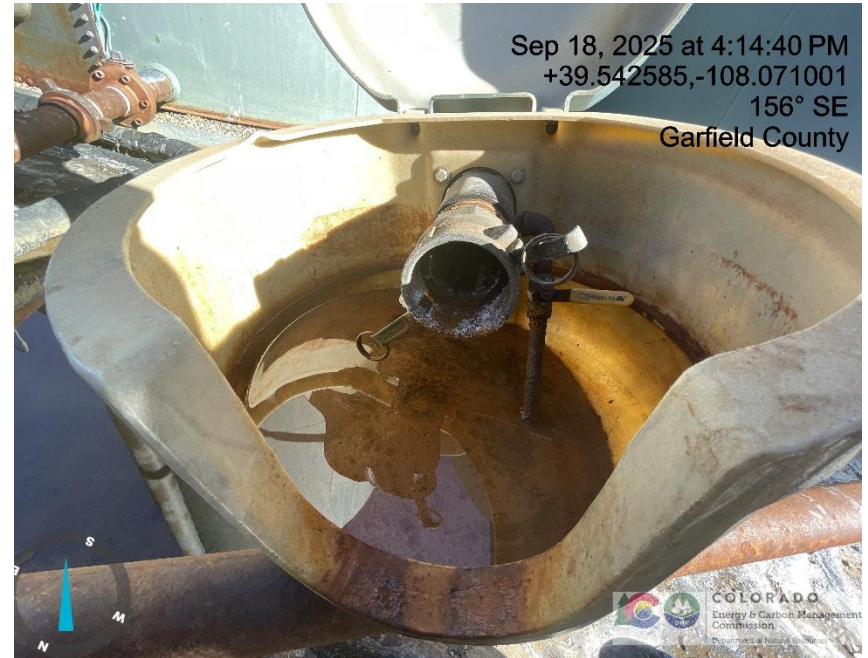
Photo # 1196 Open ended load line

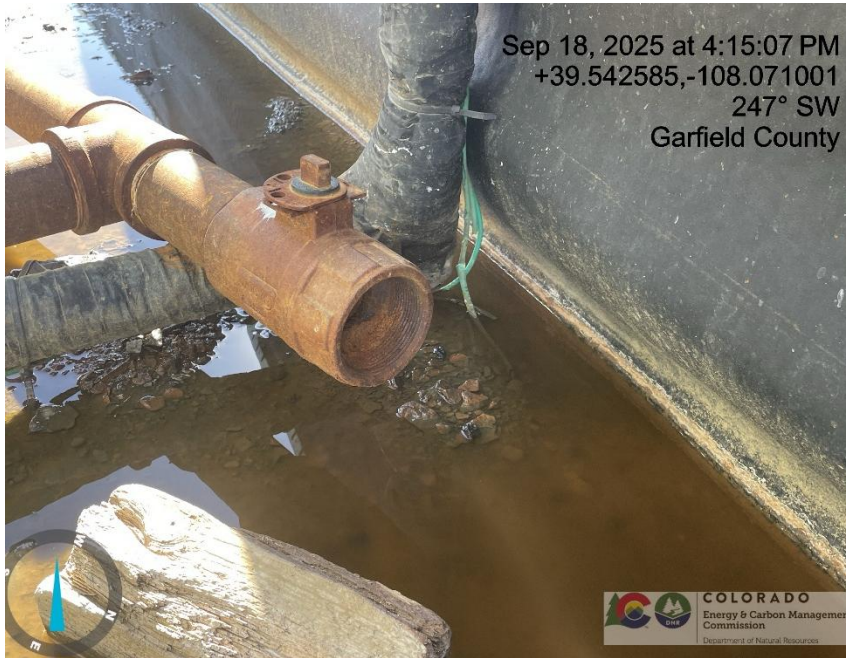
Photo # 1197 Open ended load line

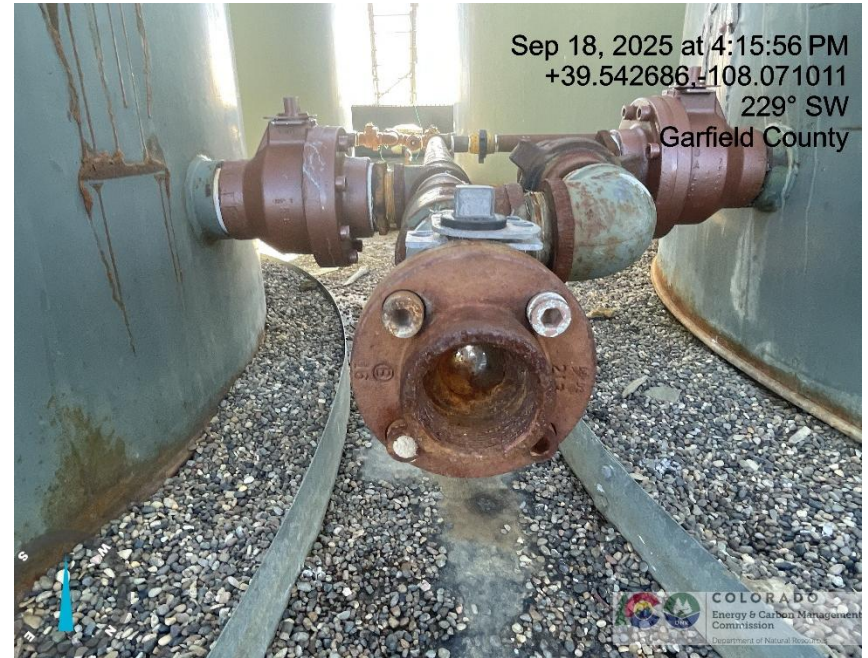
Photo # 1198 Open ended load line

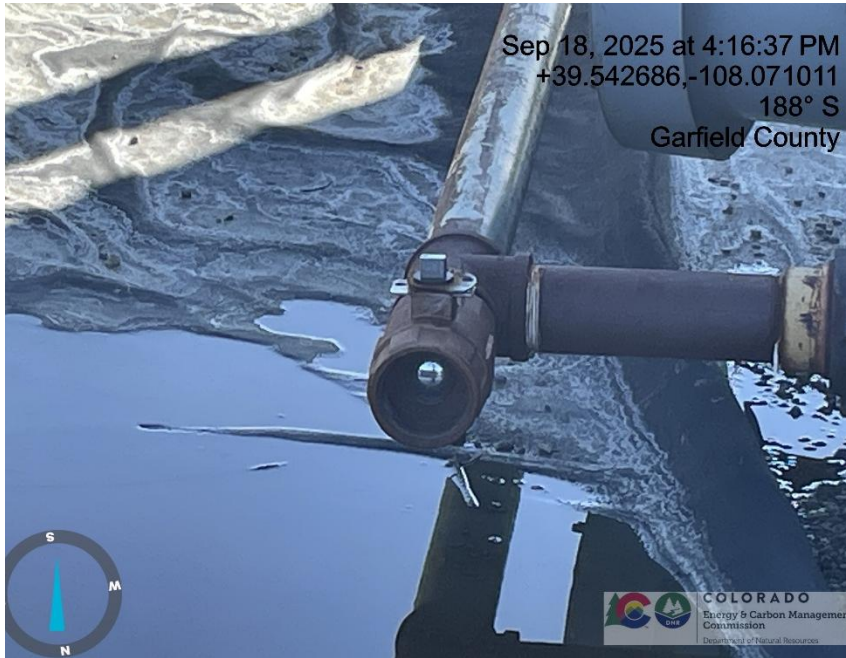
Photo # 1199 Open ended load line

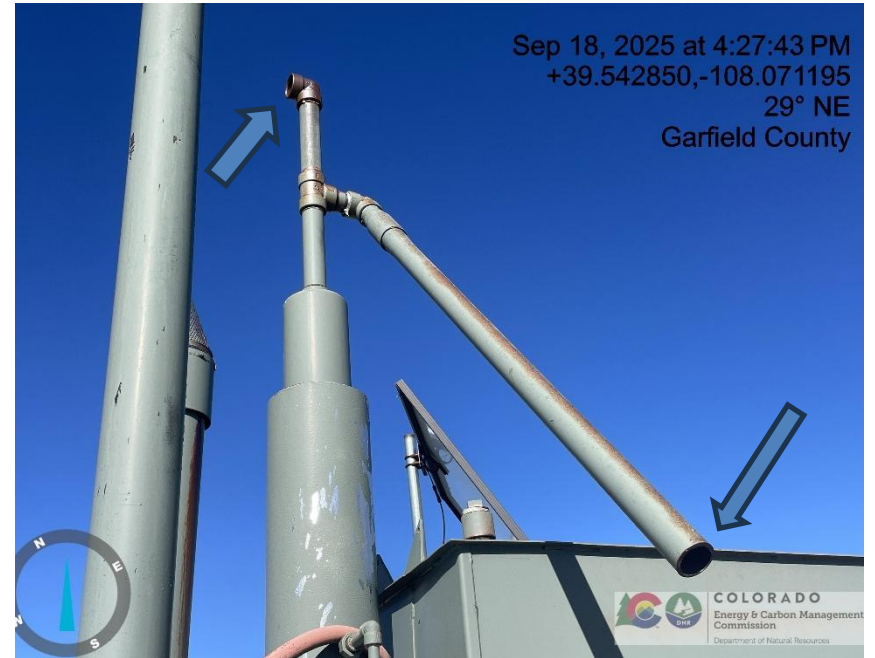
Photo # 1200 Open ended piping on separator/wildlife hazards/available for entry by wildlife

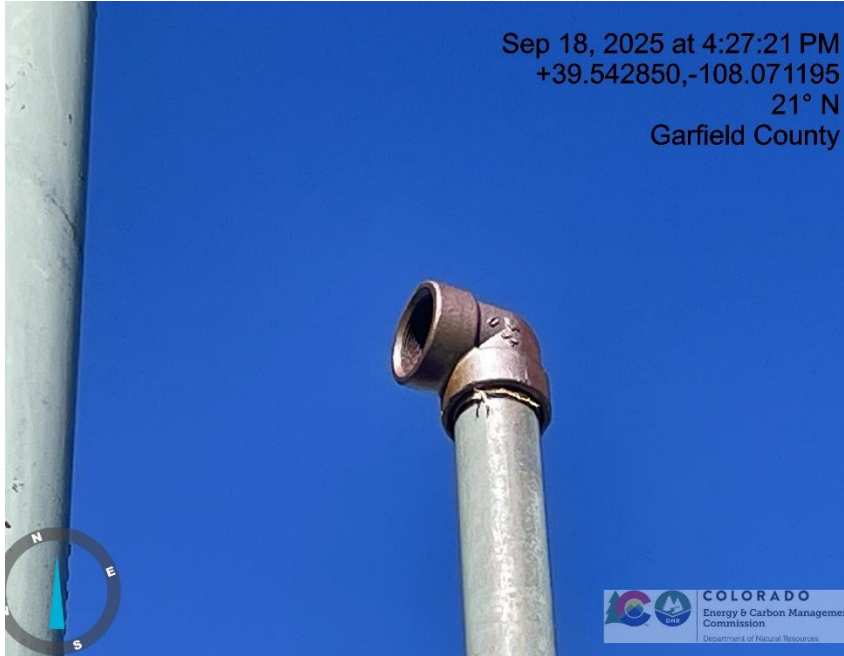
**Photo # 1201 Open ended piping on separator/wildlife hazard/available for entry by wildlife**

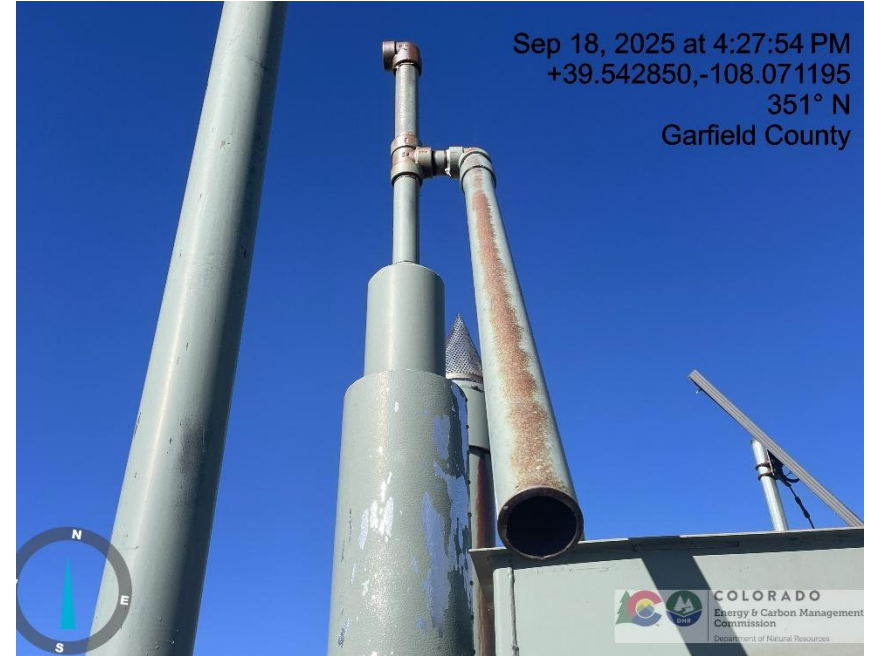
**Photo # 1202 Open ended piping on separator/wildlife hazard/available for entry by wildlife**

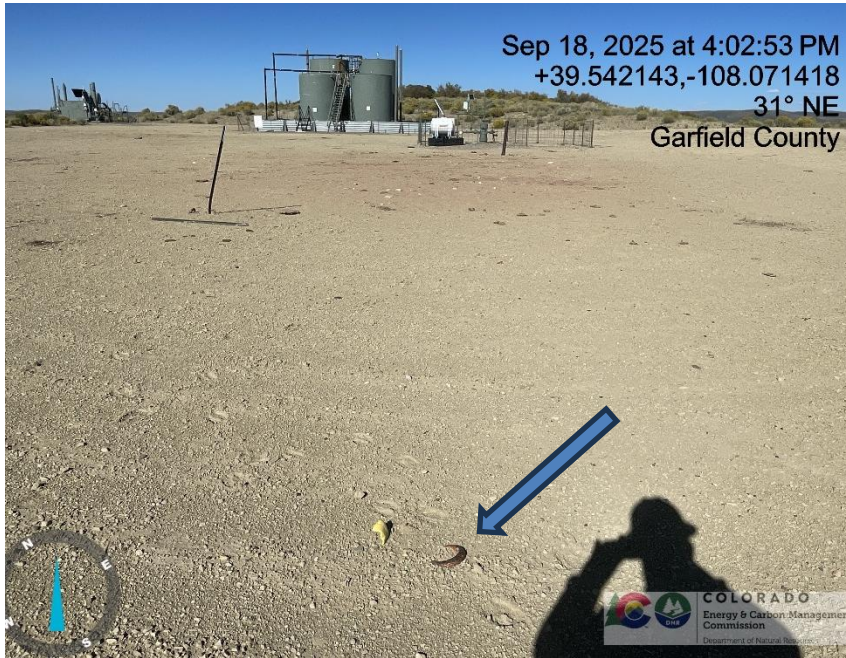
Photo # 1203 Unmarked deadman

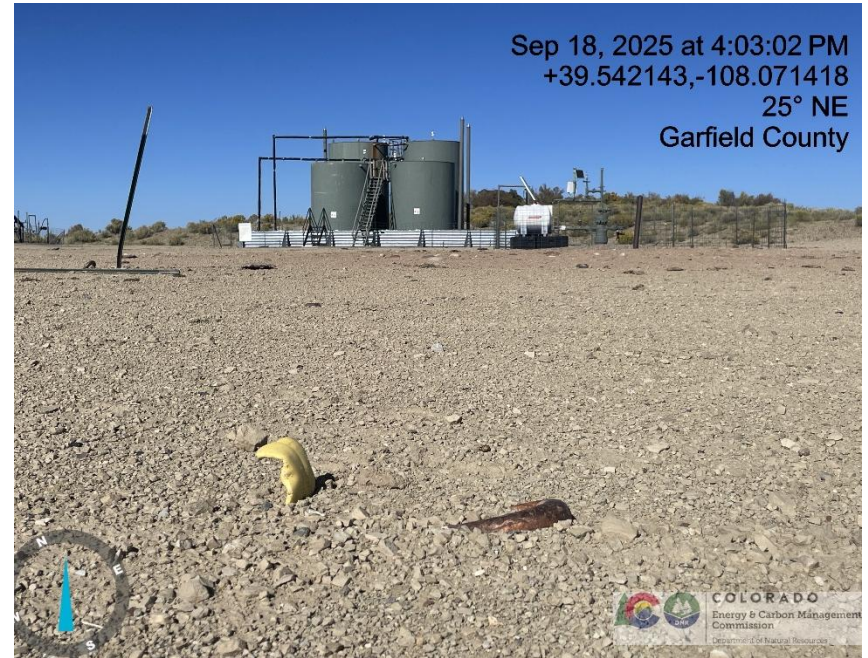
Photo # 1204 Same unmarked deadman

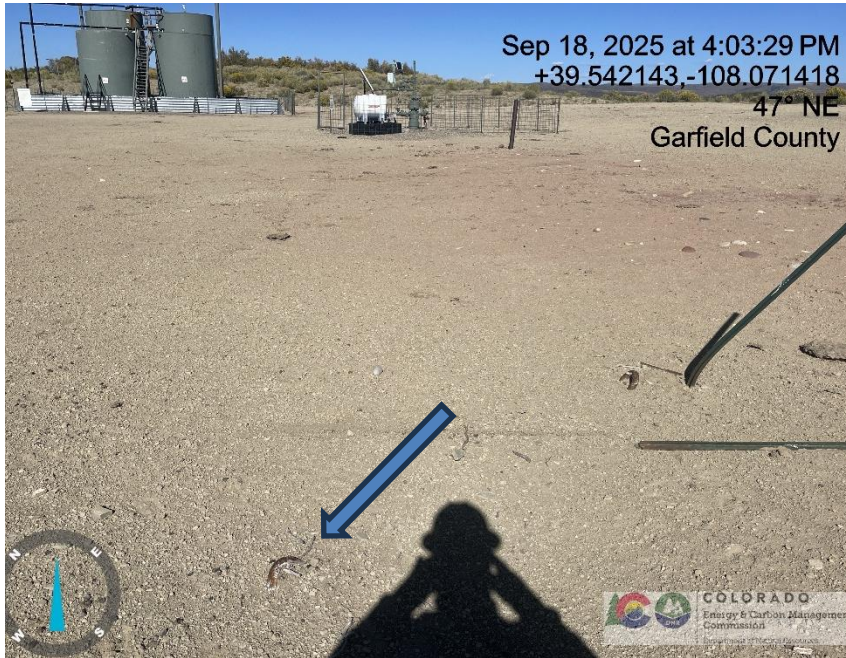
Photo # 1205 Unmarked deadman

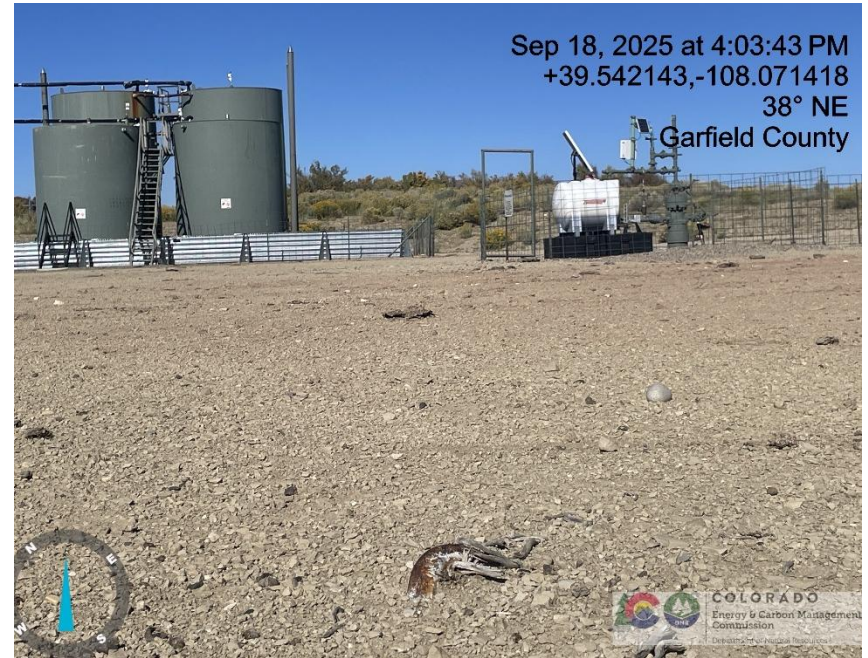
Photo # 1206 Same unmarked deadman

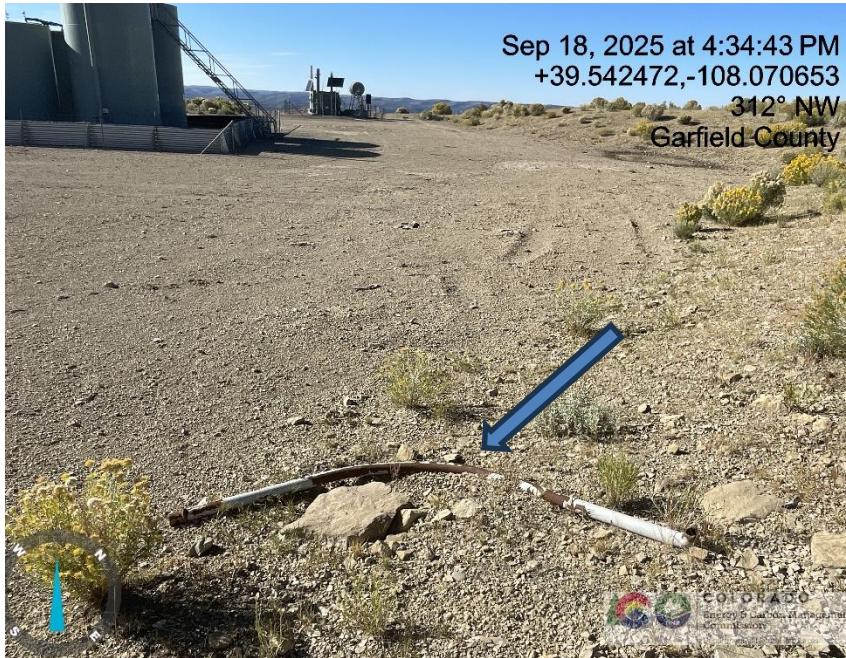
Photo # 1207 Debris

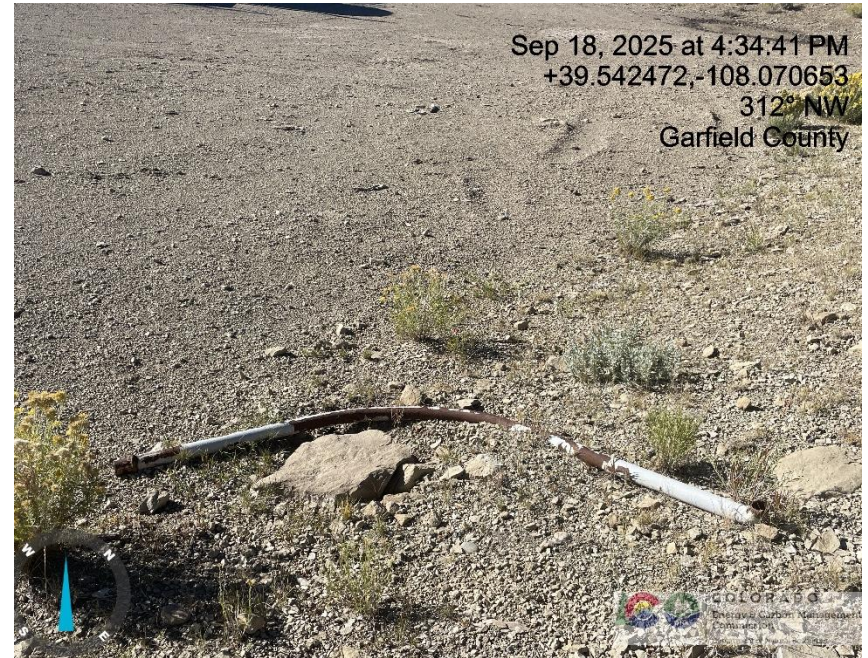
Photo # 1208 Debris

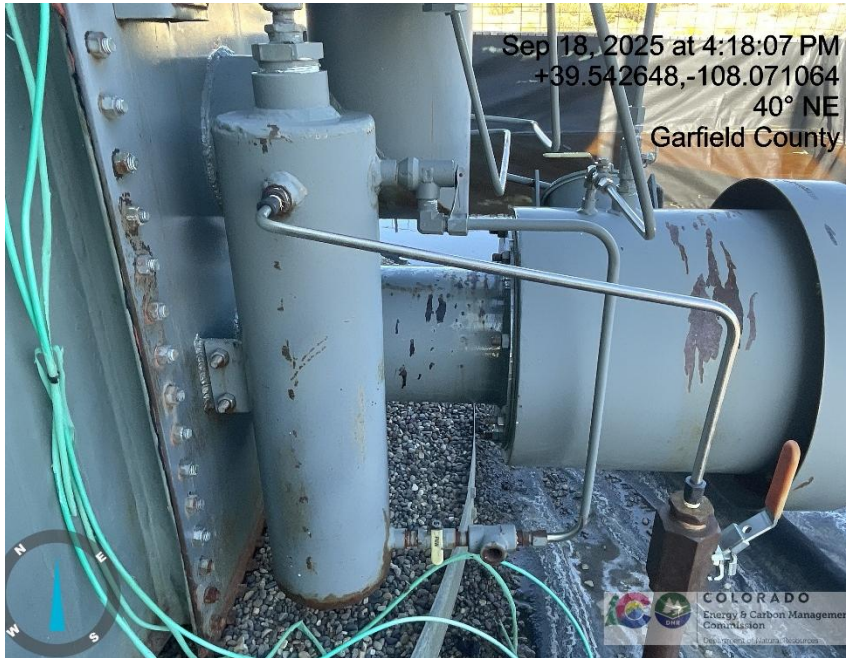
Photo # 1209 PRV vent line on tank burner does not comply with CECMC pressure safety device rules

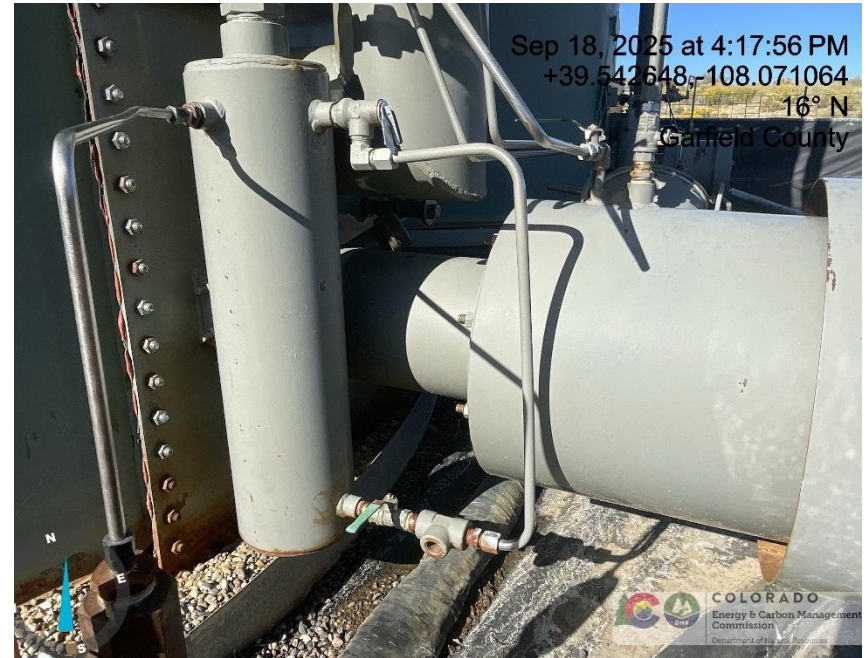
Photo # 1210 PRV vent line on tank burner does not comply with CECMC pressure safety device rules

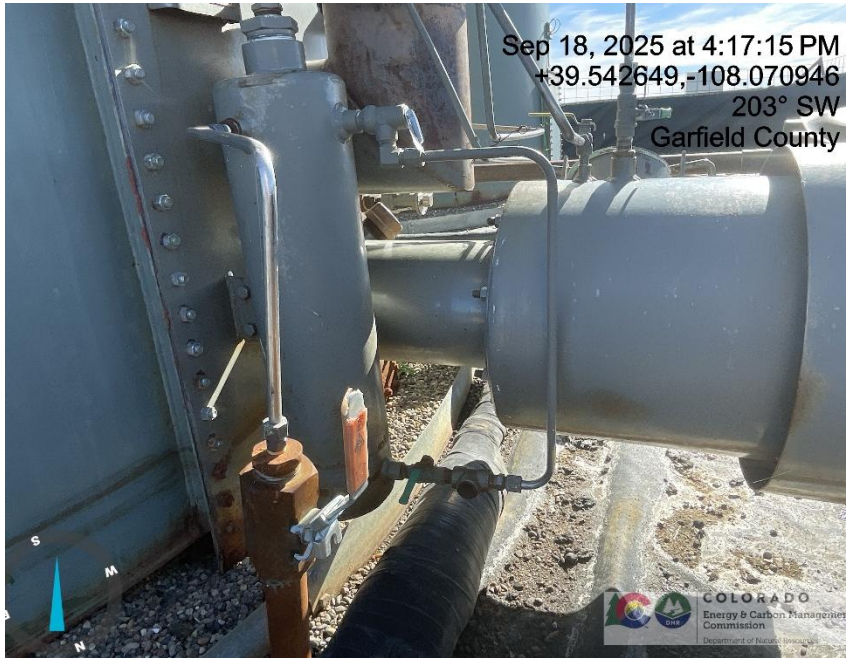
Photo # 1211 PRV vent line on tank burner does not comply with CECMC pressure safety device rules

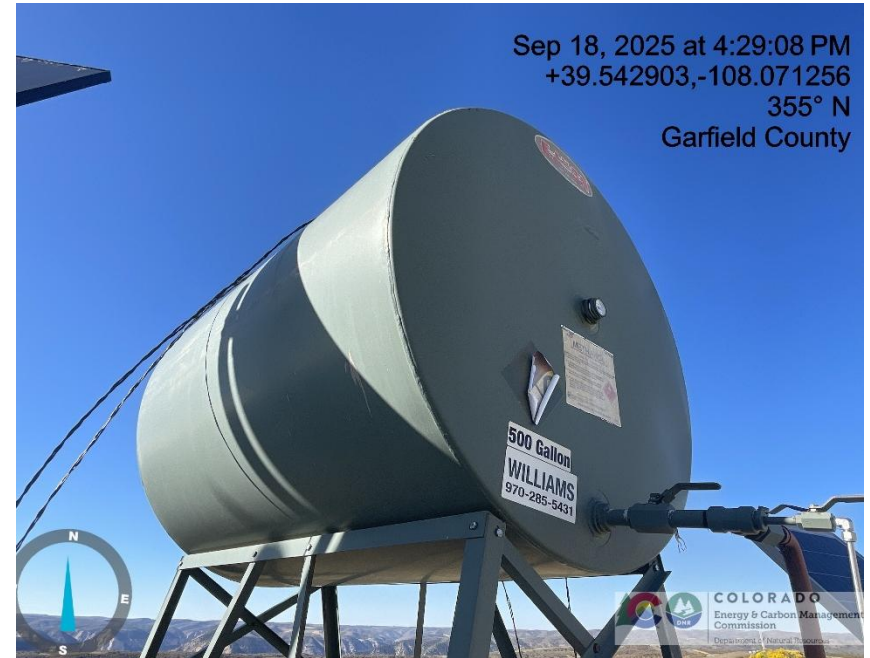
Photo # 1212 Labeling on methanol tank weathered & damaged/starting to become illegible

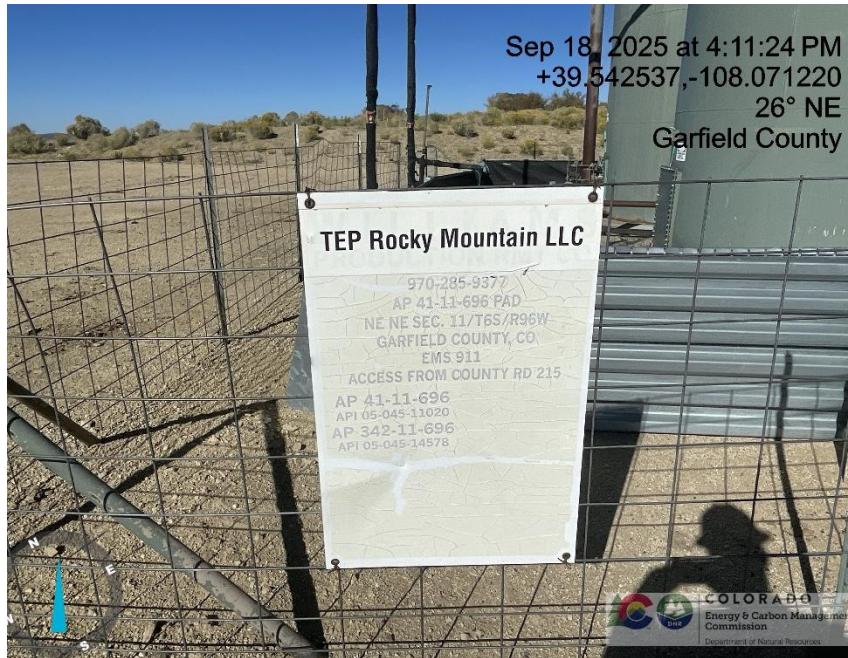
Photo # 1213 Battery sign weathered & faded/starting to become illegible

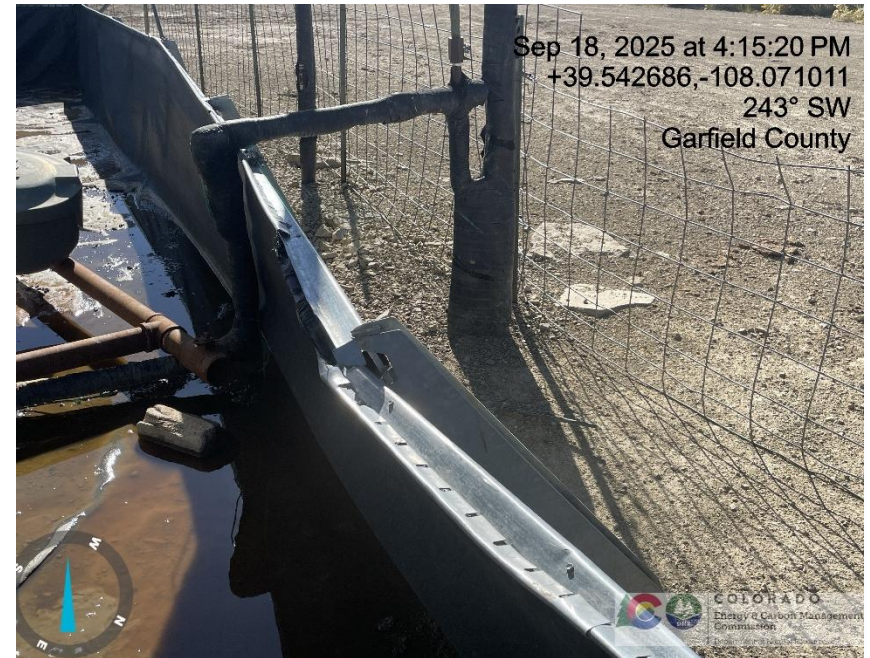
Photo # 1214 Tank battery containment showing some signs of damage

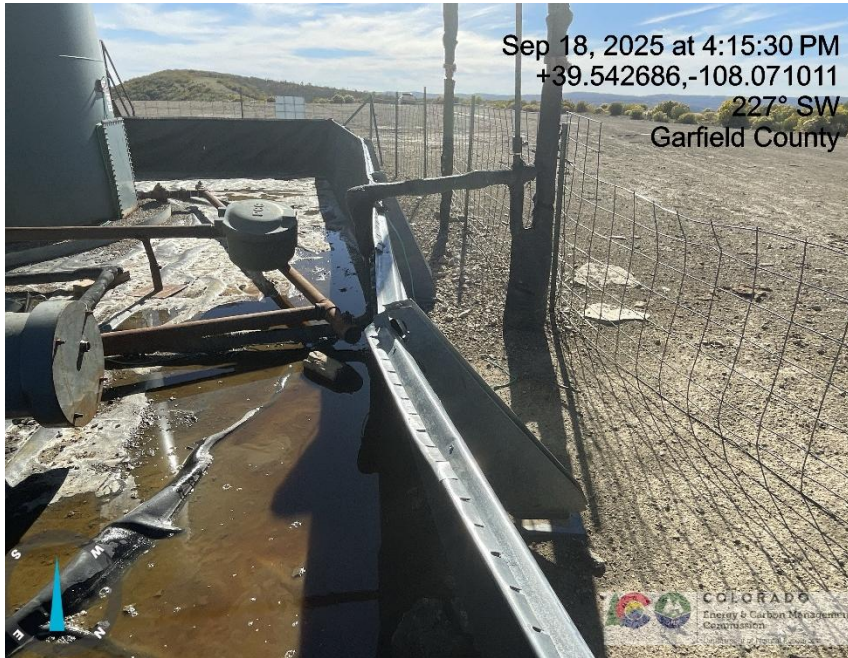
Photo # 1215 Tank battery containment showing some signs of damage
