WELL NAME: BELARDE 12-34, API #: 071-09005, INSP. # 716301430

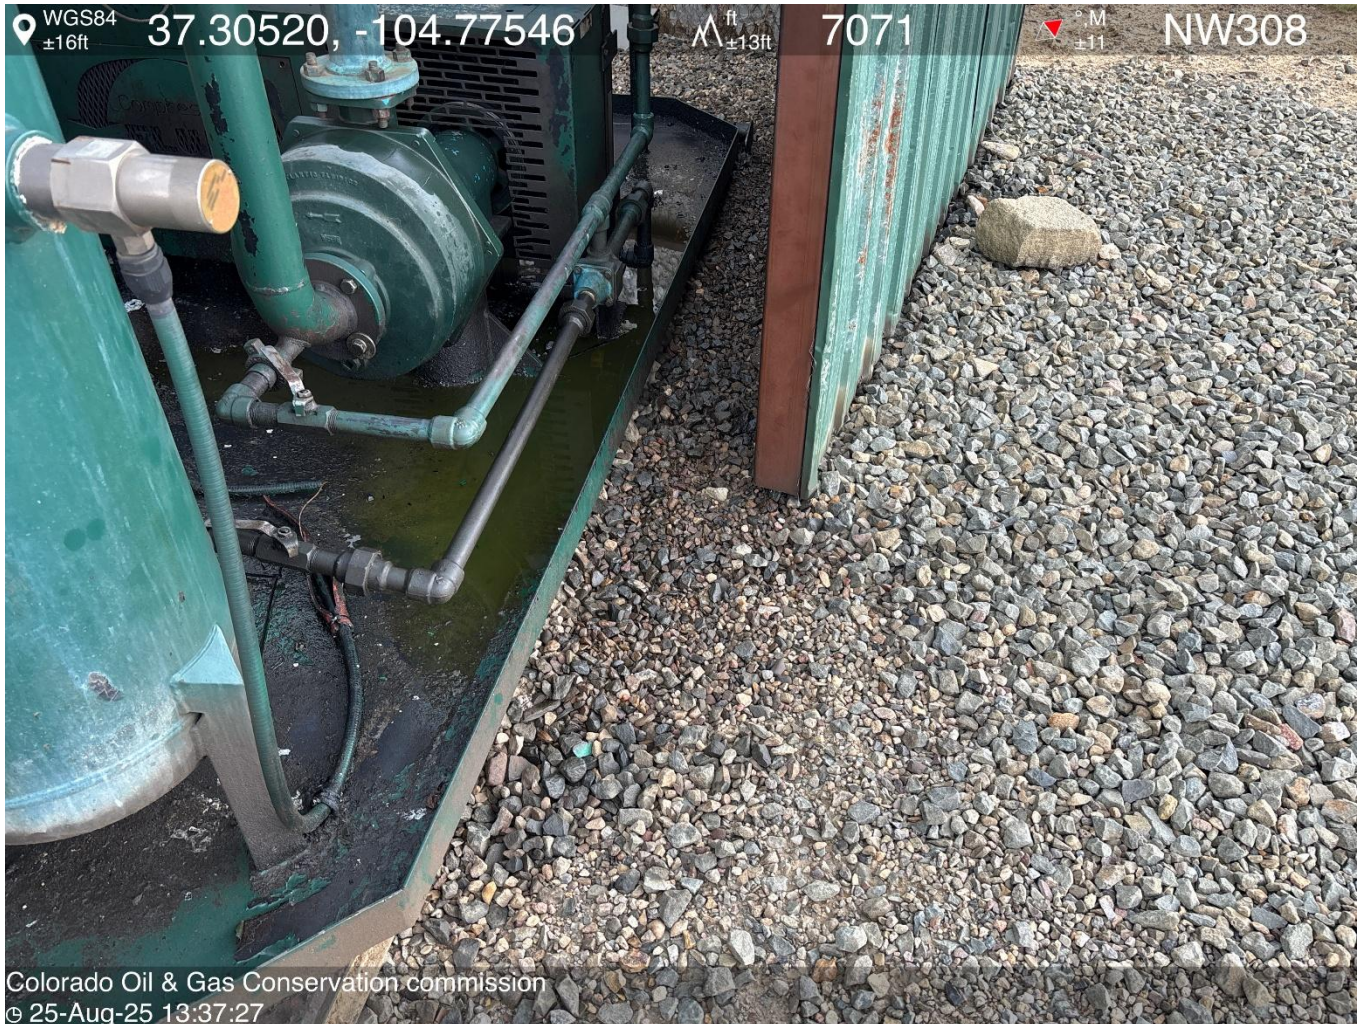
PHOTO 4: AREA OF IMPACTED SOIL NEAR COMPRESSOR SKID. Conduct maintenance on equipment, cleanup stained material and review self inspection processes. COMPLY WITH RULE 1002,(2).D. CA DATE 9-25-2025.

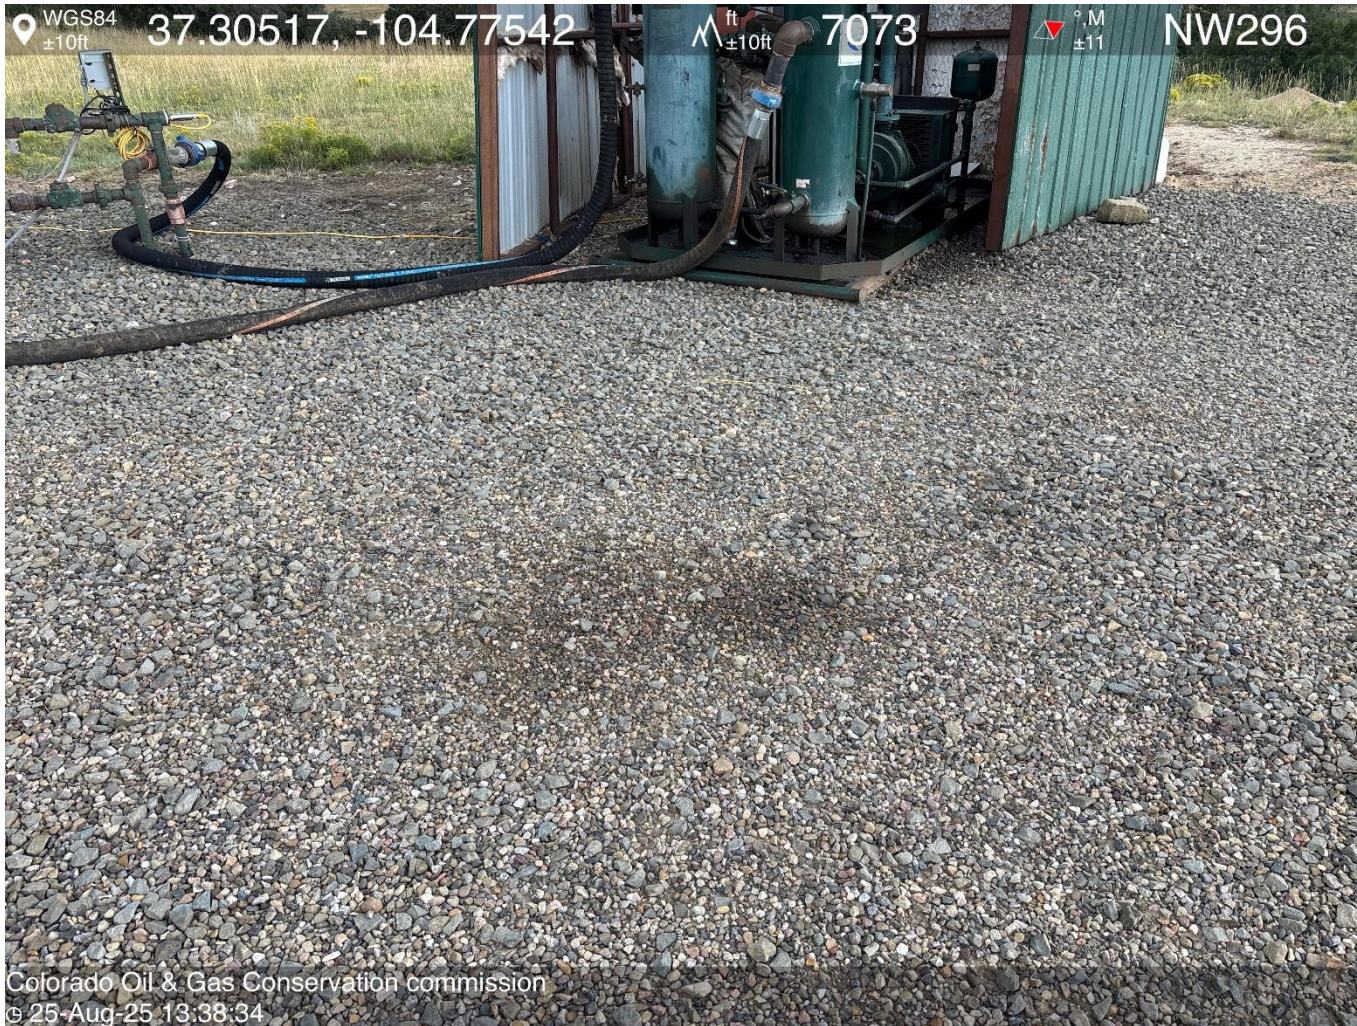
PHOTO 5: AREA OF IMPACTED SOIL NEAR COMPRESSOR SKID. Conduct maintenance on equipment, cleanup stained material and review self inspection processes. COMPLY WITH RULE 1002,(2).D. CA DATE 9-25-2025.

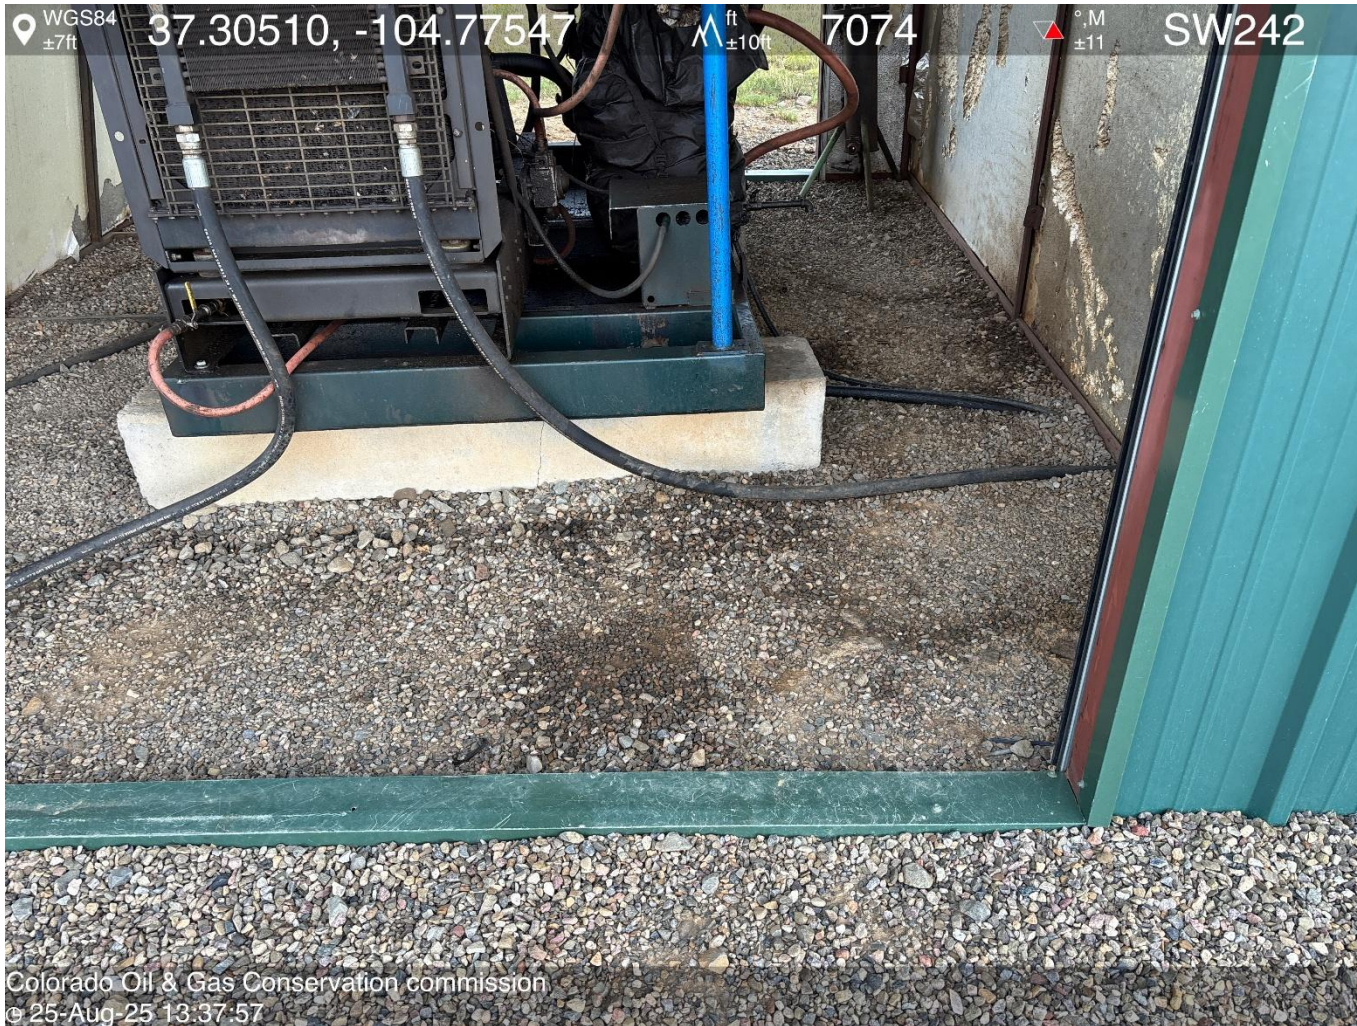
PHOTO 6: AREA OF IMPACTED SOIL NEAR PRIME MOVER ENGINE SKID. Conduct maintenance on equipment, cleanup stained material and review self inspection processes. COMPLY WITH RULE 1002,.(2).D. CA DATE 9-25-2025.

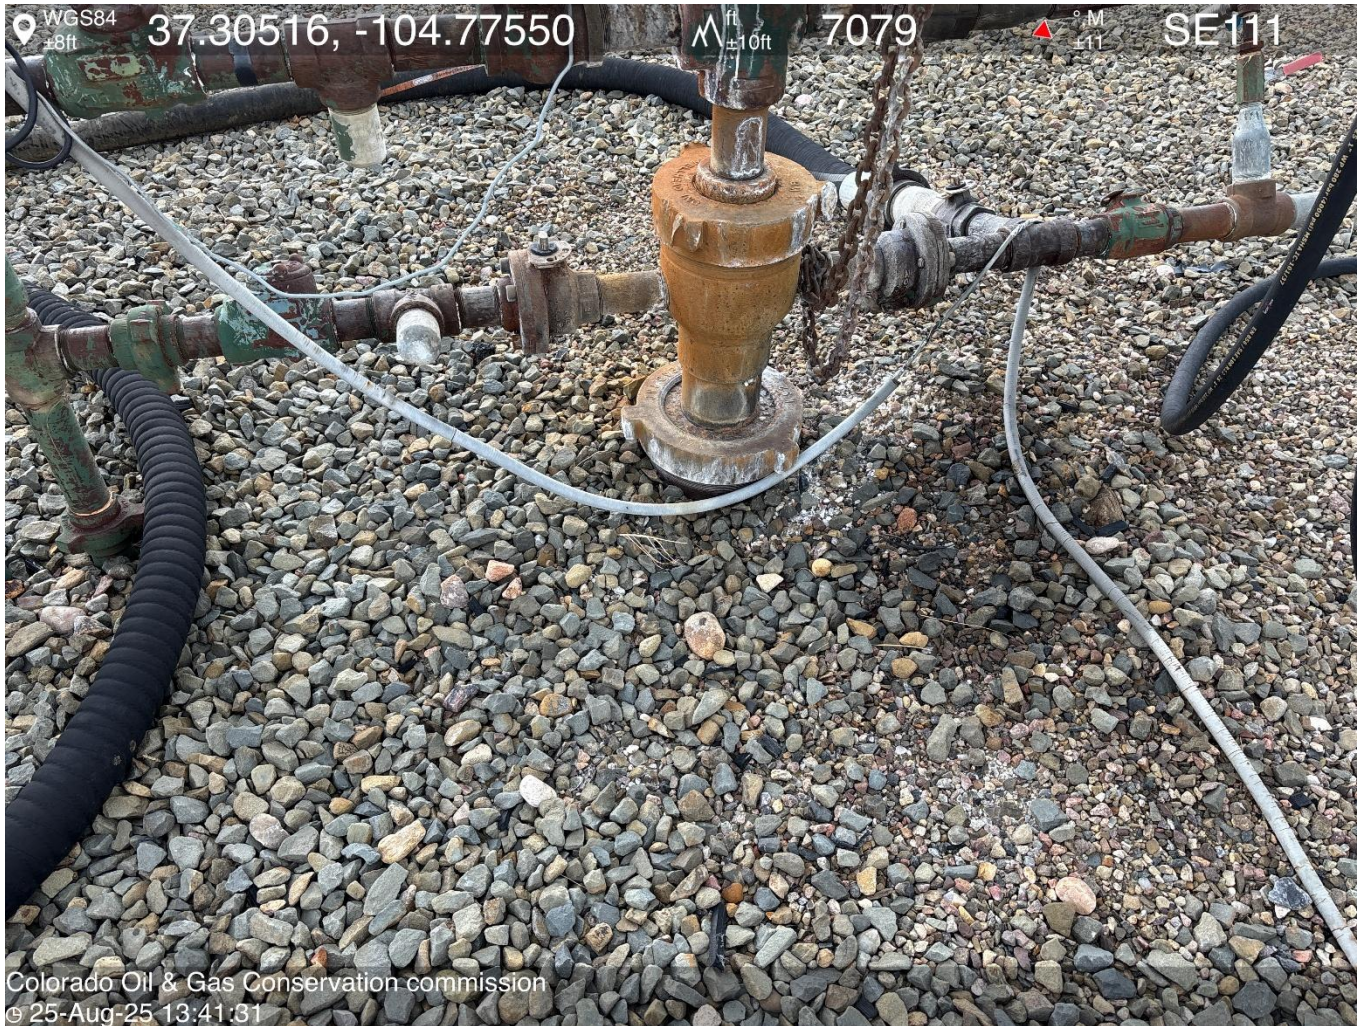
PHOTO 7: AREA OF IMPACTED SOIL NEAR WELLHEAD. Conduct maintenance on equipment, cleanup stained material and review self inspection processes. COMPLY WITH RULE 1002,(2).D. CA DATE 9-25-2025.

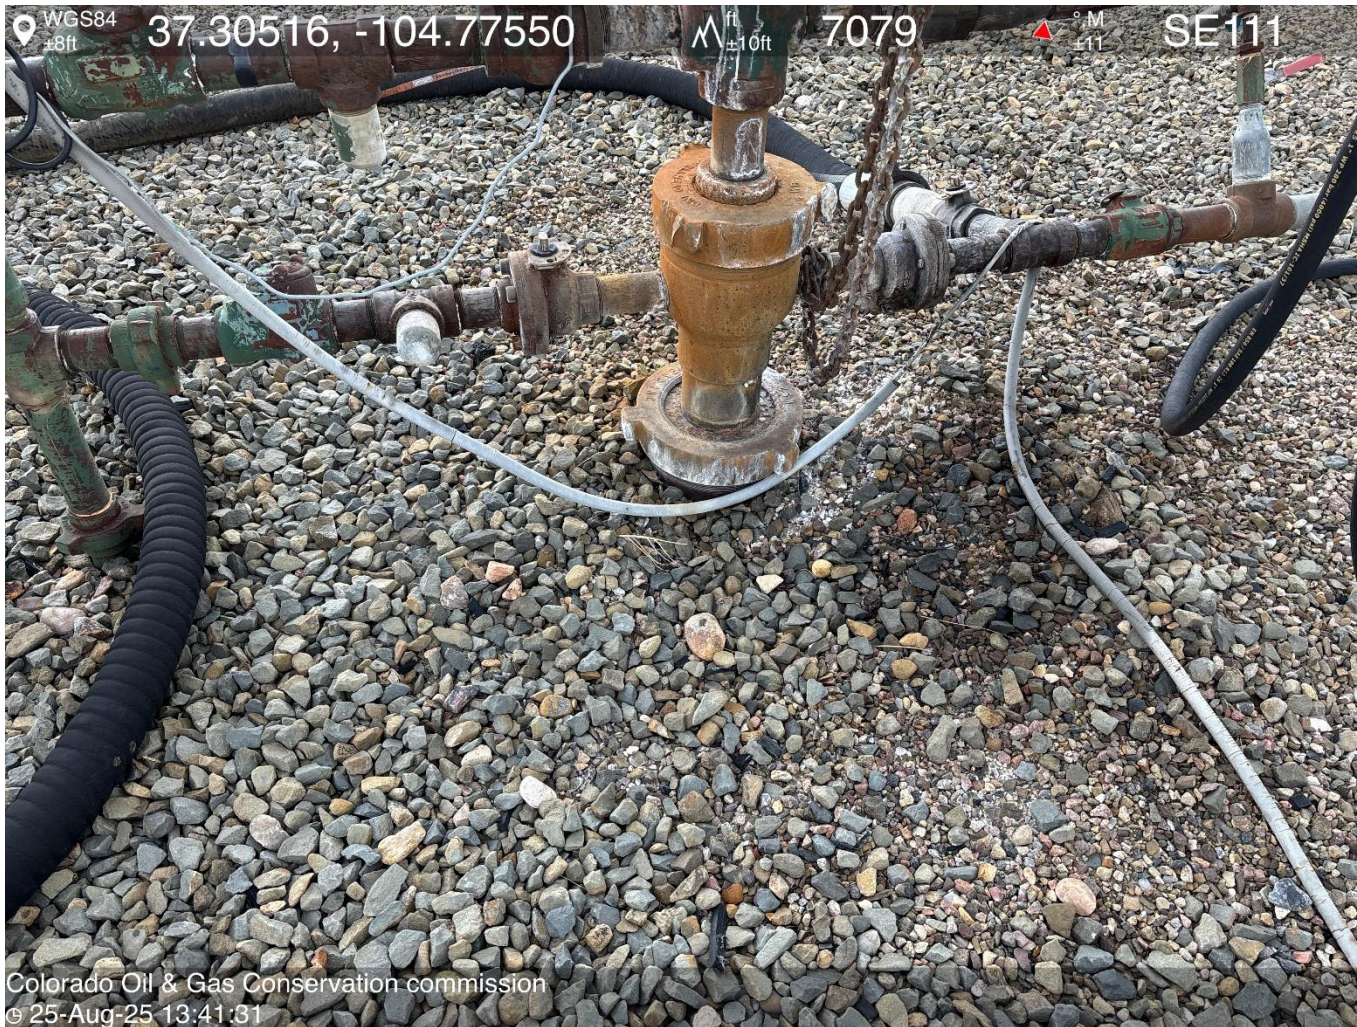
PHOTO 8: Bradenhead inaccessible. Install appropriate fittings to allow bradenhead visual inspection as per Rule 419.a.(1), (2) THIS IS THE SECOND NOTICE FOR THIS CORRECTIVE ACTION, IMMEDIATE ACTION IS REQUIRED.

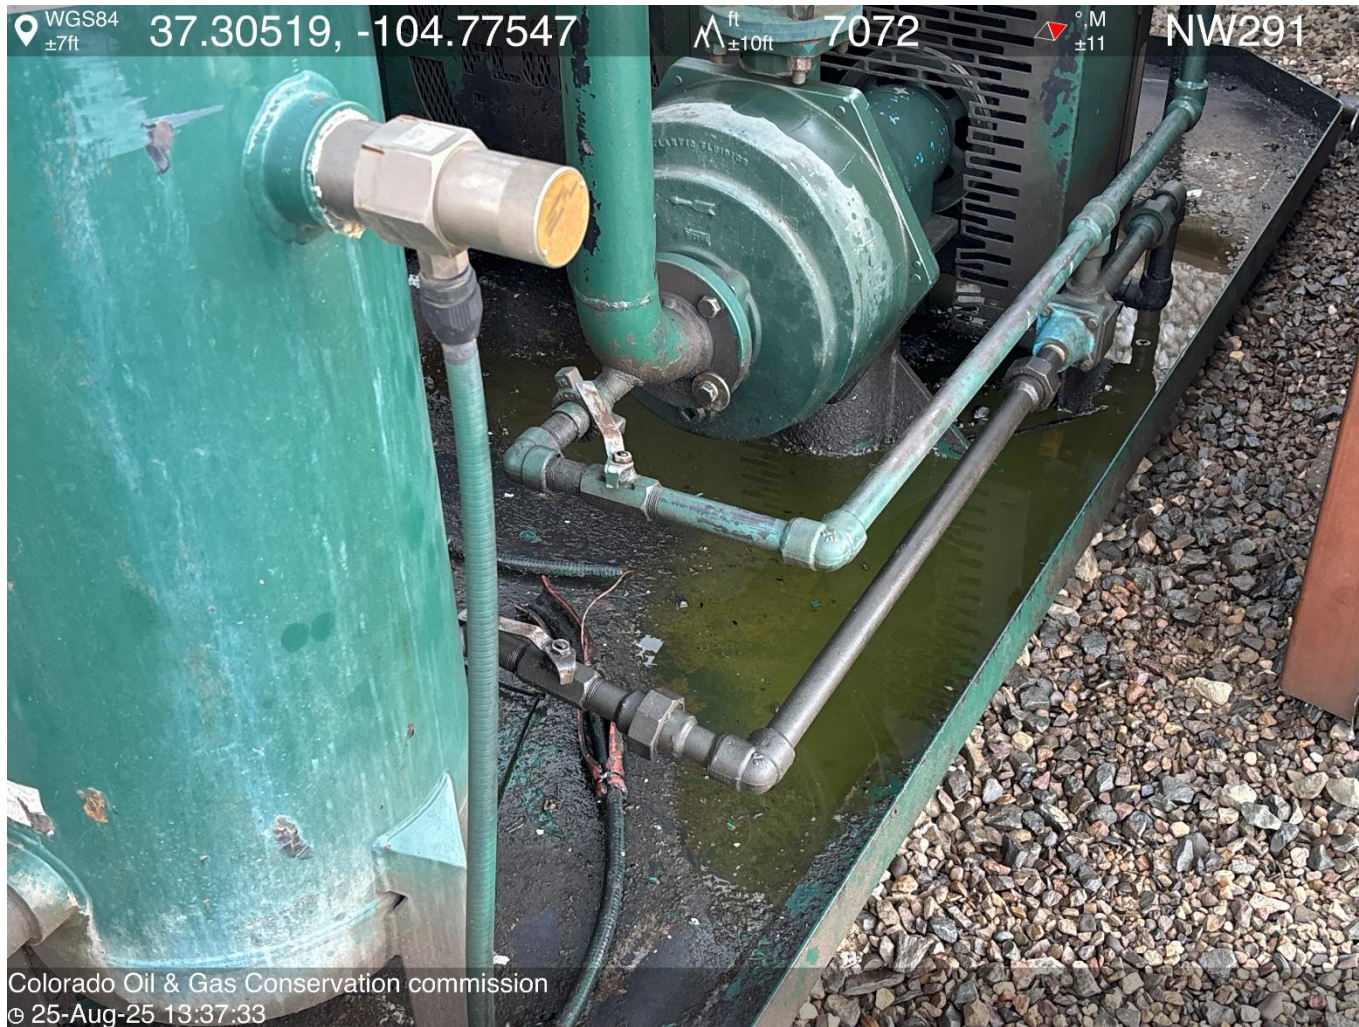
PHOTO 9: APPEARS TO BE ANTIFREEZE AND OILY WASTE IN COMPRESSOR SKID. DRAIN OILY WASTE REPAIR ALL LEAKS AND REMOVE IMPACTED SOIL PER RULE 1002..(2).D & 1002.f.(2)B, Comply with general provisions of the oil and gas act for wildlife protection AND SB-181. THIS IS THE SECOND NOTICE FOR THIS CORRECTIVE ACTION, IMMEDIATE ACTION IS REQUIRED.
