# Inspection Photos

**Operator:** TEP Rocky Mountain LLC #96850

**Location ID:** 335543

**Inspection Doc:** 719200220

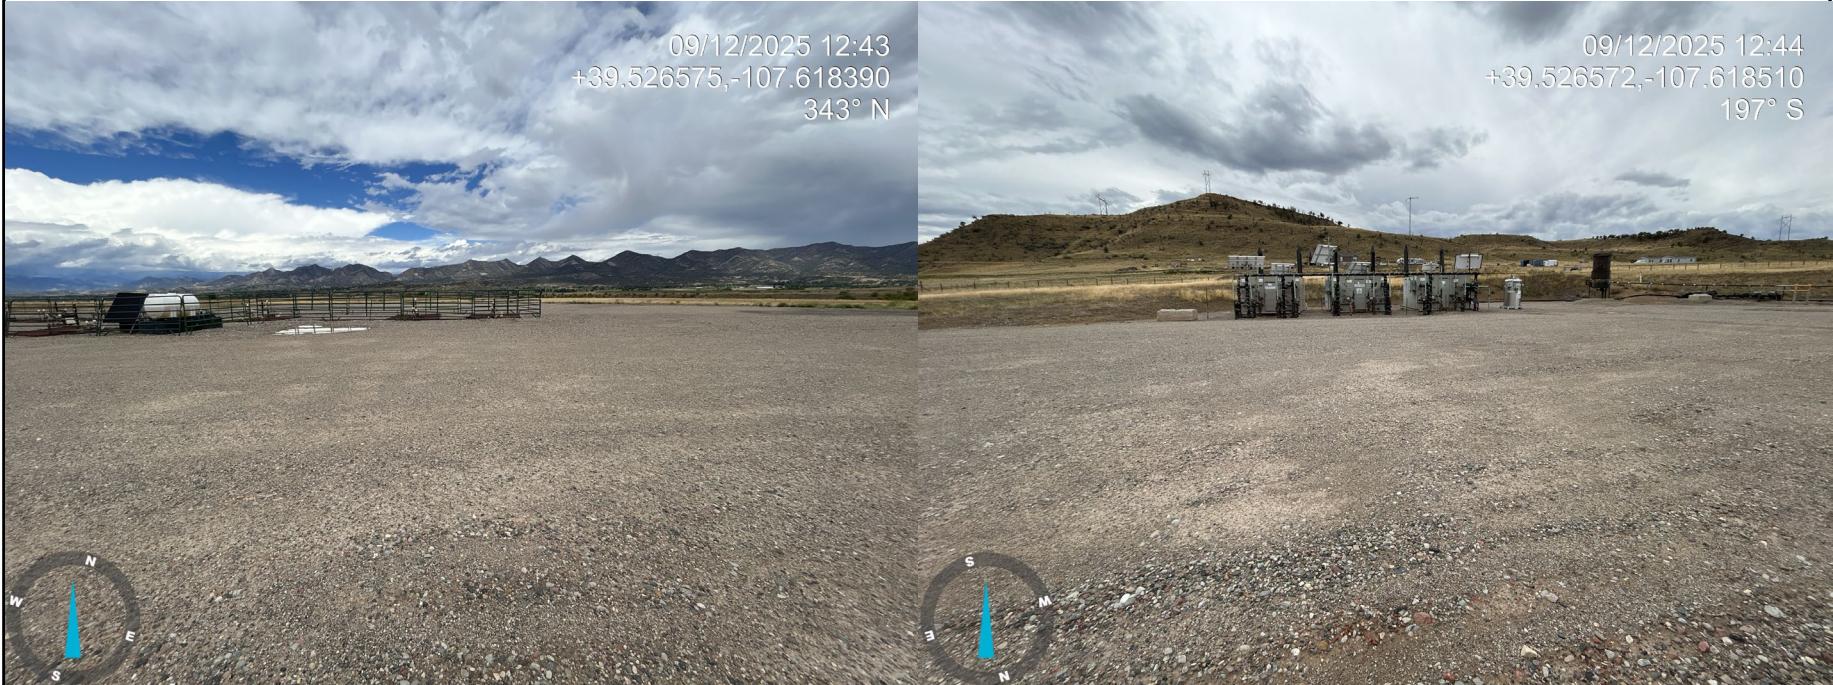
**Photo 1:** Photos show an overview of the location looking north and south, respectively.

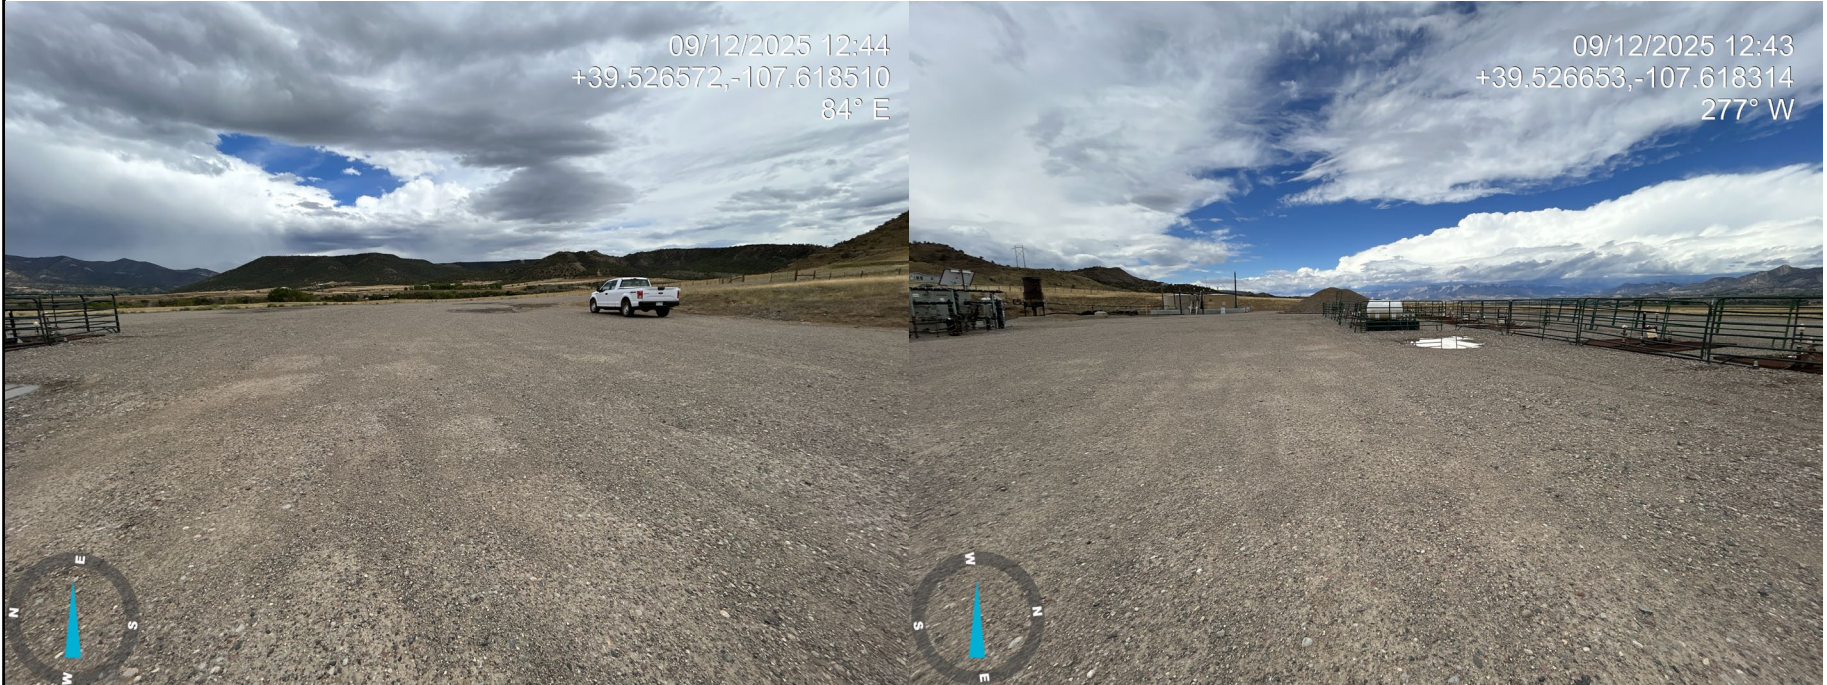
**Photo 2:** Photos show an overview of the location looking east and west, respectively.

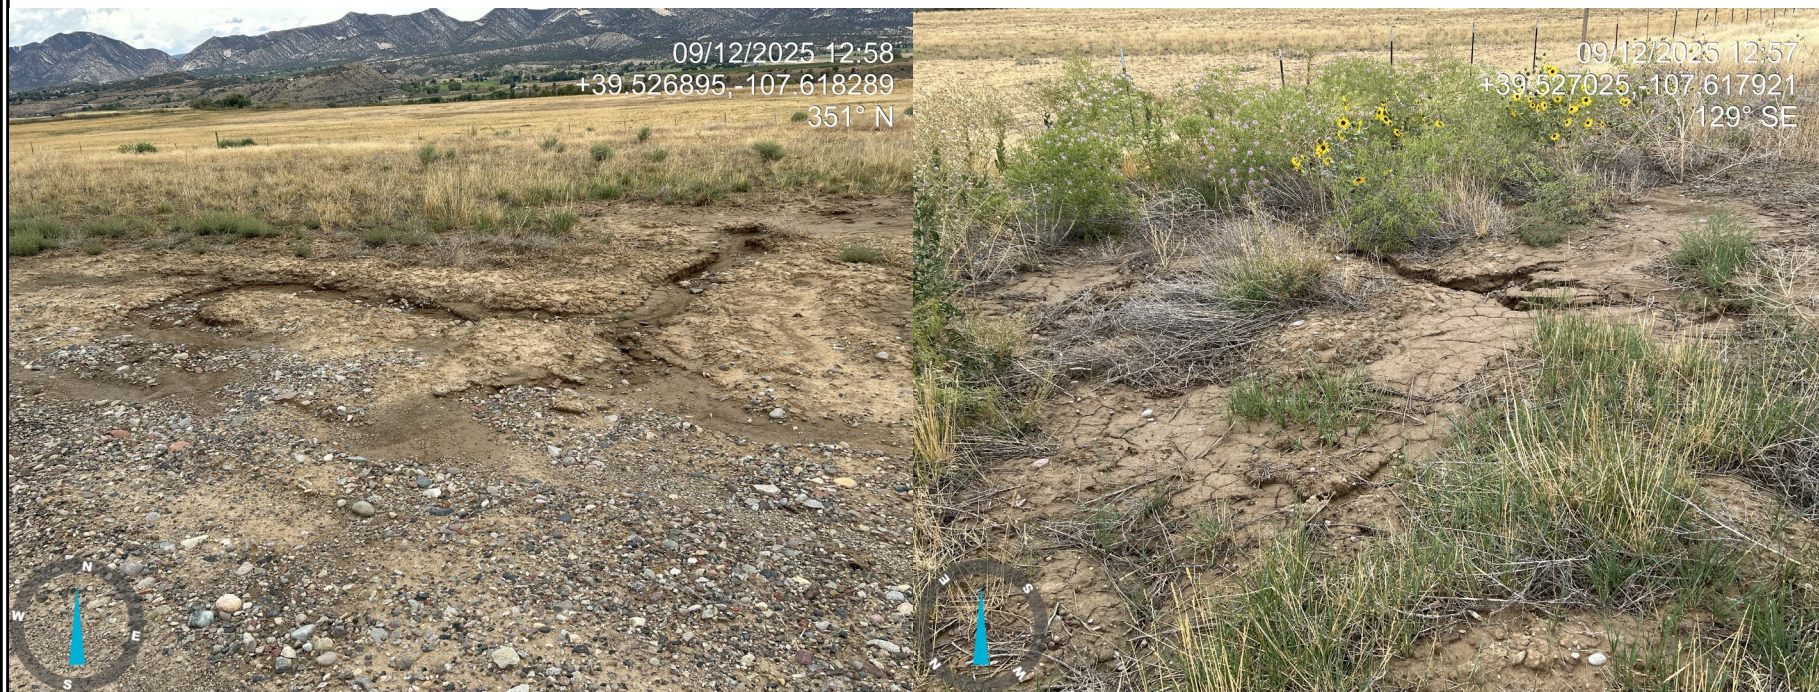
**Photo 3:** Photos showing erosion and sediment migration on the northeast portion of the location. Stormwater controls appear to be missing or insufficient; comply with Rule 1002.f.

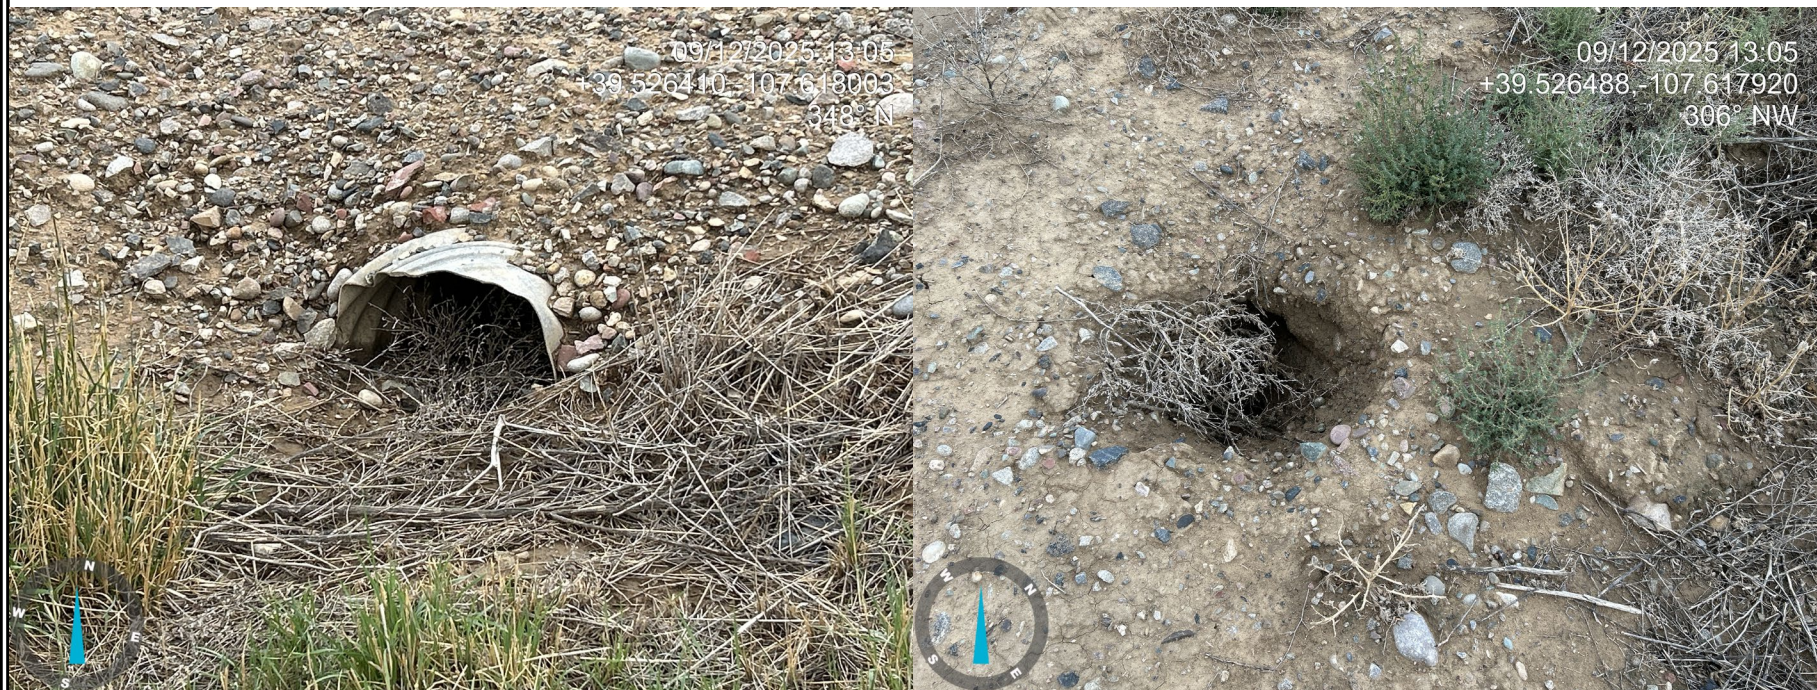
**Photo 4:** Photos showing a culvert along the access road. Sediment deposition and vegetative debris appears to be reducing capacity; install or maintain stormwater BMP's.

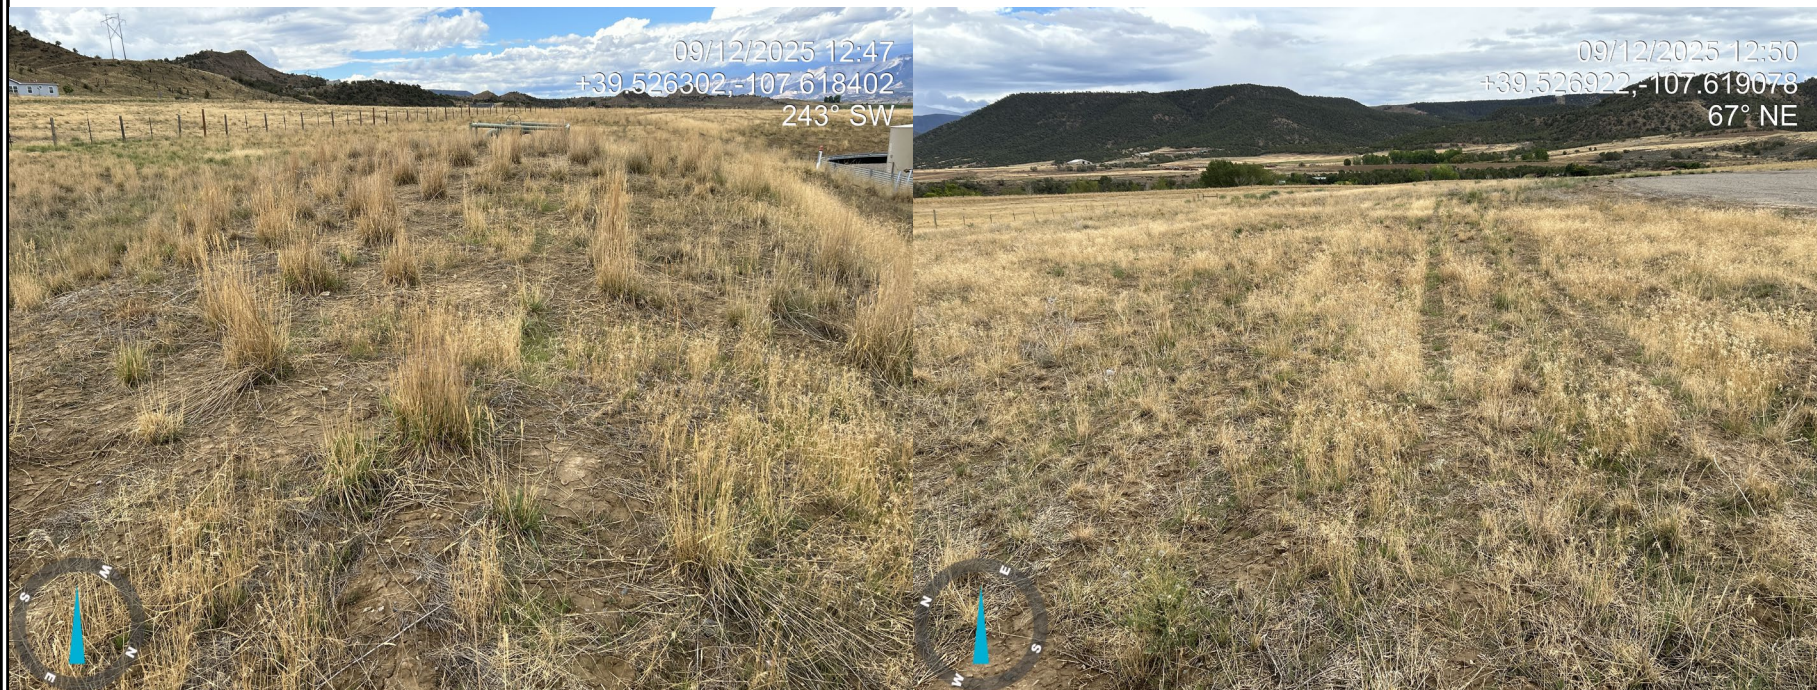
**Photo 5:** Photos showing the southern and northern interim areas, respectively. Crested wheatgrass, Sandberg bluegrass, smooth brome have established in some portions of the location. Other portions of the location are dominated by cheatgrass. Interim areas are In Process.

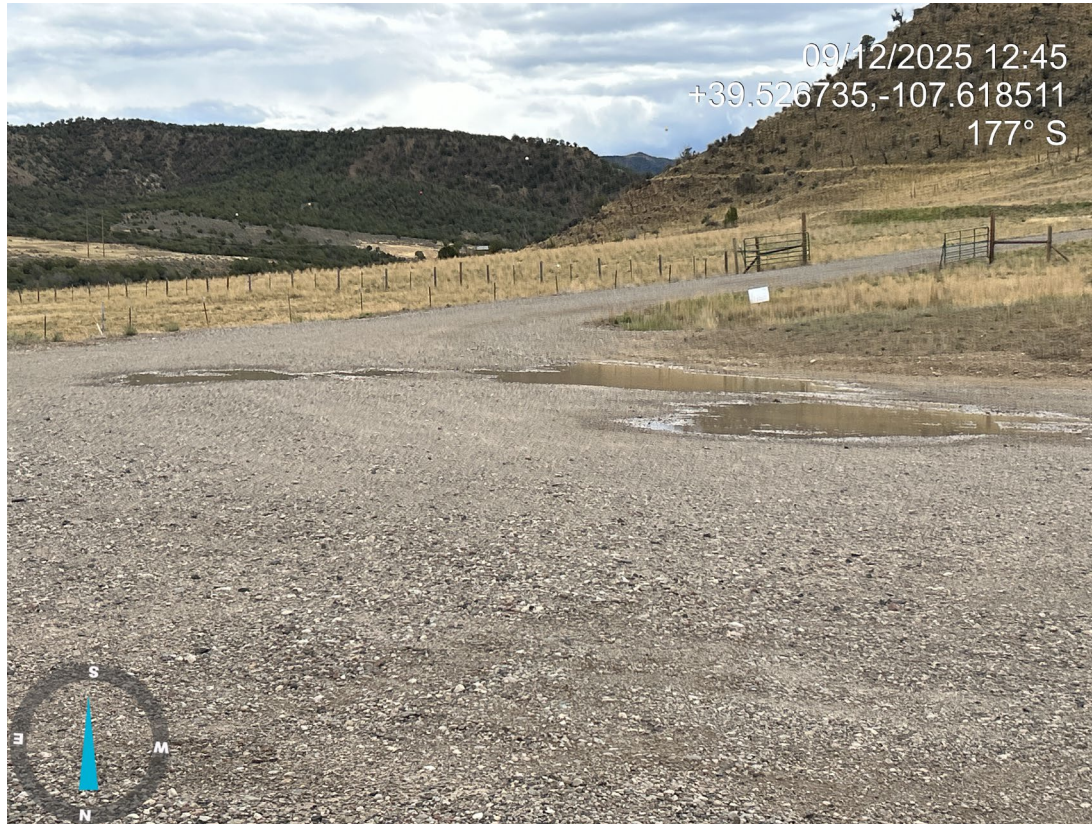
**Photo 6:** Ponded water was observed at the entrance to the location; gravel appeared sparse in some areas of the working pad surface. Maintenance is recommended.

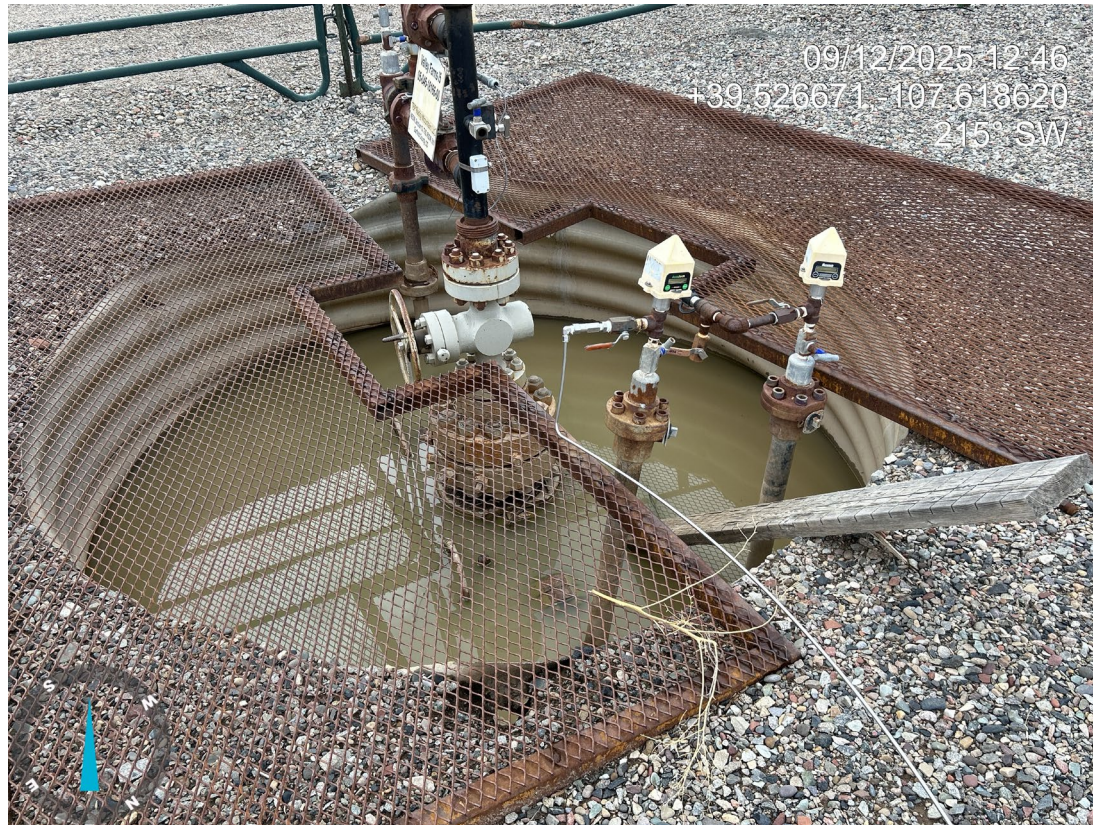
**Photo 7:** An unknown liquid was observed in some cellars at the location after adverse weather and seasonal rains; a follow-up inspection will be conducted to determine if liquids persist and require removal.
