Inspection/Audit Photos

Location Name: QB ENERGY OPERATING LLC CHEVRON 41-8D (PARACHUTE CREEK 41-8D)

Location #: 324198

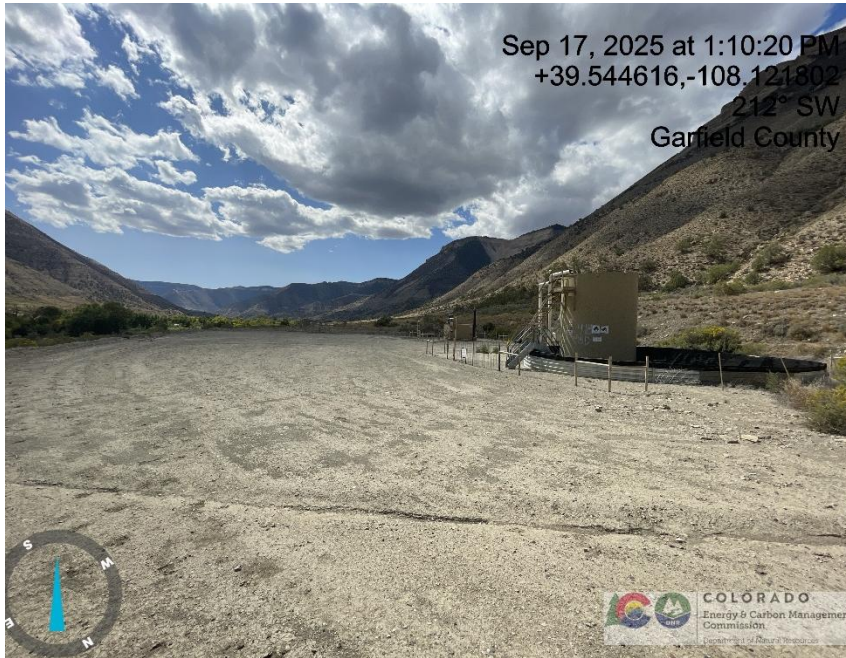
Photo # 590 From entrance to location

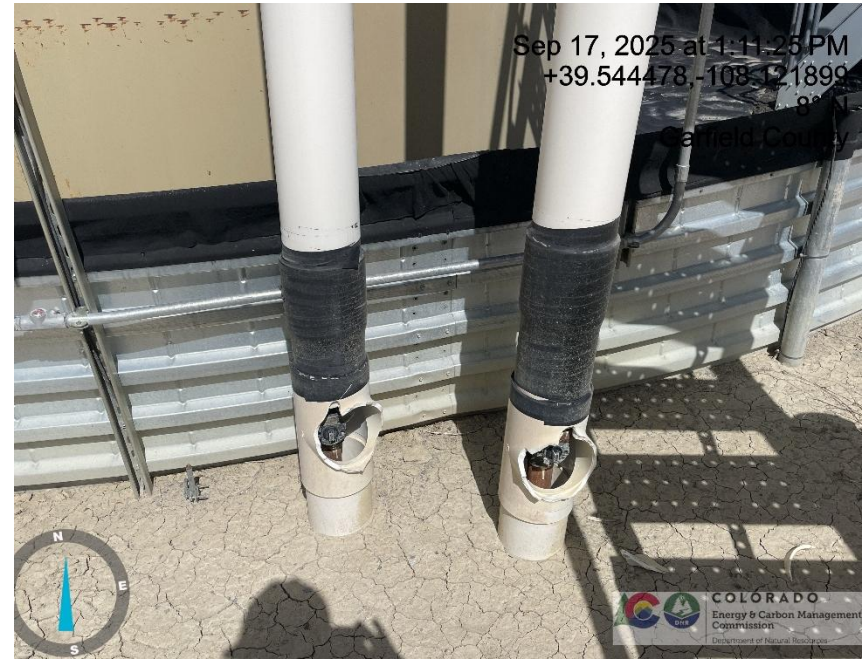
Photo # 595 Flowline heating insulation open ended/wildlife hazard/available for entry by wildlife

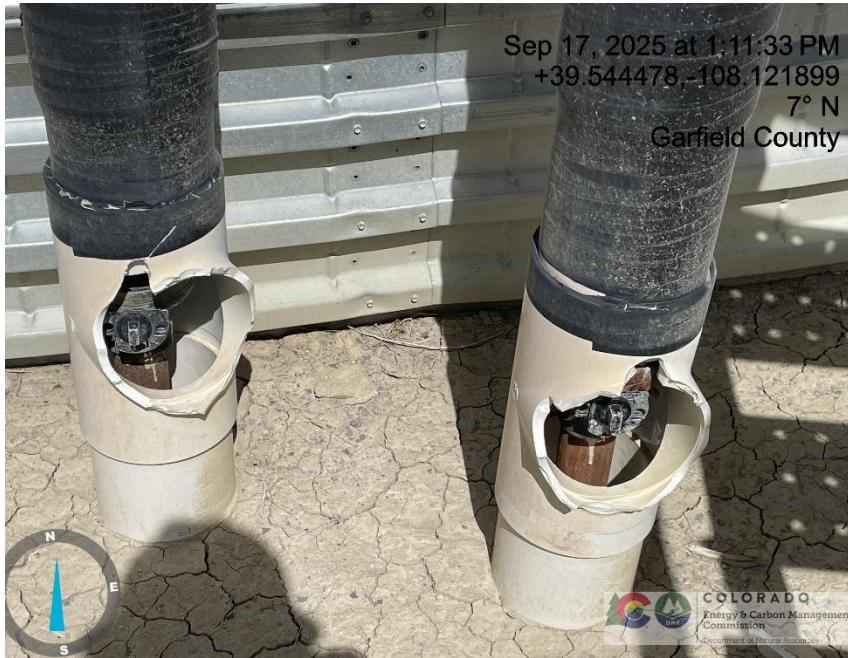
Photo # 596 Flowline heating insulation open ended/wildlife hazard/available for entry by wildlife

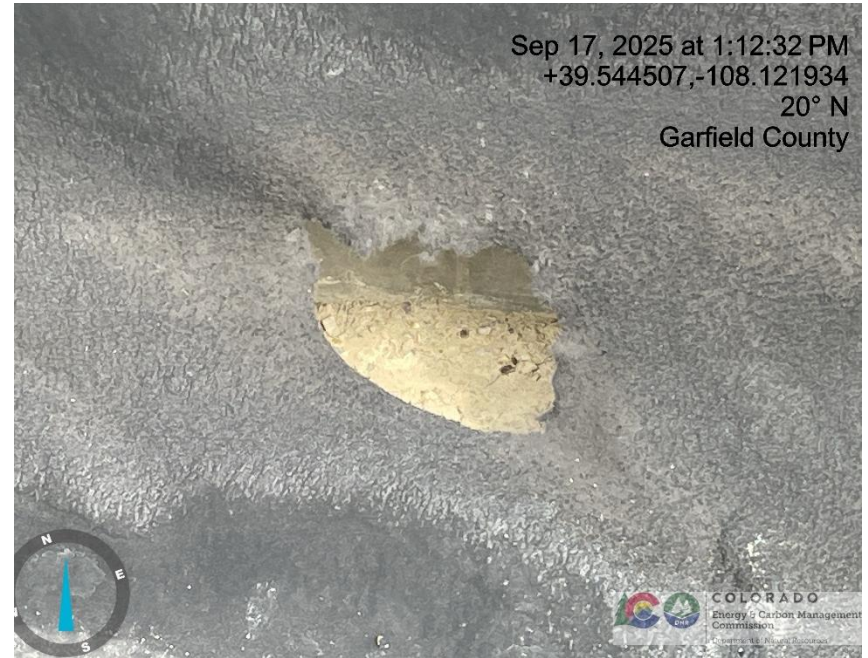
Photo # 597 Hole in secondary containment liner/liner needs maintenance

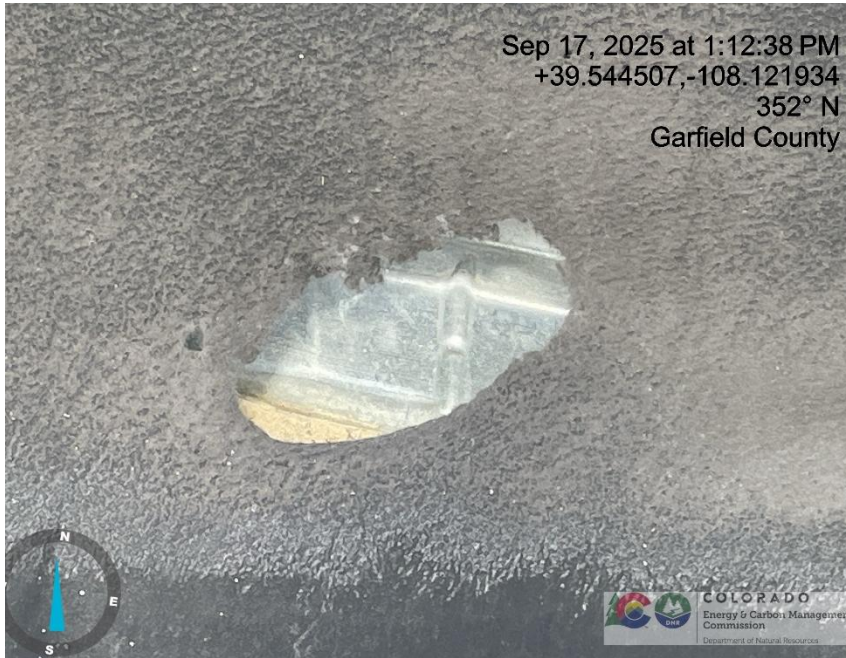
Photo # 598 Hole in secondary containment liner/liner needs maintenance

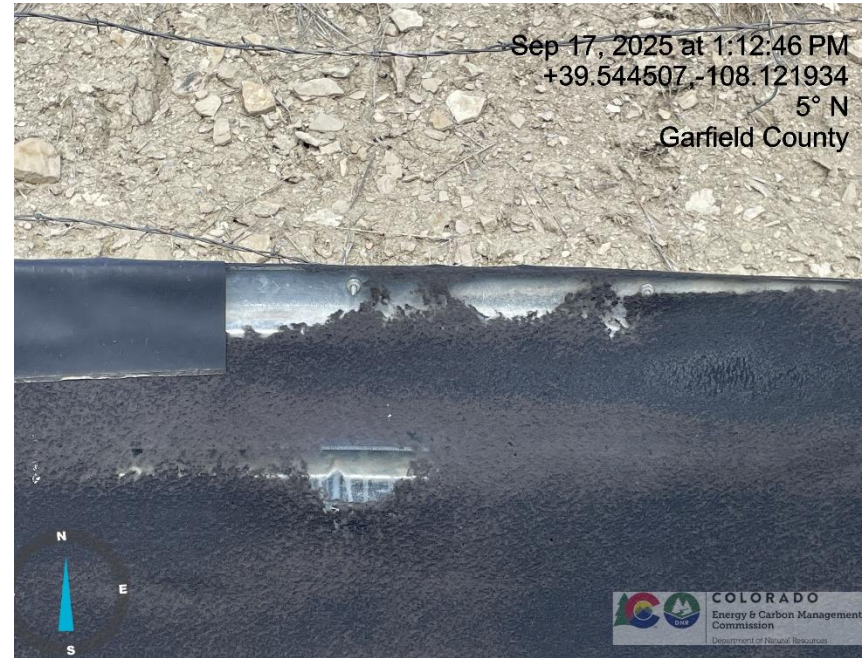
Photo # 599 Holes in secondary containment liner/liner needs maintenance

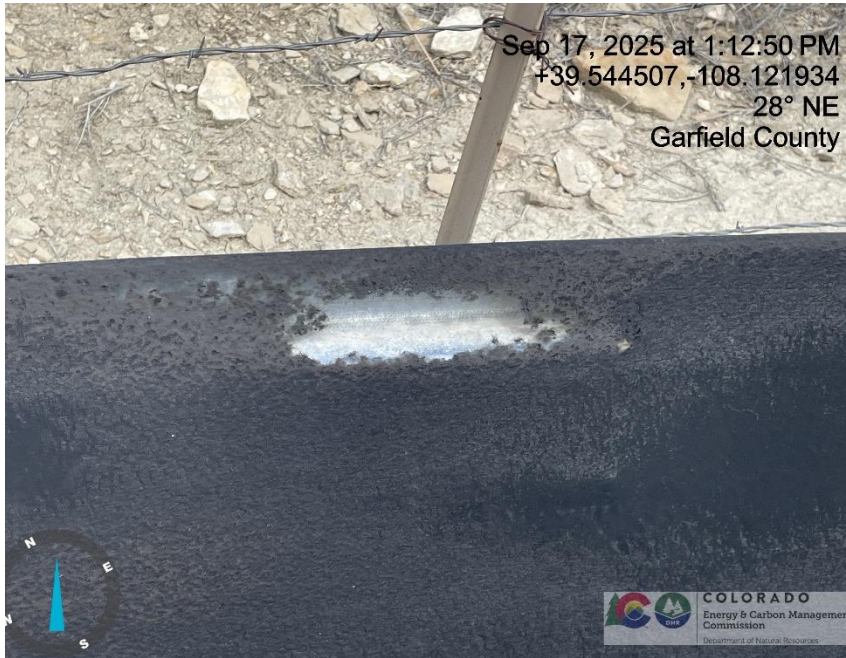
Photo # 600 Hole in secondary containment liner/liner needs maintenance

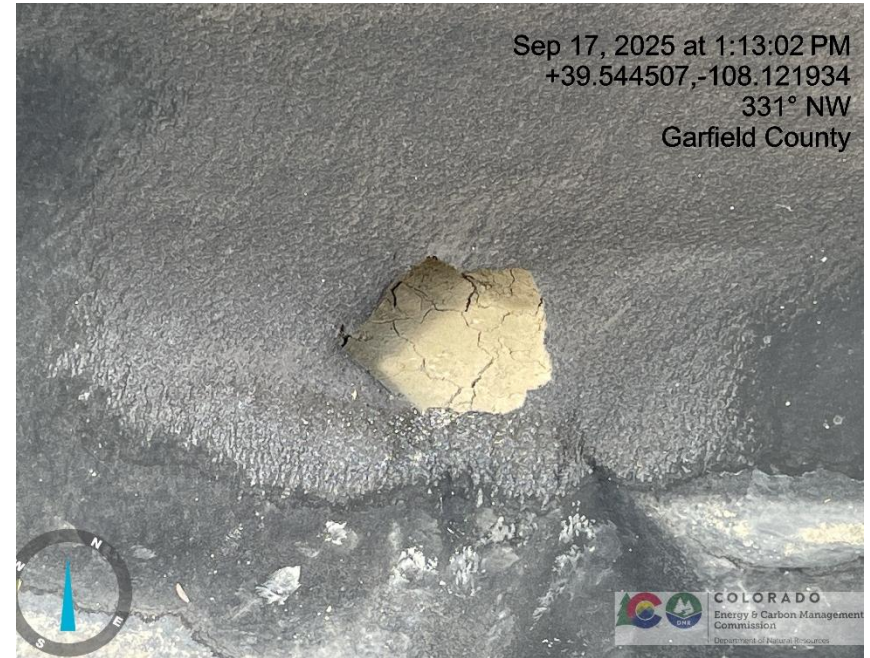
Photo # 601 Hole in secondary containment liner/liner needs maintenance

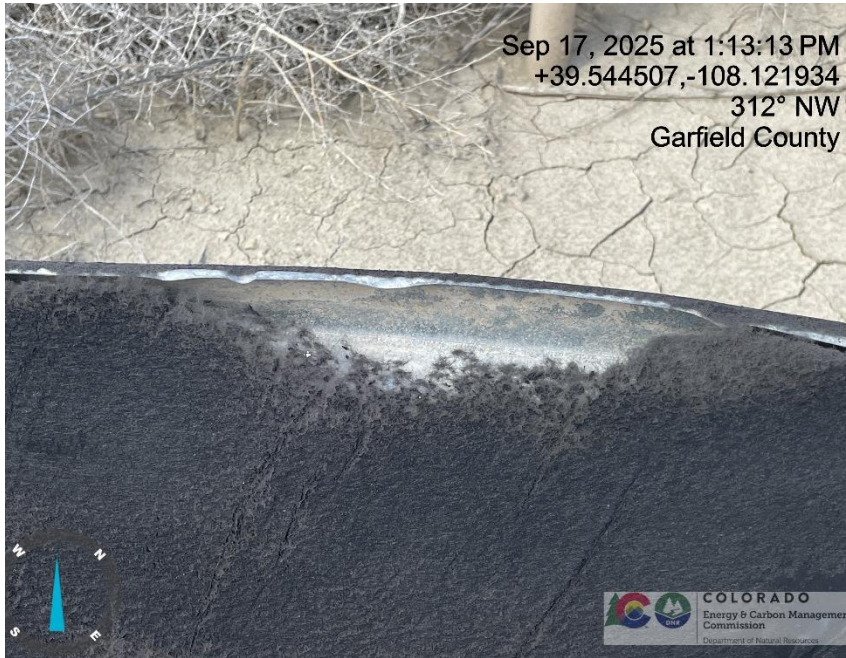
Photo # 602 Hole in secondary containment liner/liner needs maintenance

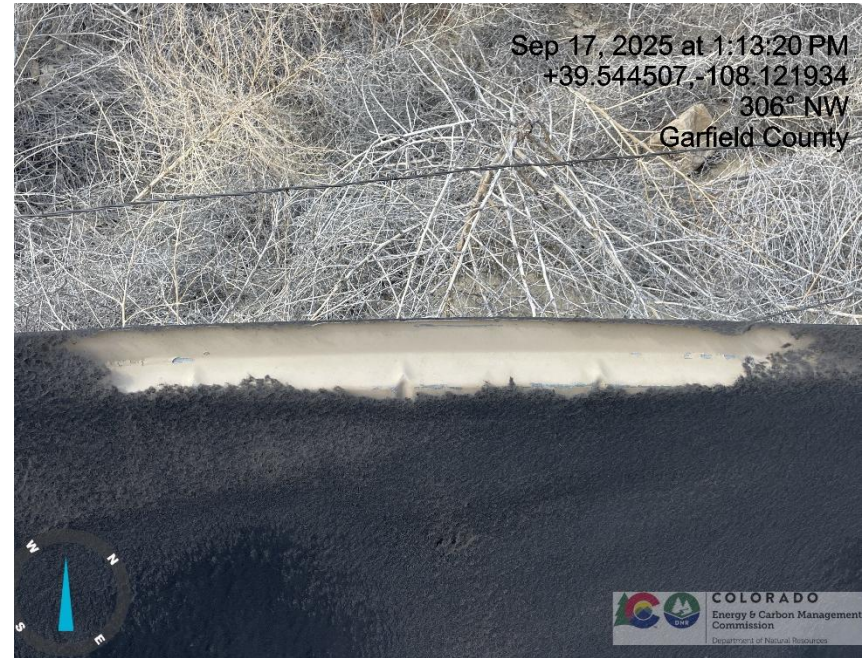
Photo # 603 Hole in secondary containment liner/liner needs maintenance

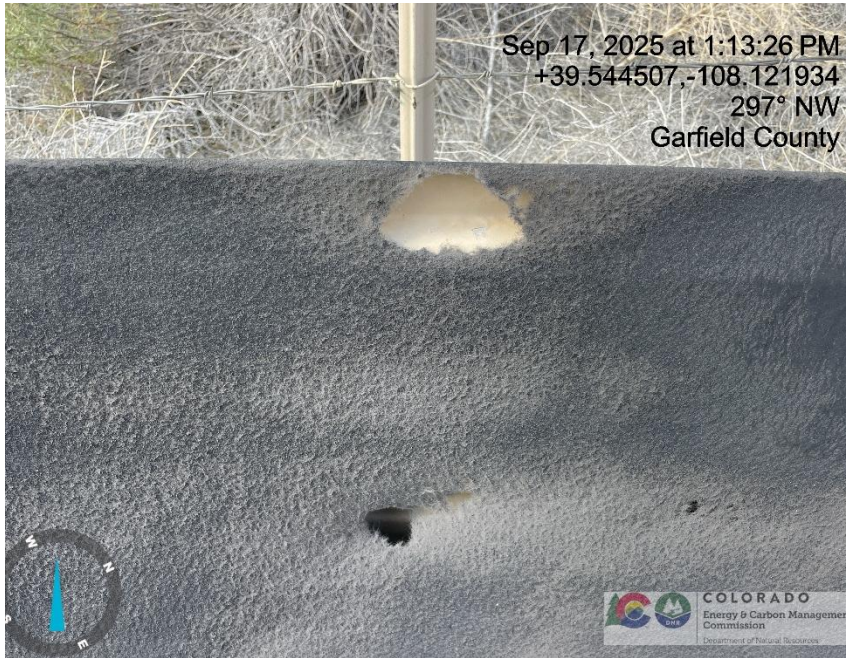
Photo # 604 Holes in secondary containment liner/liner needs maintenance

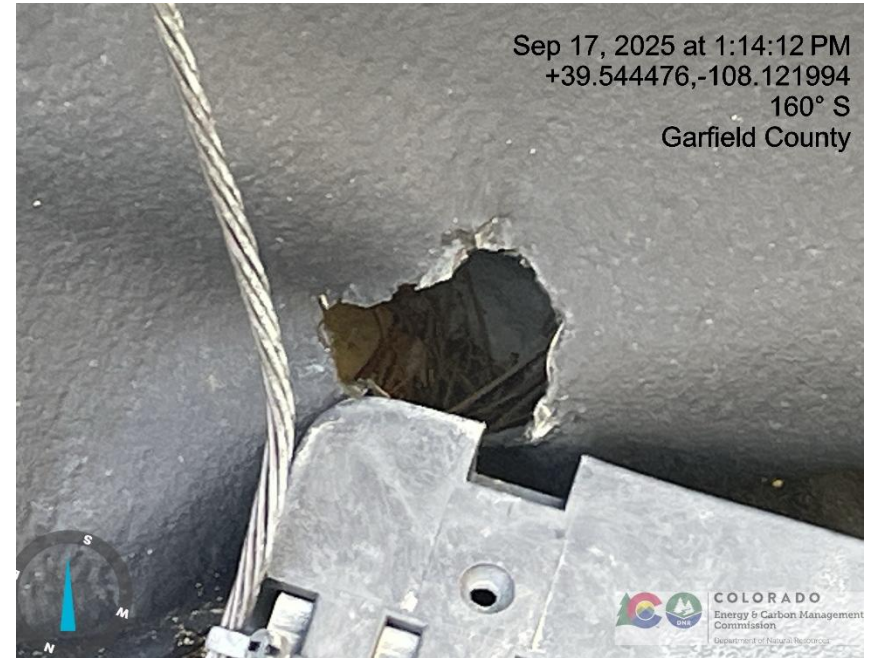
Photo # 605 Hole in secondary containment liner/liner needs maintenance

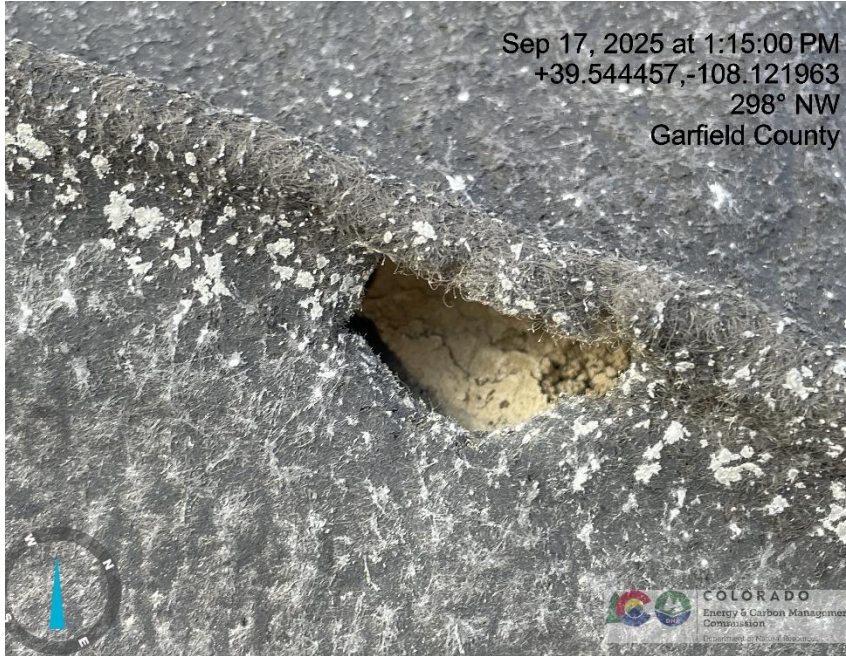
Photo # 606 Hole in secondary containment liner/liner needs maintenance

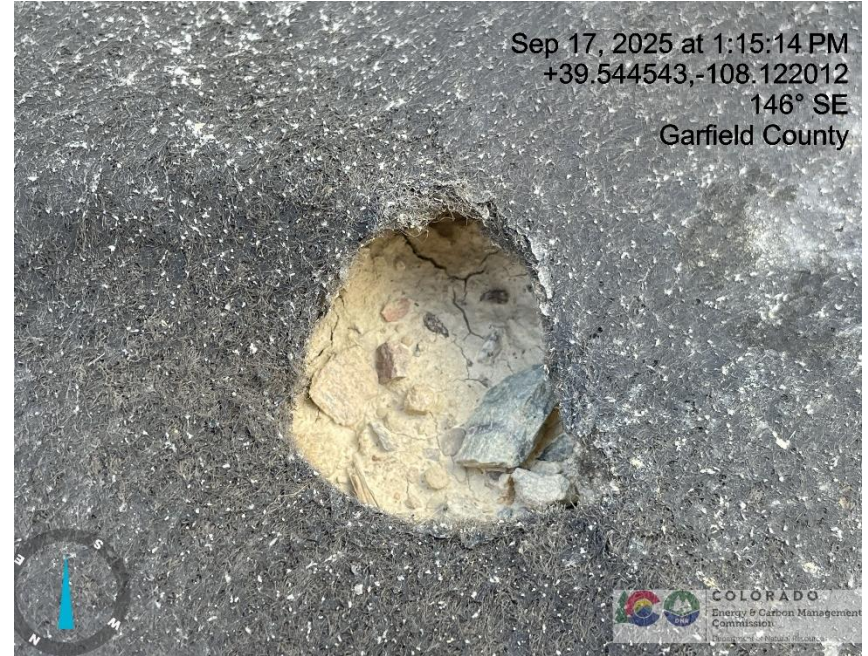
Photo # 607 Hole in secondary containment liner/liner needs maintenance

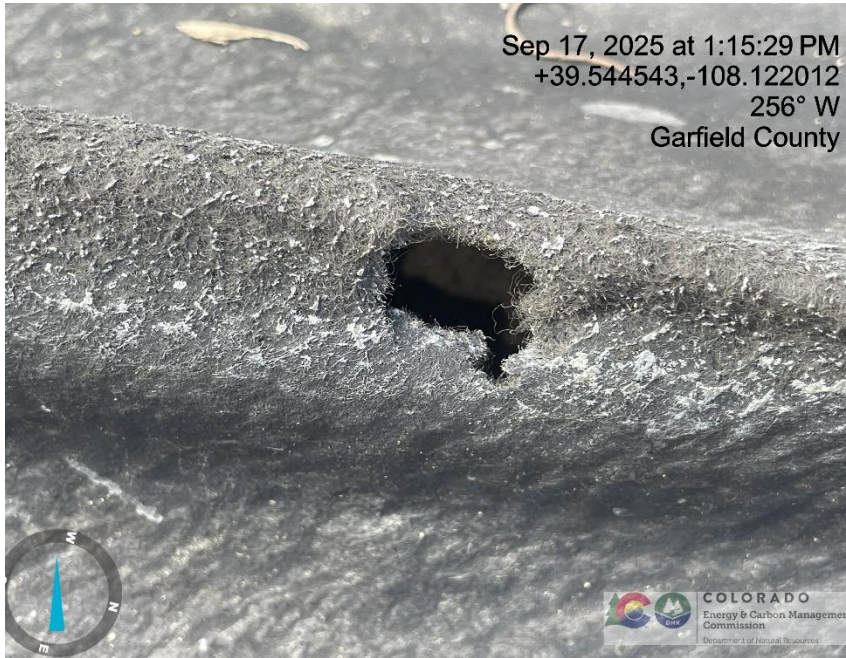
Photo # 608 Hole in secondary containment liner/liner needs maintenance

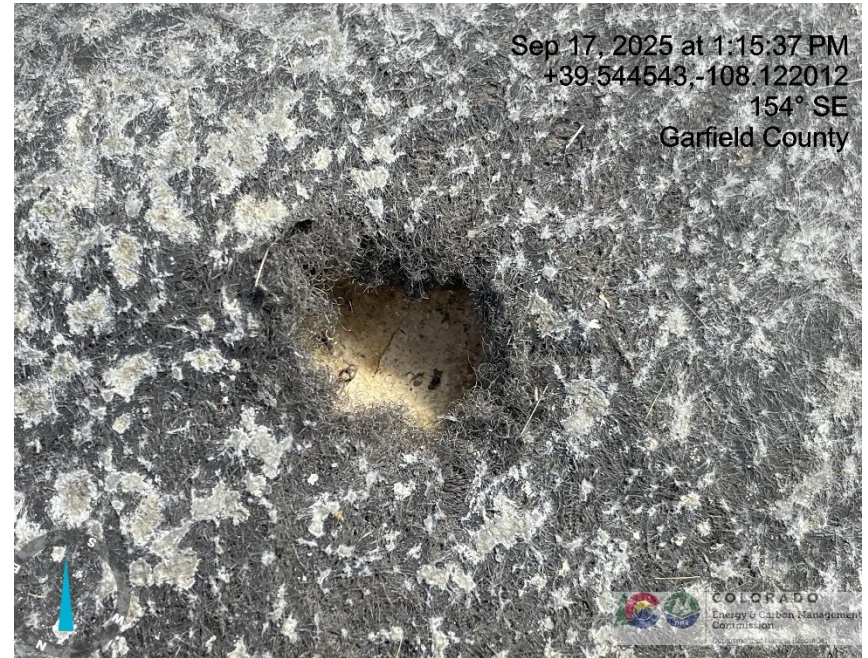
Photo # 609 Hole in secondary containment liner/liner needs maintenance

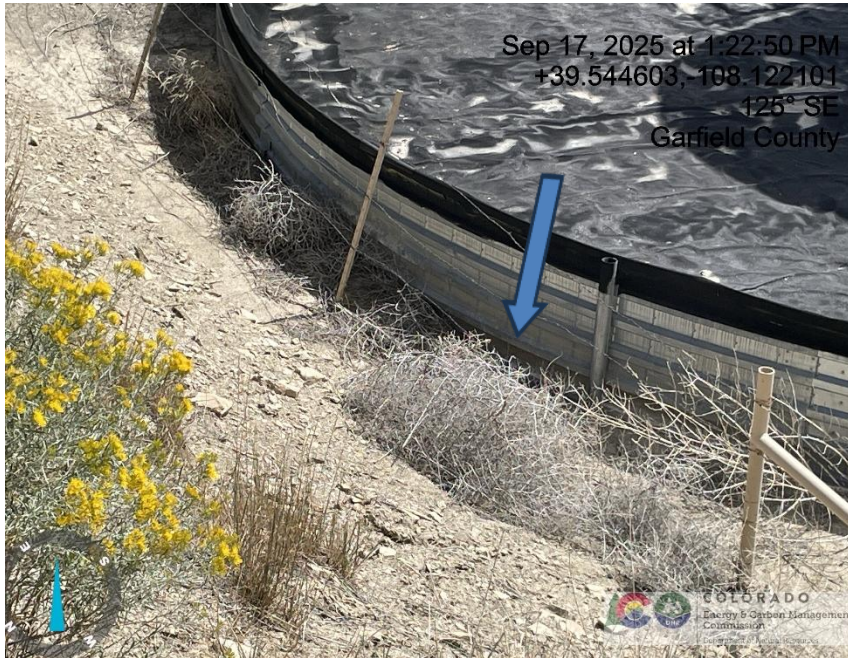
Photo # 610 Dead weeds/debris

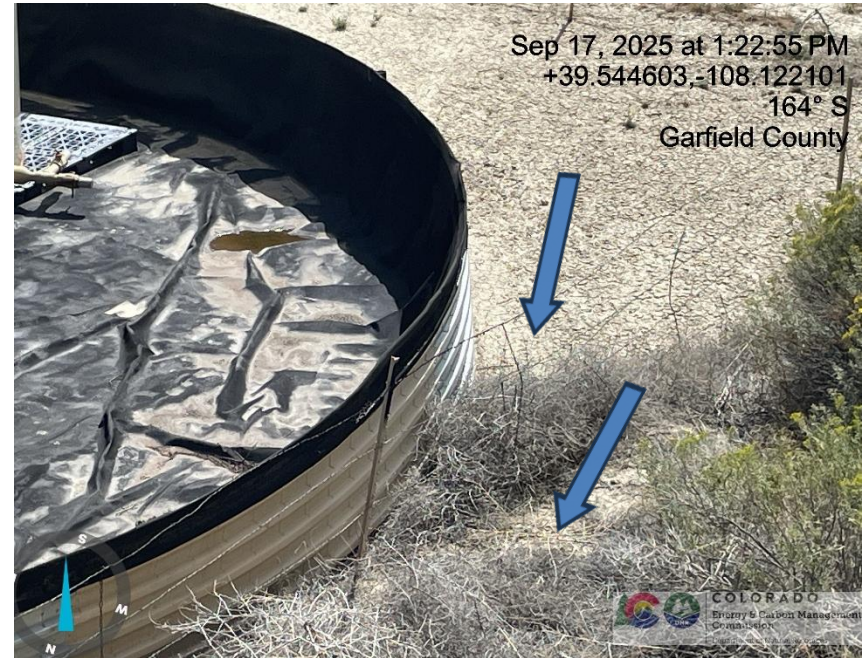
Photo # 611 Dead weeds/debris
