# Inspection Photos

Location Name: PAPPENHEIM USX AB-67N64W/13SWSW

Location #: 310329

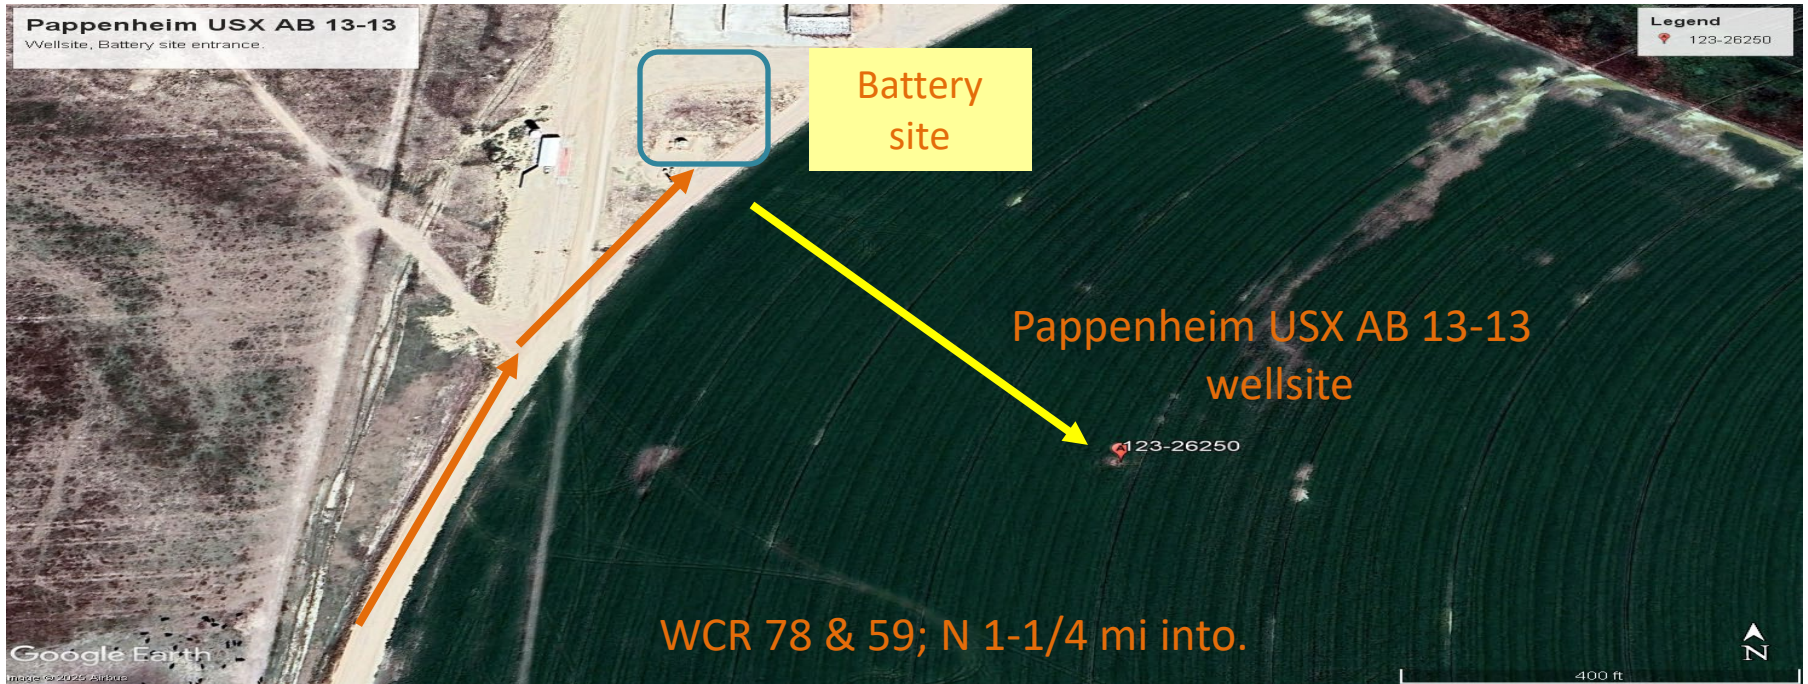
Photo #1

Pappenheim USX AB 13-13 Battery site

Inactive | Shut-down

Wellsite(s), Battery entrance

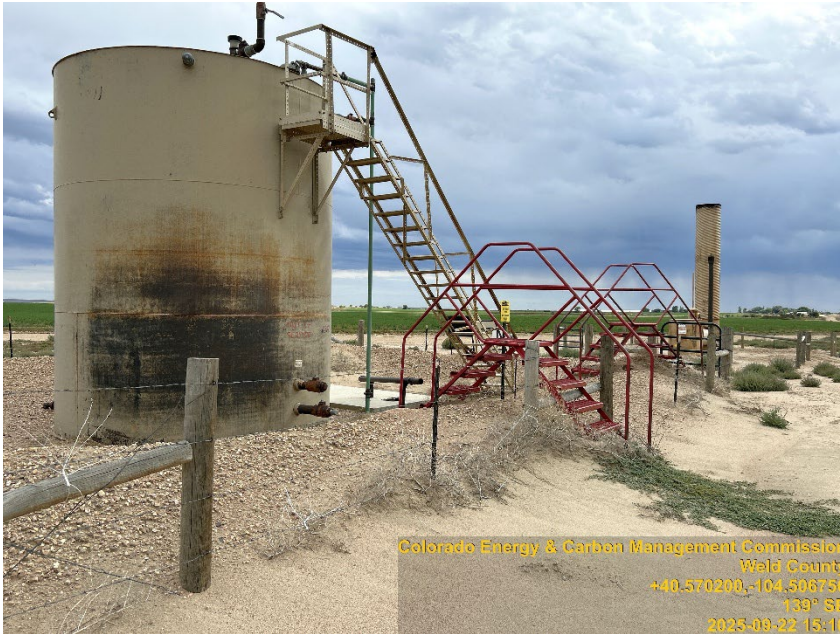
**Photo #2**

**Pappenheim USX AB 13-13 Battery site**

**Inactive | Shut-down**

**Equipment documented: Loc. ID 310329**

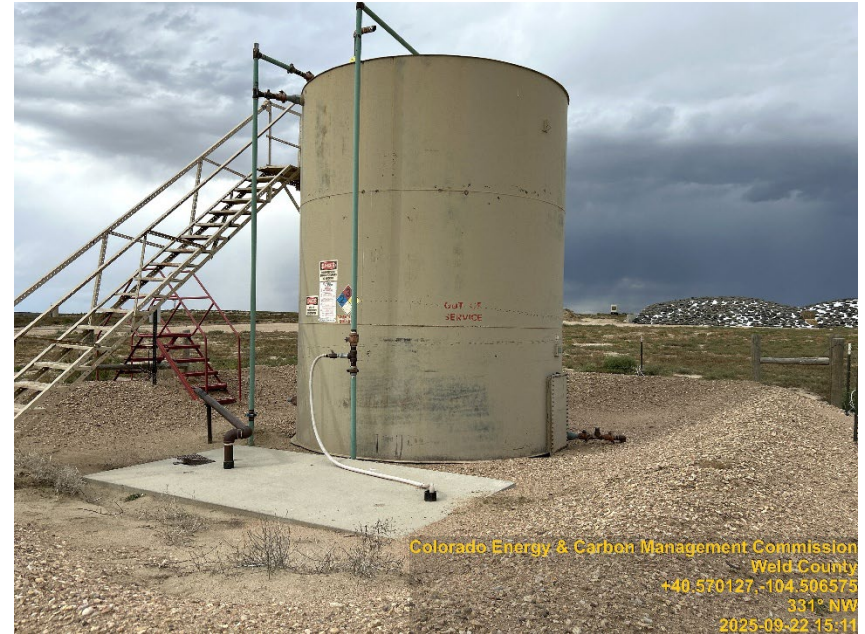
**Photo #3**

**Pappenheim USX AB 13-13 Battery site**

**Inactive | Shut-down**

**Crude Oil tank(s), Produced H2O vault(s); SE corner**

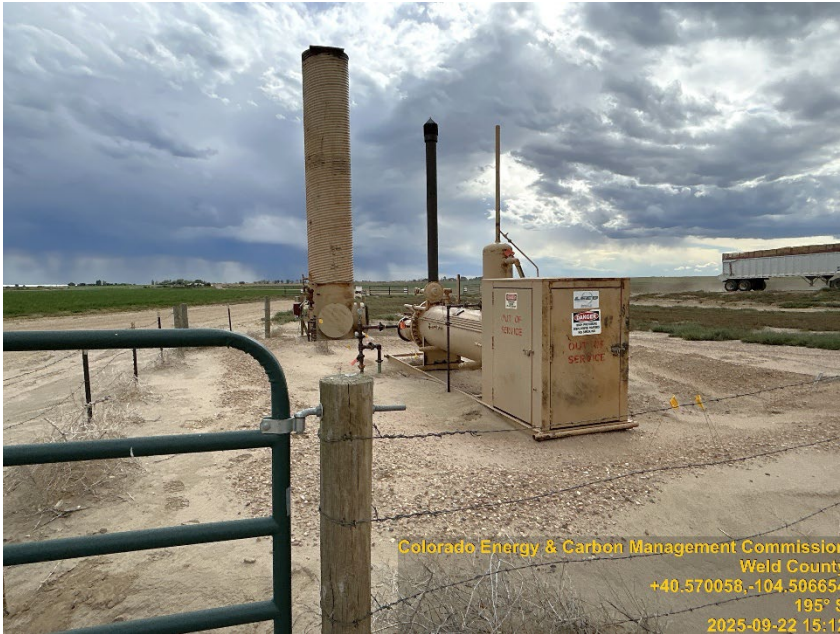
Photo #4

Pappenheim USX AB 13-13 Battery site

Inactive | Shut-down

Separator(s), ECD(s)

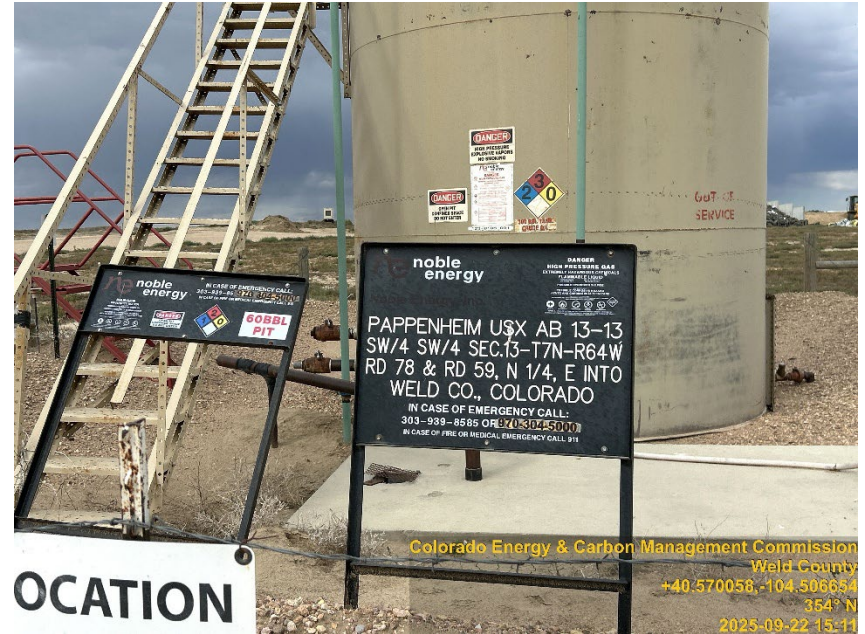
Photo #5

Pappenheim USX AB 13-13 Battery site

Inactive | Shut-down

Battery signage
