Inspection/Audit Photos

Location Name: TEP ROCKY MOUNTAIN LLC AP 22-24-696 Pad

Location ID: 335485

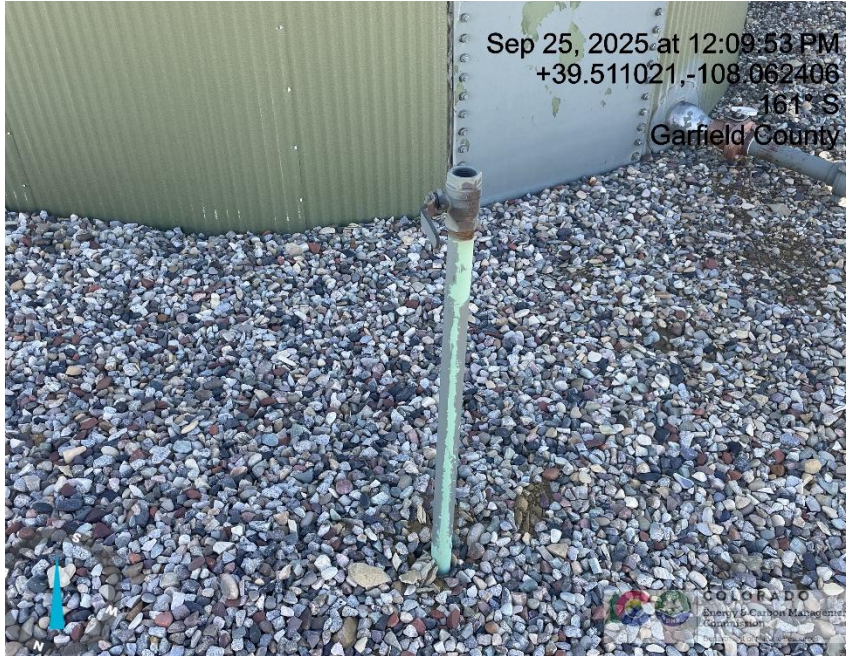
Photo # 2524 Unused flowline lacks lockout tagout (OOSLAT)

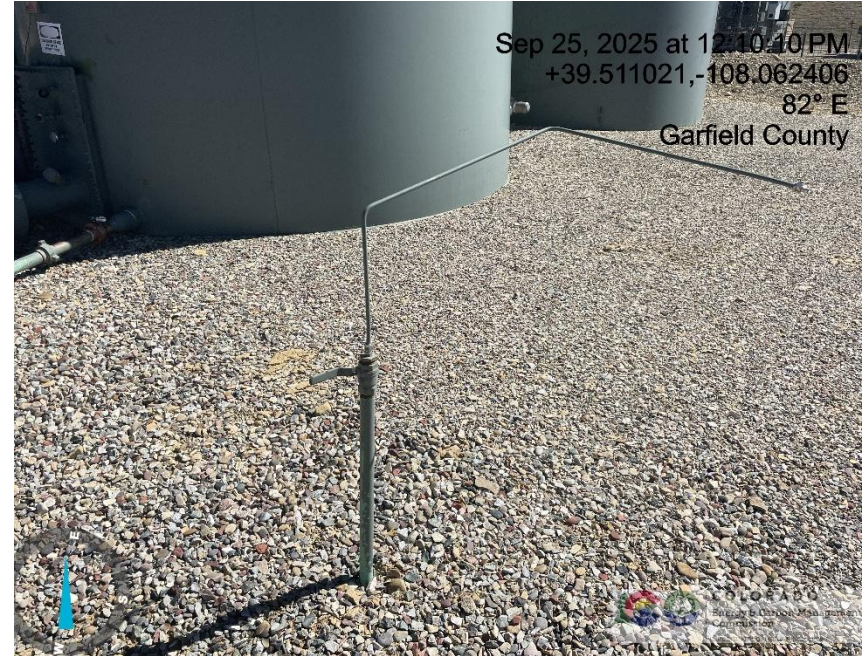
Photo # 2525 Unused flowline lacks lockout tagout (OOSLAT)

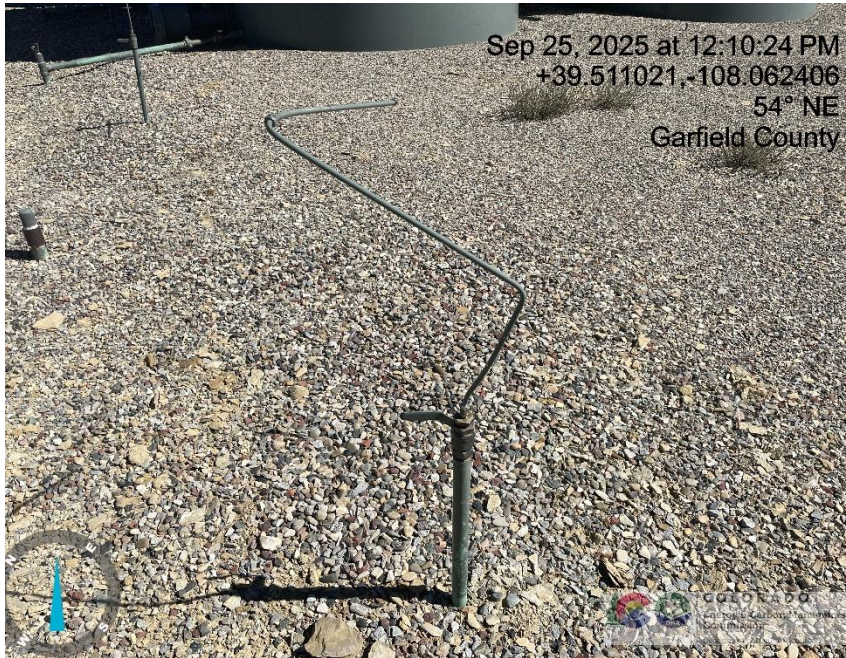
Photo # 2526 Unused flowline lacks lockout tagout (OOSLAT)

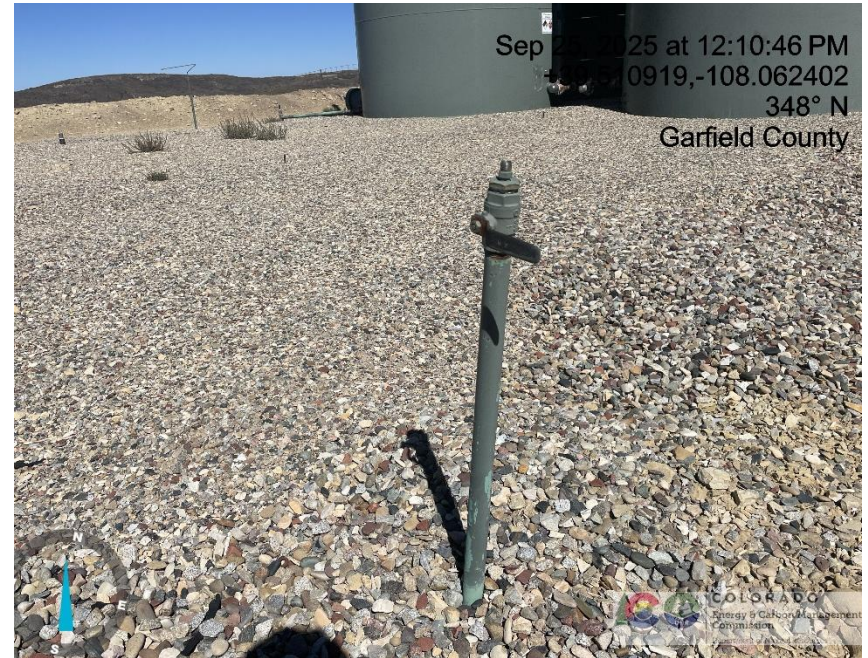
Photo # 2527 Unused flowline lacks lockout tagout (OOSLAT)

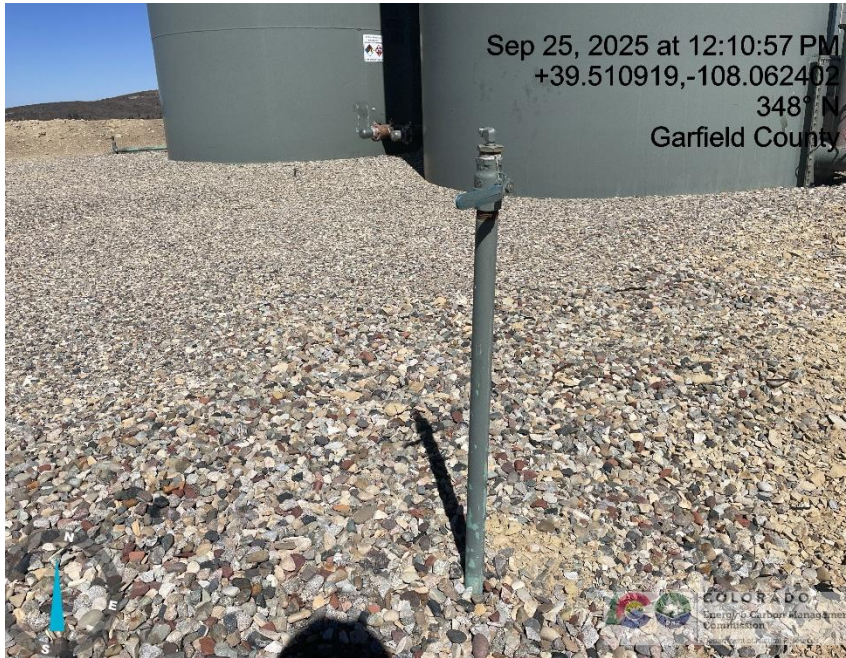
Photo # 2528 Unused flowline lacks lockout tagout (OOSLAT)

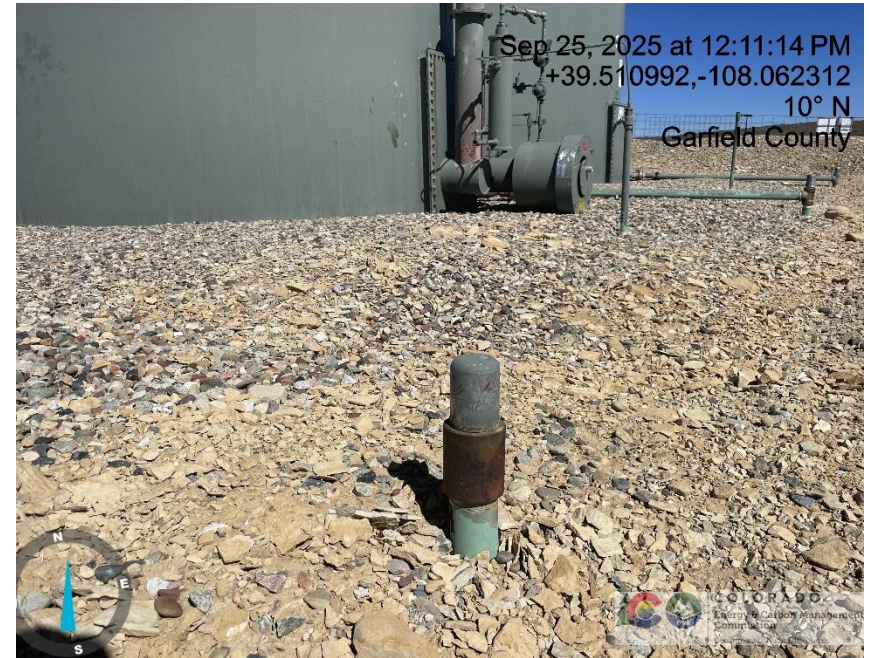
Photo # 2529 Unused flowline lacks lockout tagout (OOSLAT)

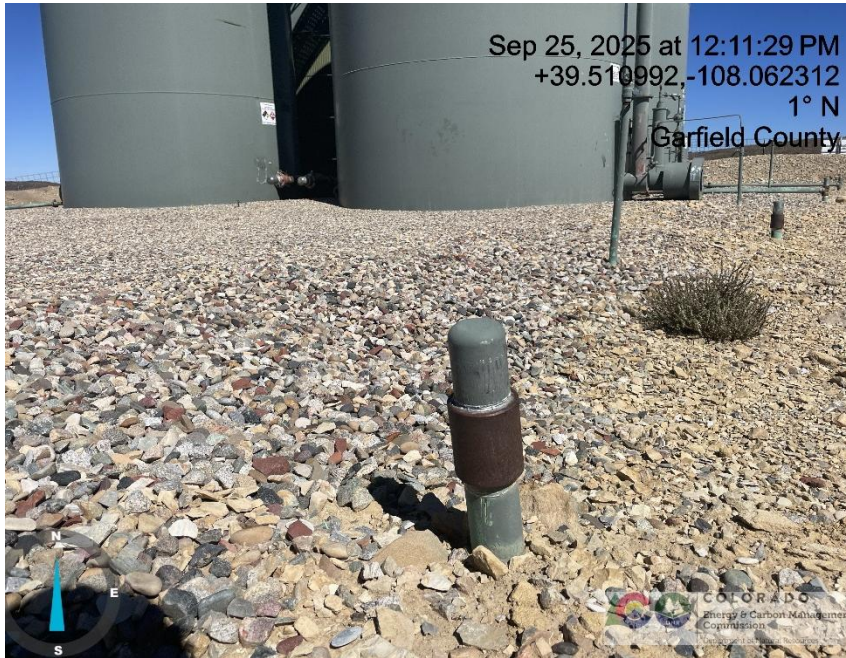
Photo # 2530 Unused flowline lacks lockout tagout (OOSLAT)

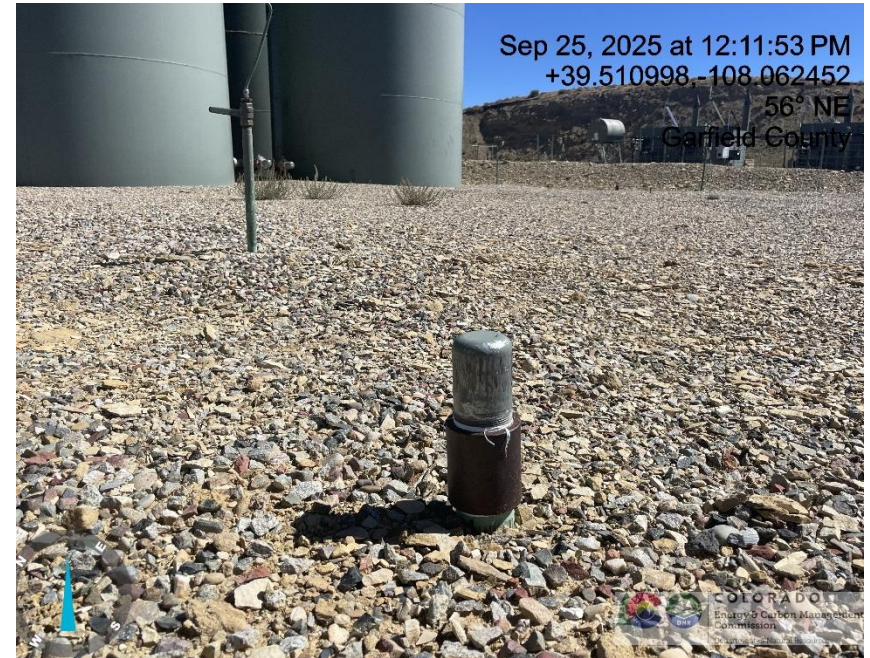
Photo # 2531 Unused flowline lacks lockout tagout (OOSLAT)

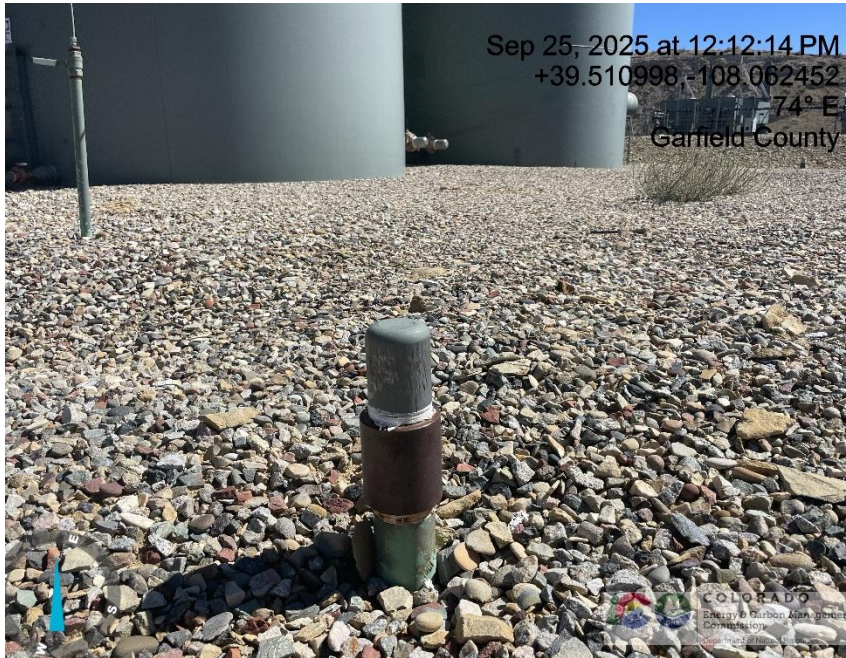
Photo # 2532 Unused flowline lacks lockout tagout (OOSLAT)

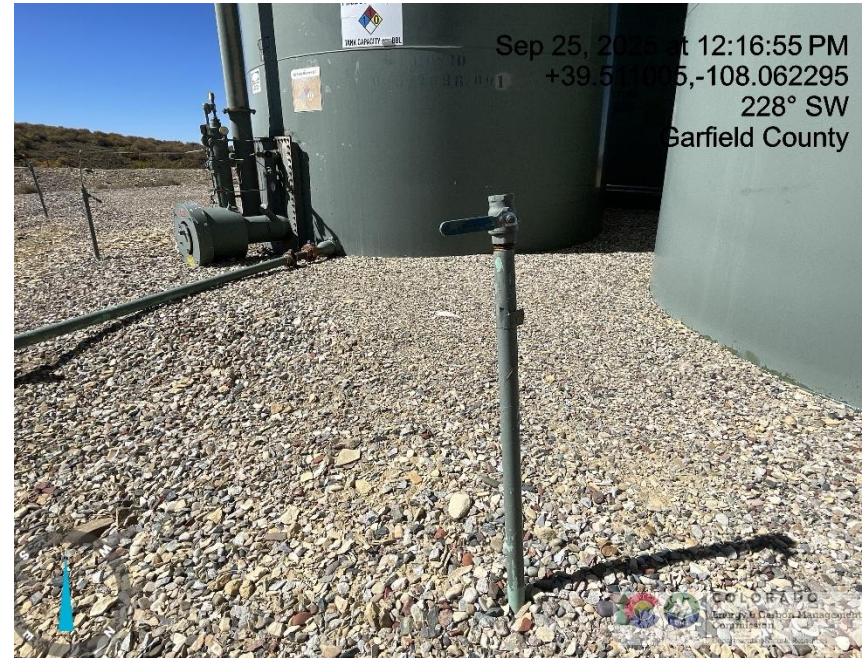
Photo # 2533 Unused flowline lacks lockout tagout (OOSLAT)

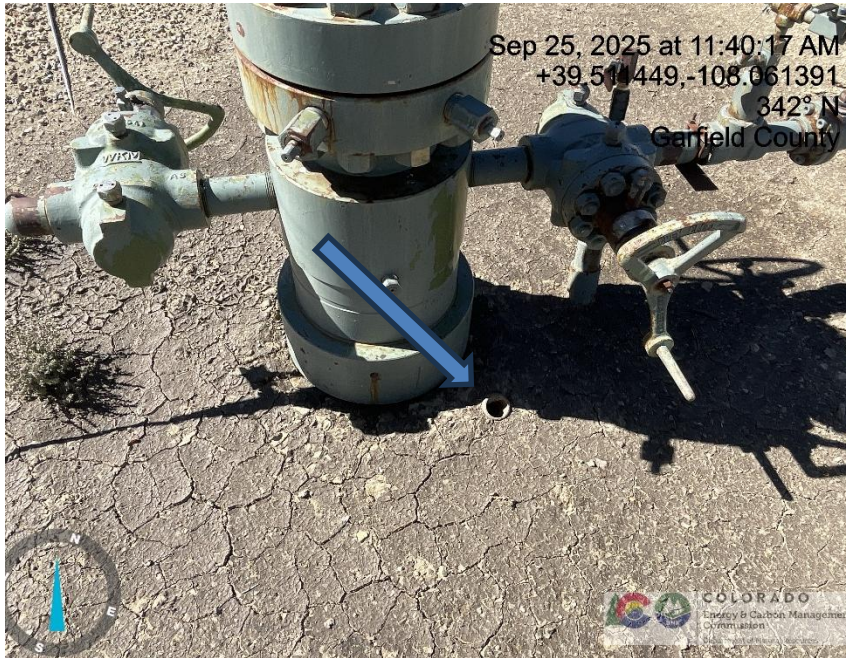
Photo # 2534 Open ended piping near wellhead/wildlife hazard/available for entry by wildlife

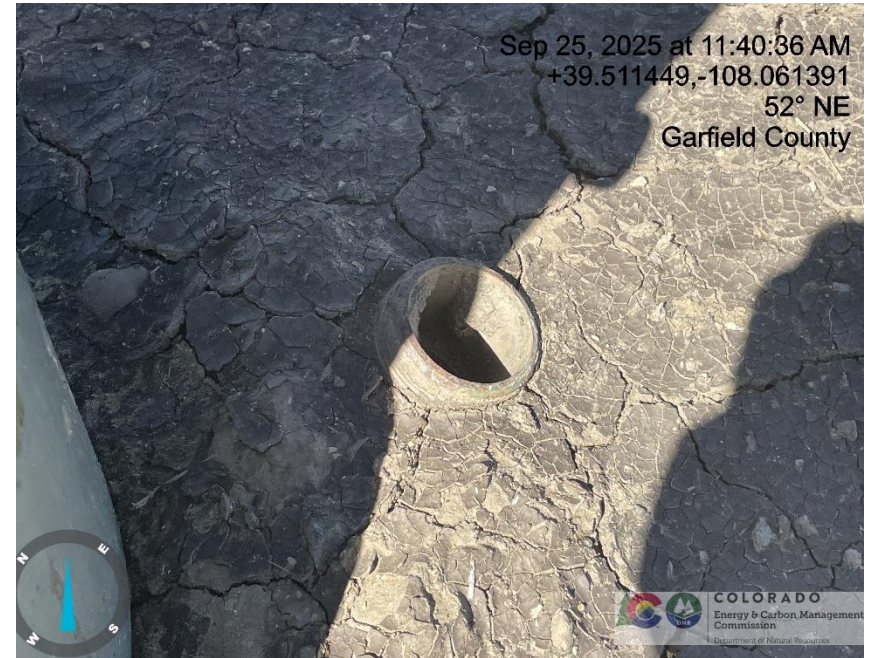
Photo # 2535 Open ended piping near wellhead/wildlife hazard/available for entry by wildlife

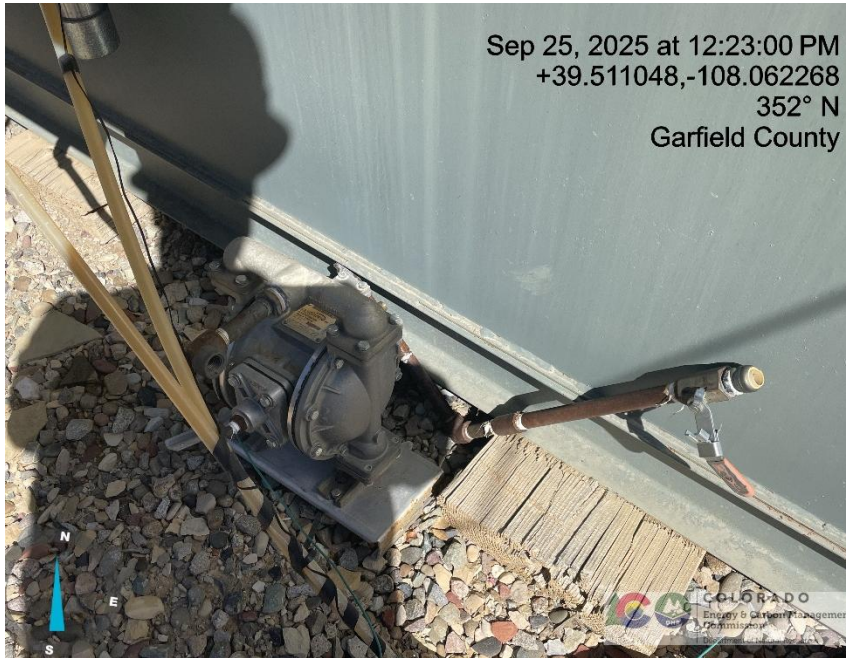
Photo # 2536 Unused equipment

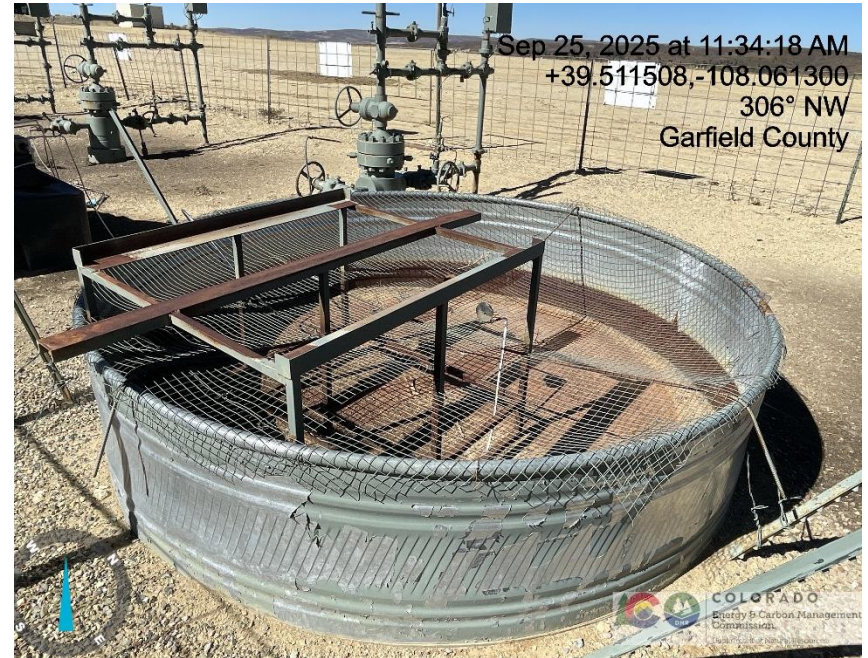
Photo # 2537 Unused equipment

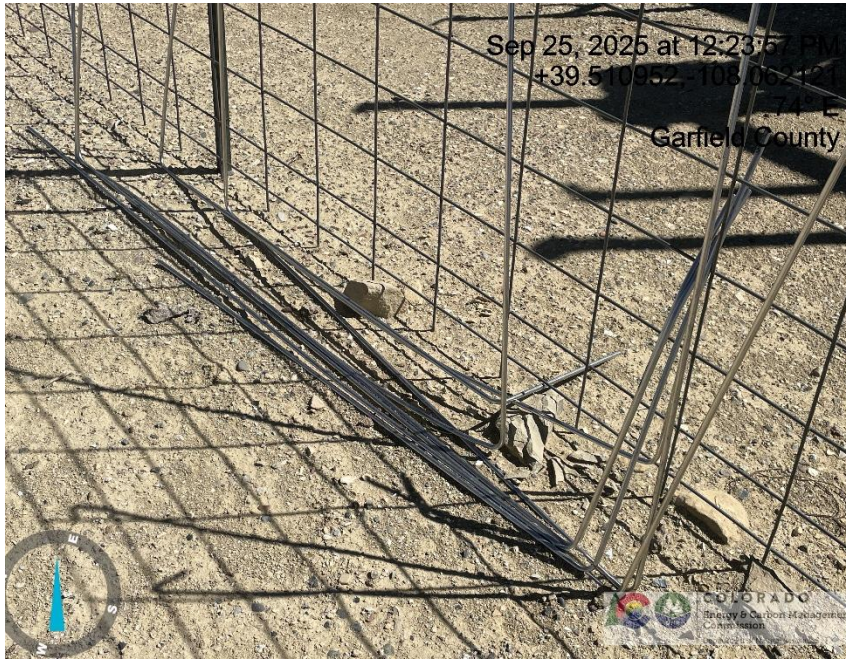
Photo # 2538 Unused equipment

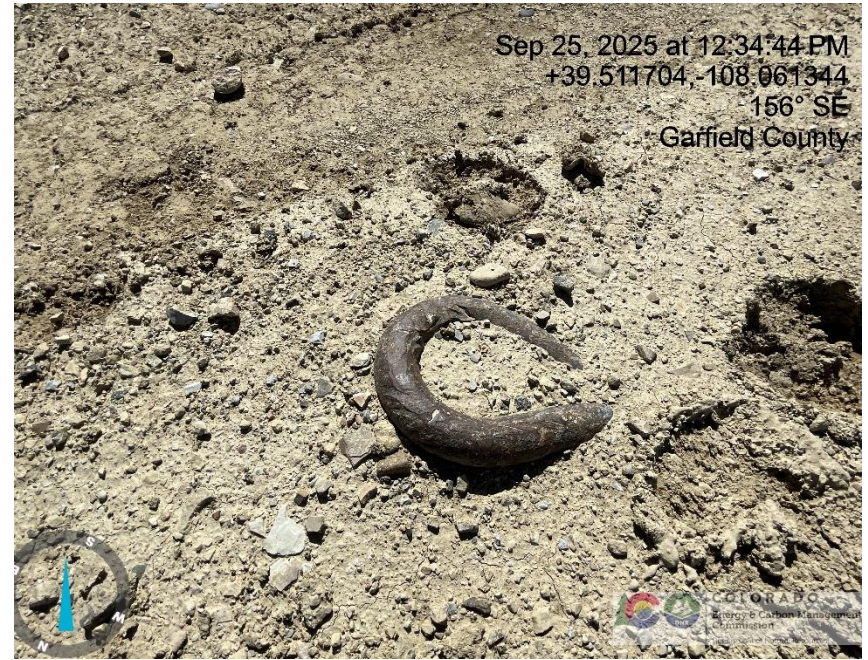
Photo # 2539 Unmarked deadman

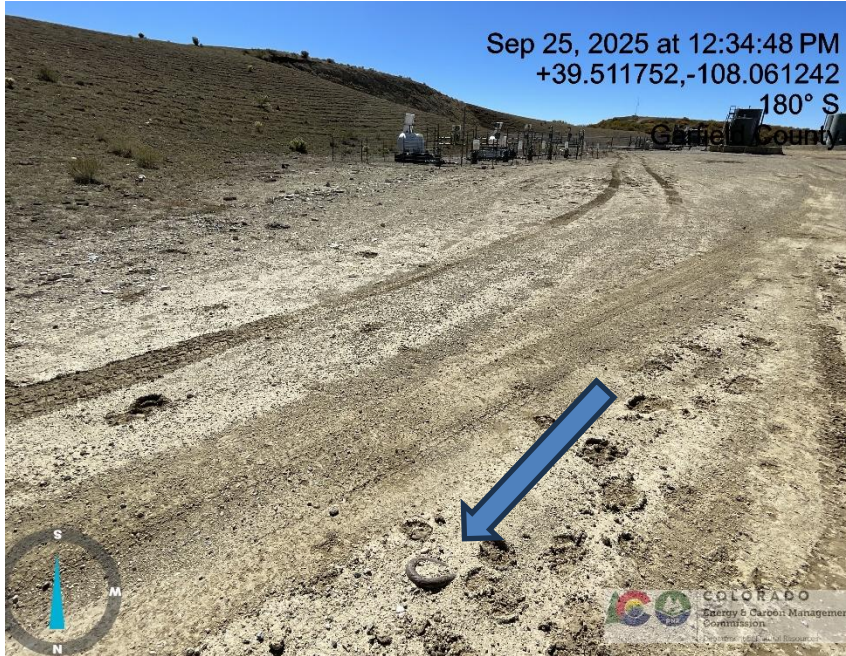
Photo # 2540 Same unmarked deadman

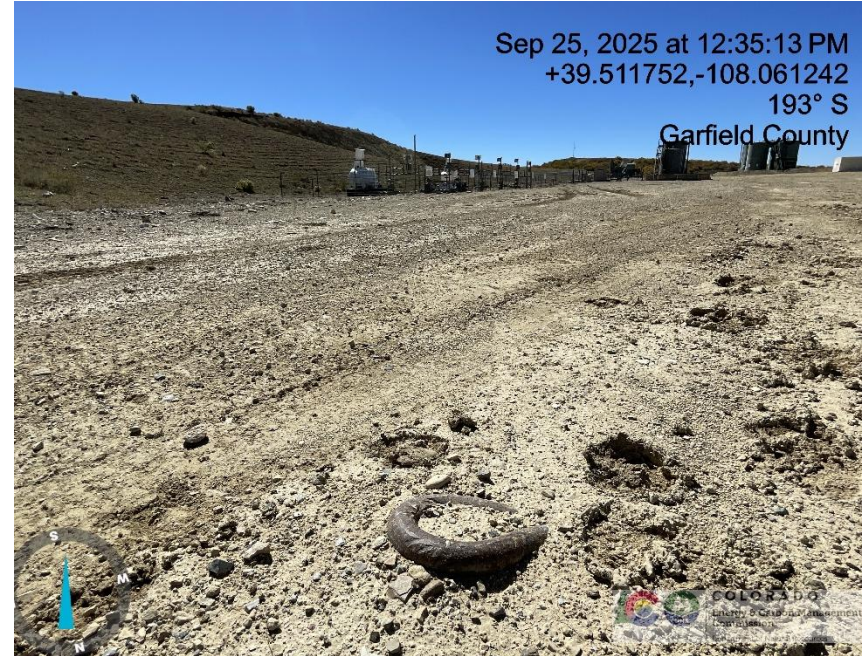
Photo # 2541 Same unmarked deadman

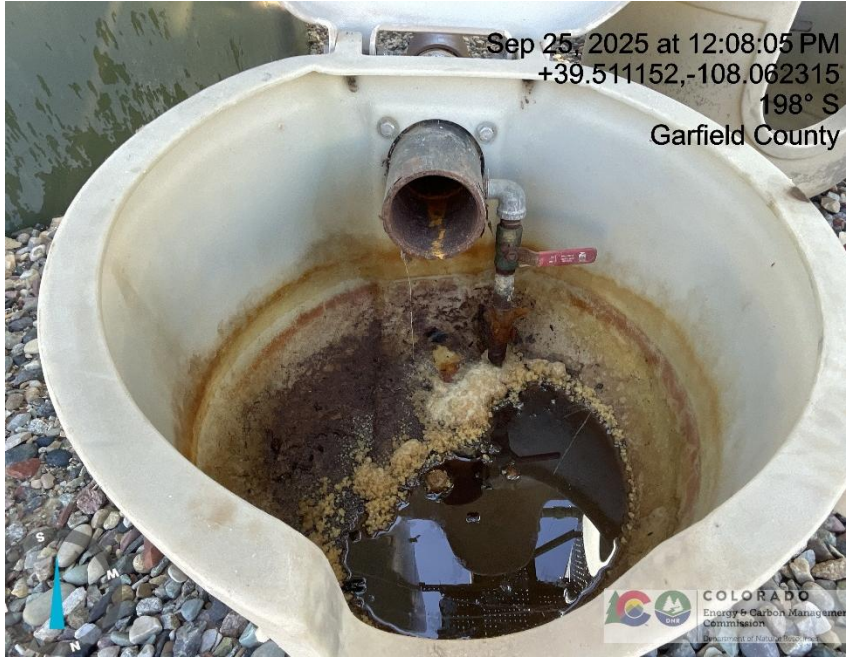
Photo # 2542 Open ended load line

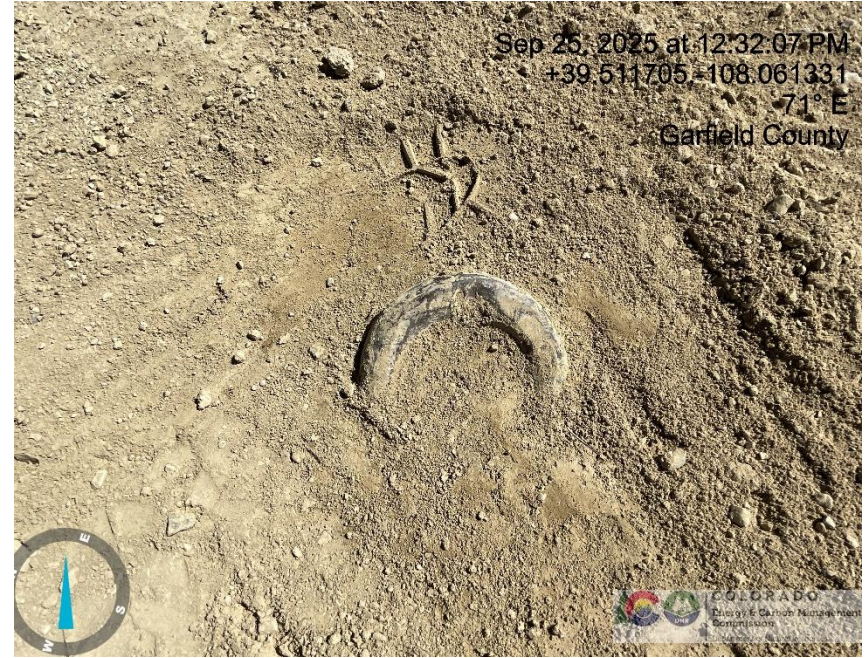
Photo # 2543 Unmarked deadman

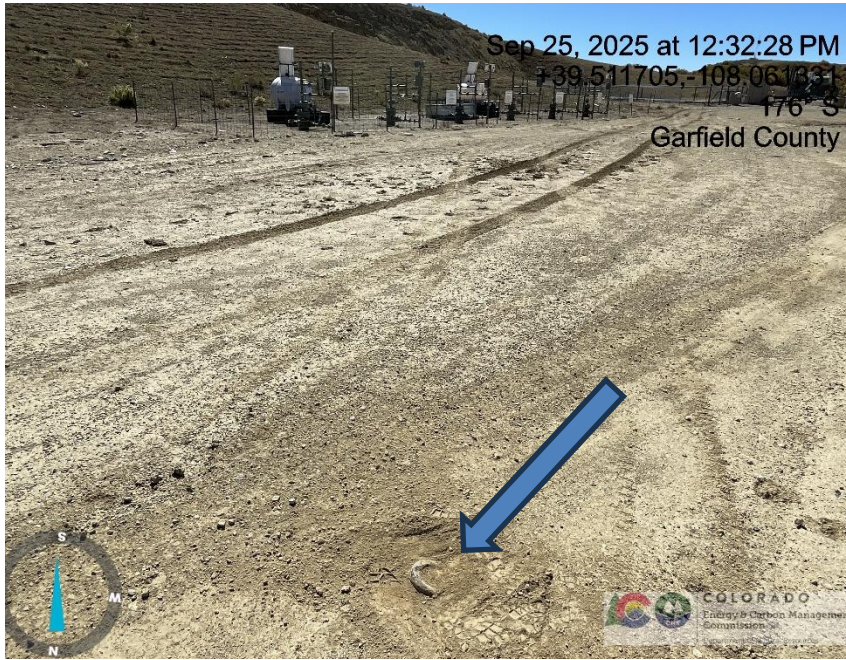
Photo # 2544 Same unmarked deadman

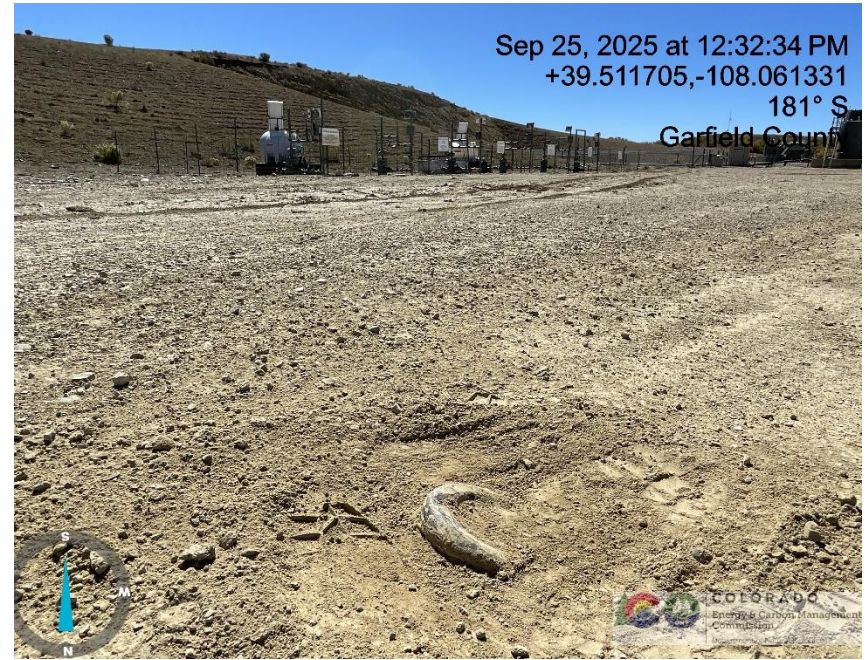
Photo # 2545 Same unmarked deadman

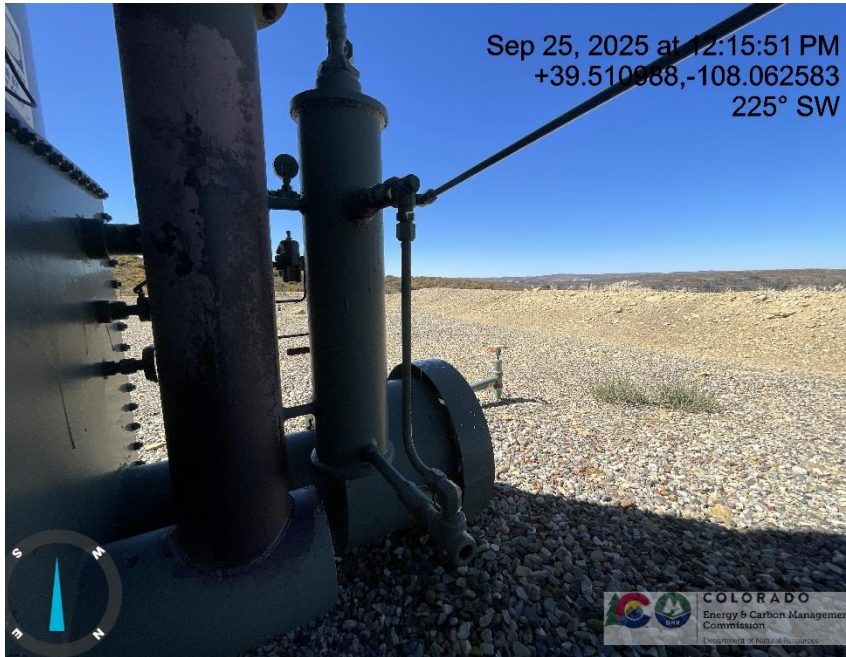
Photo # 2546 PRV vent line on tank burner does not comply with CECMC pressure safety device rules

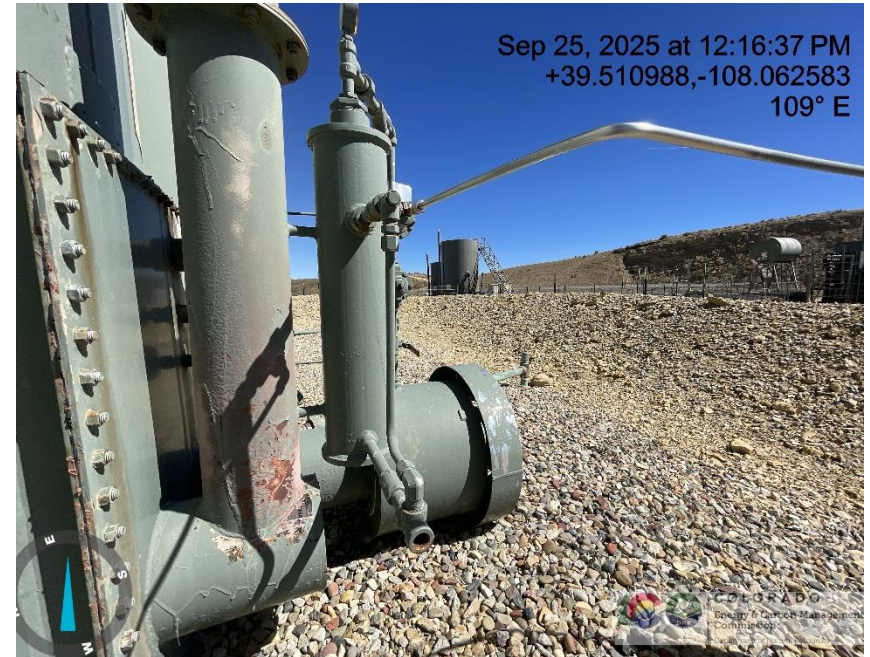
Photo # 2547 PRV vent line on tank burner does not comply with CECMC pressure safety device rules
