# Inspection Photos

**Operator:** TEP Rocky Mountain LLC #96850

**Location ID:** 335209

**Inspection Doc:** 719200247

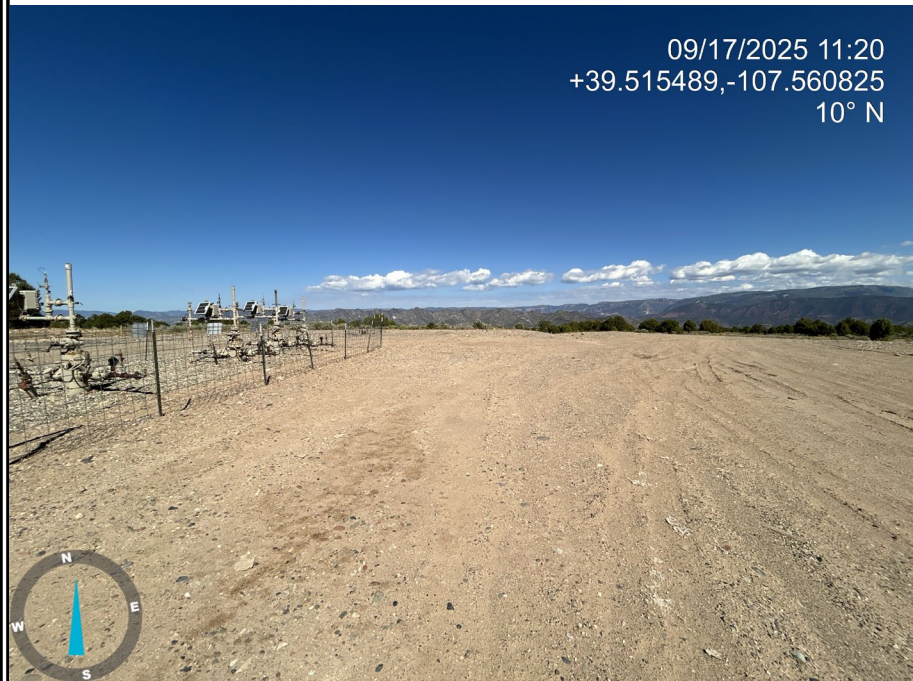
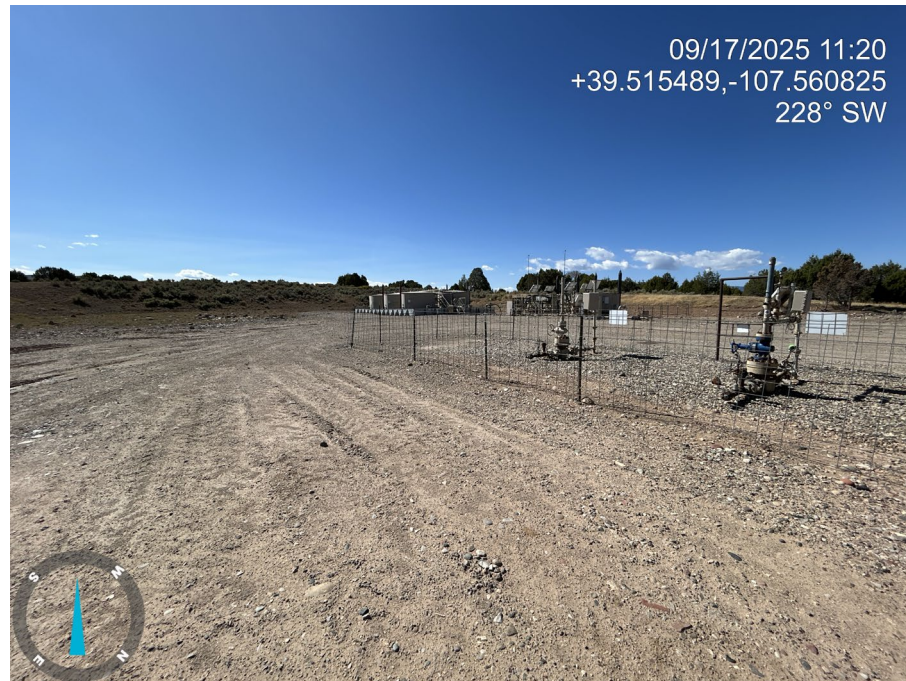
**Photo 1:** Photos showing an overview of the location looking north and southwest, respectively.

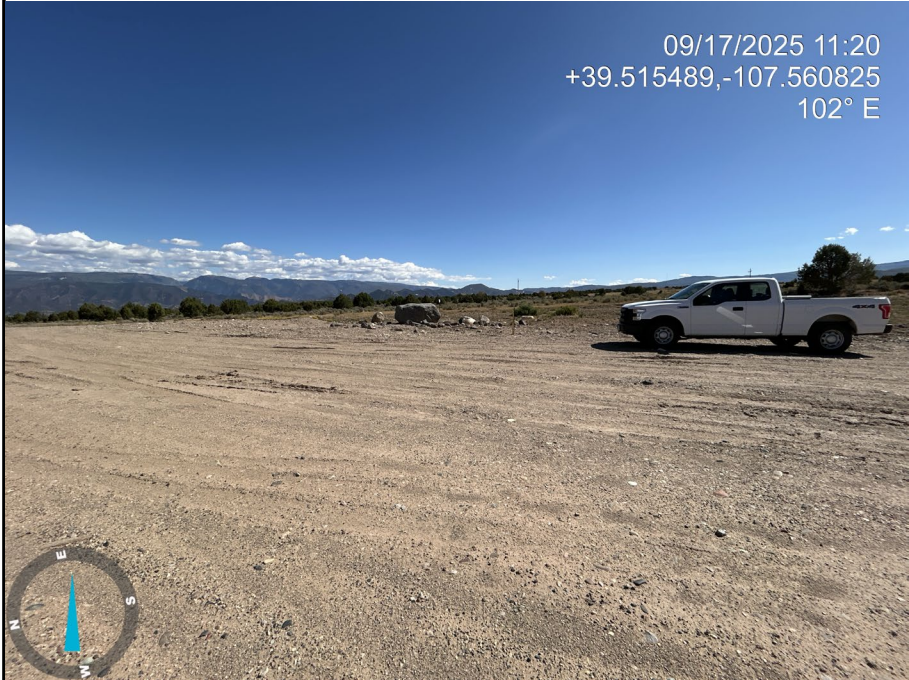
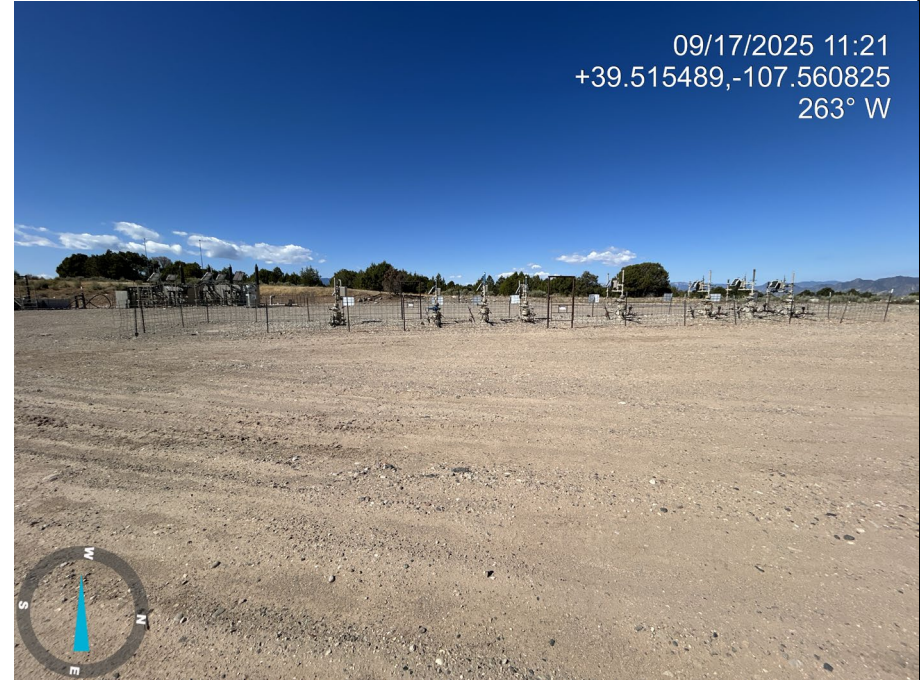
**Photo 2:** Photos showing an overview of the location looking east and west, respectively.

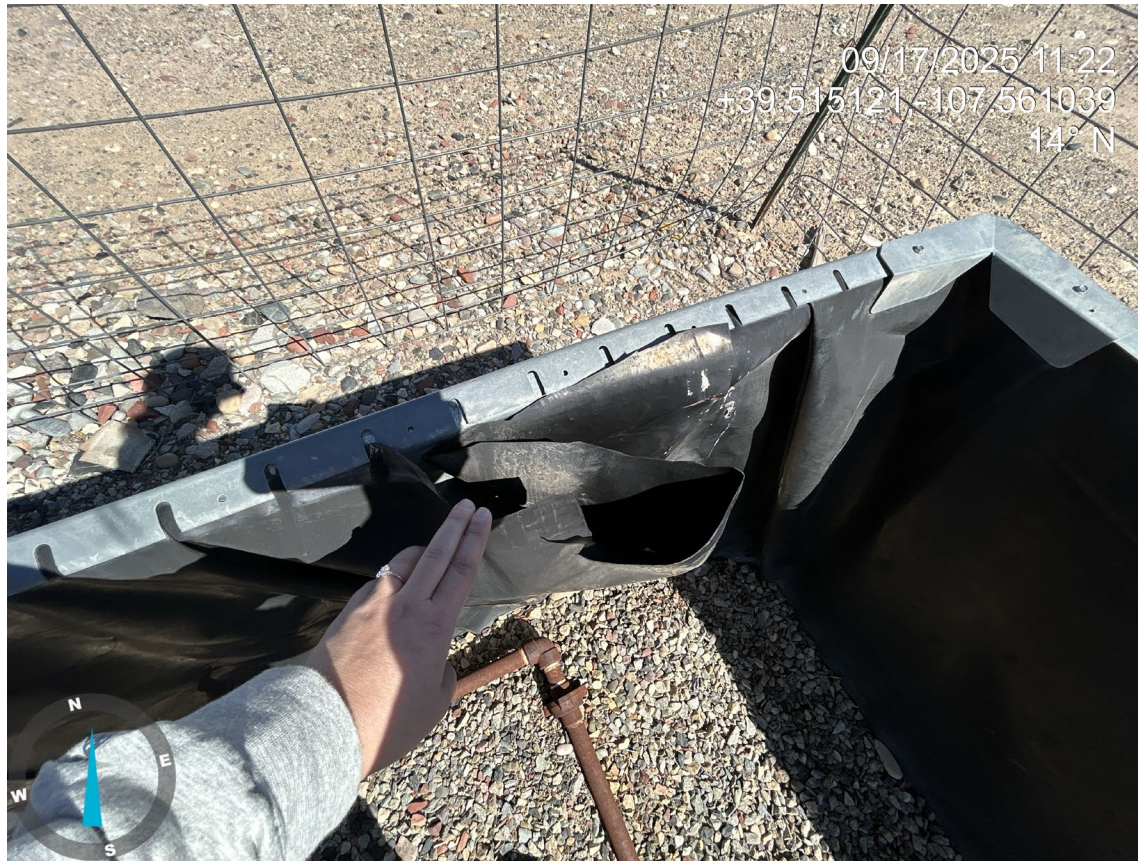
**Photo 3:** A corner of the secondary liner is not sufficiently impervious to prevent a spill or release. Comply with Rule 603.o.

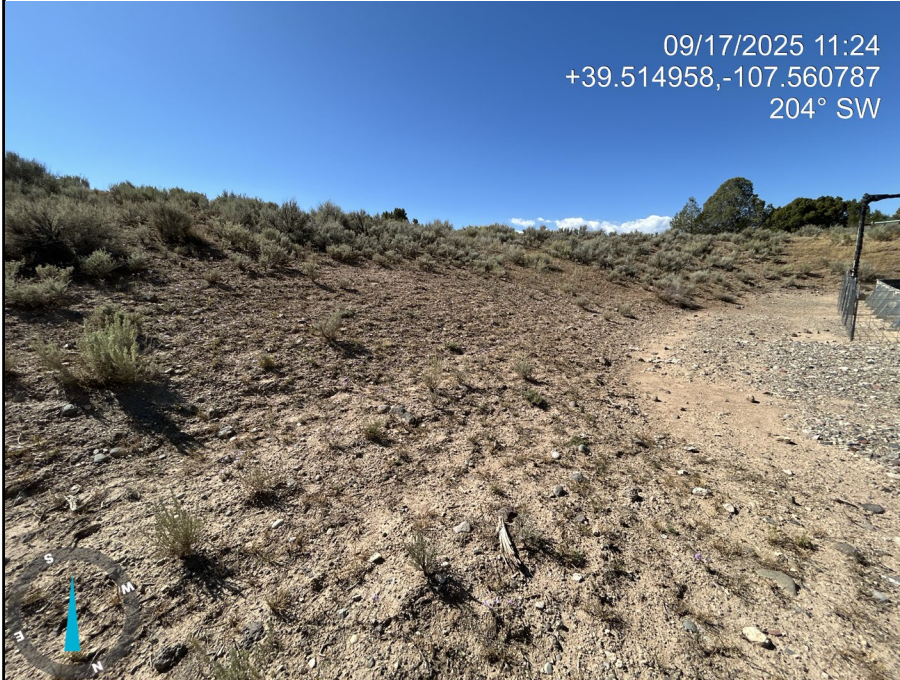
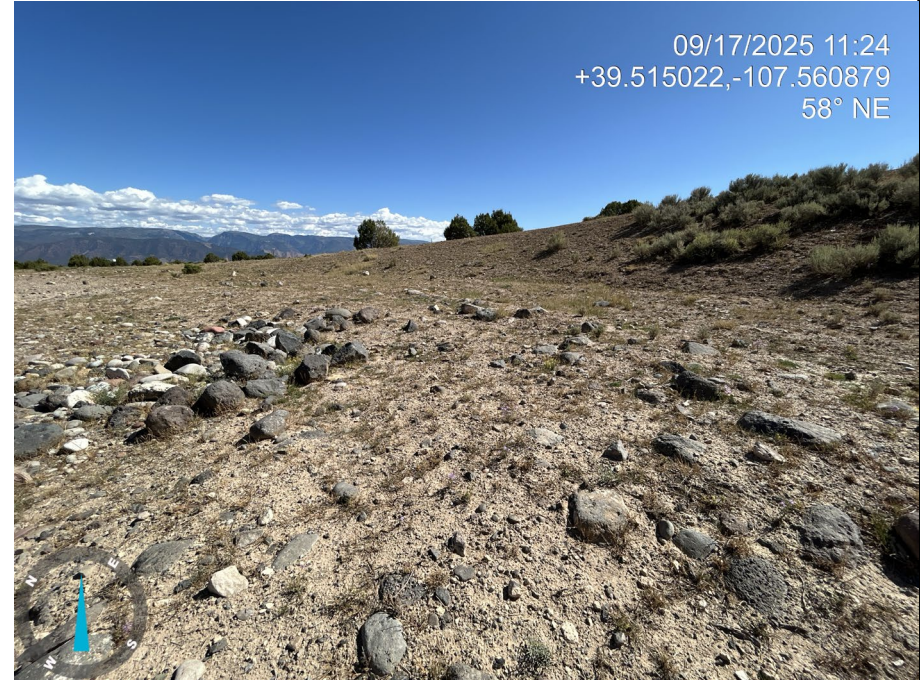
**Photo 4:** Photos showing an overview of the southeastern interim areas. Some portions of the interim areas are predominantly bare with little to no plant establishment. These areas are not progressing towards 1003 reclamation requirements.

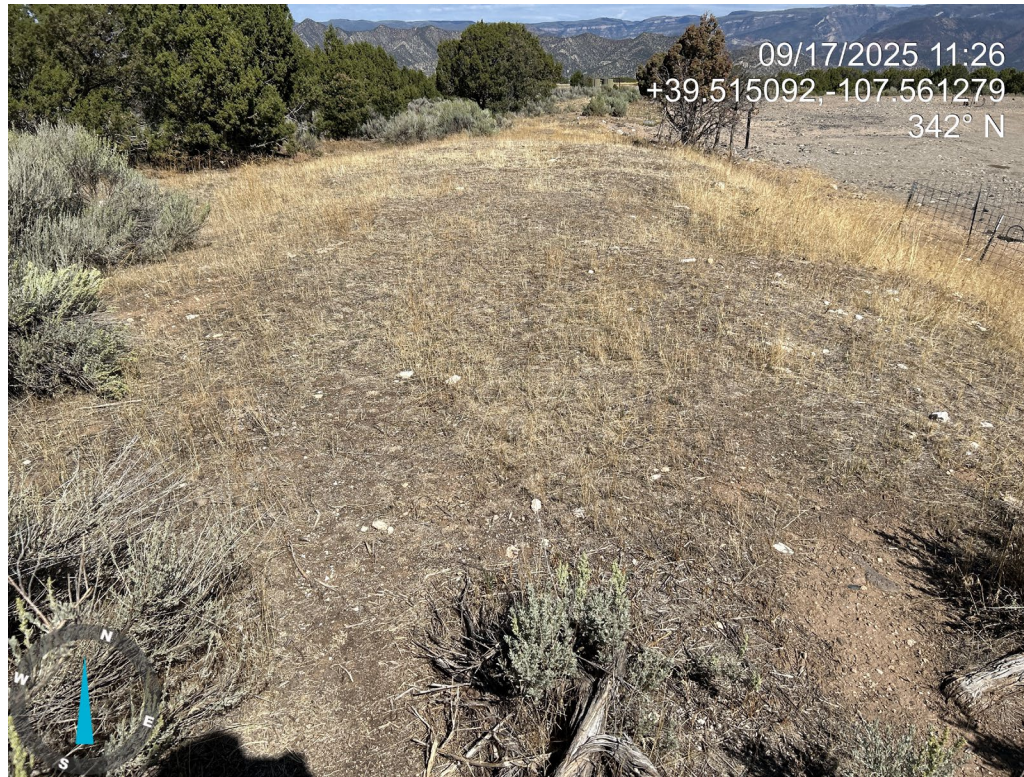
**Photo 5:** Photos showing an overview of the western interim area. Some portions of the interim areas are predominantly composed of undesirable plant species. These areas are not progressing towards 1003 reclamation requirements. Conduct additional 1003 reclamation efforts.

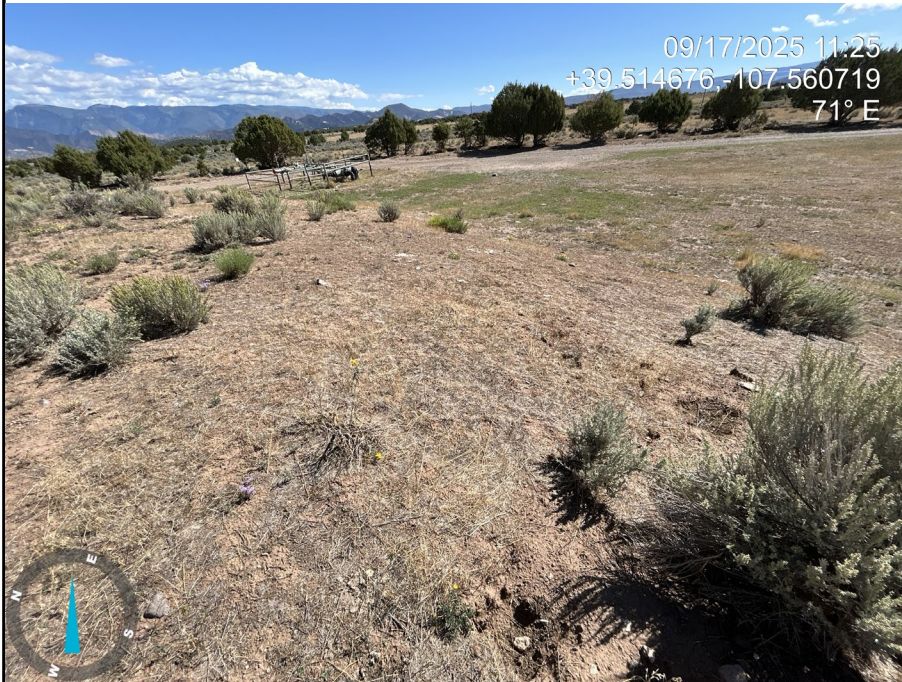
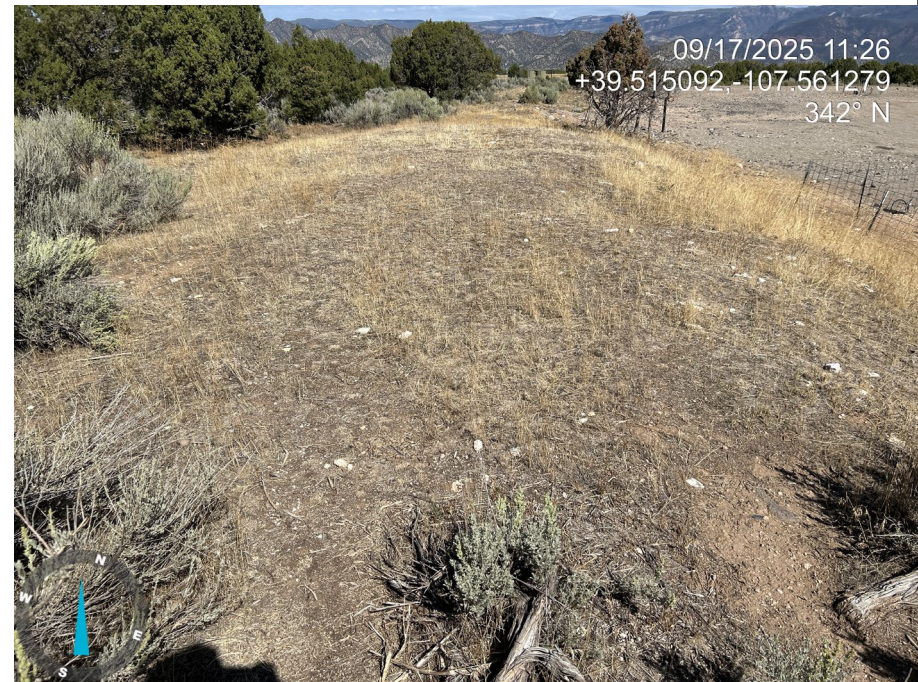
**Photo 6:** Photos showing an overview of the southern interim areas. Some portions of the interim areas are predominantly bare with little to no plant establishment. These areas are not progressing towards 1003 reclamation requirements. Conduct additional 1003 reclamation efforts.

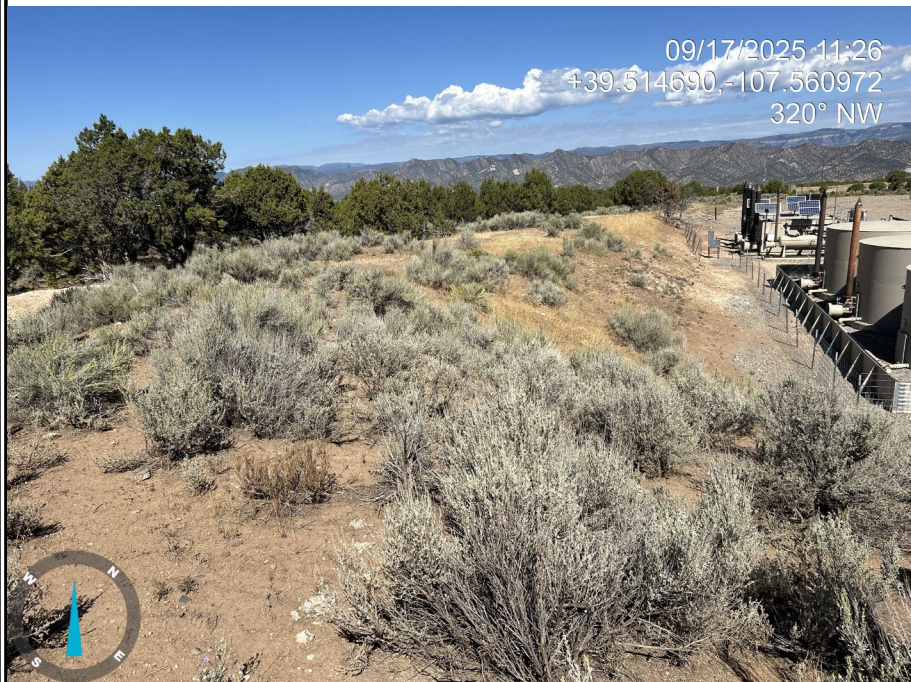
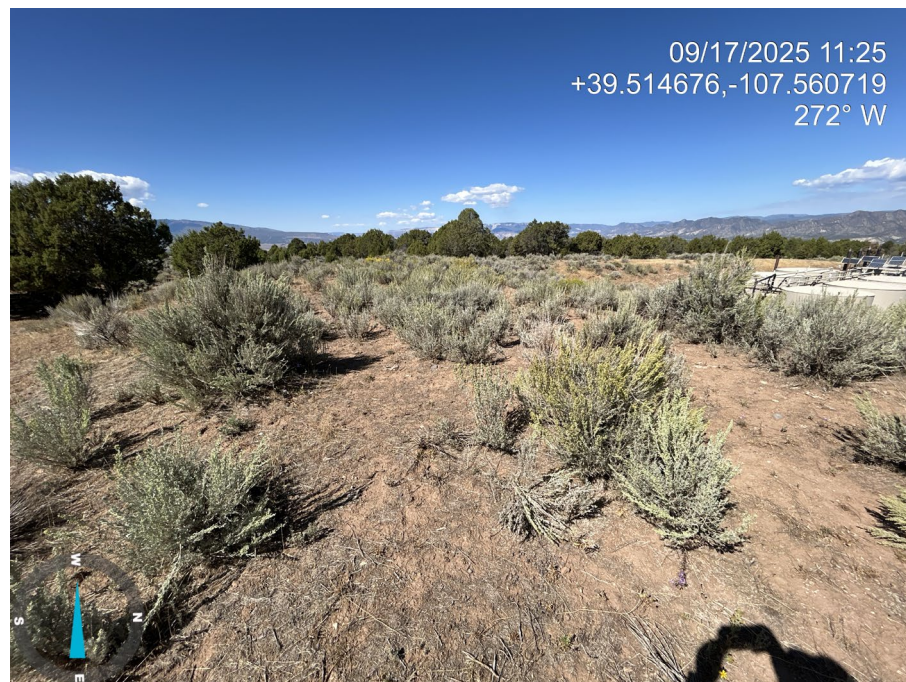
**Photo 7:** Photos showing an overview of the southern interim area above the cut slopes. Big sagebrush has established; however, establishment does not appear to be uniform throughout the interim areas.

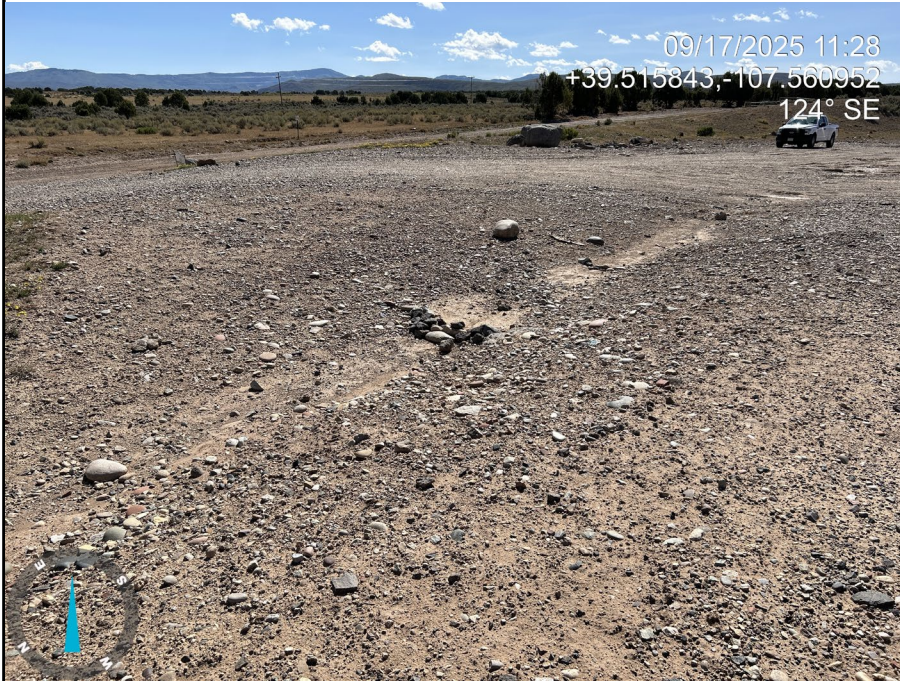
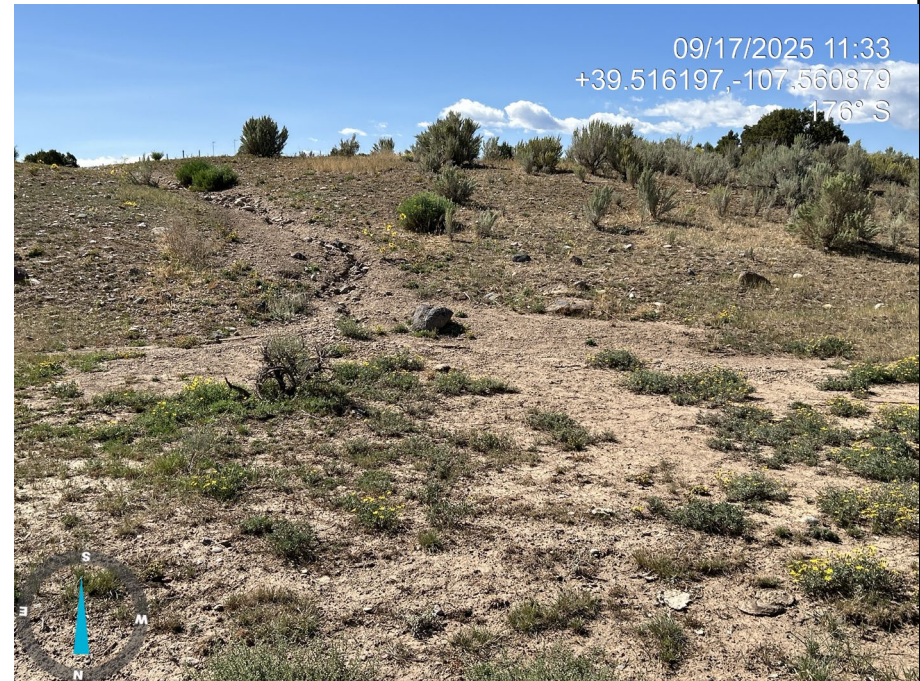
**Photo 8:** Photos showing a stormwater control on the northern portion of the site is in disrepair, and erosion and sediment transportation is occurring. Stormwater BMP's appear to be missing or insufficient; comply with Rule 1002.f.
