Inspection Photos

Location Name: R. MILLER-67N64W/24NWSW

Location #: 306145

**Energy & Carbon Management
Commission**

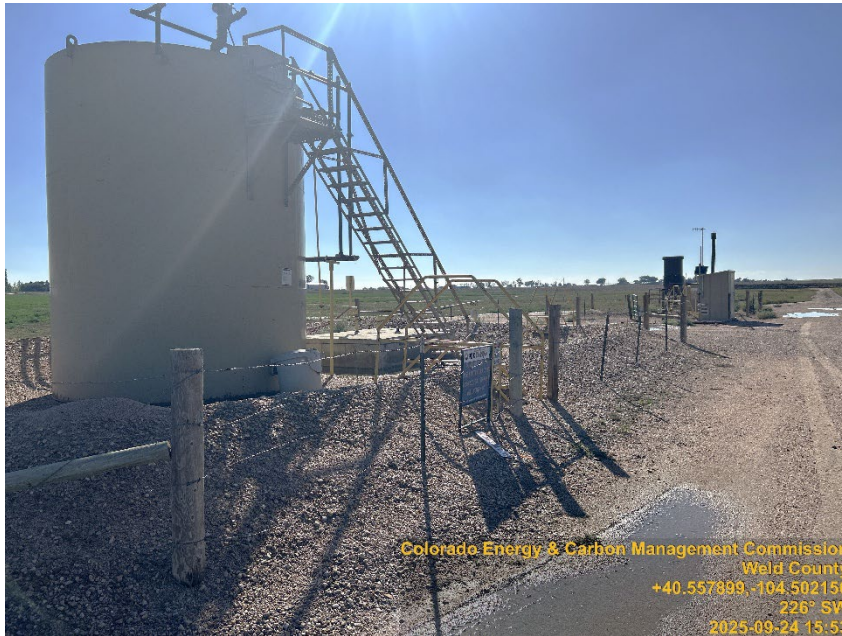
Photo #1

Inactive | Shut-down

Equipment documented: Loc. ID 306145

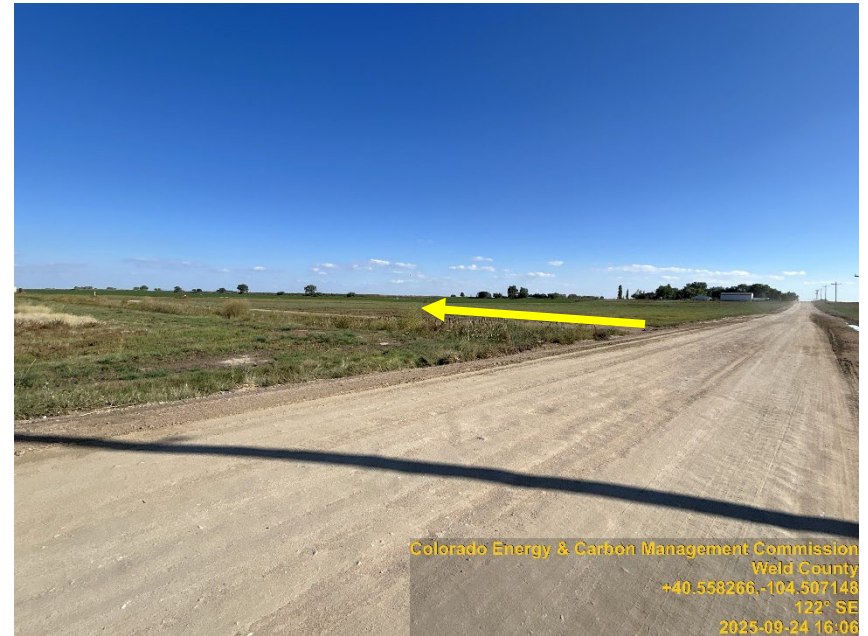
Photo #2

Inactive | Shut-down

Wellsite(s), Battery entrance

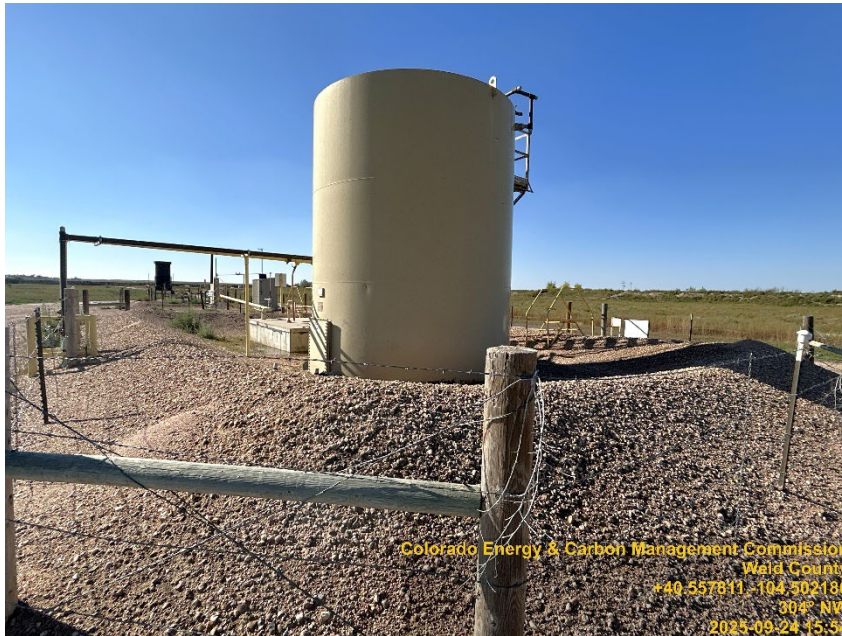
Photo #3

Inactive | Shut-down

Crude oil, produced H2O tank(s), vault(s): SE corner

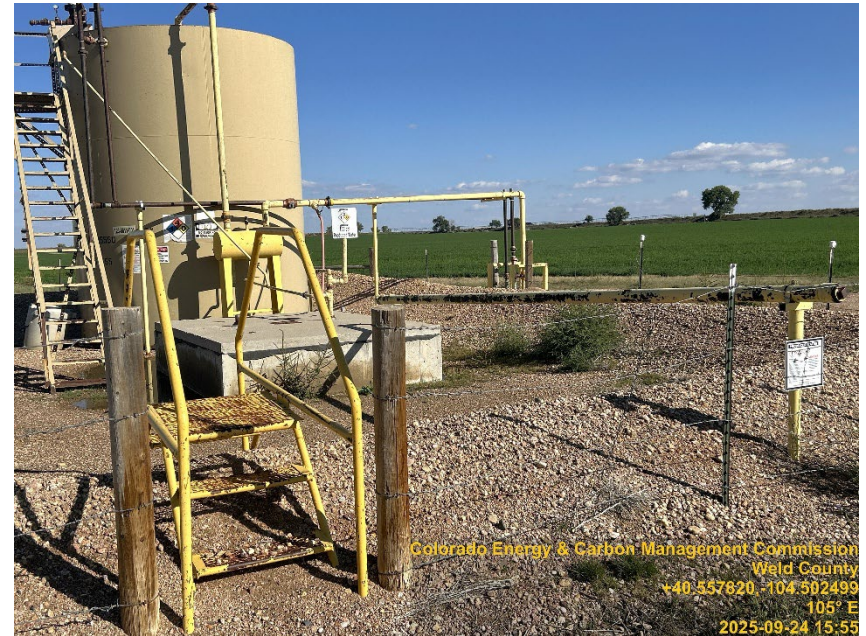
Photo #4

Inactive | Shut-down

Crude oil, produced H2O tank(s), vault(s)

CA: Overgrown vegetation

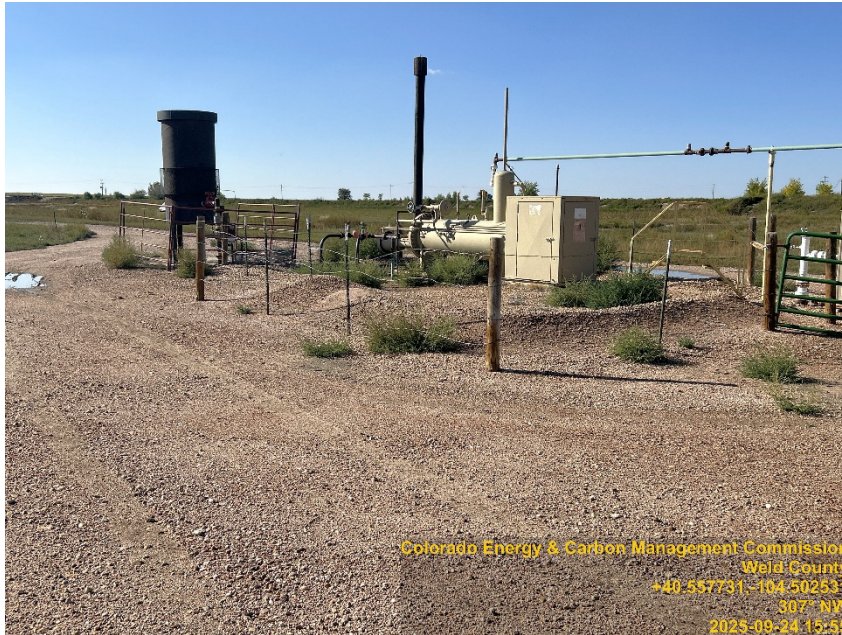
Photo #5

Inactive | Shut-down

ECD(s), Separator(s)

CA: Overgrown vegetation

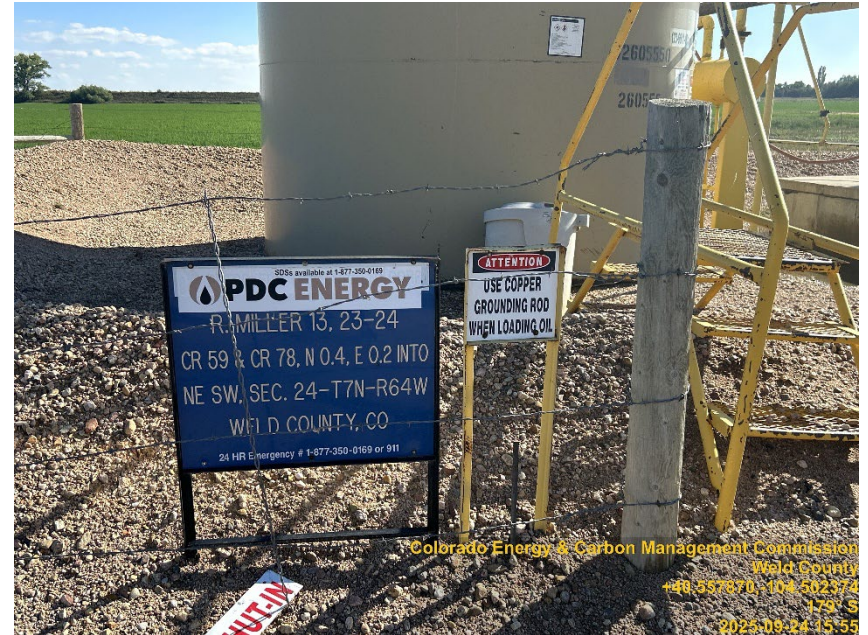
Photo #6

Inactive | Shut-down

Battery signage
