WELL NAME: HORN SPRINGS GAS COM 3-32-33, API #: 071-06101, INSP. # 716301577

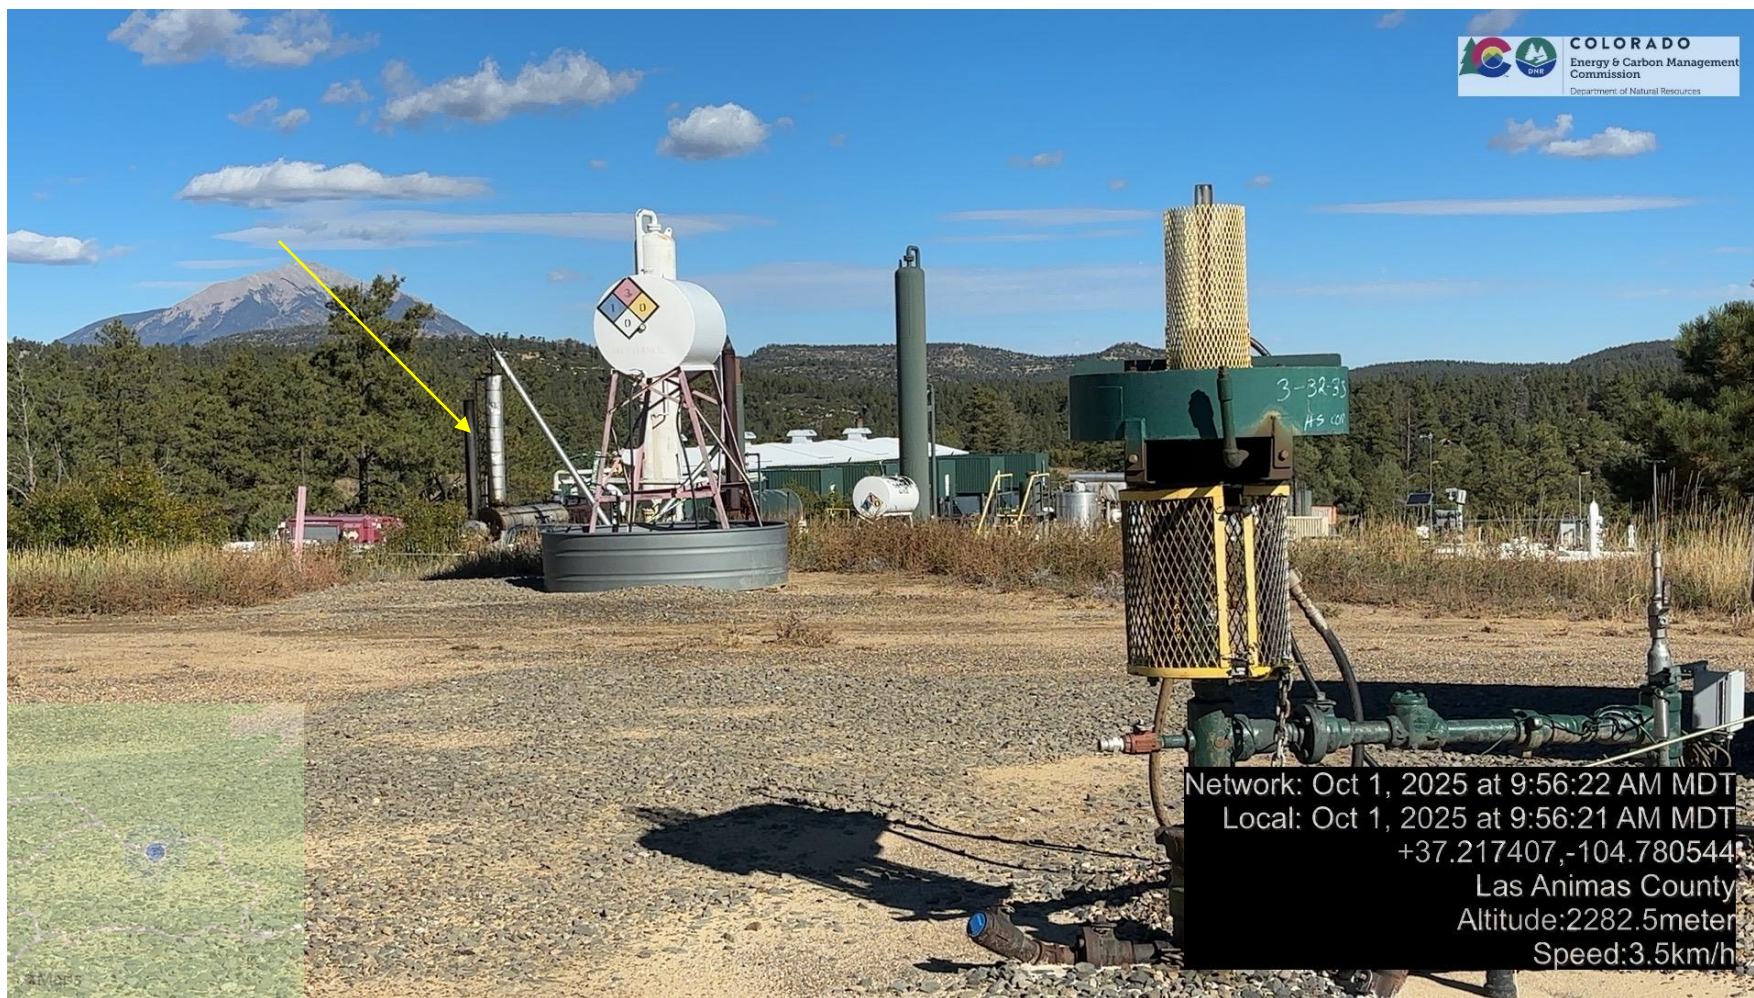
**PHOTO 3: AROW SHOWING THE EQUIPMENT WITH THE FAILURE APP. 120' TO THE NORTH OF THE EDGE OF LOCATION, THERE IS A ROW BETWEEN THE METHANOL TANK AND THE DEHYDRATOR EQUIPMENT THAT IS NOT SHOWN IN PHOTO.**

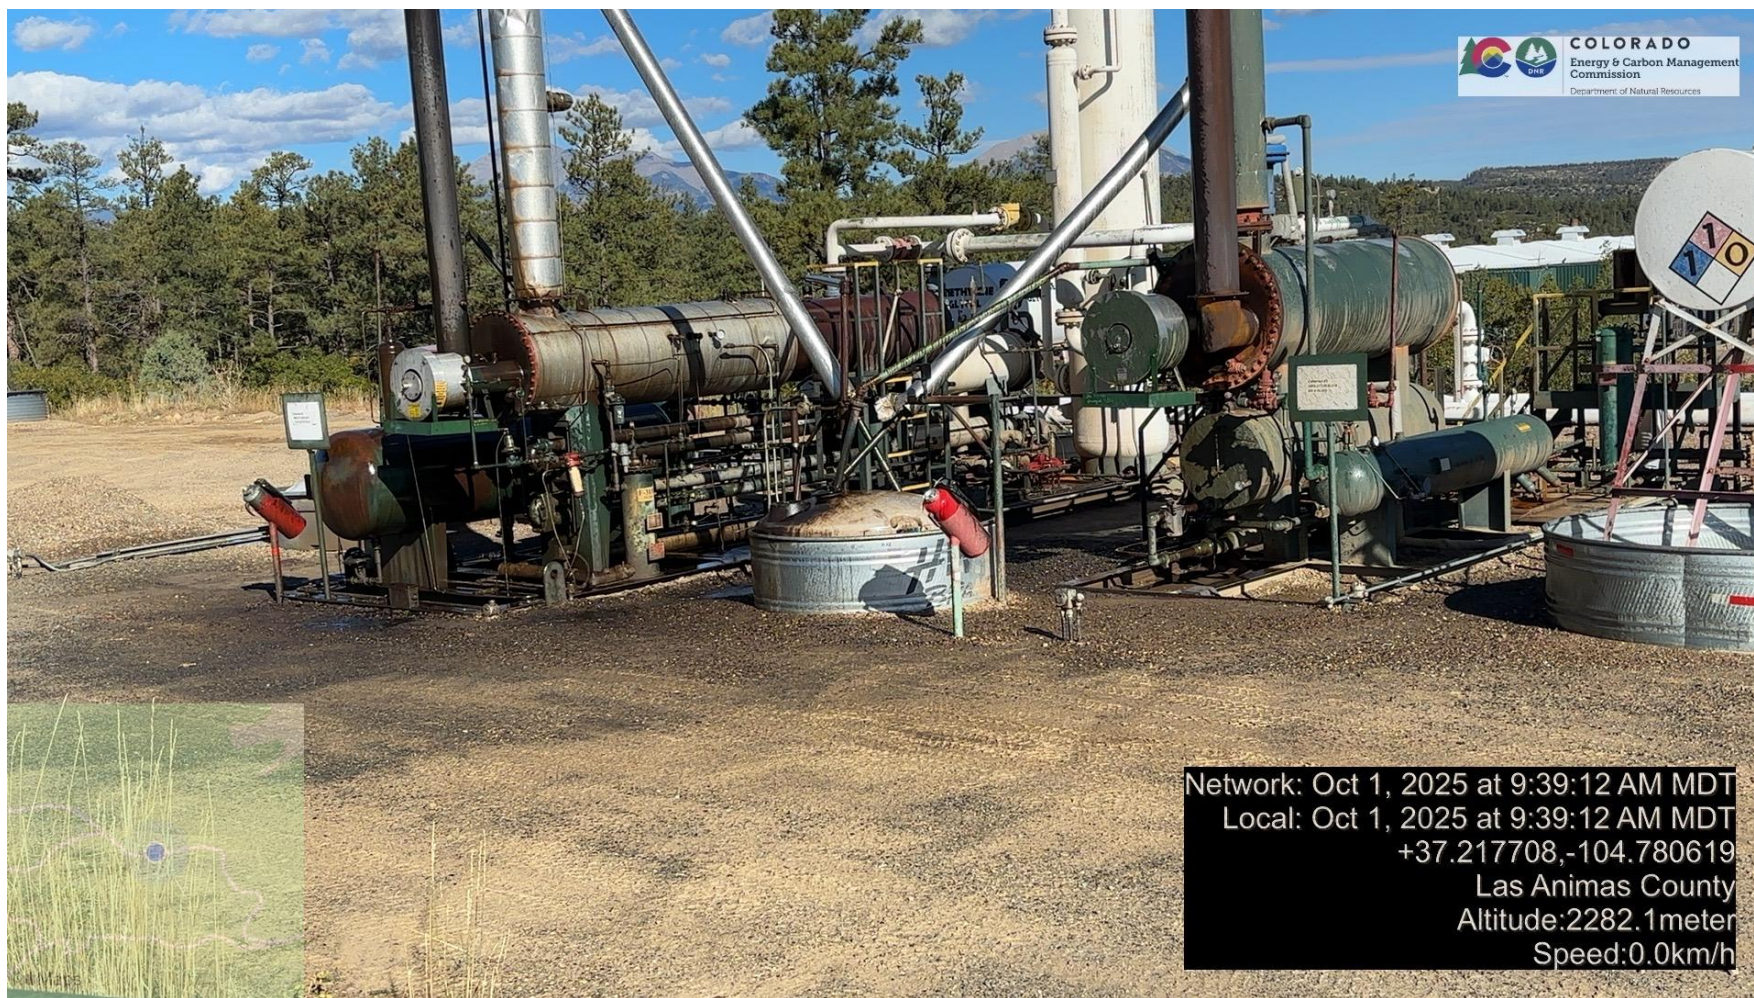
**PHOTO 4: IMAGE SHOWING THE SPILL AREA. THE BULK OF THE SPILL FLUID IS APP. 35' AROUND THE EQUIPMENT WITH SOME SPRAY REACHING OUT TO THE EAST AND SOUTH APP. 50'.**

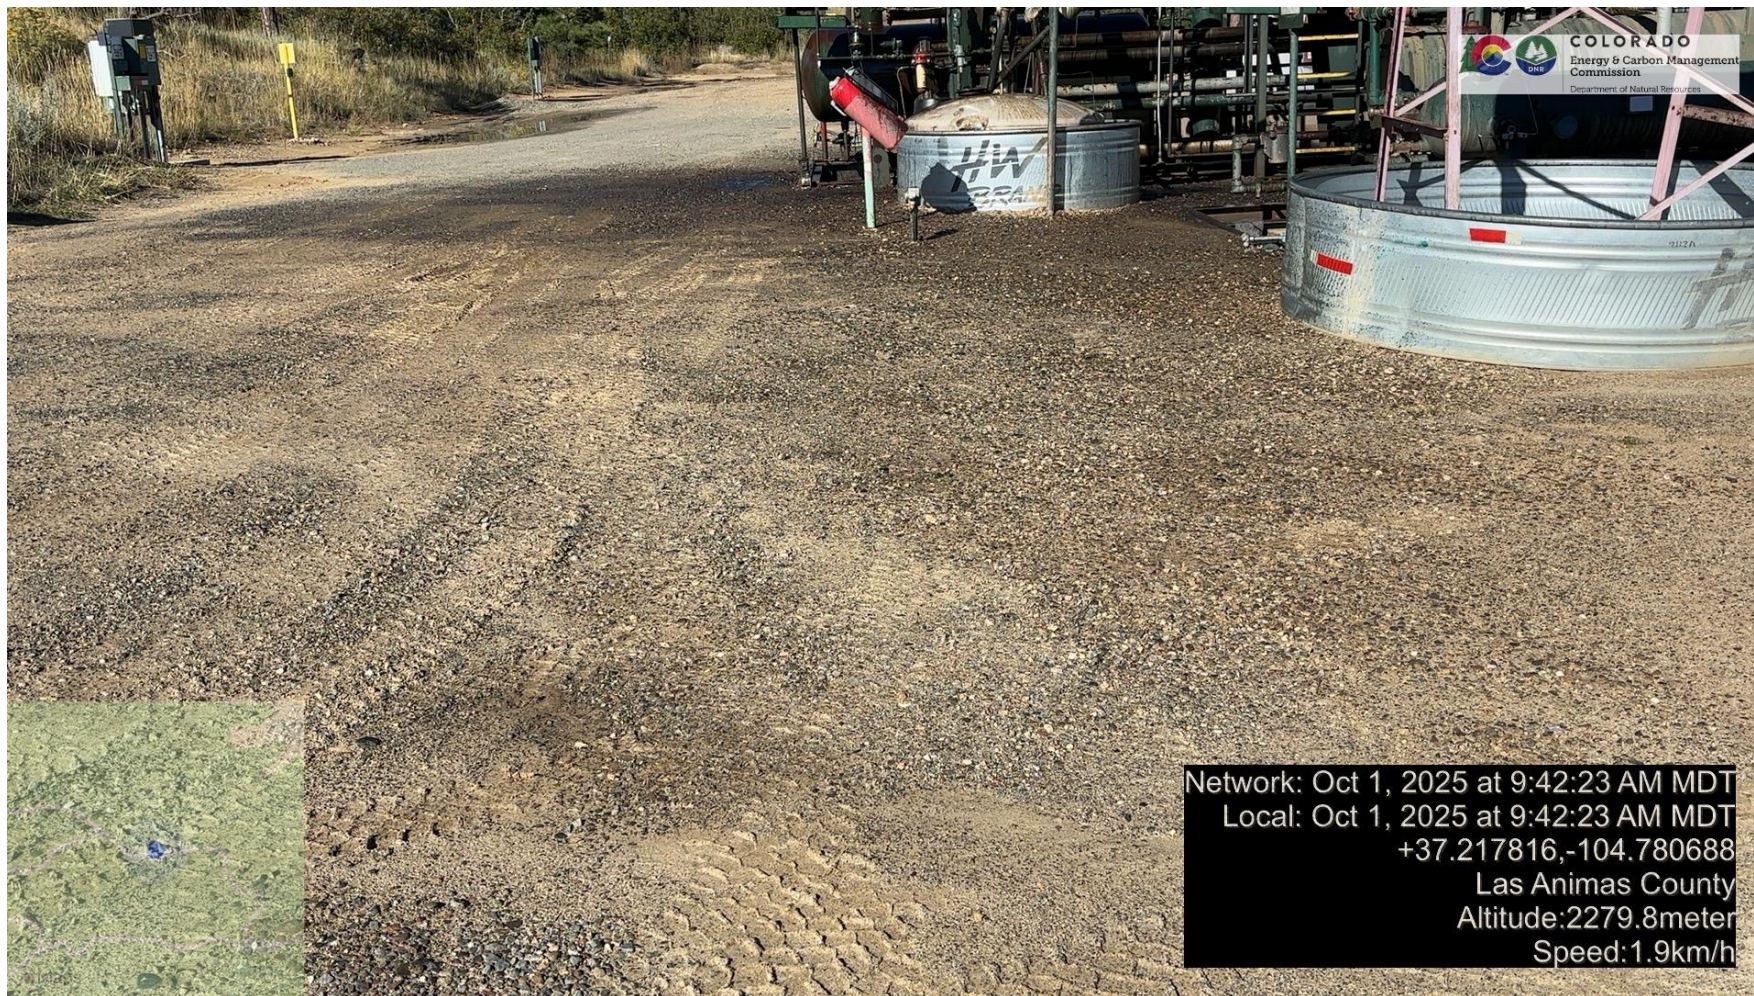
**PHOTO 5: ANOTHER IMAGE SHOWING THE SPILL AREA. THE BULK OF THE SPILL FLUID IS APP. 35' AROUND THE EQUIPMENT WITH SOME SPRAY REACHING OUT TO THE EAST AND SOUTH APP. 50'.**

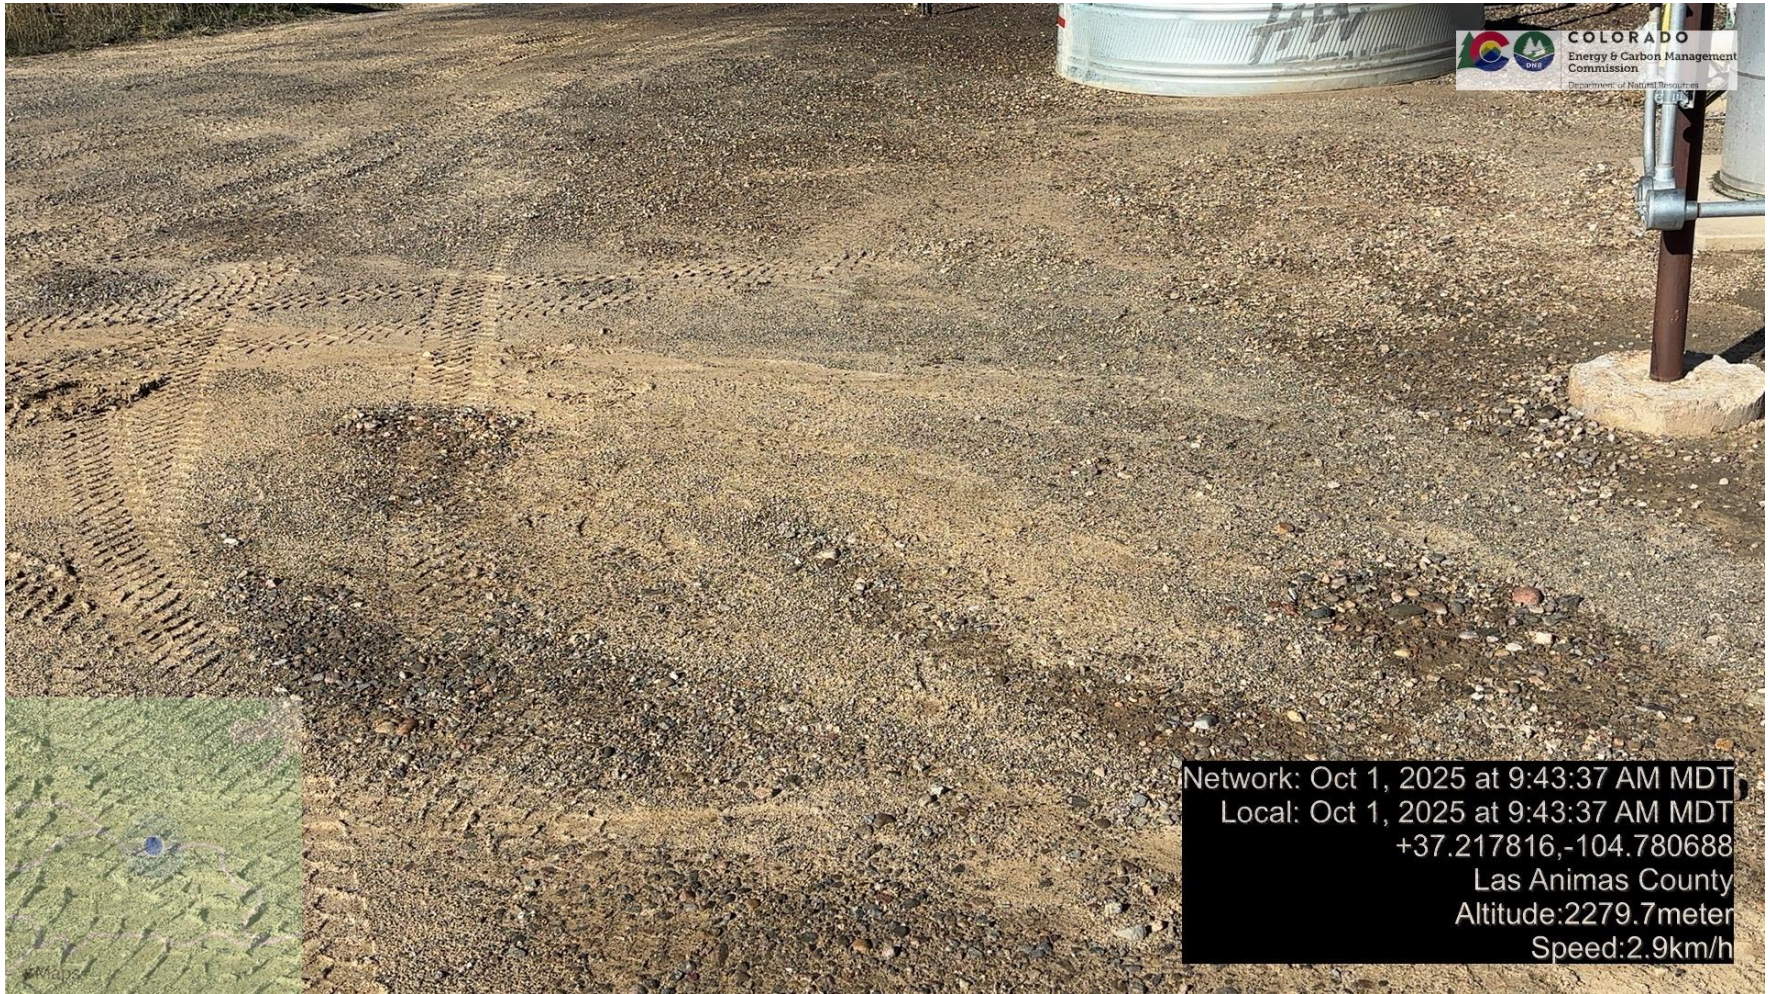
**PHOTO 6: ANOTHER IMAGE SHOWING THE SPILL AREA. THE BULK OF THE SPILL FLUID IS APP. 35' AROUND THE EQUIPMENT WITH SOME SPRAY REACHING OUT TO THE EAST AND SOUTH APP. 50'.**

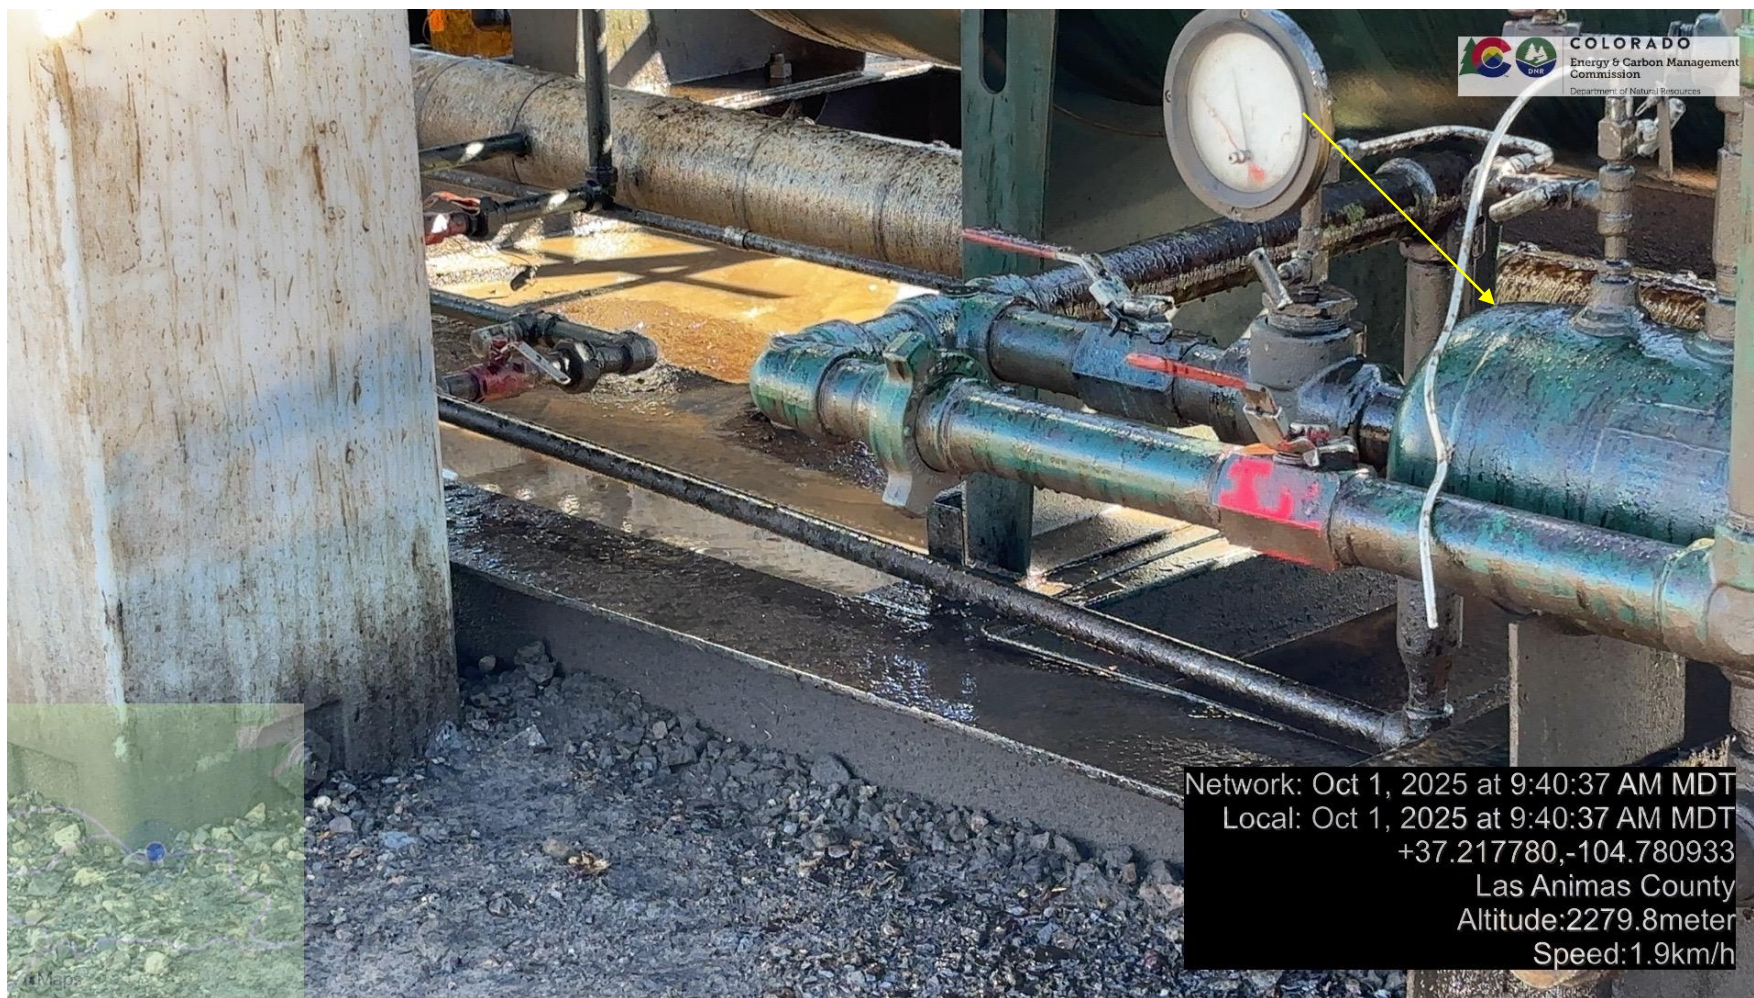
**PHOTO 7: CLOSER IMAGE OF THE EQUIPMENT WITH THE MECHANICAL FAILURE. OPERATOR INFORMED ECMC STAFF THAT THE FILTER MARKED BY THE ARROW PLUGGED AND CAUSED THE FAILURE.**
